**TMAK381GFMJ034668**

## Zustandsbericht

Besichtigungsdatum: 09.06.2026  
**Protokollnummer: 45840868**  
Erstellt durch: Paula Kube  
Besichtigt durch: Paula Kube

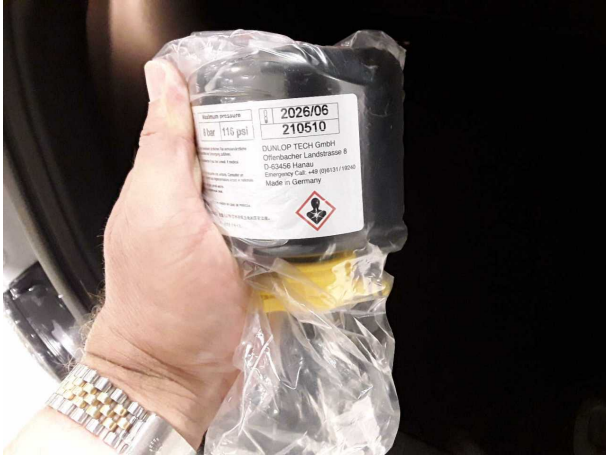
| Nr. | Bauteilgruppe | Beschreibung |
|---|---|--|
| 1 | Ausrüstung | Tirefit Füllmittel - abgelaufen - erneuern |

**Beschädigung #1:** Ausrüstung: Tirefit Füllmittel - abgelaufen - erneuern

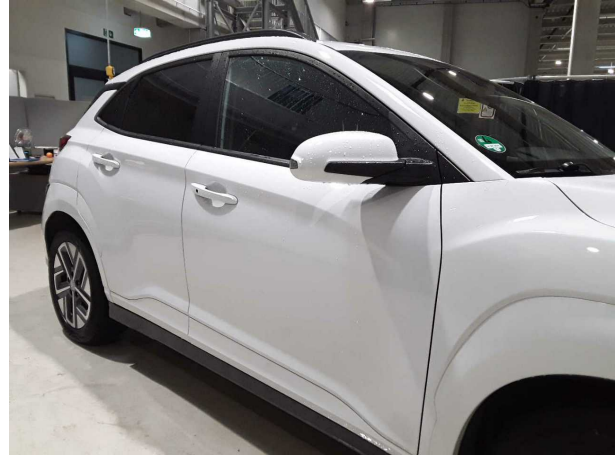
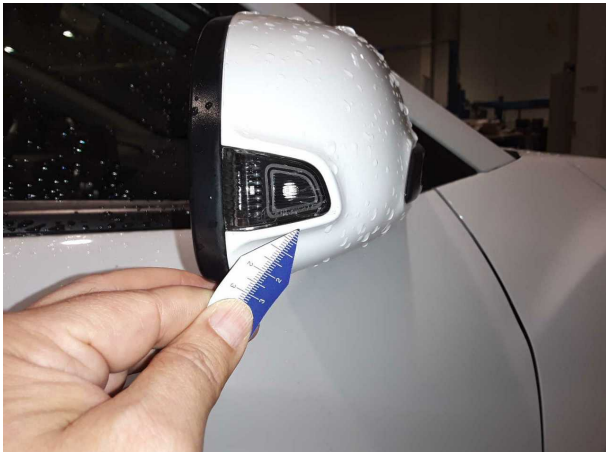
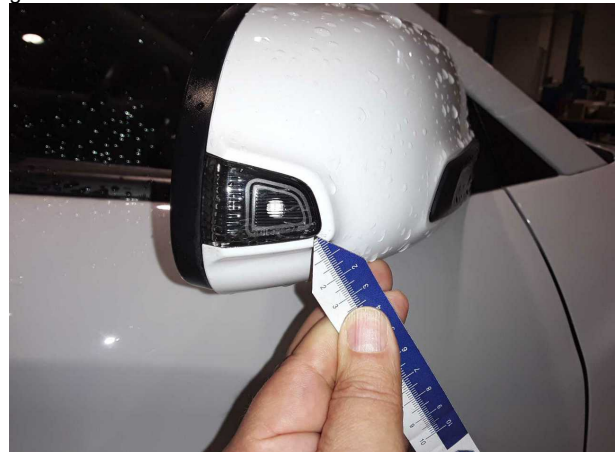
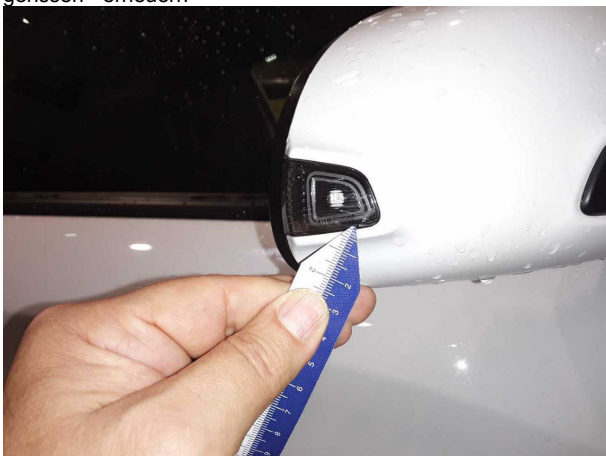
| Nr. | Bauteilgruppe | Beschreibung |
|---|---|--|
| 2 | Blinkleuchte | Spiegel rechts - gebrochen / gerissen - erneuern |

**Beschädigung #2:** Blinkleuchte: Spiegel rechts - gebrochen / gerissen - erneuern

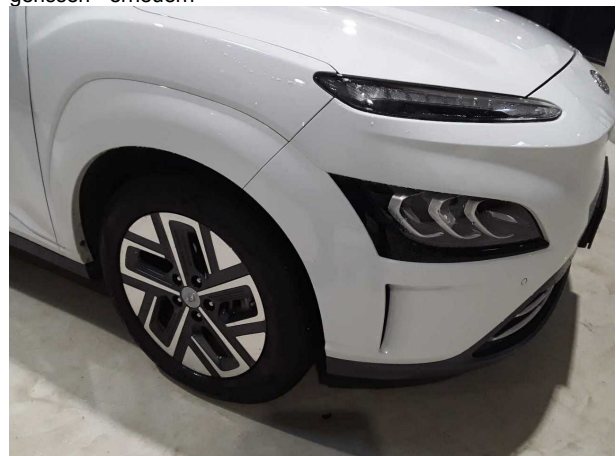
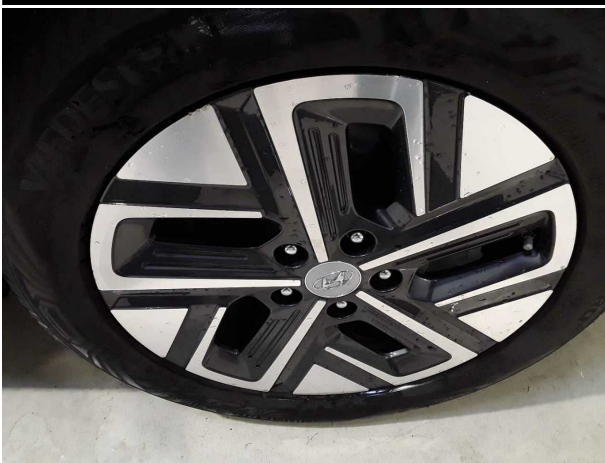
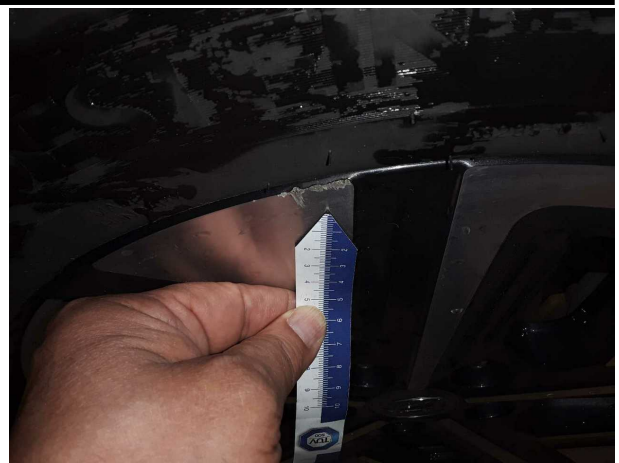
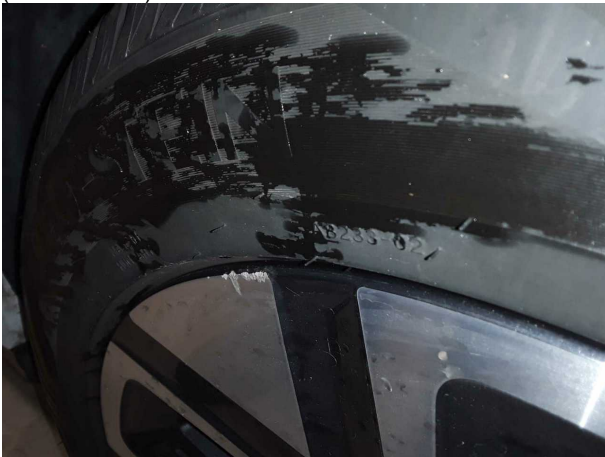
| Nr. | Bauteilgruppe | Beschreibung |
|---|---|--|
| 3 | Rad/Reifen | Leichtmetallfelge vorn rechts (Materialabrieb) - verkratzt / verschürft - erneuern |

**Beschädigung #3:** Rad/Reifen: Leichtmetallfelge vorn rechts (Materialabrieb) - verkratzt / verschürft - erneuern

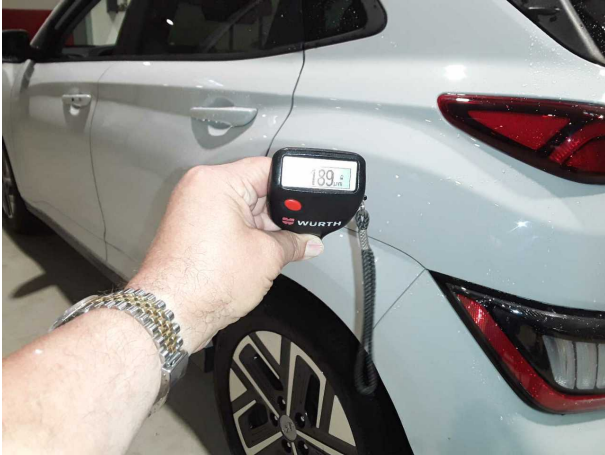
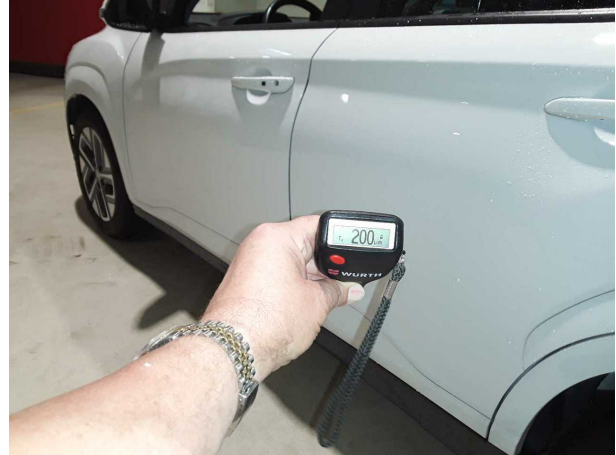
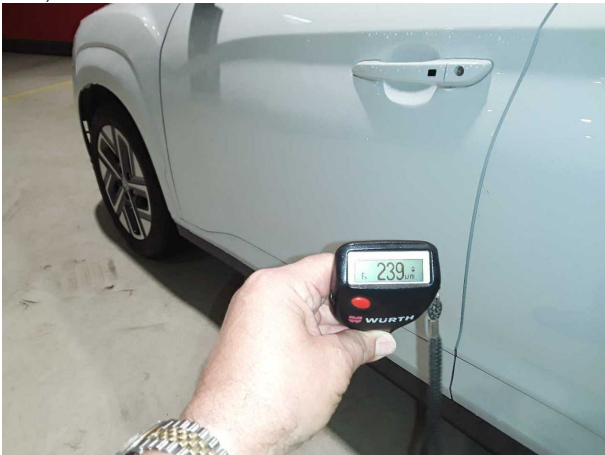
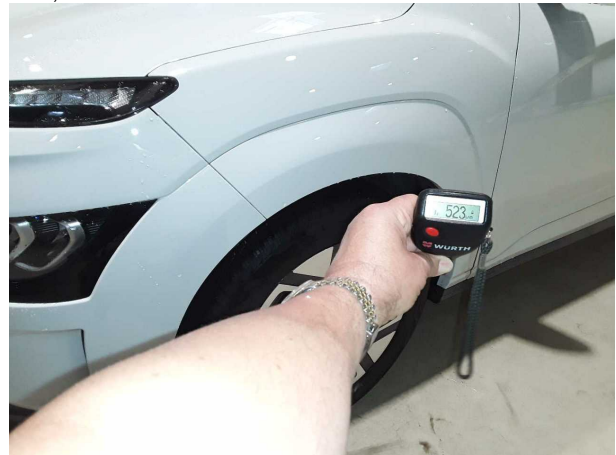
| Nr. | Ort |
|---|---|
| 1 | Kotflügel links, Seitenwand links, Tür hinten links, Tür vorne links, fachgerecht ausgeführt, Reparaturrechnung nicht vorhanden |

**Nachlackierung 1:** Kotflügel links, Seitenwand links, Tür hinten links, Tür vorne links
