Expertise

Protocol number: 45839013
Order No. / Reference: 25907409
Inspection date: 9 Jun 2026

Model: V90 T6 Recharge AWD Plus Dark

VIN: YV1PWH1V6R1218435

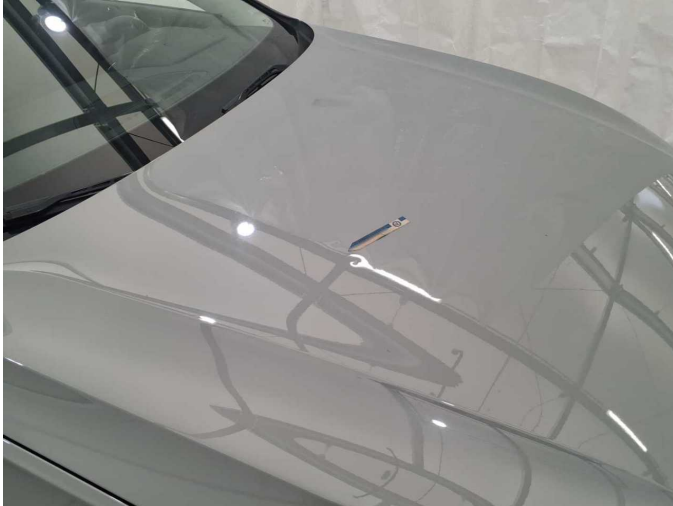
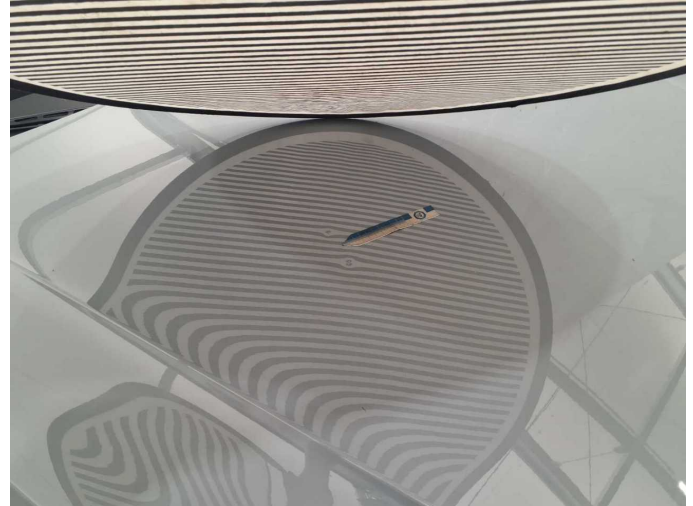
Damage 1: Bonnet: Bonnet - dent(s) - Smooth repair work

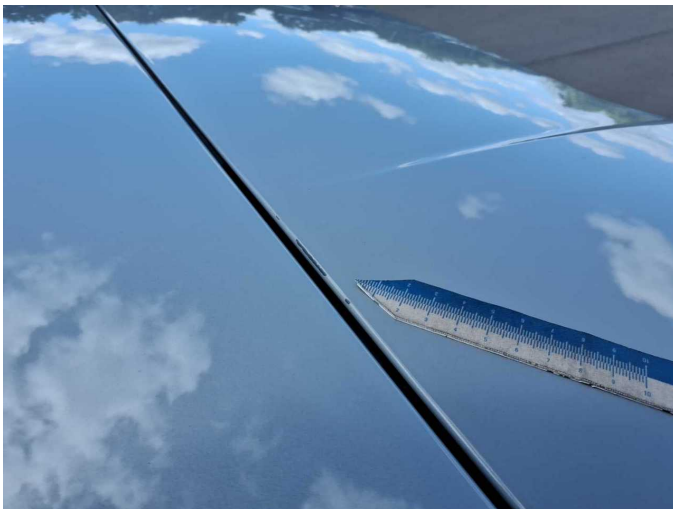
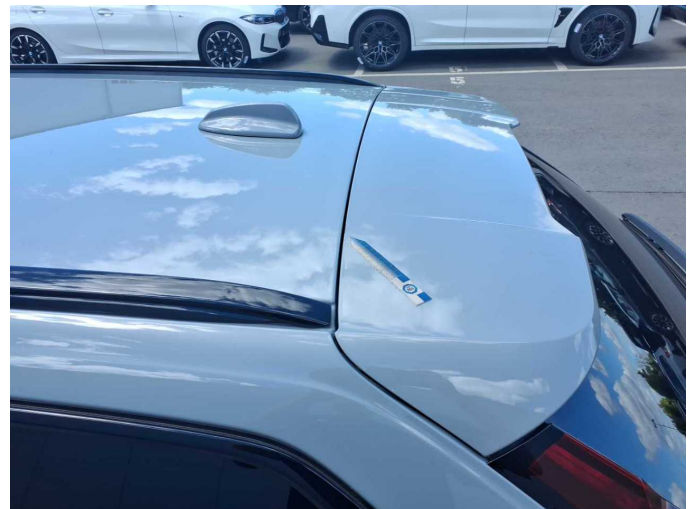
Damage 2: Boot lid / rear door: Rear spoiler - Scratch(es) - Smart repair

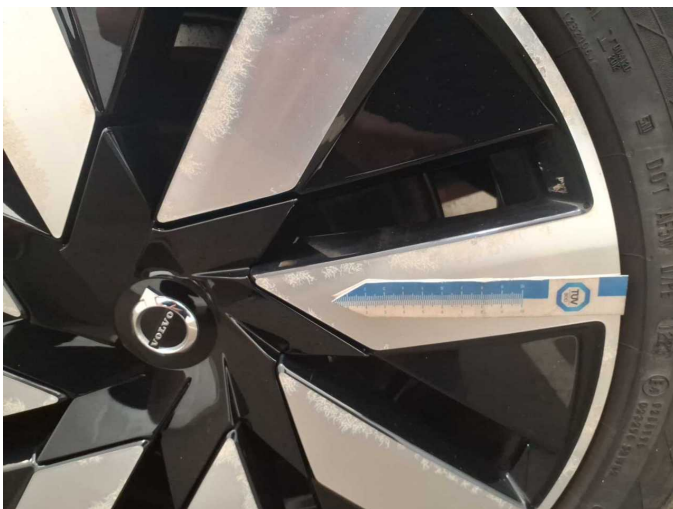
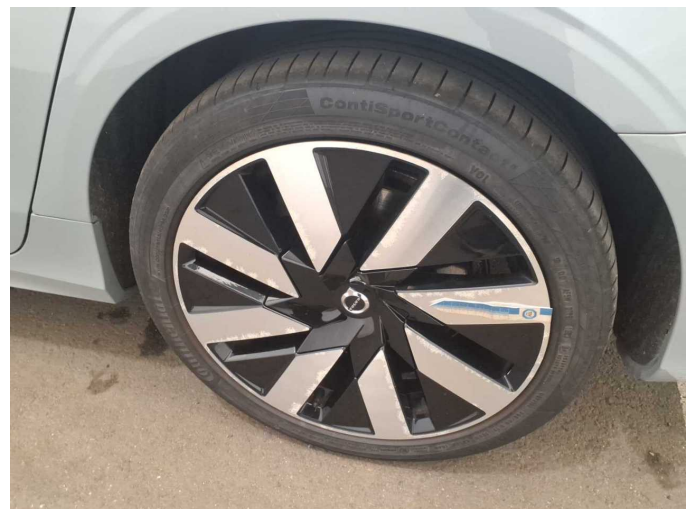
Damage 3: Wheel / tyres: Alloy rim - rear left side (Material Veränderung an glanzgedrehten stellen) - Differs from the original configuration - Replace

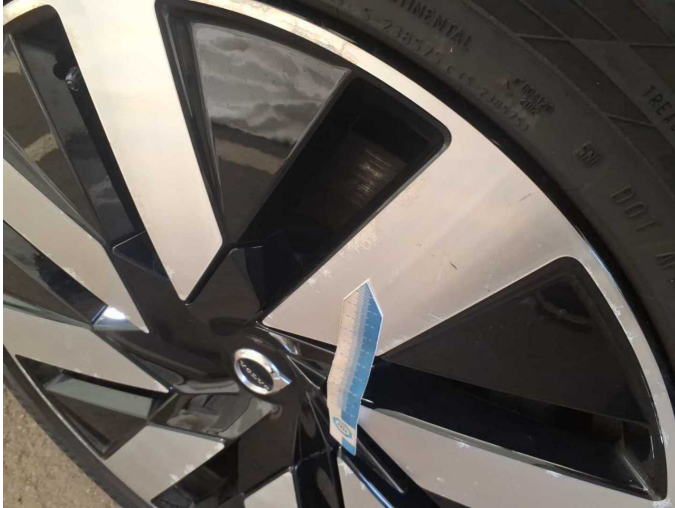
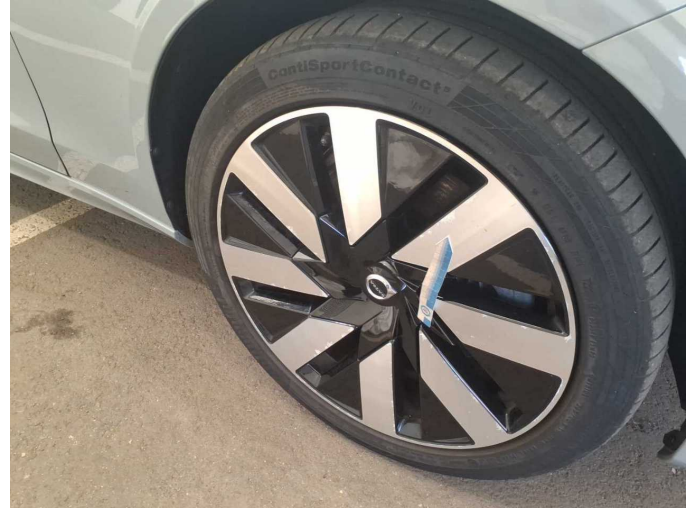
Damage 4: Wheel / tyres: Alloy rim - front right side (Material Veränderung an glanzgedrehten stellen) - Corrosion - Loss in value

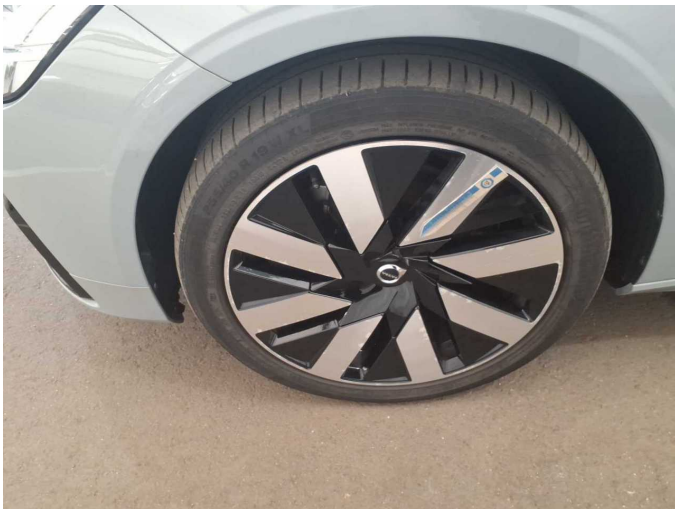
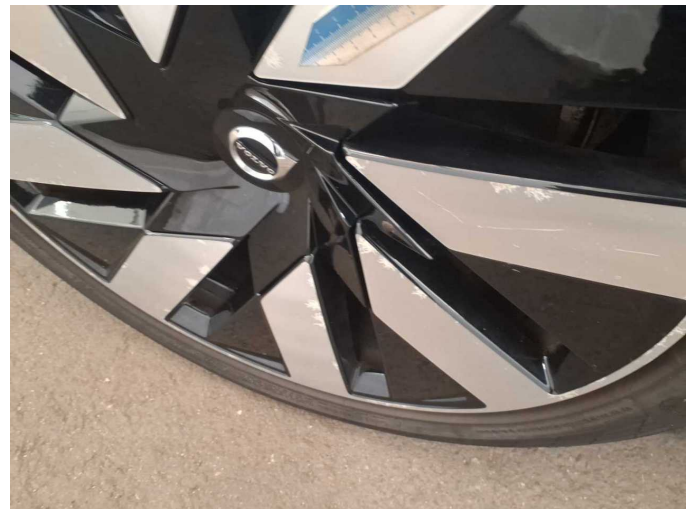
Damage 5: Wheel / tyres: Alloy rim - front left side (Material Veränderung an glanzgedrehten stellen) - Corrosion - Loss in value

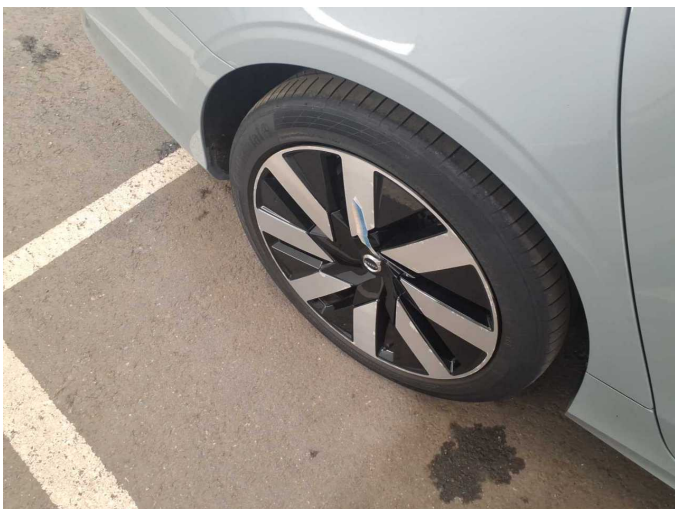
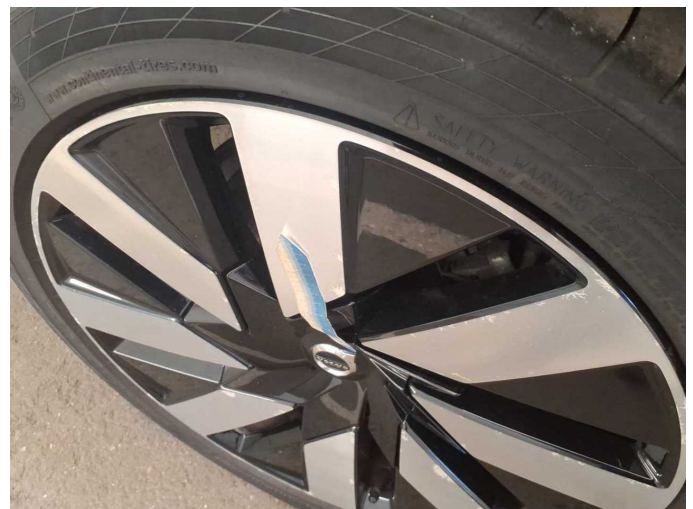
Damage 6: Wheel / tyres: Alloy rim - rear right side (Material Veränderung an glanzgedrehten stellen) - Corrosion - Loss in value

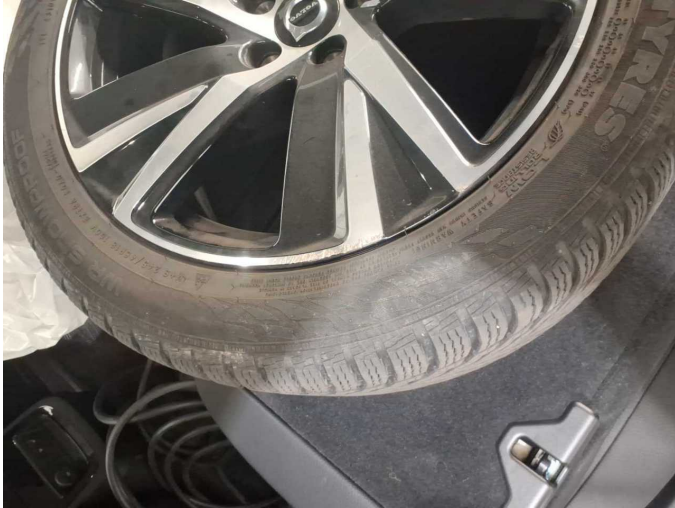
Wear and tear 5: 2nd wheel set: 1 alloy rim (Nicht Bestandteil der Ausstattung) - Scratch(es) - No deduction
