## Expertise

Protocol number: 44534314  
Order number / reference: 26152069  
Inspection date: 20 Mar 2026

Model: Vito 116 Kasten CDI Extralang HA PRO

VIN: W1VVLCEZ0T4545160

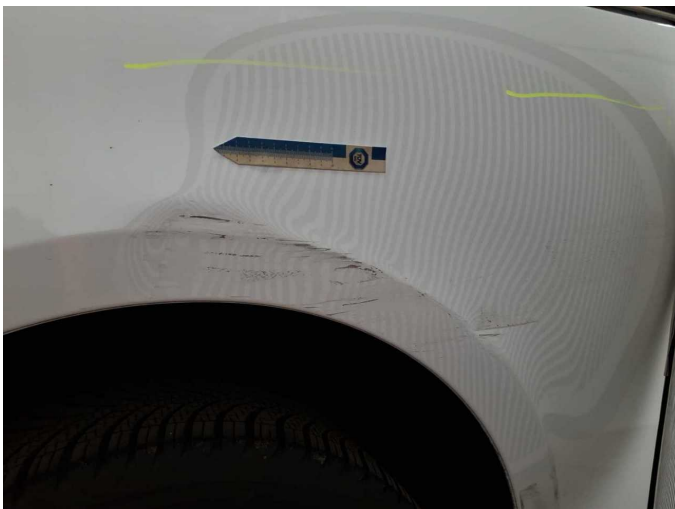
No.	Component group	Description
1	Side panel - rear right side	Side panel (Unterhalb) - Dent / paintcoat damage - Repair and paint

**Damage 1:** Side panel - rear right side: Side panel (Unterhalb) - Dent / paintcoat damage - Repair and paint

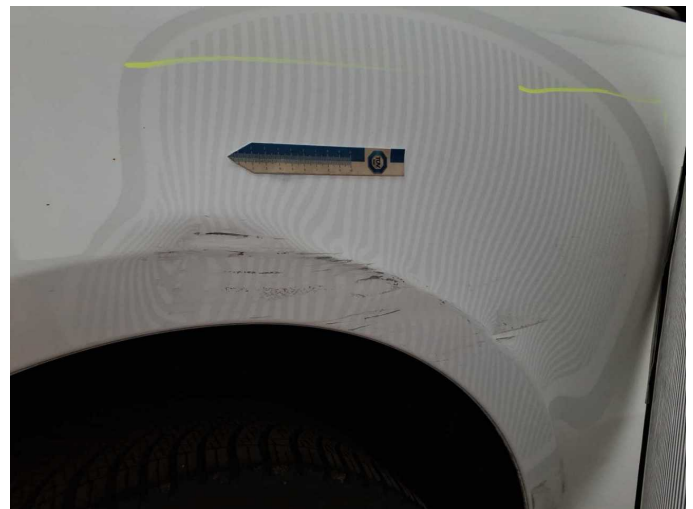
**Damage 1:** Side panel - rear right side: Side panel (Unterhalb) - Dent / paintcoat damage - Repair and paint

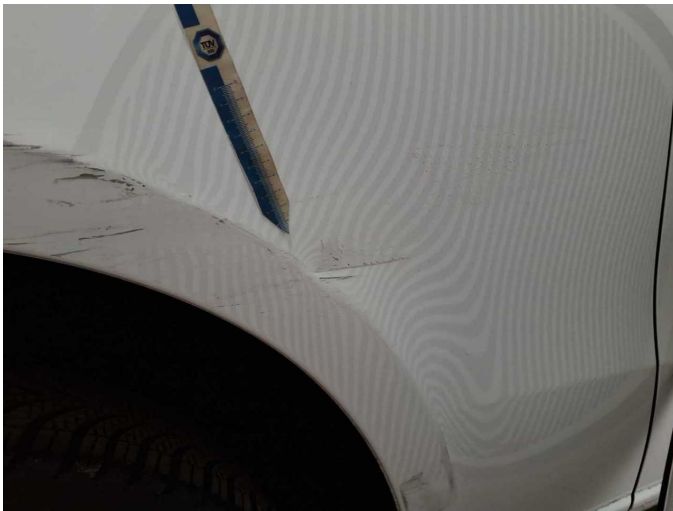
**Damage 1:** Side panel - rear right side: Side panel (Unterhalb) - Dent / paintcoat damage - Repair and paint

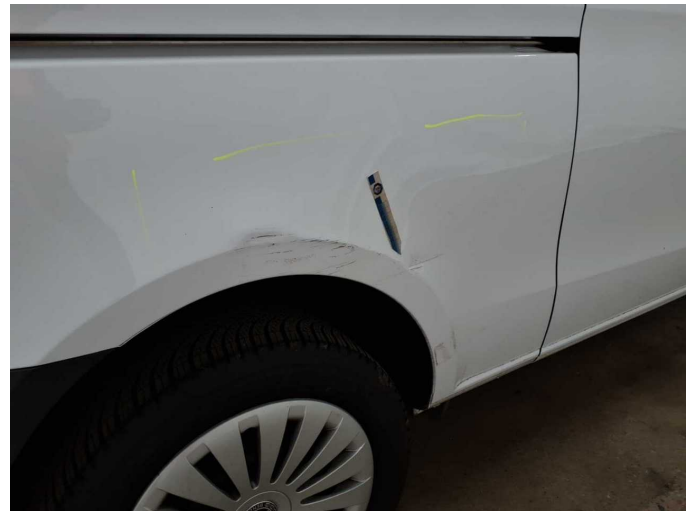
**Damage 1:** Side panel - rear right side: Side panel (Unterhalb) - Dent / paintcoat damage - Repair and paint

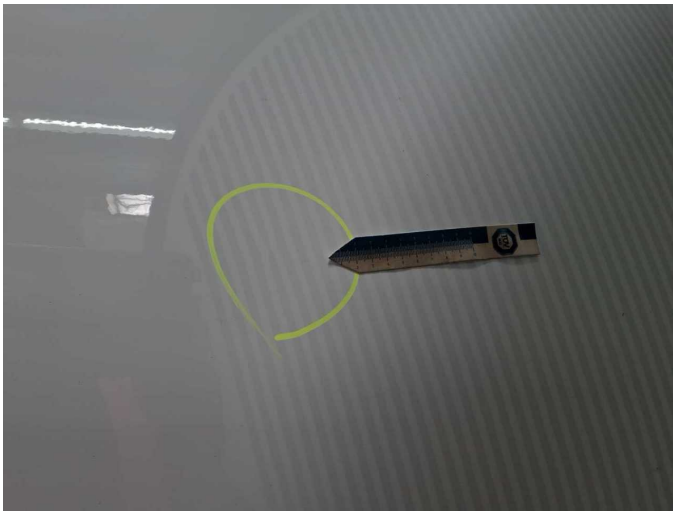
**Wear and tear 4:** Boot lid / rear door: Rear door - right side - dent(s) - No deduction

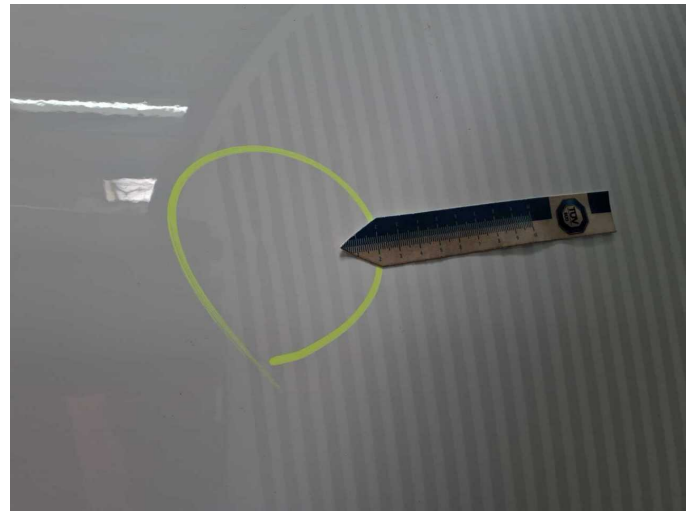
**Wear and tear 4:** Boot lid / rear door: Rear door - right side - dent(s) - No deduction

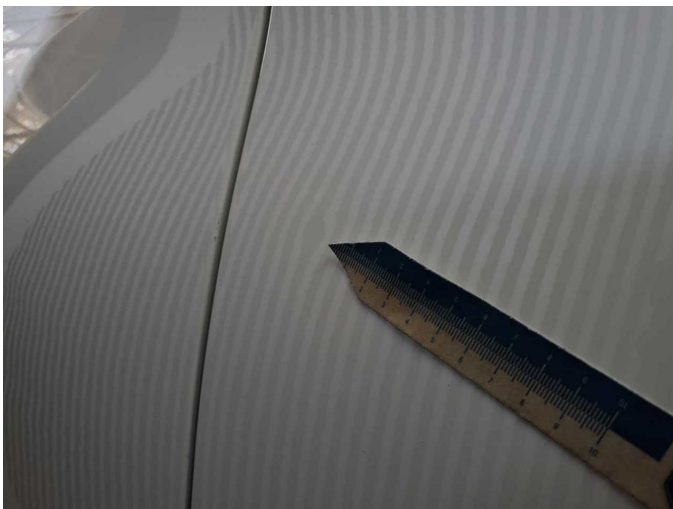
**Wear and tear 5:** Door - front right side: Door - dent(s) - No deduction

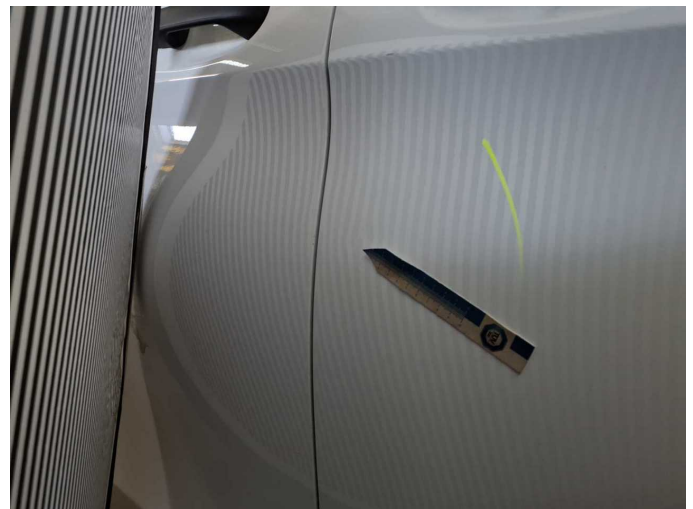
**Wear and tear 5:** Door - front right side: Door - dent(s) - No deduction

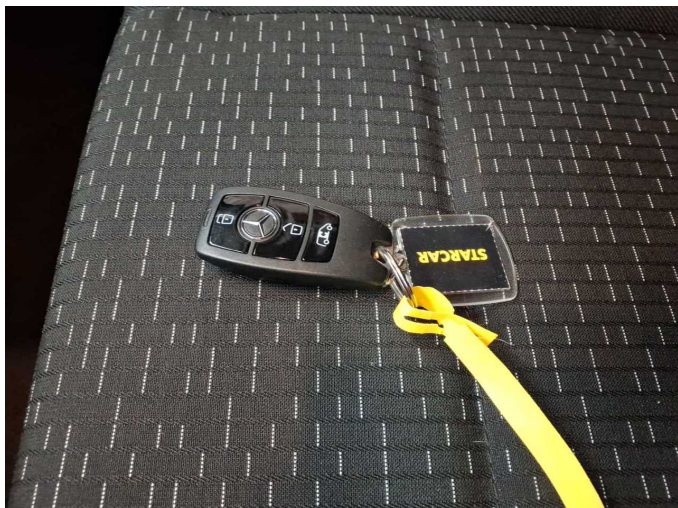
**Missing part 1:** Equipment: Vehicle key - Missing - Replace
