Expertise

Protocol number: 45508679
Order No. / Reference: 26276464
Inspection date: 16 May 2026

Manufacturer: Opel

Model: Movano 2.2 BlueHDi 140 L3H2 VA

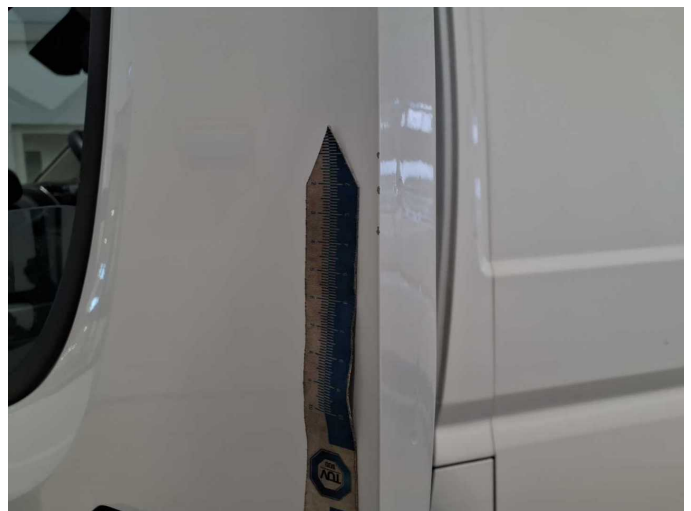
Damage 1: Door - front left side: Door - Scratch(es) - Smart repair

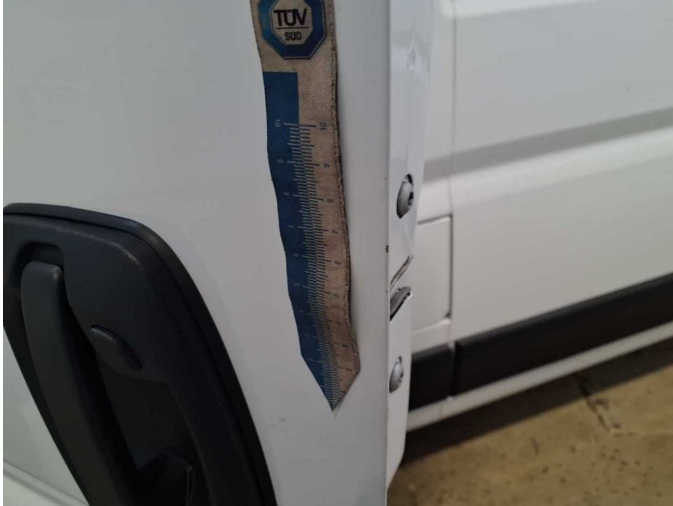
Damage 1: Door - front left side: Door - Scratch(es) - Smart repair

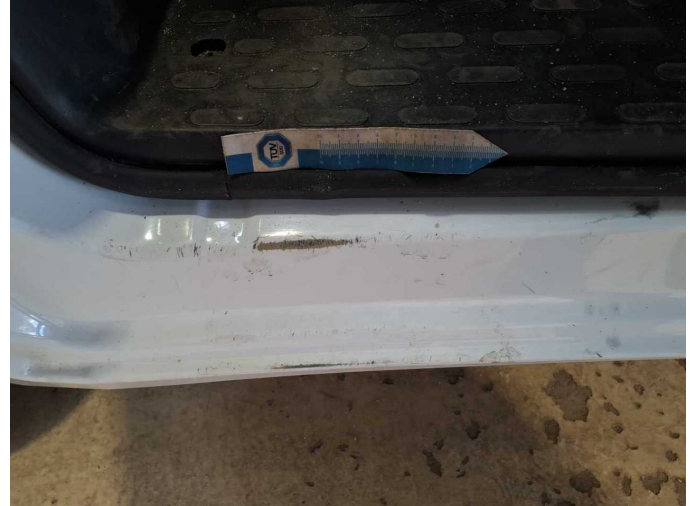
Damage 2: Sill - left side: Sill - Scratch(es) - Smart repair

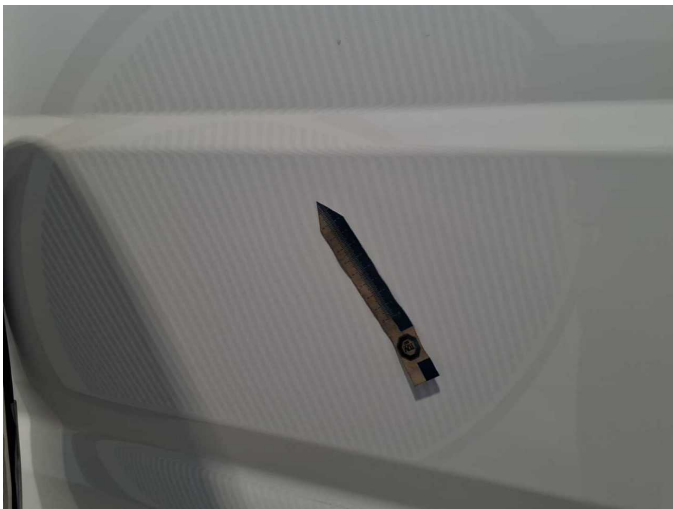
Damage 3: Side panel - rear left side: Side panel - Dent / paintcoat damage - Smart repair

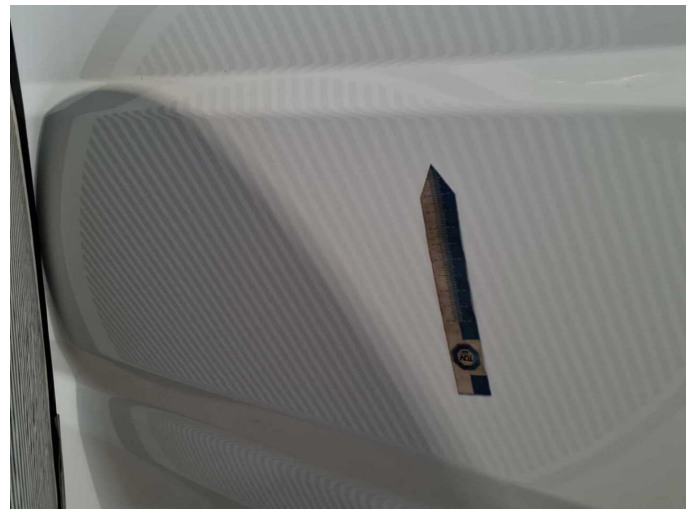
Damage 3: Side panel - rear left side: Side panel - Dent / paintcoat damage - Smart repair

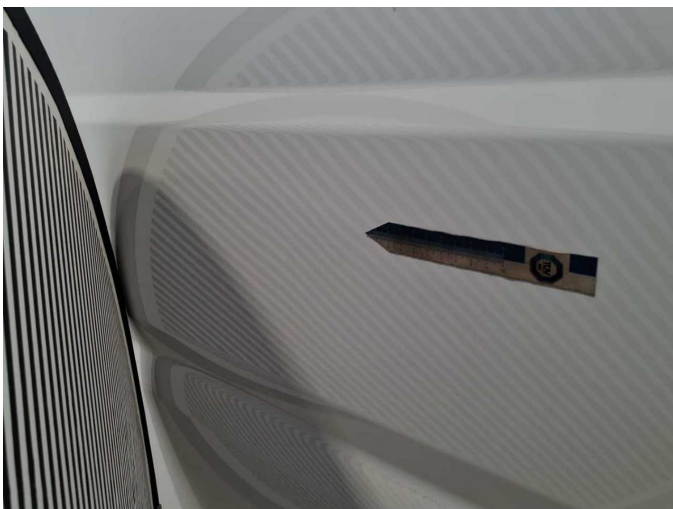
Damage 3: Side panel - rear left side: Side panel - Dent / paintcoat damage - Smart repair

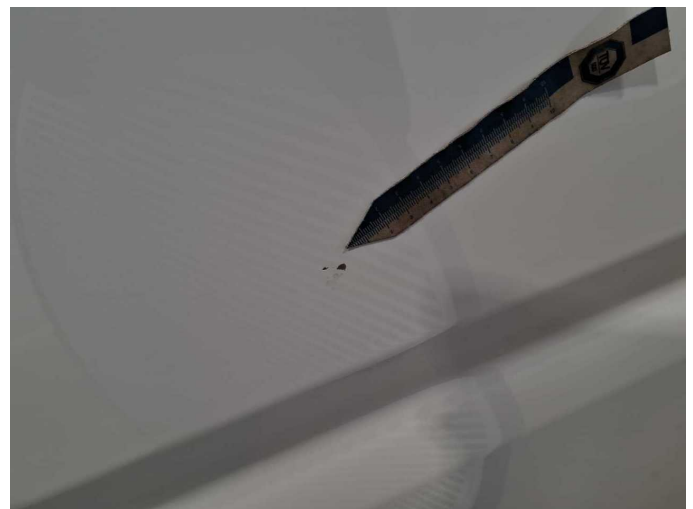
Damage 3: Side panel - rear left side: Side panel - Dent / paintcoat damage - Smart repair
