Expertise

Protocol number: 46345286
Order No. / Reference: 26184104
Inspection date: 30 Jun 2026

Manufacturer: Mercedes-Benz

Model: Vito 116 CDI Lang HA Aut. PRO

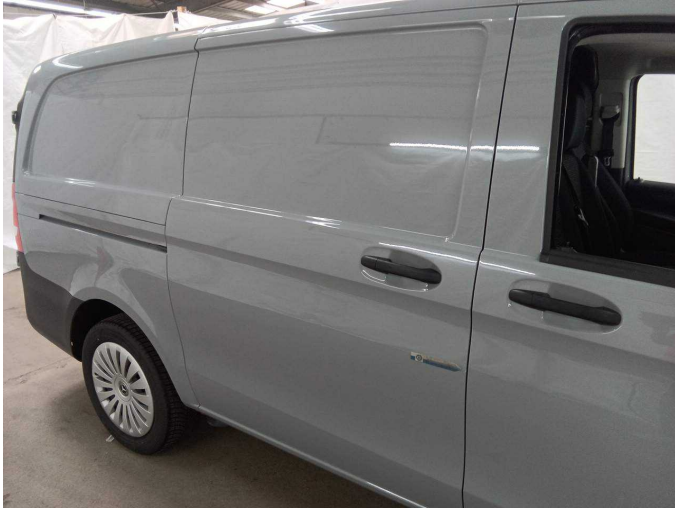
Damage 1: Sliding door, right: Sliding door - Scratch(es) - Smart repair

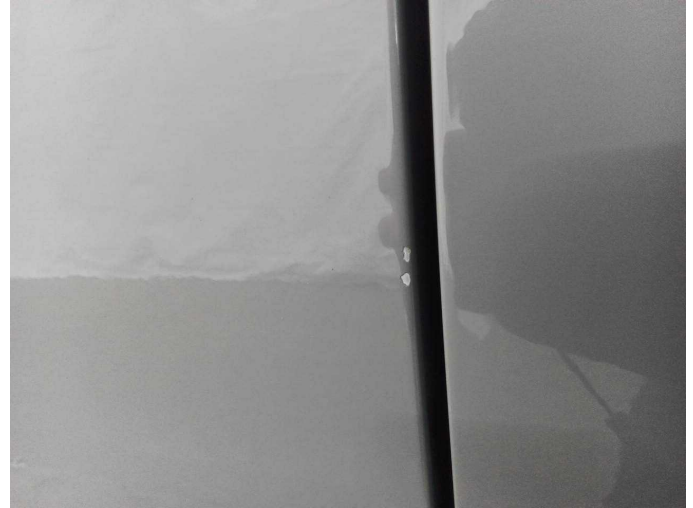
Damage 1: Sliding door, right: Sliding door - Scratch(es) - Smart repair

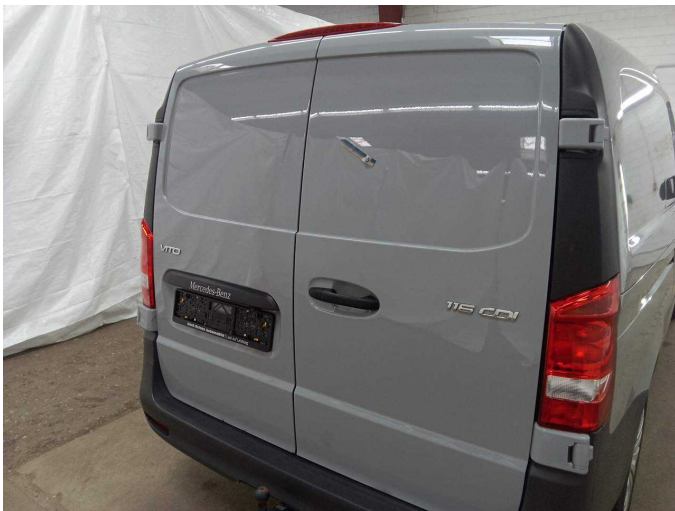
Damage 2: Boot lid / rear door: Rear door - right side (2) - dent(s) - Smooth repair work

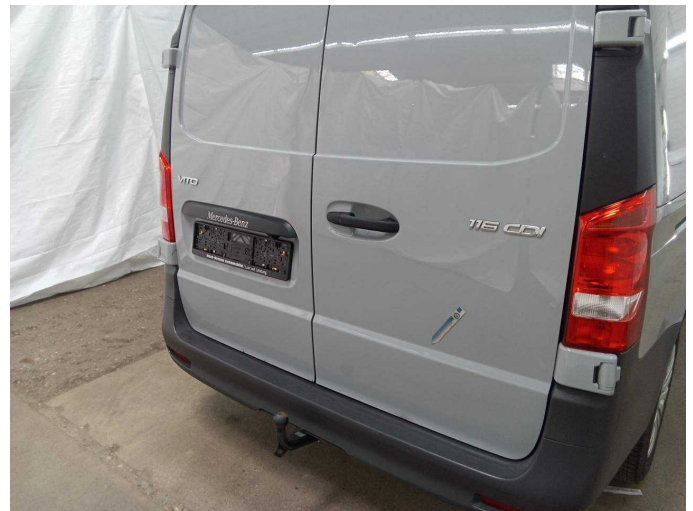
Damage 2: Boot lid / rear door: Rear door - right side (2) - dent(s) - Smooth repair work

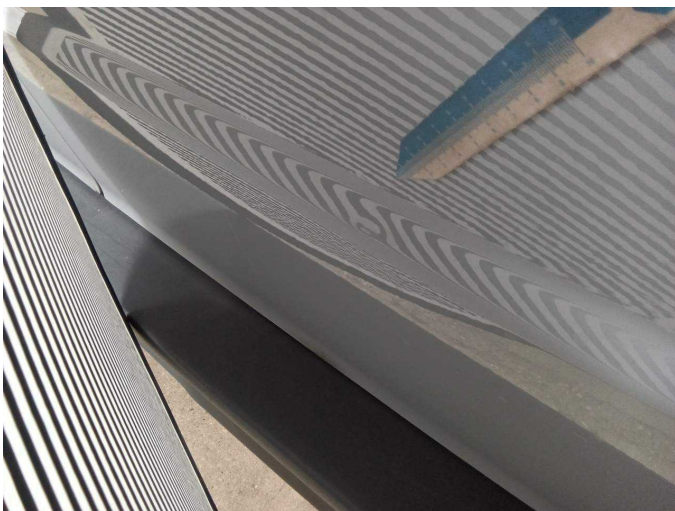
Damage 2: Boot lid / rear door: Rear door - right side (2) - dent(s) - Smooth repair work

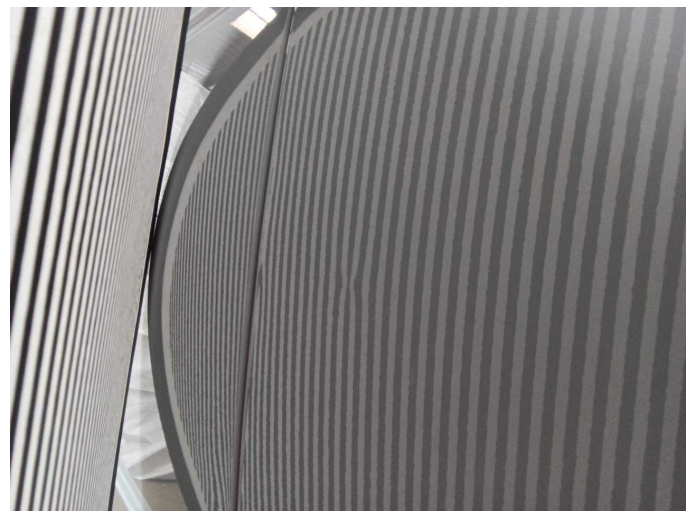
Damage 2: Boot lid / rear door: Rear door - right side (2) - dent(s) - Smooth repair work

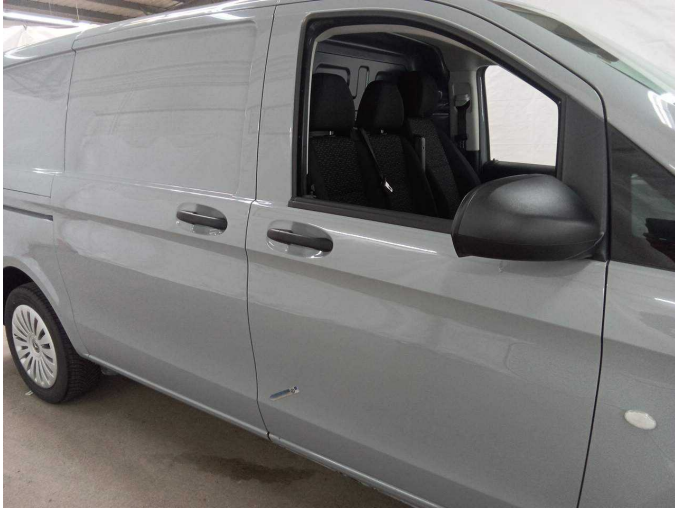
Damage 3: Door - front right side: Door - Scratch(es) - Smart repair

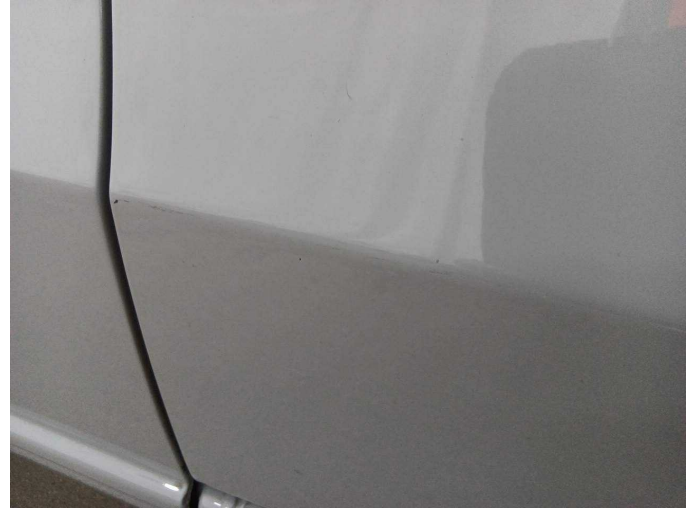
Damage 3: Door - front right side: Door - Scratch(es) - Smart repair

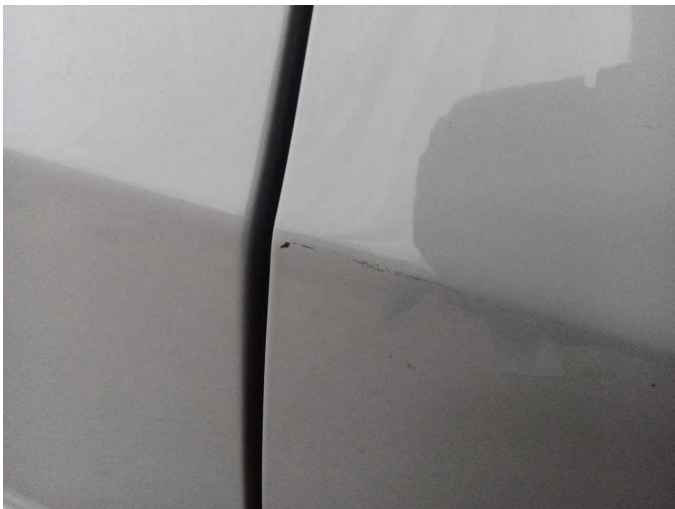
Damage 3: Door - front right side: Door - Scratch(es) - Smart repair

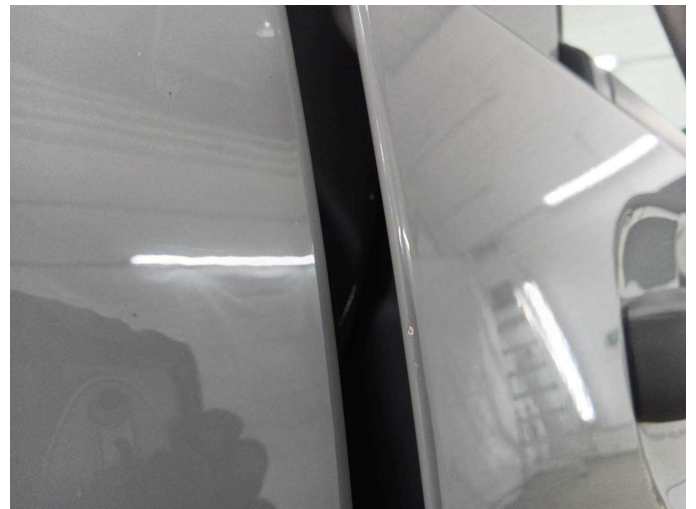
Damage 3: Door - front right side: Door - Scratch(es) - Smart repair

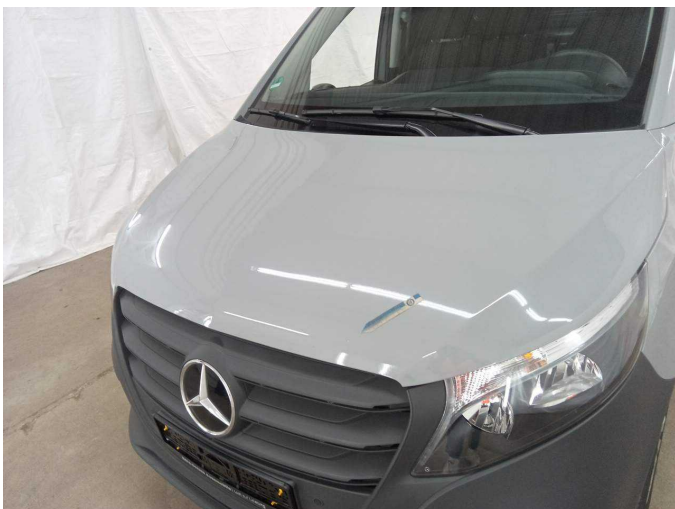
Damage 4: Bonnet: Bonnet - Stone chips - Paint

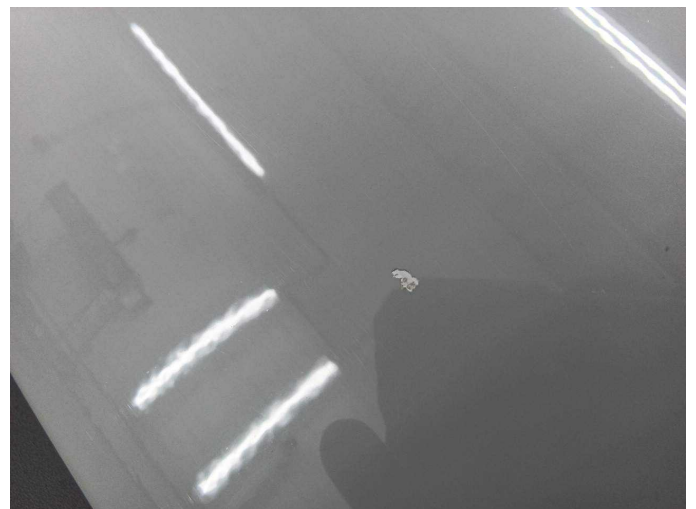
Damage 4: Bonnet: Bonnet - Stone chips - Paint

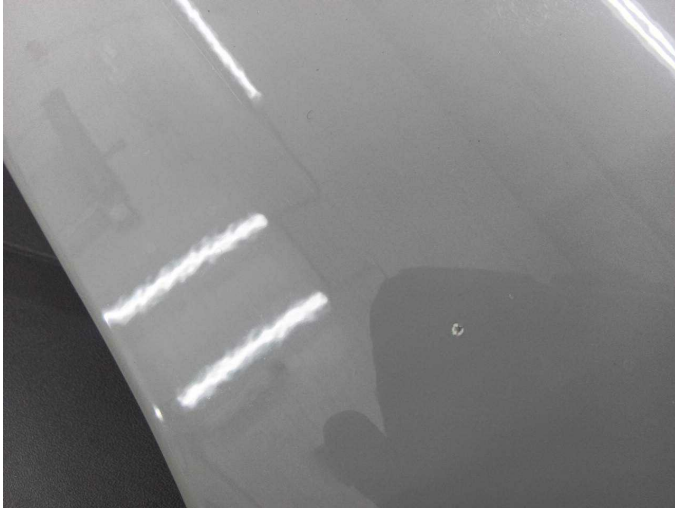
Damage 4: Bonnet: Bonnet - Stone chips - Paint

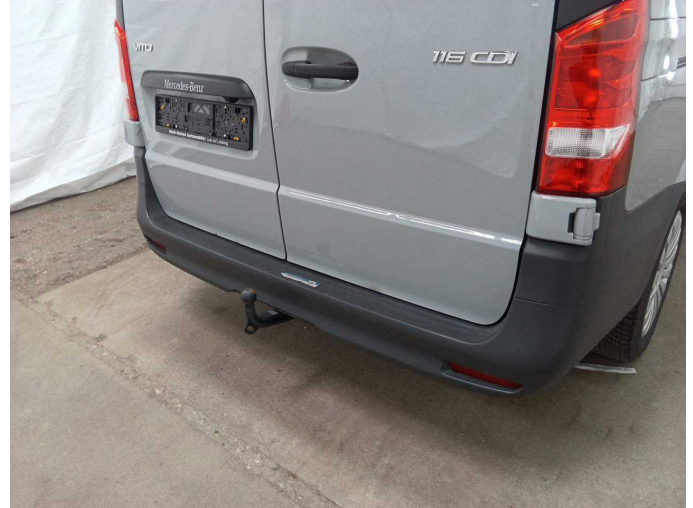
Damage 5: Rear bumper: Rear bumper - Scratch(es) - Replace

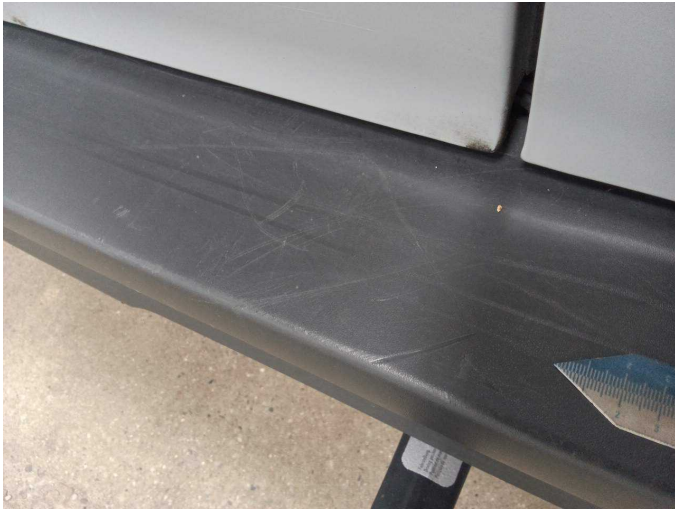
Damage 5: Rear bumper: Rear bumper - Scratch(es) - Replace

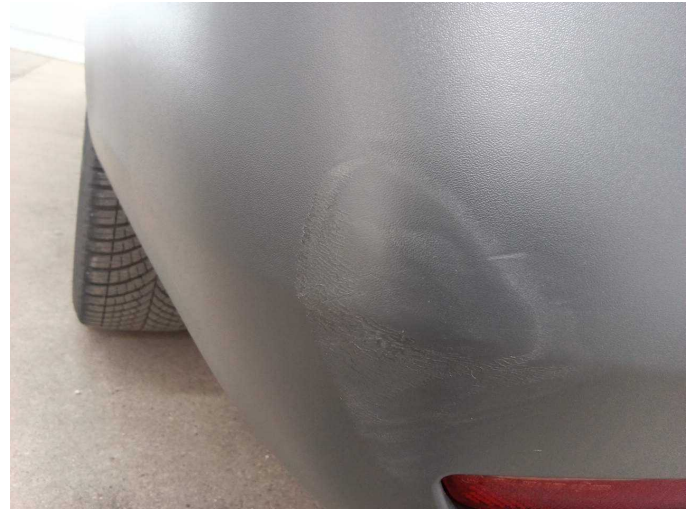
Damage 5: Rear bumper: Rear bumper - Scratch(es) - Replace

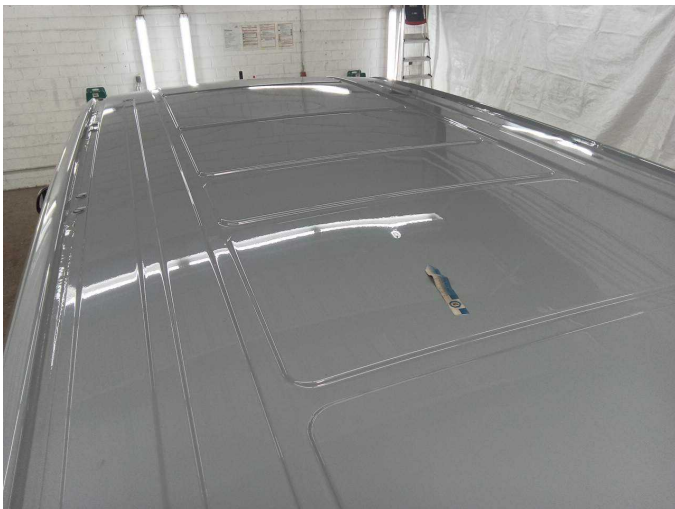
Damage 6: Roof: Roof - Dent / paintcoat damage - Repair and paint

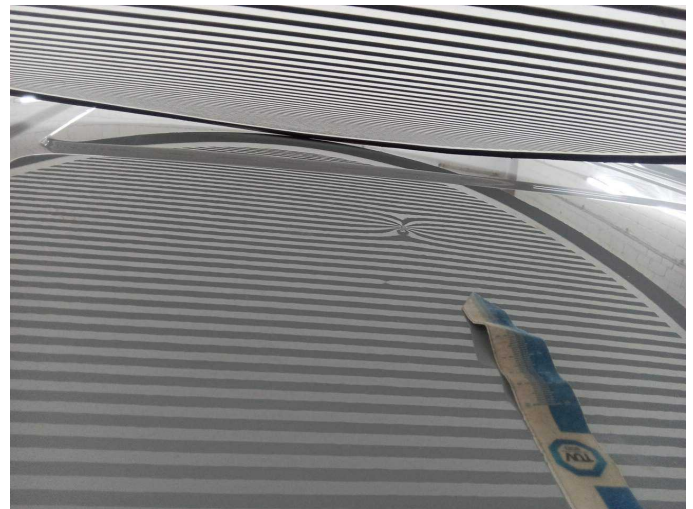
Damage 6: Roof: Roof - Dent / paintcoat damage - Repair and paint

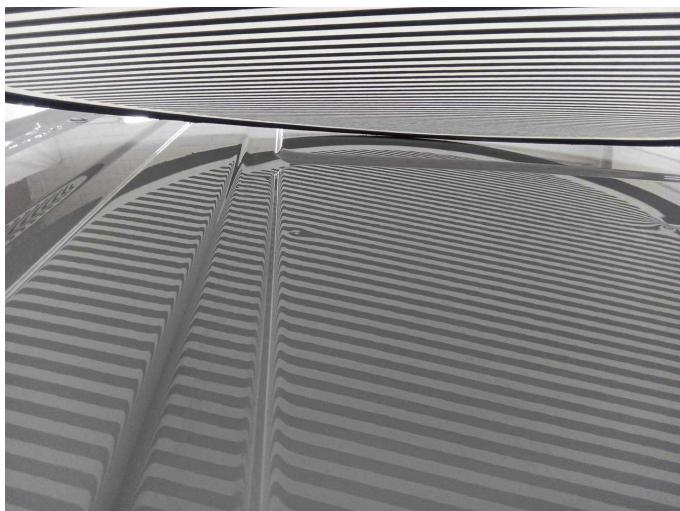
Damage 6: Roof: Roof - Dent / paintcoat damage - Repair and paint

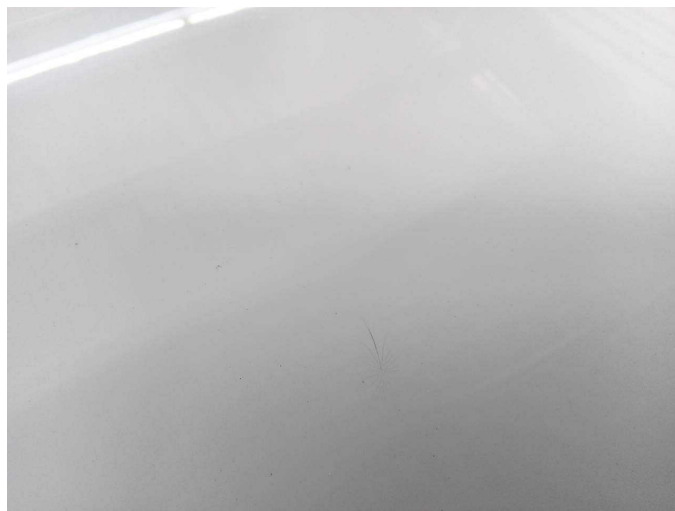
Damage 6: Roof: Roof - Dent / paintcoat damage - Repair and paint
