Expertise

Protocol number: 45577524  
Order No. / Reference: 26264814  
Inspection date: 15 May 2026

Manufacturer: Ford

Model: Focus Turnier 1.5 EcoBlue Start-Stopp-System  
COOL&CONNECT

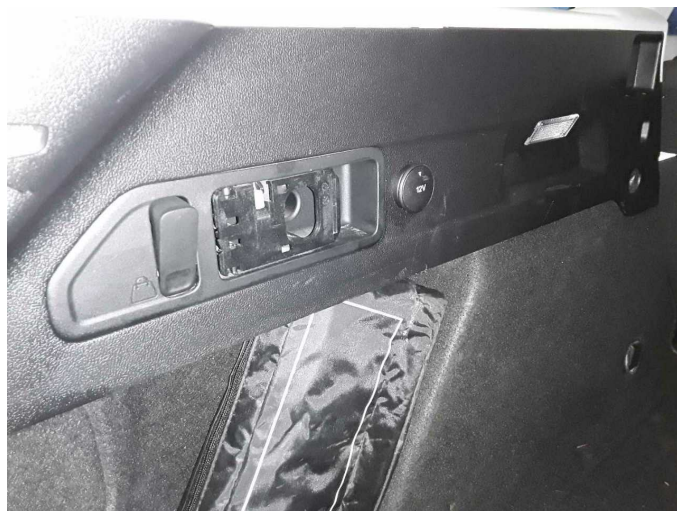
| No. | Component group | Description |
|---|---|---|
| 1 | Seat - front | Lever seat adjustment (Hinten) - Damaged - Replace |

**Damage 1:** Seat - front: Lever seat adjustment (Hinten) - Damaged - Replace

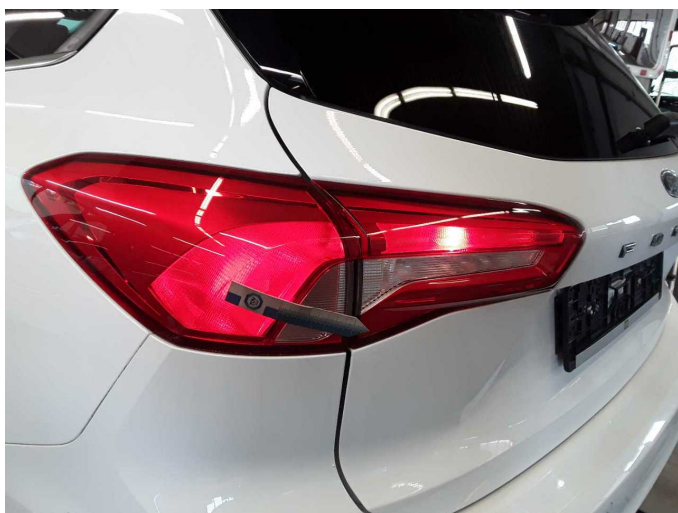
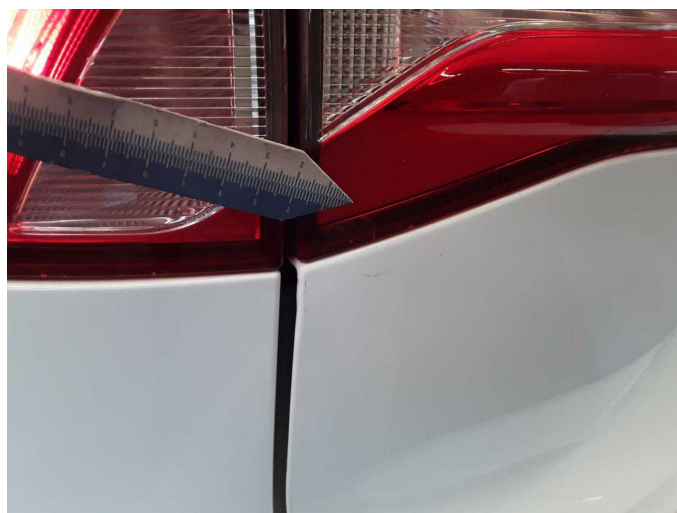
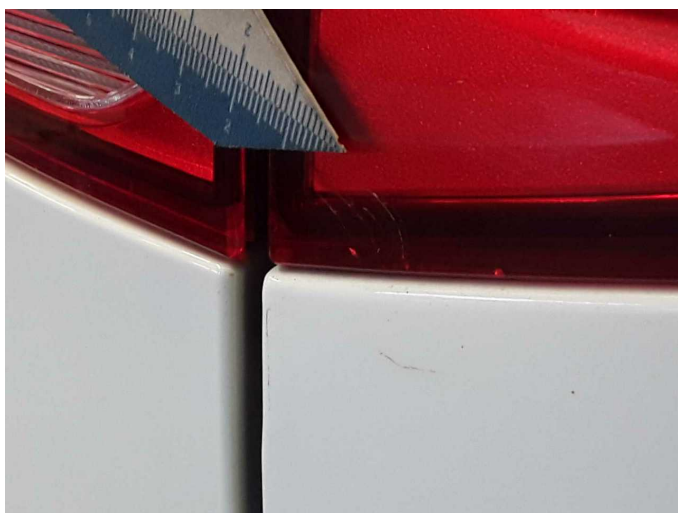
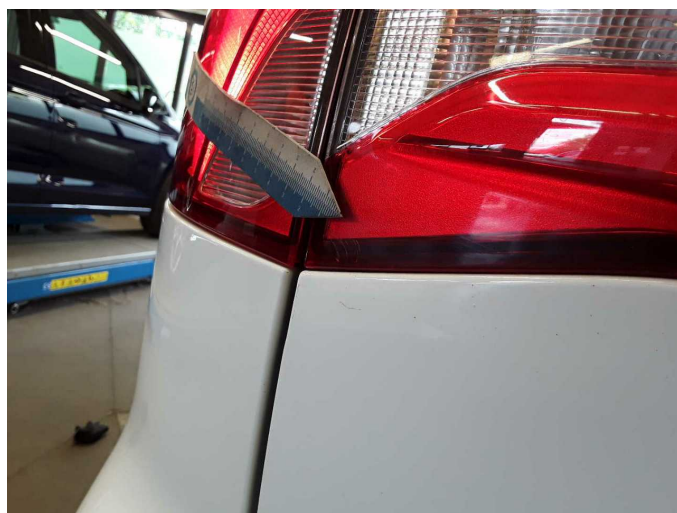
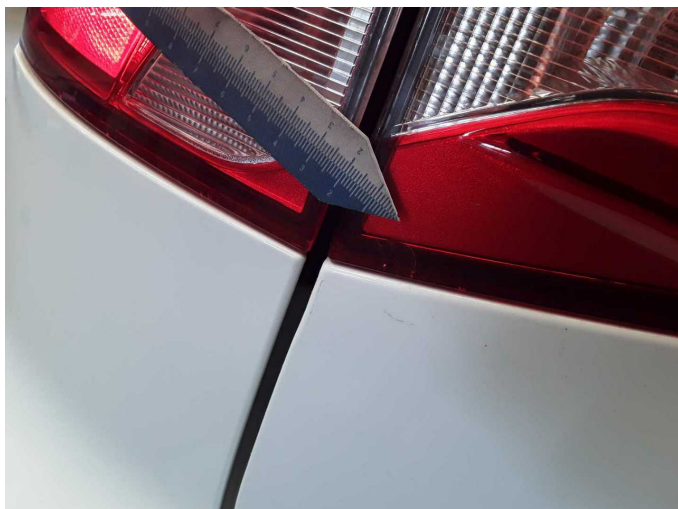
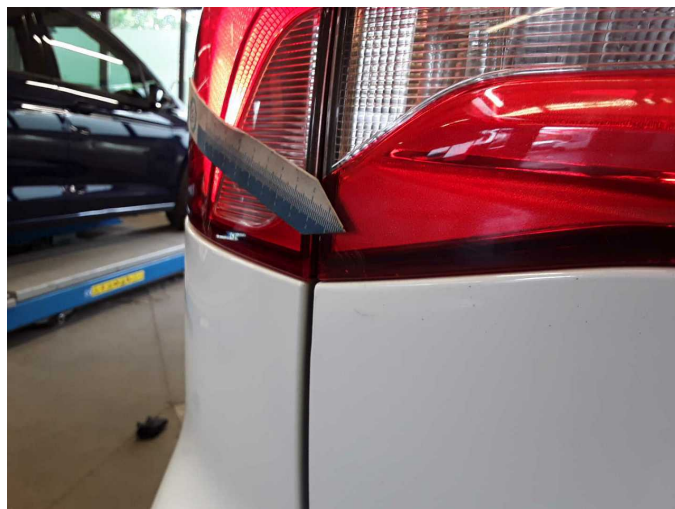
| No. | Component group | Description |
|---|---|---|
| 2 | Tail light | Tail lamp - left side - Scratch(es) - Replace |

**Damage 2:** Tail light: Tail lamp - left side - Scratch(es) - Replace

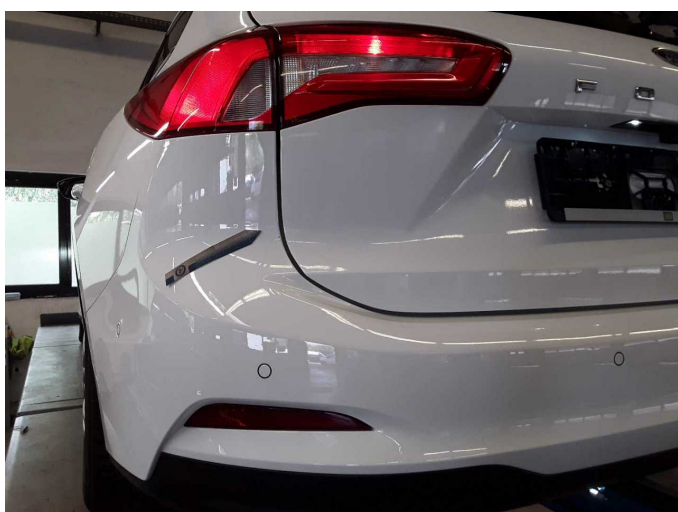
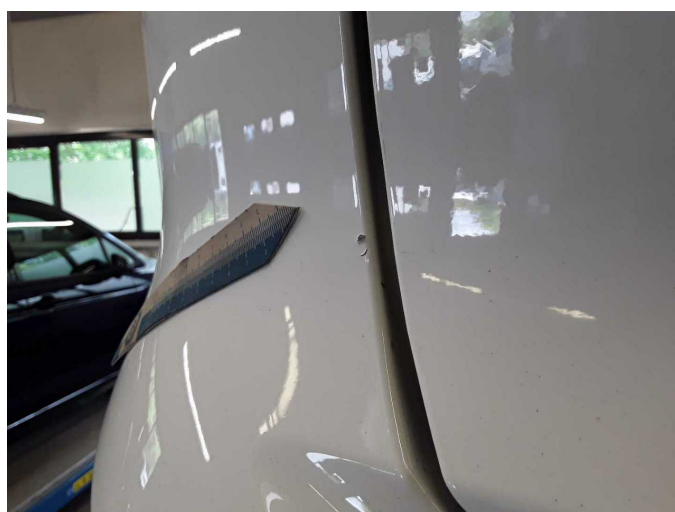
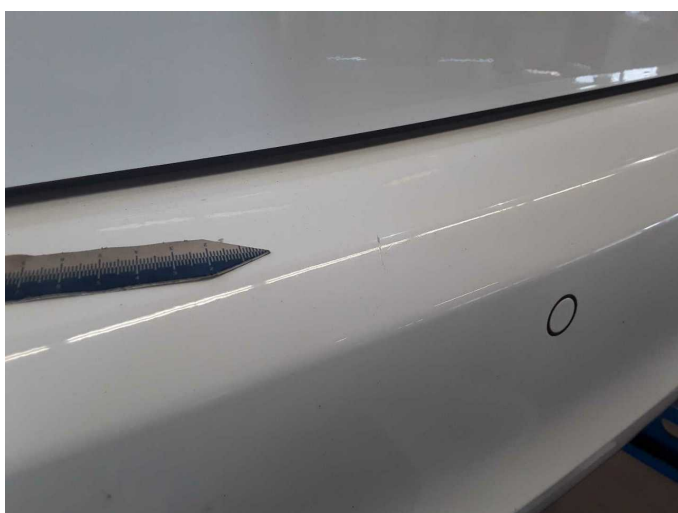
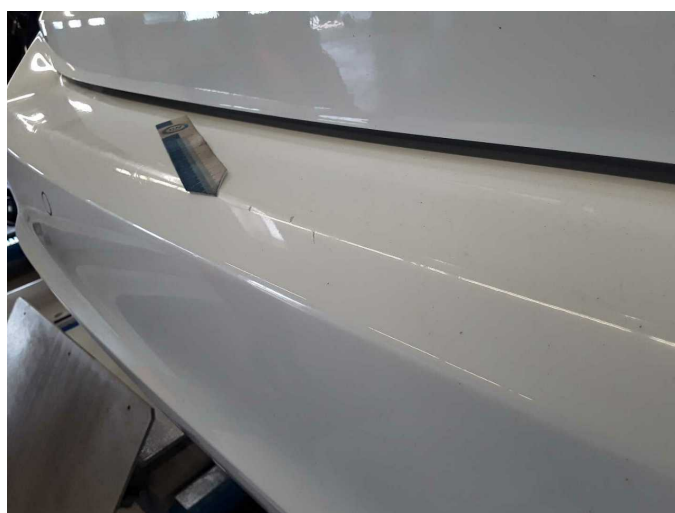
| No. | Component group | Description |
|---|---|---|
| 3 | Rear bumper | Rear bumper - Scratch(es) - Paint |

**Damage 3:** Rear bumper: Rear bumper - Scratch(es) - Paint

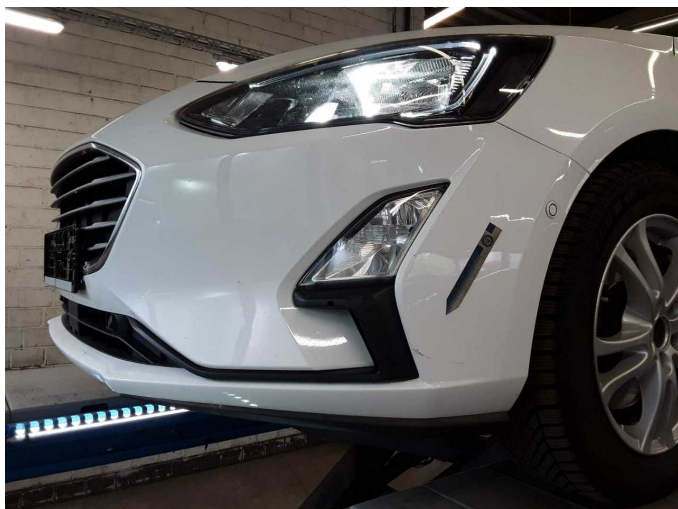
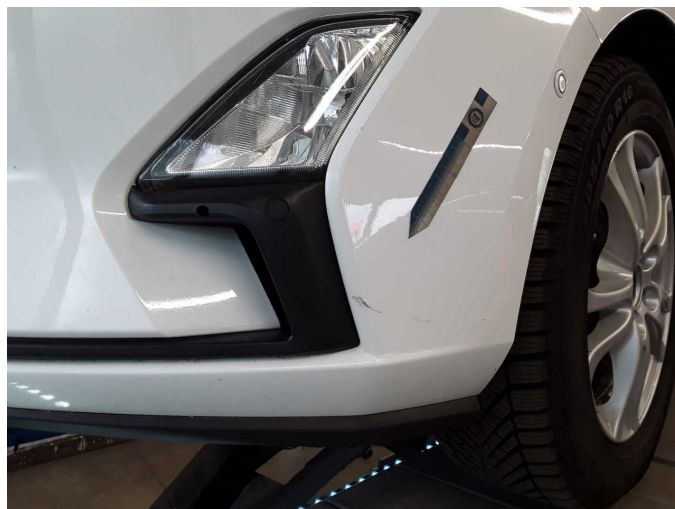
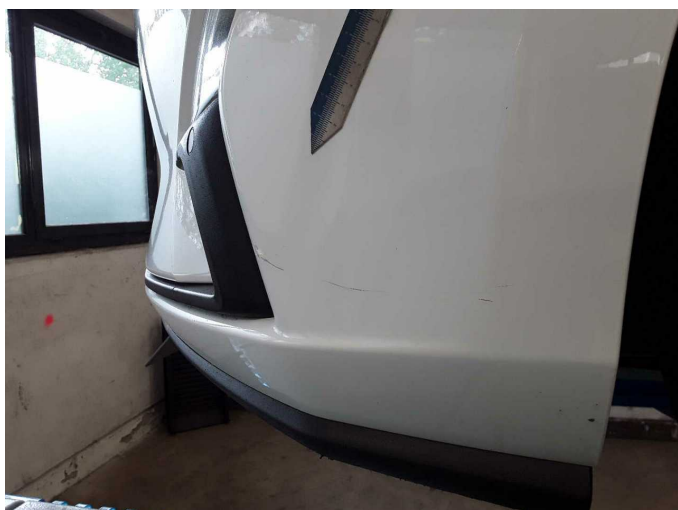
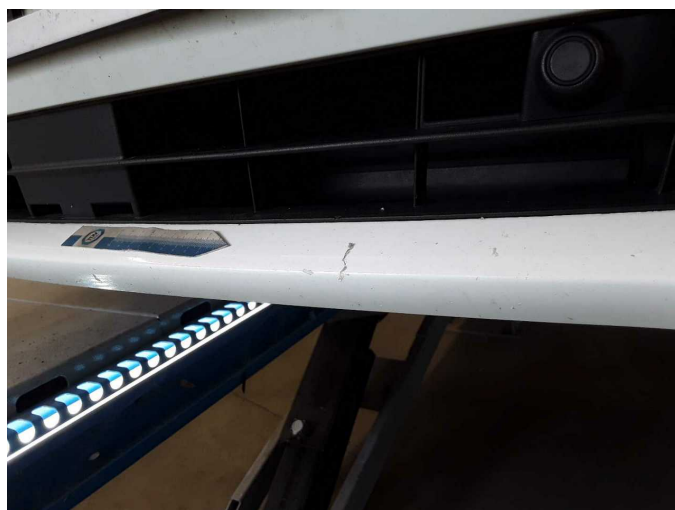
| No. | Component group | Description |
|---|---|---|
| 4 | Front bumper | Front bumper - Scratch(es) - Paint |

**Damage 4:** Front bumper: Front bumper - Scratch(es) - Paint

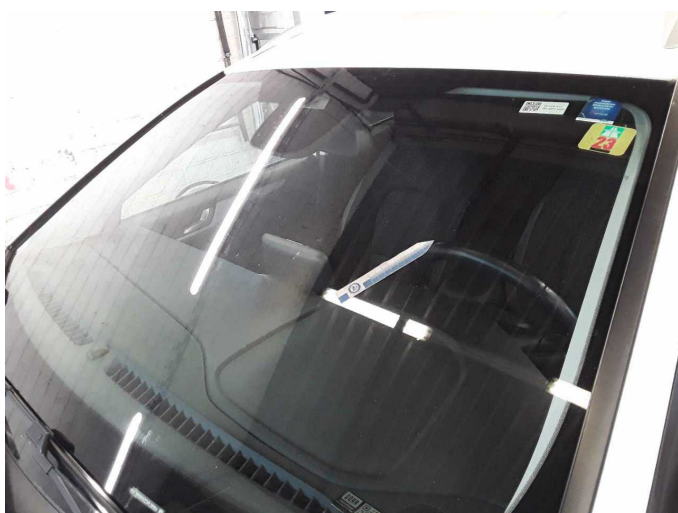
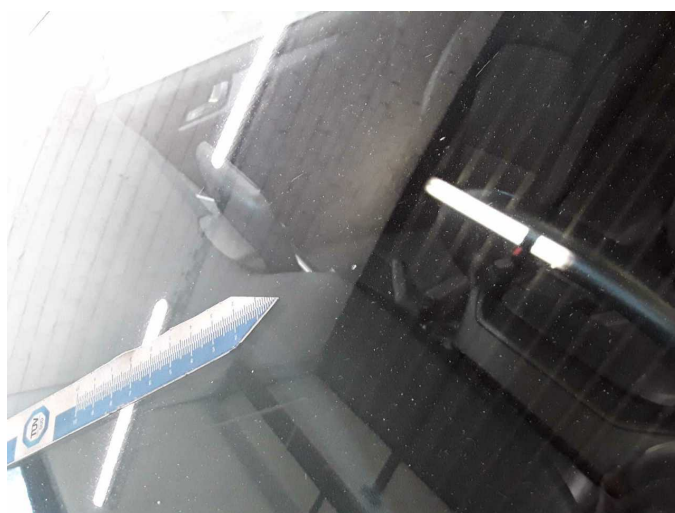
| No. | Component group | Description |
|---|---|---|
| 1 | Vehicle glazing | Windscreen - Stone chips - No deduction |

**Wear and tear 1:** Vehicle glazing: Windscreen - Stone chips - No deduction

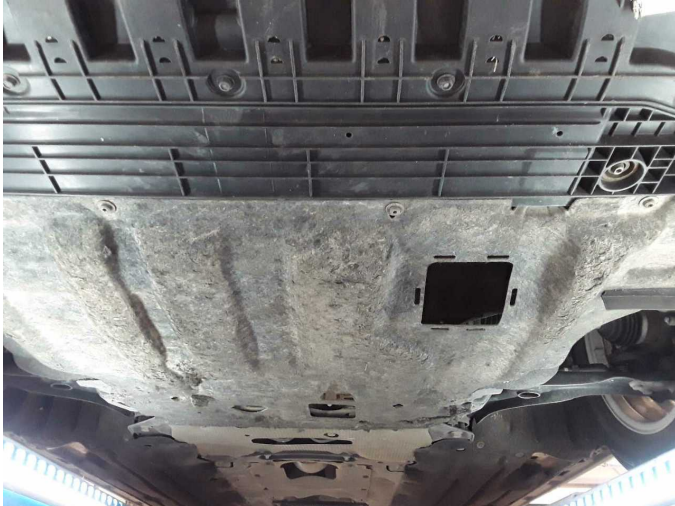
| No. | Component group | Description |
|---|---|---|
| 2 | Body | Underbody panelling - Scratched - No deduction |

**Wear and tear 2:** Body: Underbody panelling - Scratched - No deduction

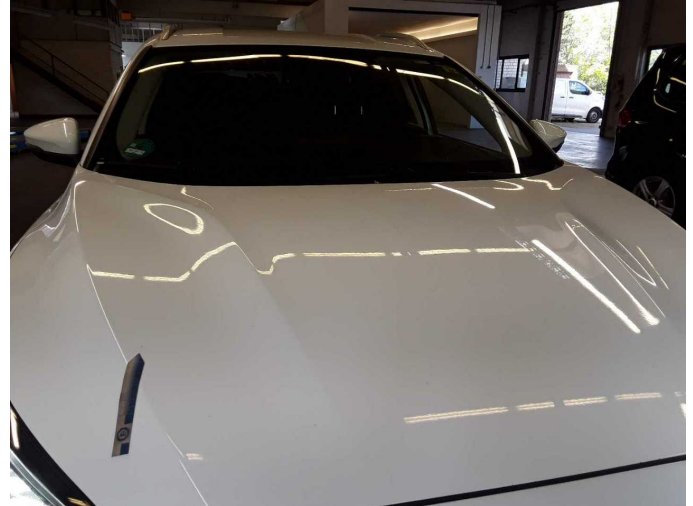
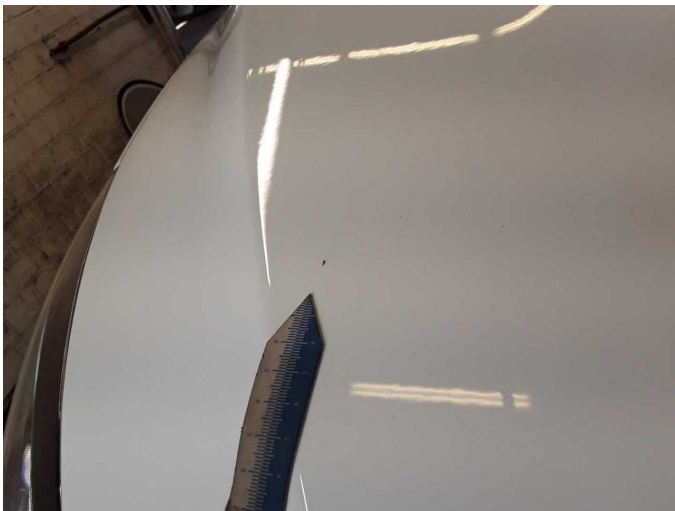
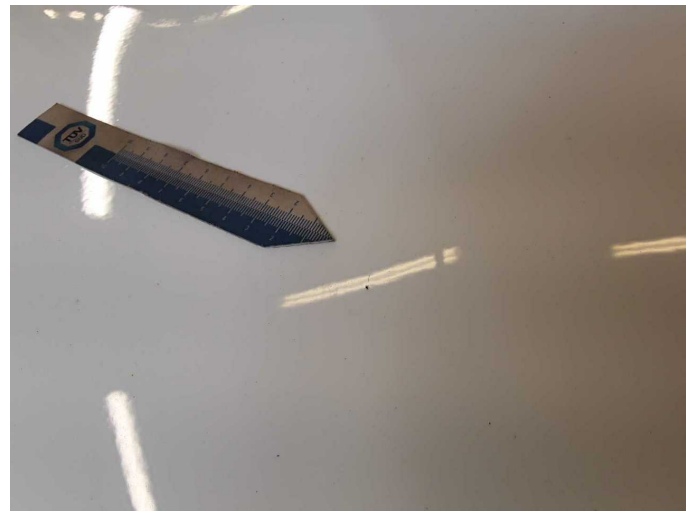
| No. | Component group | Description |
|---|---|---|
| 3 | Bonnet | Bonnet - Stone chips - No deduction |

**Wear and tear 3:** Bonnet: Bonnet - Stone chips - No deduction

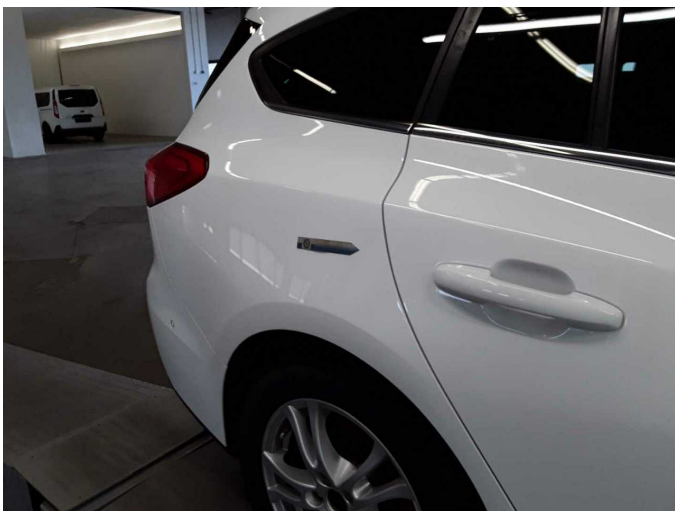
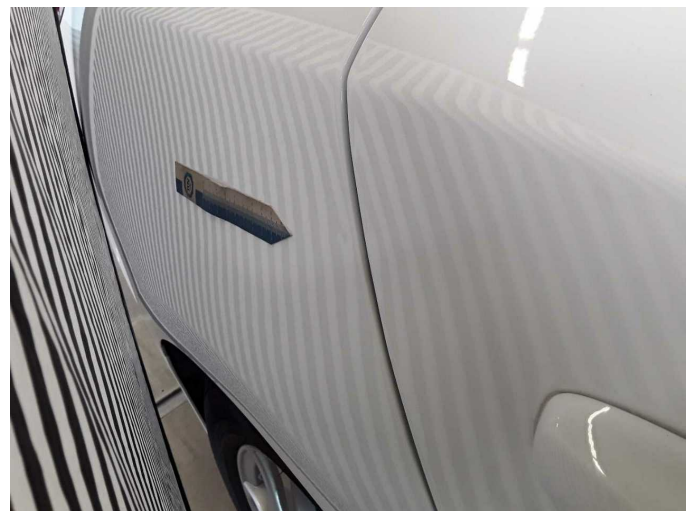
| No. | Component group | Description |
|---|---|---|
| 4 | Side panel - rear right side | Side panel - dent(s) - No deduction |

**Wear and tear 4:** Side panel - rear right side: Side panel - dent(s) - No deduction

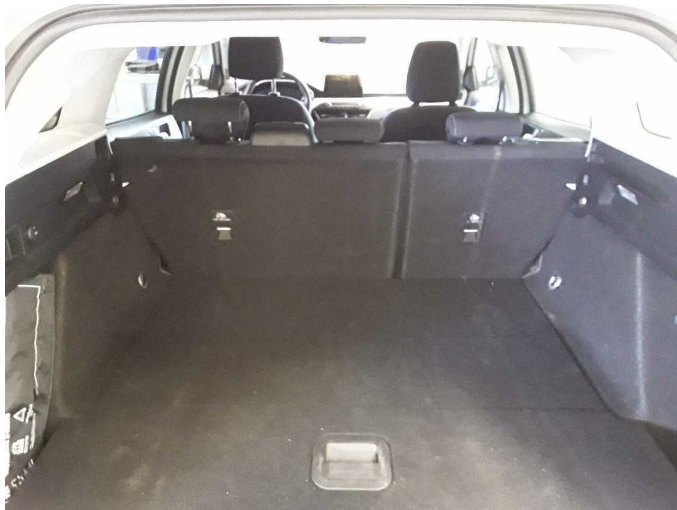
**Missing part 1:** Interior: Separation net - Missing - Replace

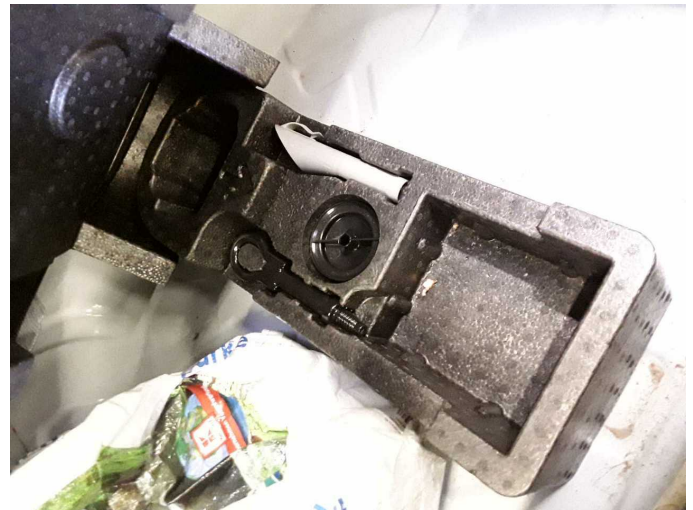
**Missing part 2:** Equipment: Tirefit complete - Missing - Replace

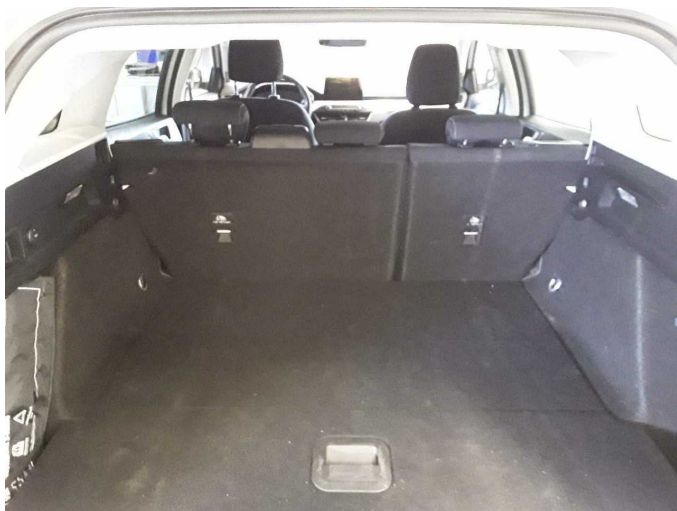
**Missing part 3:** Interior: Boot cover / roller cover - Missing - Replace
