Expertise

Protocol number: 46538321  
Order No. / Reference: 26652354  
Inspection date: 15 Jul 2026

Manufacturer: Renault

Model: Master dCi 135 L3H3 VA Basis

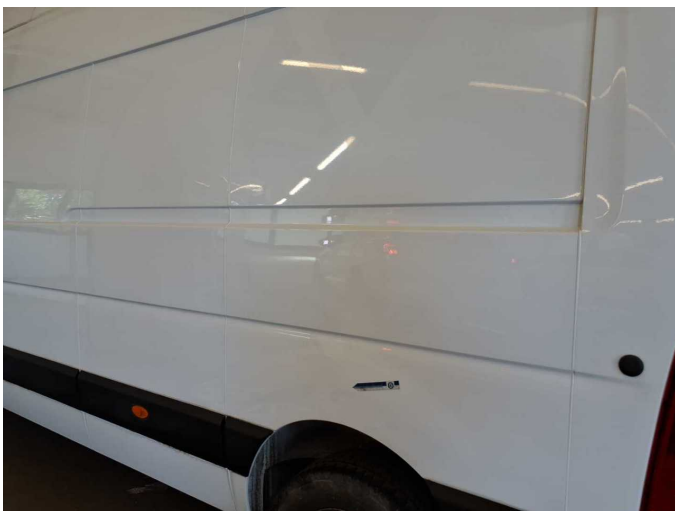
| No. | Component group | Description |
|---|---|---|
| 2 | Side panel - rear left side | Side panel - dent(s) - Smooth repair work |

**Damage 2:** Side panel - rear left side: Side panel - dent(s) - Smooth repair work

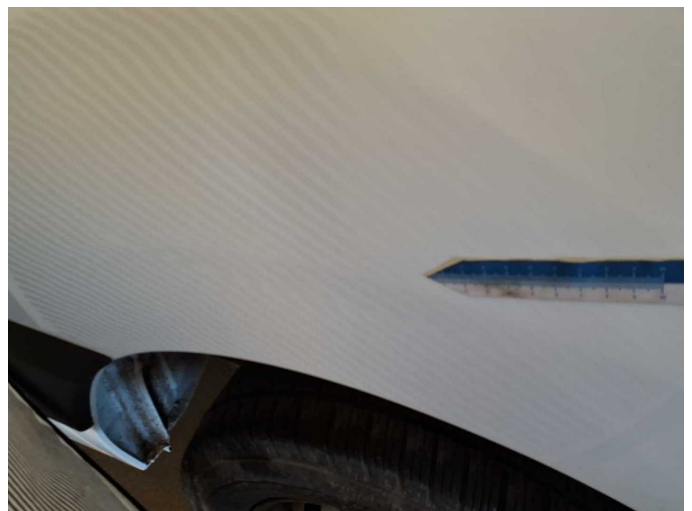
**Damage 2:** Side panel - rear left side: Side panel - dent(s) - Smooth repair work

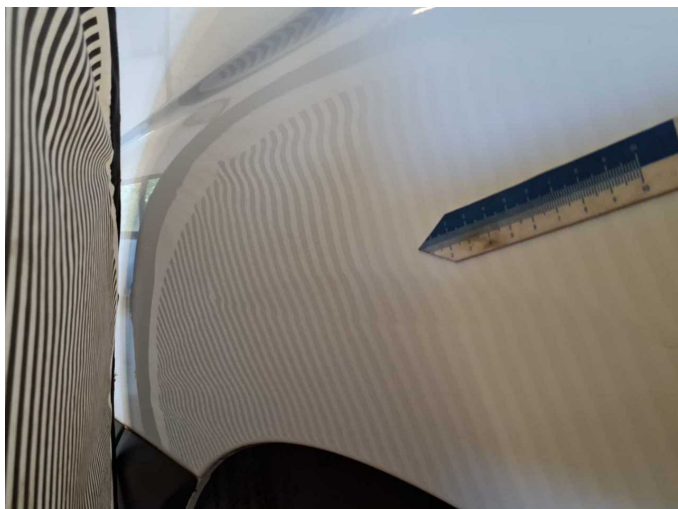
**Damage 2:** Side panel - rear left side: Side panel - dent(s) - Smooth repair work

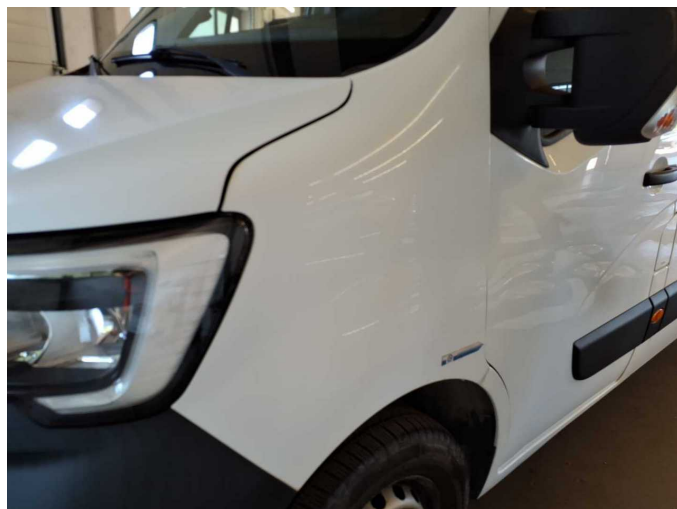
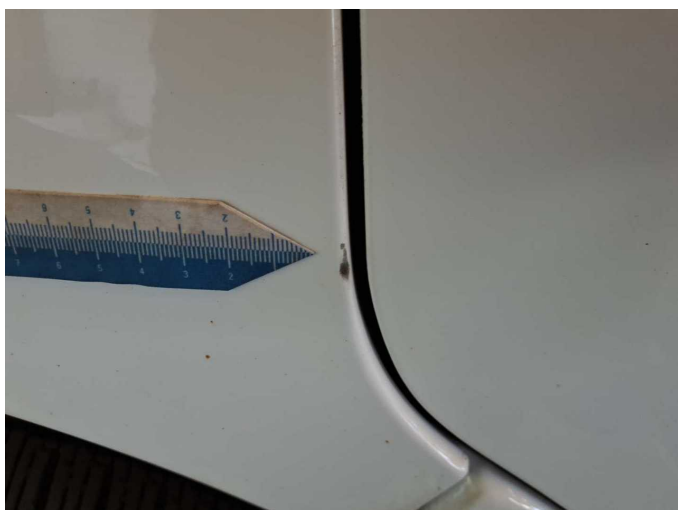
| No. | Component group | Description |
|---|---|---|
| 3 | Mudguard - left side | Mudguard - left side - Scratched - Smart repair |

**Damage 3:** Mudguard - left side: Mudguard - left side - Scratched - Smart repair

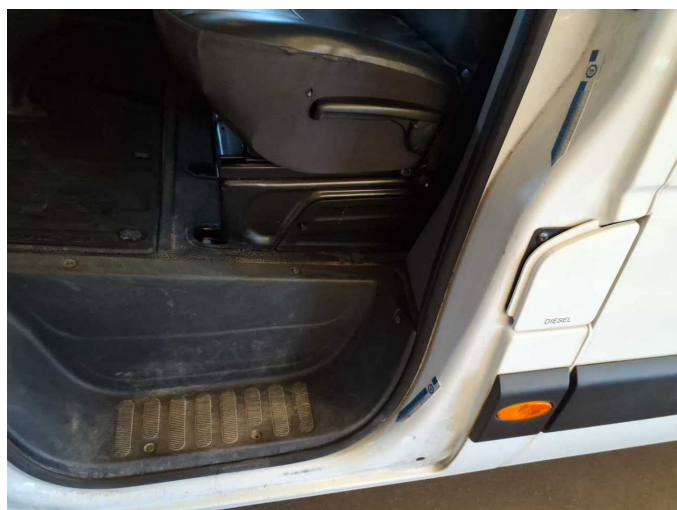
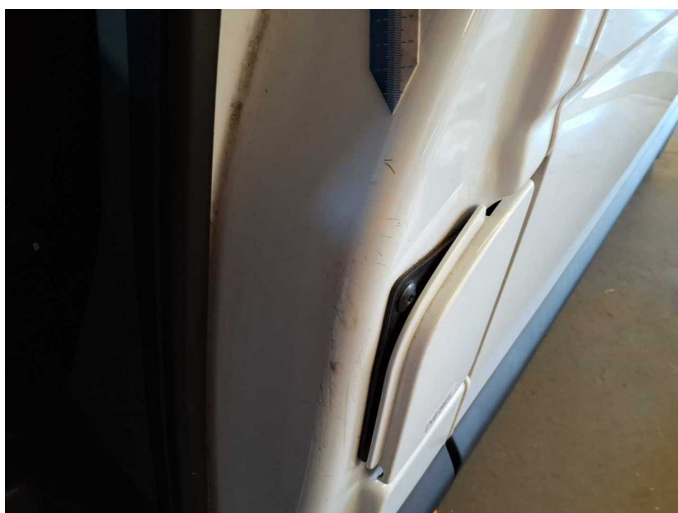
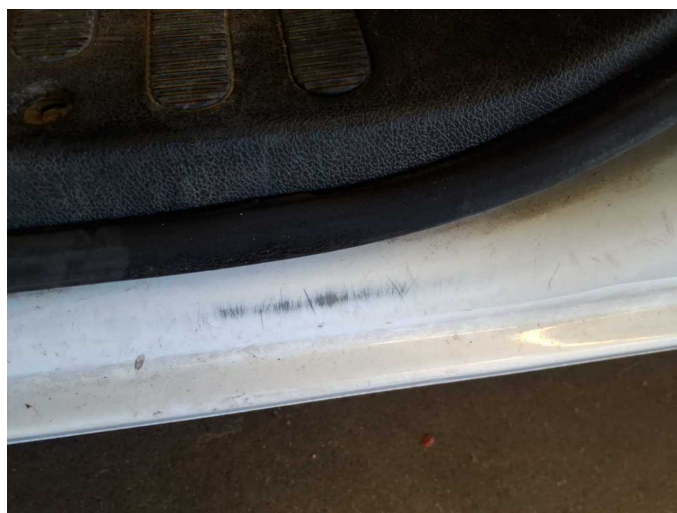
| No. | Component group | Description |
|---|---|---|
| 4 | Sill - left side | Sill - Scratched - Smart repair |

**Damage 4:** Sill - left side: Sill - Scratched - Smart repair

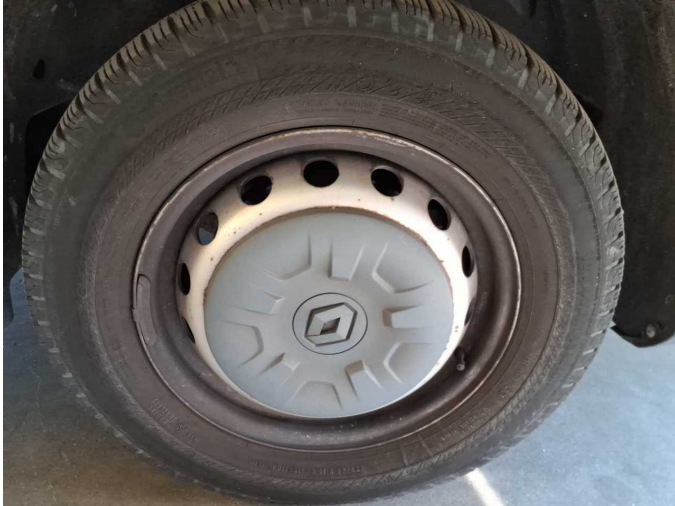
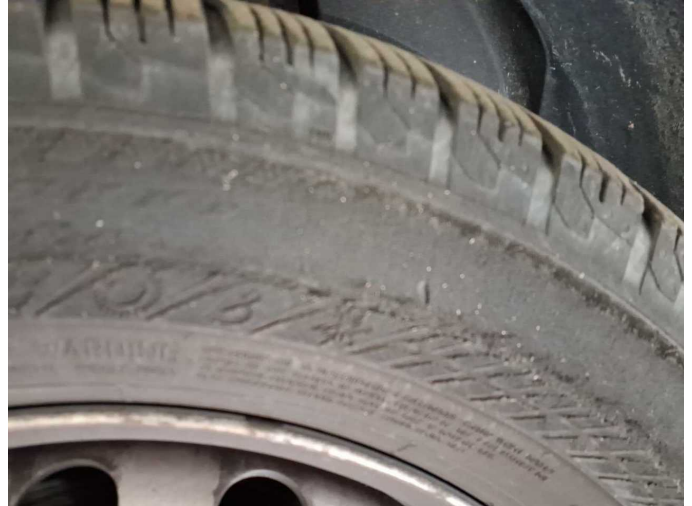
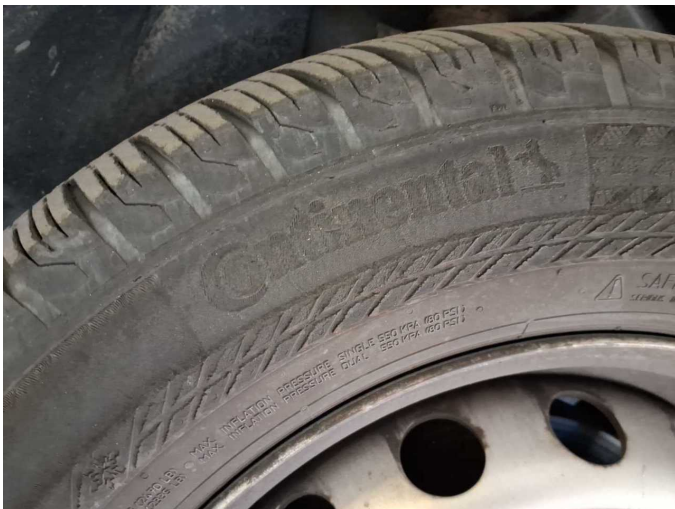
| No. | Component group | Description |
|---|---|---|
| 5 | Wheel / tyres | Tyre - front right side (225,65,16,g) - Broken / torn - Replace |

**Damage 5:** Wheel / tyres: Tyre - front right side (225,65,16,g) - Broken / torn - Replace

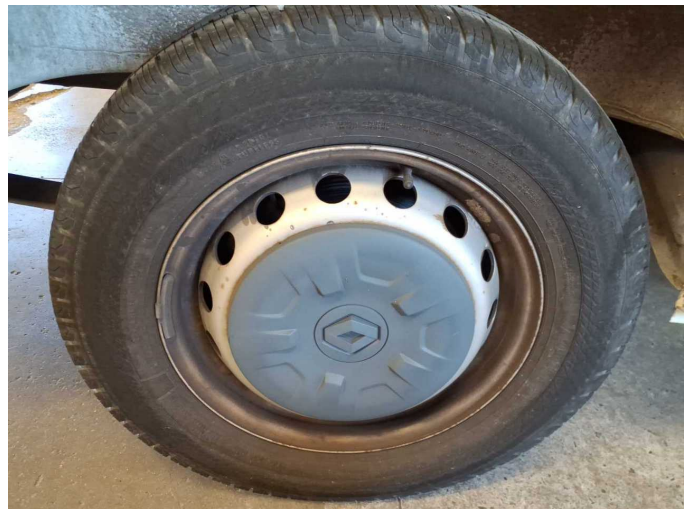
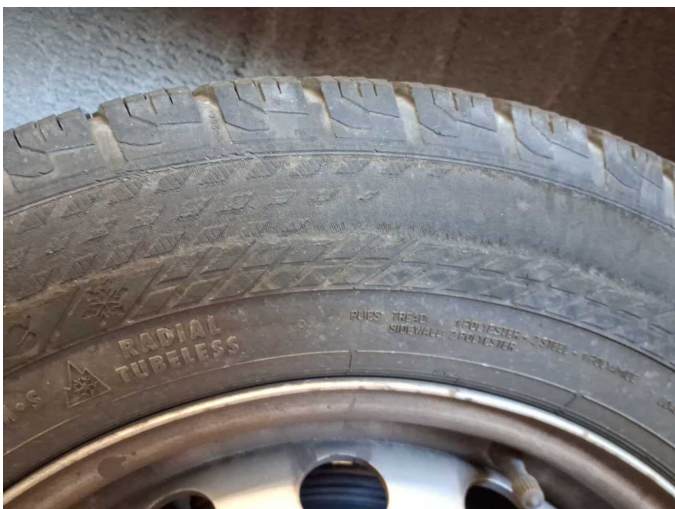
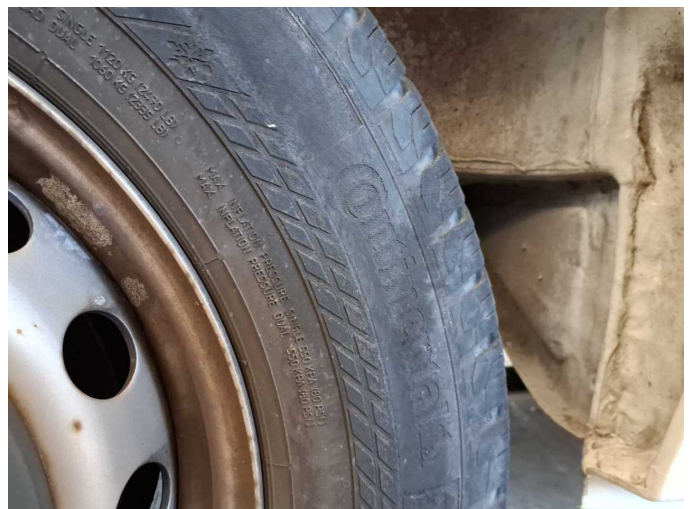
| No. | Component group | Description |
|---|---|---|
| 6 | Wheel / tyres | Tyre - rear right side (225,65,16g) - Broken / torn - Replace |

**Damage 6:** Wheel / tyres: Tyre - rear right side (225,65,16g) - Broken / torn - Replace

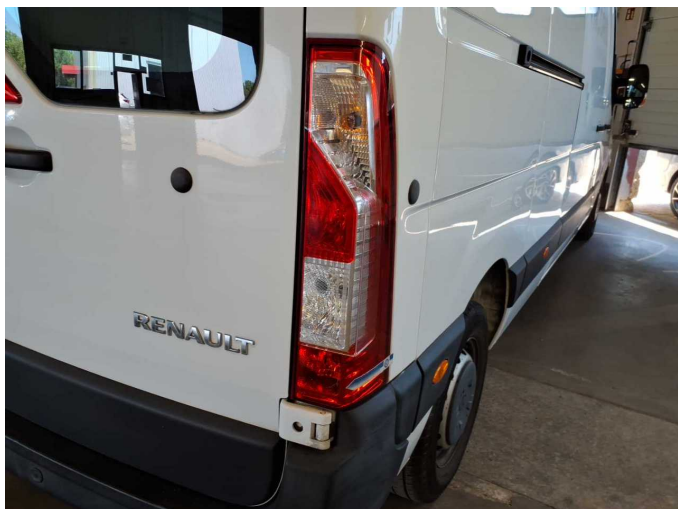
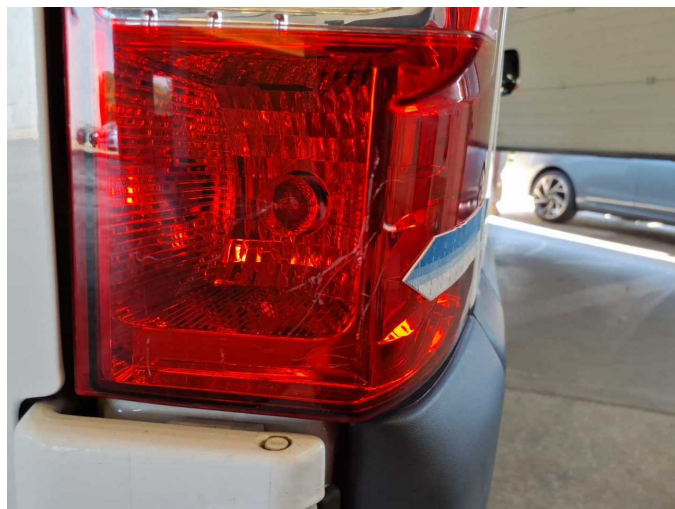
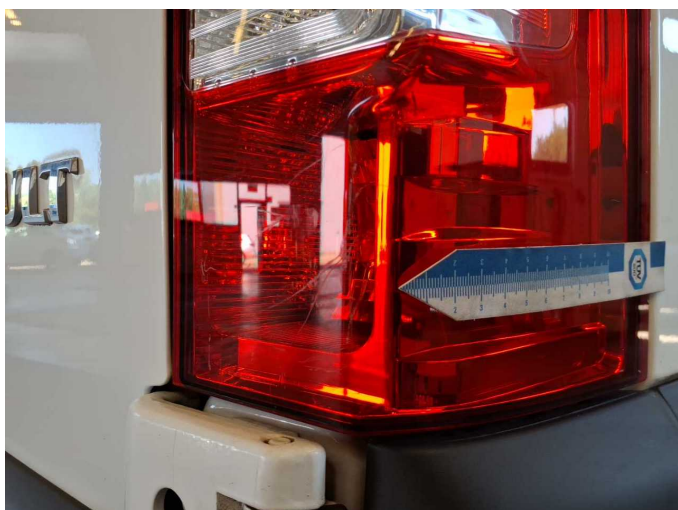
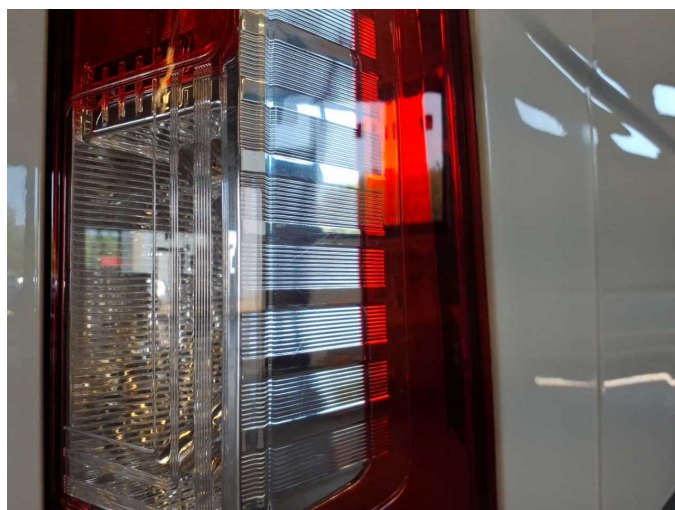
| No. | Component group | Description |
|---|---|---|
| 7 | Tail light | Tail lamp - right side - Scratched - Replace |

**Damage 7:** Tail light: Tail lamp - right side - Scratched - Replace

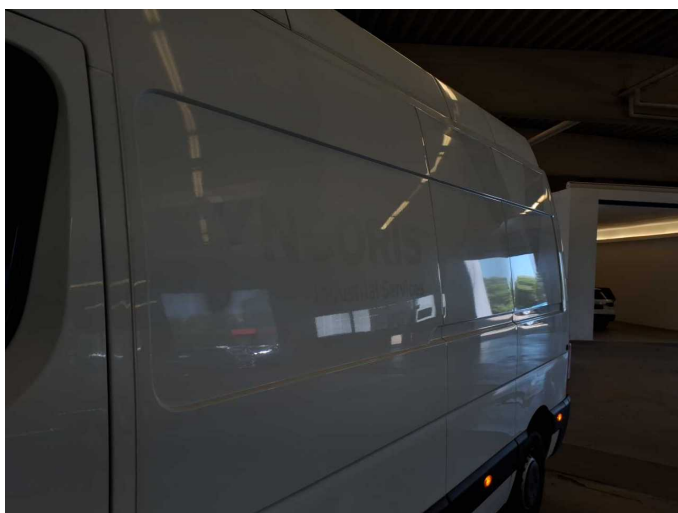
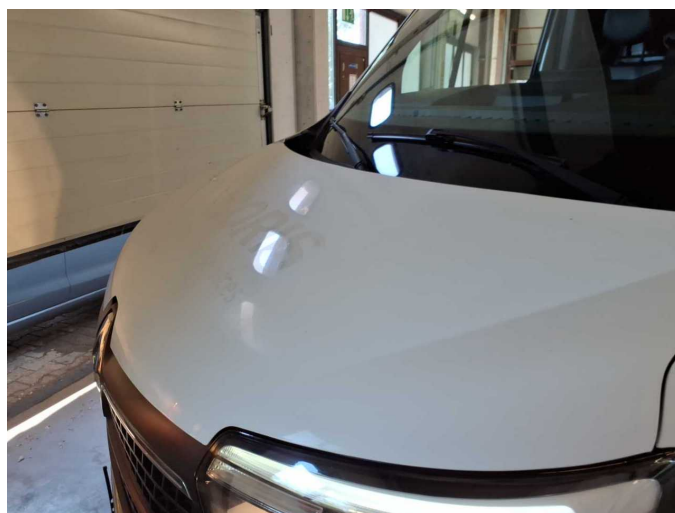
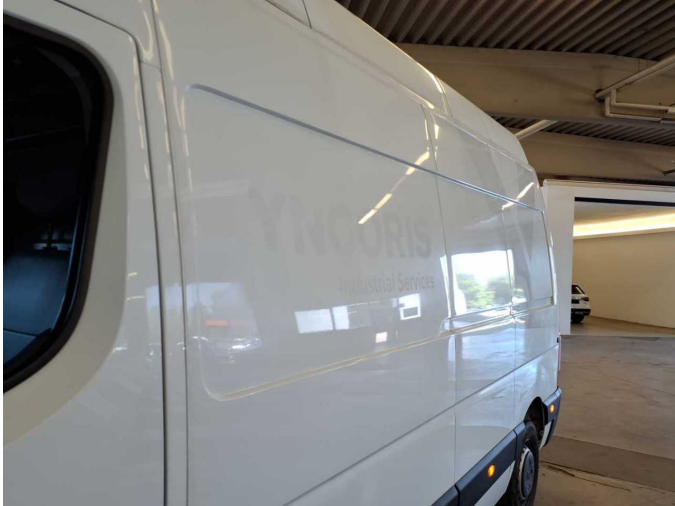
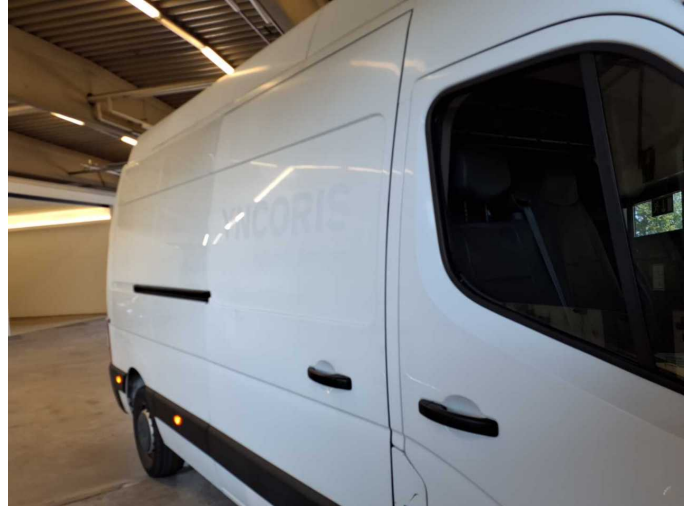
| No. | Component group | Description |
|---|---|---|
| 8 | Body | Body (Ausbleichungen) - Glued / labelled - Conditioning |

**Damage 8:** Body: Body (Ausbleichungen) - Glued / labelled - Conditioning

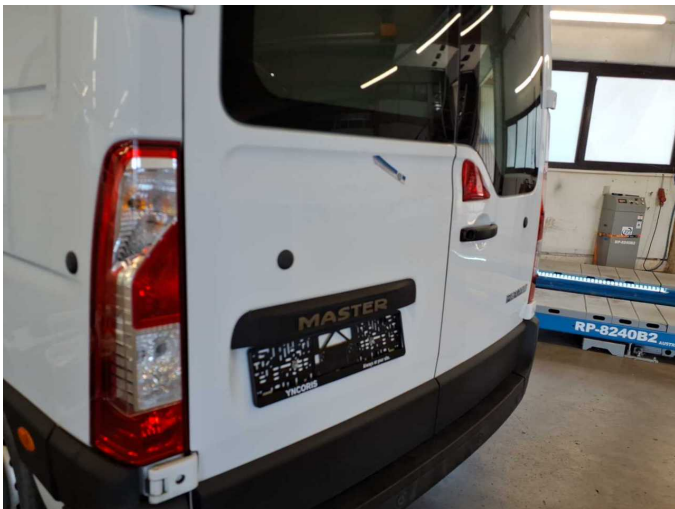
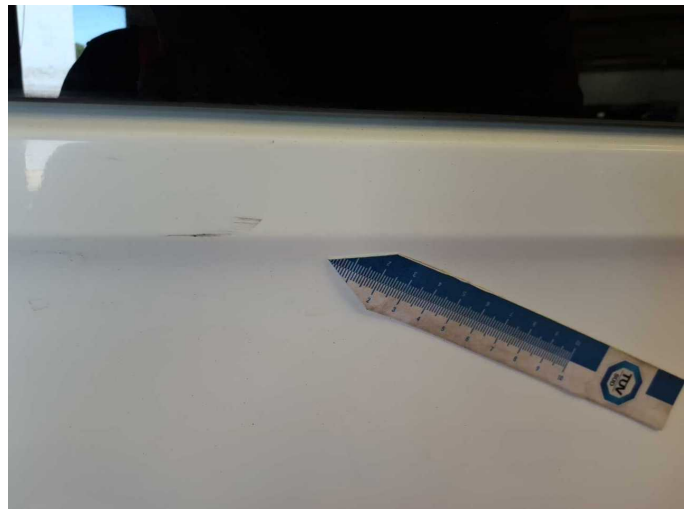
| No. | Component group | Description |
|---|---|---|
| 10 | Boot lid / rear door | Rear door - left side - Scratch(es) - Paint |

**Damage 10:** Boot lid / rear door: Rear door - left side - Scratch(es) - Paint

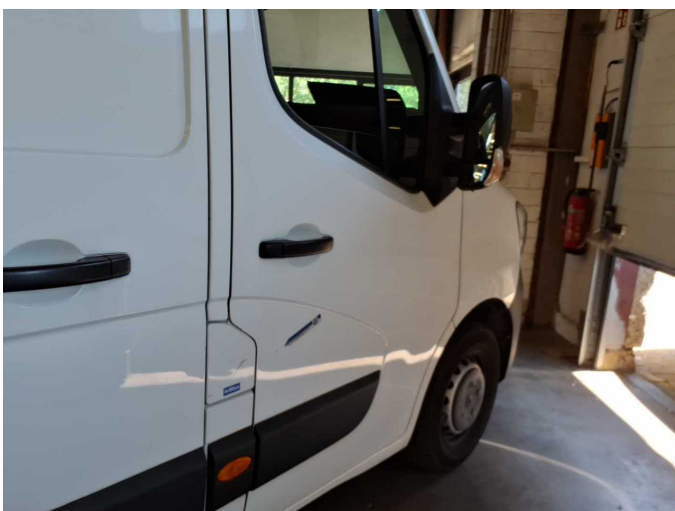
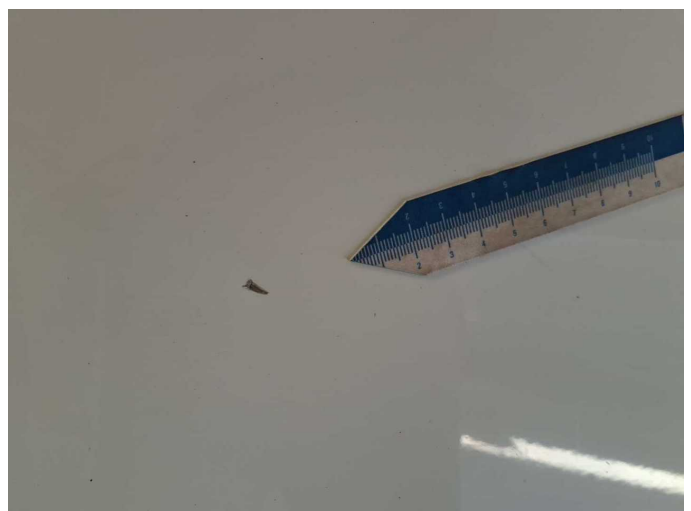
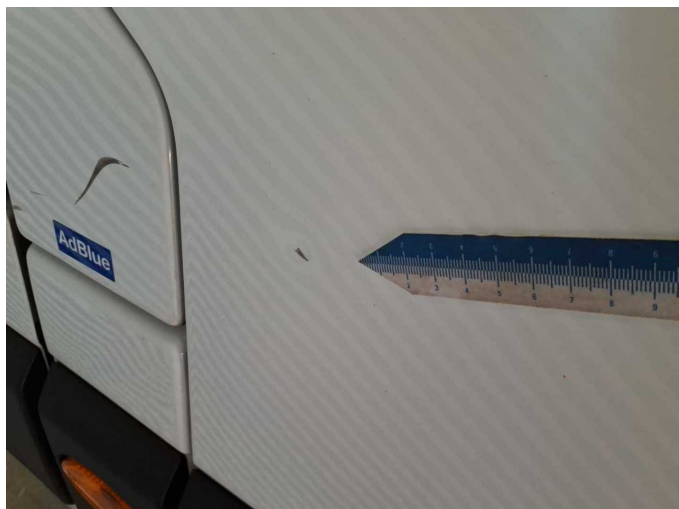
| No. | Component group | Description |
|---|---|---|
| 11 | Door - front right side | Door - Dent / paintcoat damage - Repair and paint |

**Damage 11:** Door - front right side: Door - Dent / paintcoat damage - Repair and paint

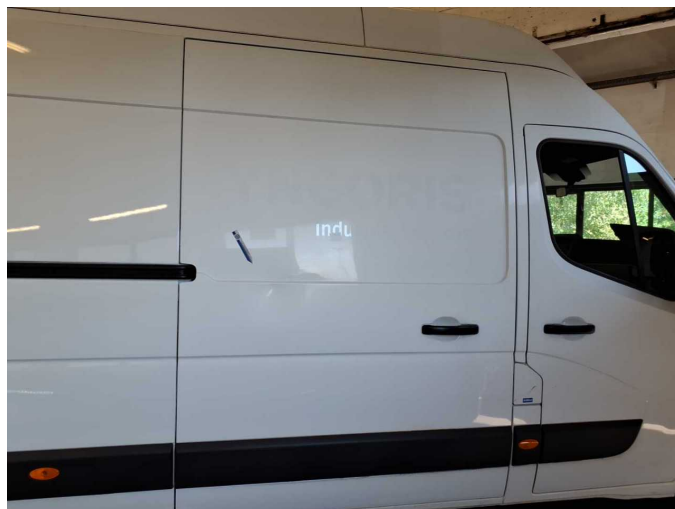
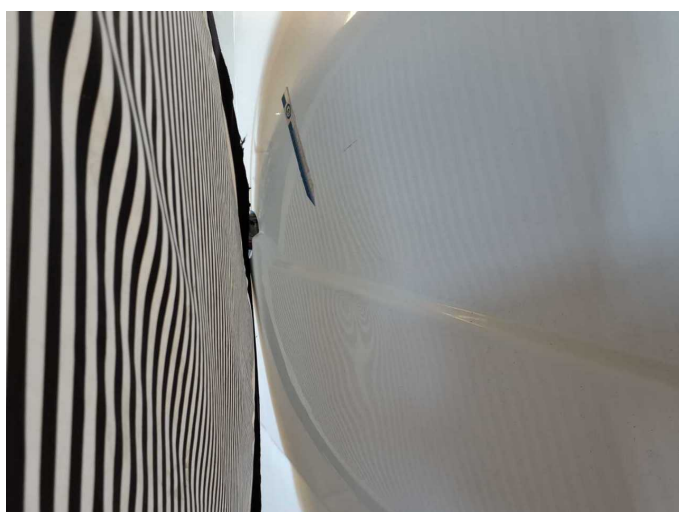
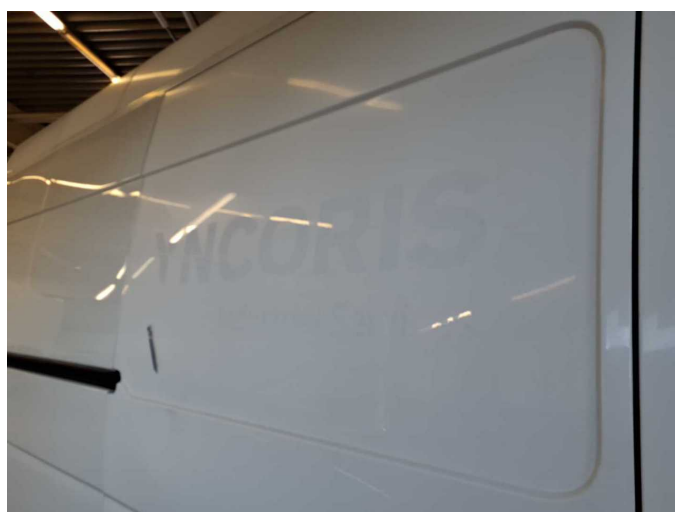
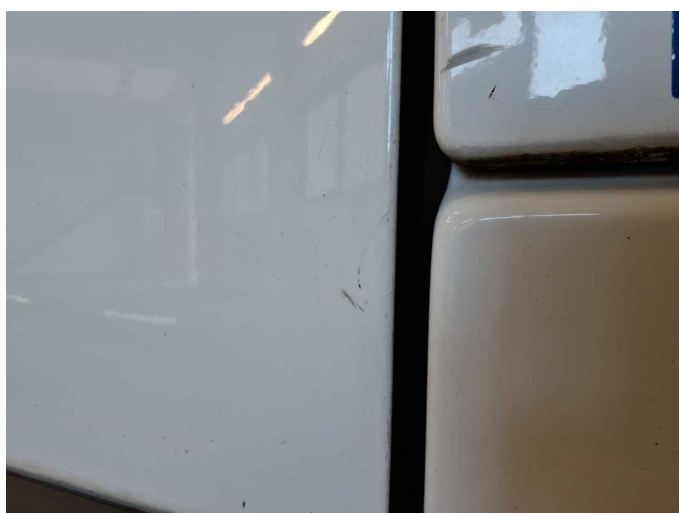
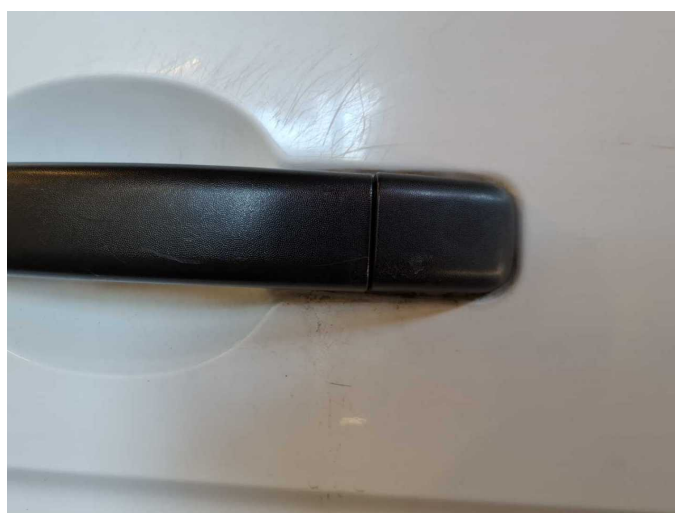
| No. | Component group | Description |
|---|---|---|
| 12 | Sliding door, right | Sliding door - Dent / paintcoat damage - Repair and paint |

**Damage 12:** Sliding door, right: Sliding door - Dent / paintcoat damage - Repair and paint

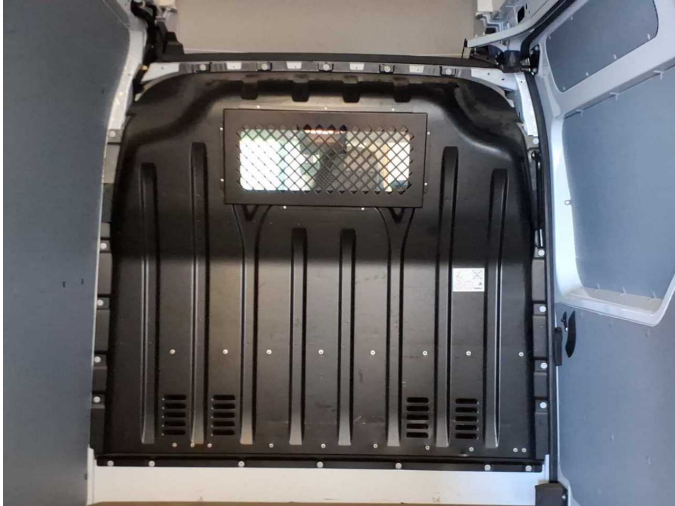
| No. | Component group | Description |
|---|---|---|
| 1 | Body | Partition wall - Dent / paintcoat damage - No deduction |

**Wear and tear 1:** Body: Partition wall - Dent / paintcoat damage - No deduction

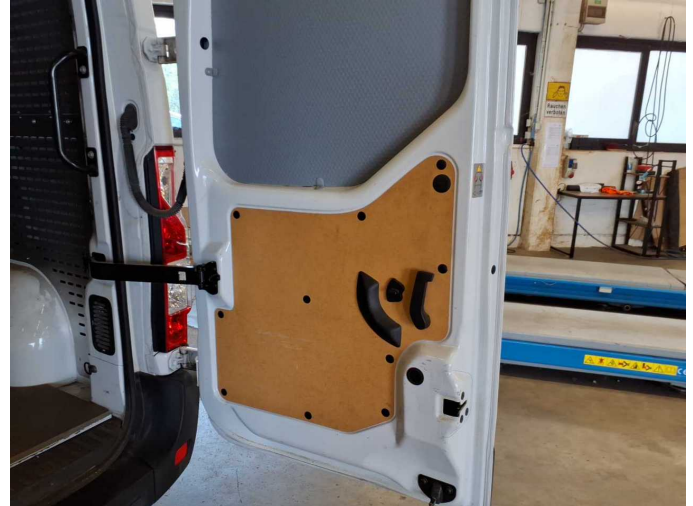
| No. | Component group | Description |
|---|---|---|
| 2 | Boot lid / rear door | Rear door - right side (Innen) - Scratched - No deduction |

**Wear and tear 2:** Boot lid / rear door: Rear door - right side (Innen) - Scratched - No deduction

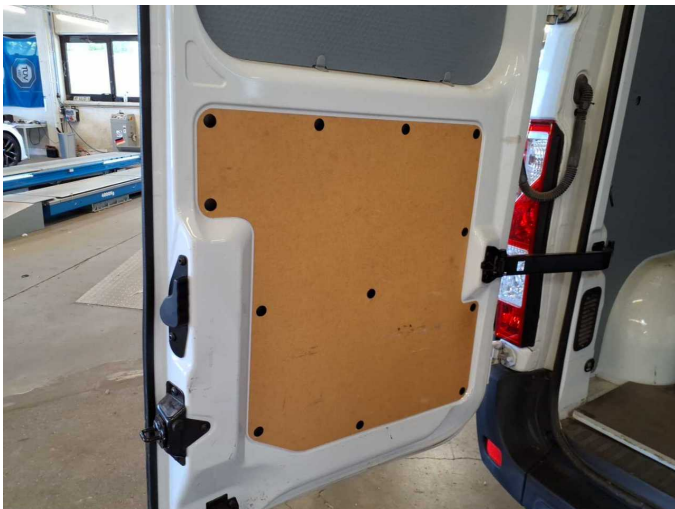
| No. | Component group | Description |
|---|---|---|
| 3 | Boot lid / rear door | Rear door - left side - Dent / paintcoat damage - No deduction |

**Wear and tear 3:** Boot lid / rear door: Rear door - left side - Dent / paintcoat damage - No deduction

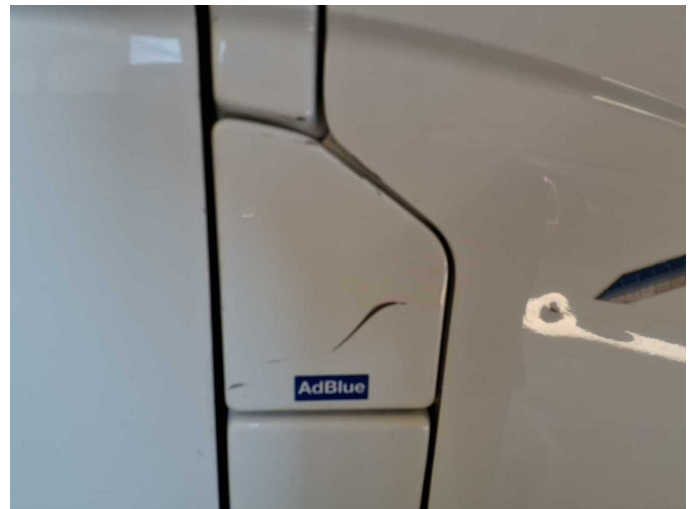
| No. | Component group | Description |
|---|---|---|
| 4 | Fuel system | Tank flap - Soiled - No deduction |

**Wear and tear 4:** Fuel system: Tank flap - Soiled - No deduction

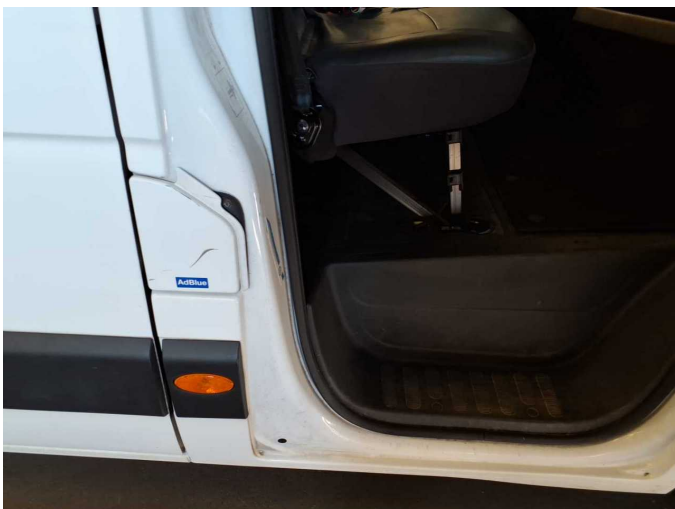
| No. | Component group | Description |
|---|---|---|
| 5 | Sill - right side | Sill - Scratched - No deduction |

**Wear and tear 5:** Sill - right side: Sill - Scratched - No deduction

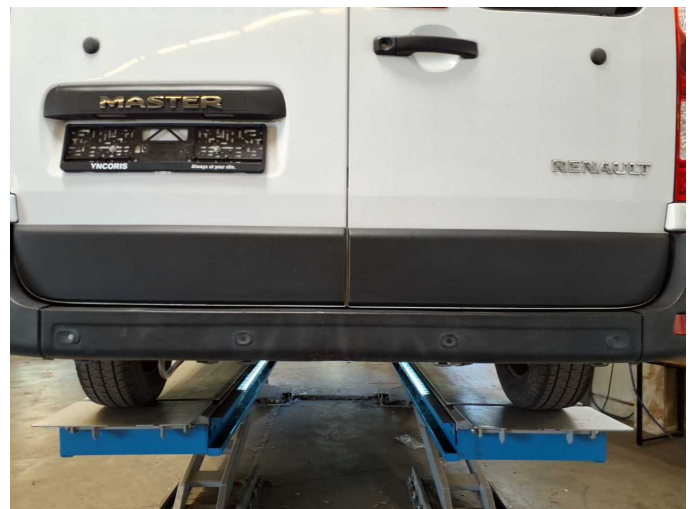
| No. | Component group | Description |
|---|---|---|
| 6 | Rear bumper | Rear bumper (unpainted) - dent(s) - No deduction |

**Wear and tear 6:** Rear bumper: Rear bumper (unpainted) - dent(s) - No deduction

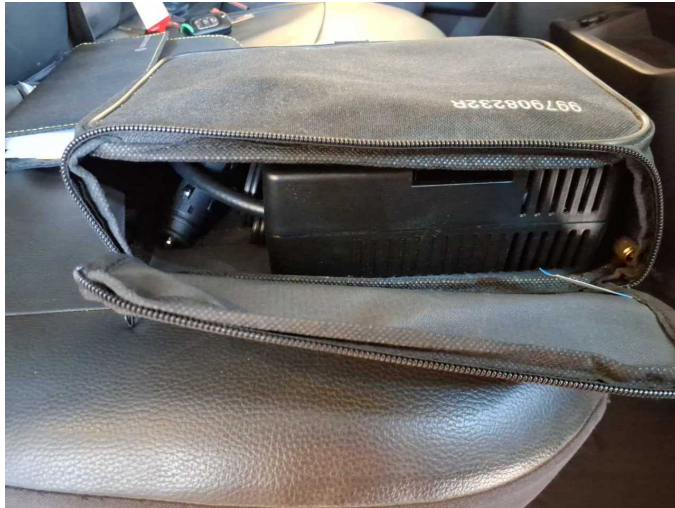
Equipment - Tirefit filler

**Missing part 1:** Equipment: Tirefit filler - Missing - Replace

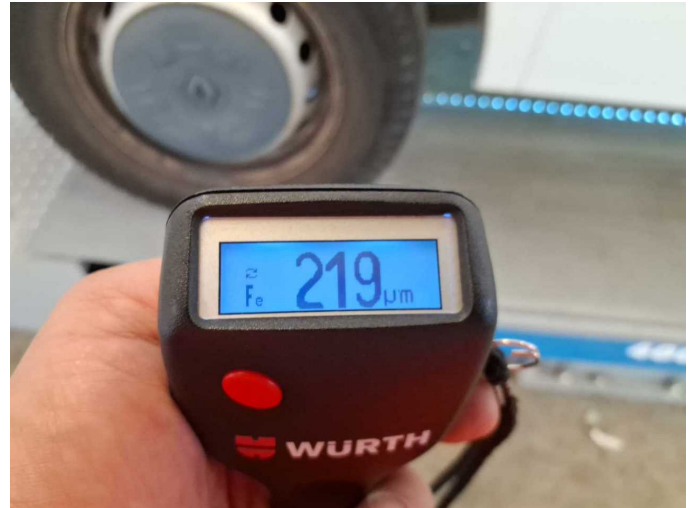
- 1 Side panel - rear right side

Side panel - rear right side

217 µm |

**Repainting 1:** Side panel - rear right side
