Expertise

Protocol number: 46703917  
Order No. / Reference: 26746743  
Inspection date: 24 Jul 2026

| Manufacturer: Opel | Model: Insignia Sports Tourer 2.0 Diesel Aut. Business Elegance |
| VIN: W0VZT8GP3M1025237 | |

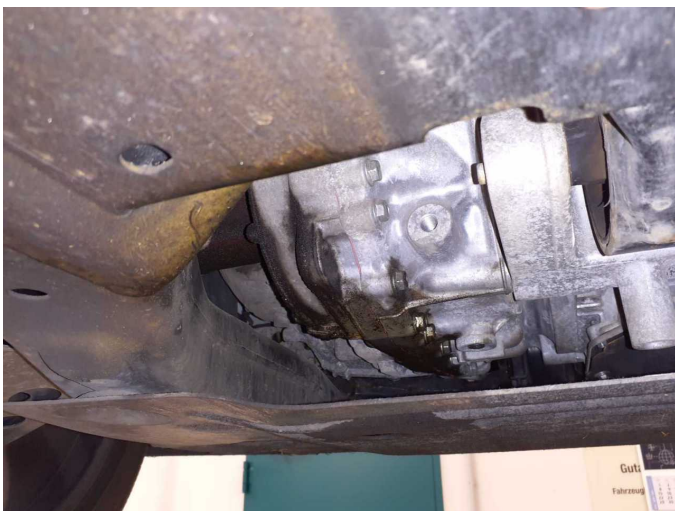
| No. | Component group | Description |
|---|---|---|
| 2 | Engine | Engine (Kostenausweitung möglich) - Leaking - Perform diagnosis |

**Damage 2:** Engine: Engine (Kostenausweitung möglich) - Leaking - Perform diagnosis

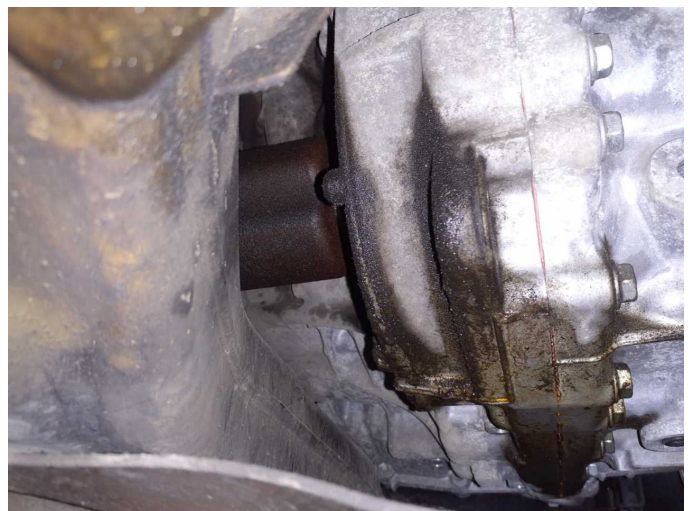
**Damage 2:** Engine: Engine (Kostenausweitung möglich) - Leaking - Perform diagnosis

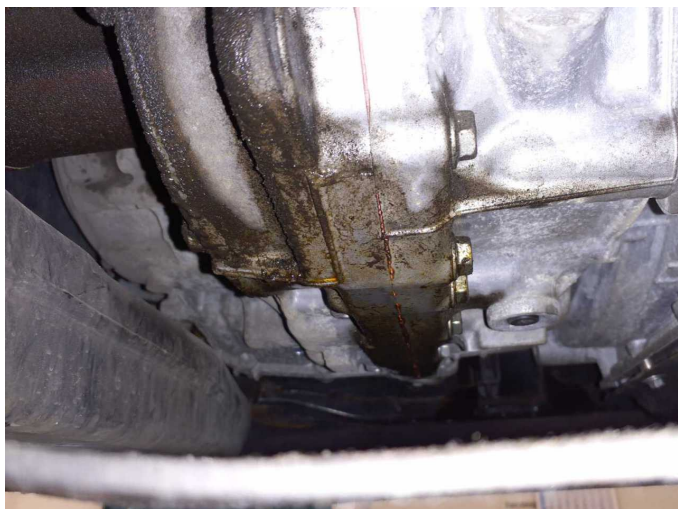
**Damage 2:** Engine: Engine (Kostenausweitung möglich) - Leaking - Perform diagnosis

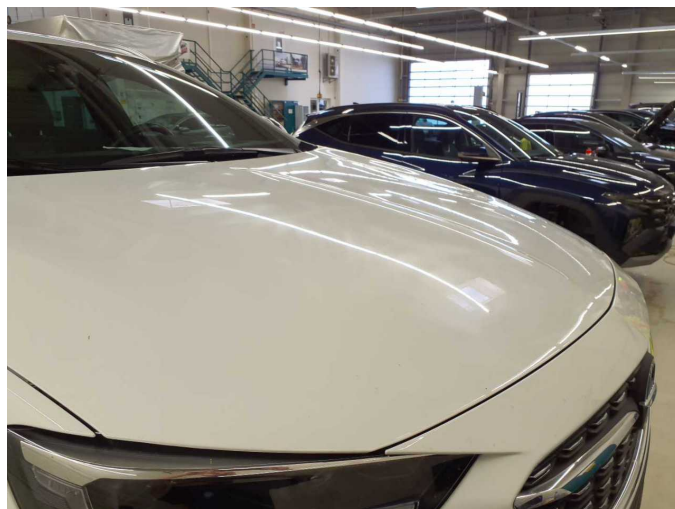
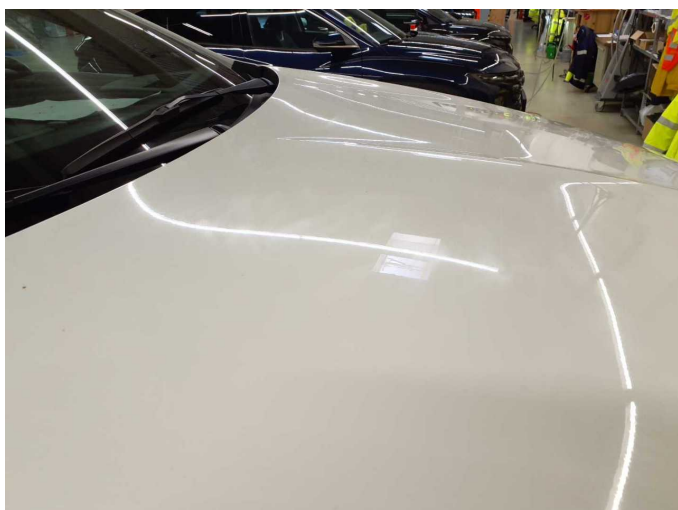
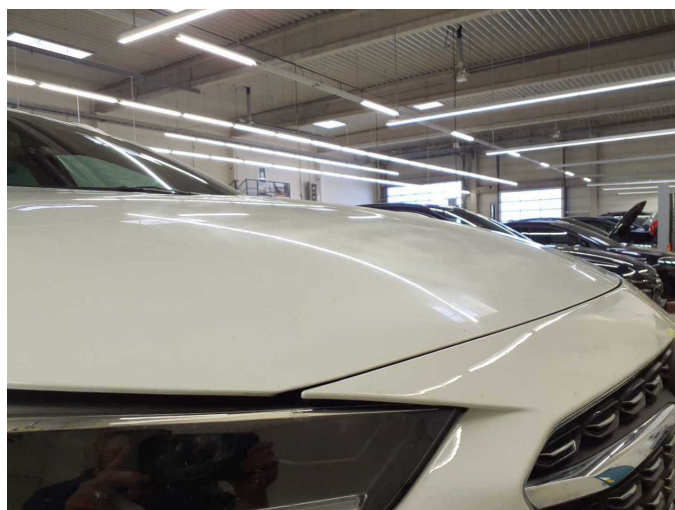
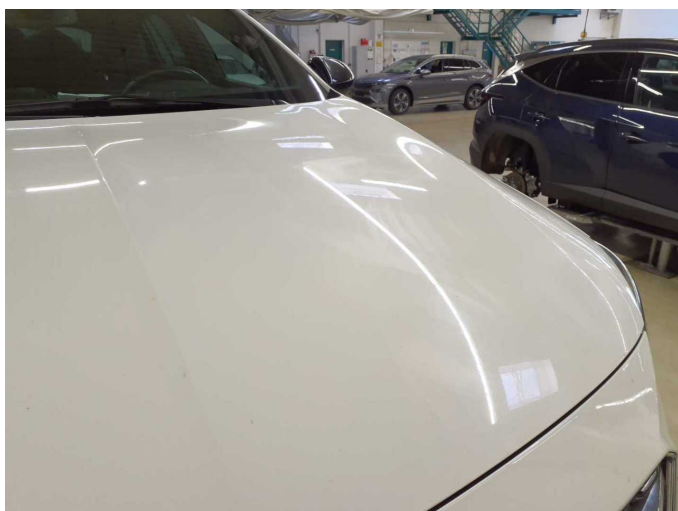
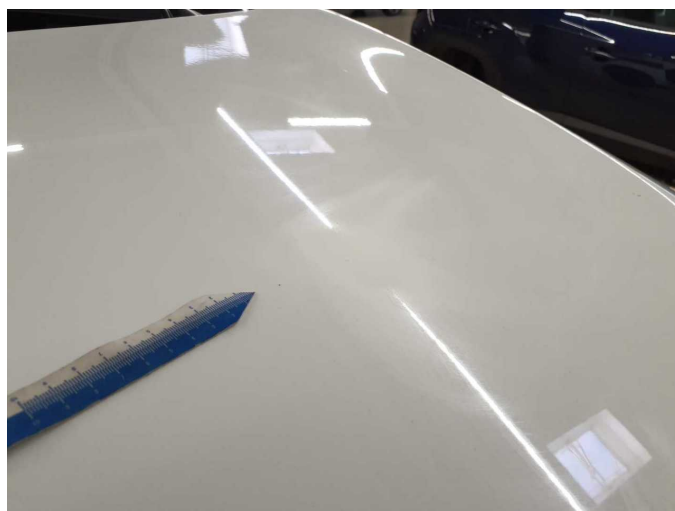
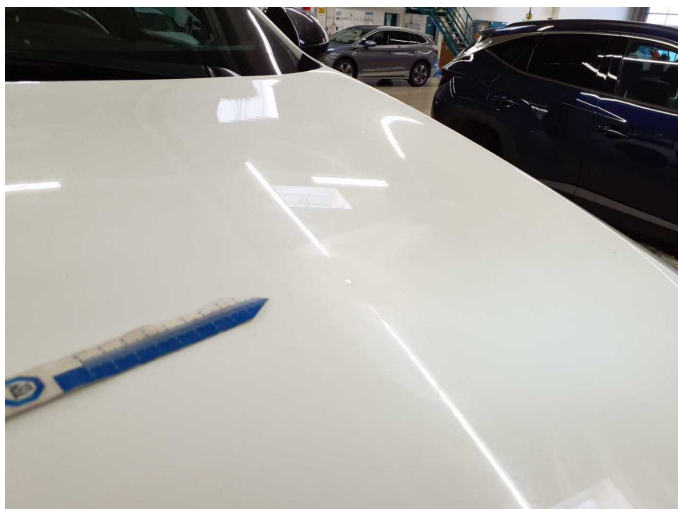
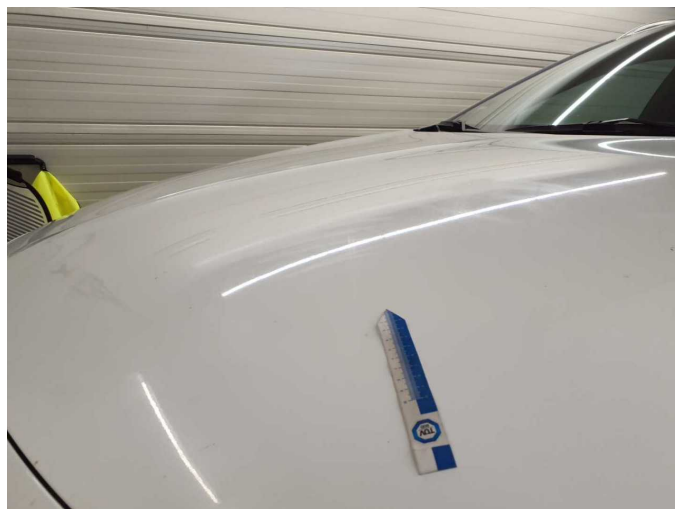
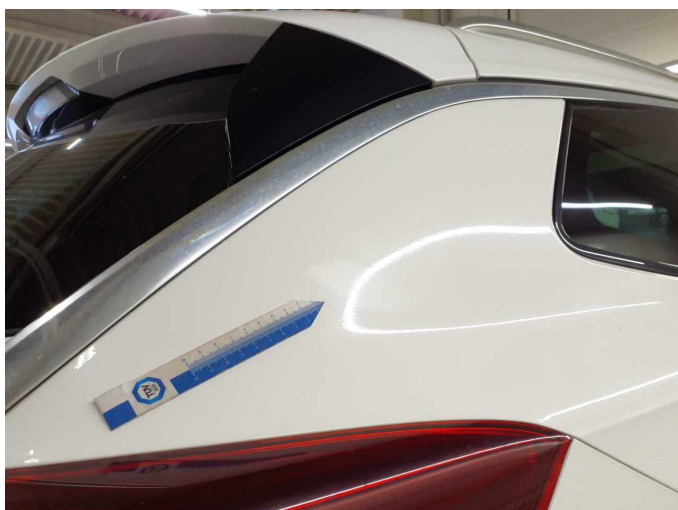
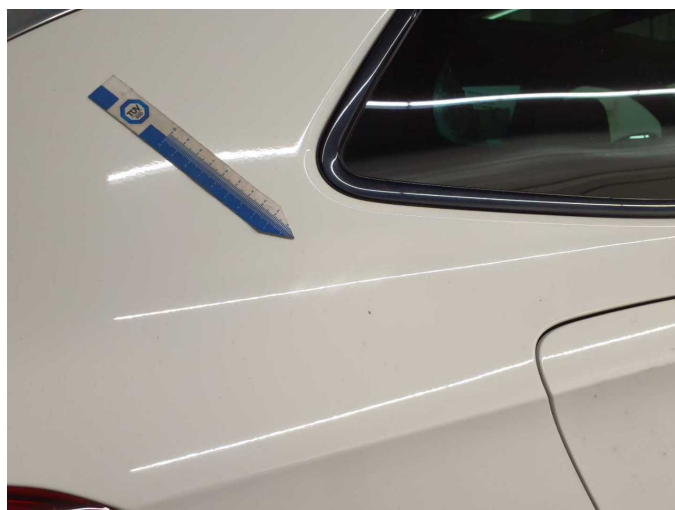
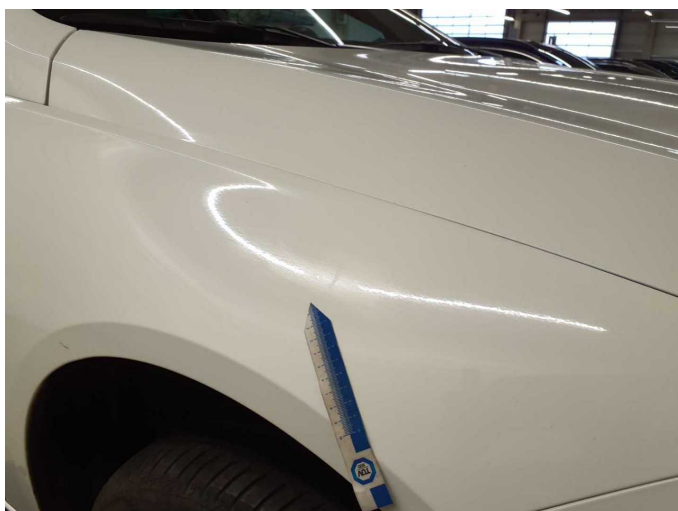
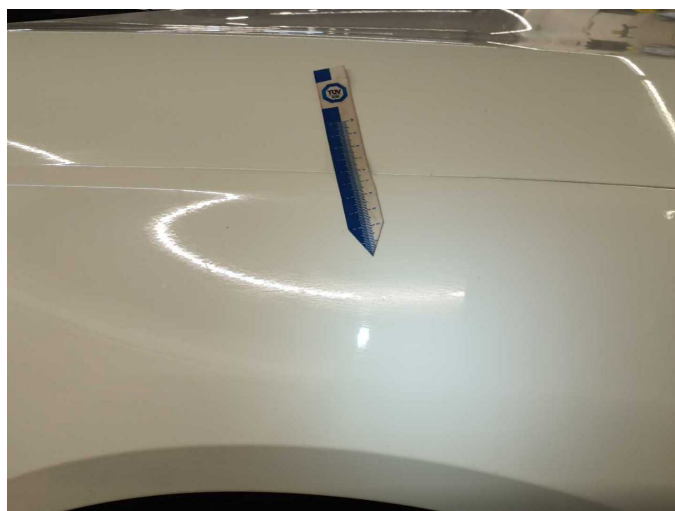
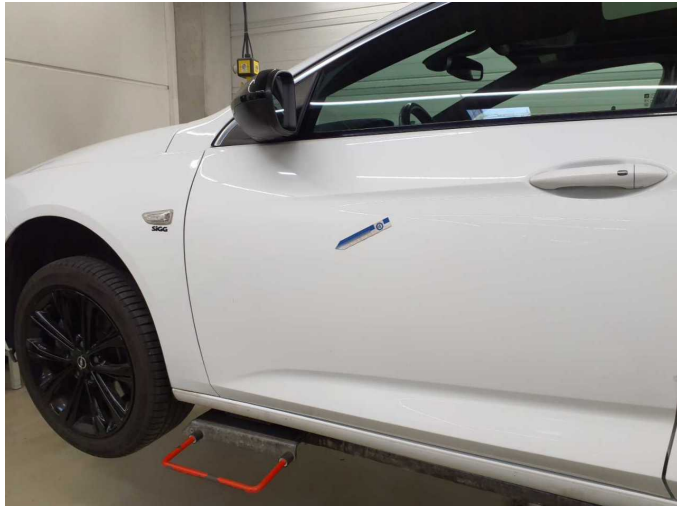
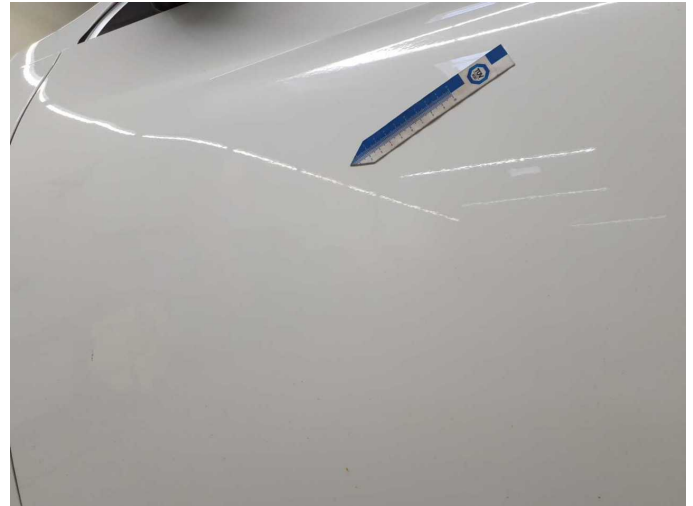
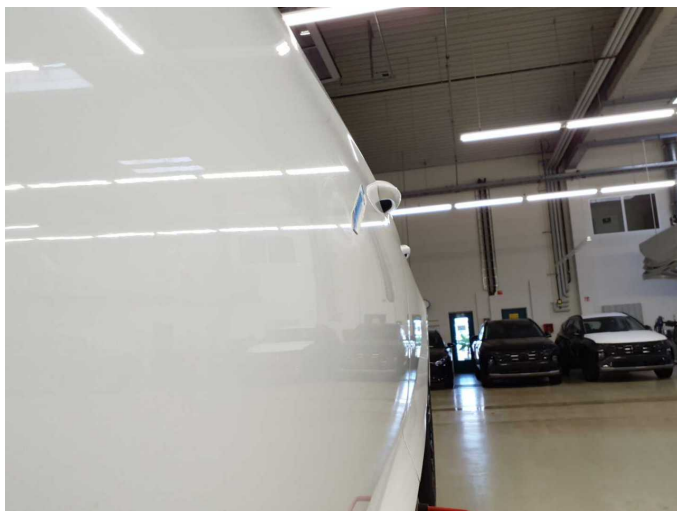
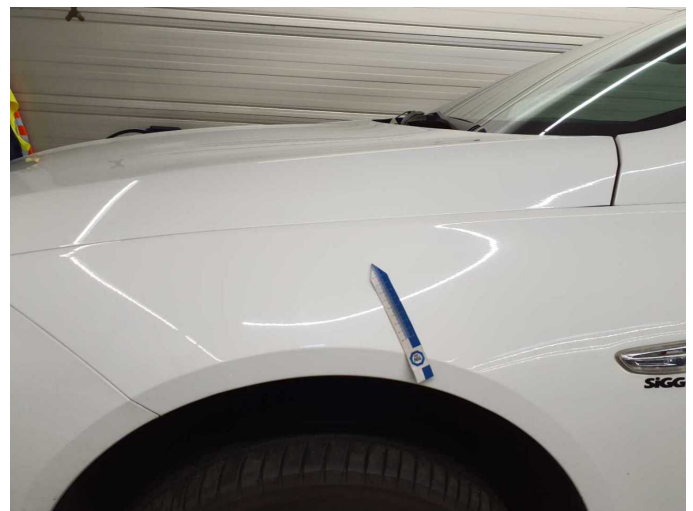
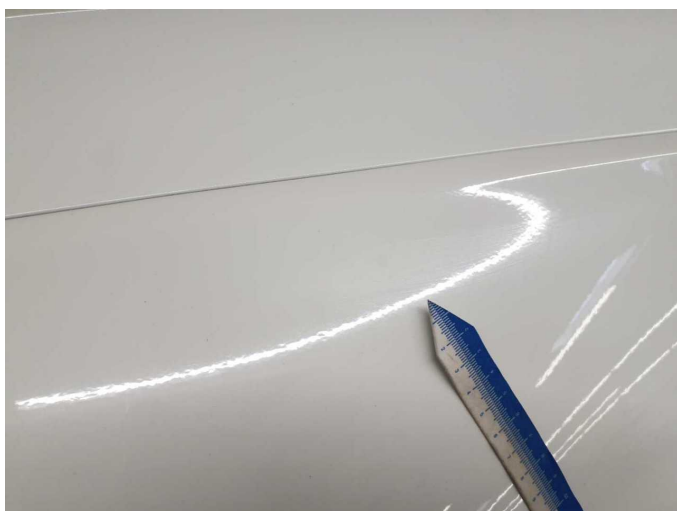
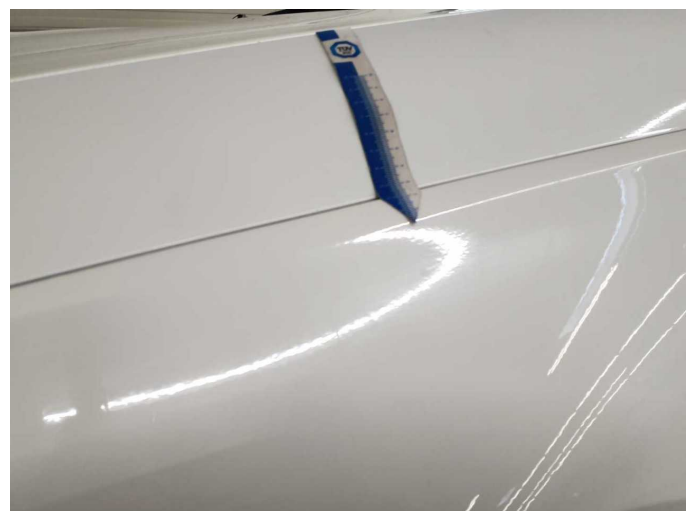
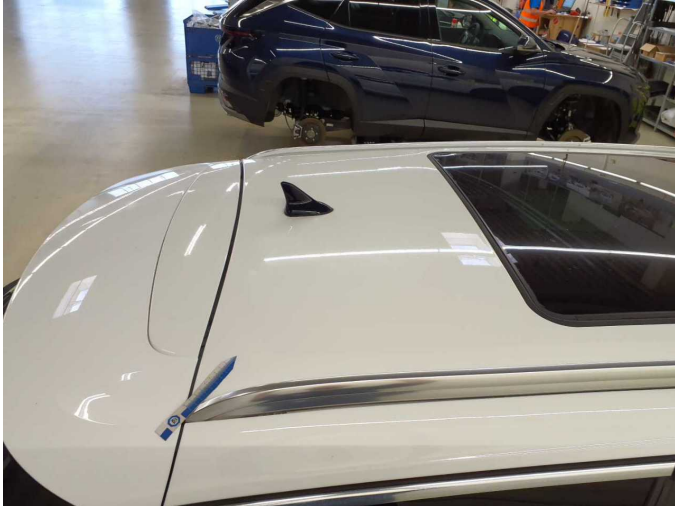
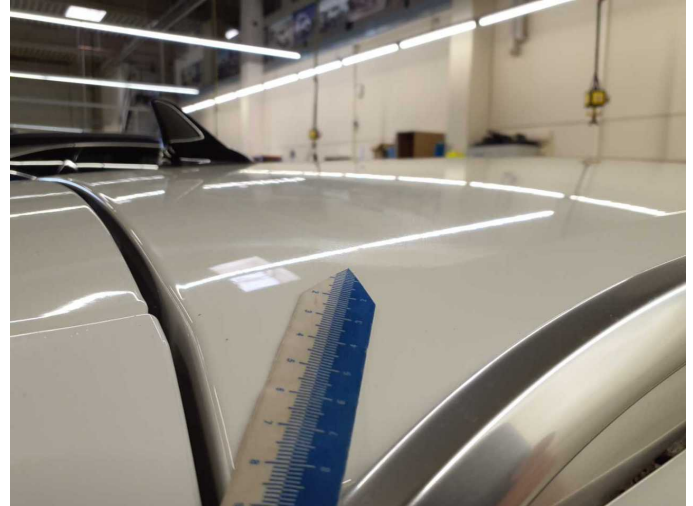
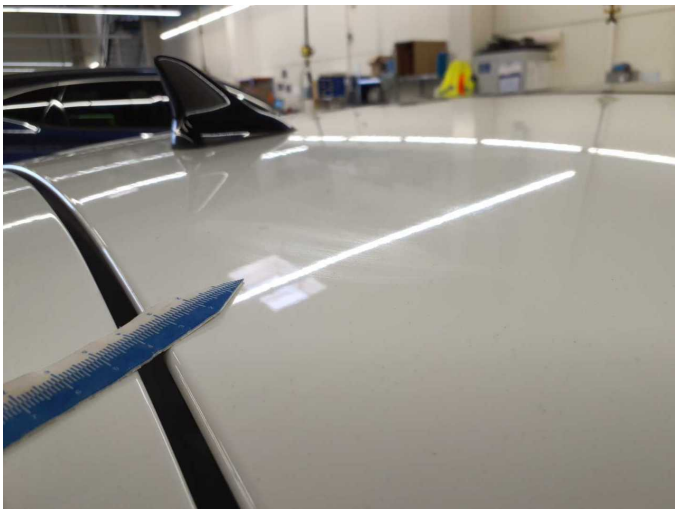
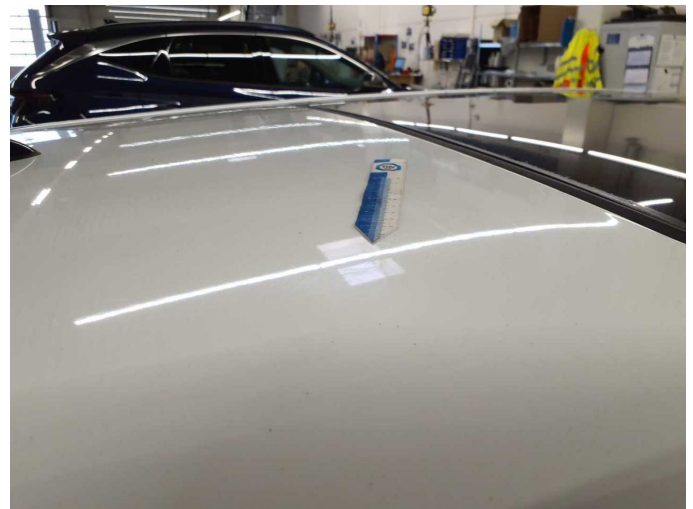
| No. | Component group | Description |
|---|---|---|
| 3 | Body | Body - Scratched - Conditioning |

**Damage 3:** Body: Body - Scratched - Conditioning

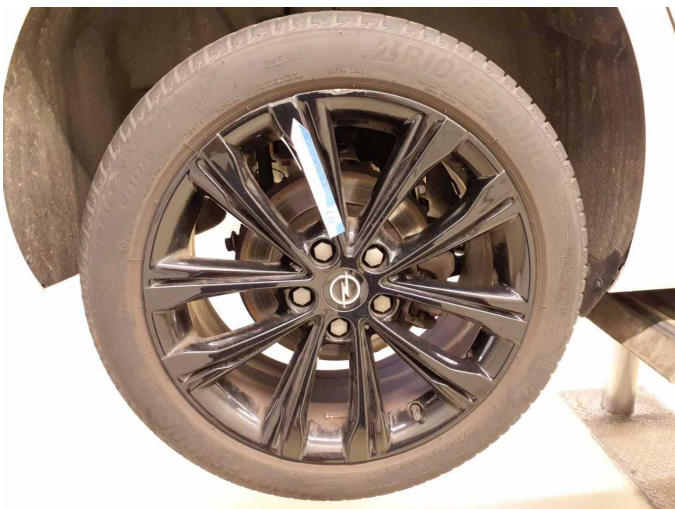
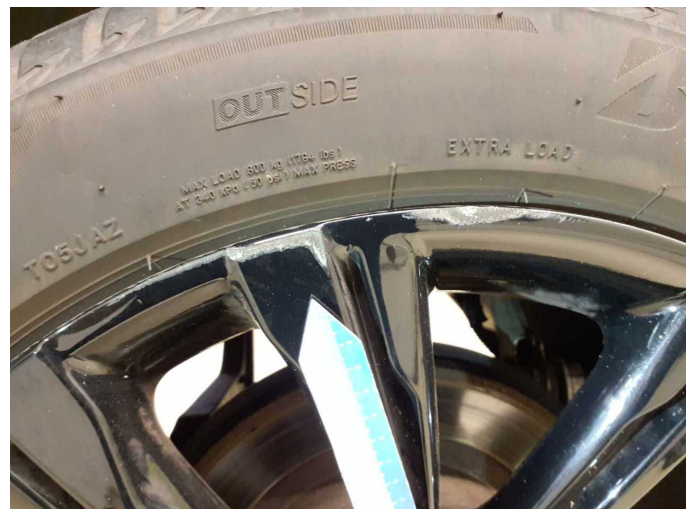
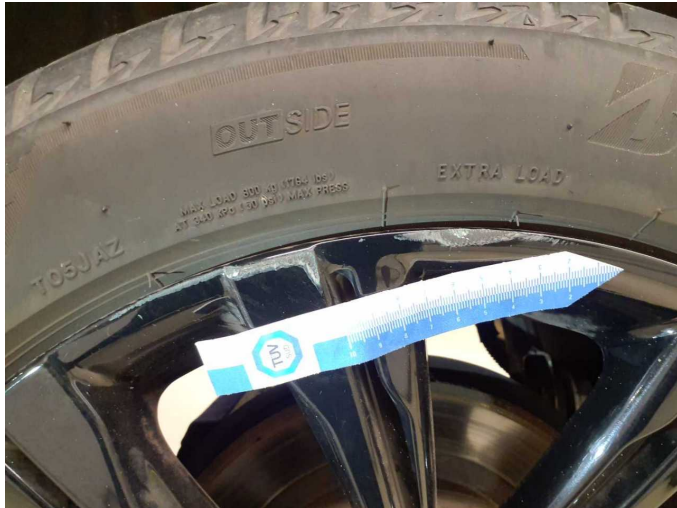
| No. | Component group | Description |
|---|---|---|
| 5 | Wheel / tyres | Alloy rim - rear right side - Scratched - Smart repair |

**Damage 5:** Wheel / tyres: Alloy rim - rear right side - Scratched - Smart repair

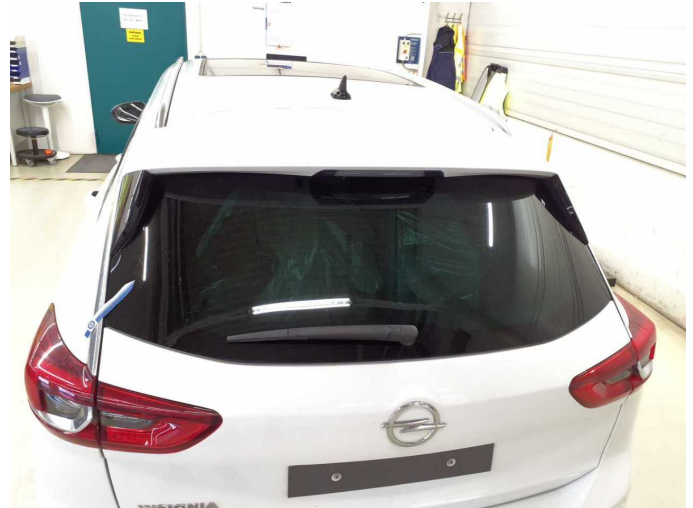
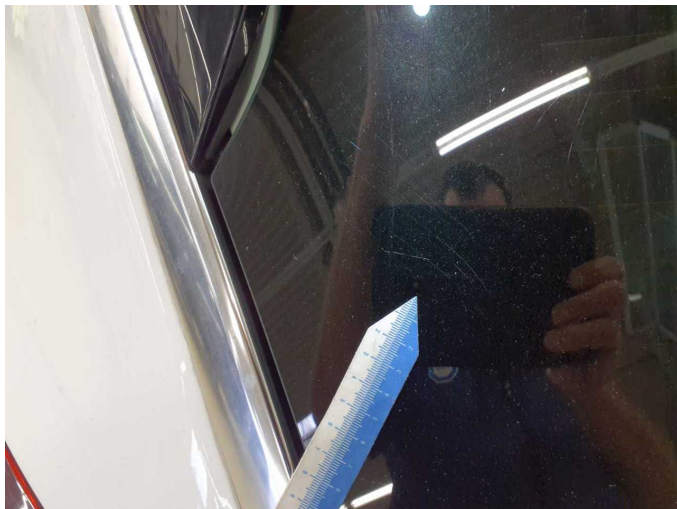
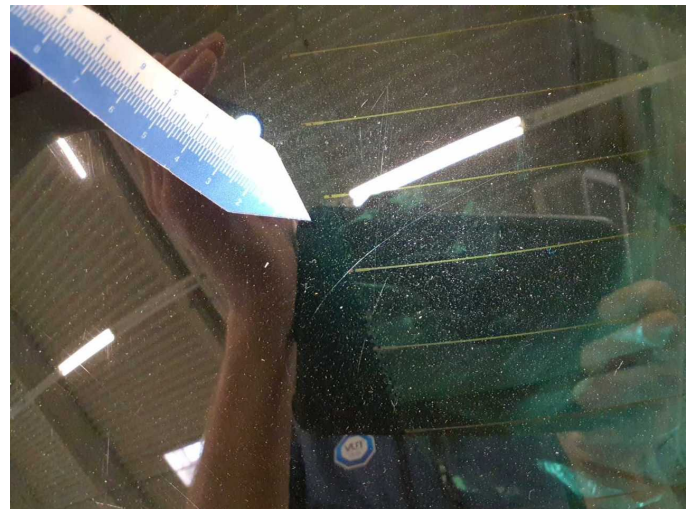
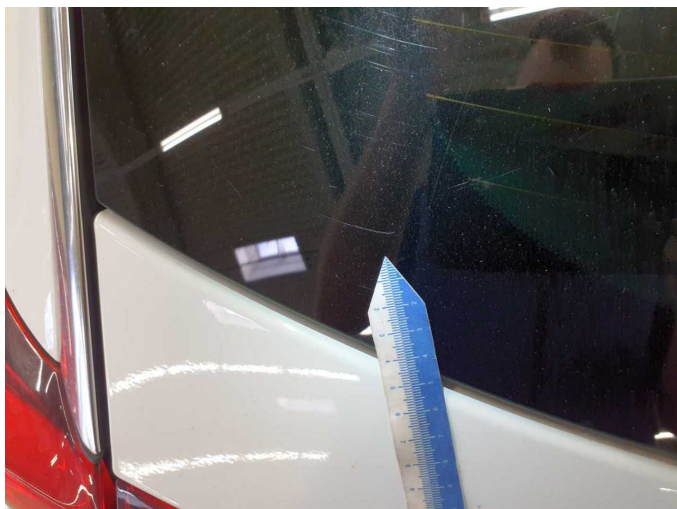
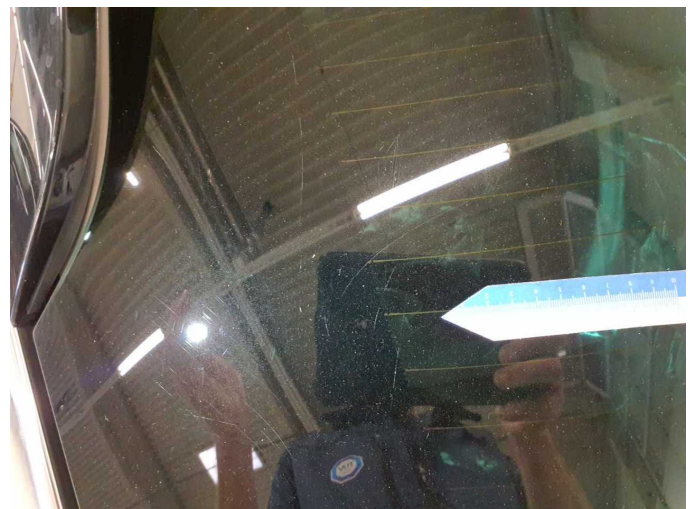
| No. | Component group | Description |
|---|---|---|
| 6 | Vehicle glazing | Rear window - Scratched - Loss in value |

**Damage 6:** Vehicle glazing: Rear window - Scratched - Loss in value

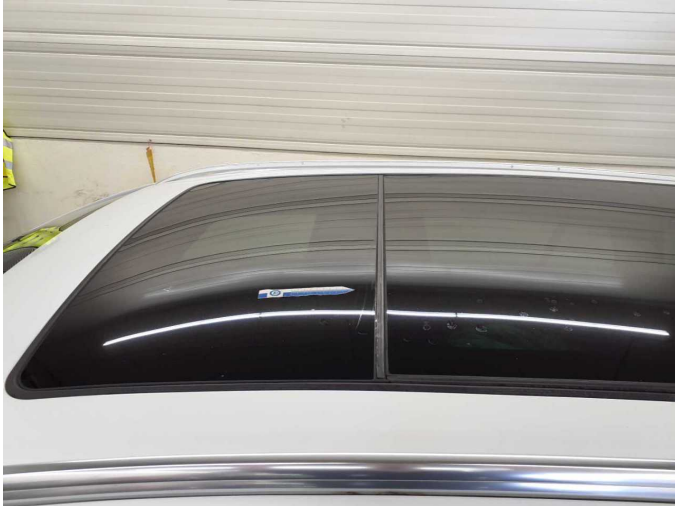
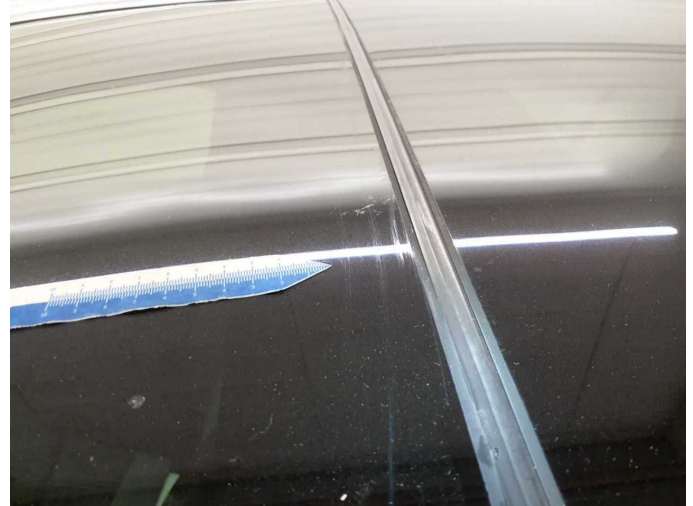
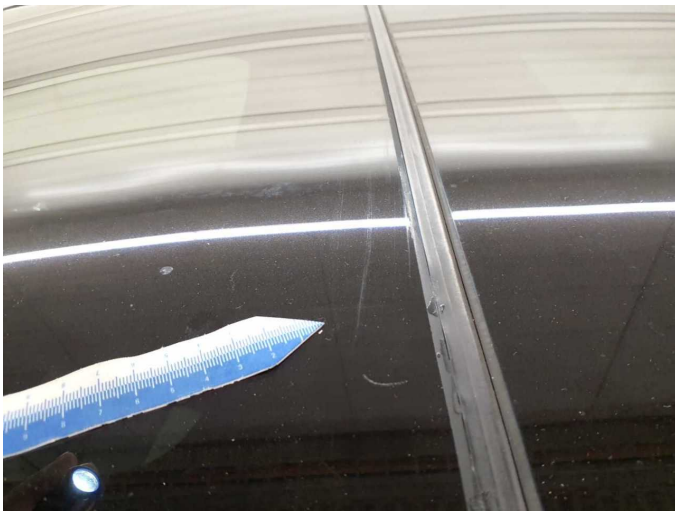
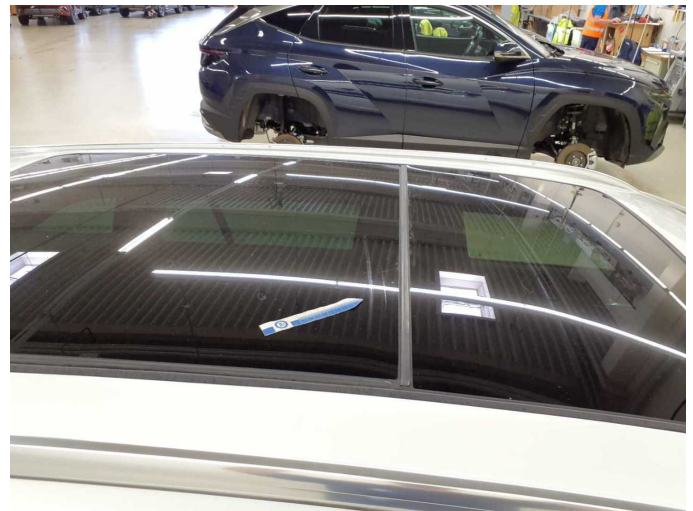
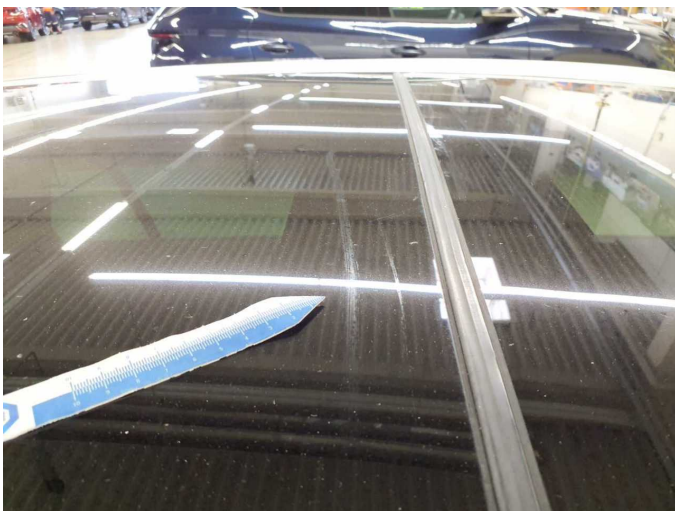
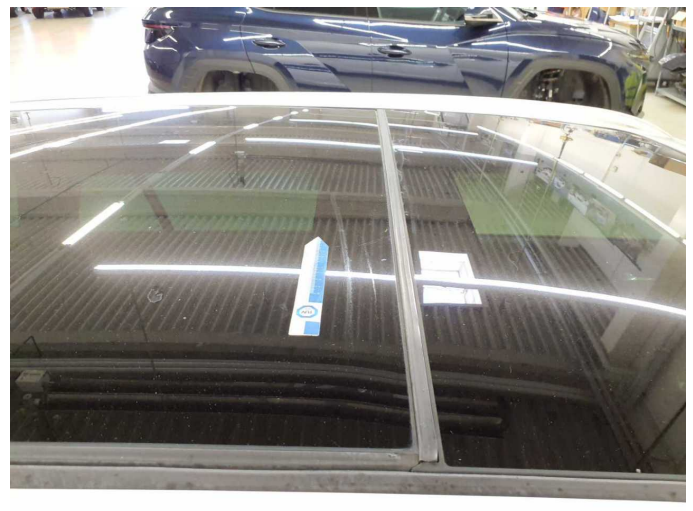
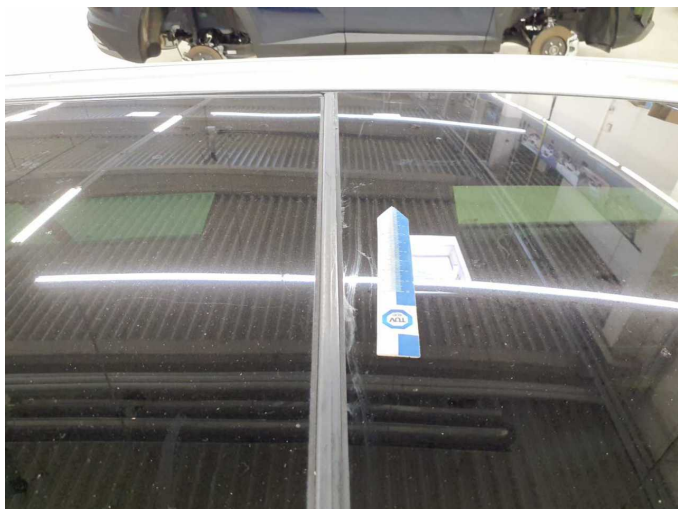
| No. | Component group | Description |
|---|---|---|
| 7 | Roof | Sun roof / glass - Scratched - Replace |

**Damage 7:** Roof: Sun roof / glass - Scratched - Replace

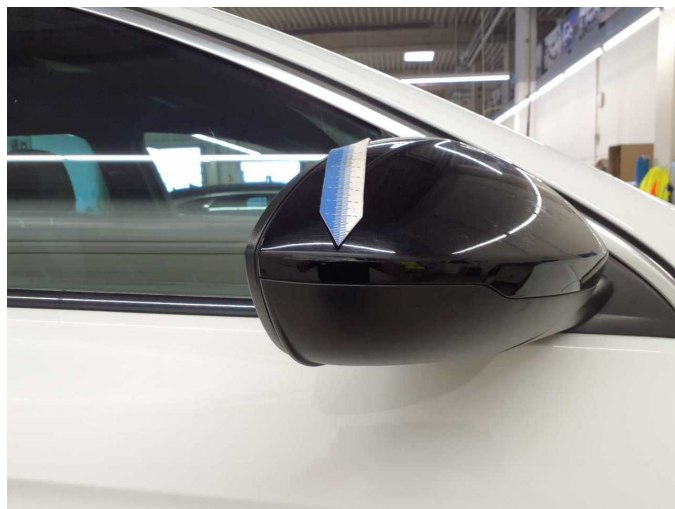
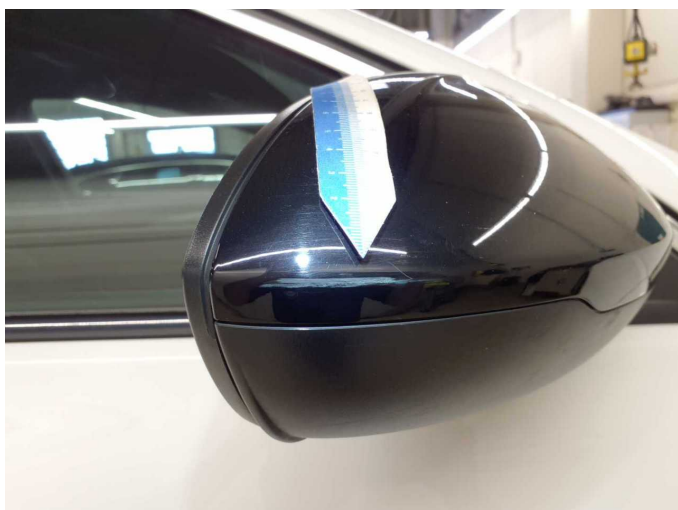
| No. | Component group | Description |
|---|---|---|
| 1 | Wing mirror - right side | Cap - Scratched - No deduction |

**Wear and tear 1:** Wing mirror - right side: Cap - Scratched - No deduction

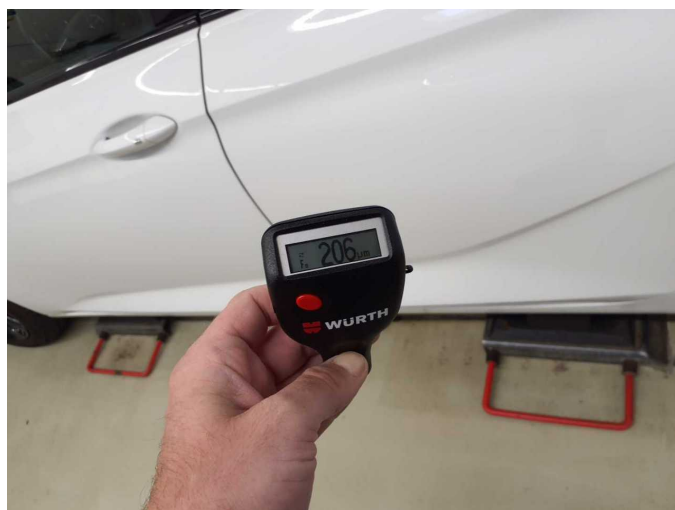
| Door - rear left side | 206 µm | Door - rear right side | 327 µm |

**Door - rear left side:** 206 µm

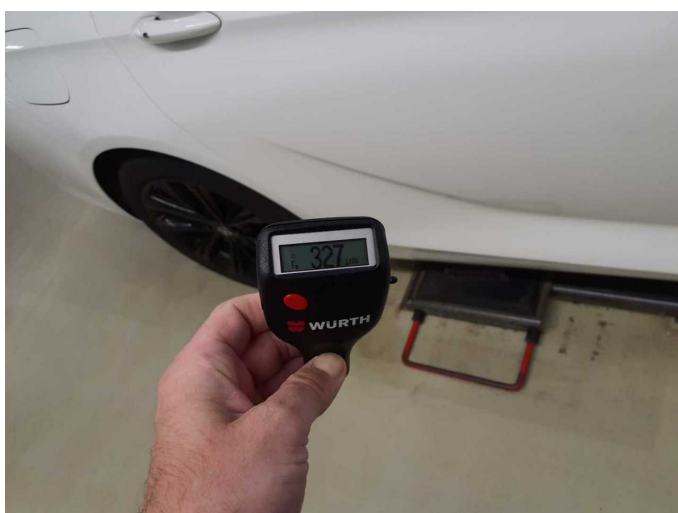
**Door - rear right side:** 327 µm

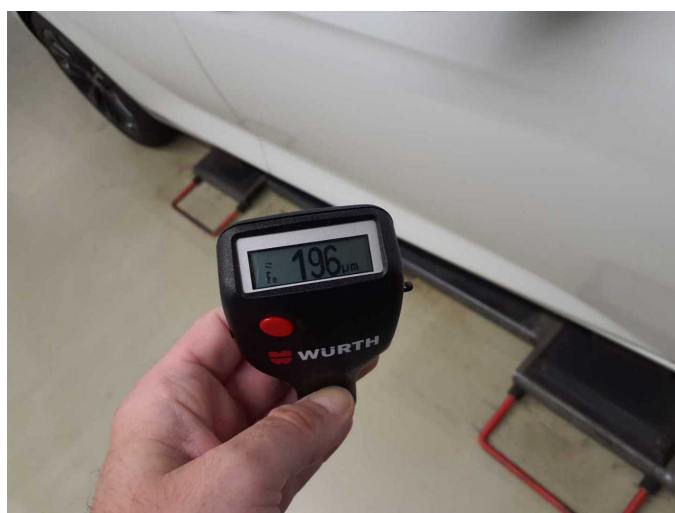
| Door - front right side | 196 µm | | |

**Door - front right side:** 196 µm
