Expertise

Protocol number: 46480243  
Order No. / Reference: 26562285-1  
Inspection date: 8 Jul 2026

Manufacturer: Ford

Model: Transit 350 L3H2 Lkw VA Trend

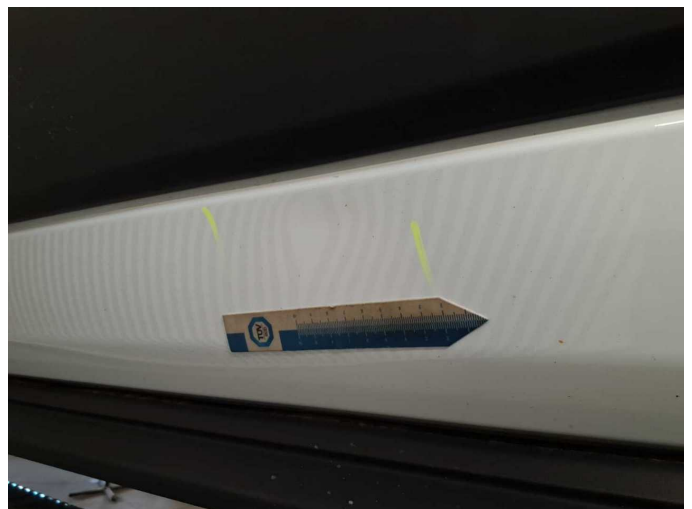
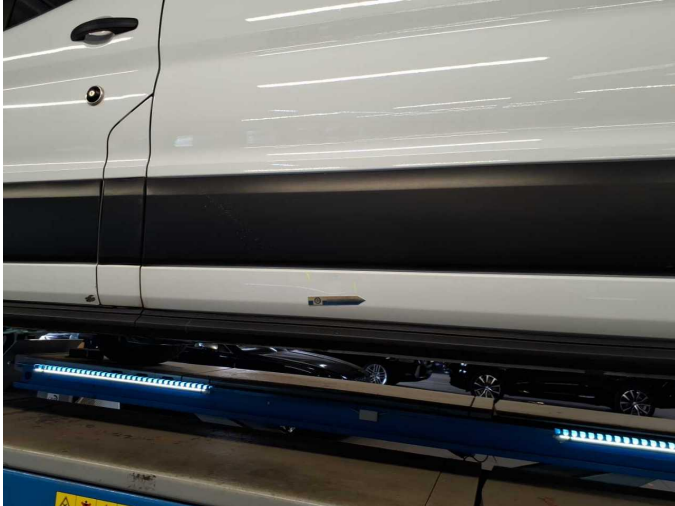
| No. | Component group | Description |
|---|---|---|
| 2 | Side panel - rear left side | Side panel - dent(s) - Smooth repair work |

Damage 2: Side panel - rear left side: Side panel - dent(s) - Smooth repair work

**Damage 2:** Side panel - rear left side: Side panel - dent(s) - Smooth repair work

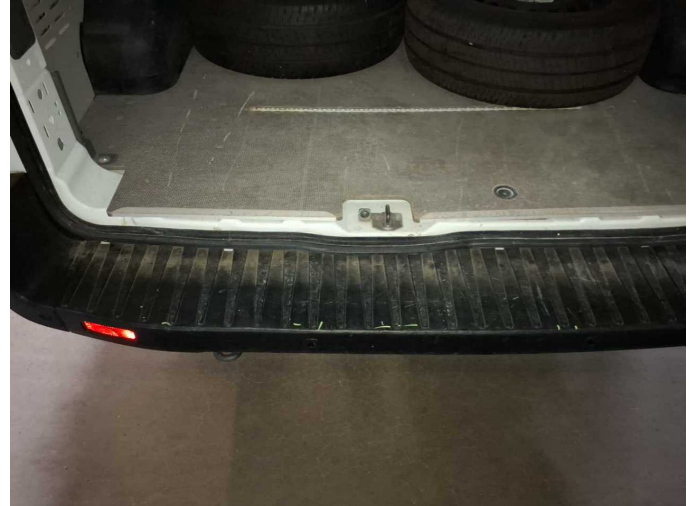
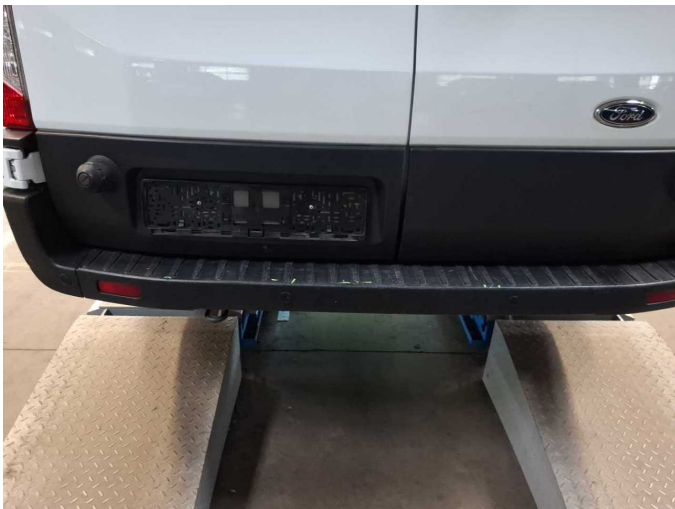
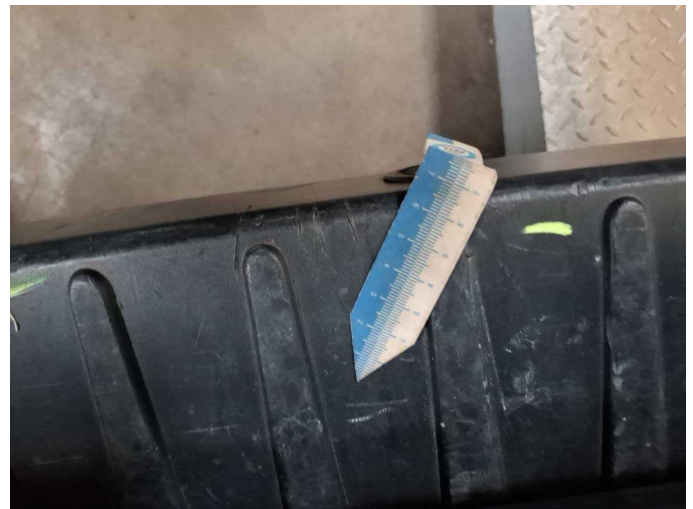
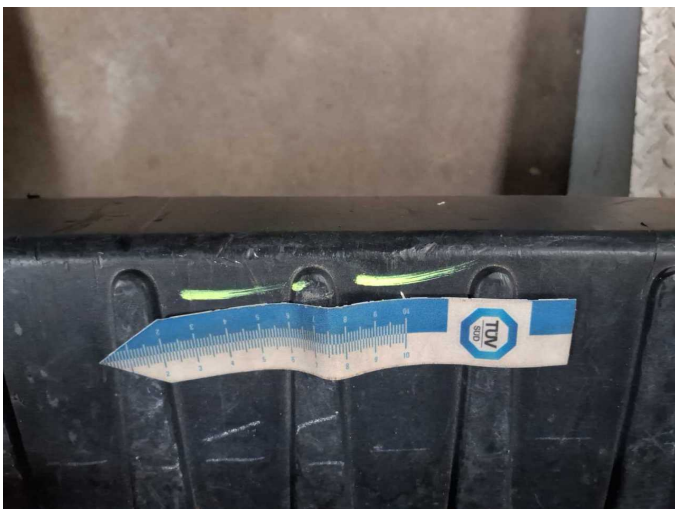
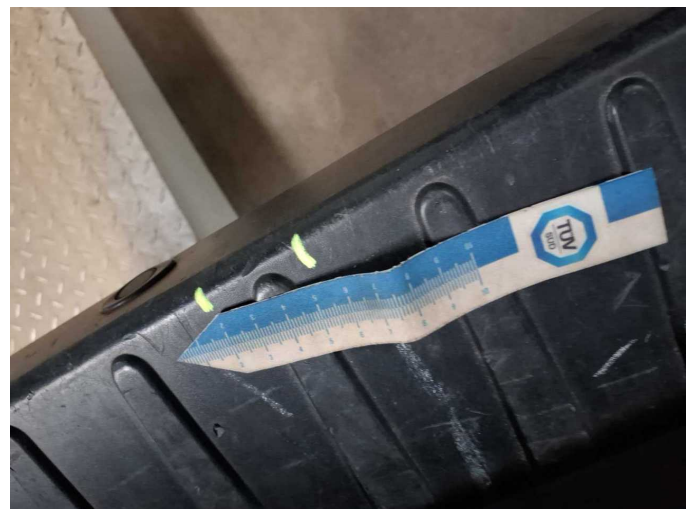
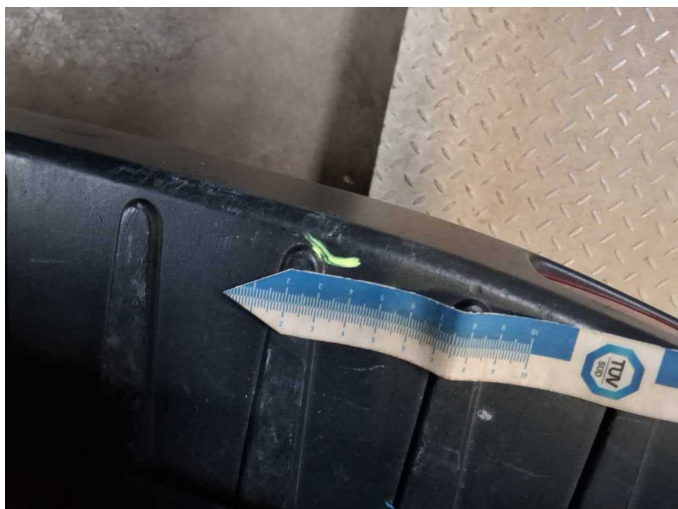
| No. | Component group | Description |
|---|---|---|
| 3 | Rear bumper | Rear bumper (unpainted) - Scratch(es) - Smart repair |

**Damage 3:** Rear bumper: Rear bumper (unpainted) - Scratch(es) - Smart repair

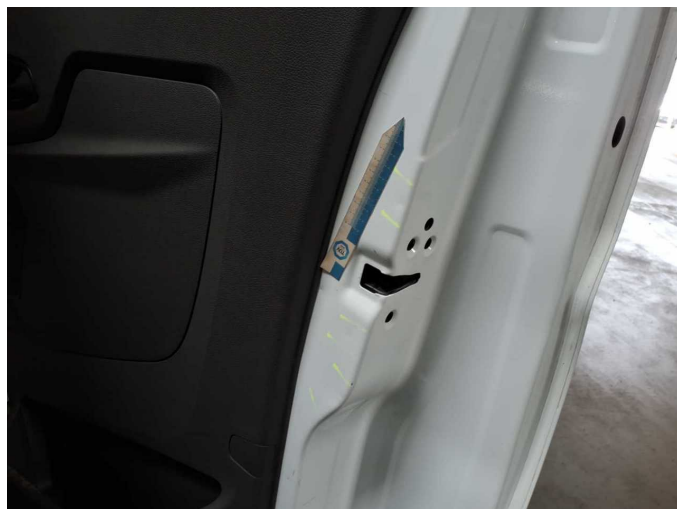
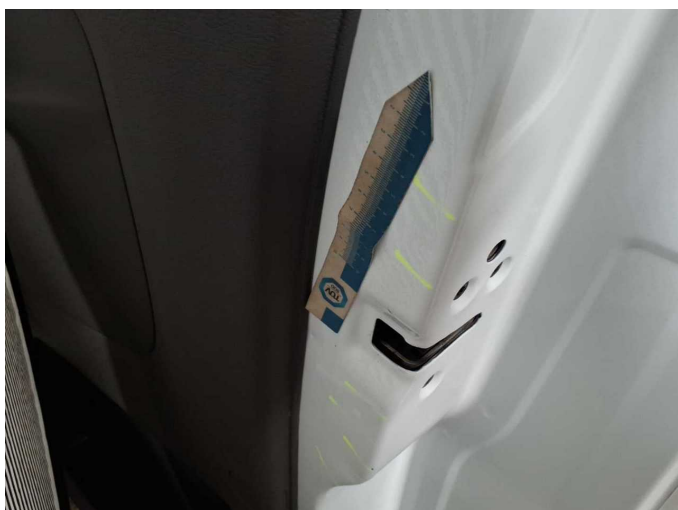
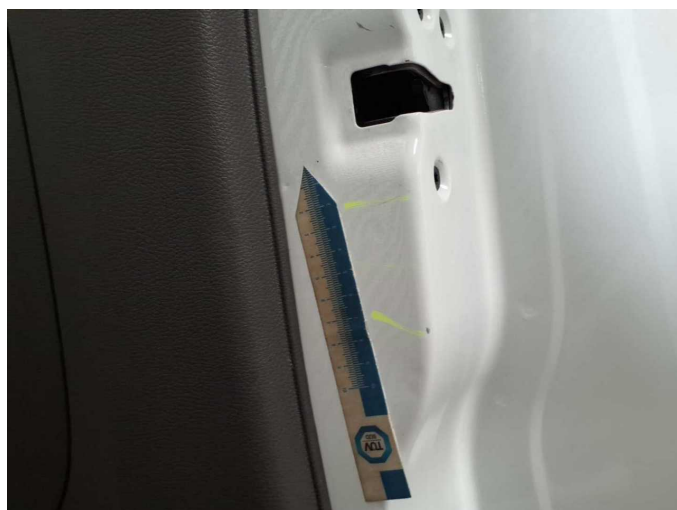
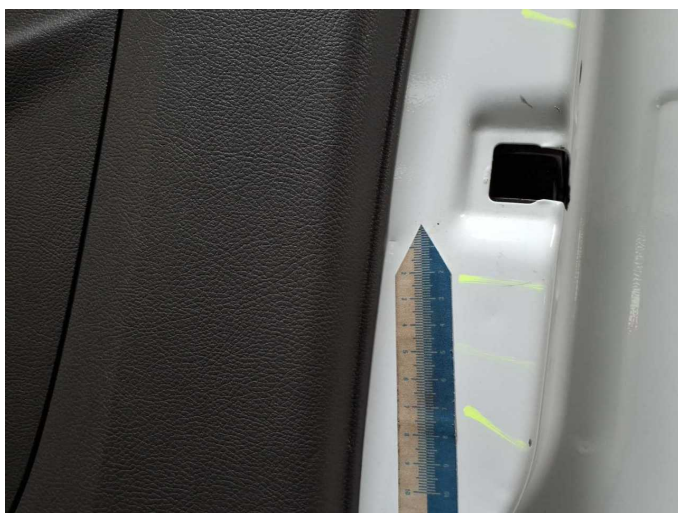
| No. | Component group | Description |
|---|---|---|
| 4 | Door - front right side | Door (innen) - dent(s) - Smooth repair work |

**Damage 4:** Door - front right side: Door (innen) - dent(s) - Smooth repair work

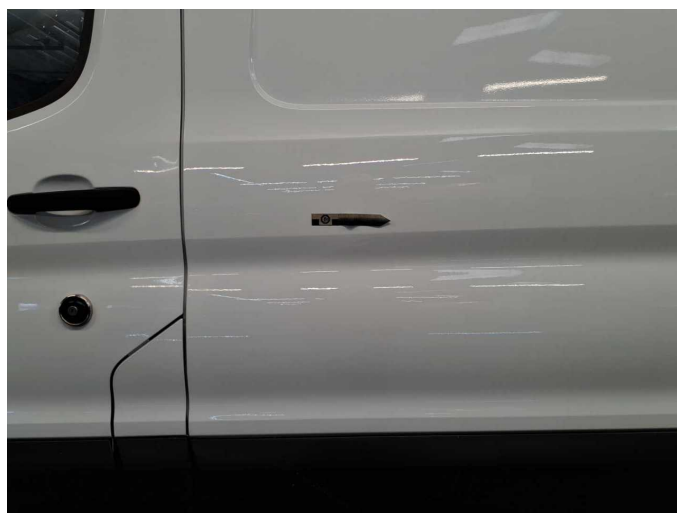
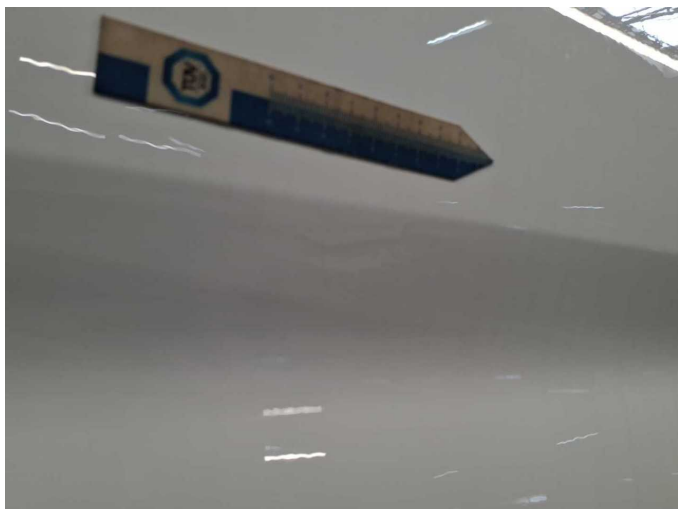
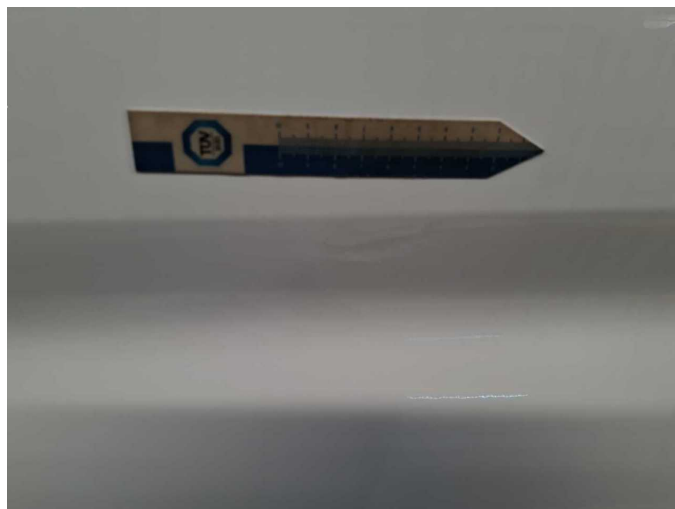
| No. | Component group | Description |
|---|---|---|
| 5 | Side panel - rear left side | Side panel (Mehrkosten möglich) - Unprofessionally repaired - Conditioning |

**Damage 5:** Side panel - rear left side: Side panel (Mehrkosten möglich) - Unprofessionally repaired - Conditioning

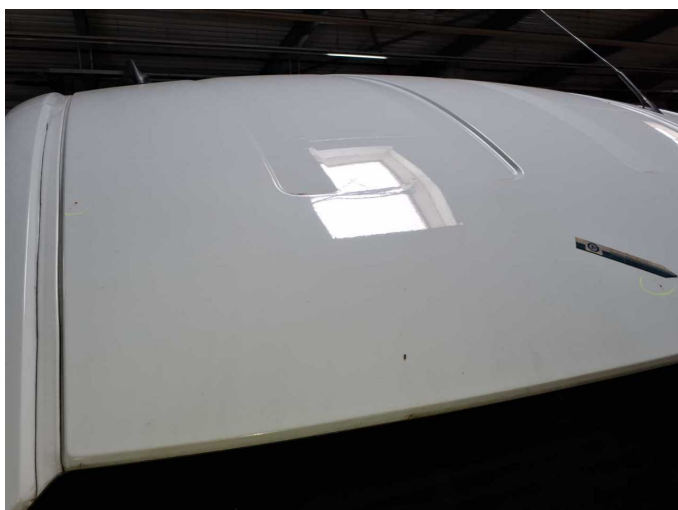
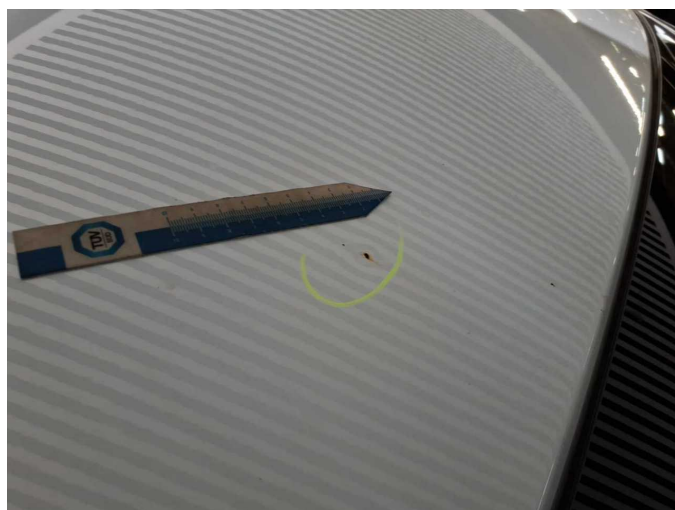
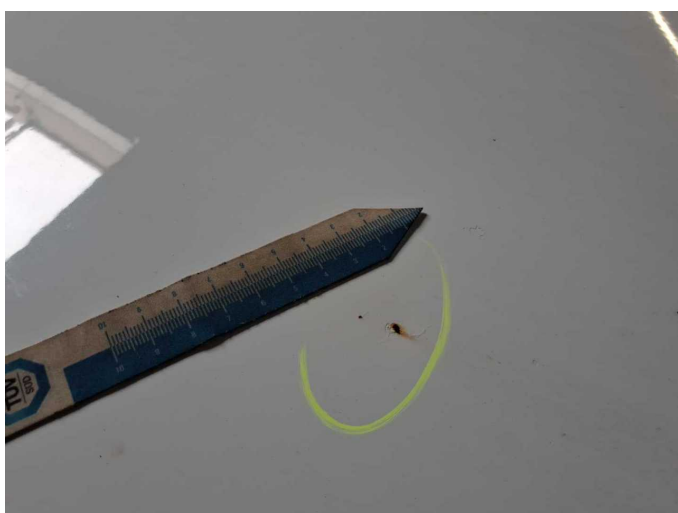
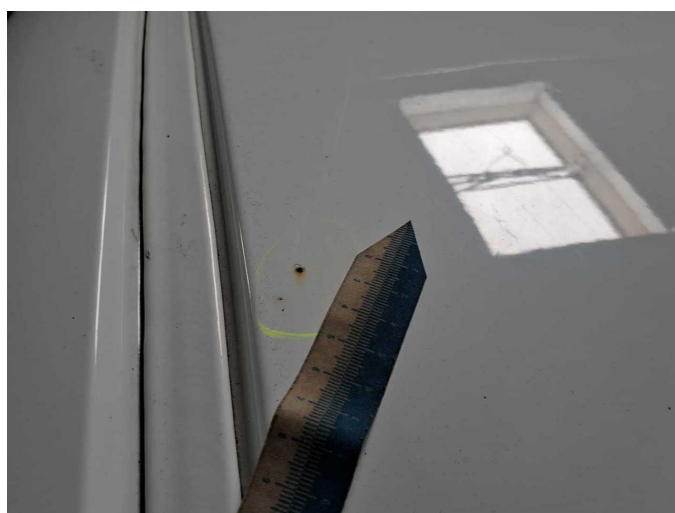
| No. | Component group | Description |
|---|---|---|
| 6 | Roof | Roof - Dent / paintcoat damage - Repair and paint |

**Damage 6:** Roof: Roof - Dent / paintcoat damage - Repair and paint

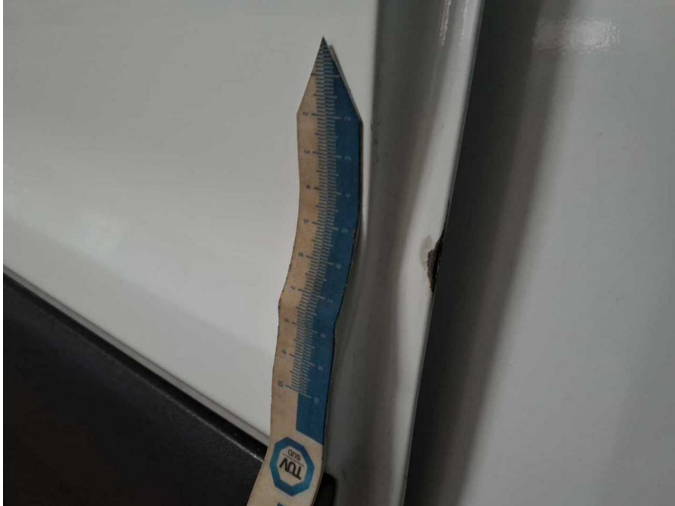
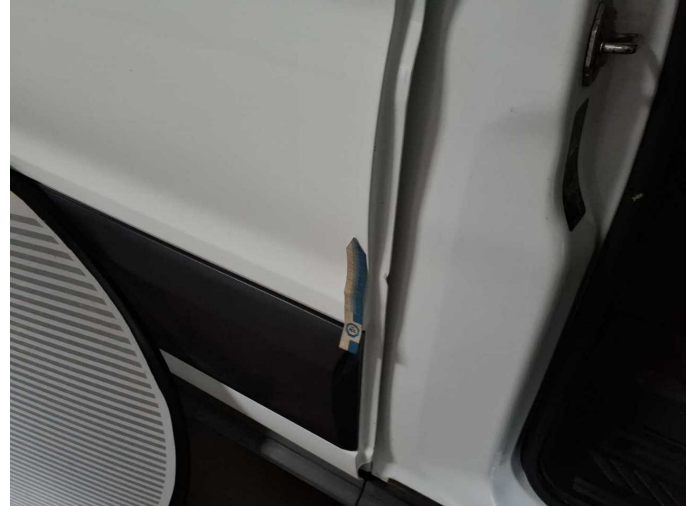
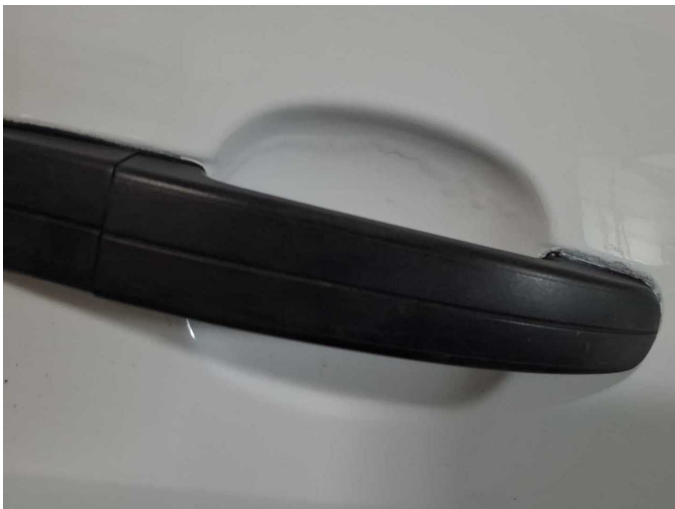
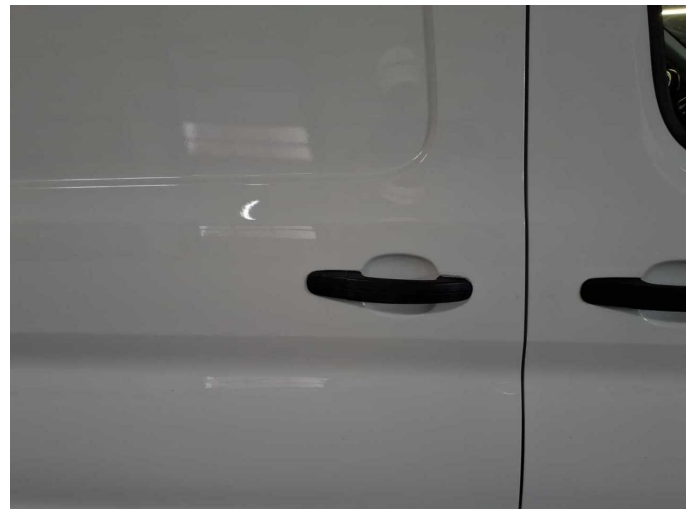
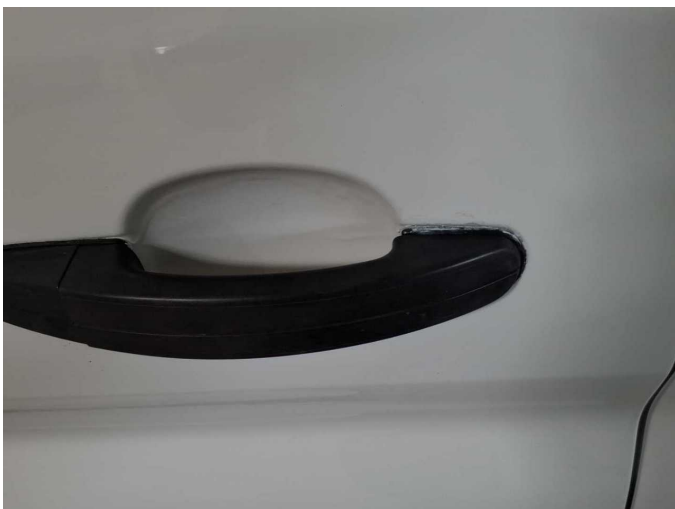
| No. | Component group | Description |
|---|---|---|
| 7 | Sliding door, right | Sliding door (Rost und lackläufer) - Unprofessionally repaired - Paint |

**Damage 7:** Sliding door, right: Sliding door (Rost und lackläufer) - Unprofessionally repaired - Paint

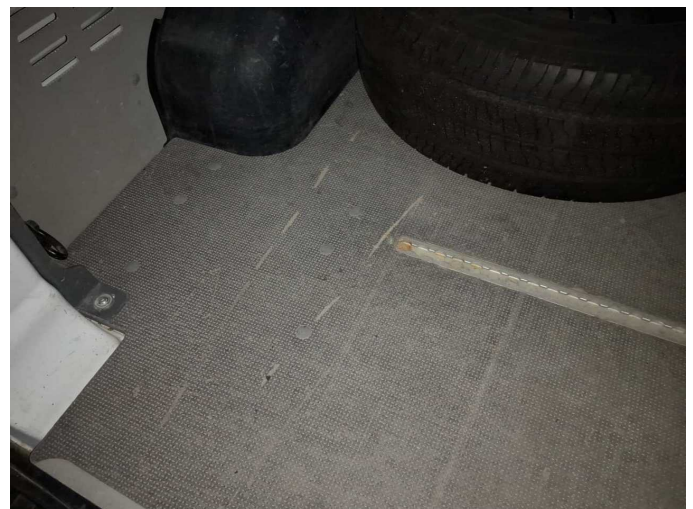
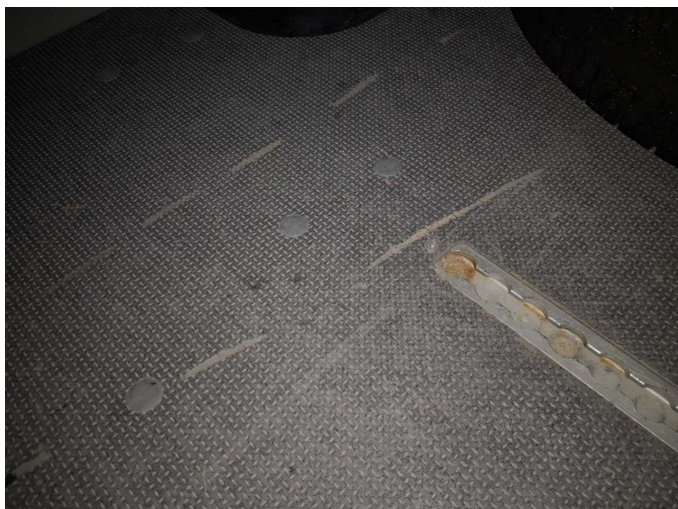
| No. | Component group | Description |
|---|---|---|
| 1 | Interior | Cargo area floor - Scratch(es) - No deduction |

**Wear and tear 1:** Interior: Cargo area floor - Scratch(es) - No deduction

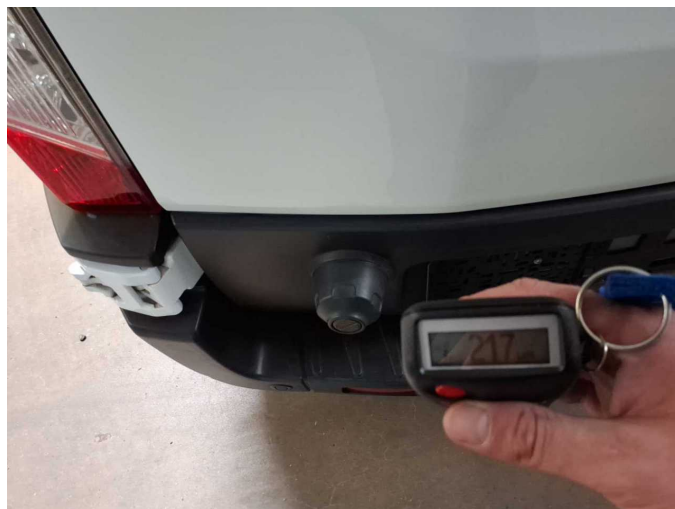
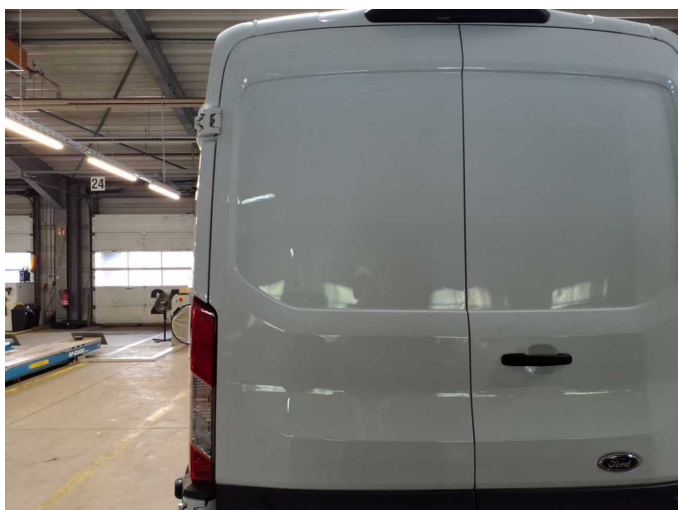
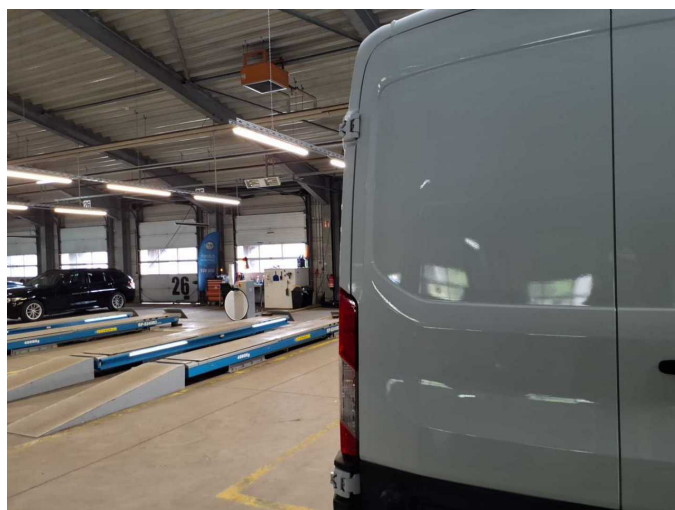
| No. | Repainting |
|---|---|
| 1 | Boot lid / rear door |

**Repainting 1:** Boot lid / rear door

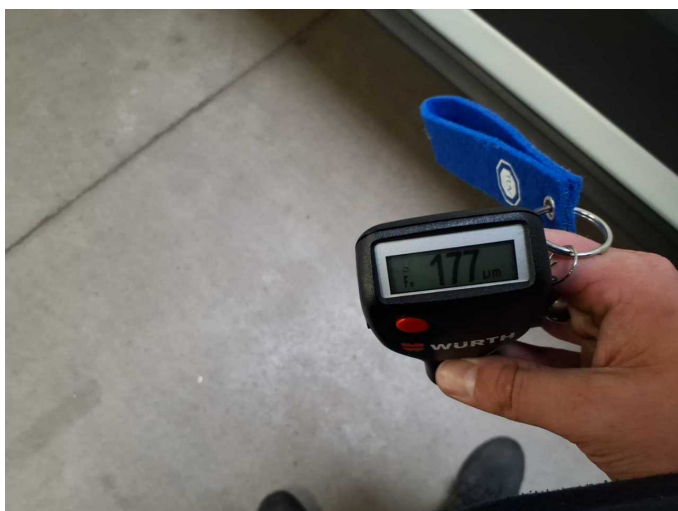
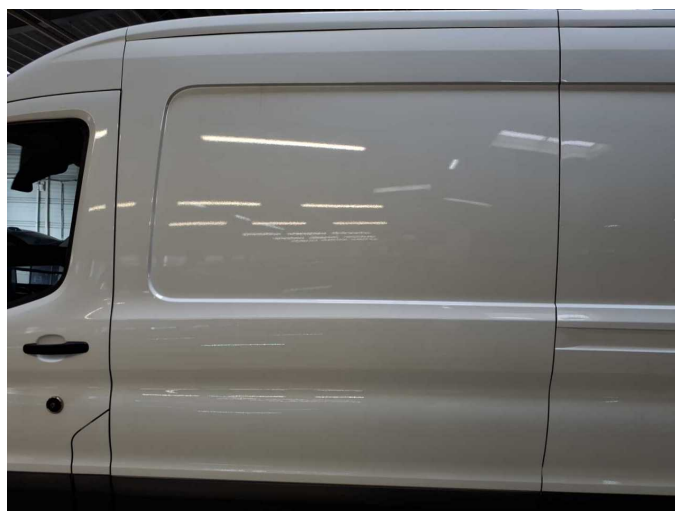
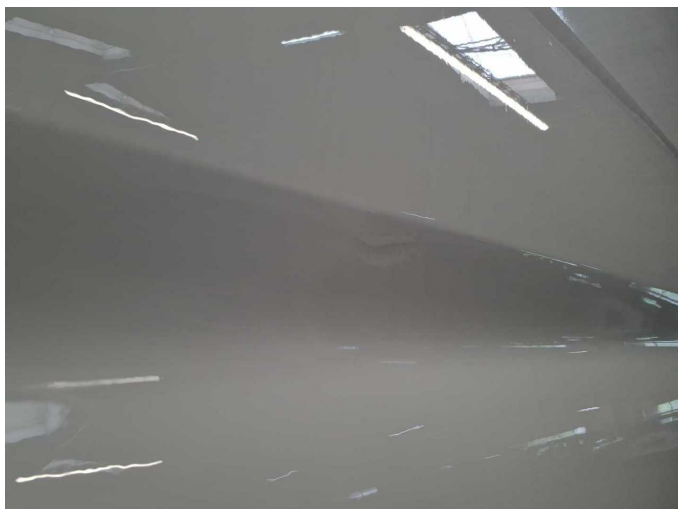
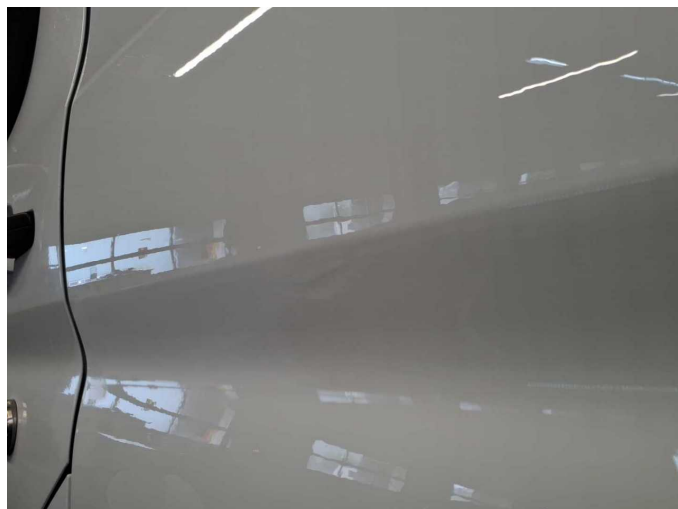
| No. | Repainting |
|---|---|
| 2 | Side panel - rear left side, Unprofessionally carried out, Invoice of repair done Non-existent |

**Repainting 2:** Side panel - rear left side

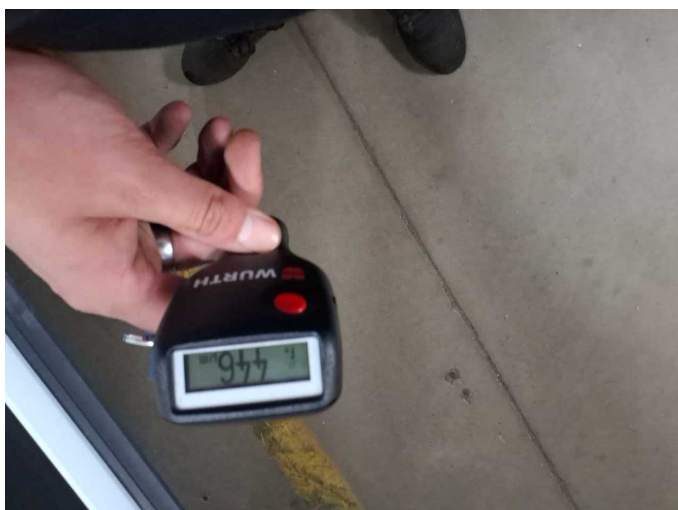
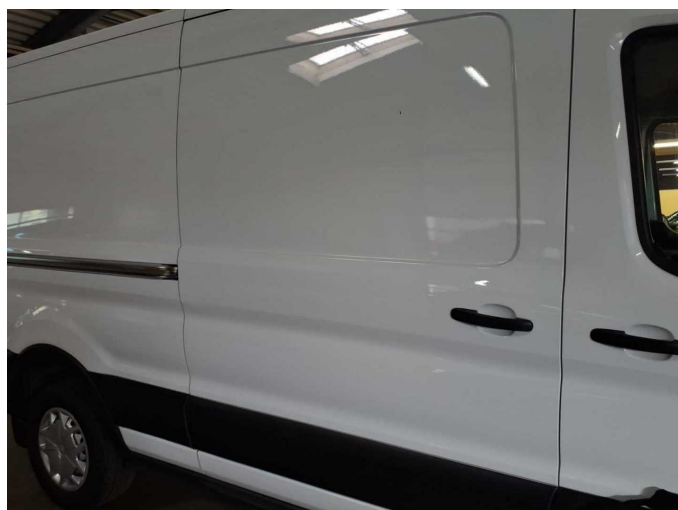
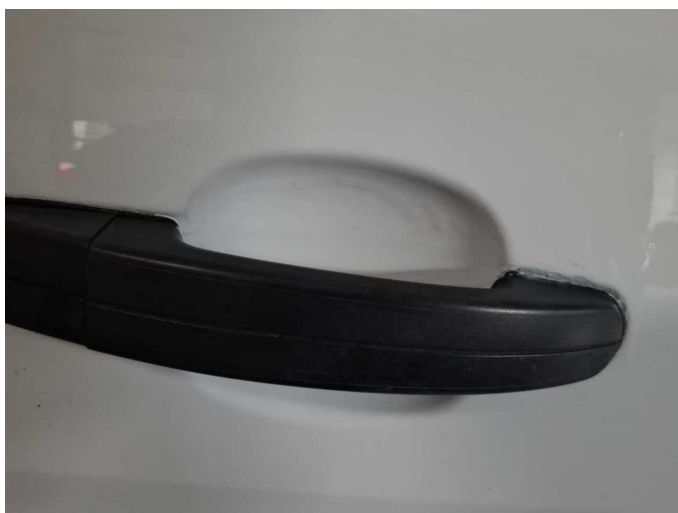
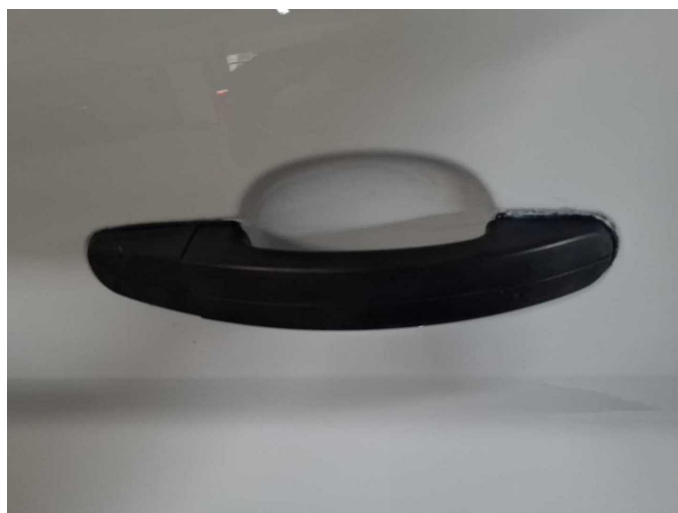
| No. | Repainting |
|---|---|
| 3 | Door - rear right side, Unprofessionally carried out, Invoice of repair done Non-existent |

**Repainting 3:** Door - rear right side

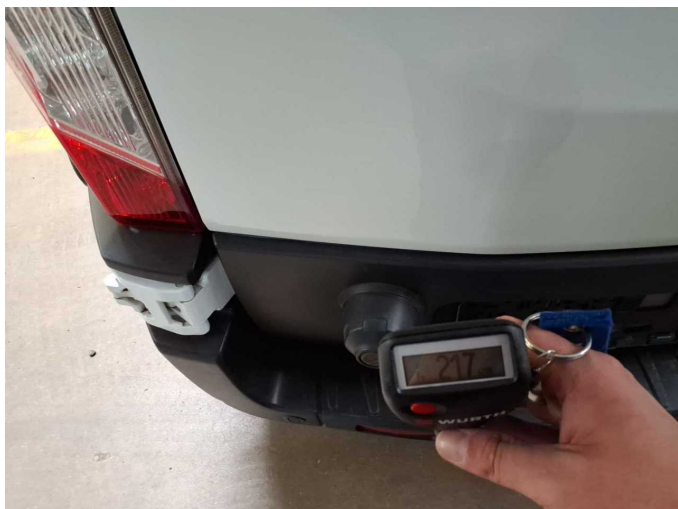
**Boot lid / rear door: 217  $\mu\text{m}$**

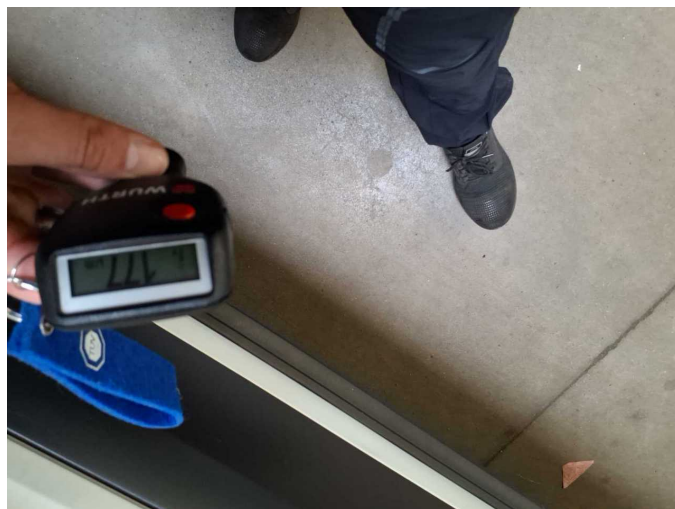
**Side panel - rear left side: 177  $\mu\text{m}$**

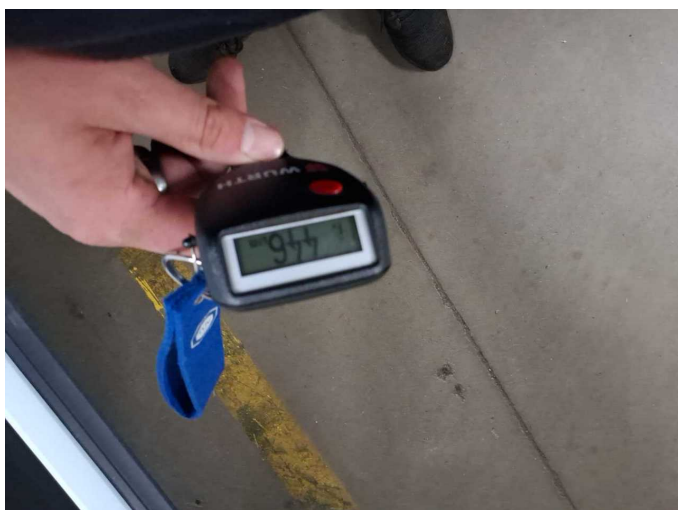
**Door - rear right side: 446  $\mu\text{m}$**
