Expertise

Protocol number: 46182116
Order No. / Reference: 26495033
Inspection date: 26 Jun 2026

Model: Insignia Sports Tourer 2.0 Diesel Aut. Business Elegance

VIN: W0VZT8GP1M1016200

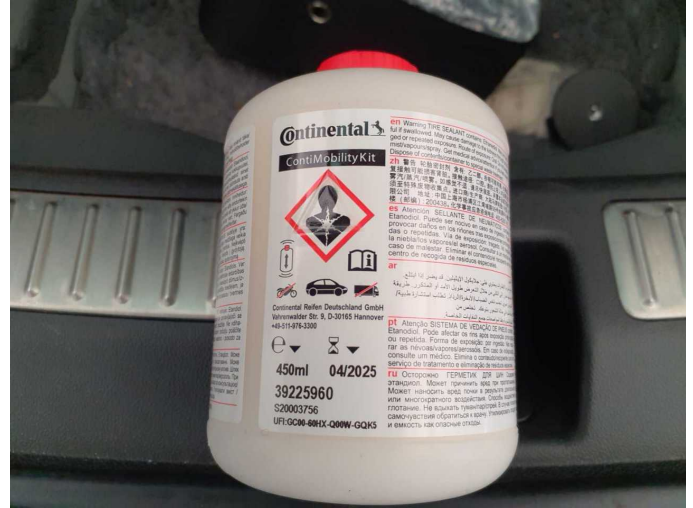
Damage 1: Equipment: Tirefit filler - Expired - Replace

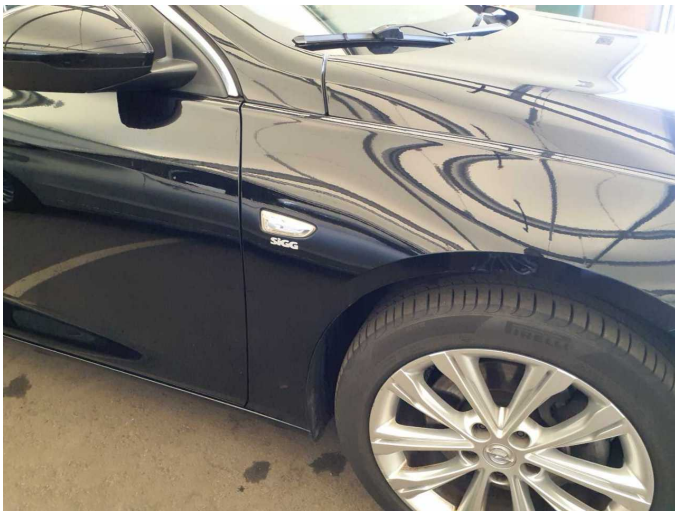
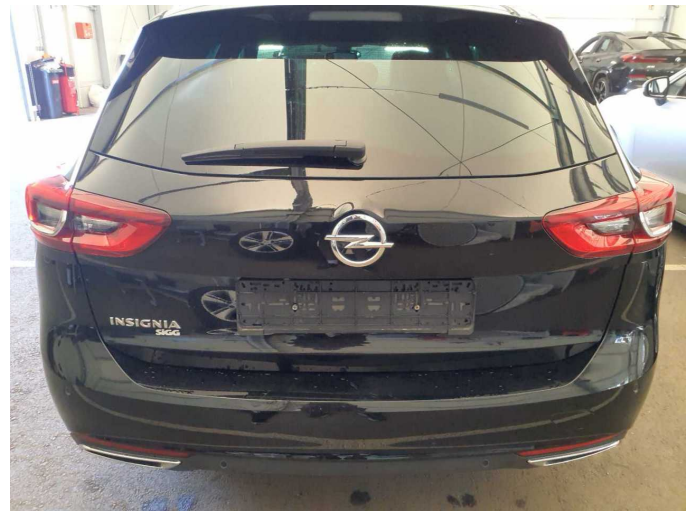
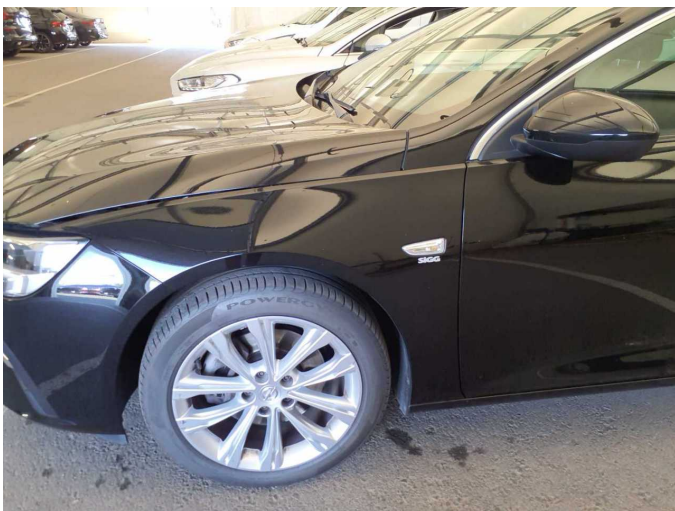
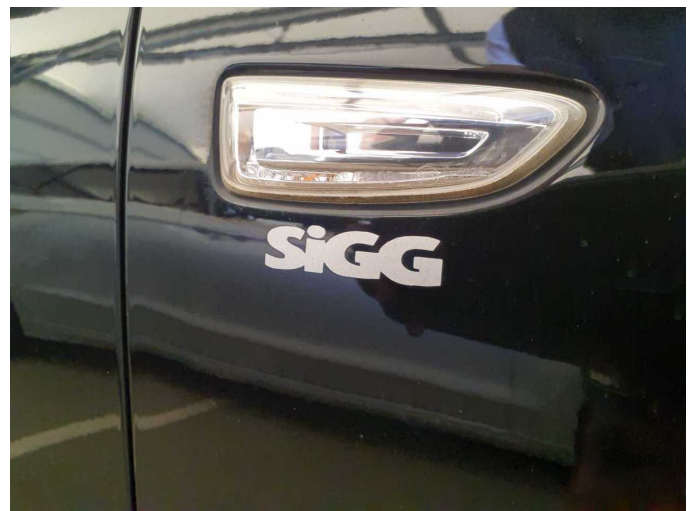
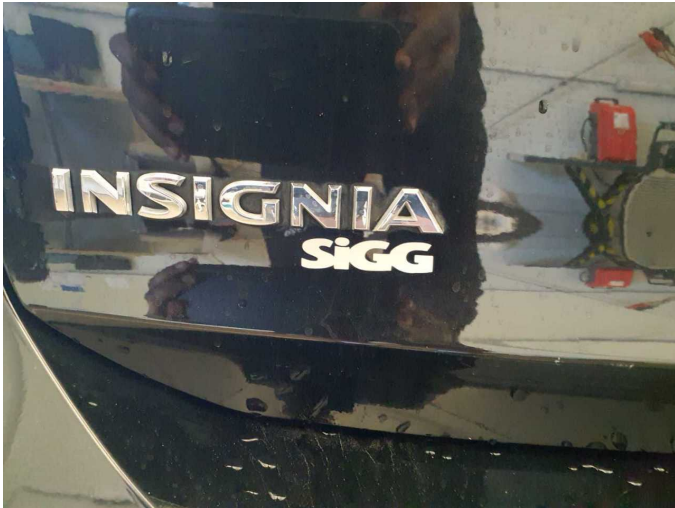
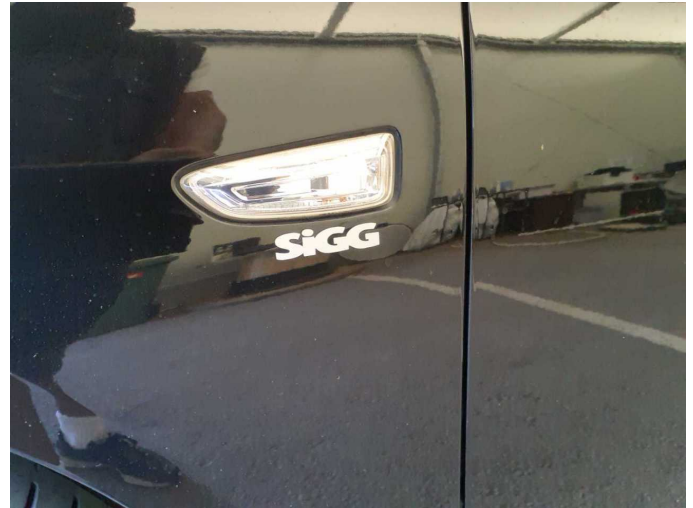
Damage 2: Mudguard - right side: Mudguard - right side - Glued / labelled - De-glue / neutralise

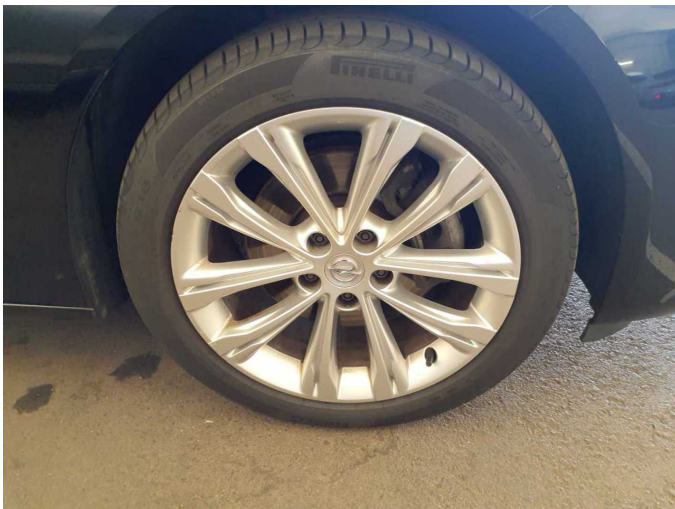
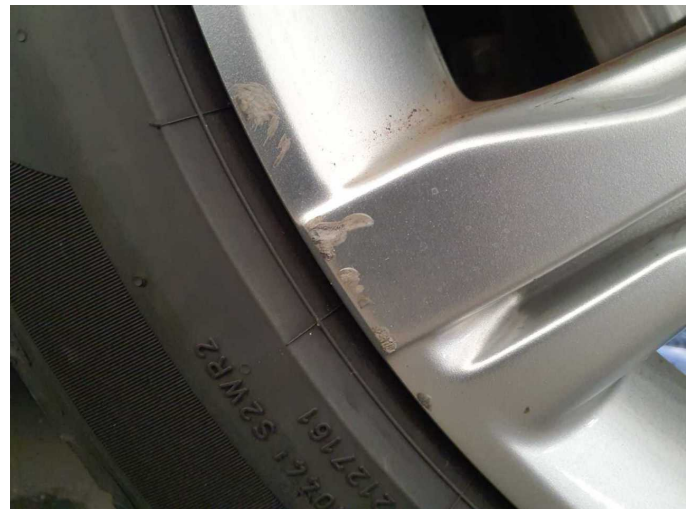
Damage 3: Wheel / tyres: Alloy rim - front right side - Scratch(es) - Loss in value

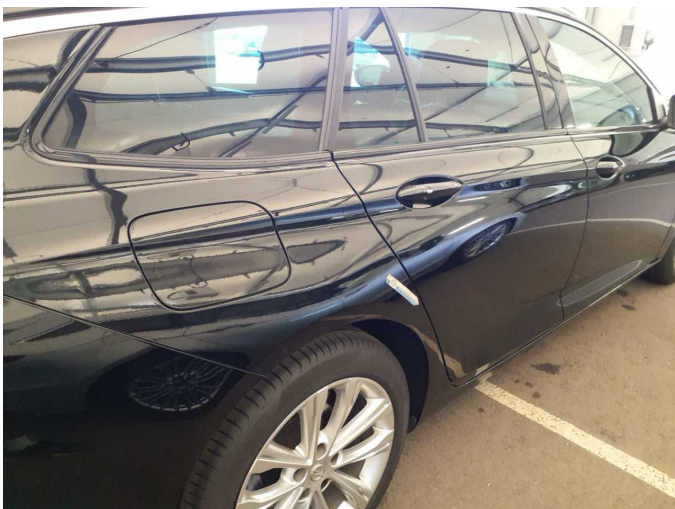
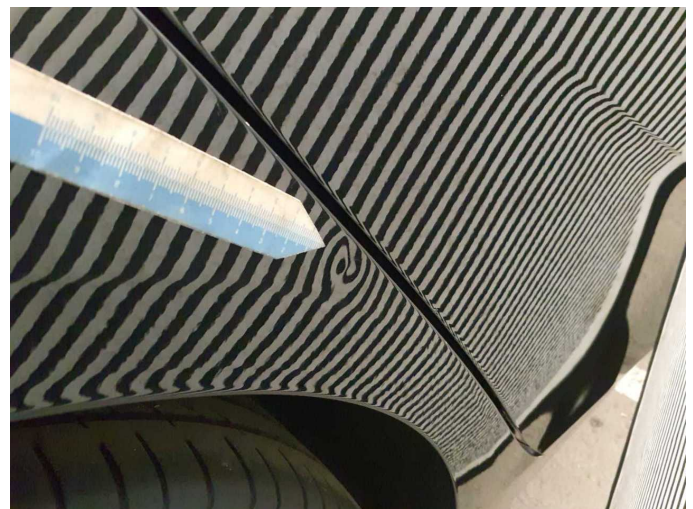
Damage 4: Side panel - rear right side: Side panel - dent(s) - Smart repair

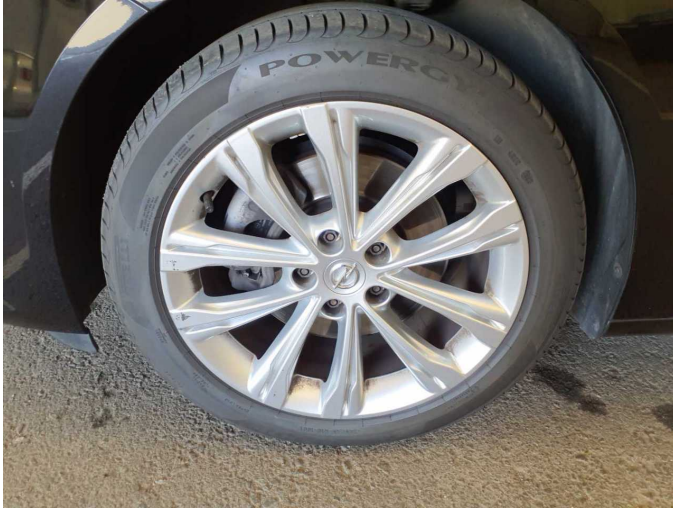
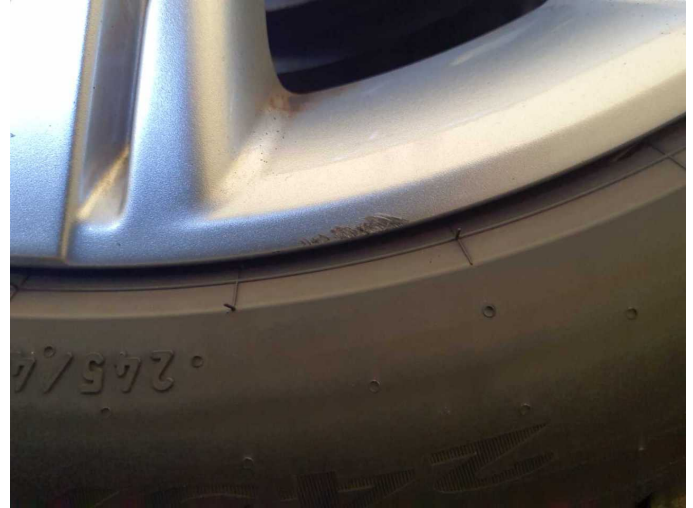
Damage 5: Wheel / tyres: Alloy rim - front left side - Scratch(es) - Loss in value

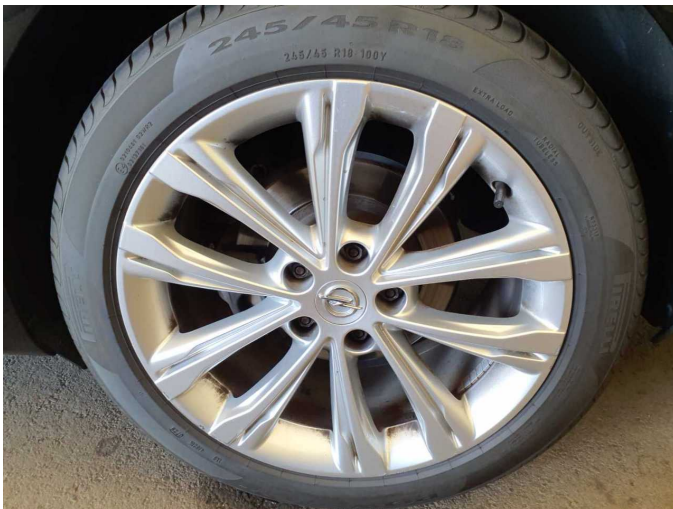
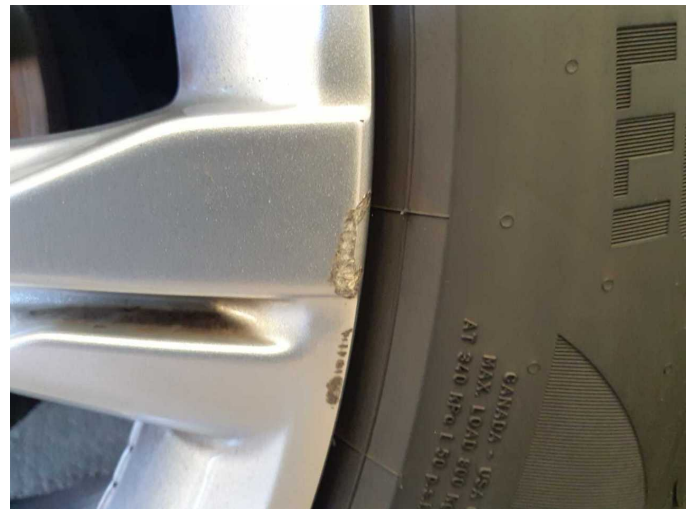
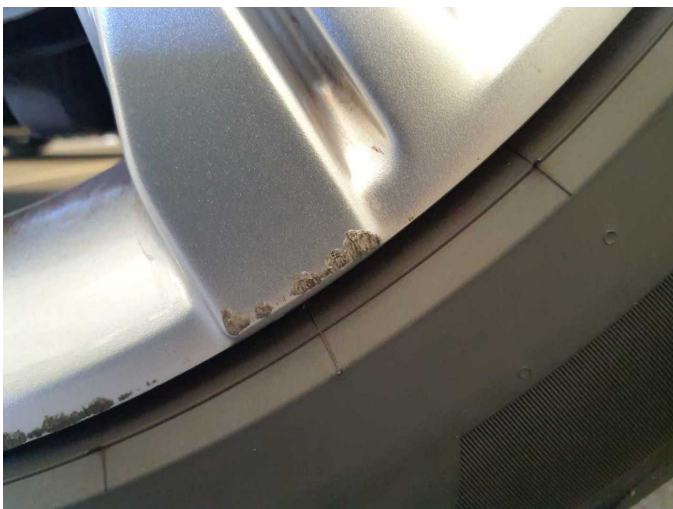
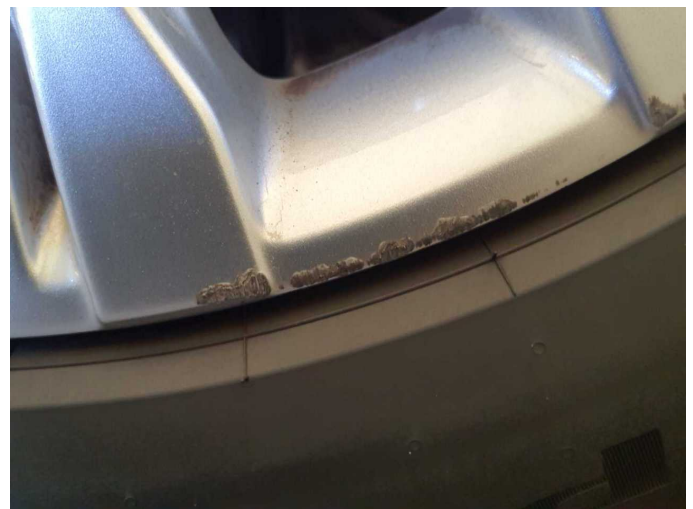
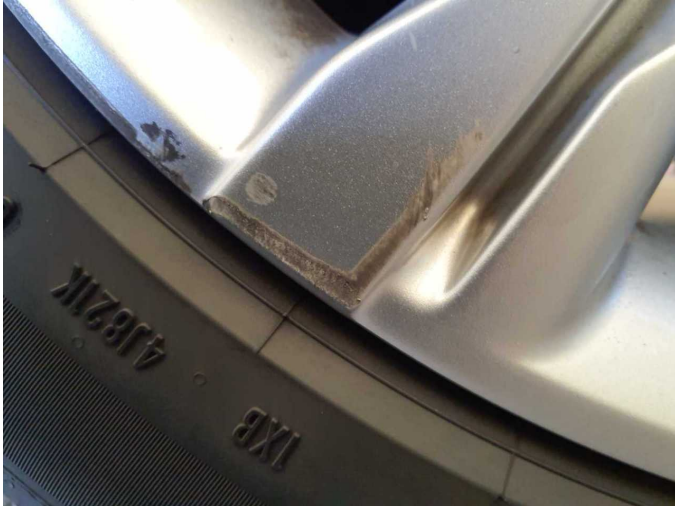
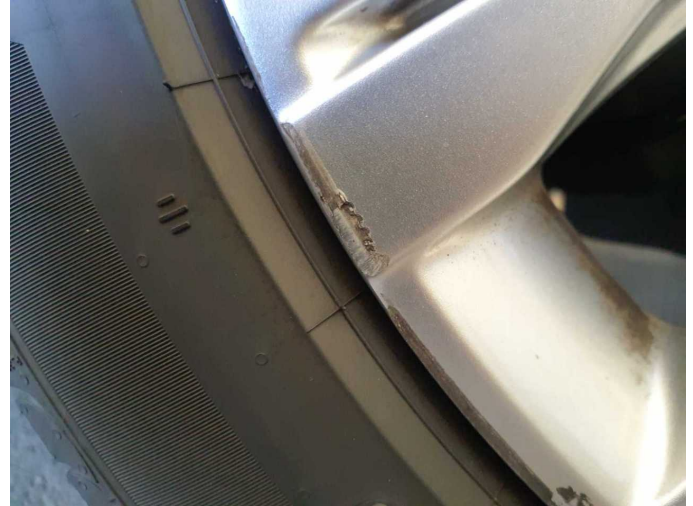
Damage 6: Wheel / tyres: Alloy rim - rear left side (- Materialabtrag) - Scratched - Replace

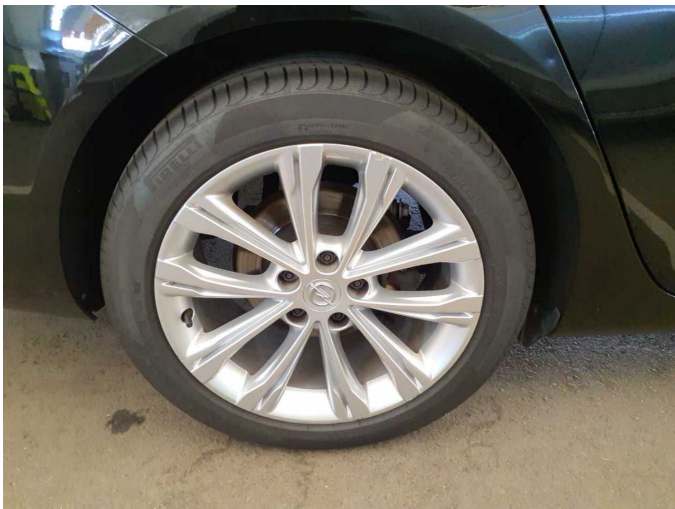
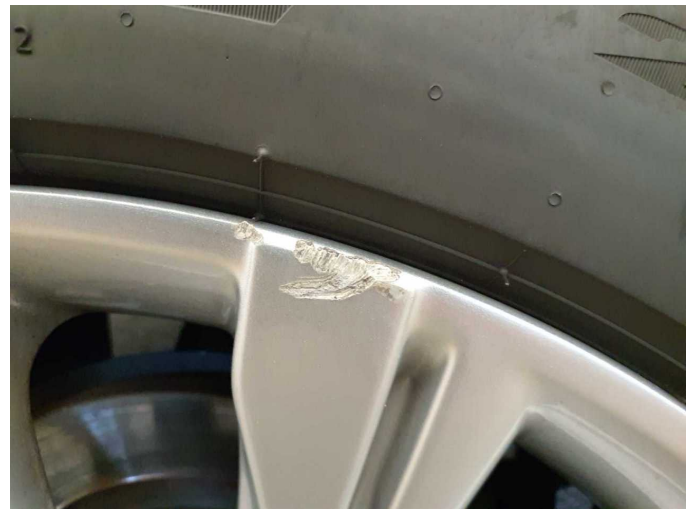
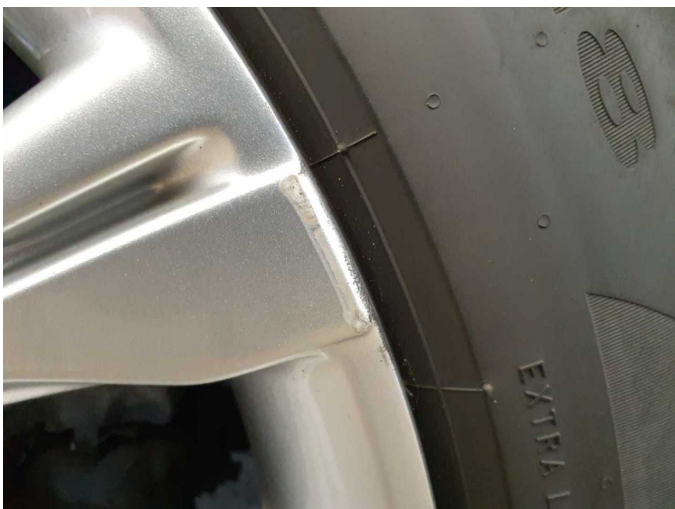
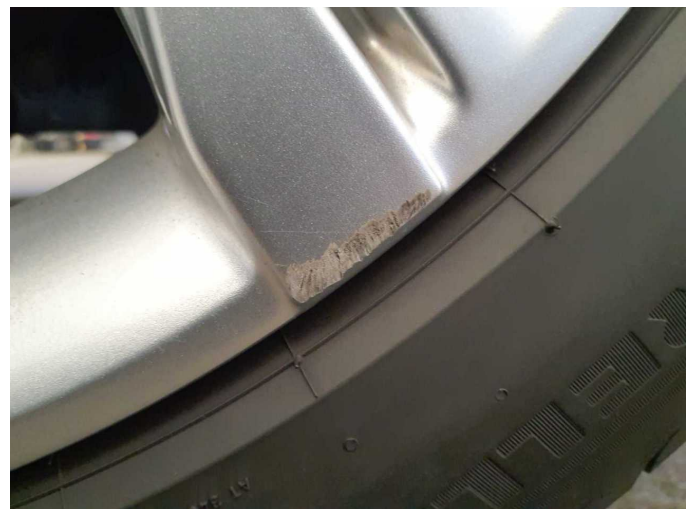
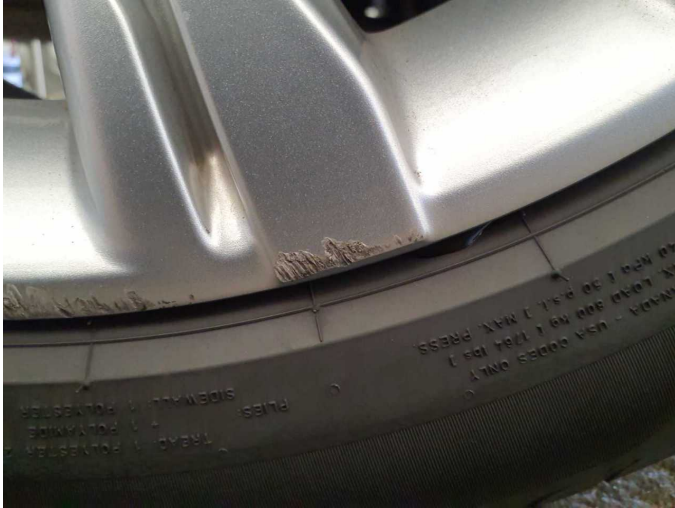
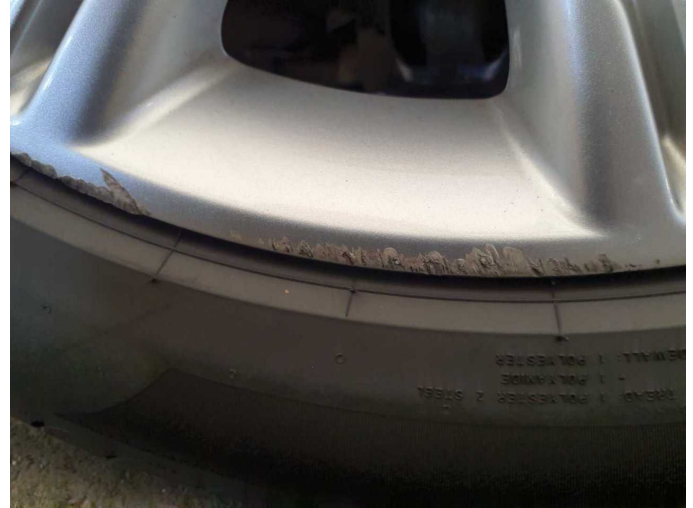
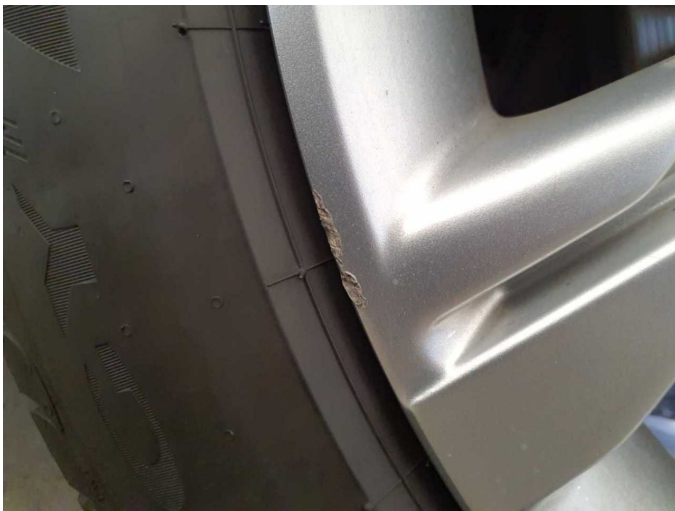
Damage 7: Wheel / tyres: Alloy rim - rear right side (- Materialabtrag) - Scratched - Replace

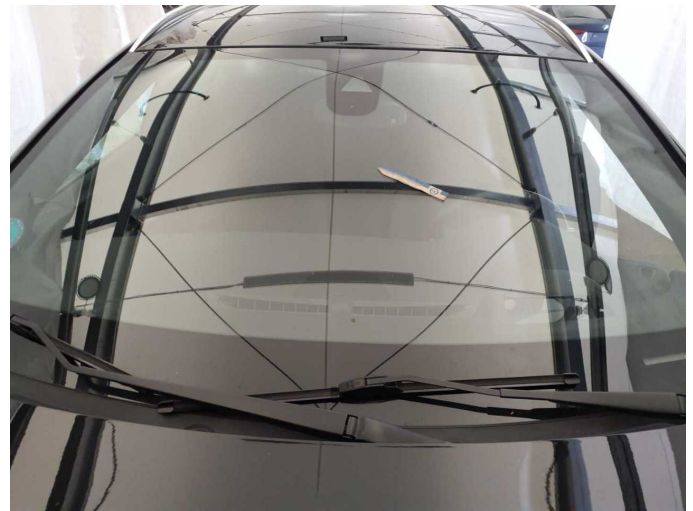
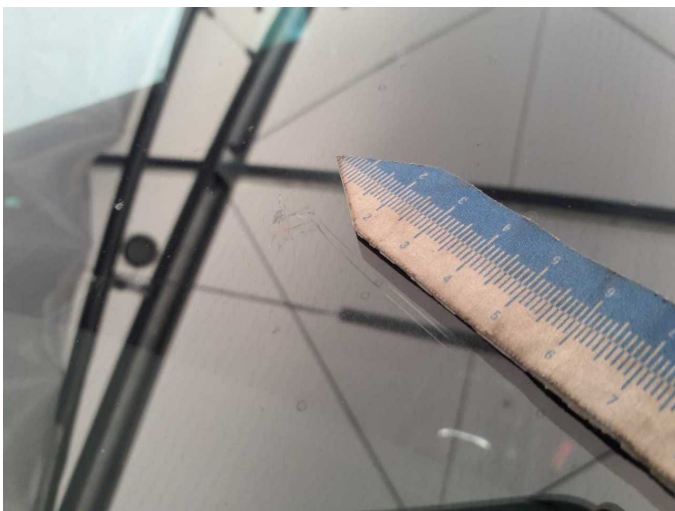
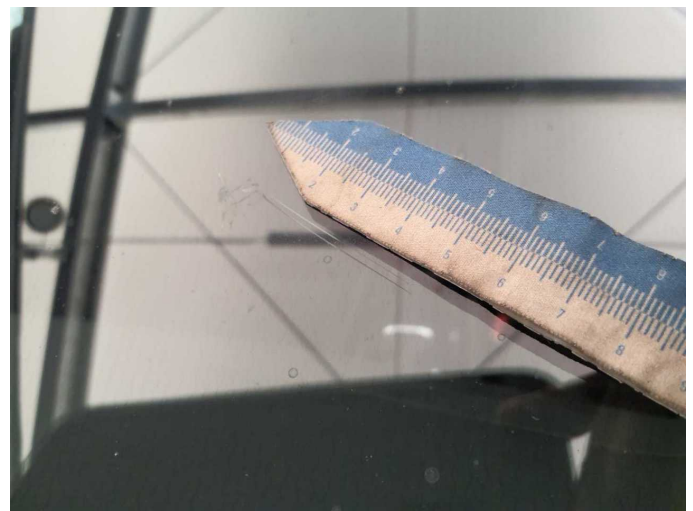
Damage 8: Vehicle glazing: Windscreen with lane departure assistant - Broken / torn - Replace

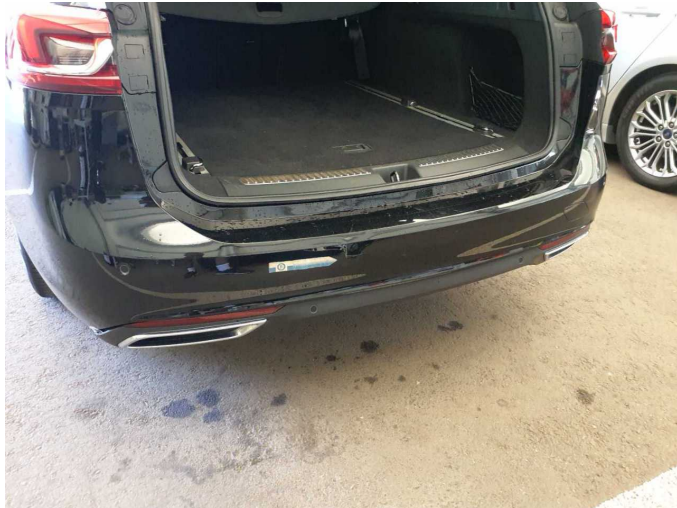
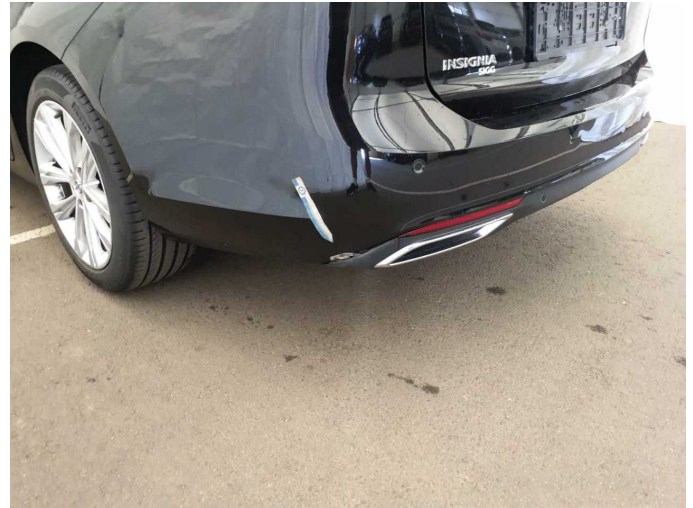
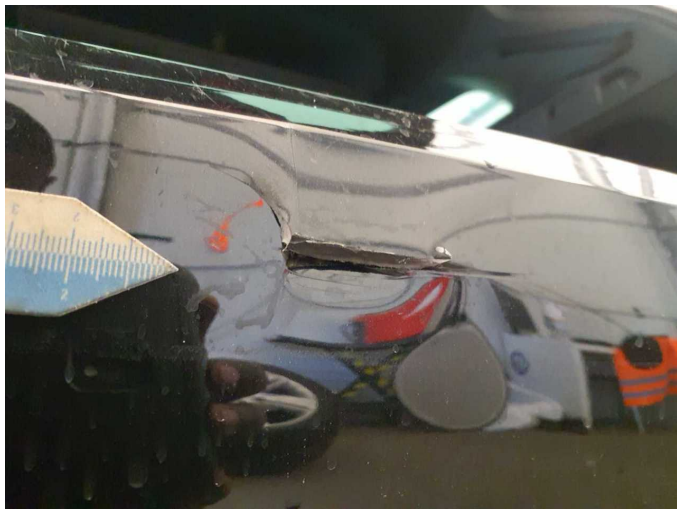
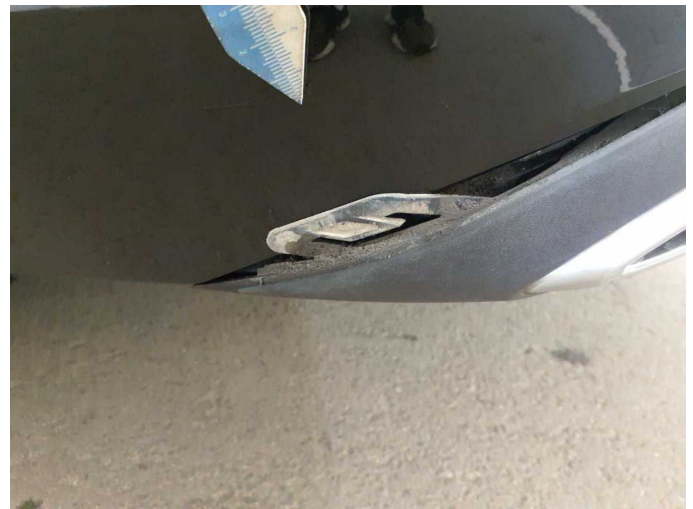
Damage 9: Rear bumper: Rear bumper - Broken / torn - Replace
