## Vehicle information

| Model: | <b>#5</b> | VIN: | <b>HESYA5C40SG203904</b> |

## Damage summary

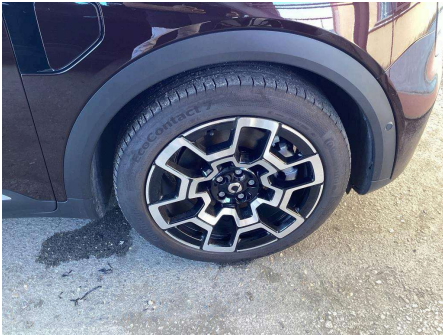
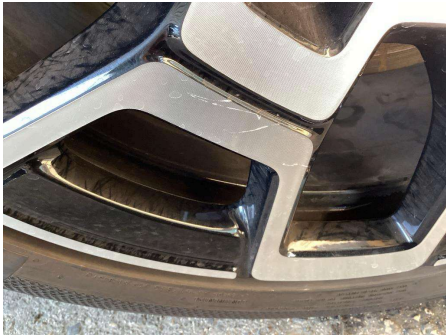
Alloy rim FR polished  
Scratch(es)  
Repair and paint (complete)  
Right

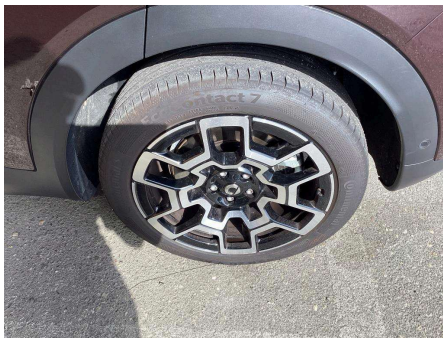
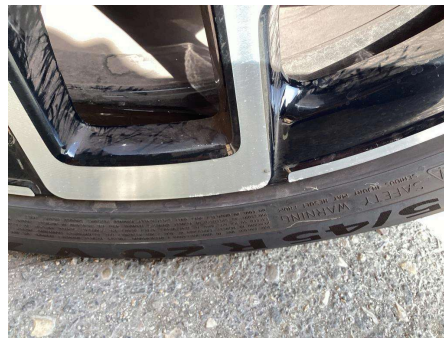
Left

**Alloy rim RL polished**

Scratch(es)

Repair and paint (complete)

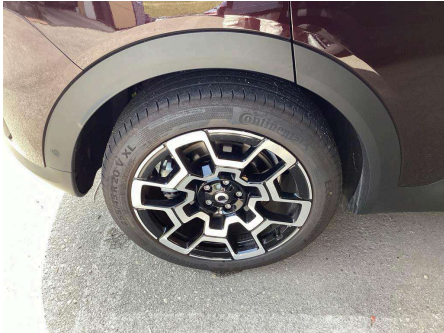
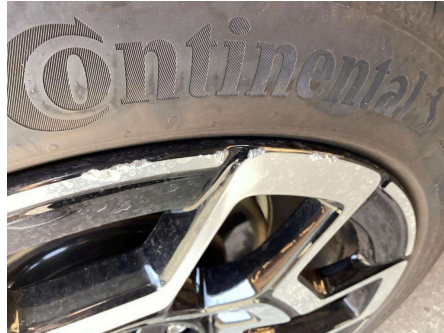
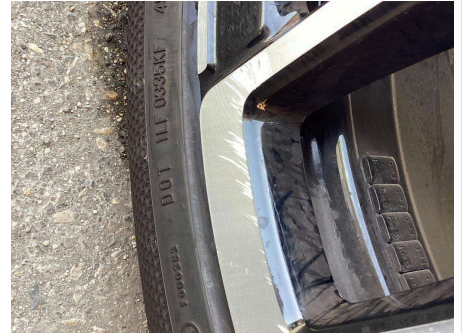
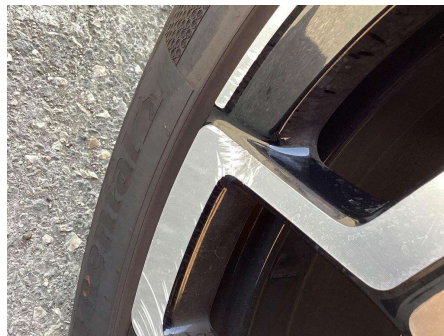
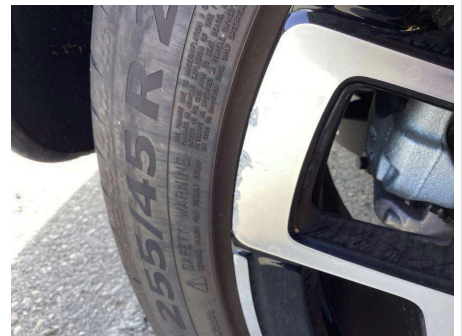
Right

**Alloy rim RR polished**

Scratch(es)

Repair and paint (complete)

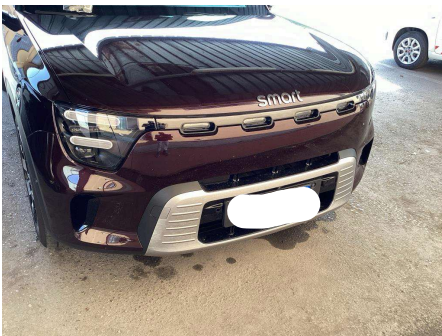
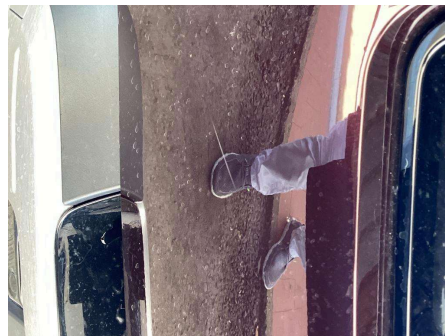
Front

**Bumper F**

Scratch(es)

Spot repair

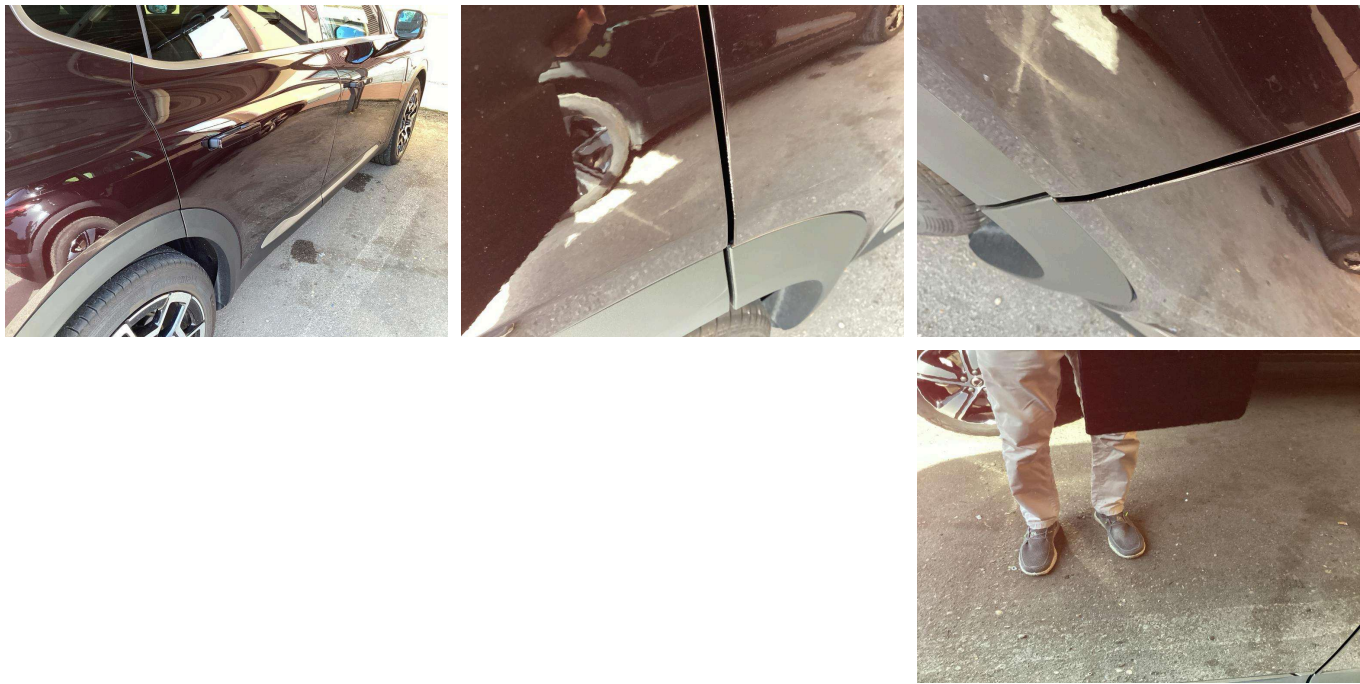
Door RR  
Scratch(es)  
Spot repair  
Right
