## Expertise

Protocol number: 45444541  
Order No. / Reference: 26173256  
Inspection date: 12 May 2026

Model: Proace 2,0-I-D-4D L1 (9-Si.) Comfort

VIN: YARVEEHTMGZ210130

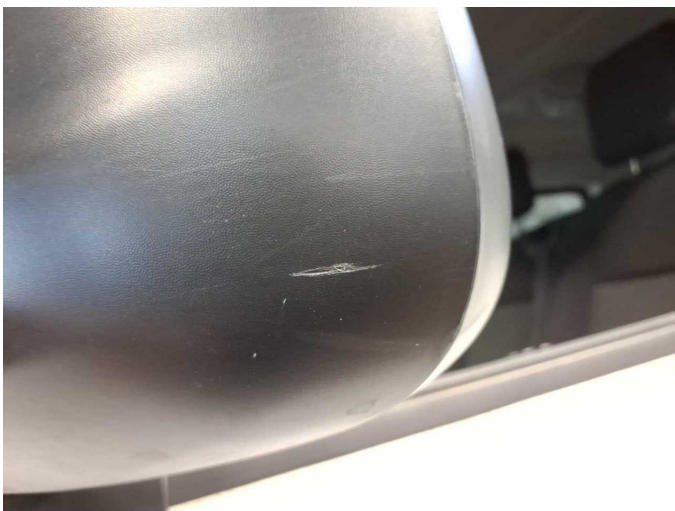
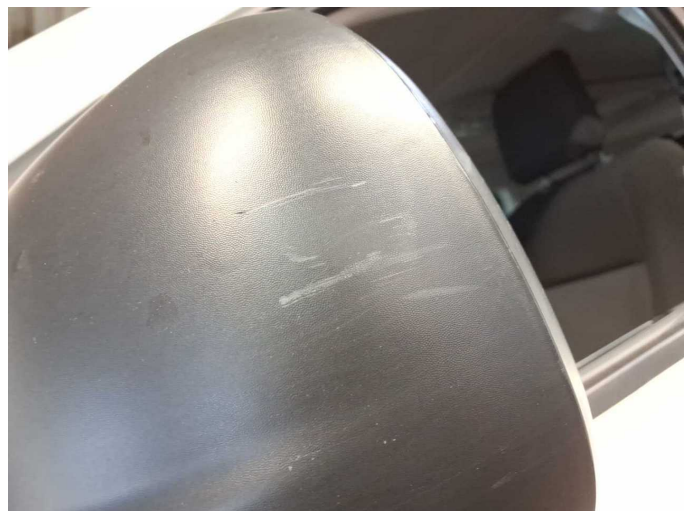
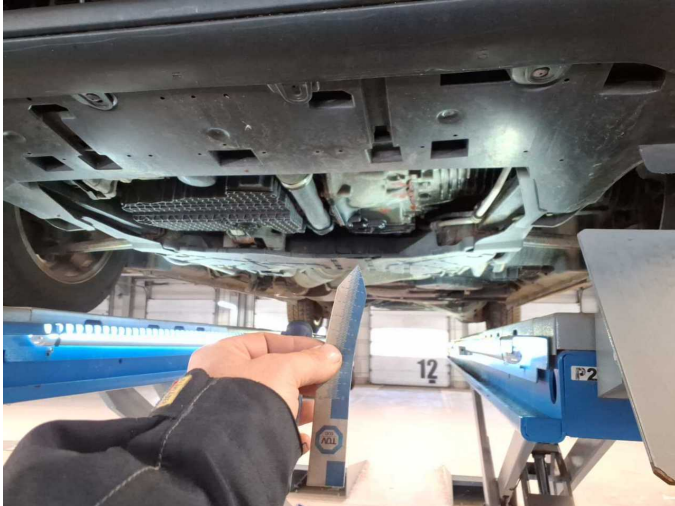
No.	Component group	Description
1	Wing mirror - left side	Cap - Scratched - Replace
2	Body	Underbody panelling - Broken / torn - Replace
3	Engine	Engine (+ Getriebe) - Leaking - Perform diagnosis
4	Tail light	Tail lamp - right side - Broken / torn - Replace
5	Fog lamp	Fog lamp - front right side (Chromrahmen) - Deformed - Replace
6	Bonnet	Bonnet - Stone chips - Paint
7	Rear bumper	Rear bumper (unpainted) - Scratched - Replace
8	Mudguard - left side	Mudguard - left side - Deformed - Repair and paint
9	Door - front right side	Door - Scratch(es) - Paint
10	Roof	Roof (Korrosion) - Stone chips - Paint
11	Sliding door - left side	Sliding door (Korrosion) - Scratched - Repair and paint
12	Front bumper	Front bumper (unpainted) (Rechts) - Scratched - Replace

Damage 1: Wing mirror - left side: Cap - Scratched - Replace

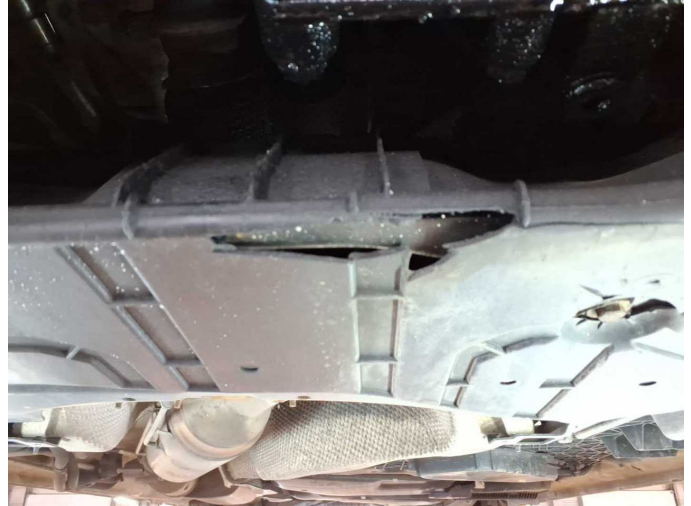
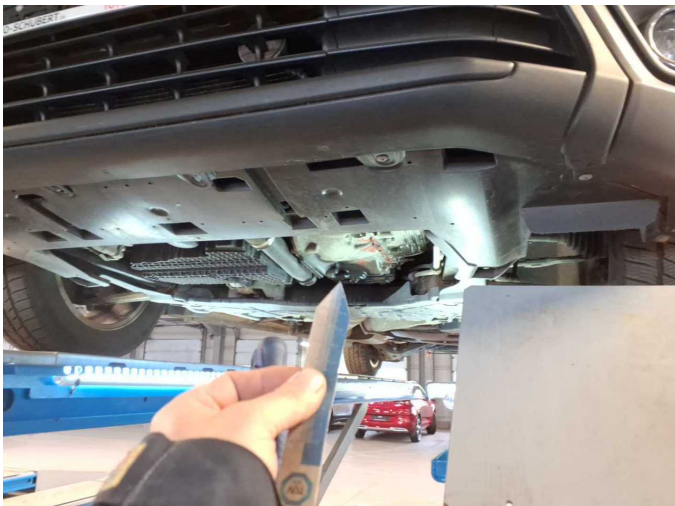
**Damage 2:** Body: Underbody panelling - Broken / torn - Replace

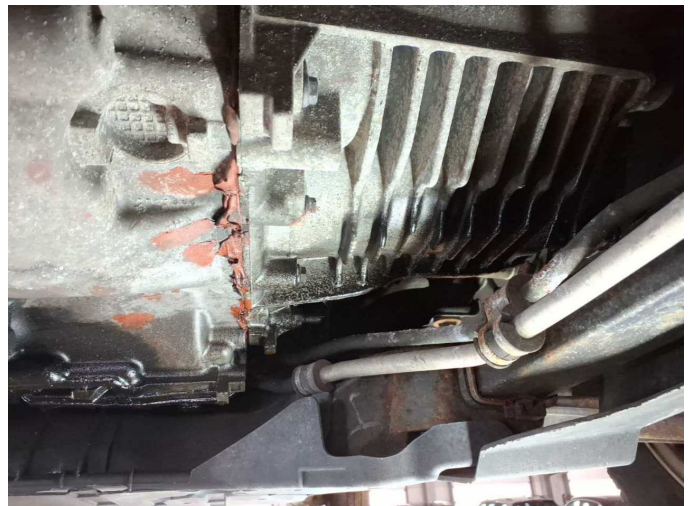
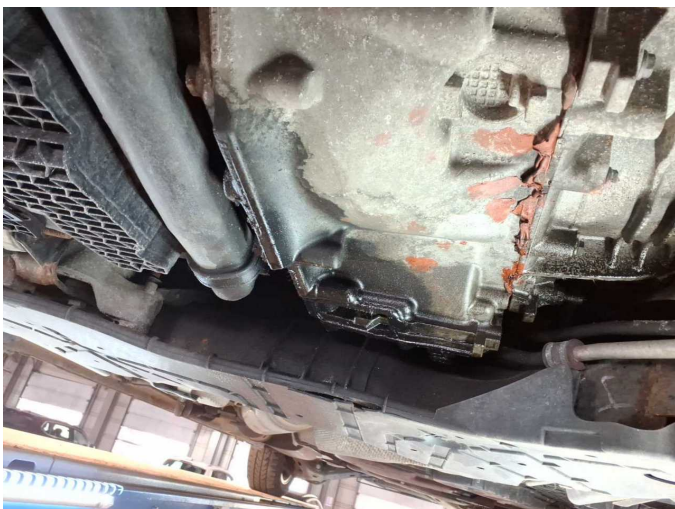
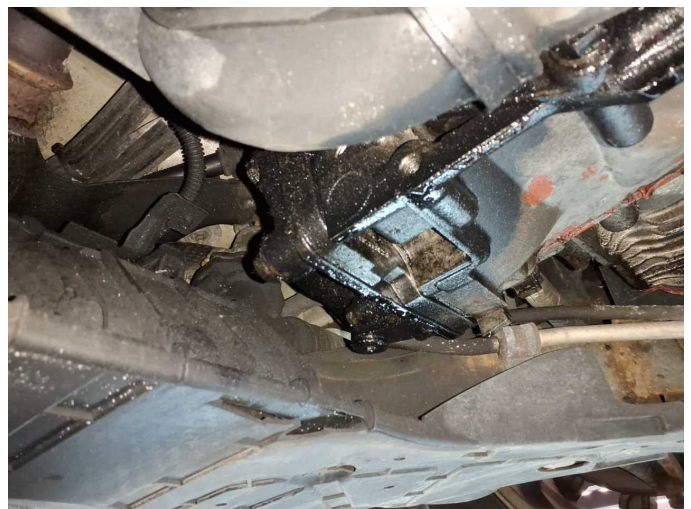
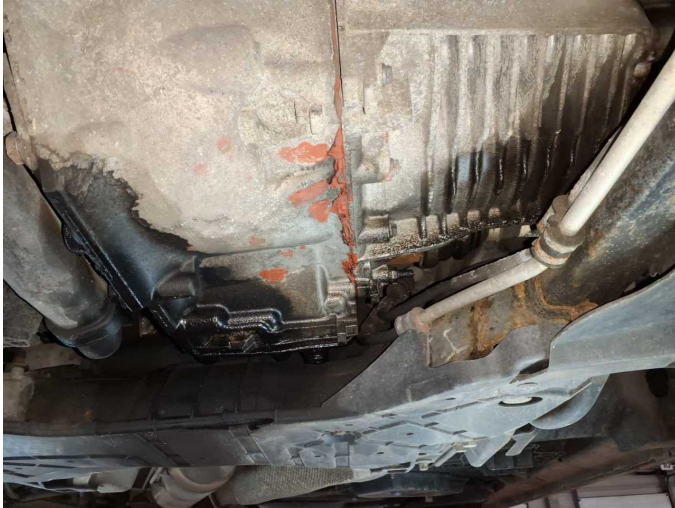
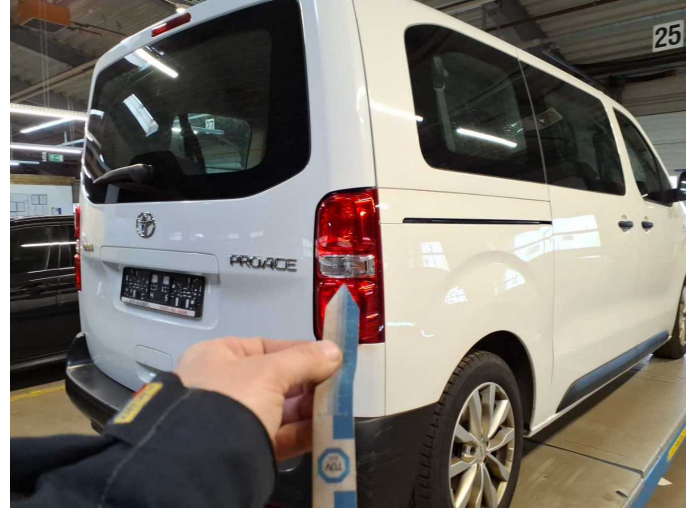
**Damage 3:** Engine: Engine (+ Getriebe) - Leaking - Perform diagnosis

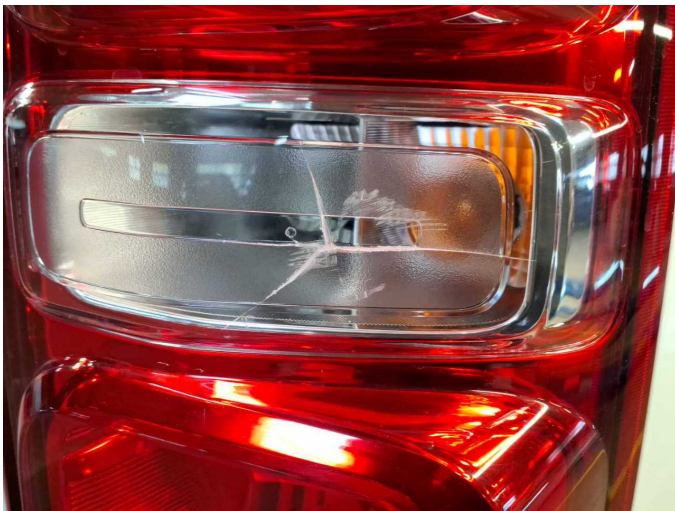
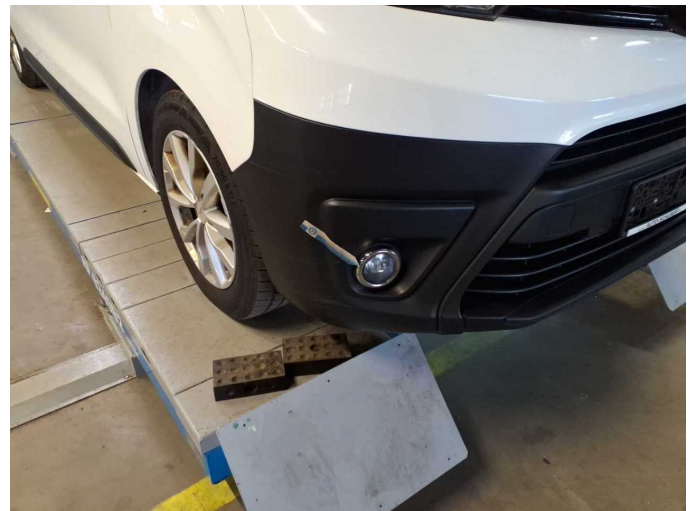
**Damage 4:** Tail light: Tail lamp - right side - Broken / torn - Replace

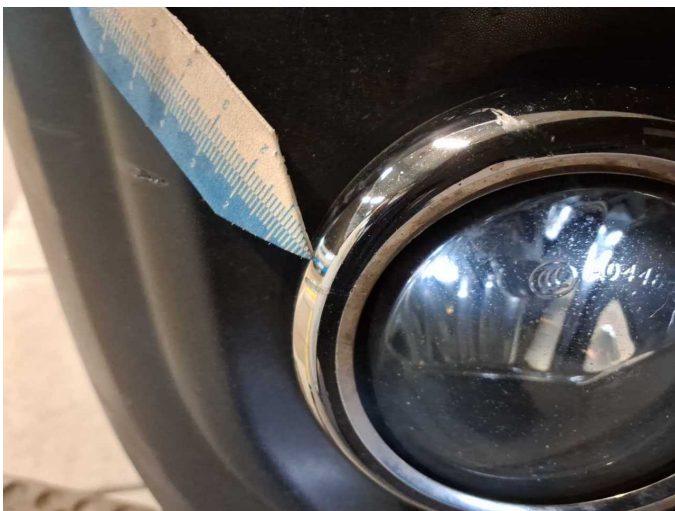
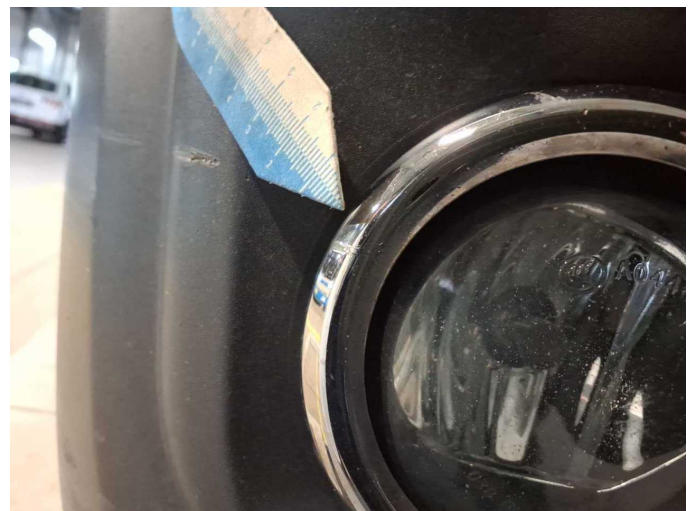
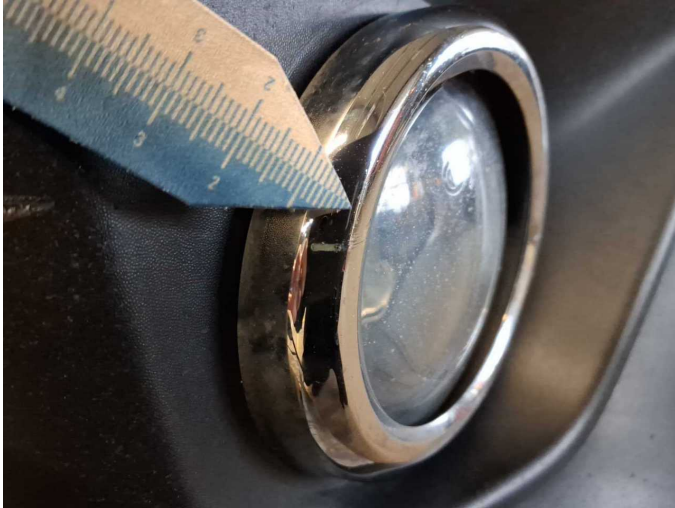
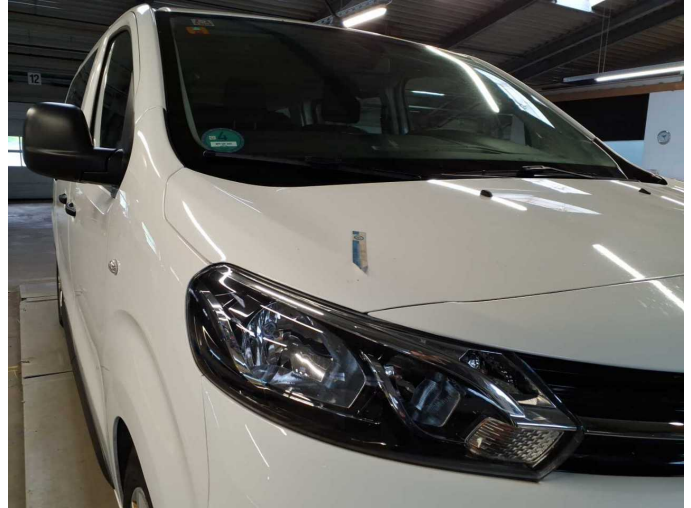
**Damage 5:** Fog lamp: Fog lamp - front right side (Chromrahmen) - Deformed - Replace

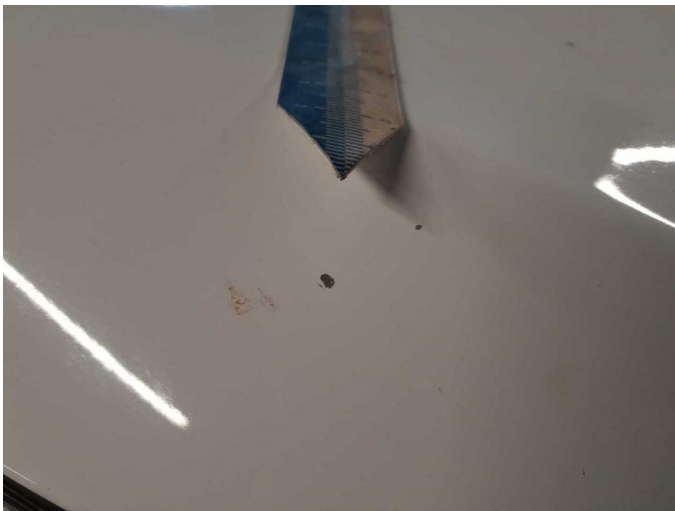
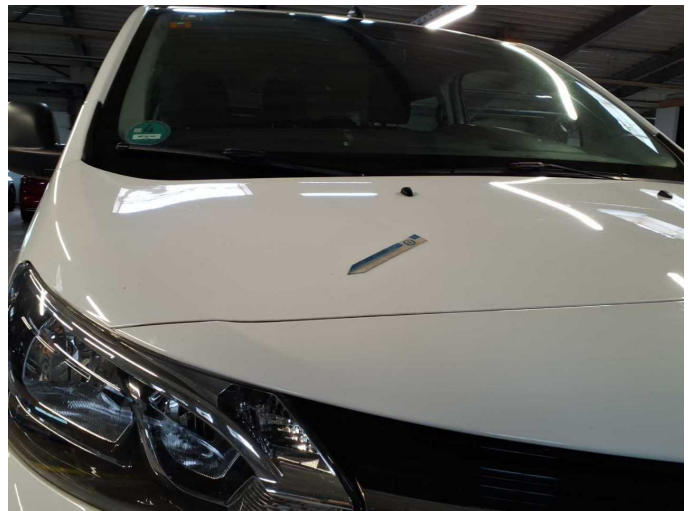
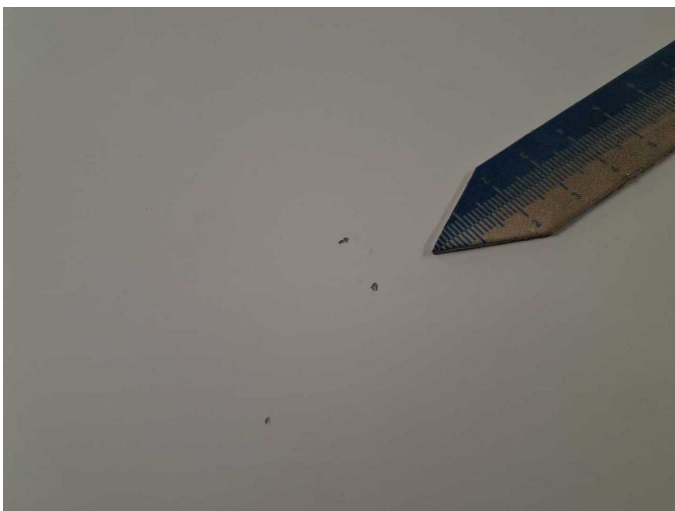
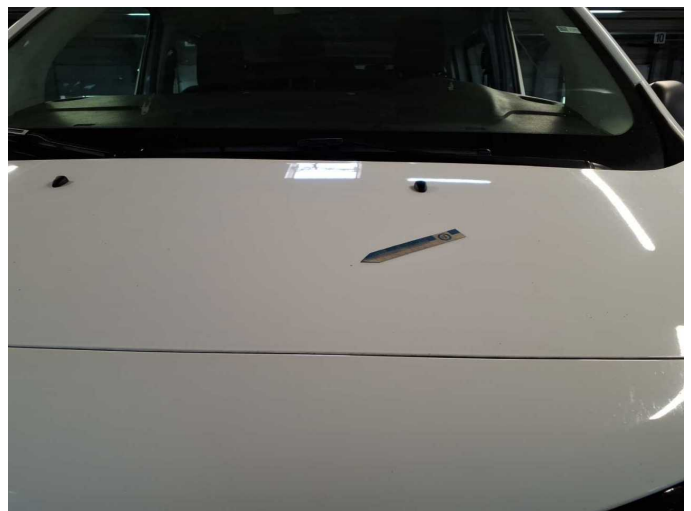
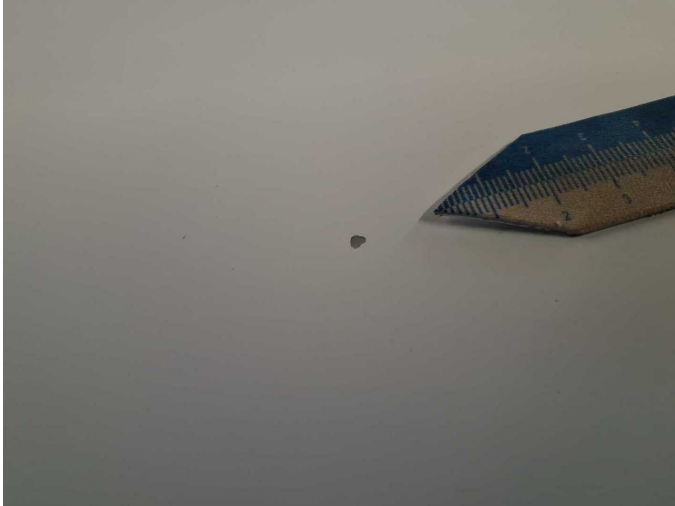
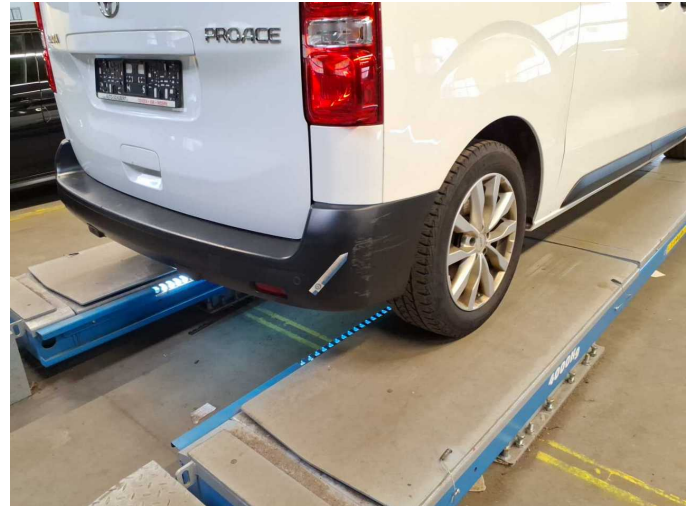
**Damage 6:** Bonnet: Bonnet - Stone chips - Paint

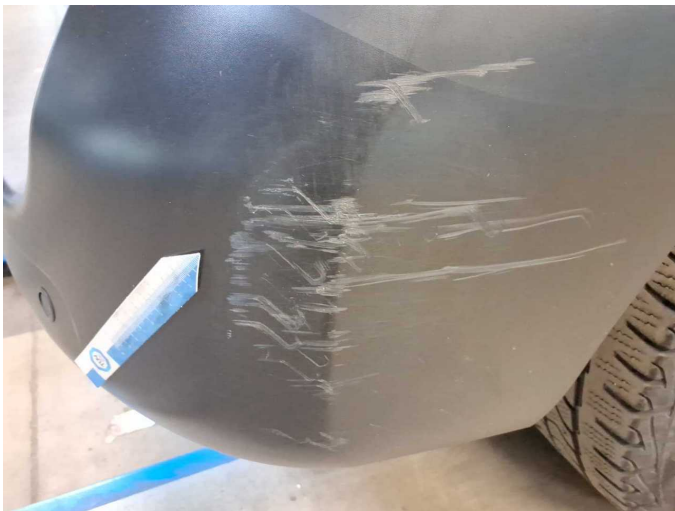
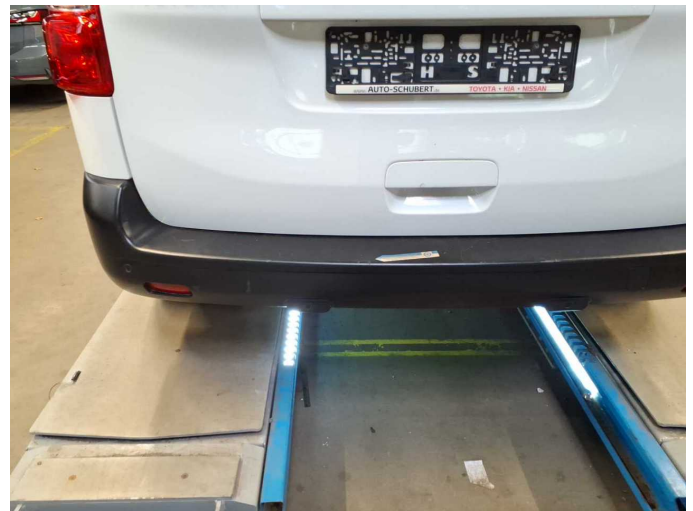
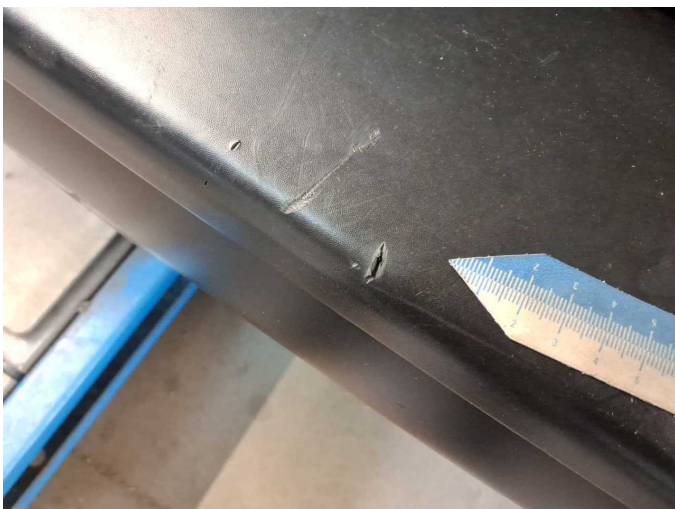
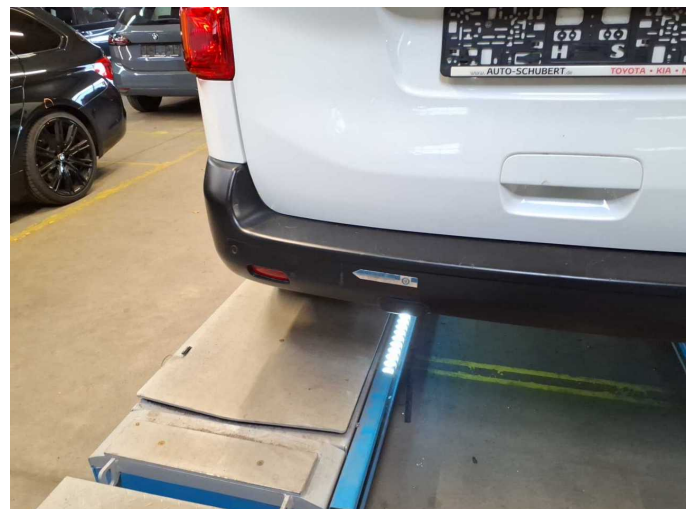
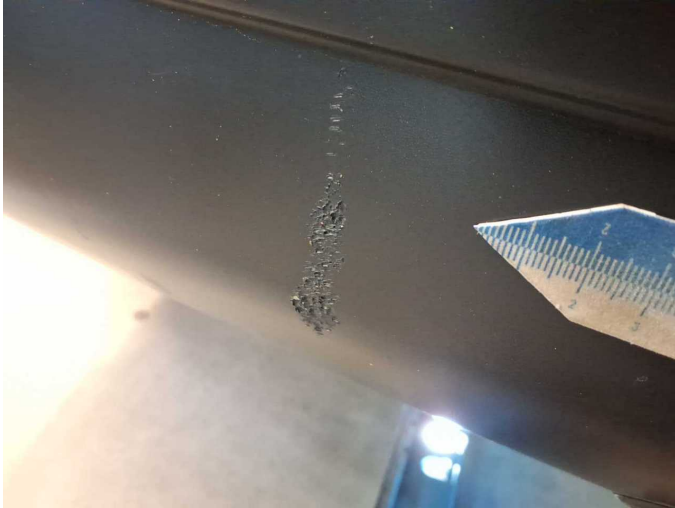
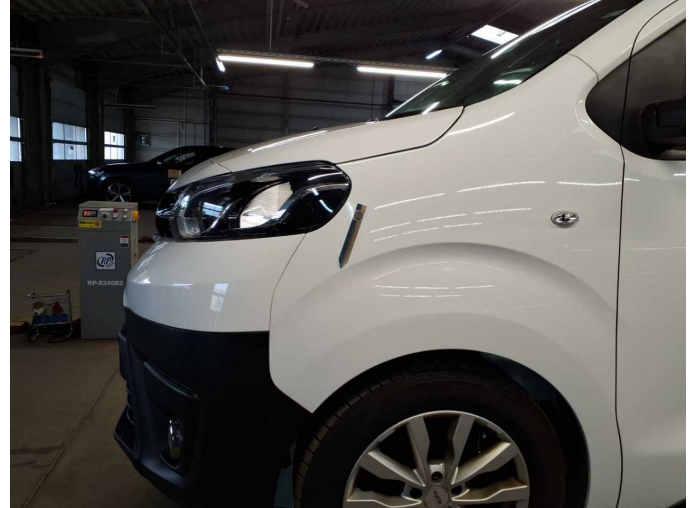
**Damage 7:** Rear bumper: Rear bumper (unpainted) - Scratched - Replace

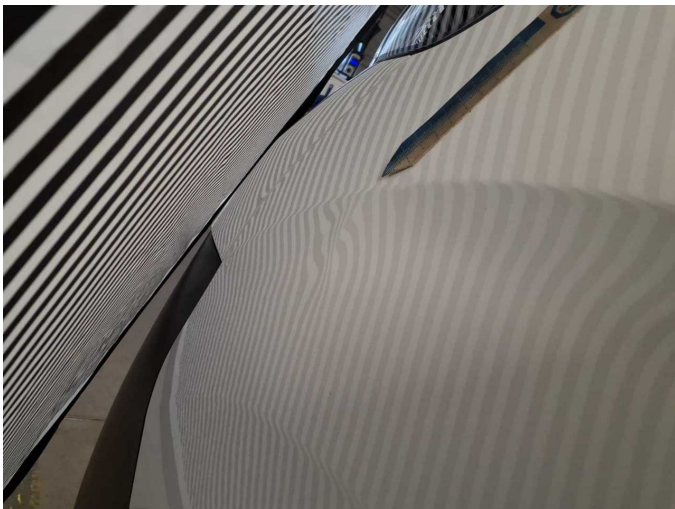
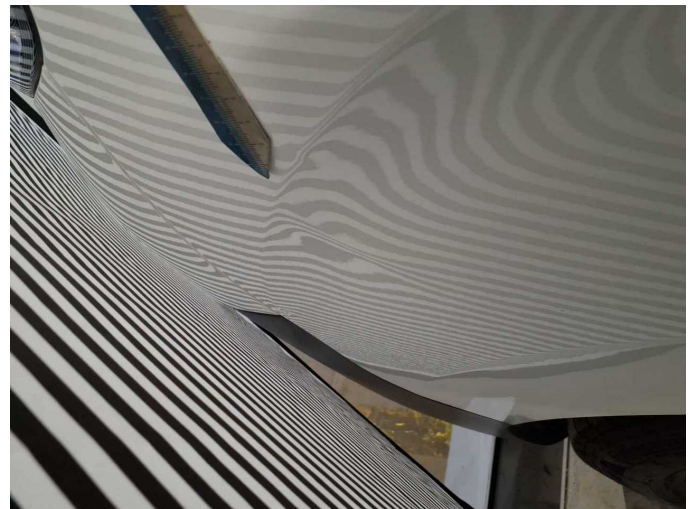
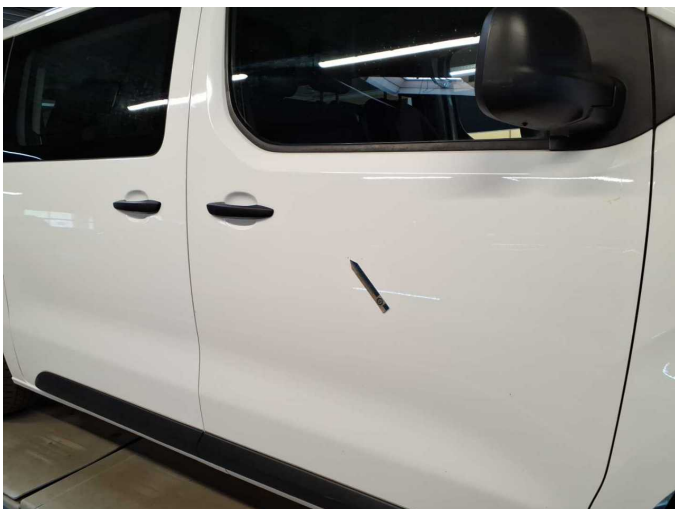
**Damage 8:** Mudguard - left side: Mudguard - left side - Deformed - Repair and paint

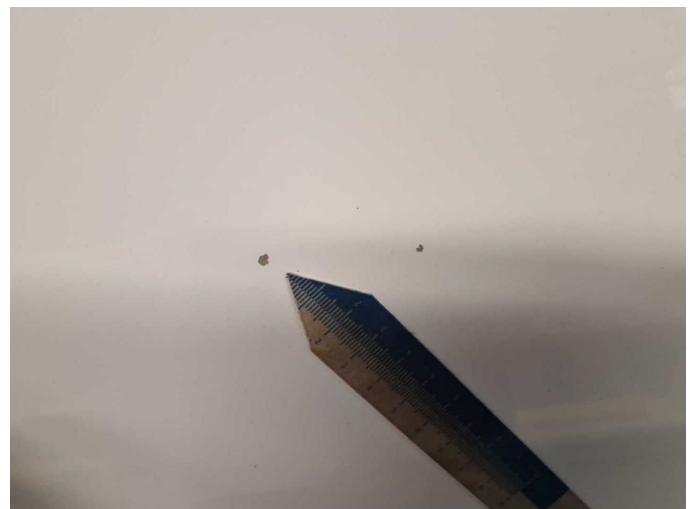
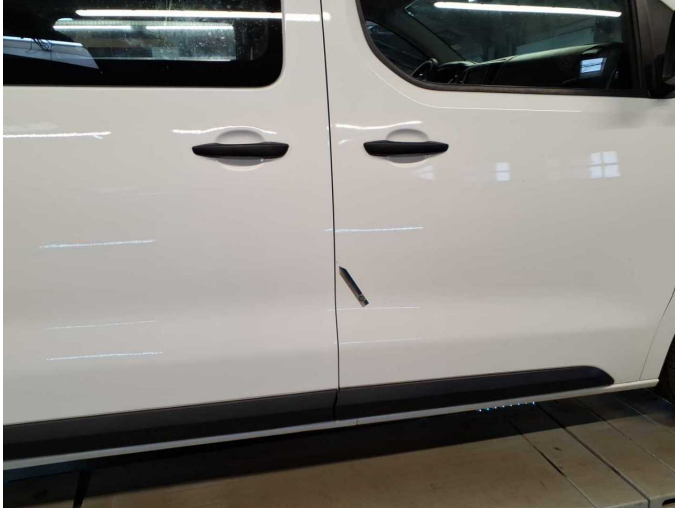
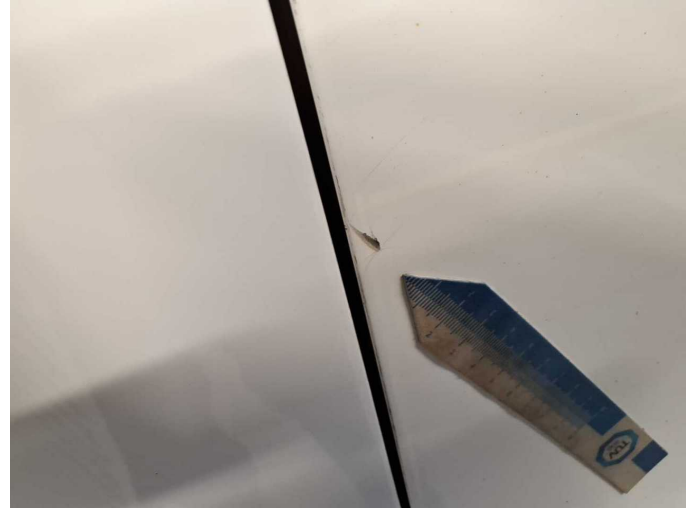
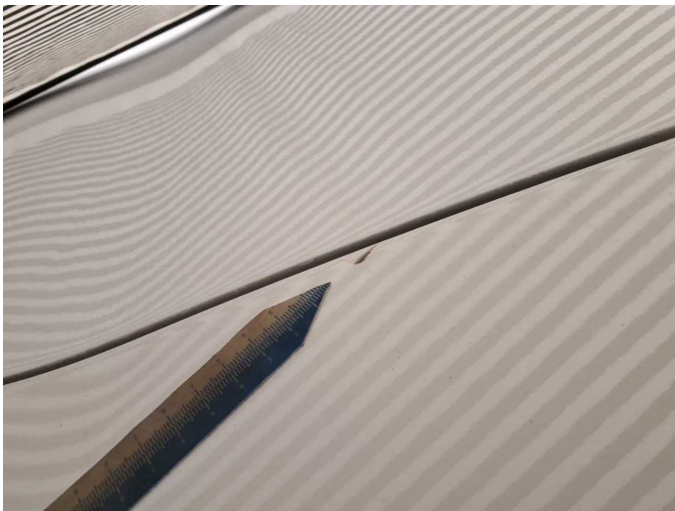
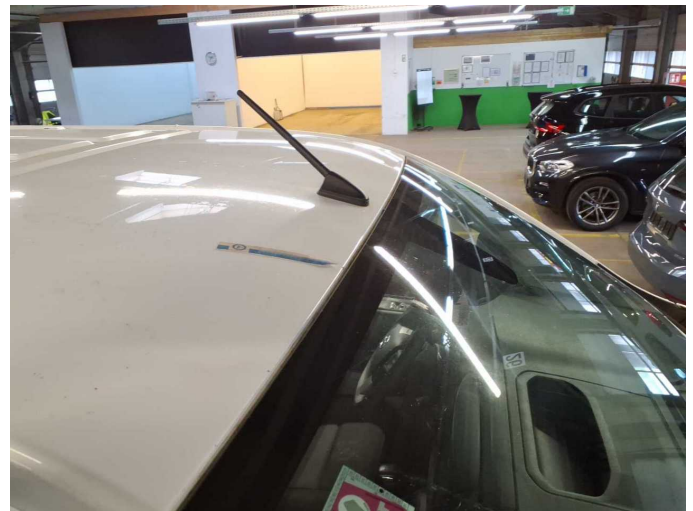
**Damage 9:** Door - front right side: Door - Scratch(es) - Paint

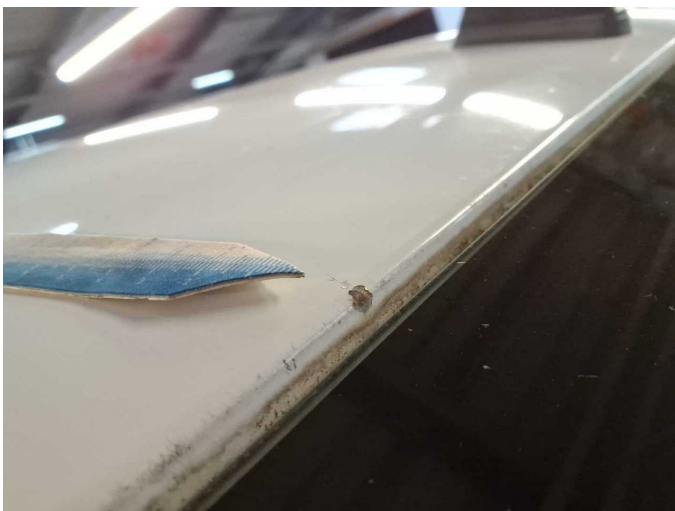
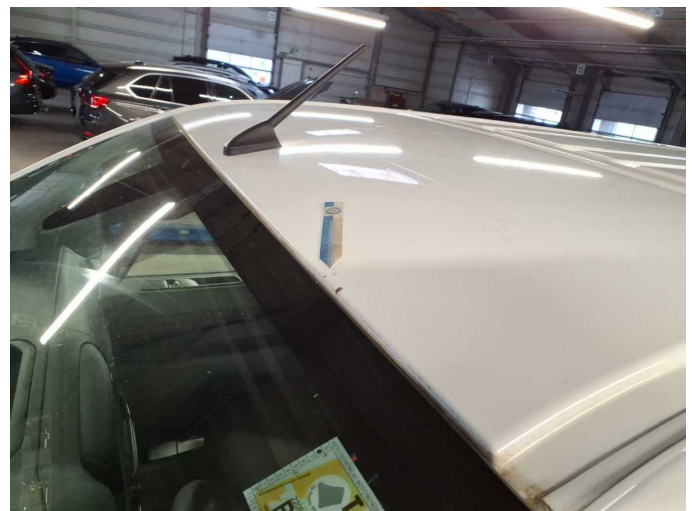
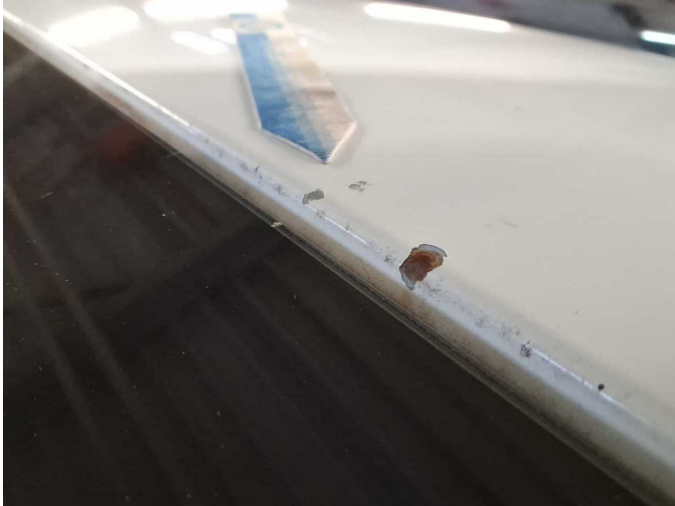
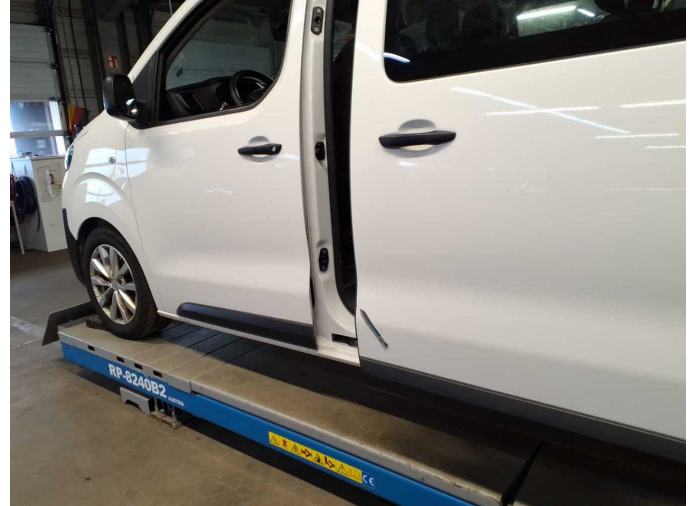
**Damage 10:** Roof: Roof (Korrosion) - Stone chips - Paint

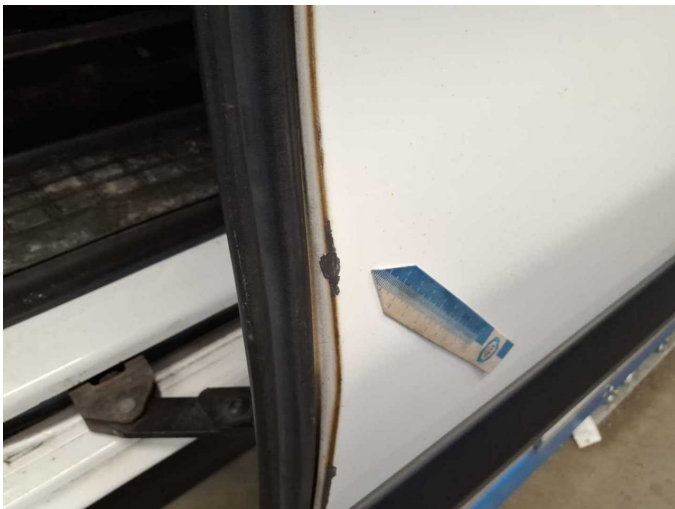
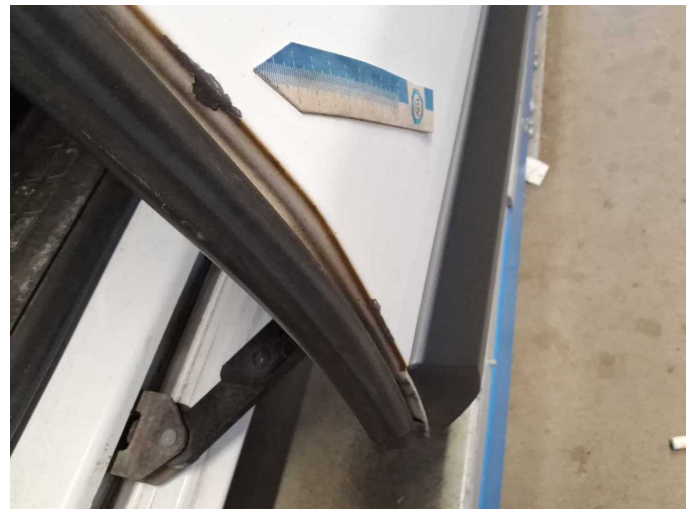
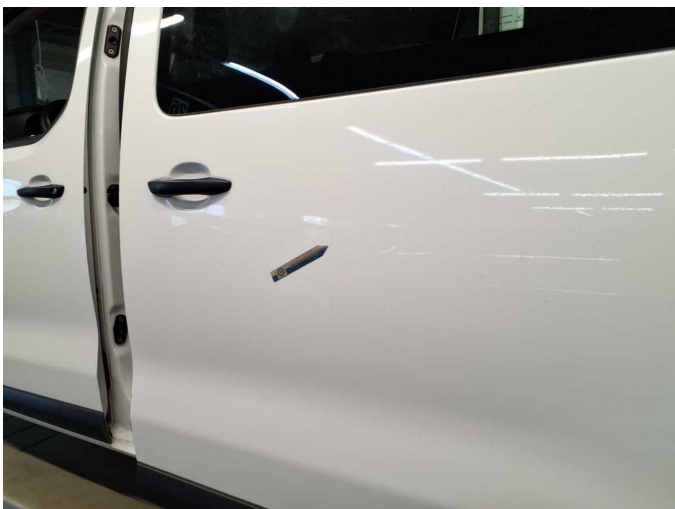
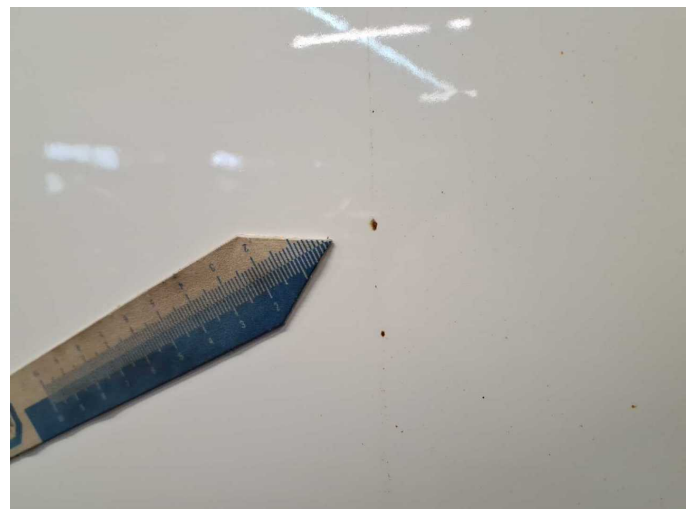
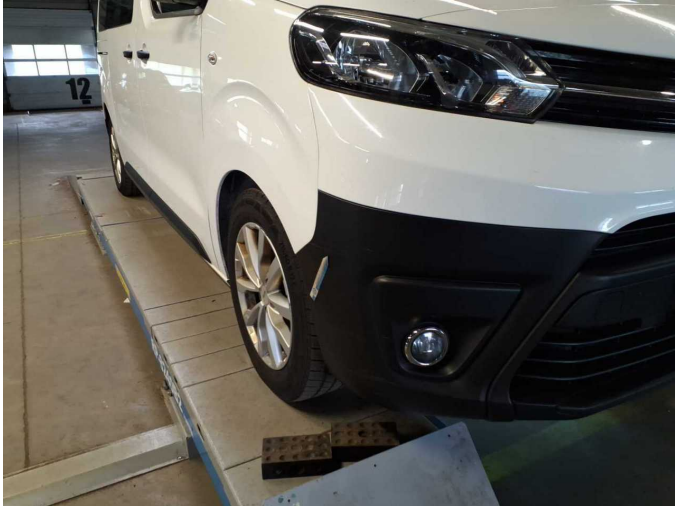
**Damage 11:** Sliding door - left side: Sliding door (Korrosion) - Scratched - Repair and paint

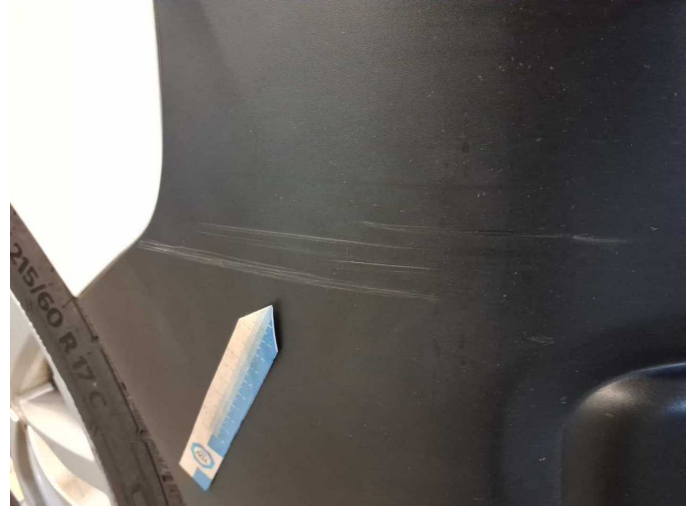
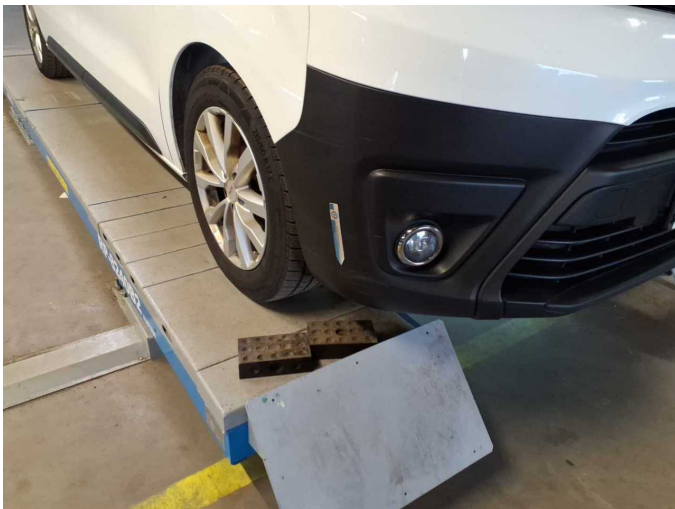
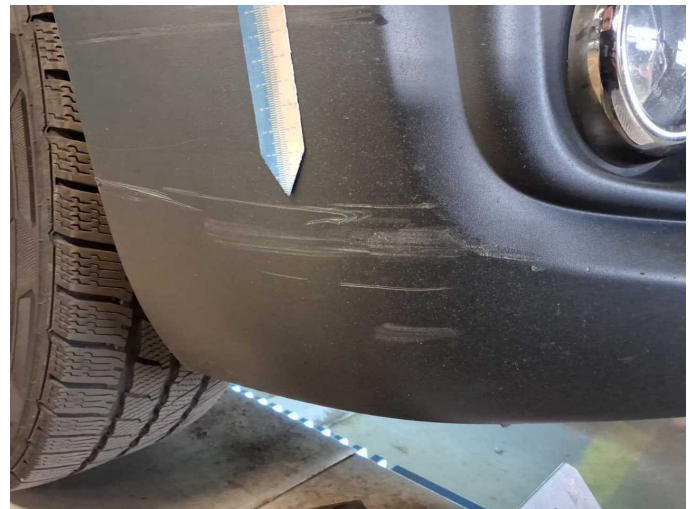
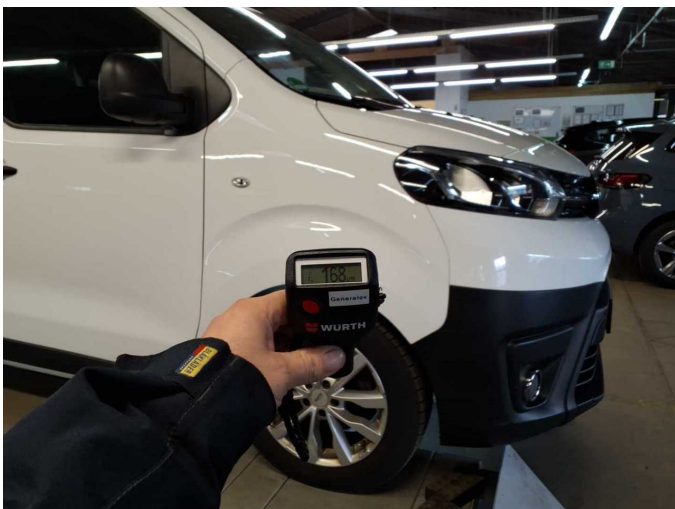
**Damage 12:** Front bumper: Front bumper (unpainted) (Rechts) - Scratched - Replace

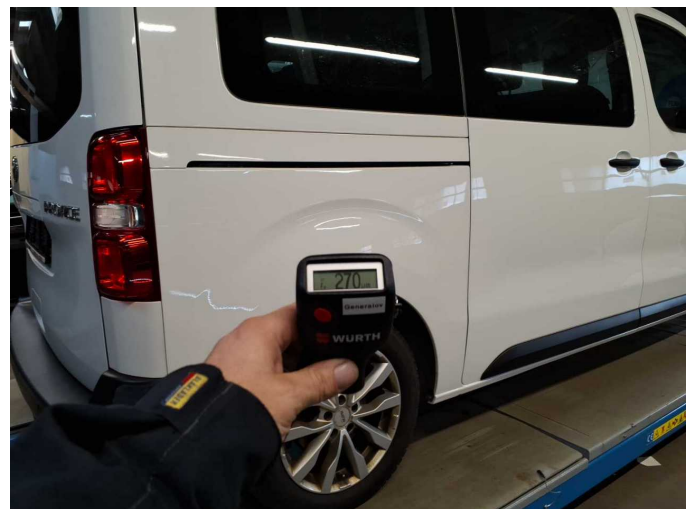
No.	Repainting
1	Mudguard - right side, Professionally carried out, Invoice of repair done Non-existent
2	Side panel - rear right side, Professionally carried out, Invoice of repair done Non-existent
3	Door - rear right side, Unprofessionally carried out, Invoice of repair done Non-existent

Mudguard - right side	168 µm	Side panel - rear right side	270 µm
Door - rear right side	330 µm

**Repainting 1:** Mudguard - right side
