## Expertise

Protocol number: 46041409  
Order No. / Reference: 26154470  
Inspection date: 16 Jun 2026

Manufacturer: Mercedes-Benz

Model: Vito 116 CDI Lang HA Aut. PRO

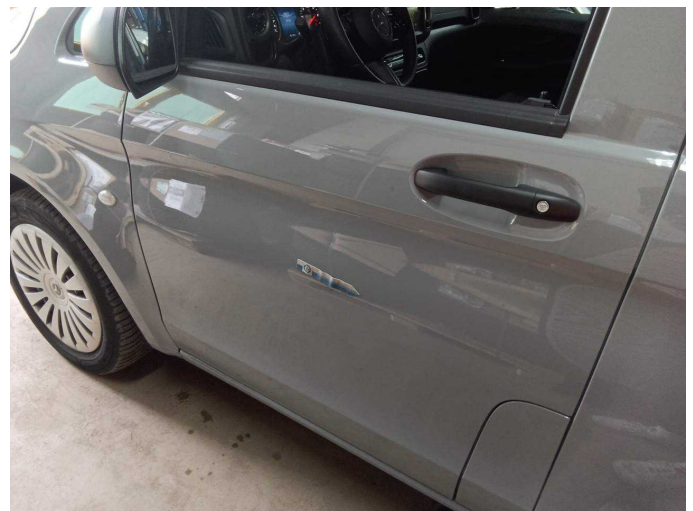
Damage 3: Door - front left side: Door - Dent / paintcoat damage - Smooth repair work

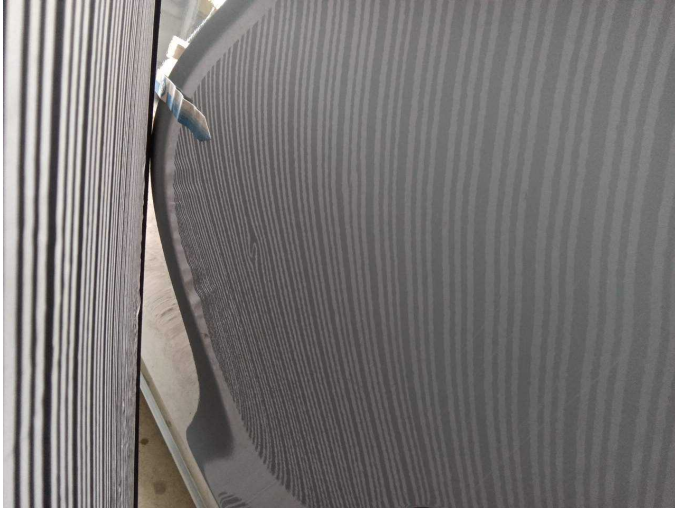
**Damage 3:** Door - front left side: Door - Dent / paintcoat damage - Smooth repair work

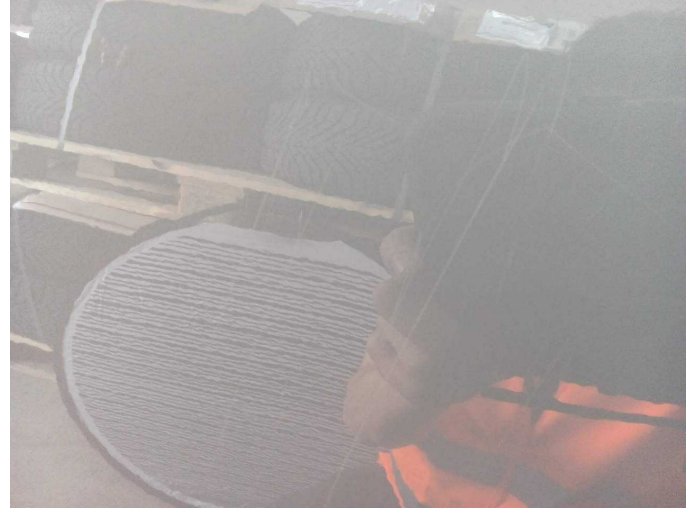
**Damage 3:** Door - front left side: Door - Dent / paintcoat damage - Smooth repair work

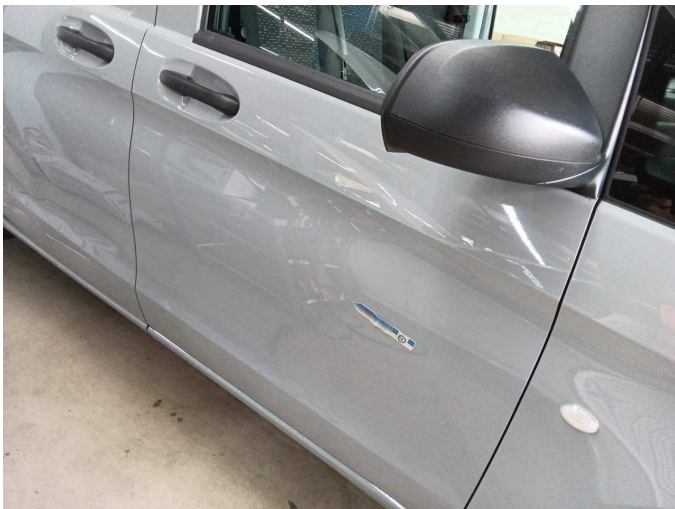
**Damage 4:** Door - front right side: Door - Dent / paintcoat damage - Smooth repair work

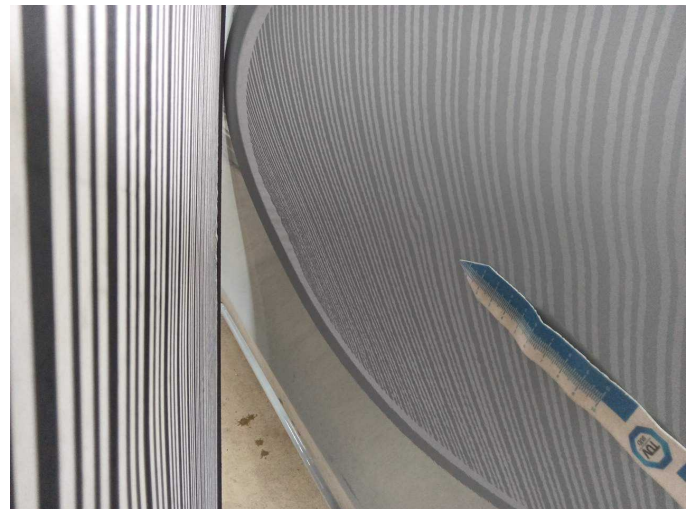
**Damage 4:** Door - front right side: Door - Dent / paintcoat damage - Smooth repair work

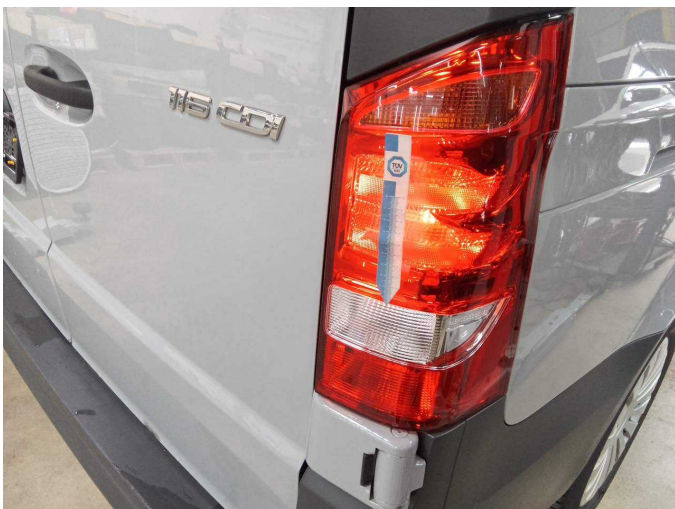
**Damage 5:** Tail light: Tail lamp - right side - Scratch(es) - Replace

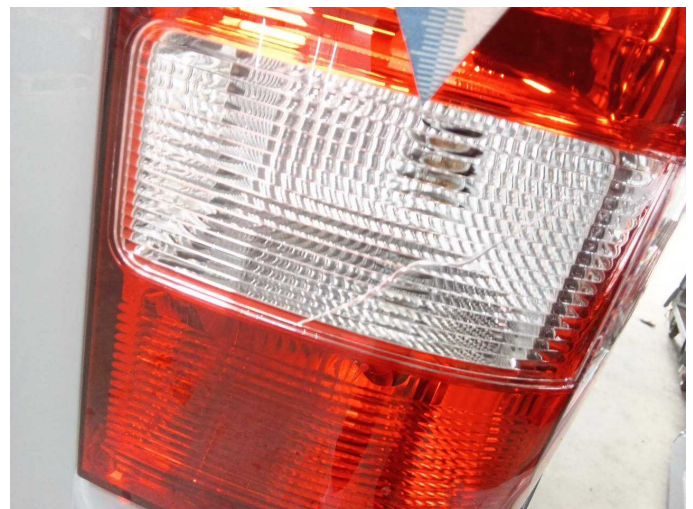
**Damage 5:** Tail light: Tail lamp - right side - Scratch(es) - Replace

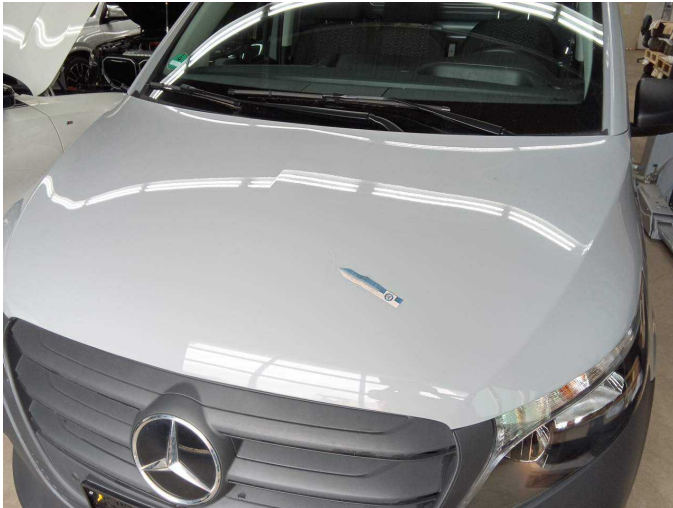
**Damage 6:** Bonnet: Bonnet - Scratch(es) - Paint

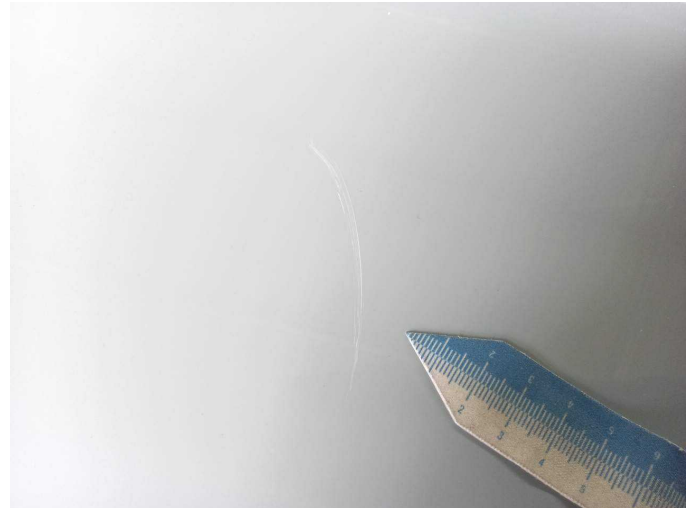
**Damage 6:** Bonnet: Bonnet - Scratch(es) - Paint

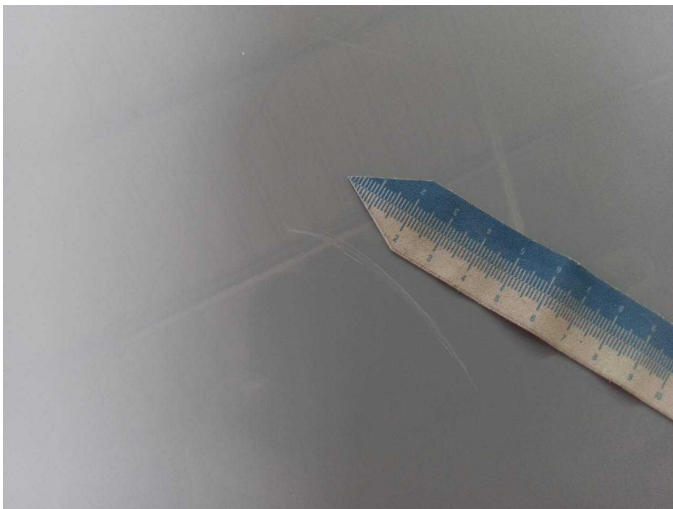
**Damage 6:** Bonnet: Bonnet - Scratch(es) - Paint

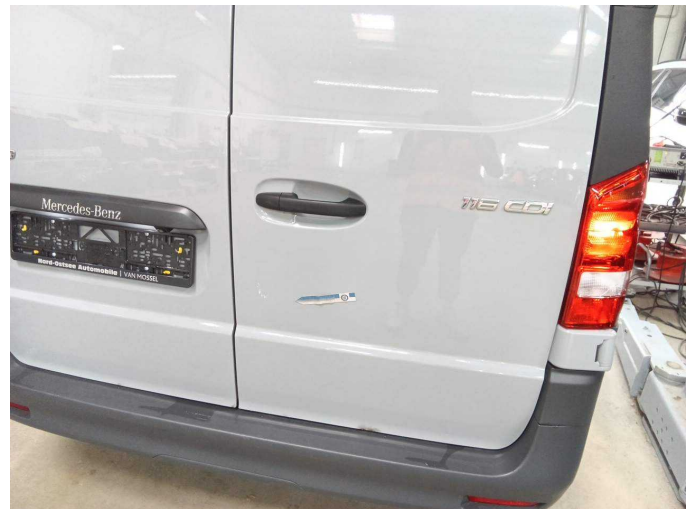
**Damage 7:** Boot lid / rear door: Rear door - right side - Scratch(es) - Paint

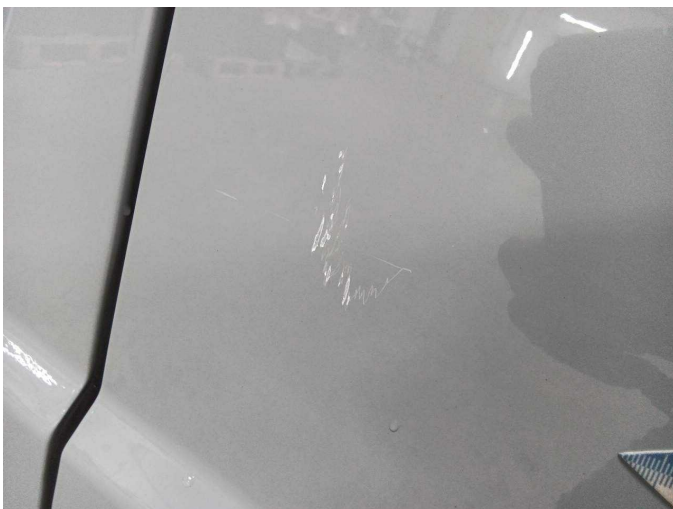
**Damage 7:** Boot lid / rear door: Rear door - right side - Scratch(es) - Paint

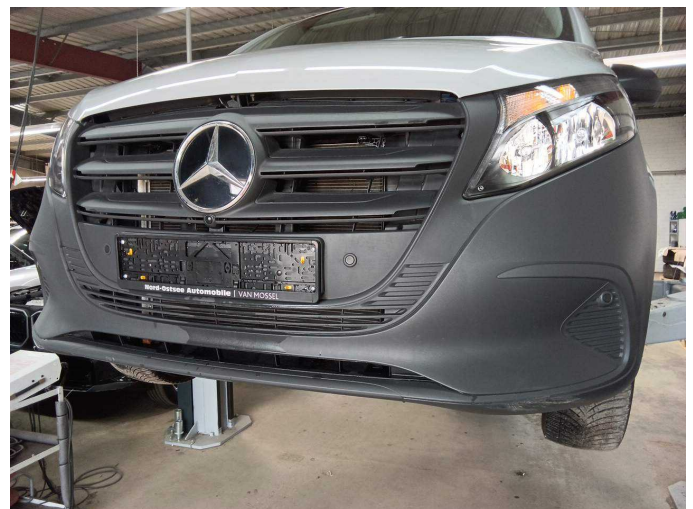
**Damage 8:** Front bumper: Front bumper - Scratch(es) - Replace

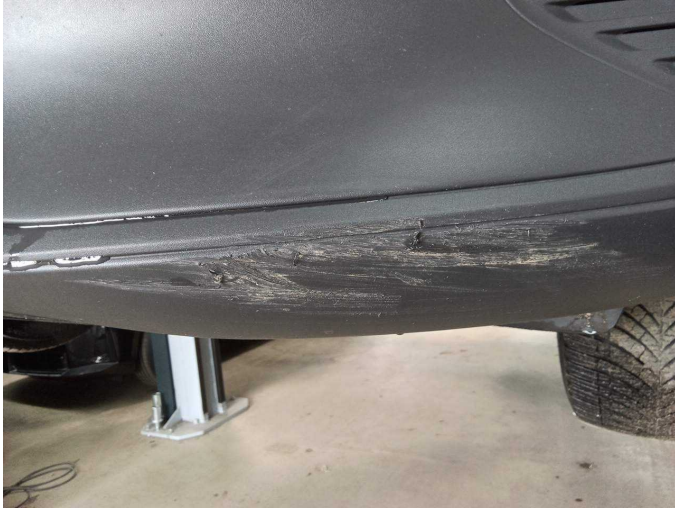
**Damage 8:** Front bumper: Front bumper - Scratch(es) - Replace

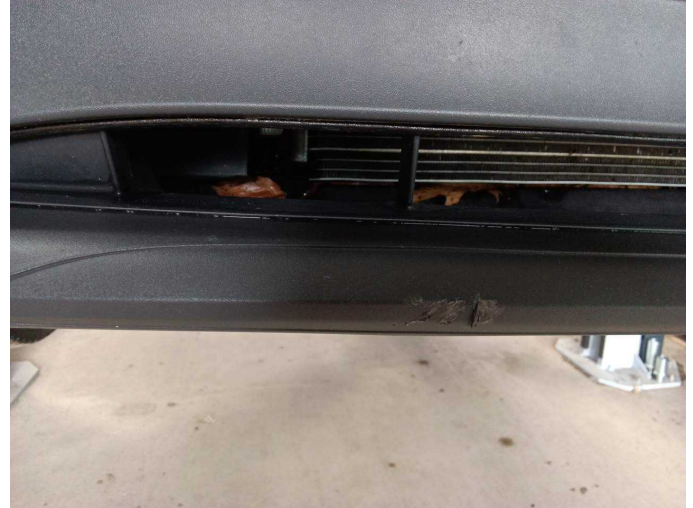
**Damage 8:** Front bumper: Front bumper - Scratch(es) - Replace

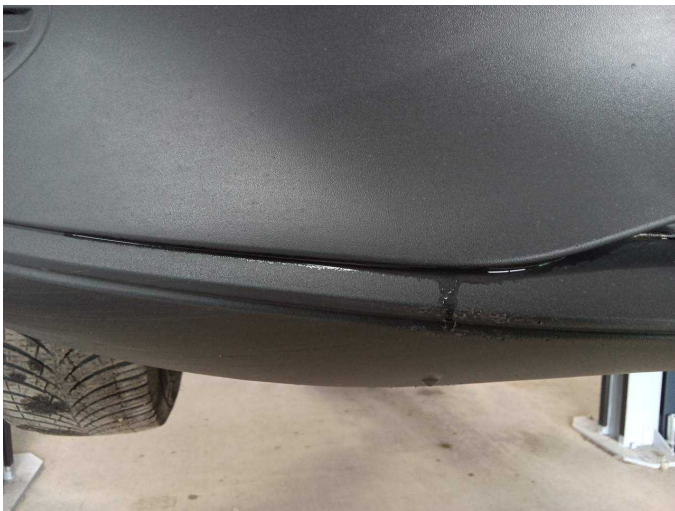
**Damage 8:** Front bumper: Front bumper - Scratch(es) - Replace

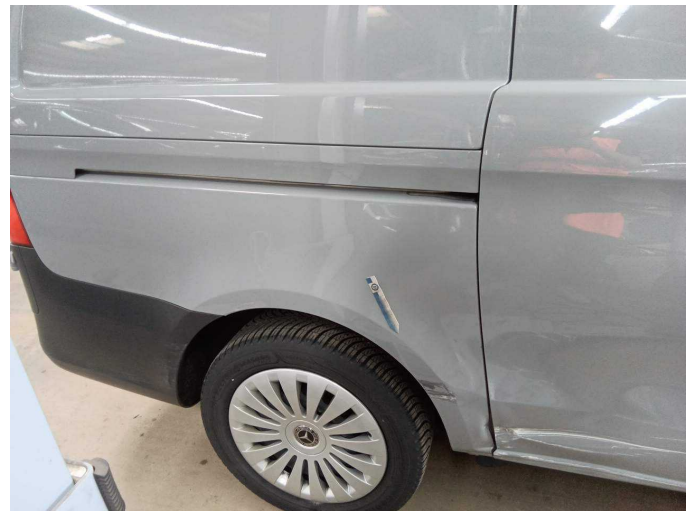
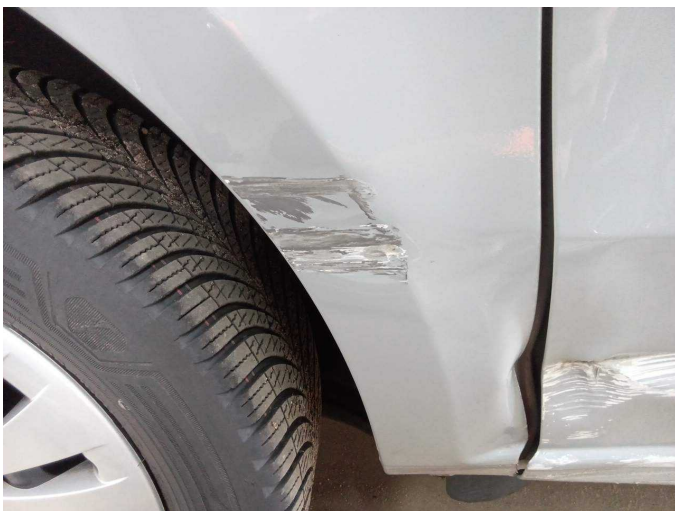
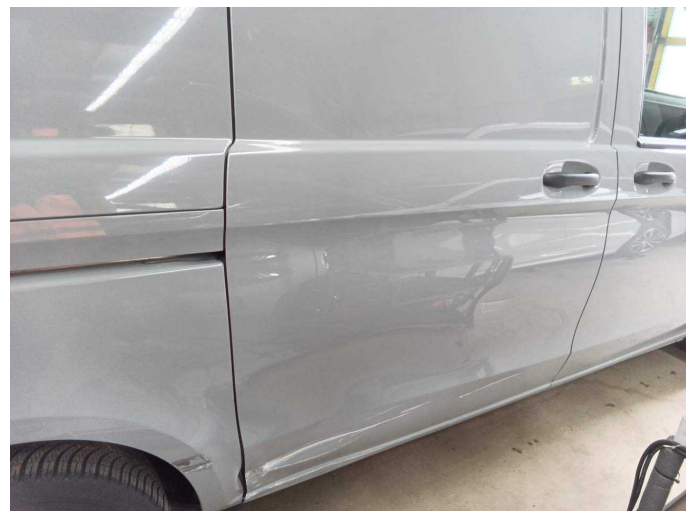
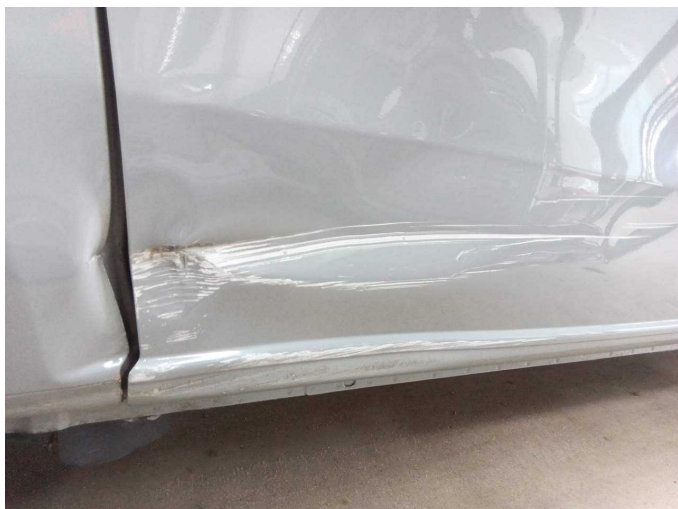
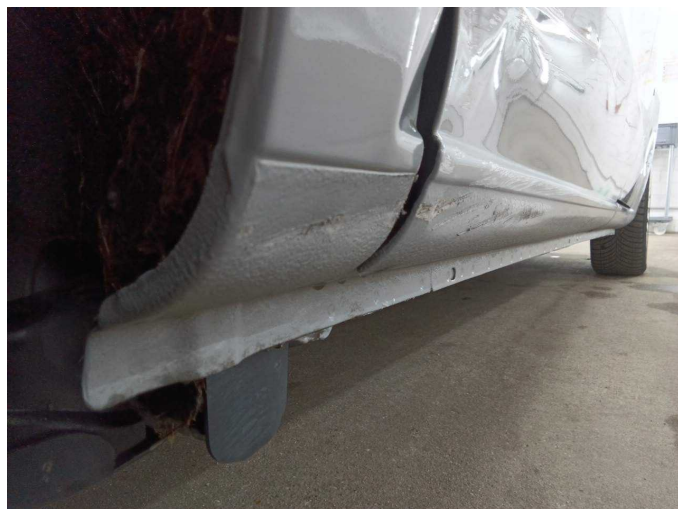
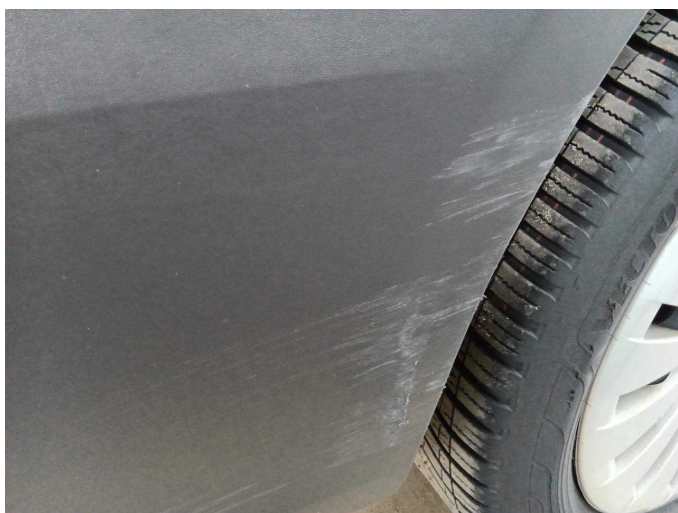
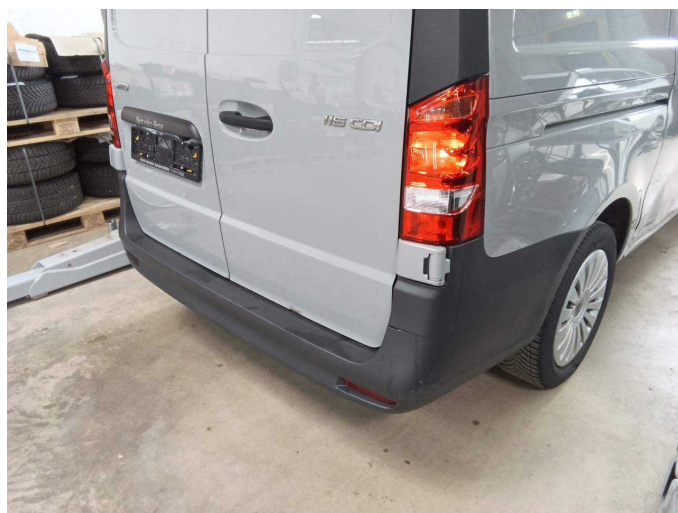
**Accident 1:**

Seitenwand wurde nur teilweise ersetzt.
