Expertise

Protocol number: 46791414  
Order No. / Reference: 26777074  
Inspection date: 27 Jul 2026

Manufacturer: Kia

Model: Ceed SW 1.6 CRDi (48V Mild-Hybrid) Vision

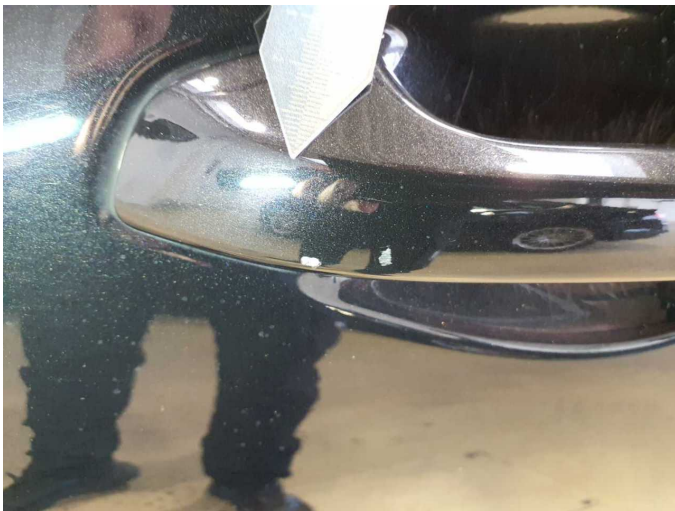
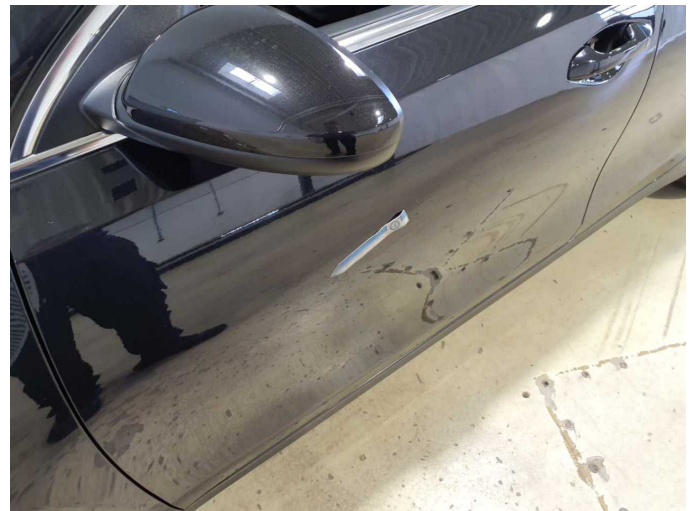
| No. | Component group | Description |
|---|---|---|
| 1 | Door - front left side | Door handle - outside - Scratch(es) - Smart repair |

**Damage 1:** Door - front left side: Door handle - outside - Scratch(es) - Smart repair

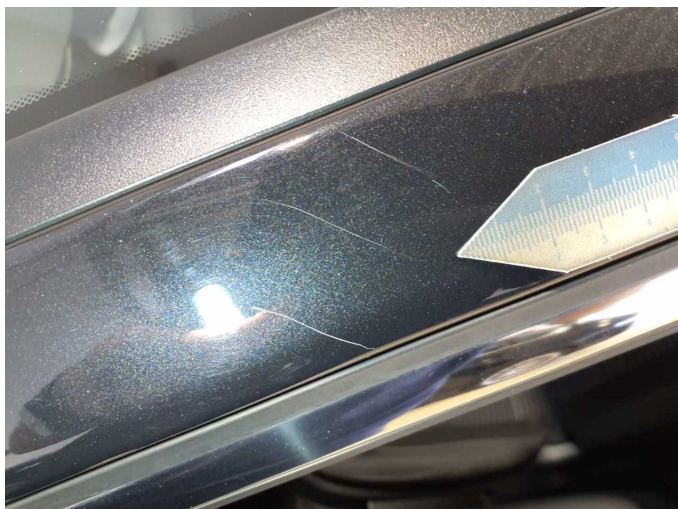
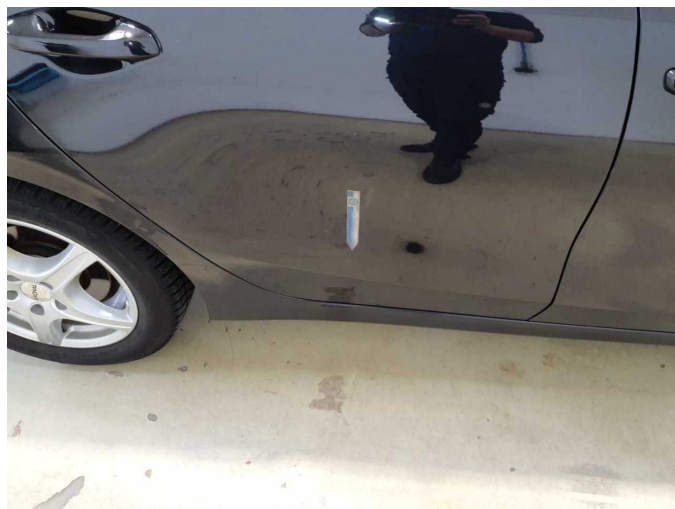
| No. | Component group | Description |
|---|---|---|
| 6 | Body | A-pillar - left side - Scratch(es) - Smart repair |

**Damage 6:** Body: A-pillar - left side - Scratch(es) - Smart repair

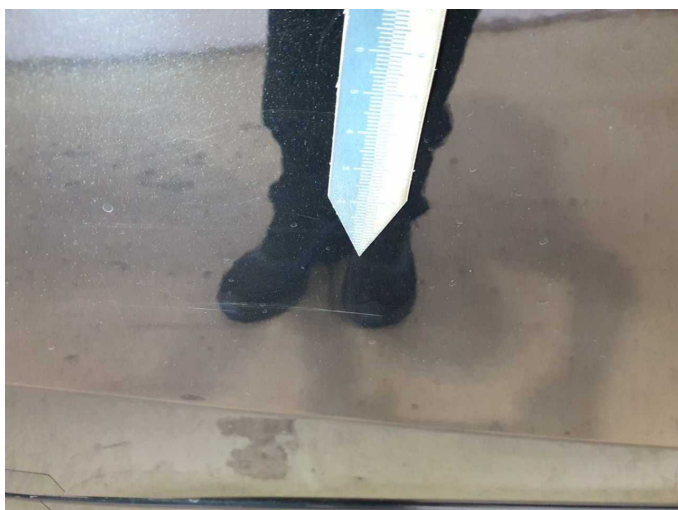
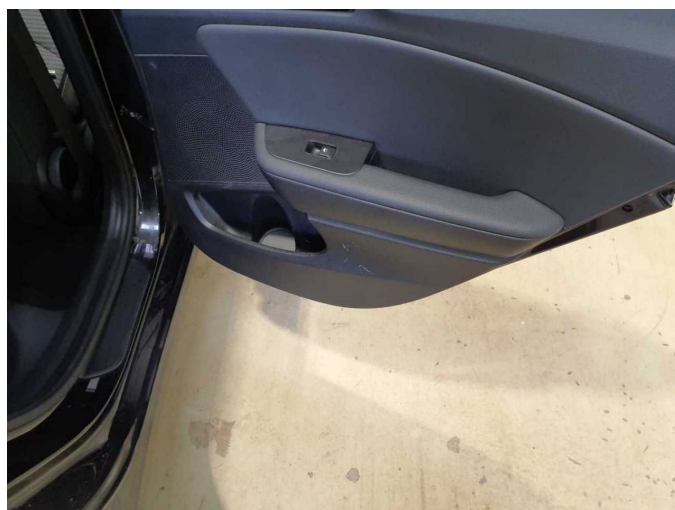
| No. | Component group | Description |
|---|---|---|
| 7 | Door - rear right side | Door - Scratch(es) - Smart repair |

**Damage 7:** Door - rear right side: Door - Scratch(es) - Smart repair

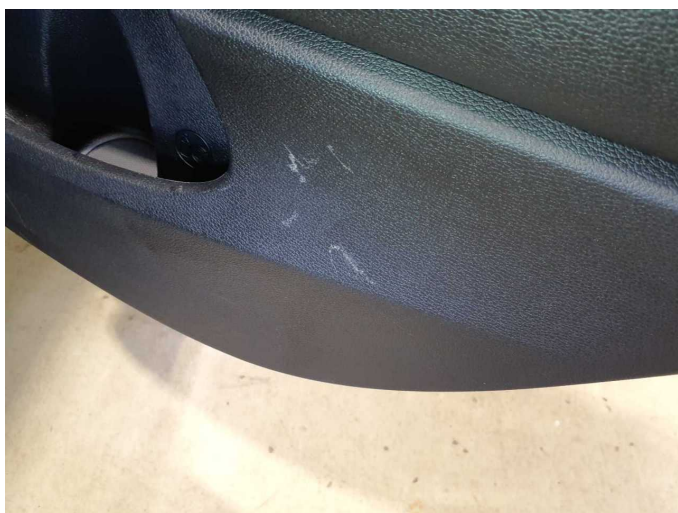
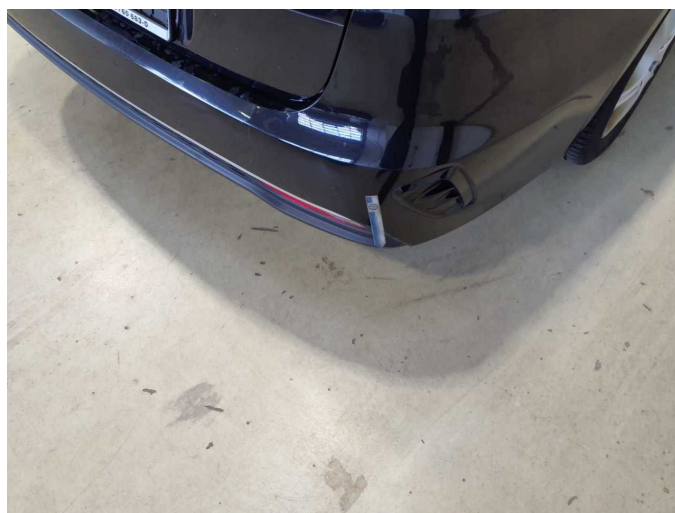
| No. | Component group | Description |
|---|---|---|
| 8 | Trim / covers | Door trim - rear right side - Scratch(es) - Loss in value |

**Damage 8:** Trim / covers: Door trim - rear right side - Scratch(es) - Loss in value

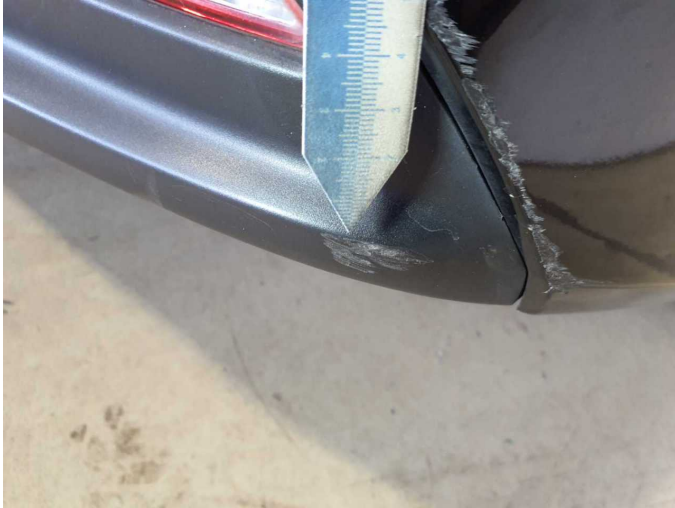
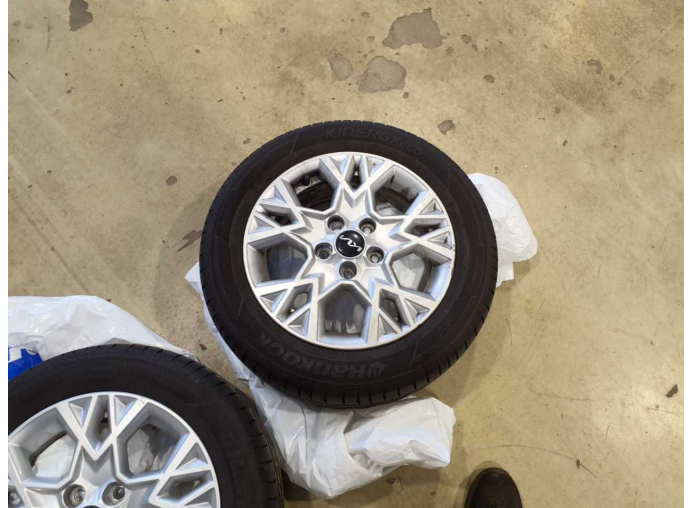
| No. | Component group | Description |
|---|---|---|
| 9 | Rear bumper | Spoiler - Scratch(es) - Replace |

**Damage 9:** Rear bumper: Spoiler - Scratch(es) - Replace

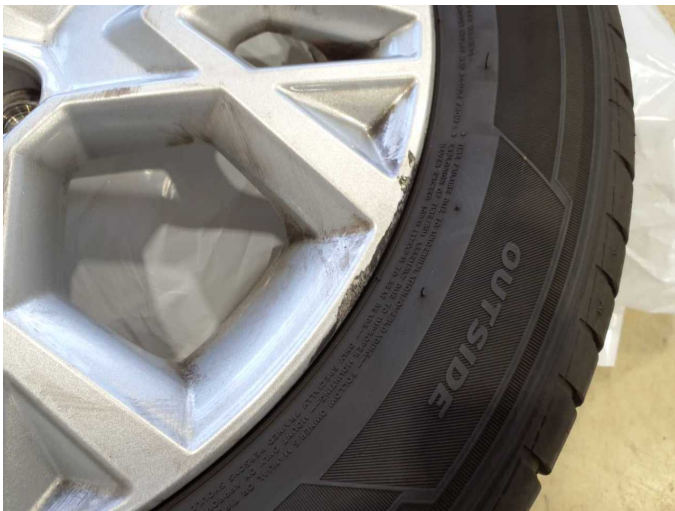
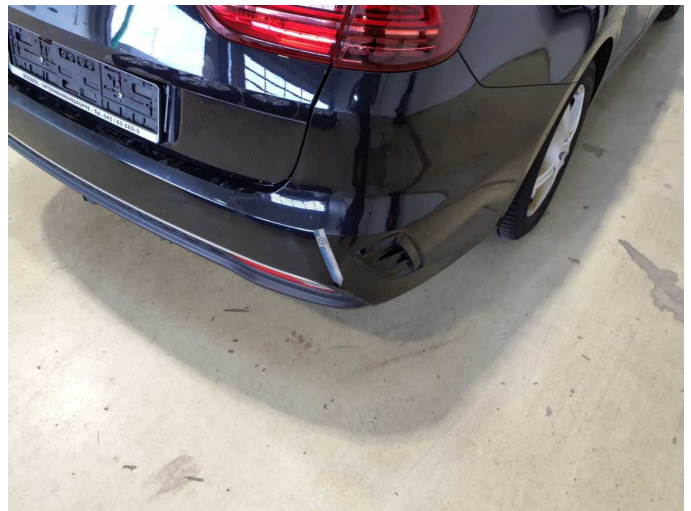
| No. | Component group | Description |
|---|---|---|
| 10 | 2nd wheel set | 1 alloy rim - Scratch(es) - Loss in value |

**Damage 10:** 2nd wheel set: 1 alloy rim - Scratch(es) - Loss in value

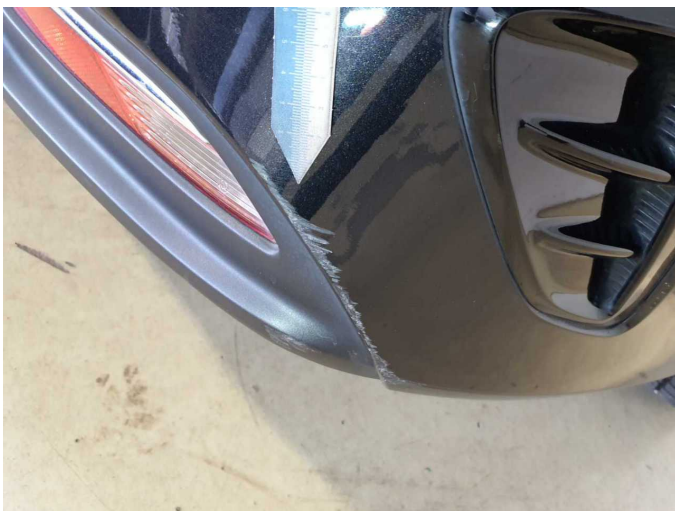
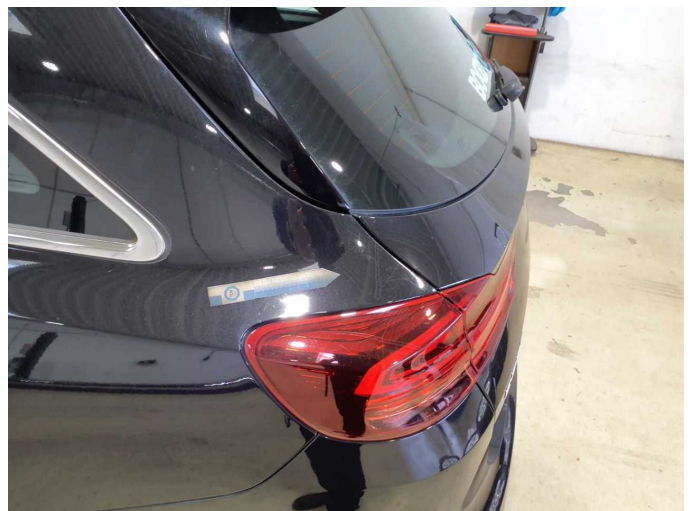
| No. | Component group | Description |
|---|---|---|
| 11 | Rear bumper | Rear bumper - Scratch(es) - Paint |

**Damage 11:** Rear bumper: Rear bumper - Scratch(es) - Paint

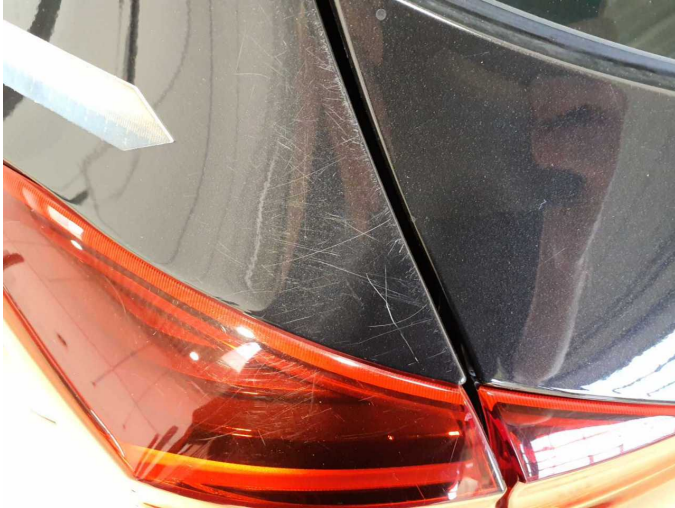
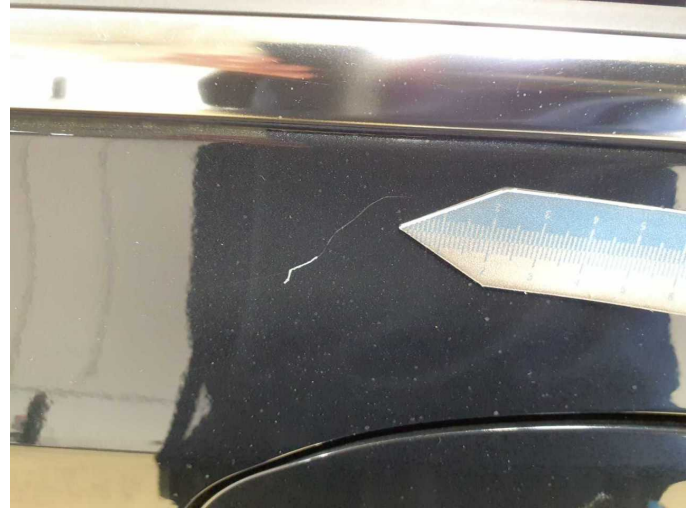
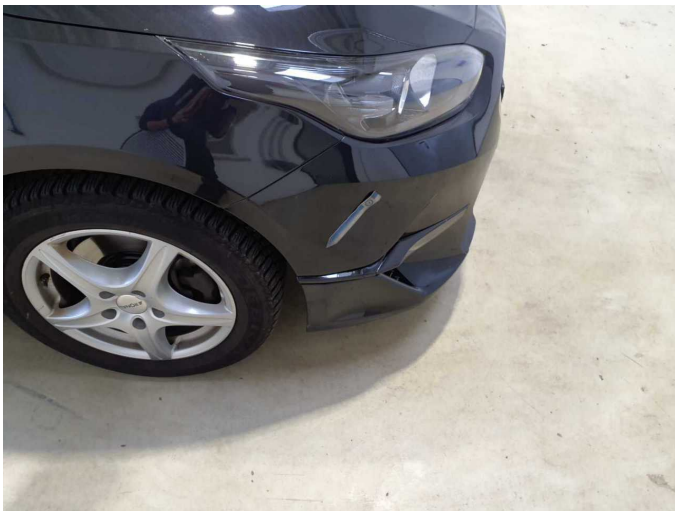
| No. | Component group | Description |
|---|---|---|
| 12 | Side panel - rear left side | Side panel - Scratch(es) - Paint |

**Damage 12:** Side panel - rear left side: Side panel - Scratch(es) - Paint

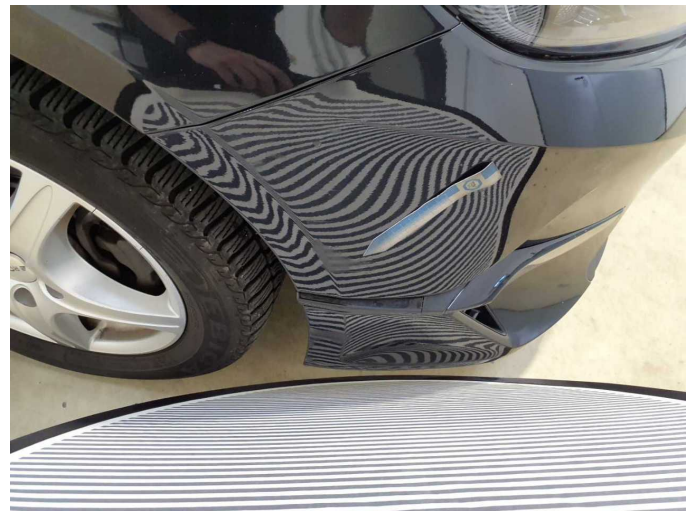
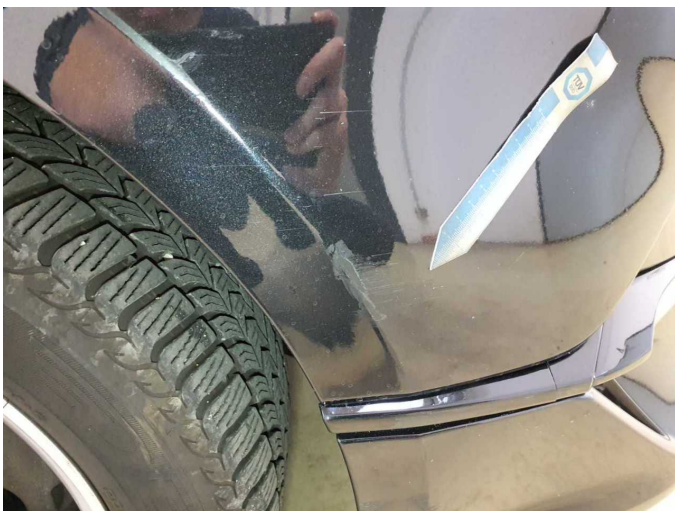
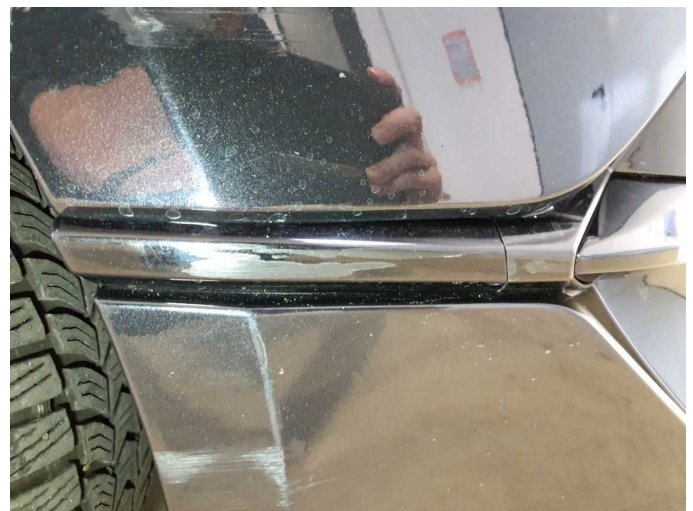
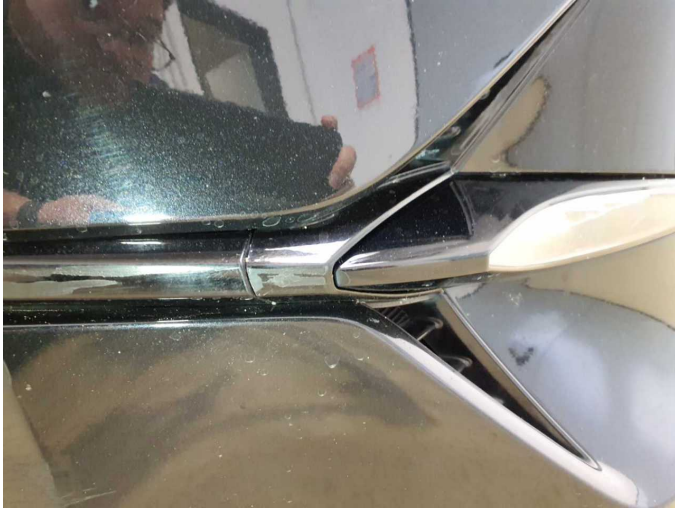
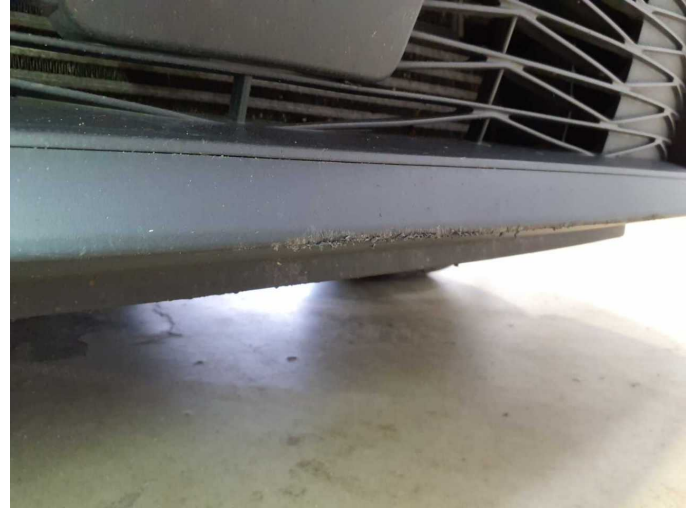
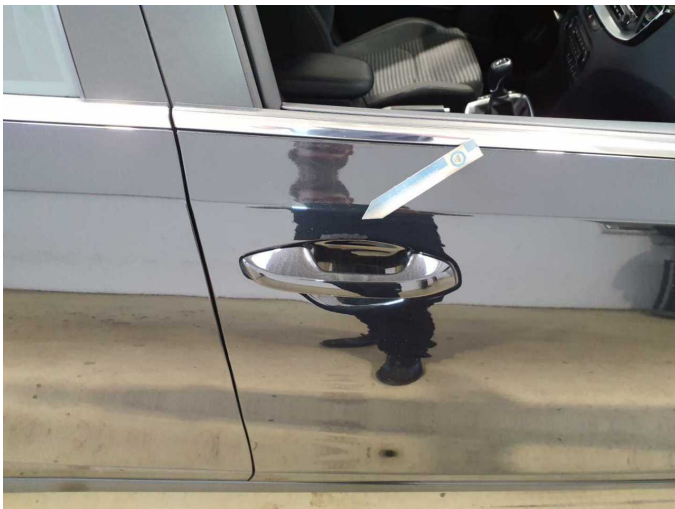
| No. | Component group | Description |
|---|---|---|
| 13 | Front bumper | Front bumper (+ Spoiler erneuern) - Dent / paintcoat damage - Paint |

**Damage 13:** Front bumper: Front bumper (+ Spoiler erneuern) - Dent / paintcoat damage - Paint

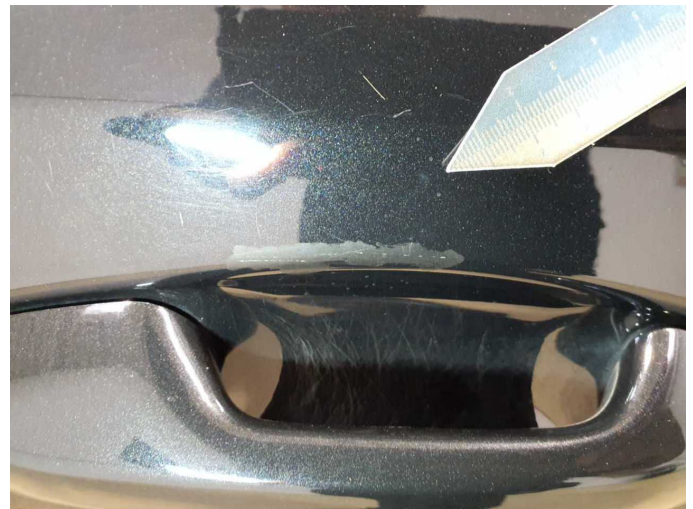
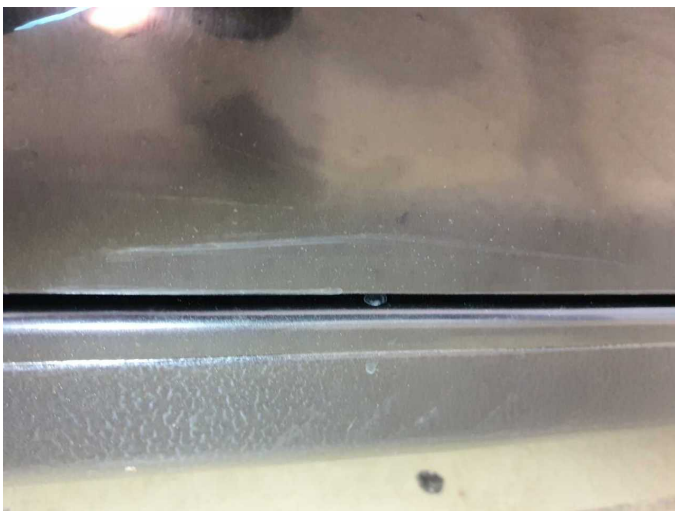
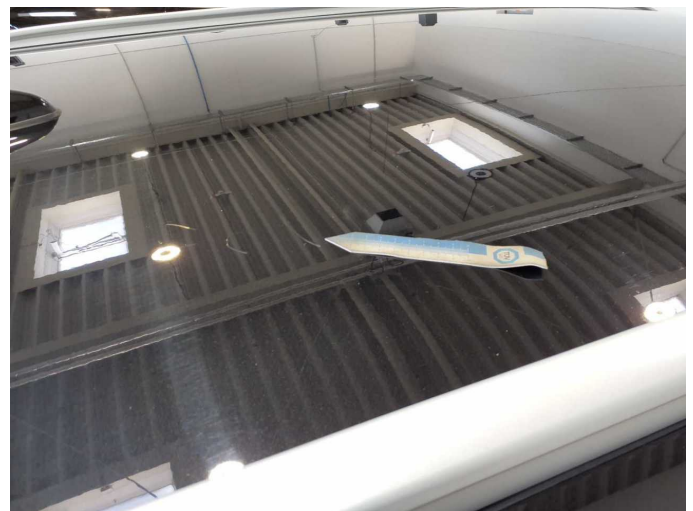
| No. | Component group | Description |
|---|---|---|
| 14 | Door - front right side | Door (Lackstift) - Paint defect - Paint |

**Damage 14:** Door - front right side: Door (Lackstift) - Paint defect - Paint

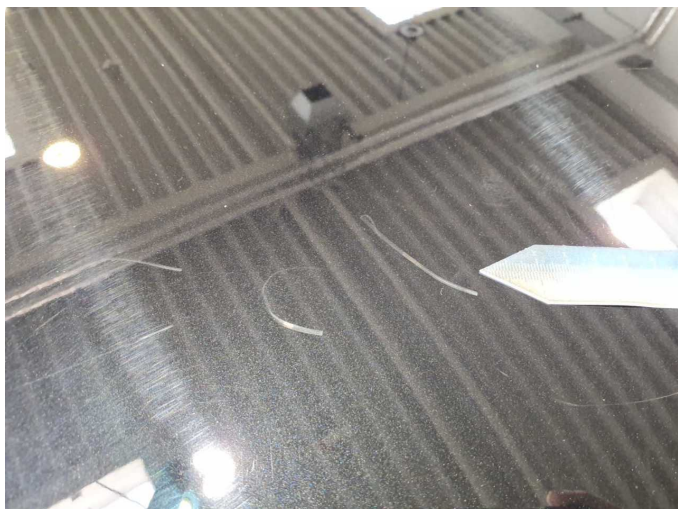
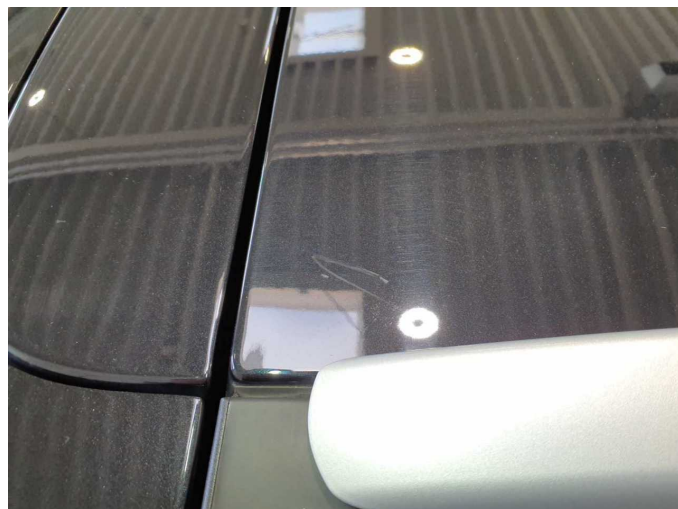
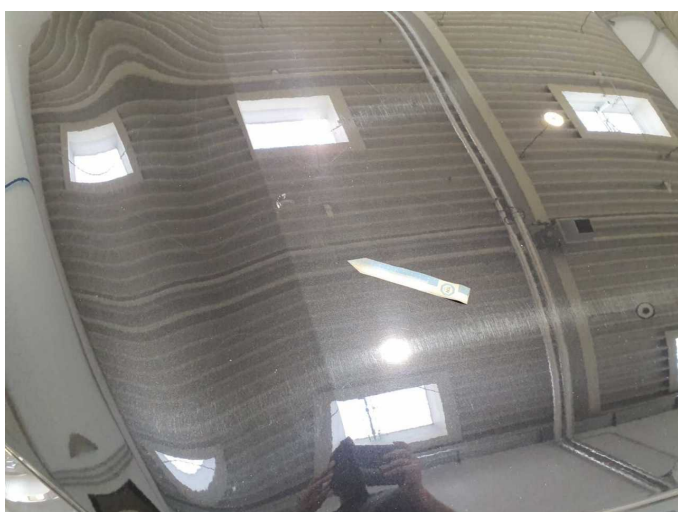
| No. | Component group | Description |
|---|---|---|
| 15 | Roof | Roof - Scratch(es) - Paint |

**Damage 15:** Roof: Roof - Scratch(es) - Paint

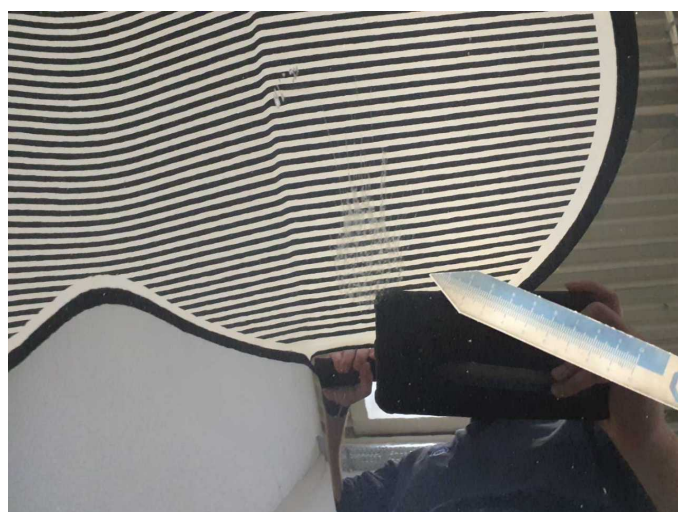
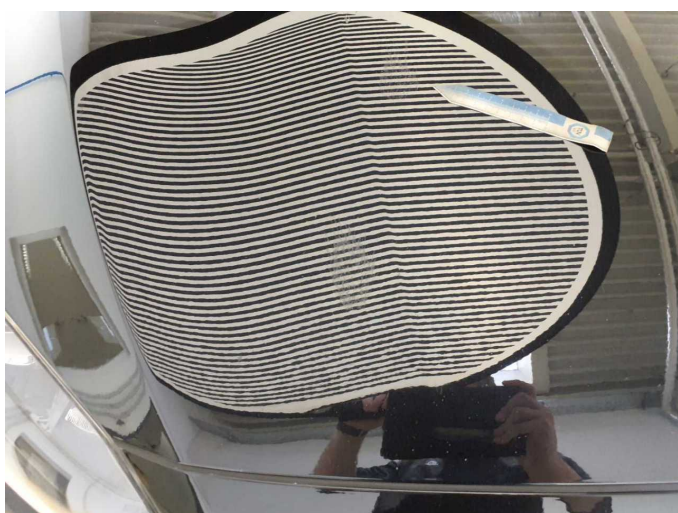
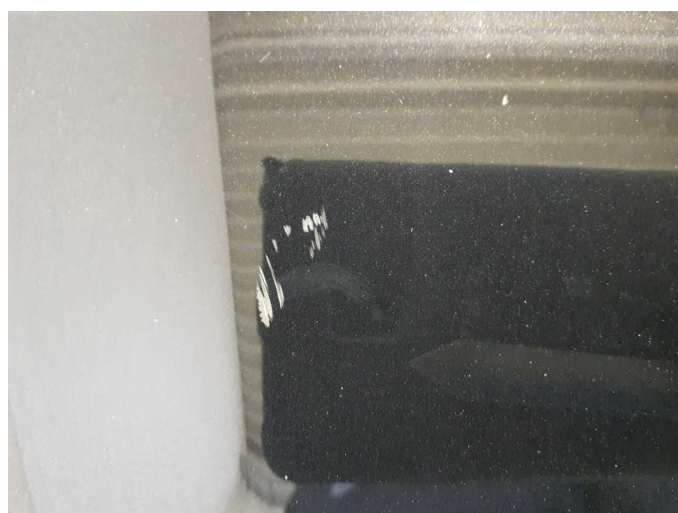
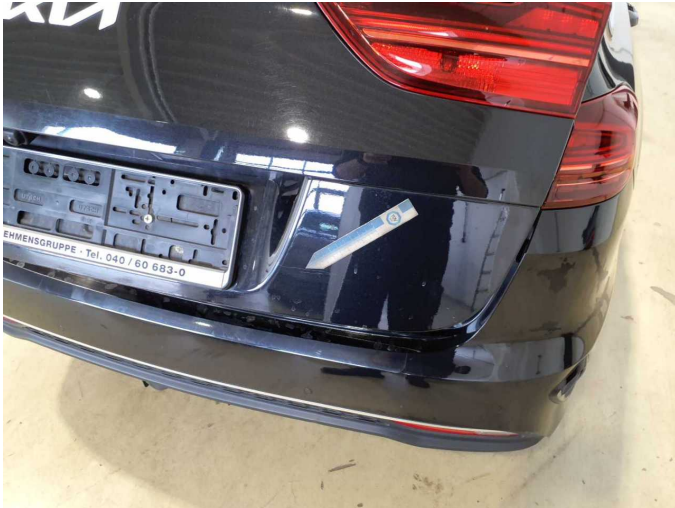
| No. | Component group | Description |
|---|---|---|
| 16 | Bonnet | Bonnet (Anätzung) - Paint defect - Paint |

**Damage 16:** Bonnet: Bonnet (Anätzung) - Paint defect - Paint

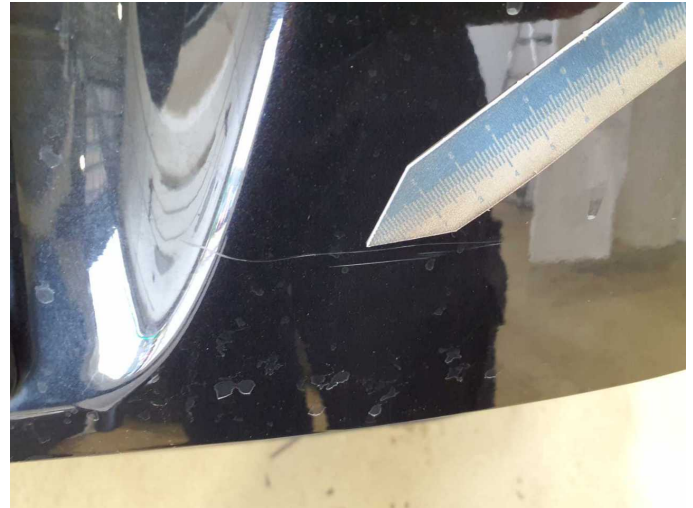
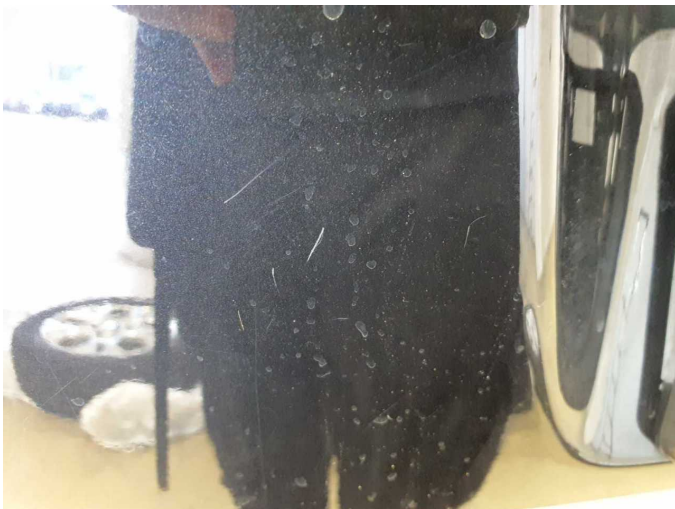
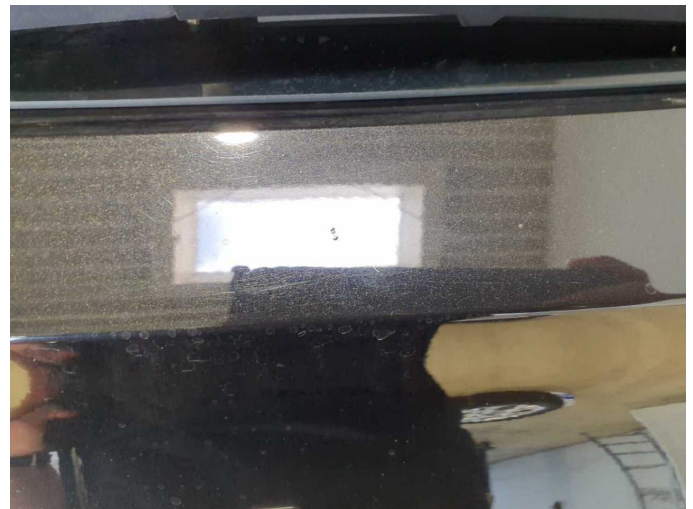
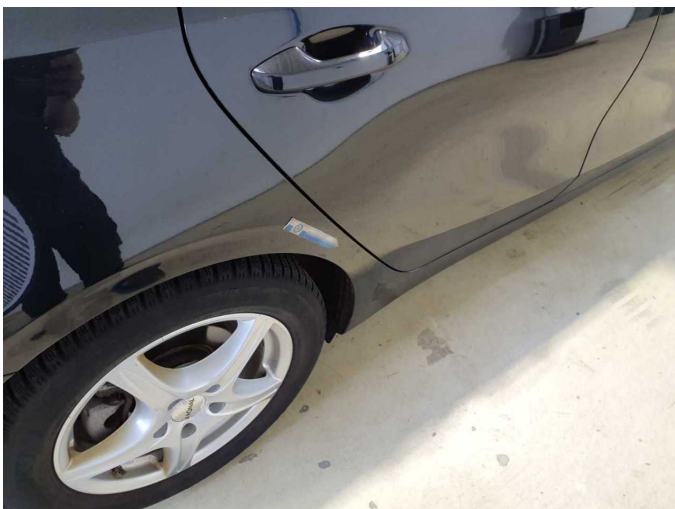
| No. | Component group | Description |
|---|---|---|
| 17 | Boot lid / rear door | Boot lid - Scratch(es) - Paint |

**Damage 17:** Boot lid / rear door: Boot lid - Scratch(es) - Paint

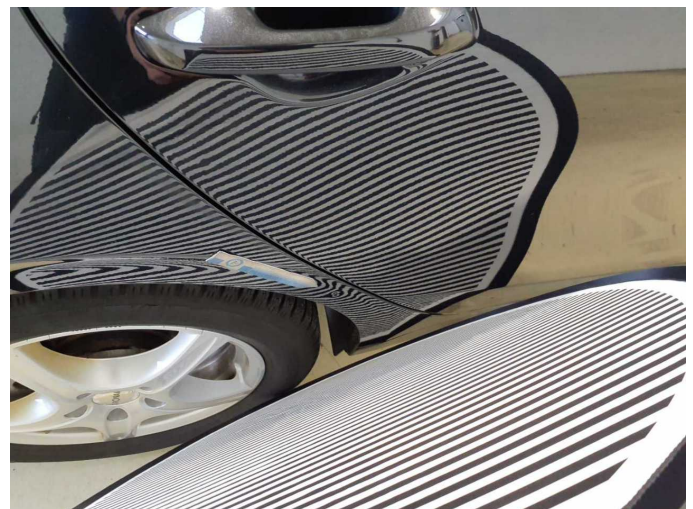
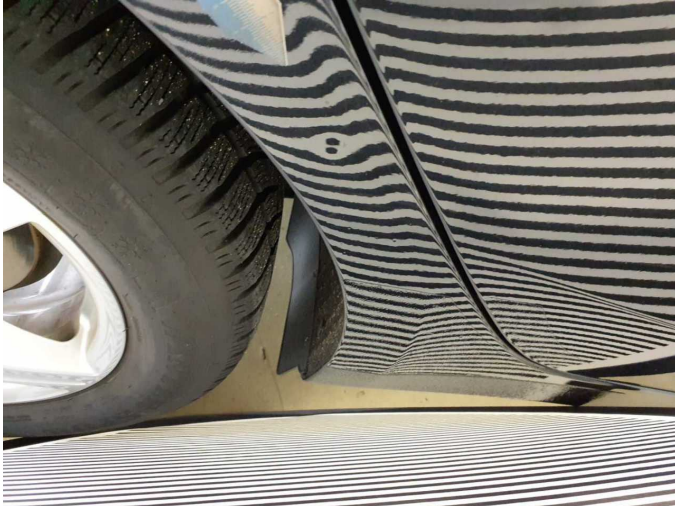
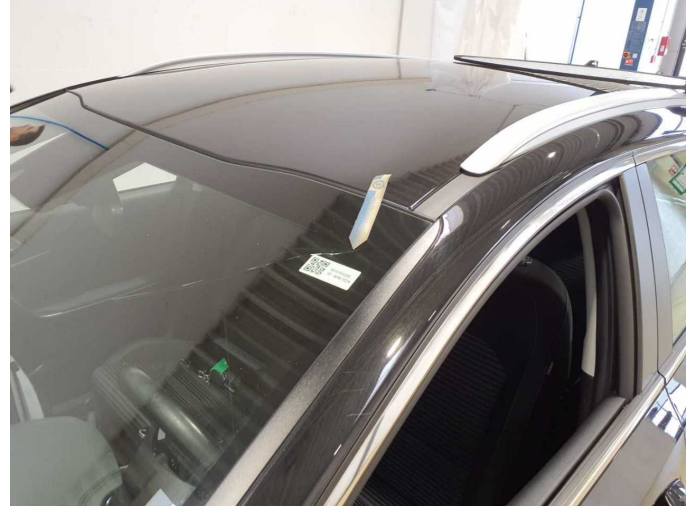
| No. | Component group | Description |
|---|---|---|
| 18 | Side panel - rear right side | Side panel (Einschlüsse) - Paint defect - Repair and paint |

**Damage 18:** Side panel - rear right side: Side panel (Einschlüsse) - Paint defect - Repair and paint

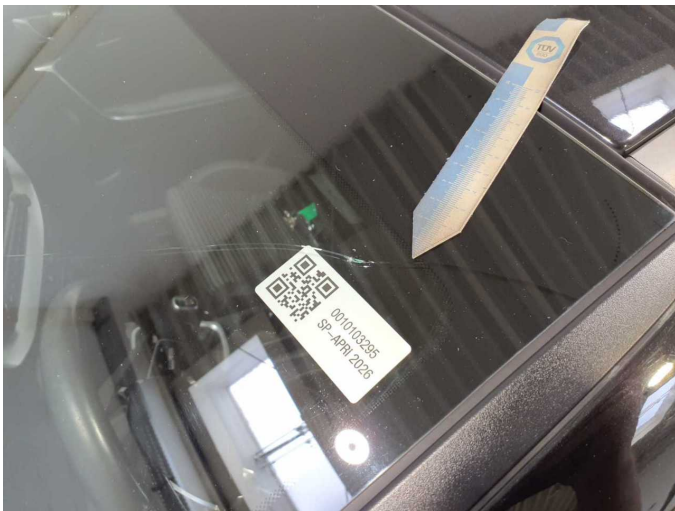
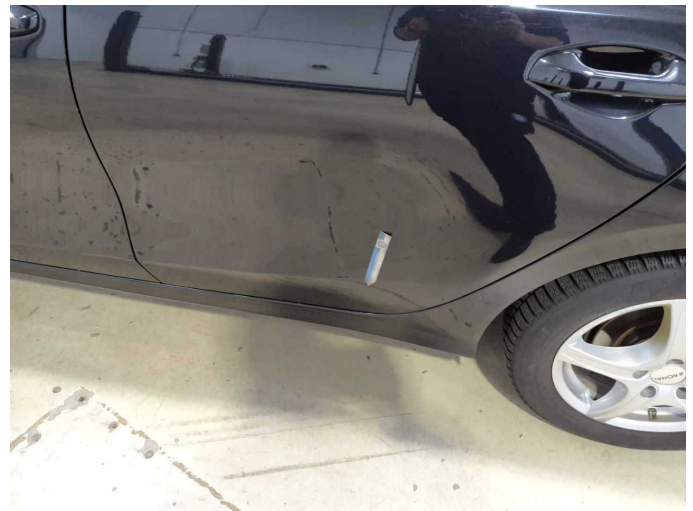
| No. | Component group | Description |
|---|---|---|
| 19 | Vehicle glazing | Windscreen - Broken / torn - Replace |

**Damage 19:** Vehicle glazing: Windscreen - Broken / torn - Replace

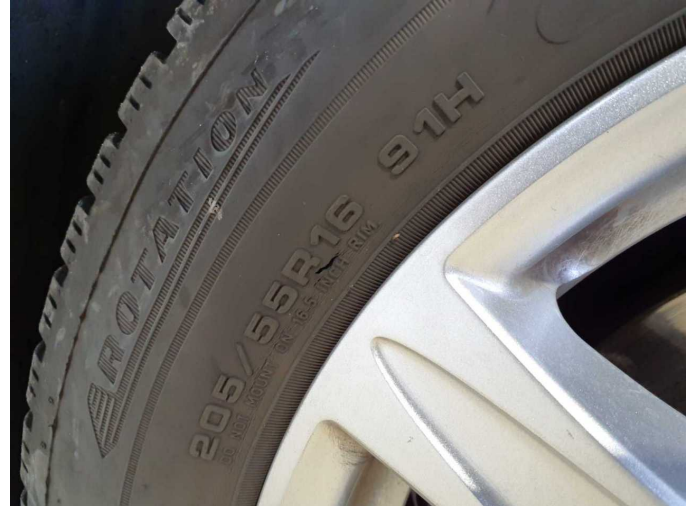
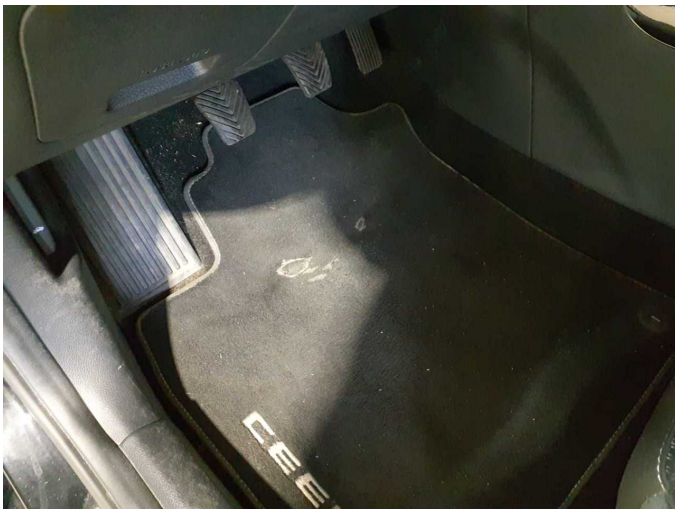
| No. | Component group | Description |
|---|---|---|
| 2 | Wheel / tyres | Tyre - front left side - Broken / torn - No deduction |

**Wear and tear 2:** Wheel / tyres: Tyre - front left side - Broken / torn - No deduction
