Expertise

Protocol number: 46131818
Order No. / Reference: 26471398
Inspection date: 19 Jun 2026

Model: Caddy 2.0 TDI (7-Si.) Maxi Comfortline

VIN: WV2ZZZ2KZLX018164

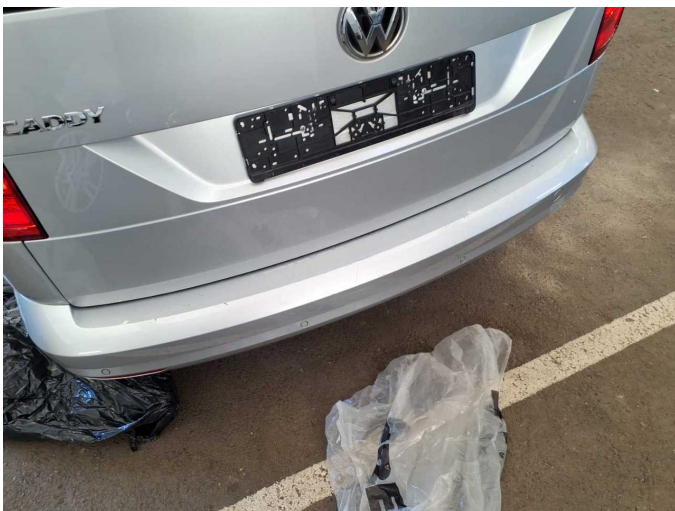
No.	Component group	Description
1	Rear bumper	Rear bumper - Scratched - Paint
2	Vehicle glazing	Windscreen (Mit Rissbildung im Fahrersichtfeld) - Stone chips - Replace

Damage 1: Rear bumper: Rear bumper - Scratched - Paint

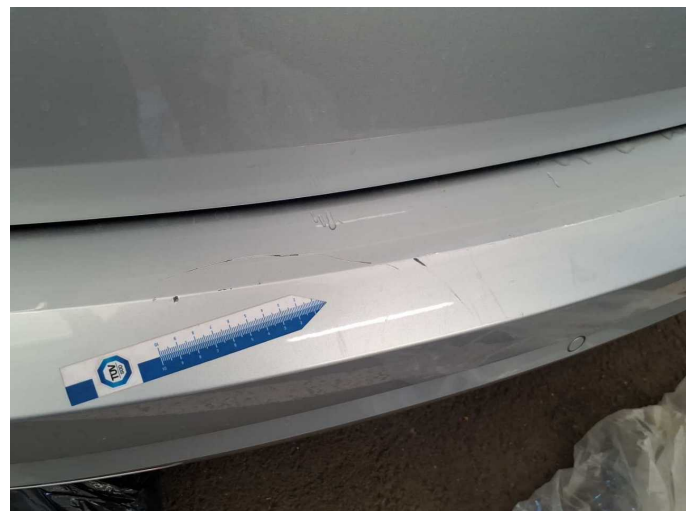
Damage 1: Rear bumper: Rear bumper - Scratched - Paint

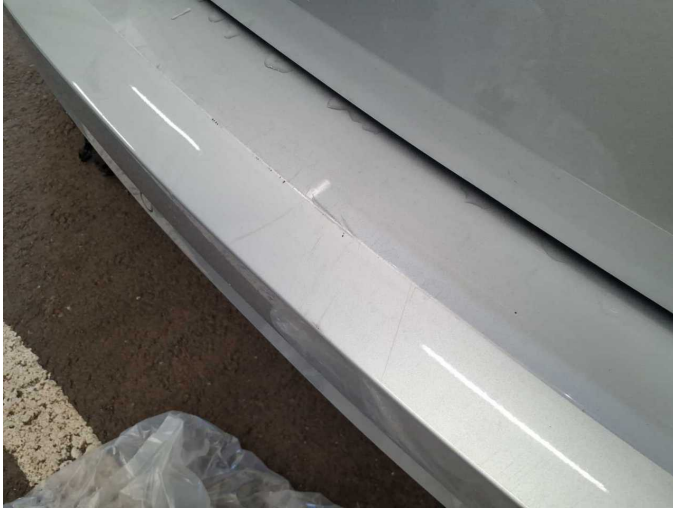
Damage 1: Rear bumper: Rear bumper - Scratched - Paint

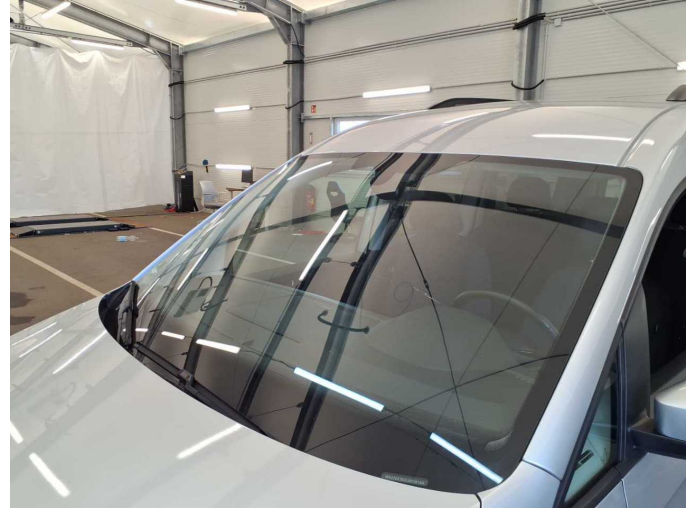
Damage 2: Vehicle glazing: Windscreen (Mit Rissbildung im Fahrersichtfeld) - Stone chips - Replace

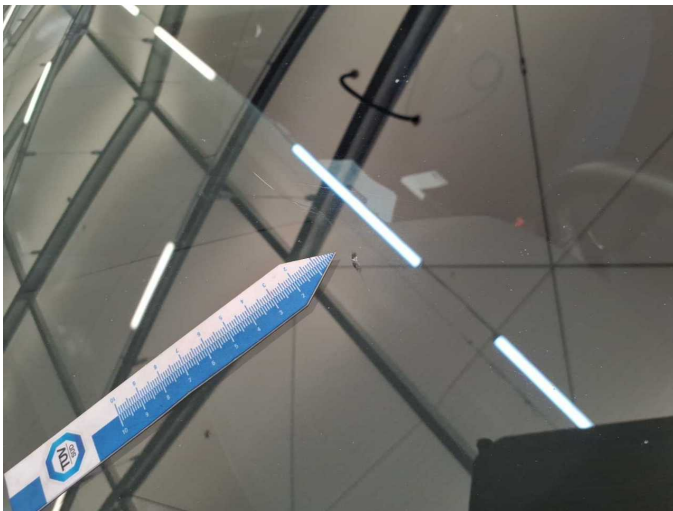
Damage 2: Vehicle glazing: Windscreen (Mit Rissbildung im Fahrersichtfeld) - Stone chips - Replace

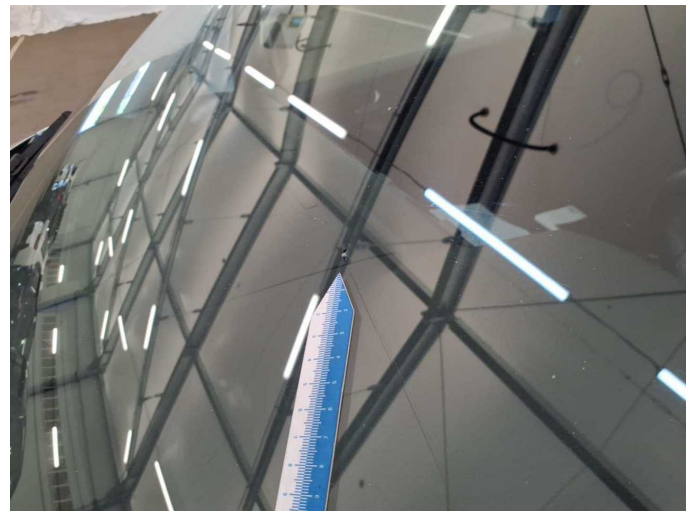
Damage 2: Vehicle glazing: Windscreen (Mit Rissbildung im Fahrersichtfeld) - Stone chips - Replace
