Expertise

Protocol number: 46305561
Order No. / Reference: 26553644
Inspection date: 1 Jul 2026

Manufacturer: Opel

Model: Zafira Life 2.0 D L Aut. Tourer

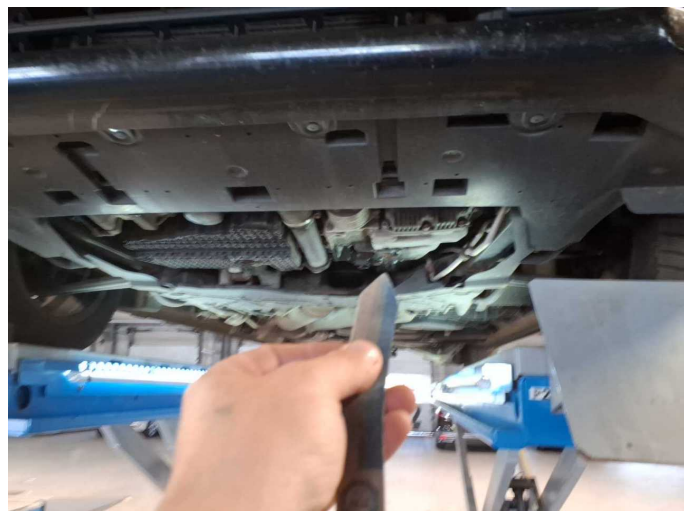
Damage 1: Gearbox: Gearbox - Leaking - Perform diagnosis

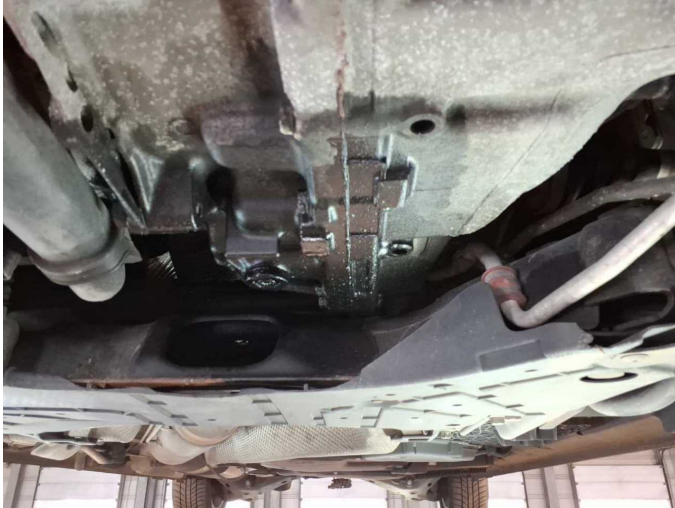
Damage 1: Gearbox: Gearbox - Leaking - Perform diagnosis

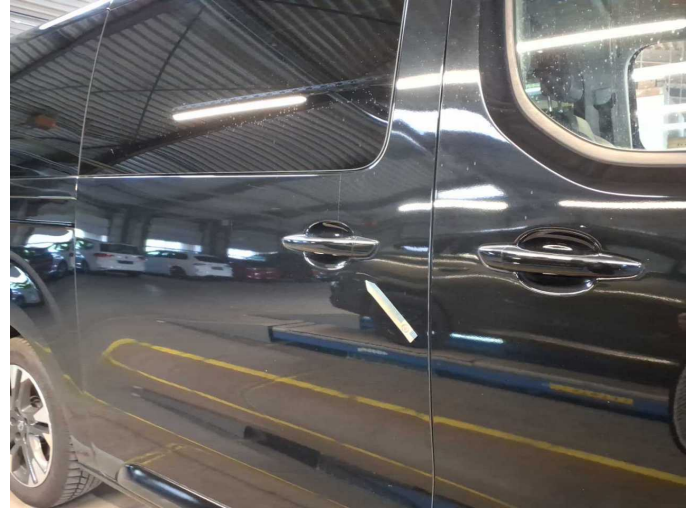
Damage 3: Sliding door, right: Sliding door with glass panel - Scratch(es) - Smart repair

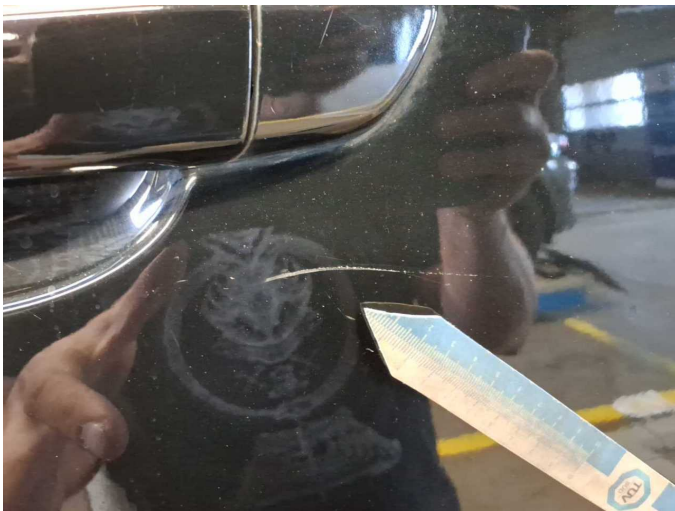
Damage 3: Sliding door, right: Sliding door with glass panel - Scratch(es) - Smart repair

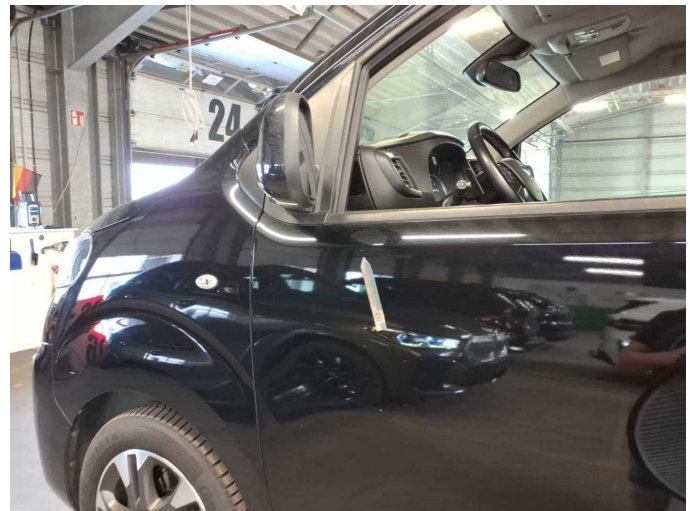
Damage 4: Door - front left side: Door - Dent / paintcoat damage - Smart repair

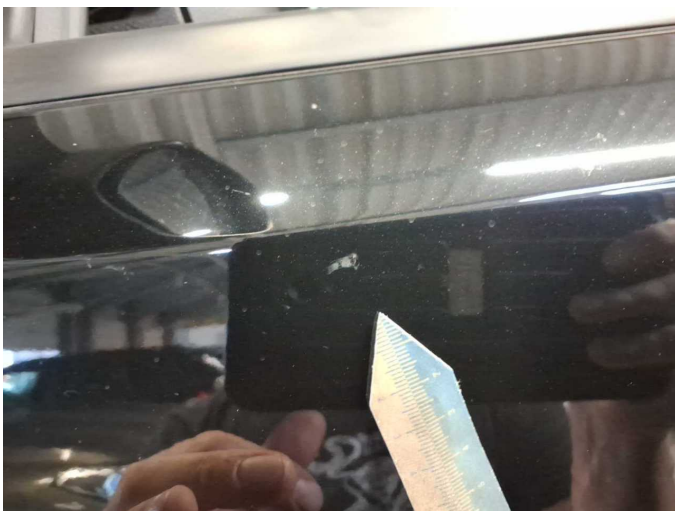
Damage 4: Door - front left side: Door - Dent / paintcoat damage - Smart repair

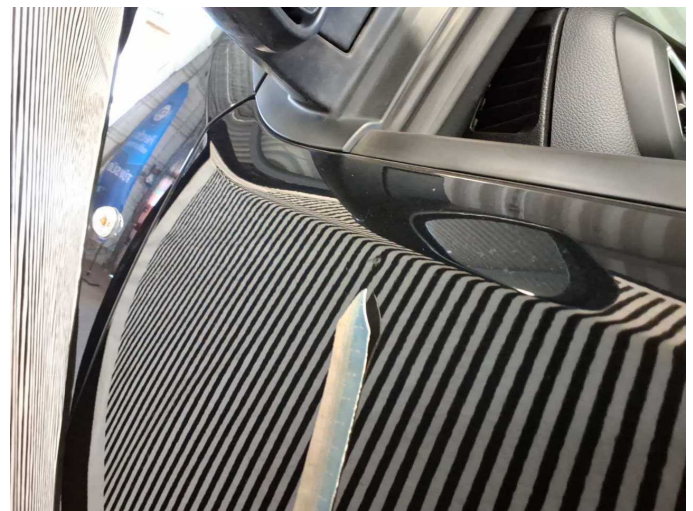
Damage 4: Door - front left side: Door - Dent / paintcoat damage - Smart repair

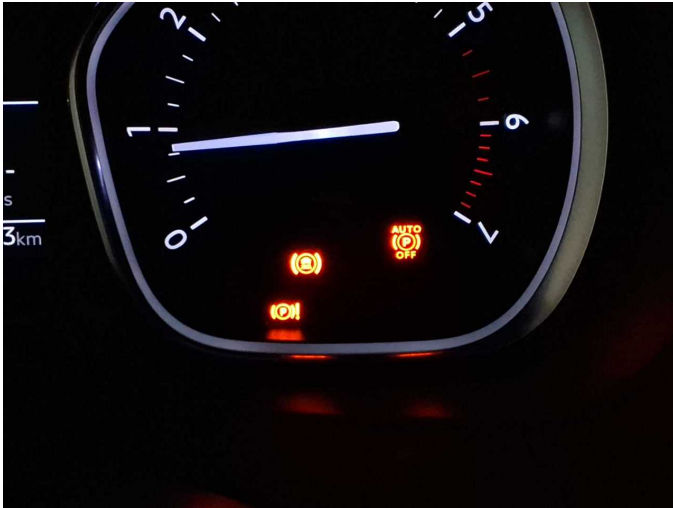
Damage 5: Electronic systems: Electronic systems (Unterspannung) - Functional / admissibility - Perform diagnosis

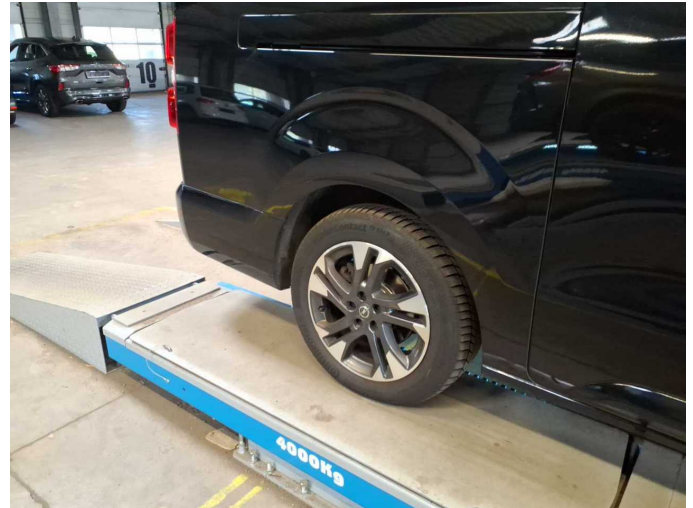
Damage 6: Wheel / tyres: Alloy rim - rear right side (Materialabtrag) - Scratched - Replace

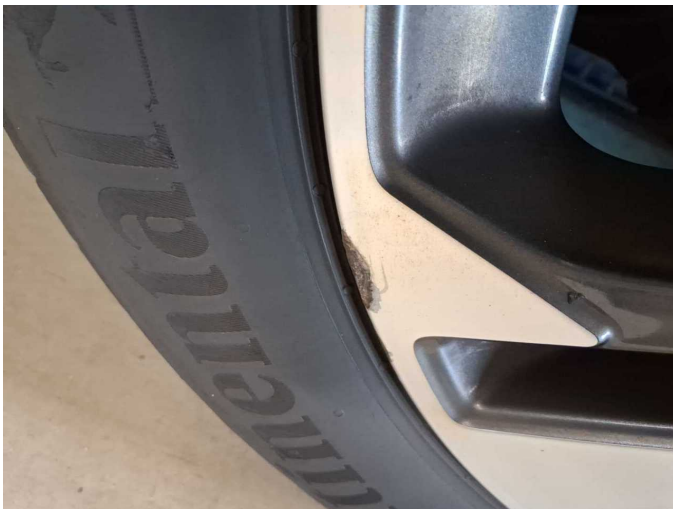
Damage 6: Wheel / tyres: Alloy rim - rear right side (Materialabtrag) - Scratched - Replace

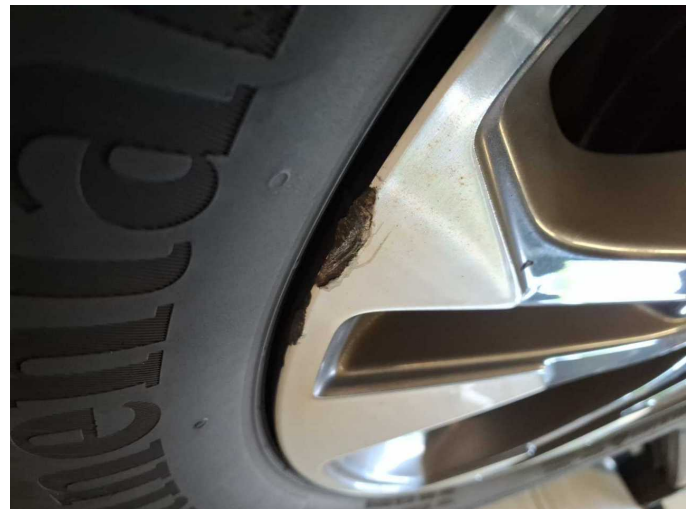
Damage 6: Wheel / tyres: Alloy rim - rear right side (Materialabtrag) - Scratched - Replace

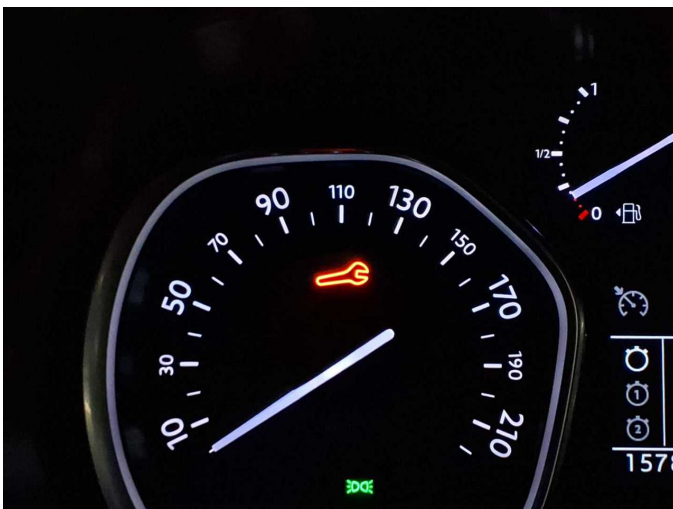
Damage 7: Misc.: Inspection / maintenance - Due - Perform

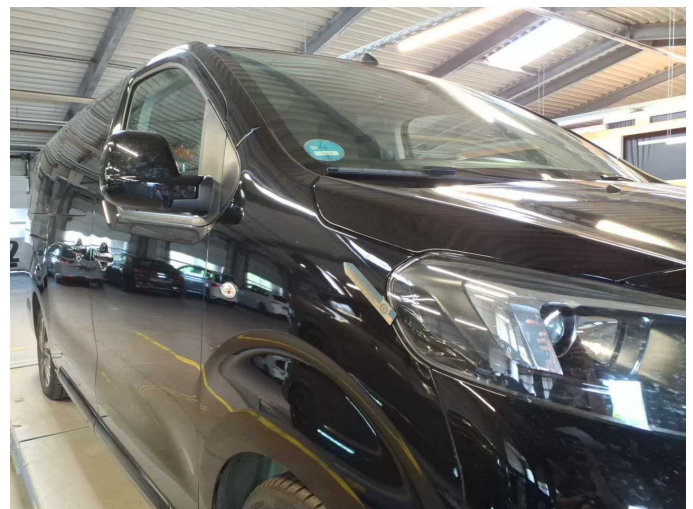
Damage 8: Mudguard - right side: Mudguard - right side - Dent / paintcoat damage - Repair and paint

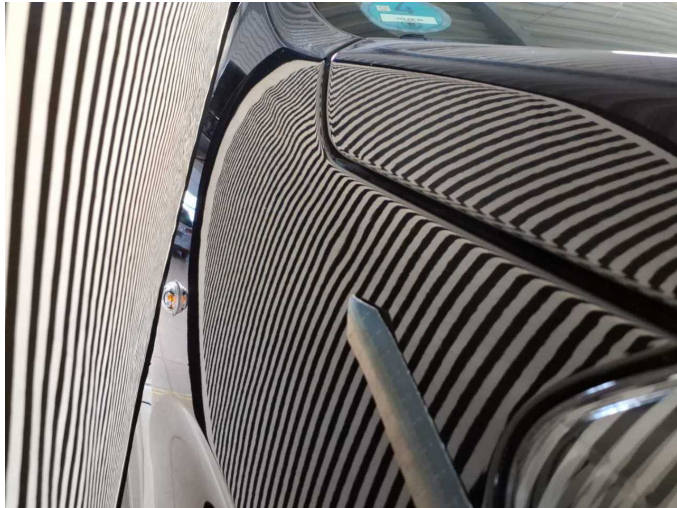
Damage 8: Mudguard - right side: Mudguard - right side - Dent / paintcoat damage - Repair and paint

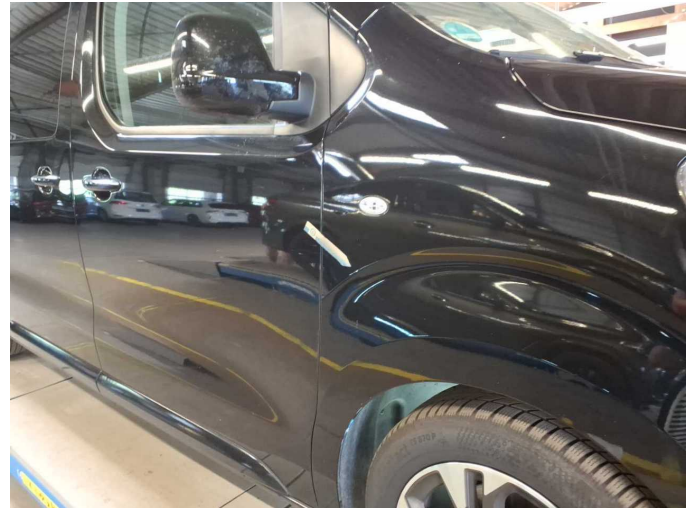
Damage 8: Mudguard - right side: Mudguard - right side - Dent / paintcoat damage - Repair and paint

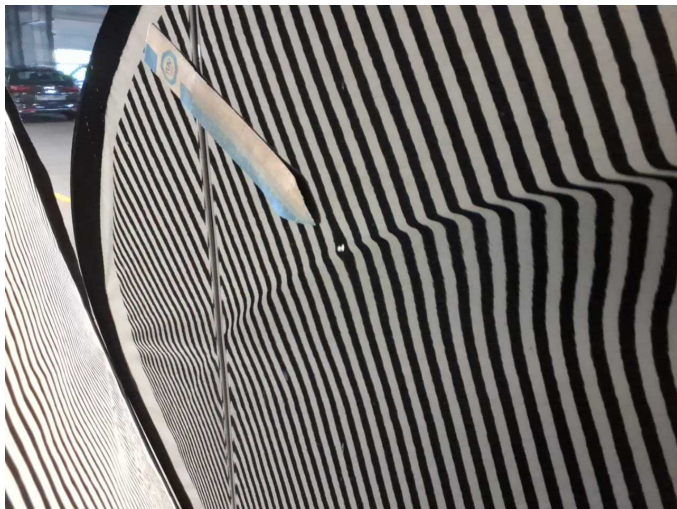
Damage 8: Mudguard - right side: Mudguard - right side - Dent / paintcoat damage - Repair and paint

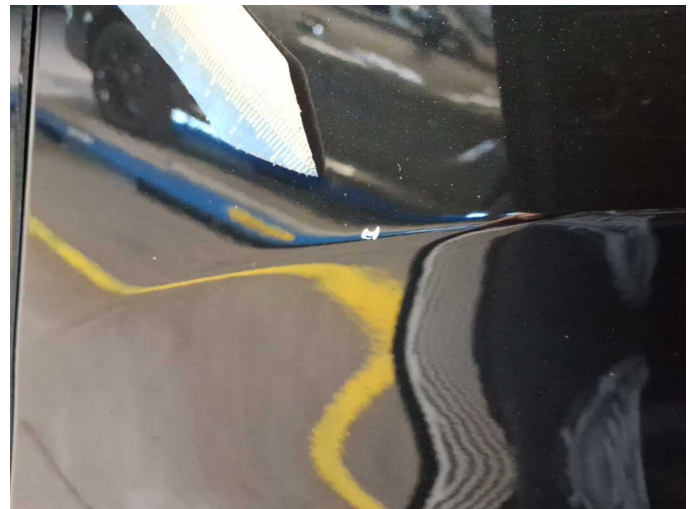
Damage 8: Mudguard - right side: Mudguard - right side - Dent / paintcoat damage - Repair and paint

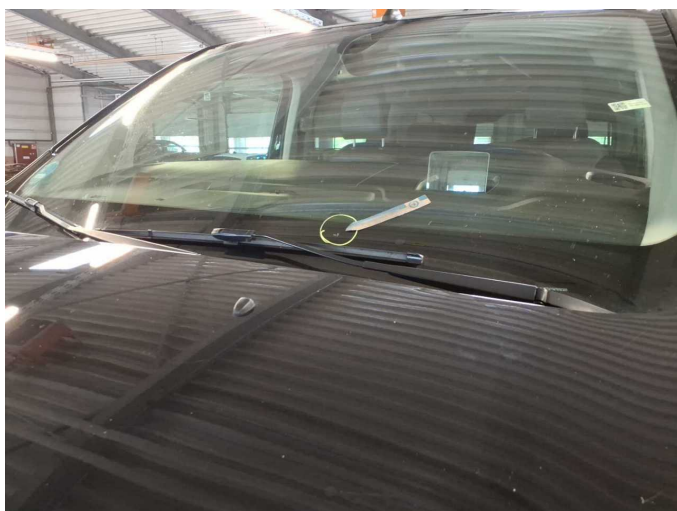
Damage 9: Vehicle glazing: Windscreen - Stone chips - Replace

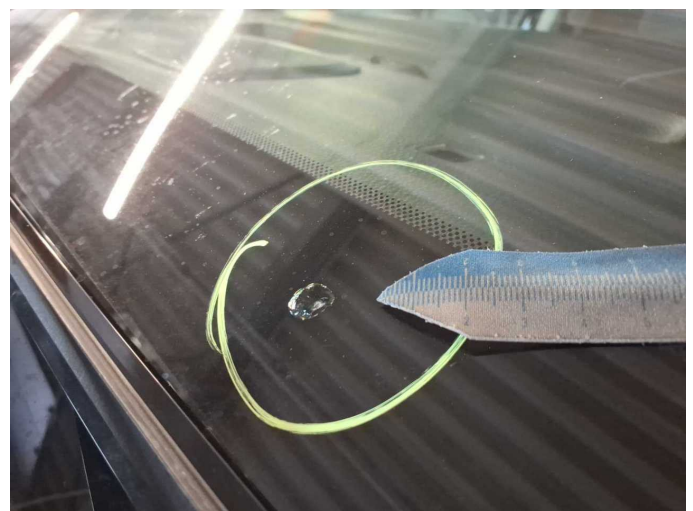
Damage 9: Vehicle glazing: Windscreen - Stone chips - Replace

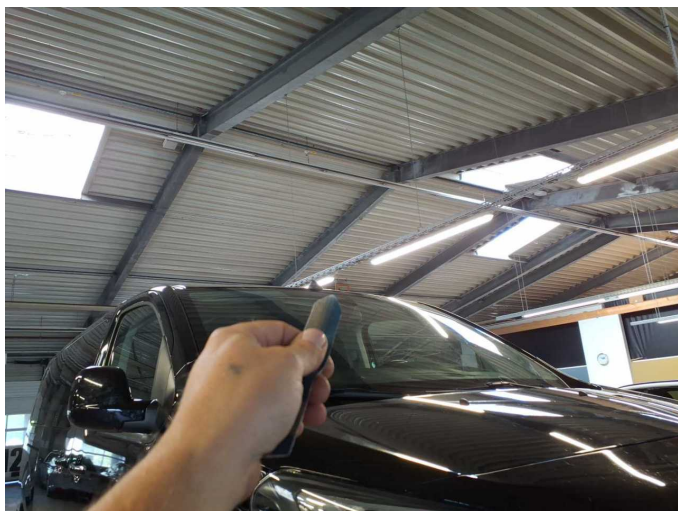
Missing part 2: Roof: Stub aerial - Missing - Replace

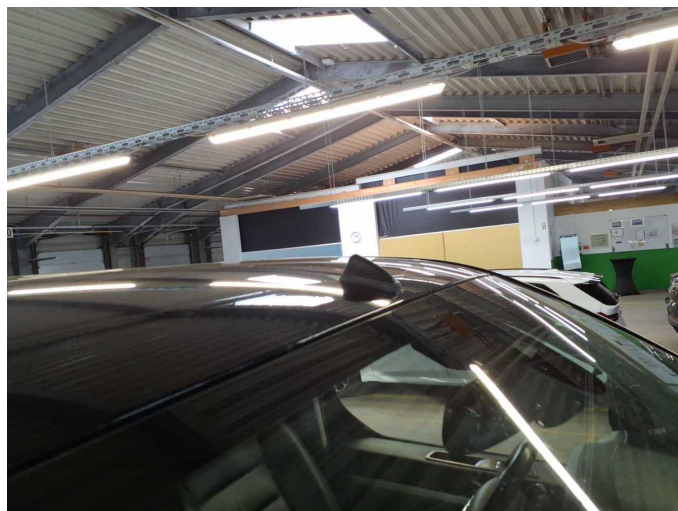
Missing part 2: Roof: Stub aerial - Missing - Replace
