Expertise

Protocol number: 46498993  
Order No. / Reference: 26294479  
Inspection date: 10 Jul 2026

Manufacturer: Mercedes-Benz

Model: Vito 116 CDI Tourer Lang Aut. PRO

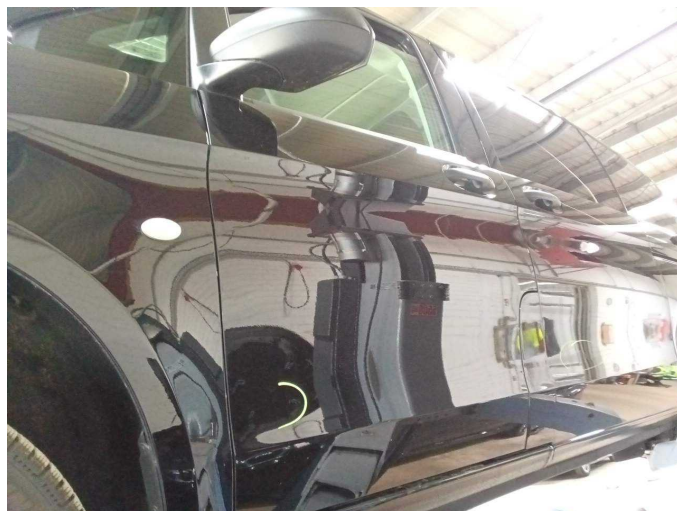
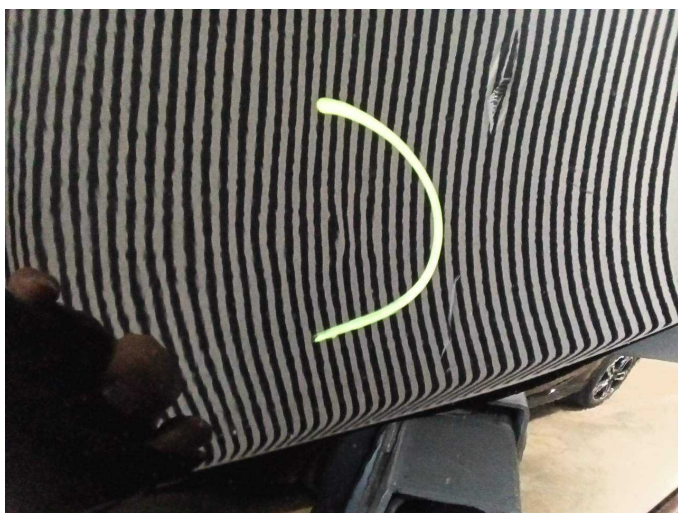
| No. | Component group | Description |
|---|---|---|
| 1 | Door - front left side | Door - dent(s) - Smooth repair work |

**Damage 1:** Door - front left side: Door - dent(s) - Smooth repair work

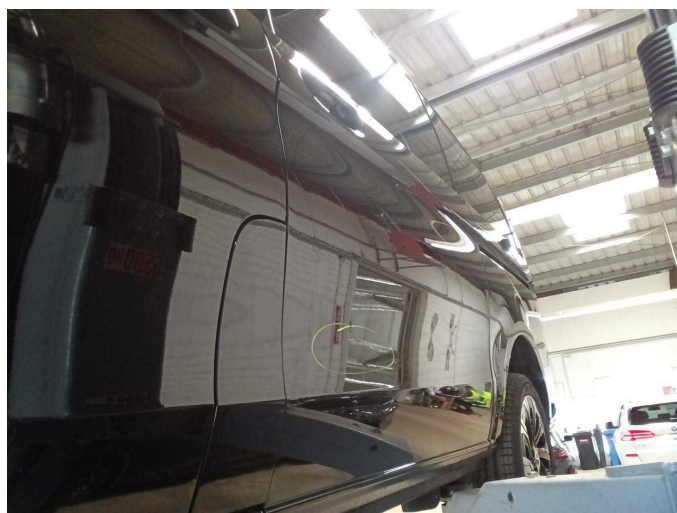
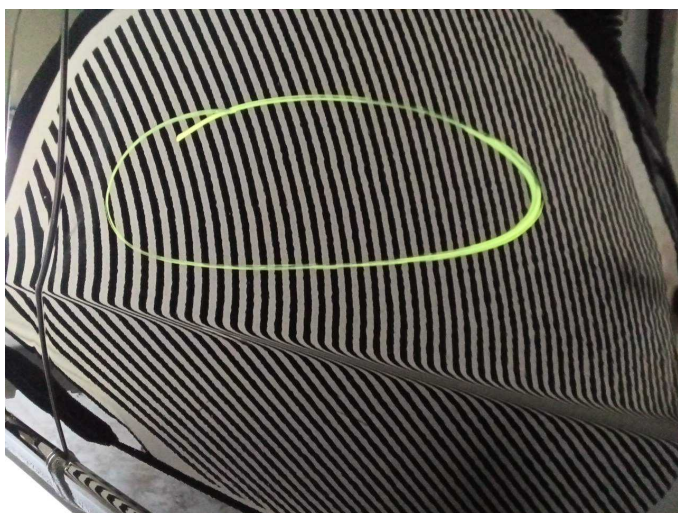
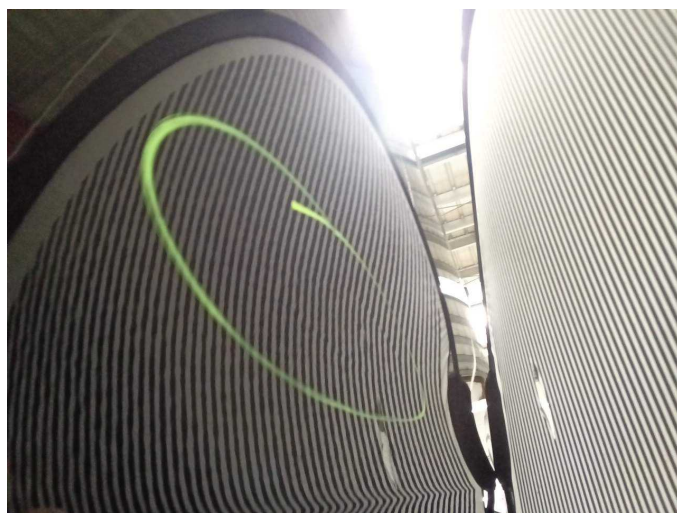
| No. | Component group | Description |
|---|---|---|
| 2 | Sliding door - left side | Sliding door with glass panel - dent(s) - Smooth repair work |

**Damage 2:** Sliding door - left side: Sliding door with glass panel - dent(s) - Smooth repair work

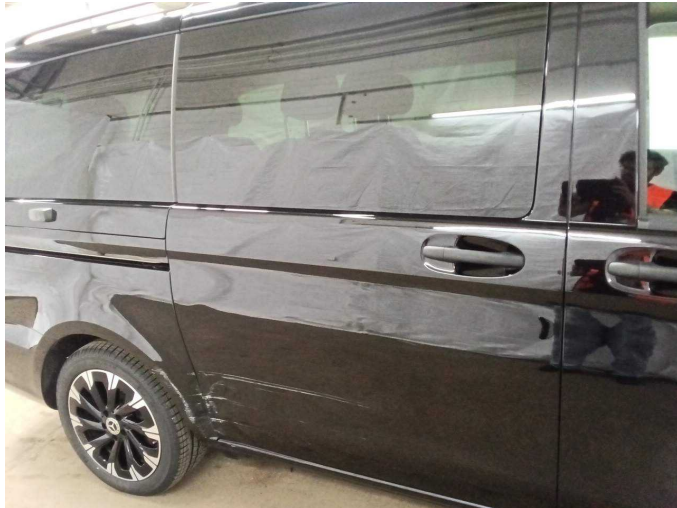
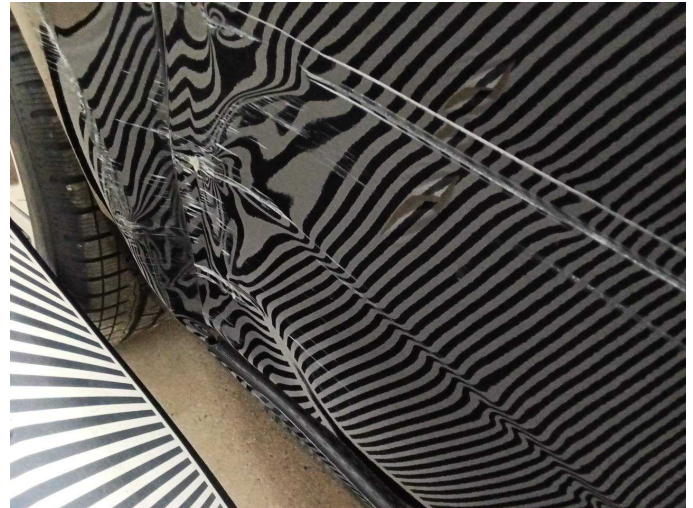
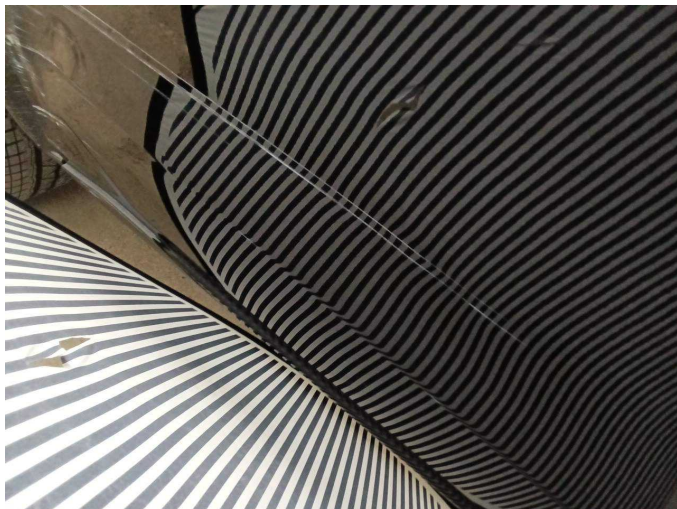
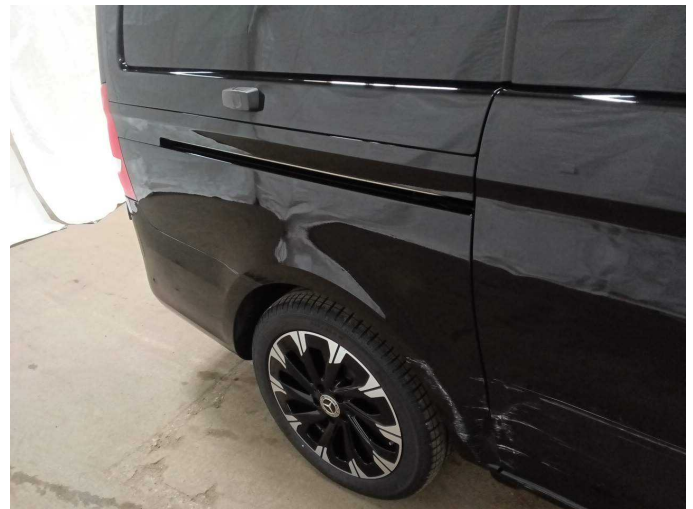
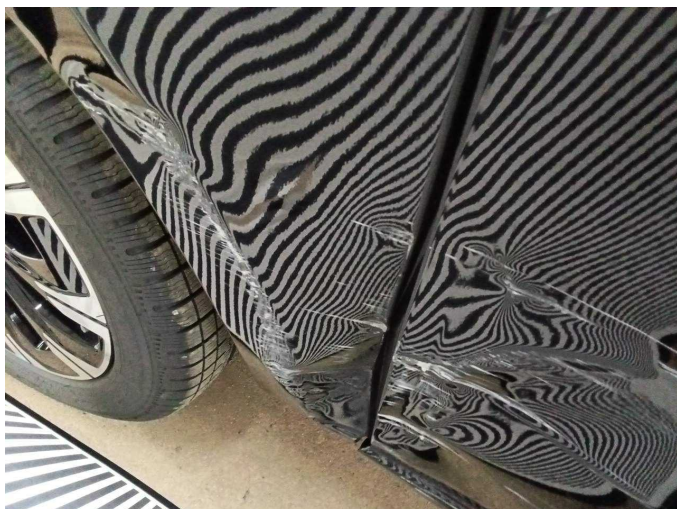
1 Side right

Non-repaired previous damages were found at the vehicle. The necessary repair costs are listed in the expert report or if necessary, are listed in detail in a separately enclosed repair cost calculation.

**Accident 1: Side right**
