Expertise

Protocol number: 46286562
Order No. / Reference: 26585907
Inspection date: 1 Jul 2026

Manufacturer: Opel

Model: Astra 1.5 D Automatik Business Elegance

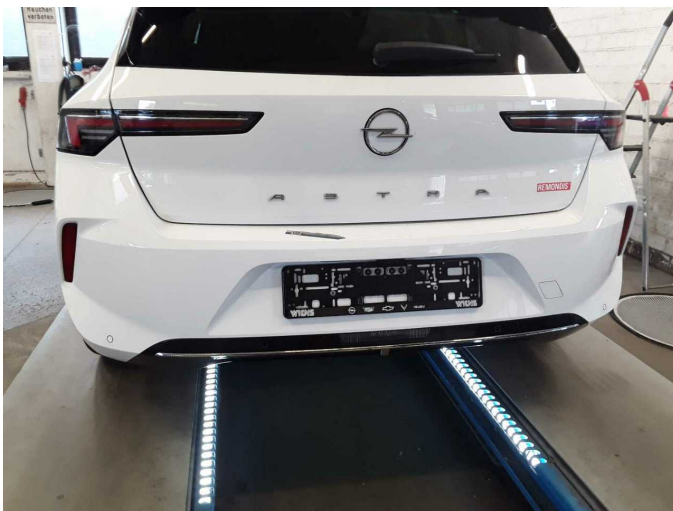
Damage 2: Rear bumper: Rear bumper - Scratch(es) - Smart repair

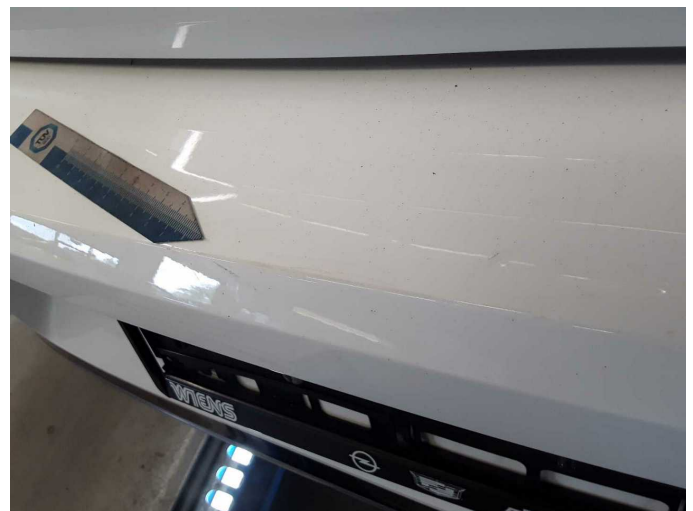
Damage 2: Rear bumper: Rear bumper - Scratch(es) - Smart repair

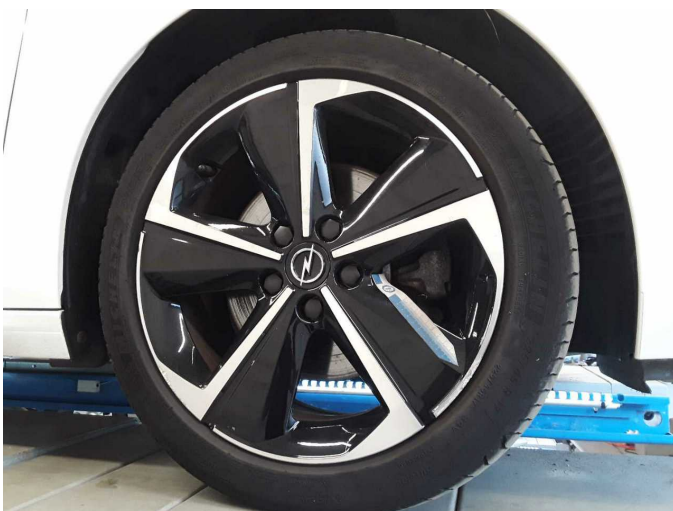
Damage 3: Wheel / tyres: Alloy rim - front right side - Scratched - Loss in value

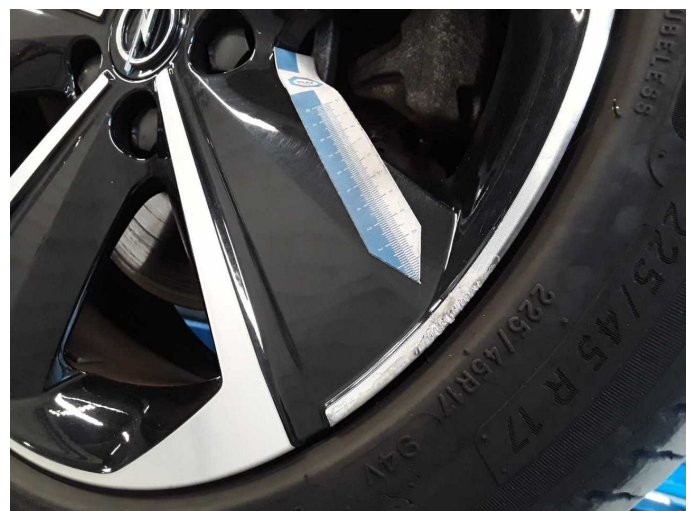
Damage 3: Wheel / tyres: Alloy rim - front right side - Scratched - Loss in value

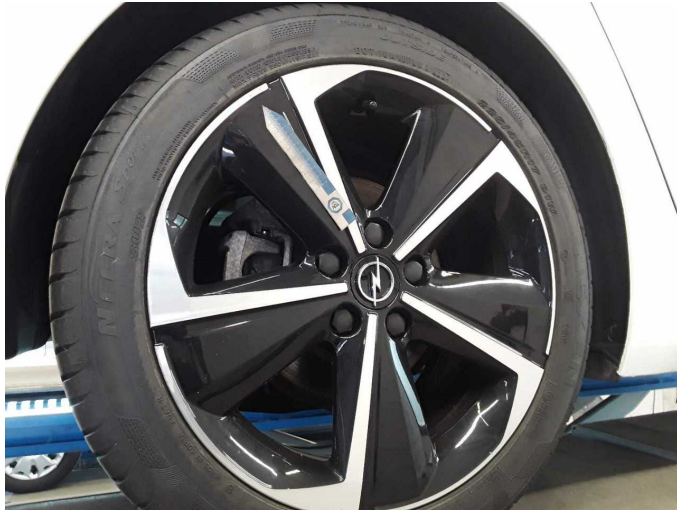
Damage 4: Wheel / tyres: Alloy rim - rear right side - Scratched - Loss in value

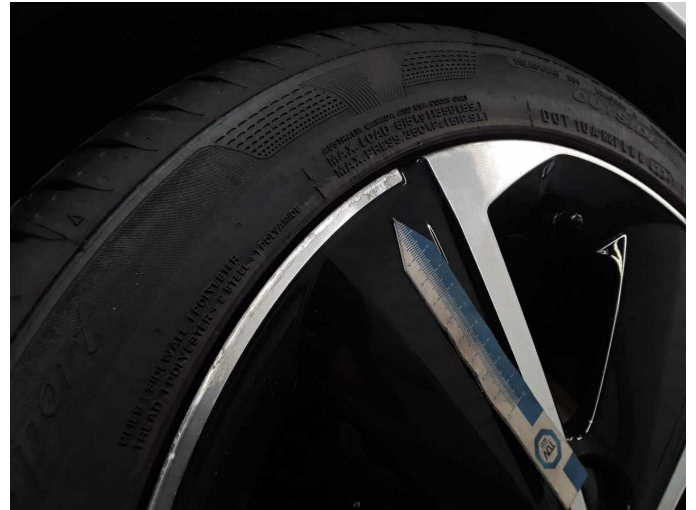
Damage 4: Wheel / tyres: Alloy rim - rear right side - Scratched - Loss in value

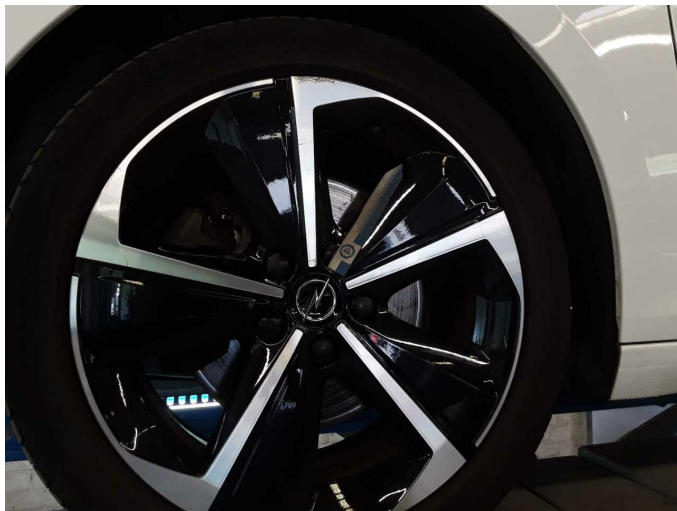
Damage 5: Wheel / tyres: Alloy rim - front left side - Scratched - Loss in value

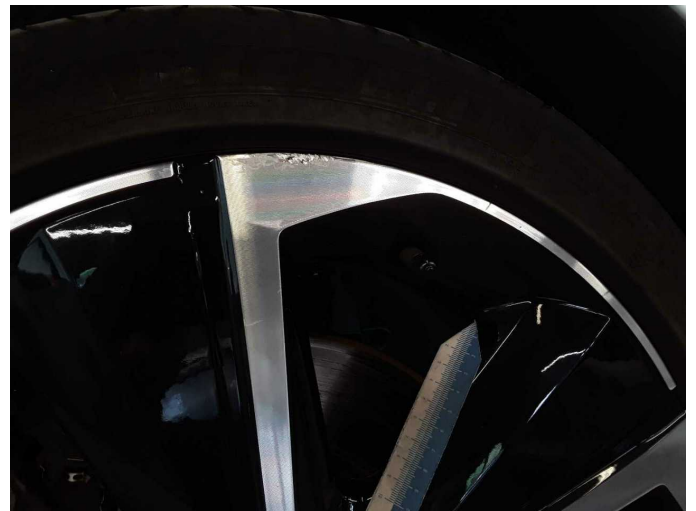
Damage 5: Wheel / tyres: Alloy rim - front left side - Scratched - Loss in value

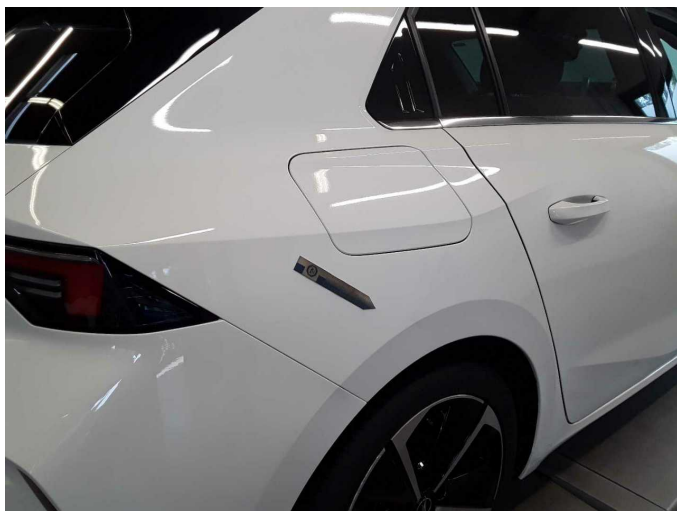
Damage 6: Side panel - rear right side: Side panel - Deformed - Repair and paint

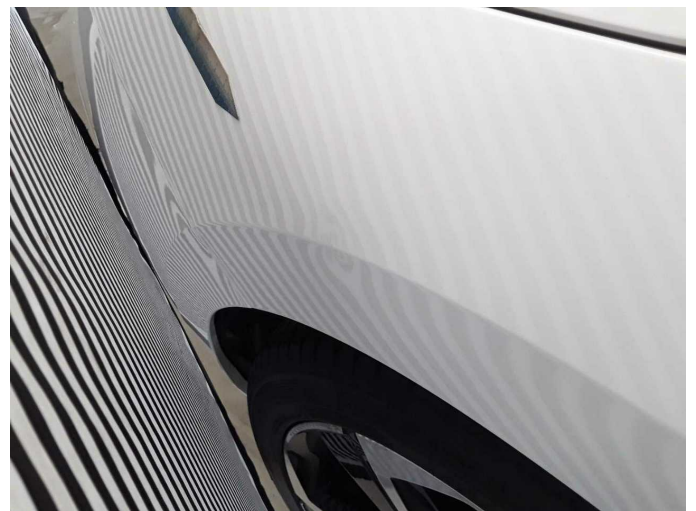
Damage 6: Side panel - rear right side: Side panel - Deformed - Repair and paint
