Expertise

Protocol number: 46794157  
Order No. / Reference: 26685288  
Inspection date: 29 Jul 2026

Manufacturer: Volvo

Model: V90 T6 Recharge AWD Plus Dark

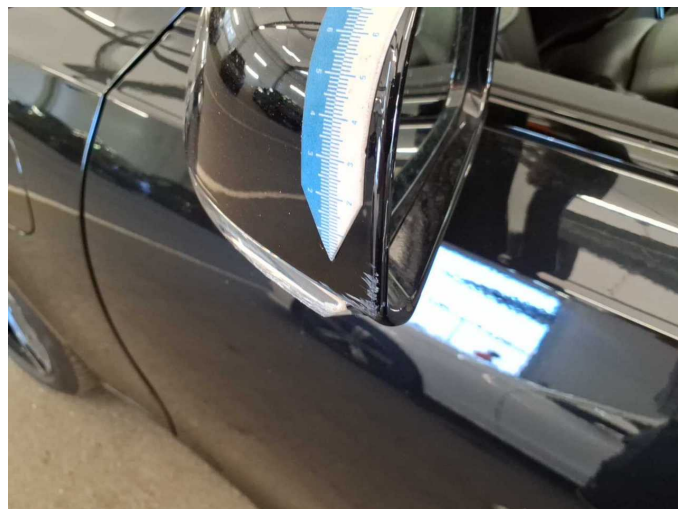
| No. | Component group | Description |
|---|---|---|
| 1 | Wing mirror - left side | Cap - Scratched - Smart repair |

**Damage 1:** Wing mirror - left side: Cap - Scratched - Smart repair

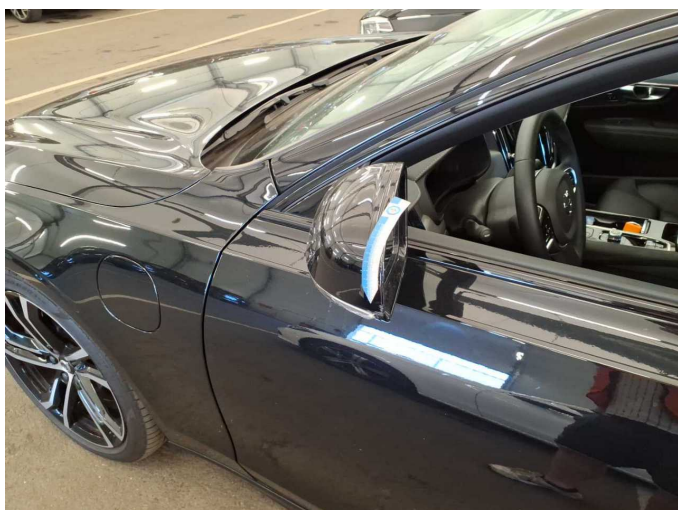
**Damage 1:** Wing mirror - left side: Cap - Scratched - Smart repair

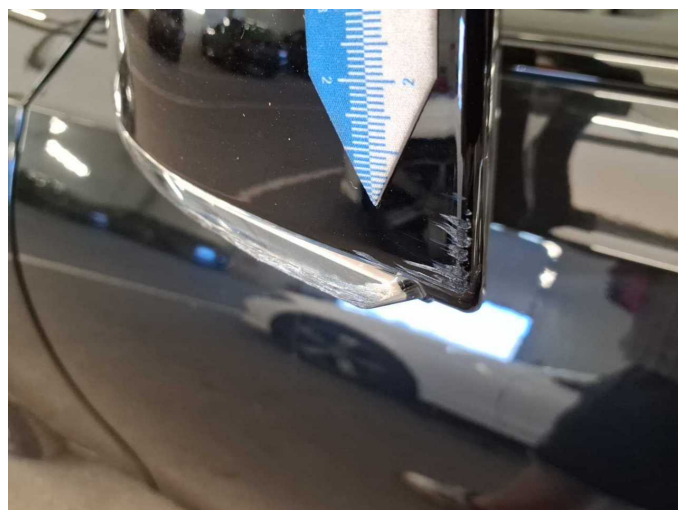
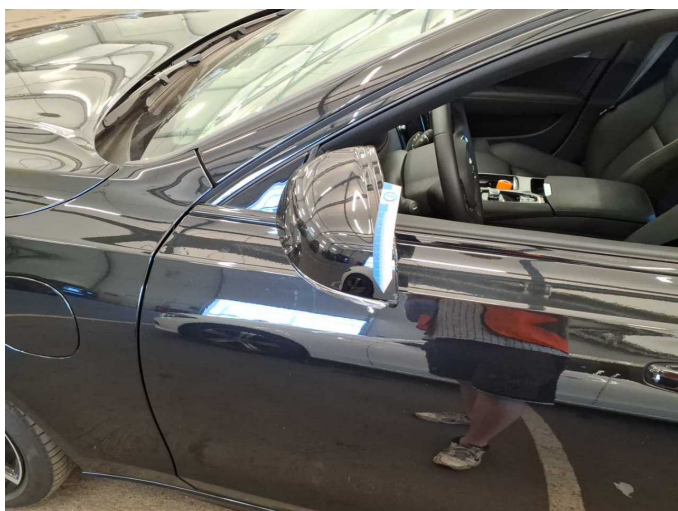
| No. | Component group | Description |
|---|---|---|
| 2 | Indicator - front | Mirror - left side - Scratched - Replace |

**Damage 2:** Indicator - front: Mirror - left side - Scratched - Replace

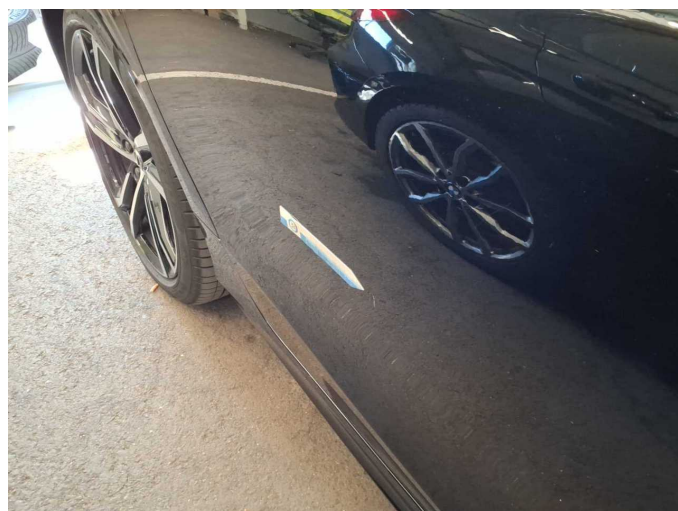
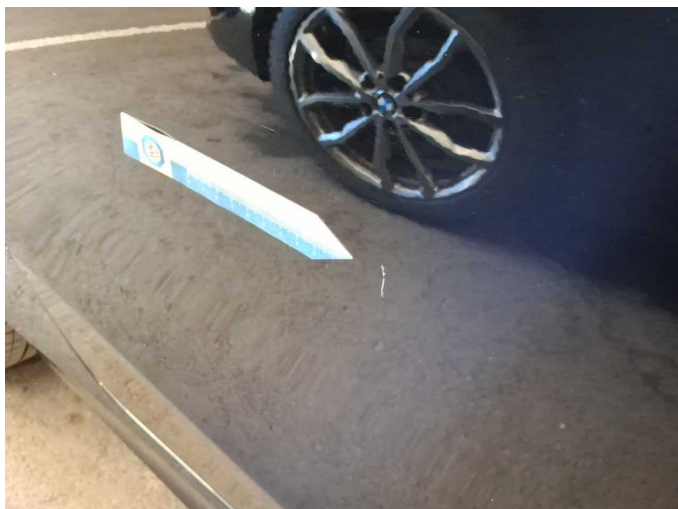
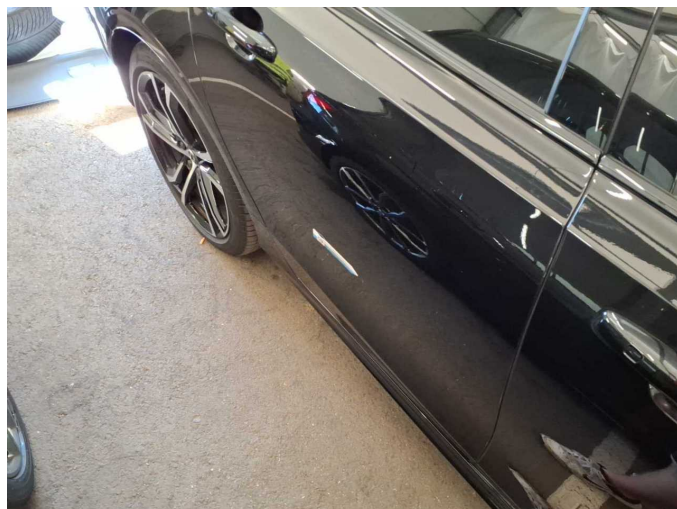
| No. | Component group | Description |
|---|---|---|
| 3 | Door - rear right side | Door - Scratch(es) - Smart repair |

**Damage 3:** Door - rear right side: Door - Scratch(es) - Smart repair

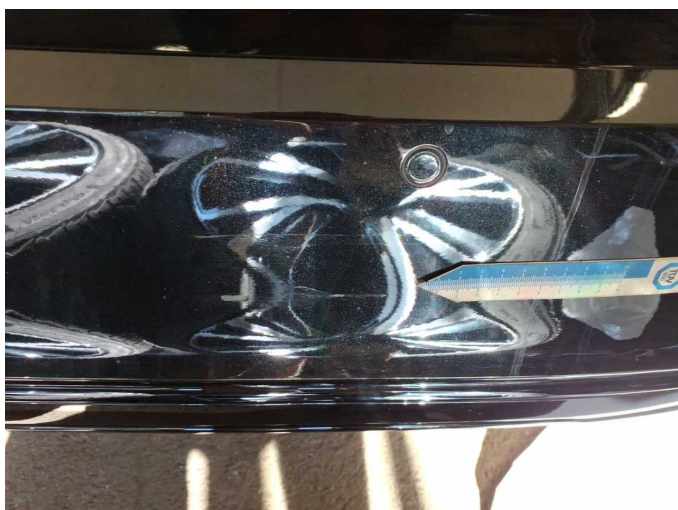
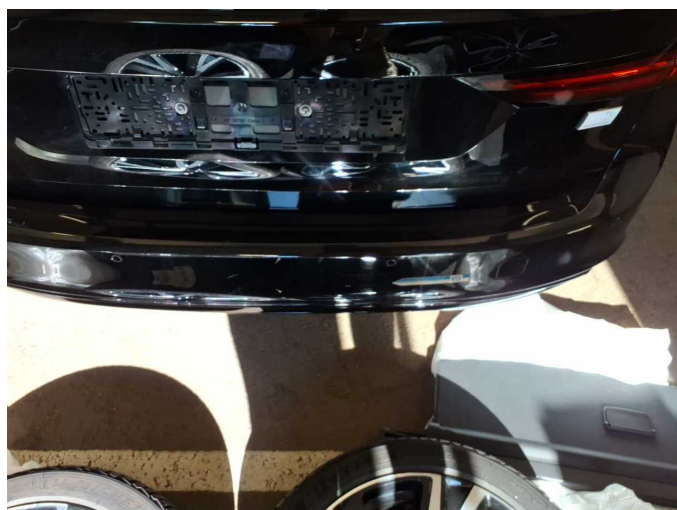
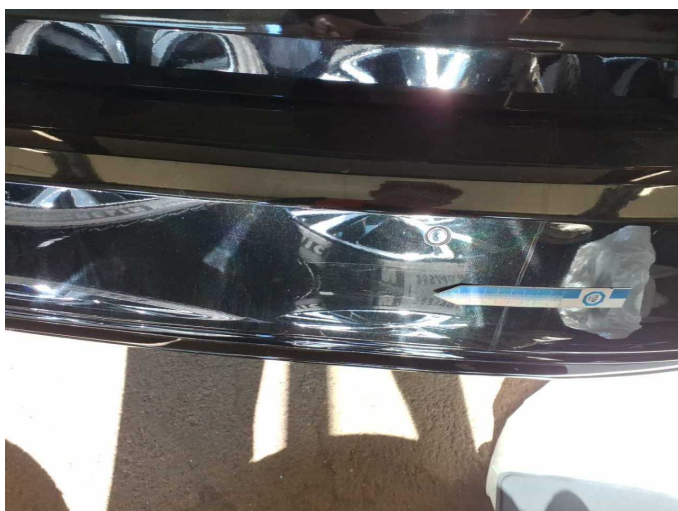
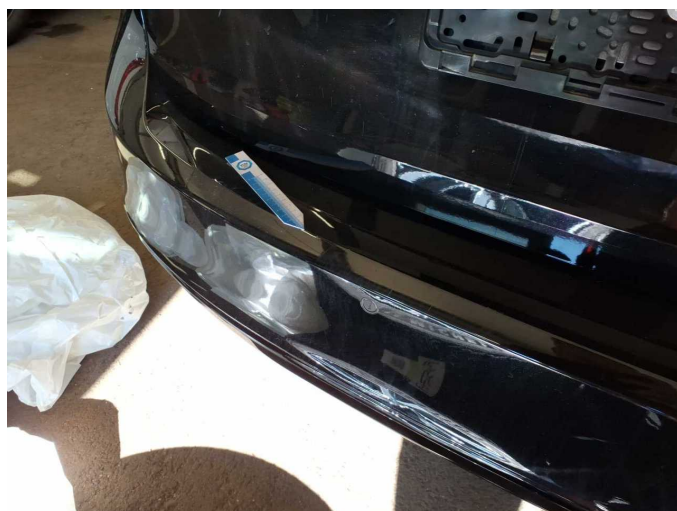
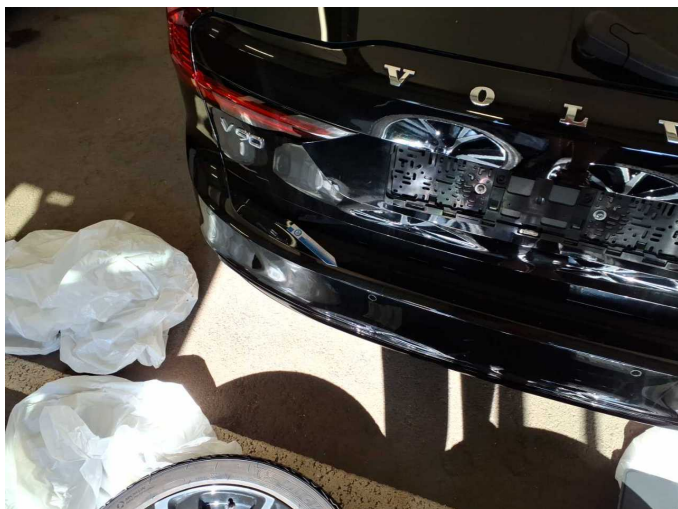
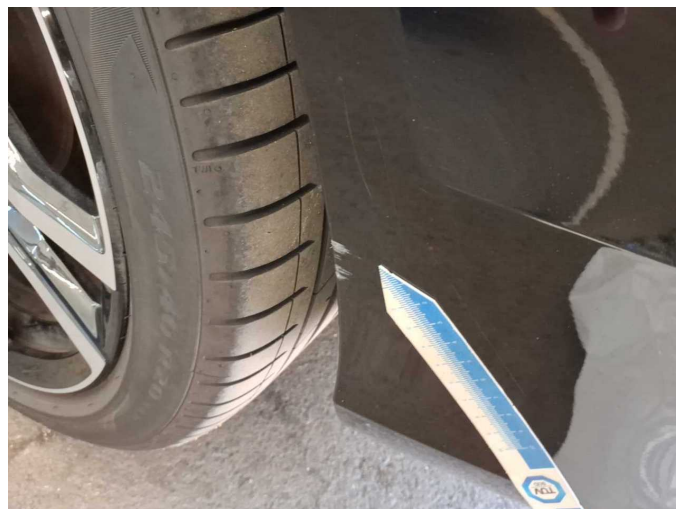
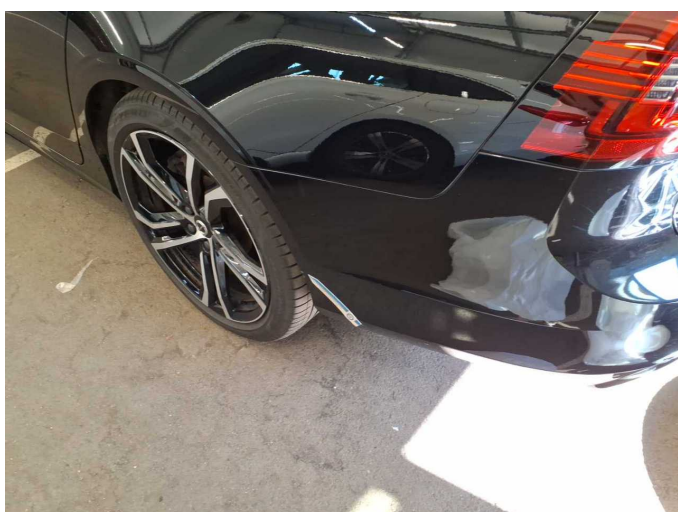
| No. | Component group | Description |
|---|---|---|
| 4 | Rear bumper | Rear bumper - Scratched - Paint |

**Damage 4:** Rear bumper: Rear bumper - Scratched - Paint

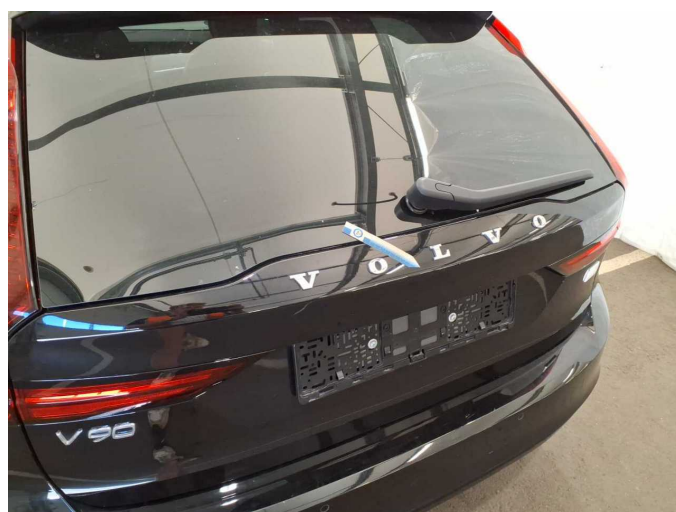
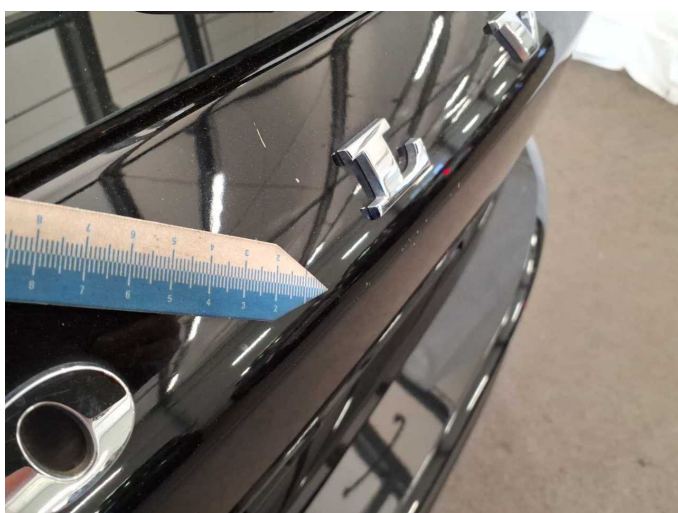
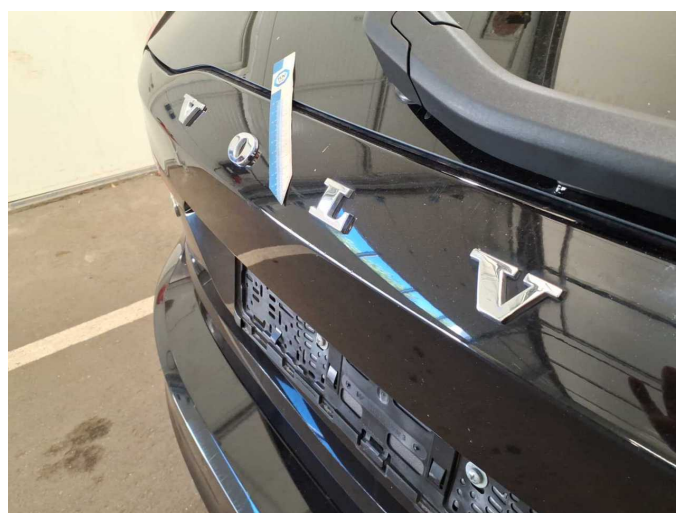
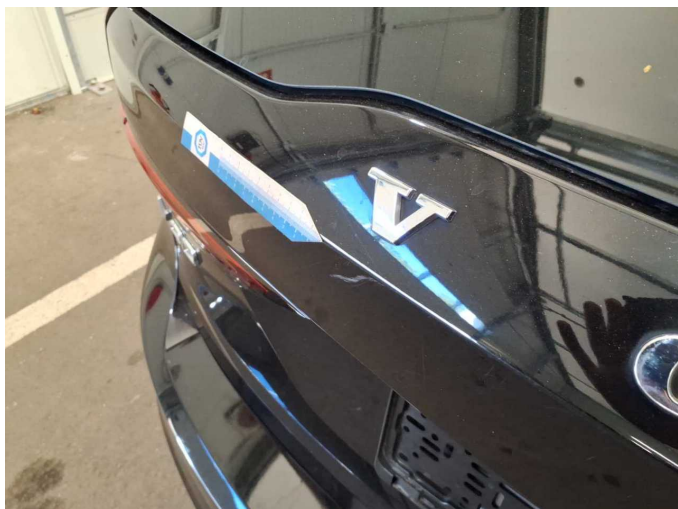
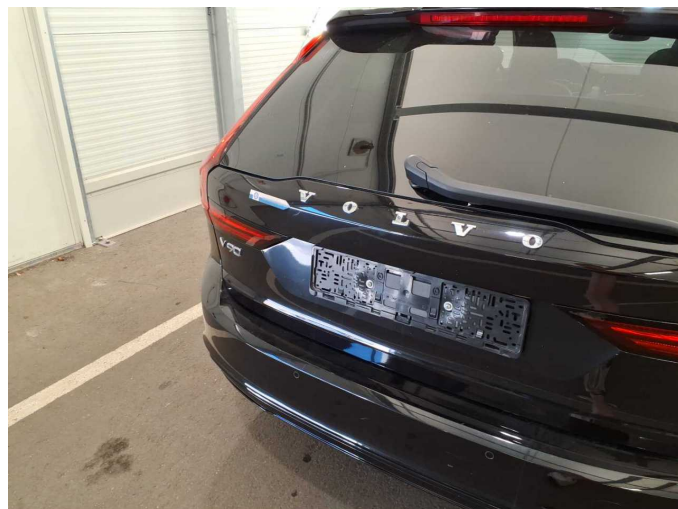
| No. | Component group | Description |
|---|---|---|
| 5 | Boot lid / rear door | Boot lid - Scratch(es) - Paint |

**Damage 5:** Boot lid / rear door: Boot lid - Scratch(es) - Paint

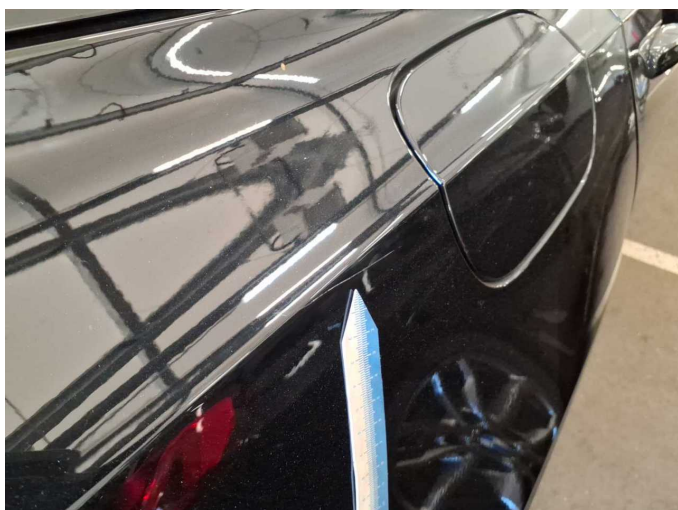
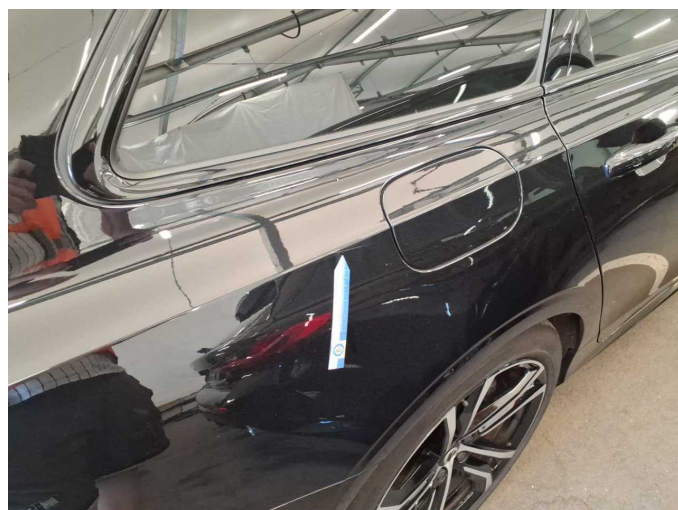
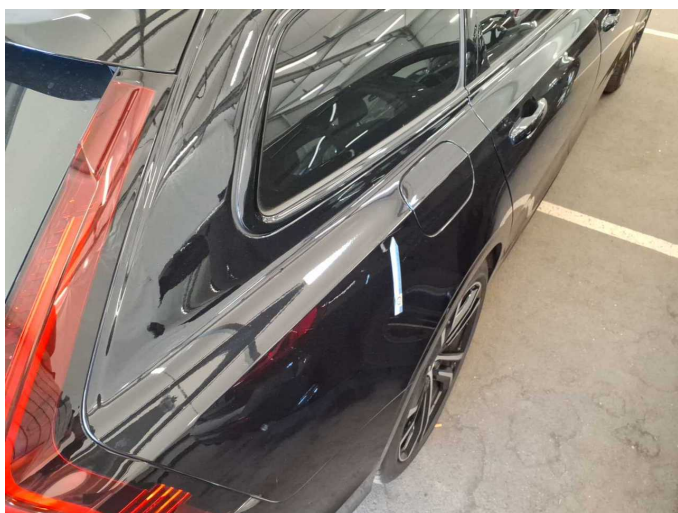
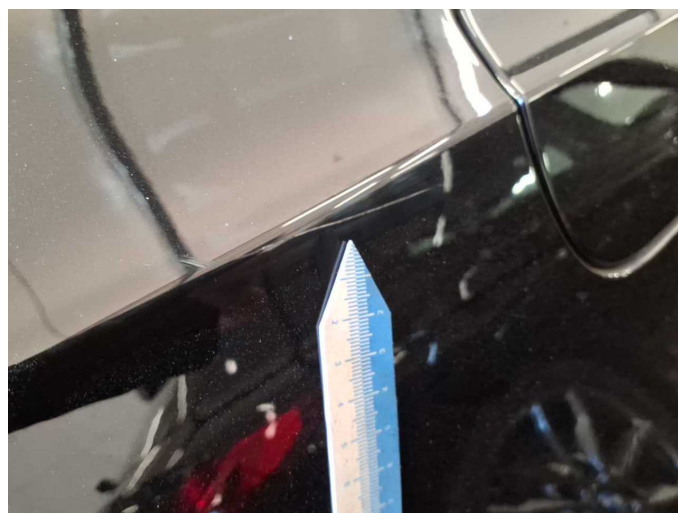
| No. | Component group | Description |
|---|---|---|
| 6 | Side panel - rear right side | Side panel - Scratch(es) - Paint |

**Damage 6:** Side panel - rear right side: Side panel - Scratch(es) - Paint

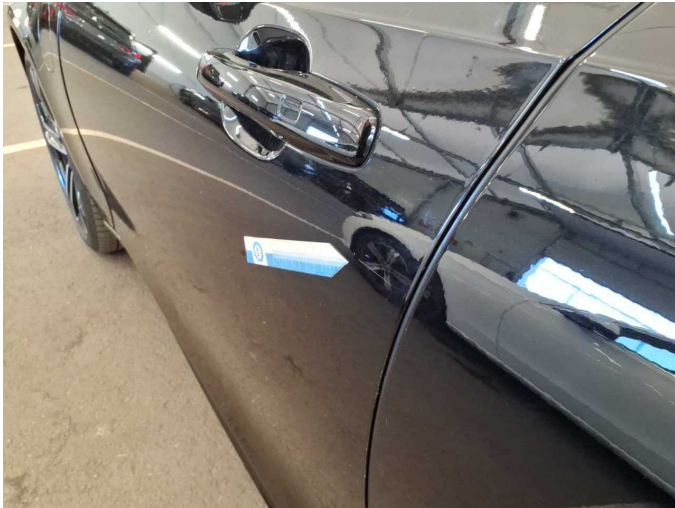
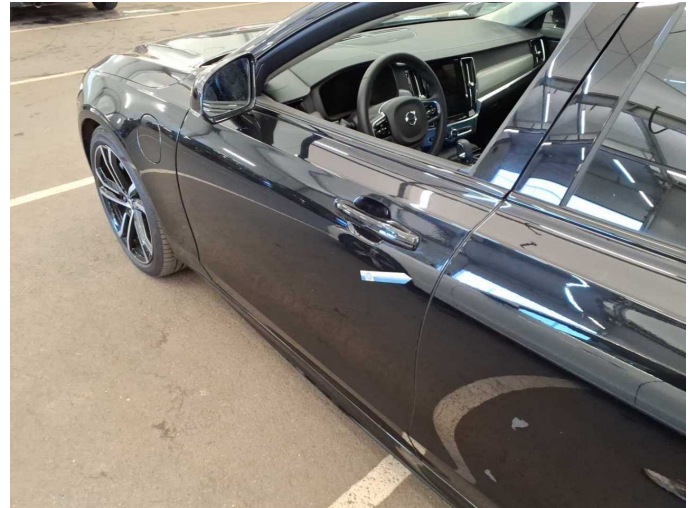
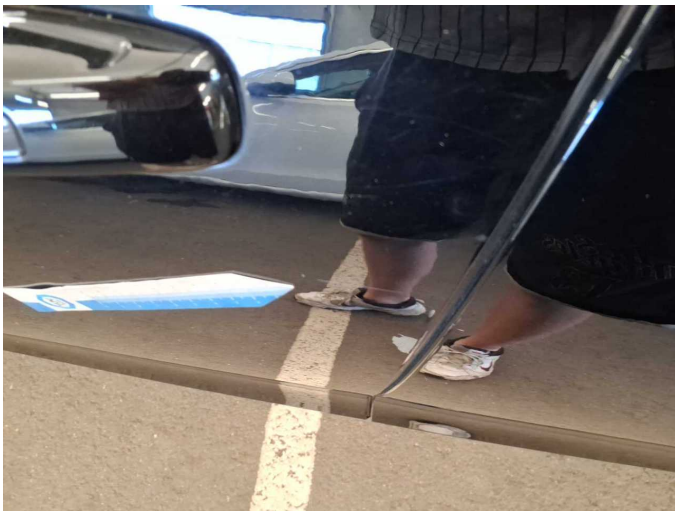
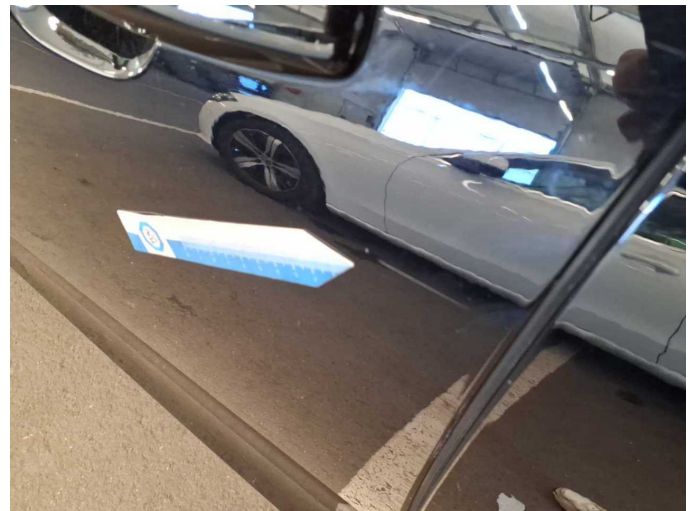
| No. | Component group | Description |
|---|---|---|
| 7 | Door - front left side | Door - Scratch(es) - Paint |

**Damage 7:** Door - front left side: Door - Scratch(es) - Paint

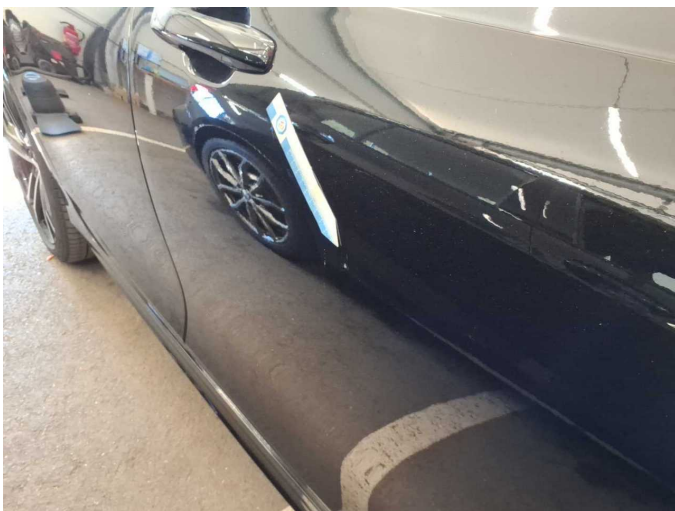
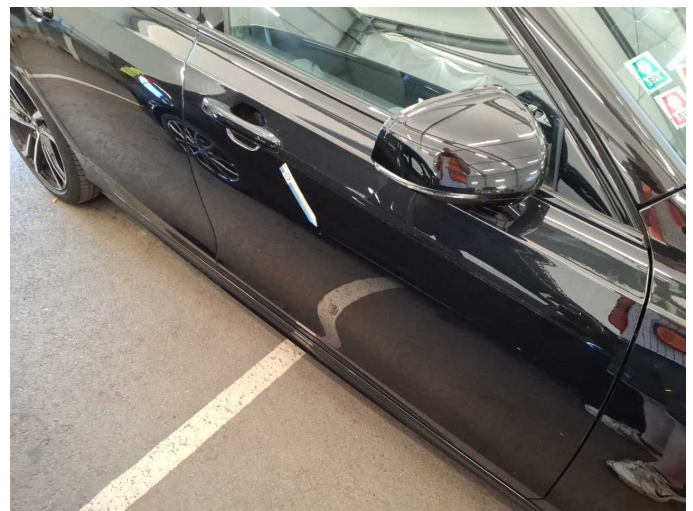
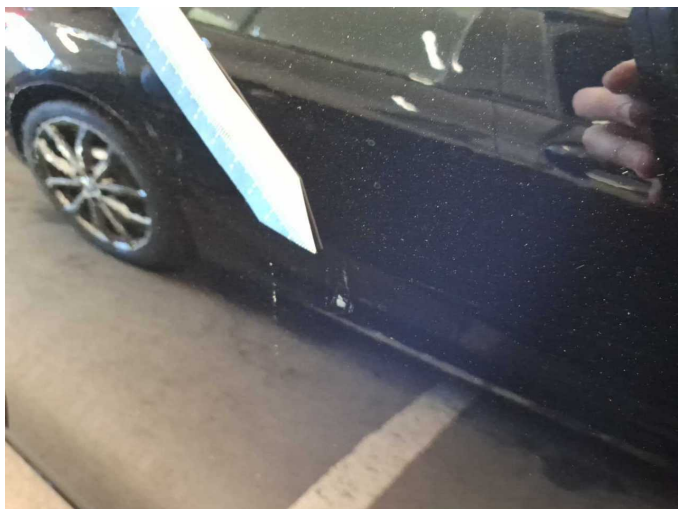
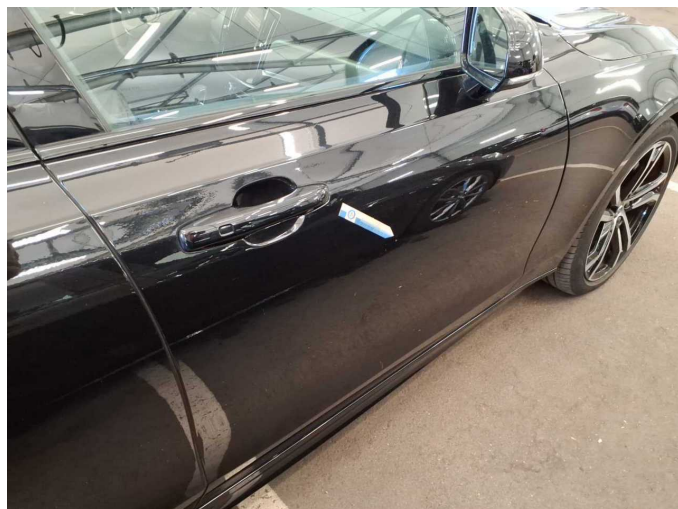
| No. | Component group | Description |
|---|---|---|
| 8 | Door - front right side | Door - Scratch(es) - Paint |

**Damage 8:** Door - front right side: Door - Scratch(es) - Paint

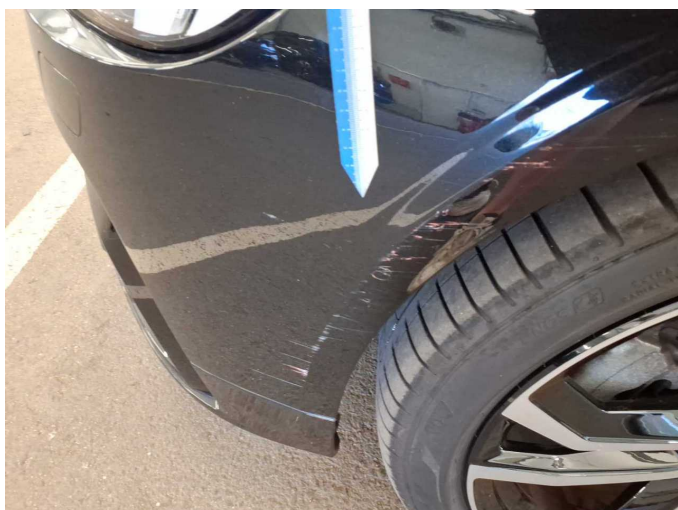
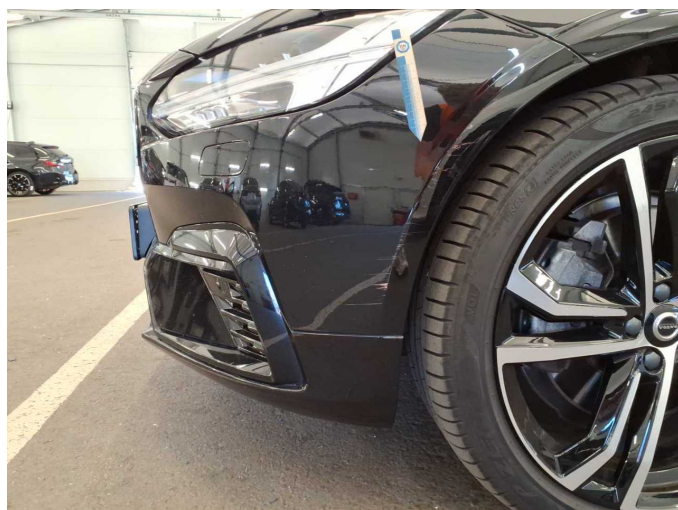
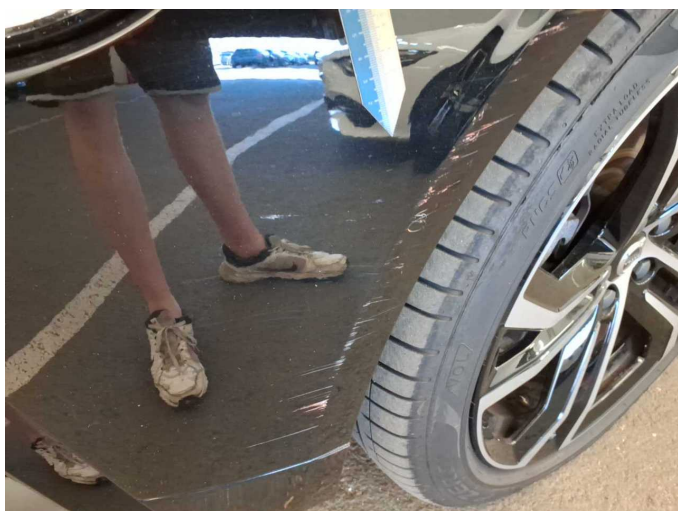
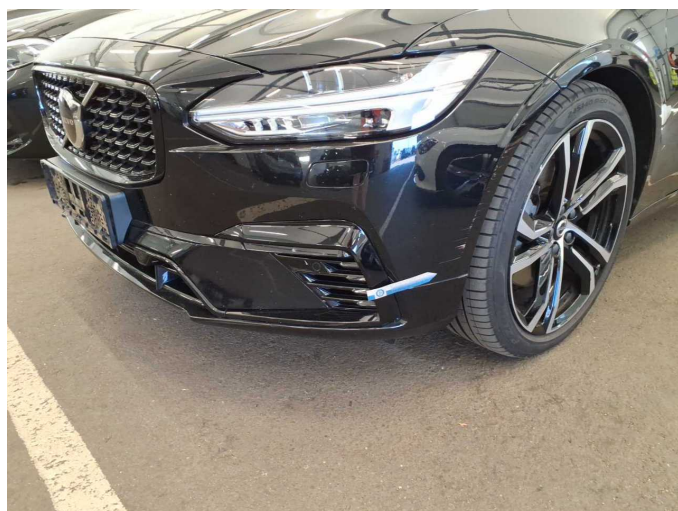
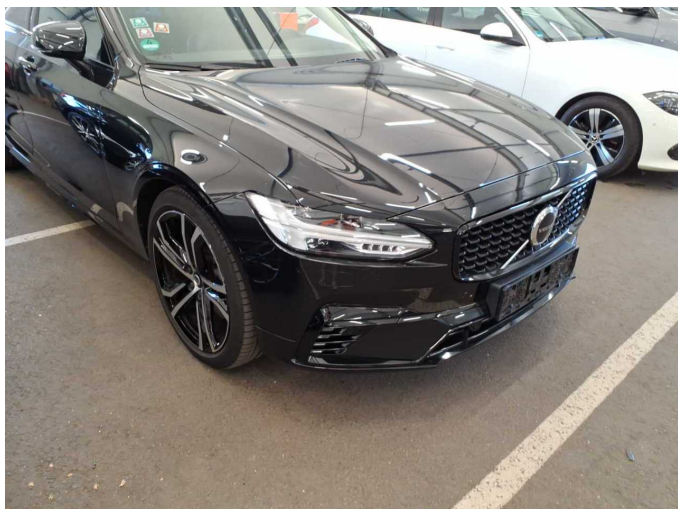
| No. | Component group | Description |
|---|---|---|
| 9 | Front bumper | Front bumper - Scratched - Paint |

**Damage 9:** Front bumper: Front bumper - Scratched - Paint

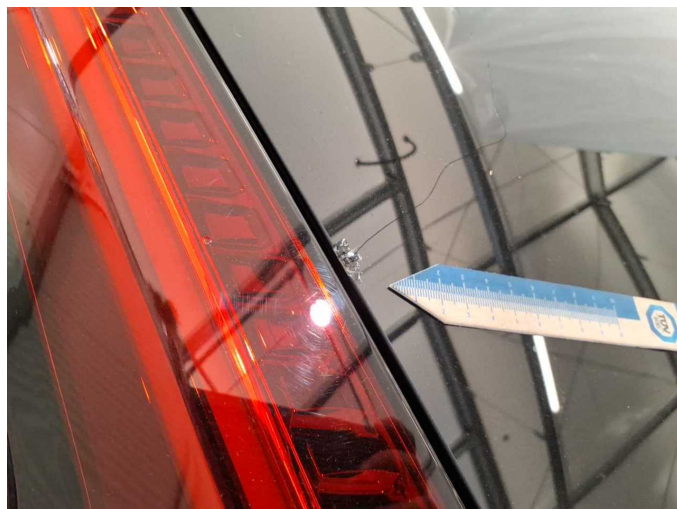
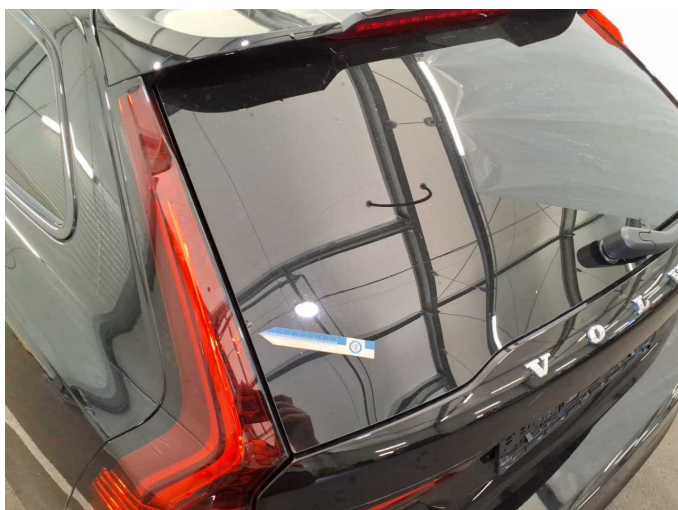
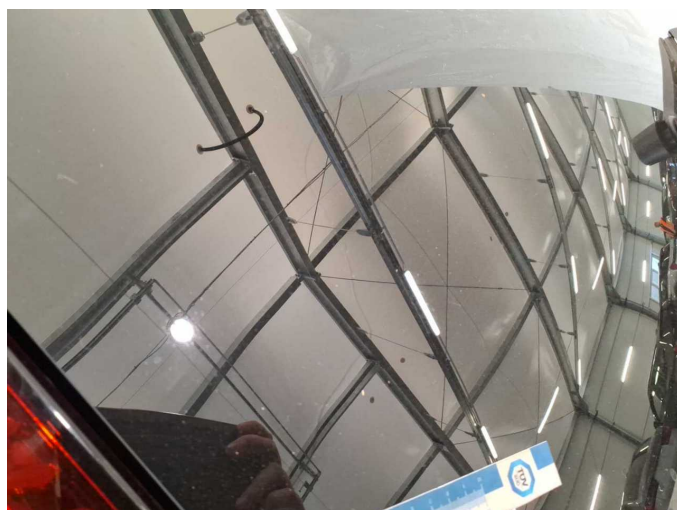
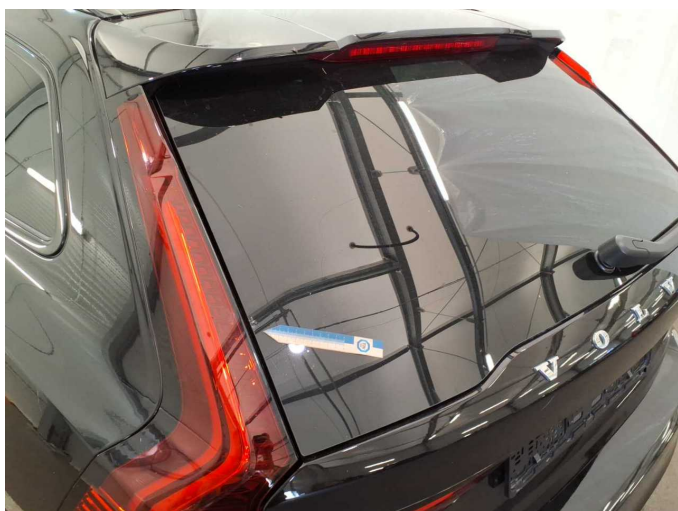
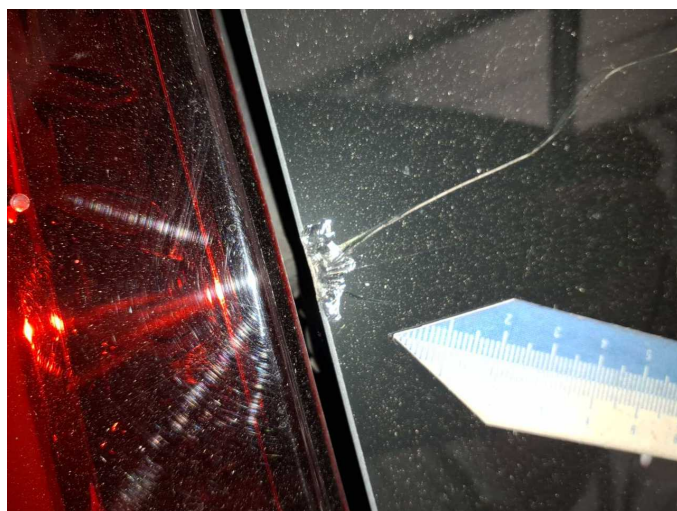
| No. | Component group | Description |
|---|---|---|
| 10 | Vehicle glazing | Rear window - Broken / torn - Replace |

**Damage 10:** Vehicle glazing: Rear window - Broken / torn - Replace

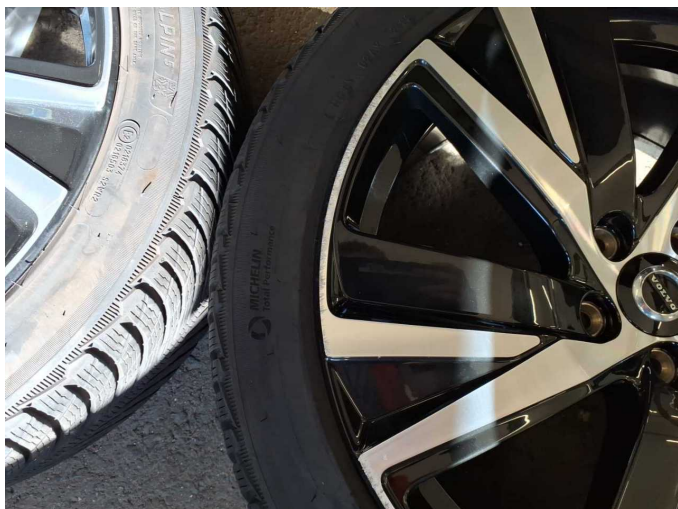
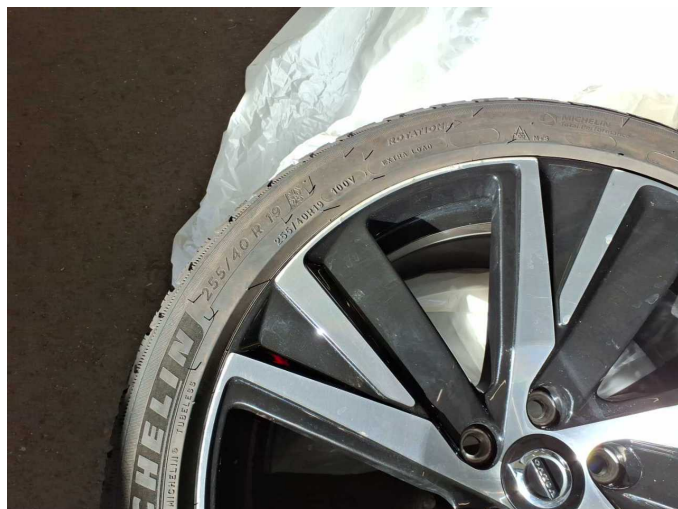
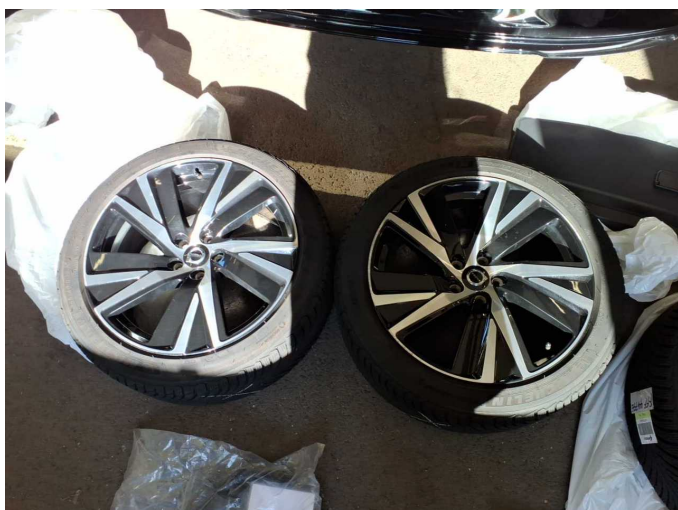
| No. | Component group | Description |
|---|---|---|
| 1 | 2nd wheel set | 2 alloy rims (Nicht Bestandteil der Ausstattung) - Scratch(es) - No deduction |

**Wear and tear 1:** 2nd wheel set: 2 alloy rims (Nicht Bestandteil der Ausstattung) - Scratch(es) - No deduction

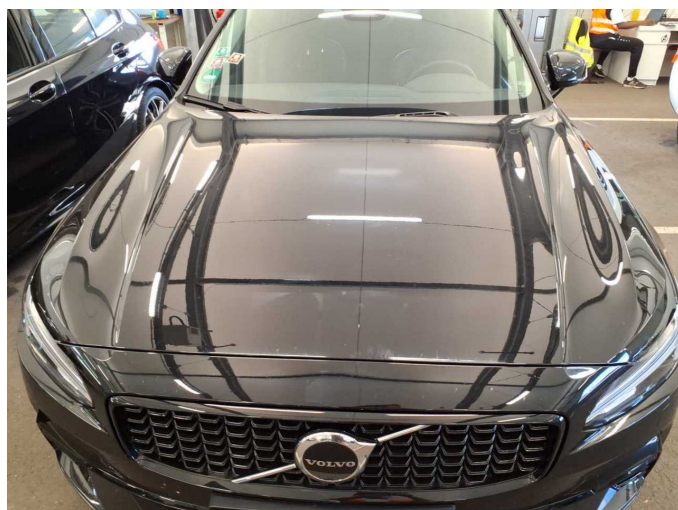
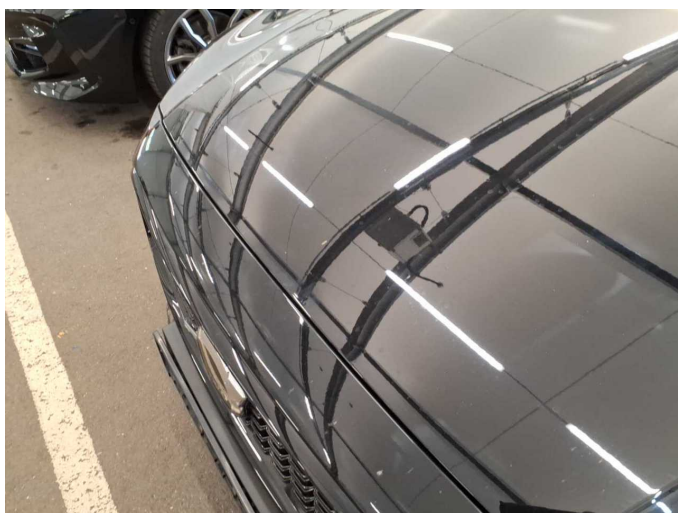
| No. | Component group | Description |
|---|---|---|
| 2 | Bonnet | Bonnet - Stone chips - No deduction |

**Wear and tear 2:** Bonnet: Bonnet - Stone chips - No deduction

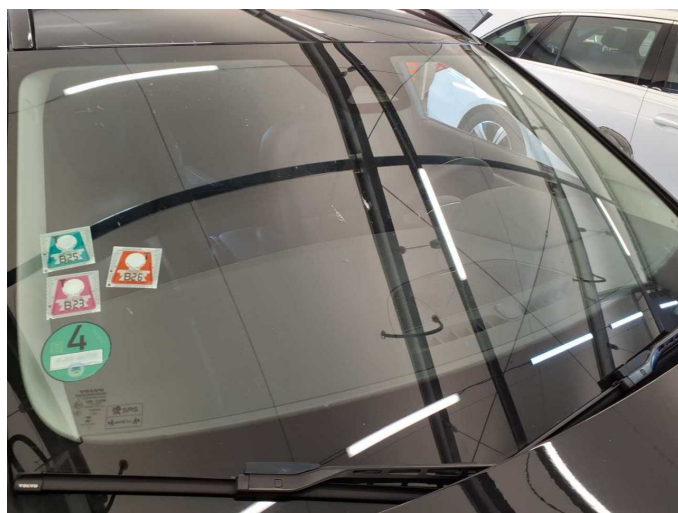
| No. | Component group | Description |
|---|---|---|
| 3 | Vehicle glazing | Windscreen - Stone chips - No deduction |

**Wear and tear 3:** Vehicle glazing: Windscreen - Stone chips - No deduction

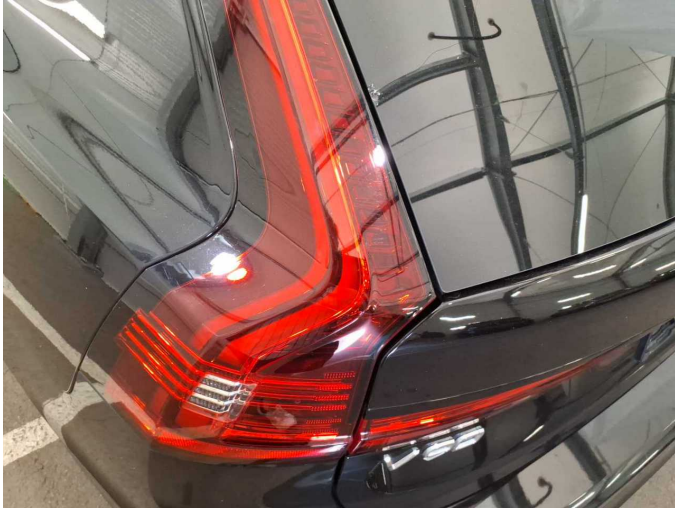
| No. | Component group | Description |
|---|---|---|
| 5 | Tail light | Tail lamp - left side - Scratch(es) - No deduction |

**Wear and tear 5:** Tail light: Tail lamp - left side - Scratch(es) - No deduction
