Expertise

Protocol number: 46593804  
Order No. / Reference: 26726466  
Inspection date: 17 Jul 2026

Manufacturer: Mercedes-Benz

Model: 317 CDI Sprinter Standard HA 9G-TRONIC

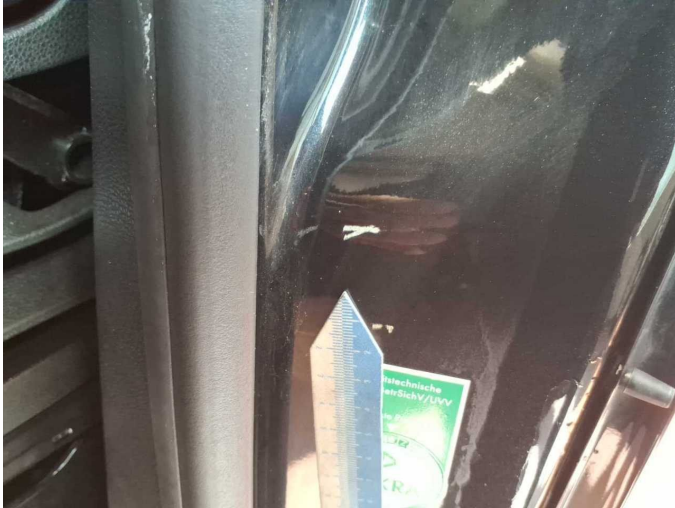
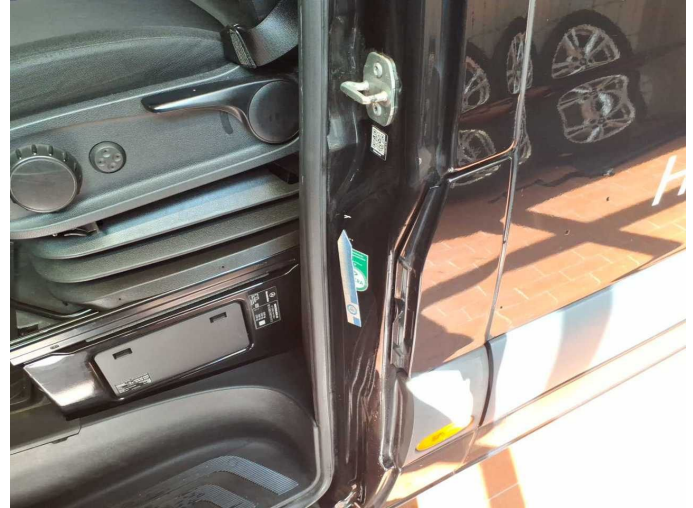
| No. | Component group | Description |
|---|---|---|
| 1 | Sill - left side | Sill - Scratch(es) - Smart repair |

**Damage 1:** Sill - left side: Sill - Scratch(es) - Smart repair

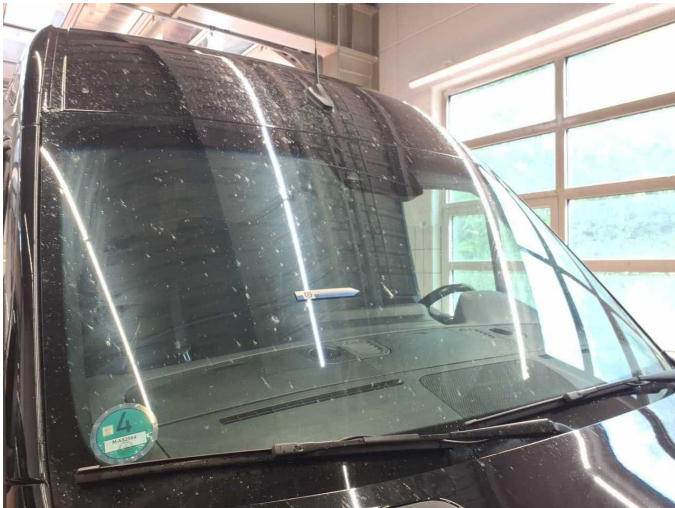
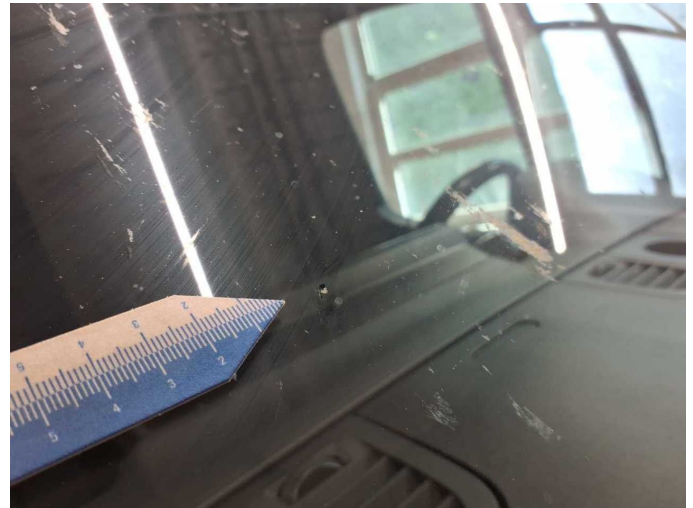
| No. | Component group | Description |
|---|---|---|
| 2 | Vehicle glazing | Windscreen - Stone chips - Smart repair |

**Damage 2:** Vehicle glazing: Windscreen - Stone chips - Smart repair

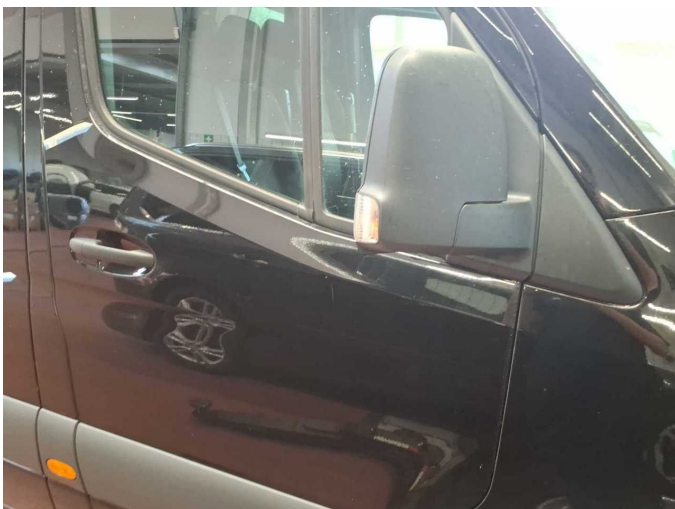
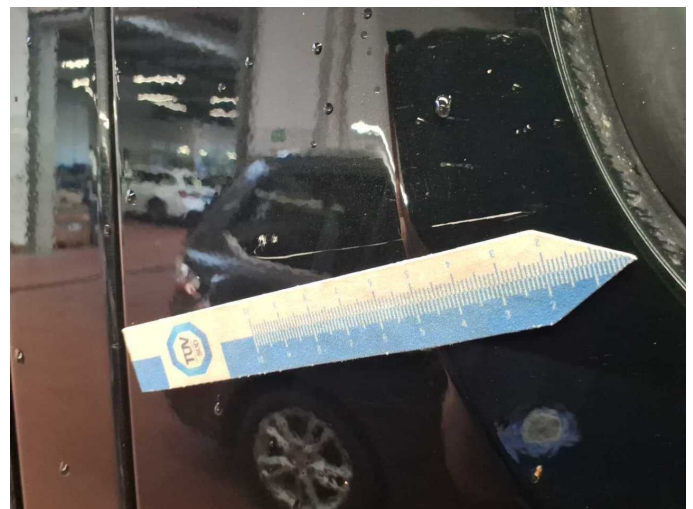
| No. | Component group | Description |
|---|---|---|
| 3 | Door - front right side | Door - Scratch(es) - Smart repair |

**Damage 3:** Door - front right side: Door - Scratch(es) - Smart repair

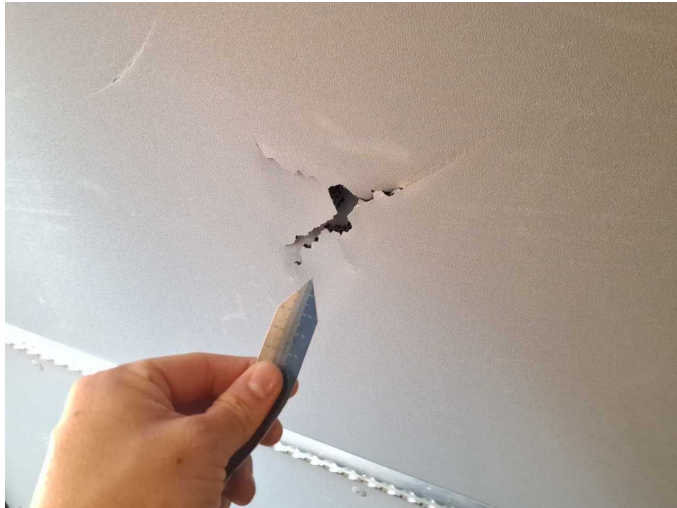
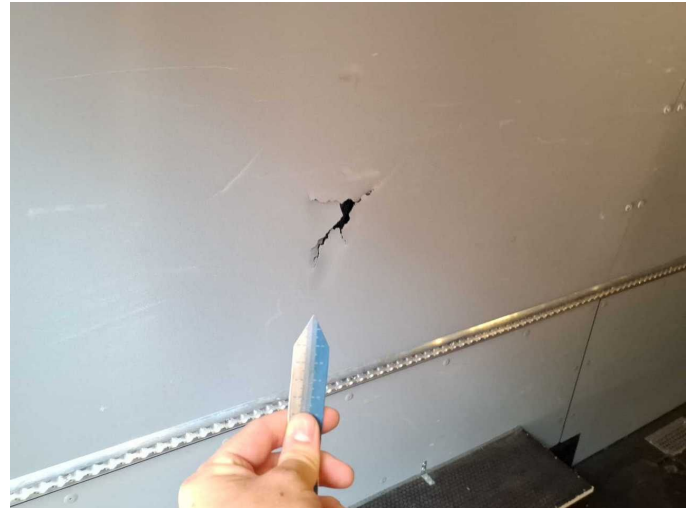
| No. | Component group | Description |
|---|---|---|
| 4 | Side panel - rear left side | Interior trim - Broken / torn - Replace |

**Damage 4:** Side panel - rear left side: Interior trim - Broken / torn - Replace

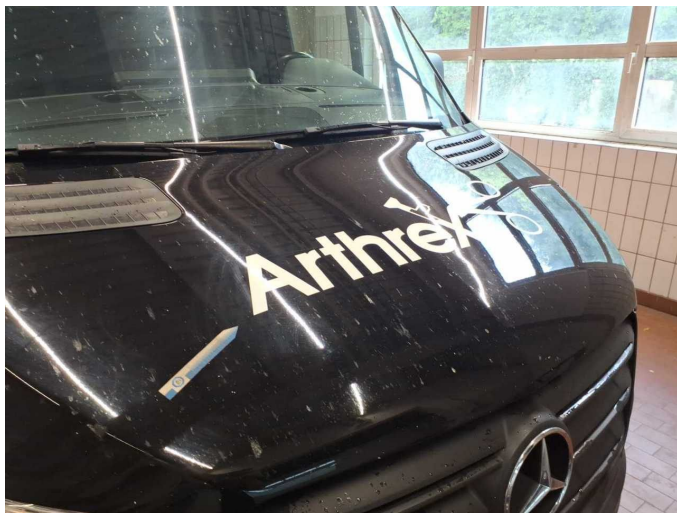
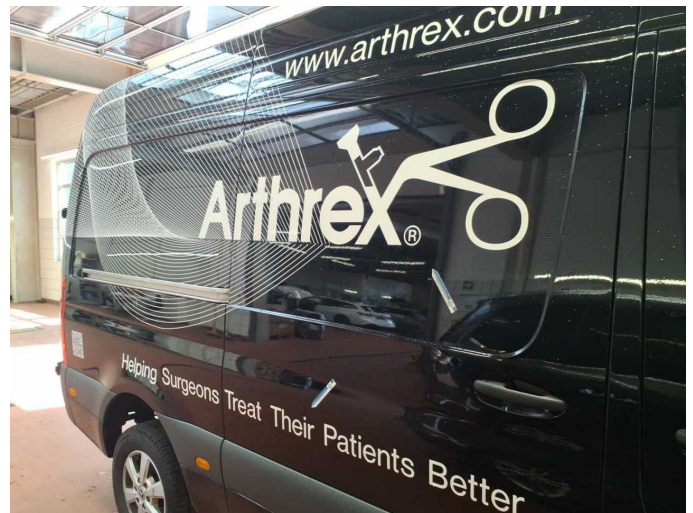
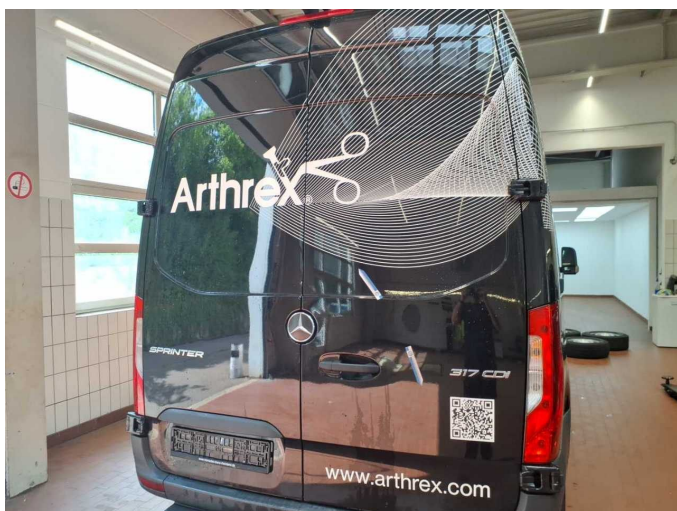
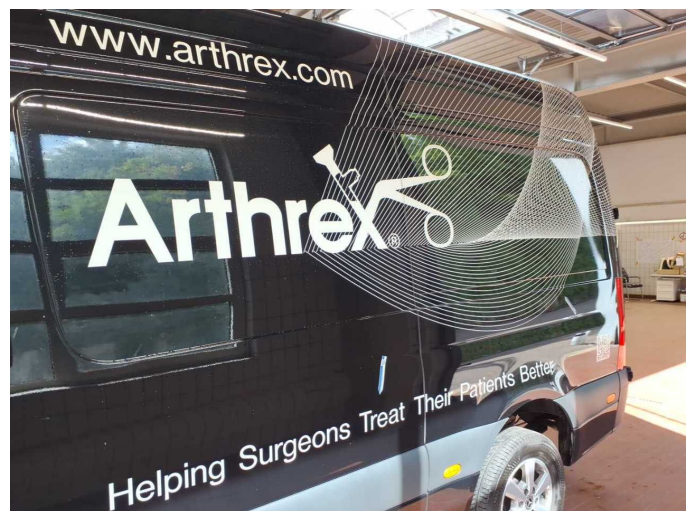
| No. | Component group | Description |
|---|---|---|
| 5 | Body | Body - Glued / labelled - De-glue / neutralise |

**Damage 5:** Body: Body - Glued / labelled - De-glue / neutralise

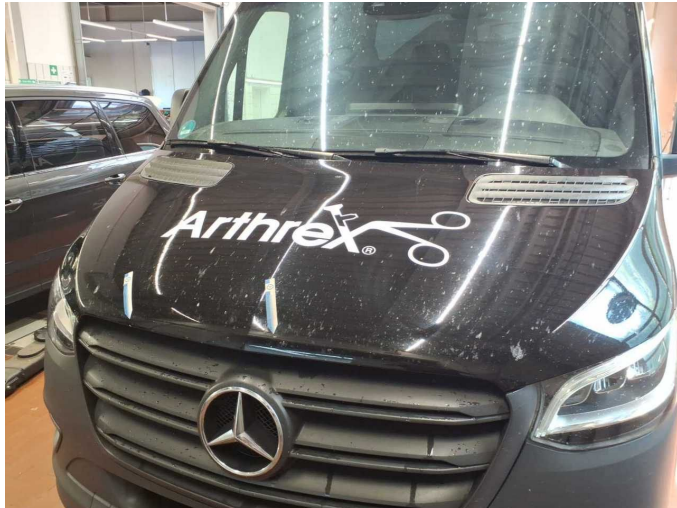
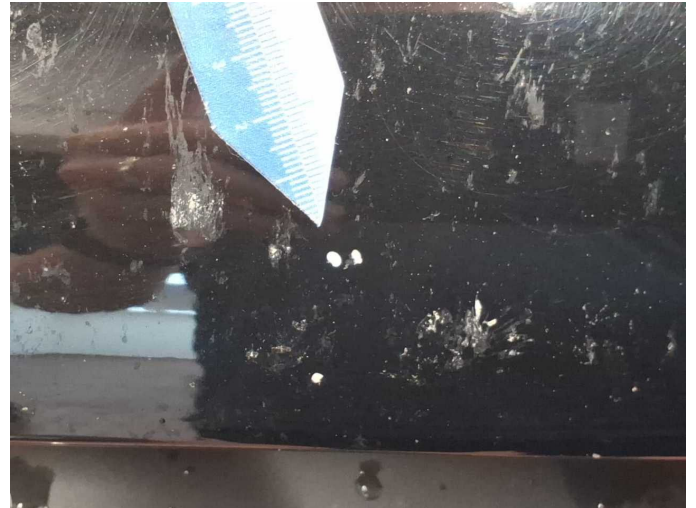
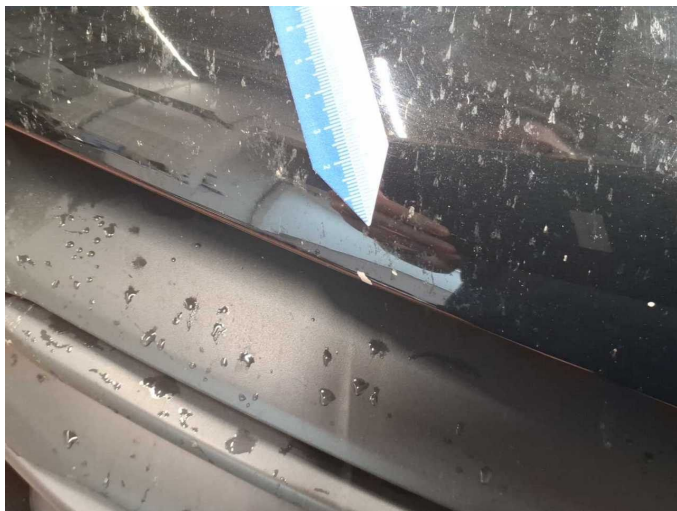
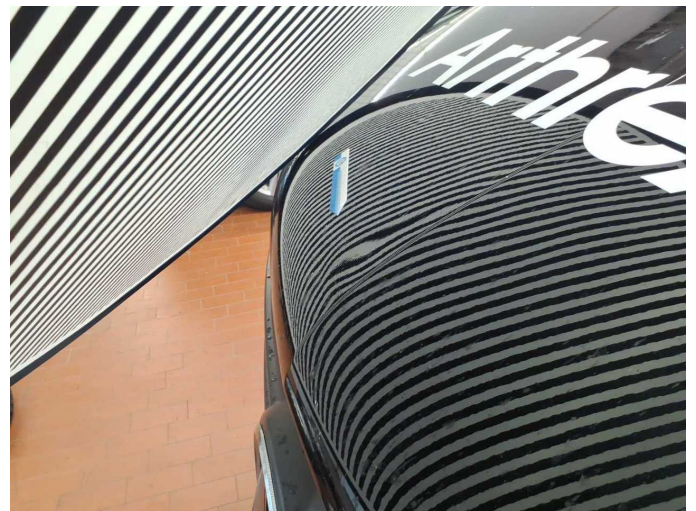
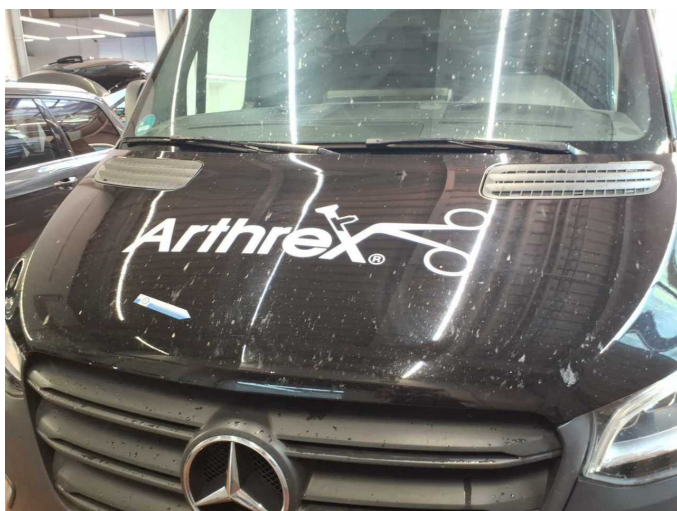
| No. | Component group | Description |
|---|---|---|
| 6 | Bonnet | Bonnet - Dent / paintcoat damage - Repair and paint |

**Damage 6:** Bonnet: Bonnet - Dent / paintcoat damage - Repair and paint

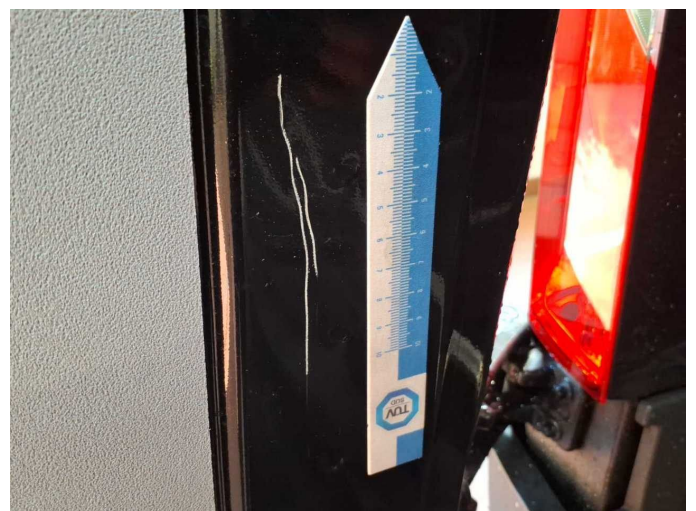
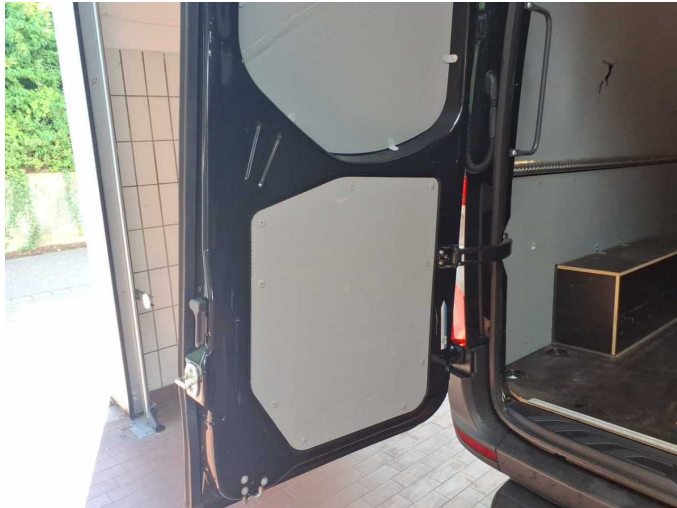
| No. | Component group | Description |
|---|---|---|
| 1 | Boot lid / rear door | Rear door - left side - Scratch(es) - No deduction |

**Wear and tear 1:** Boot lid / rear door: Rear door - left side - Scratch(es) - No deduction

**Wear and tear 1:** Boot lid / rear door: Rear door - left side - Scratch(es) -  
No deduction

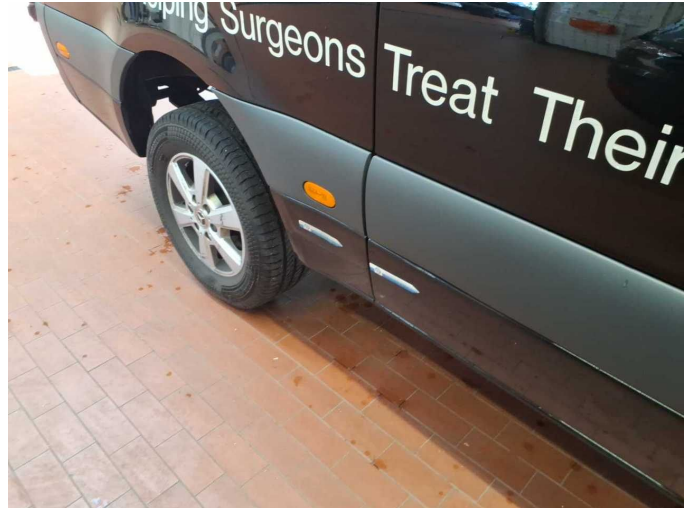
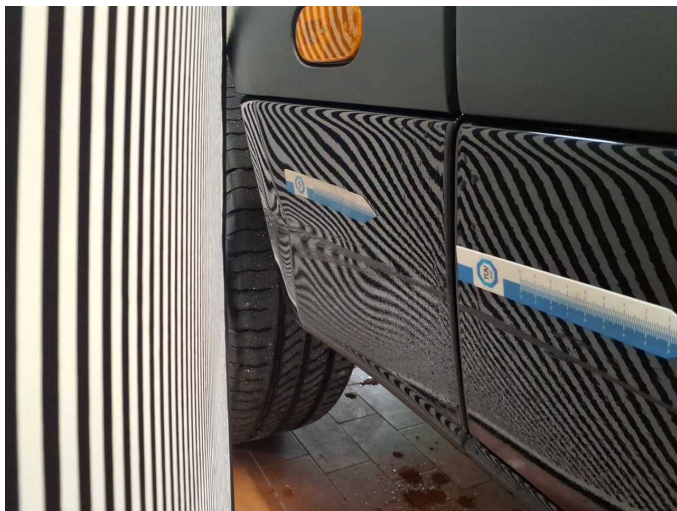
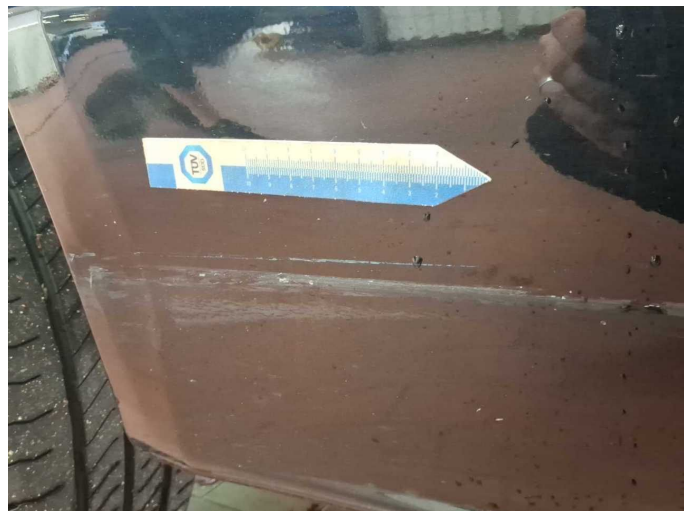
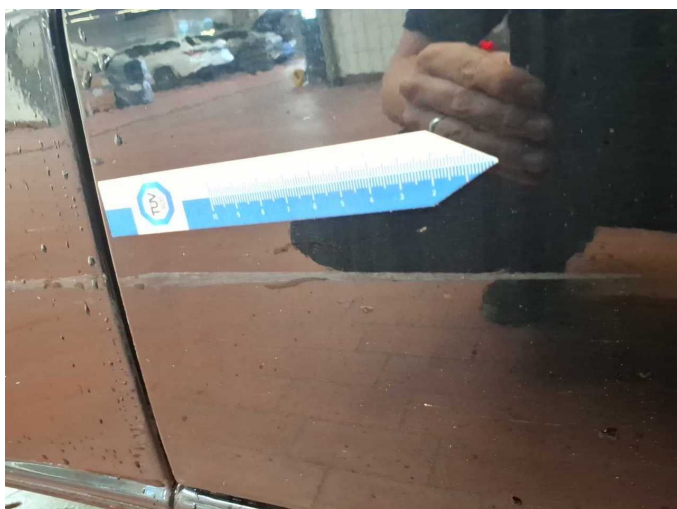
- Side right

**Accident 1:** Side right
