Expertise

Protocol number: 46220521  
Order No. / Reference: 26553758  
Inspection date: 29 Jun 2026

Manufacturer: Ford

Model: S-Max 2.0 EcoBlue Aut. TREND

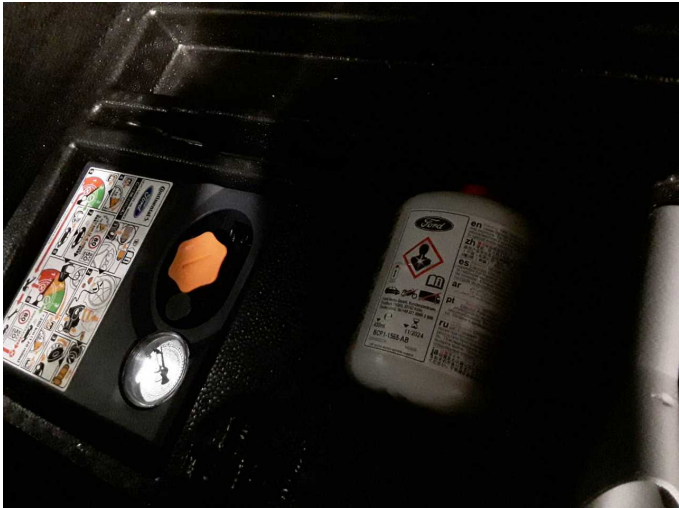
| No. | Component group | Description |
|---|---|---|
| 1 | Equipment | Tirefit filler - Expired - Replace |

Damage 1: Equipment: Tirefit filler - Expired - Replace

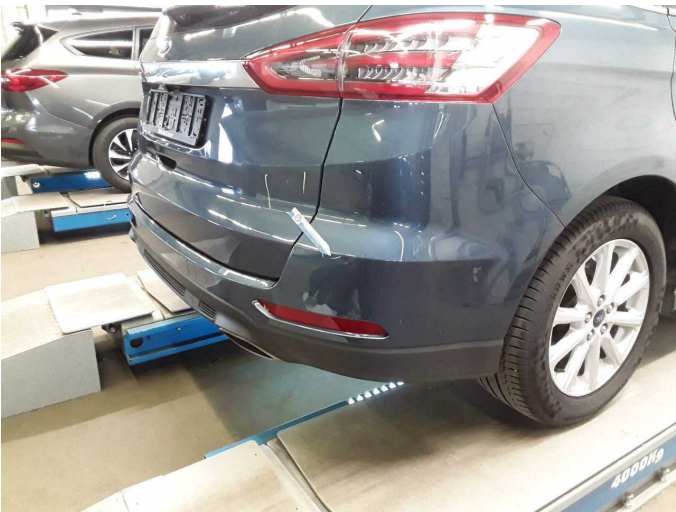
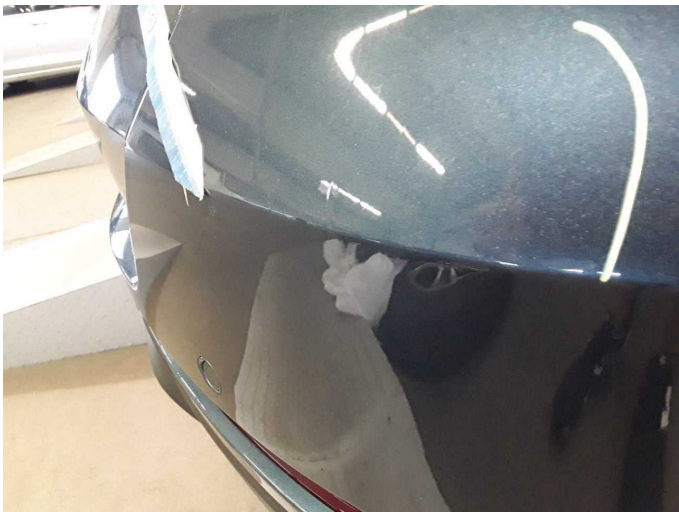
| No. | Component group | Description |
|---|---|---|
| 2 | Rear bumper | Rear bumper - Scratch(es) - Smart repair |

Damage 2: Rear bumper: Rear bumper - Scratch(es) - Smart repair

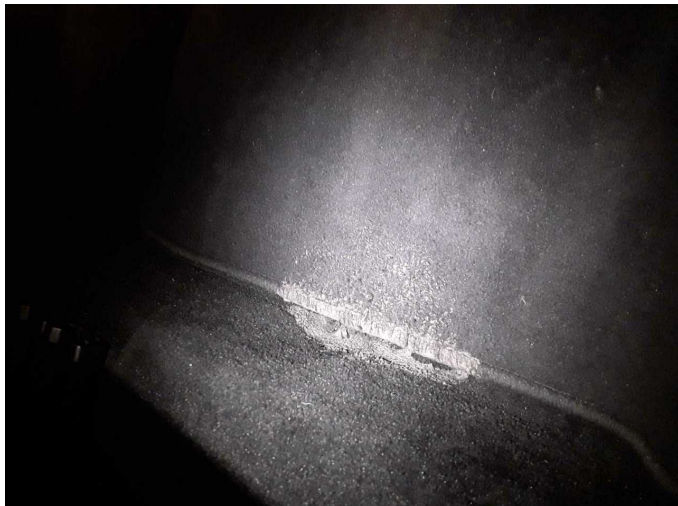
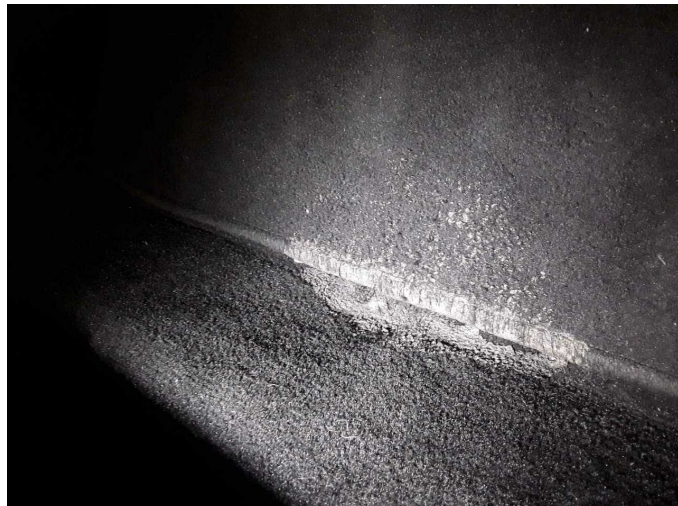
| No. | Component group | Description |
|---|---|---|
| 3 | Trim / covers | Carpet - rear right side (Verbrannt) - Damaged - Smart repair |

**Damage 3:** Trim / covers: Carpet - rear right side (Verbrannt) - Damaged  
- Smart repair

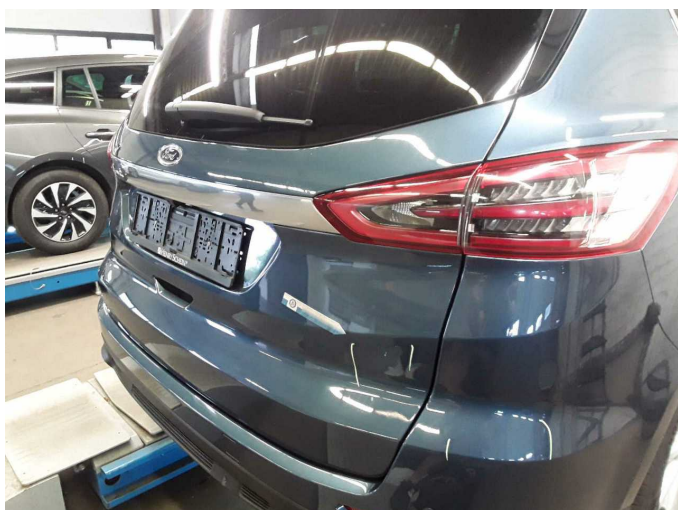
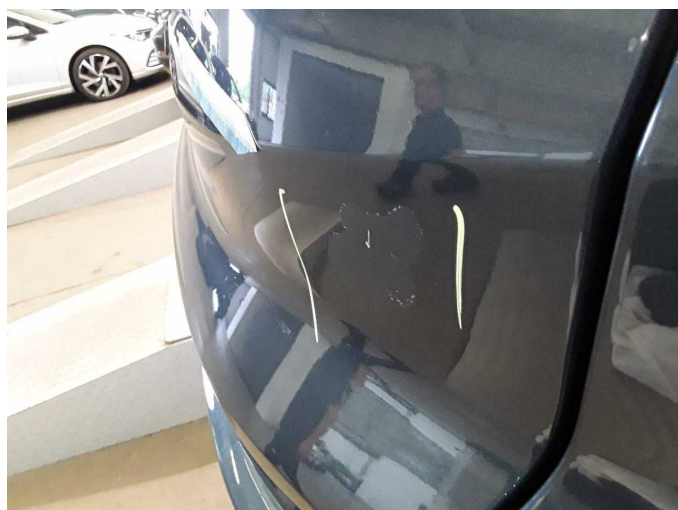
| No. | Component group | Description |
|---|---|---|
| 4 | Boot lid / rear door | Boot lid (Klarlack abgeblättert) - Paint defect - Lacquer |

**Damage 4:** Boot lid / rear door: Boot lid (Klarlack abgeblättert) - Paint  
defect - Lacquer

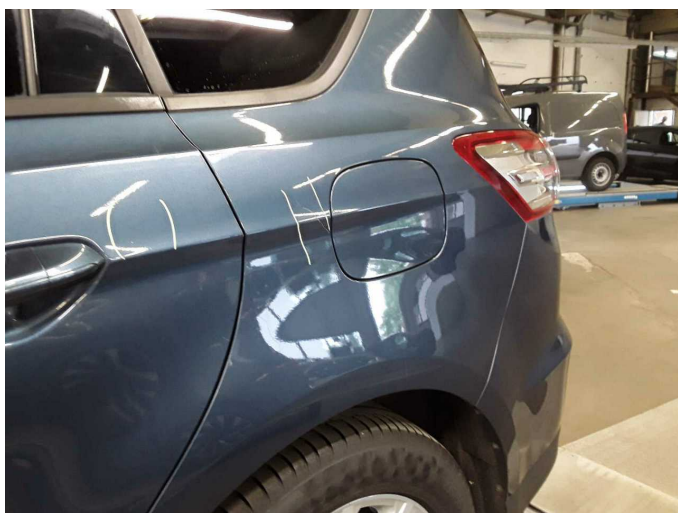
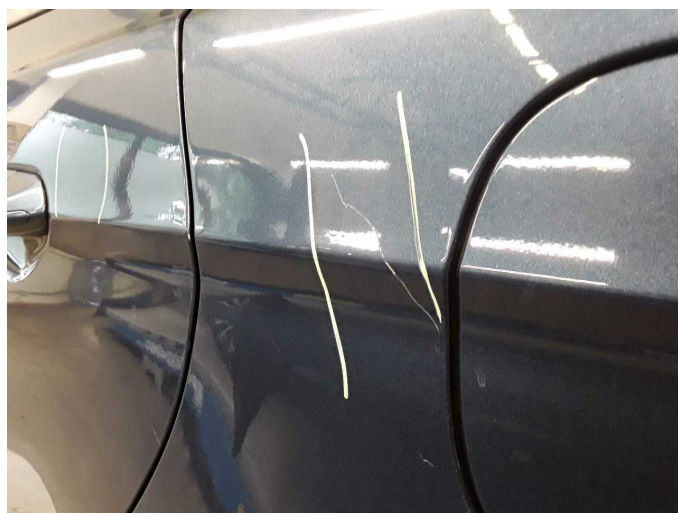
| No. | Component group | Description |
|---|---|---|
| 5 | Side panel - rear left side | Side panel - Scratch(es) - Paint |

**Damage 5:** Side panel - rear left side: Side panel - Scratch(es) - Paint

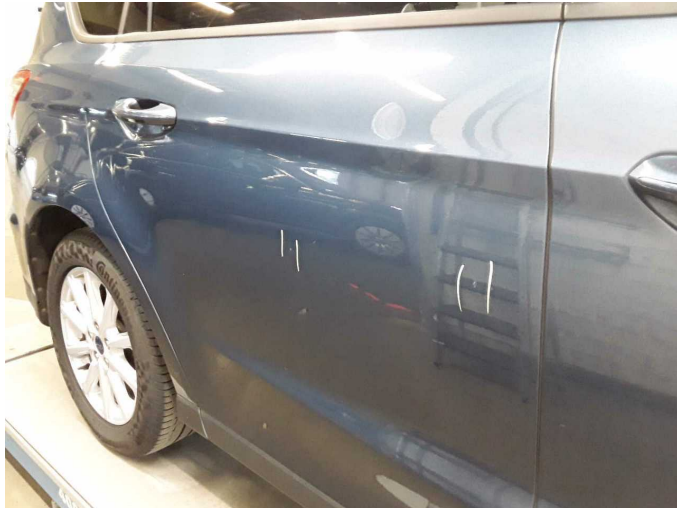
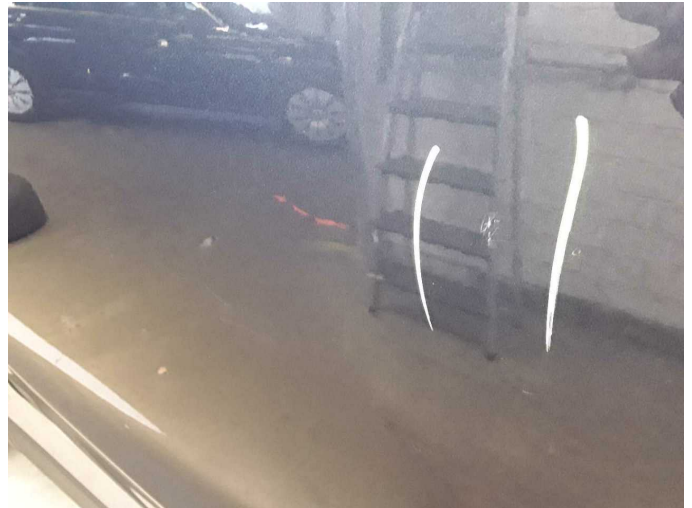
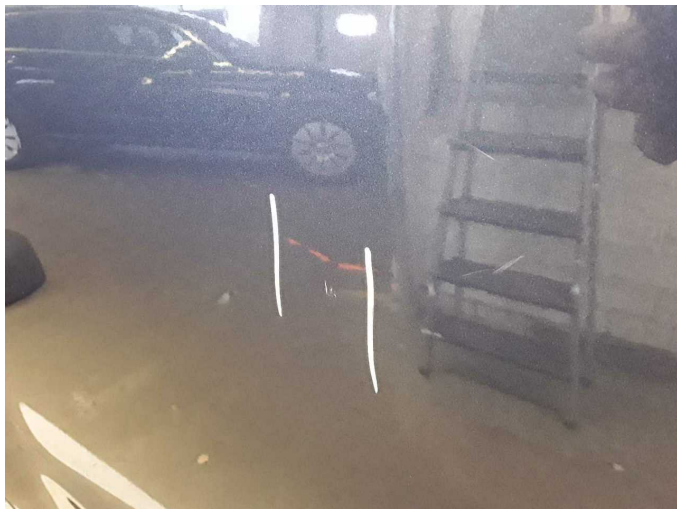
| No. | Component group | Description |
|---|---|---|
| 6 | Door - rear right side | Door - Scratch(es) - Paint |

**Damage 6:** Door - rear right side: Door - Scratch(es) - Paint

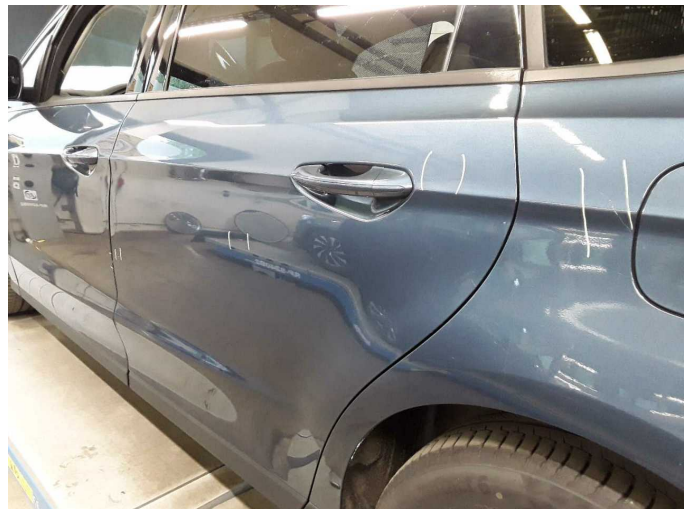
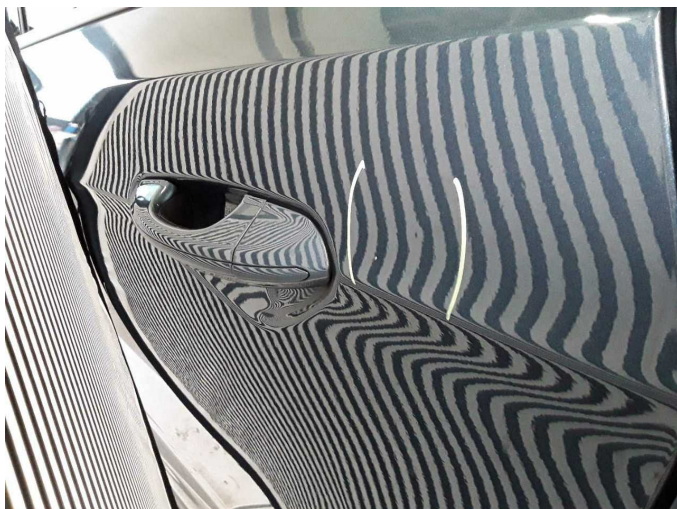
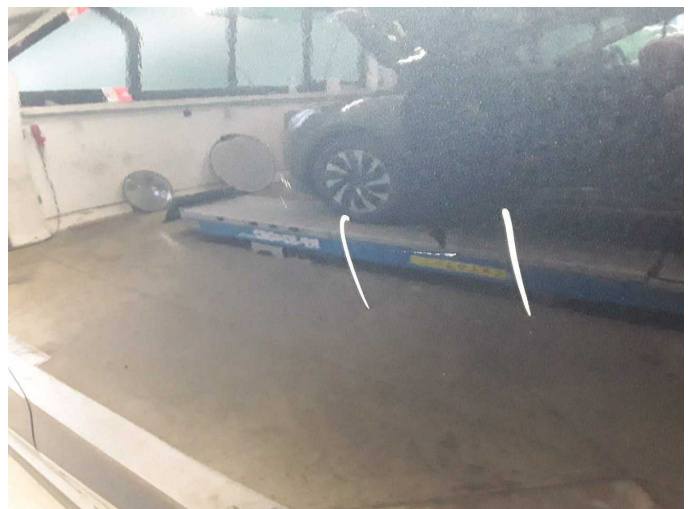
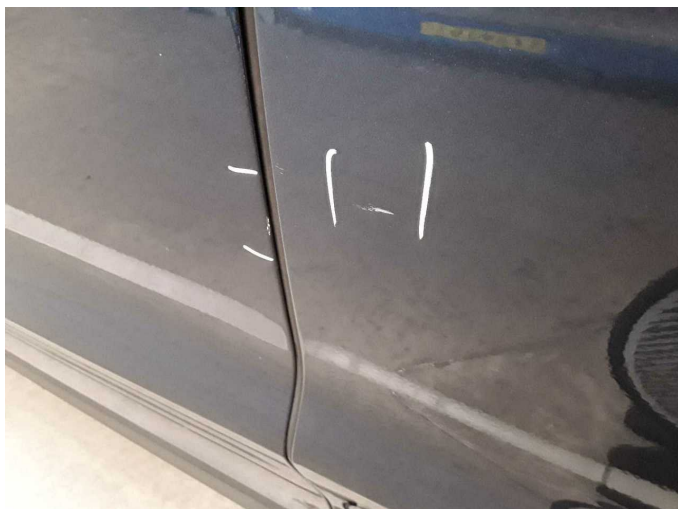
| No. | Component group | Description |
|---|---|---|
| 7 | Door - rear left side | Door - Dent / paintcoat damage - Repair and paint |

**Damage 7:** Door - rear left side: Door - Dent / paintcoat damage - Repair and paint

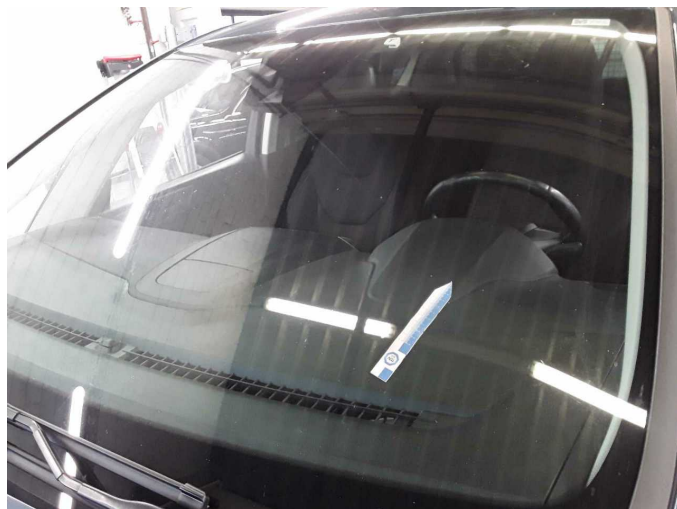
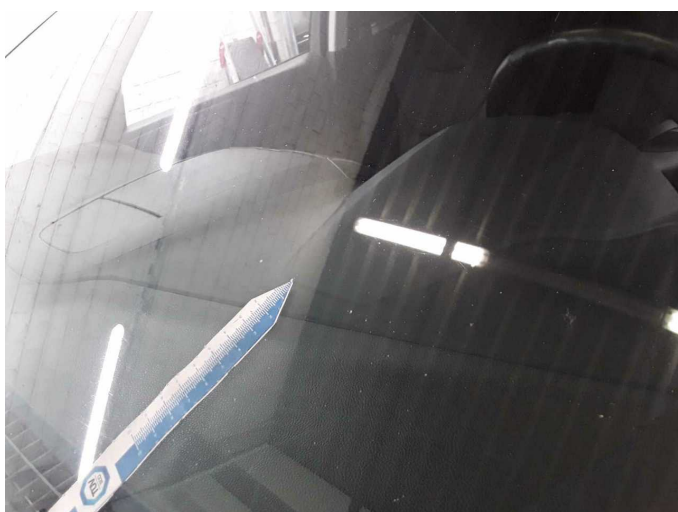
| No. | Component group | Description |
|---|---|---|
| 1 | Vehicle glazing | Windscreen - Stone chips - No deduction |

**Wear and tear 1:** Vehicle glazing: Windscreen - Stone chips - No deduction

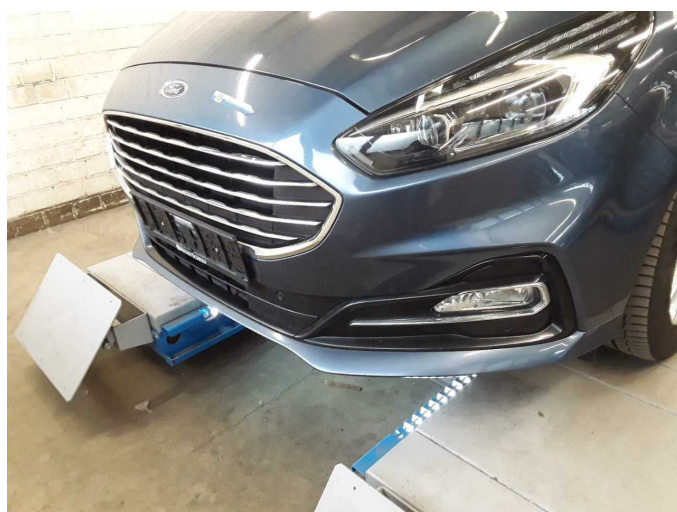
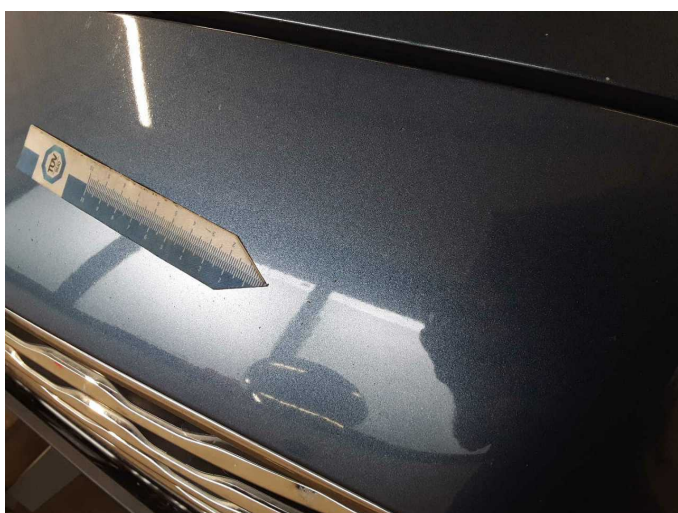
| No. | Component group | Description |
|---|---|---|
| 2 | Front bumper | Front bumper - Stone chips - No deduction |

**Wear and tear 2:** Front bumper: Front bumper - Stone chips - No deduction

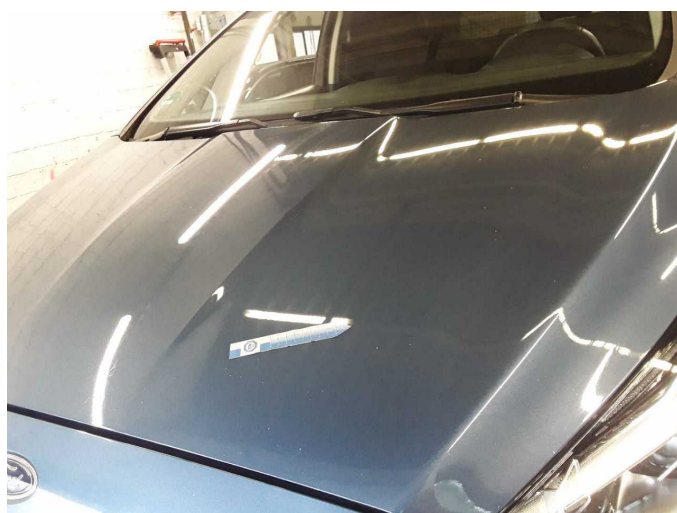
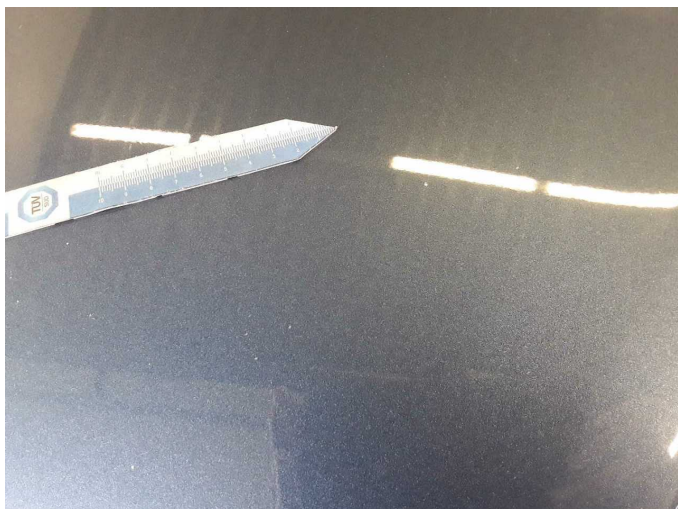
| No. | Component group | Description |
|---|---|---|
| 3 | Bonnet | Bonnet - Stone chips - No deduction |

**Wear and tear 3:** Bonnet: Bonnet - Stone chips - No deduction

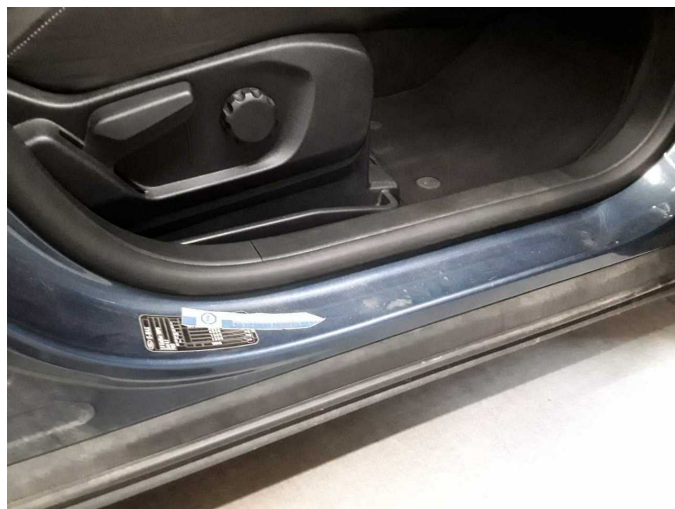
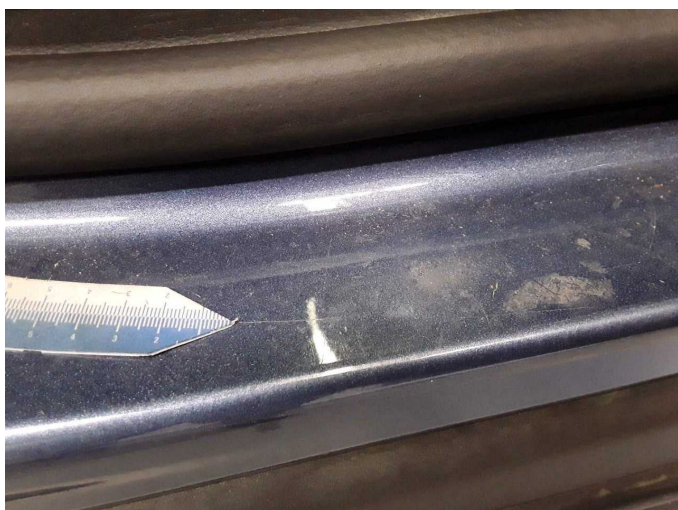
| No. | Component group | Description |
|---|---|---|
| 5 | Sill - right side | Sill - dent(s) - Smart repair |

**Wear and tear 5:** Sill - right side: Sill - dent(s) - Smart repair

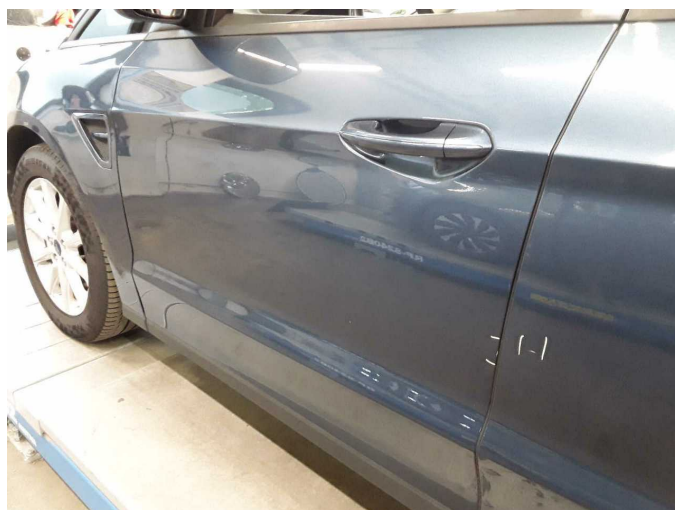
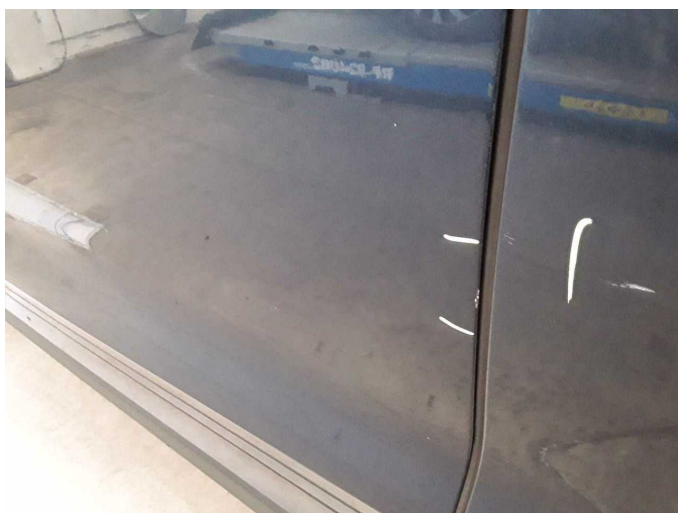
| No. | Component group | Description |
|---|---|---|
| 6 | Door - front left side | Door - Scratch(es) - Smart repair |

**Wear and tear 6:** Door - front left side: Door - Scratch(es) - Smart repair
