Expertise

Protocol number: 46516841  
Order No. / Reference: 26417256  
Inspection date: 8 Jul 2026

Manufacturer: Volkswagen

Model: Tiguan 1.4 eHybrid OPF DSG R-Line

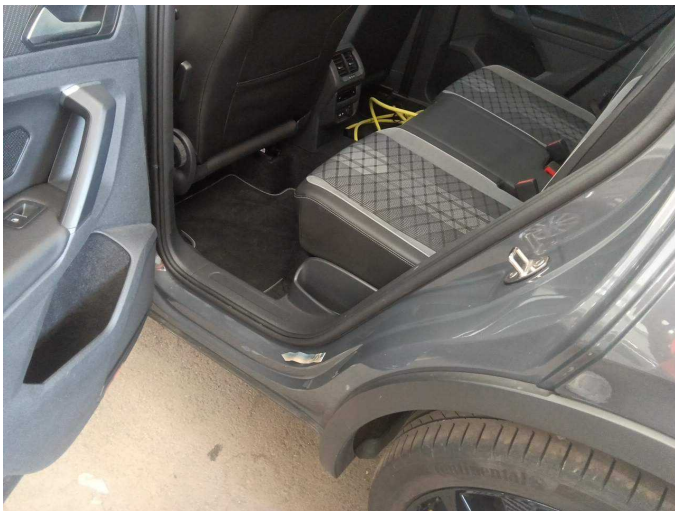
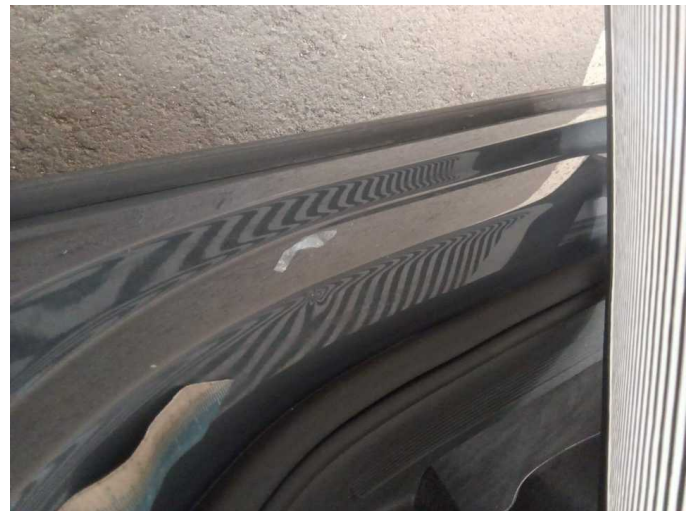
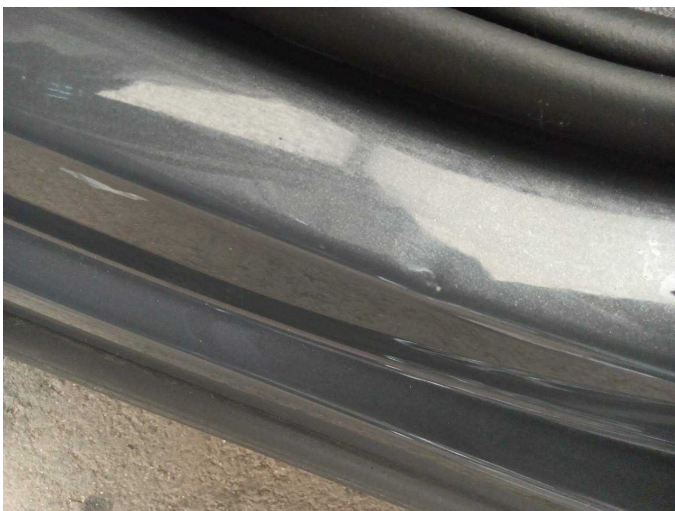
| No. | Component group | Description |
|---|---|---|
| 1 | Side panel - rear left side | Sill (Seitenwand Kniestück) - Dent / paintcoat damage - Smart repair |

**Damage 1:** Side panel - rear left side: Sill (Seitenwand Kniestück) - Dent / paintcoat damage - Smart repair

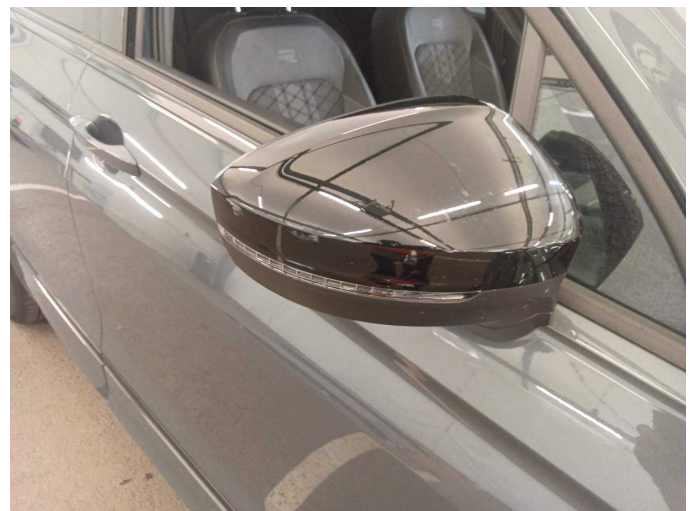
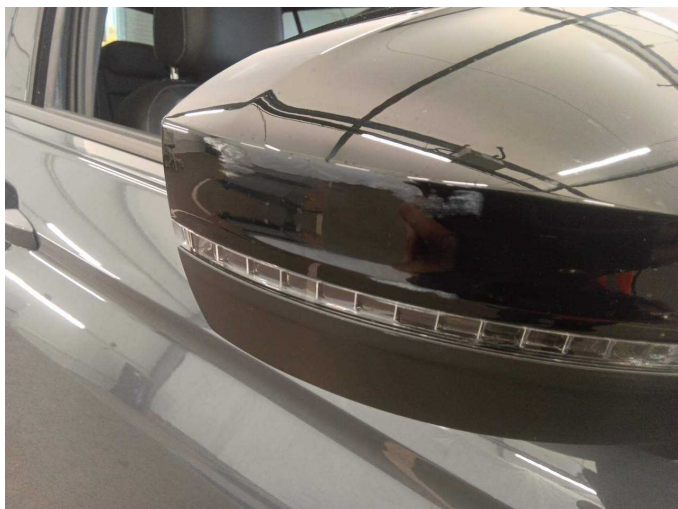
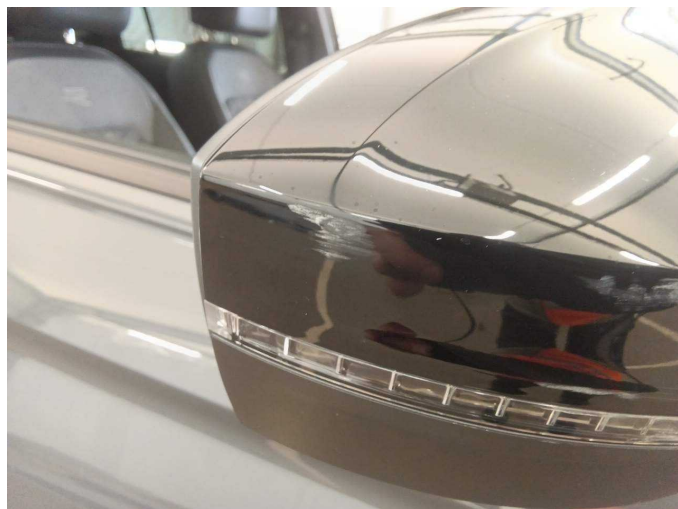
| No. | Component group | Description |
|---|---|---|
| 2 | Wing mirror - right side | Cap - Scratched - Replace |

**Damage 2:** Wing mirror - right side: Cap - Scratched - Replace

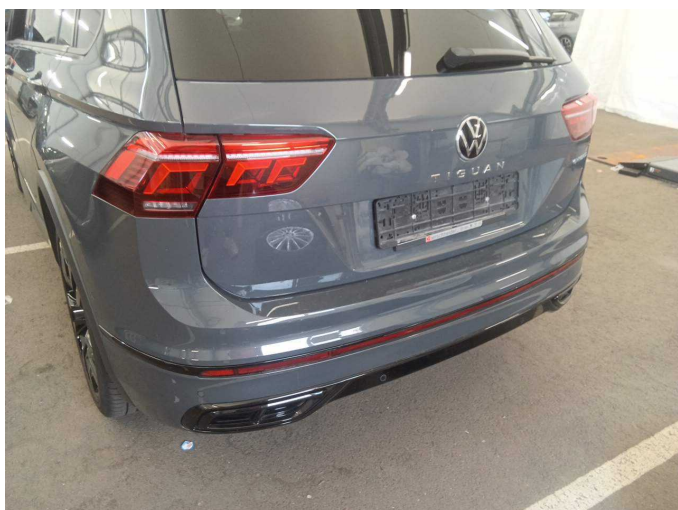
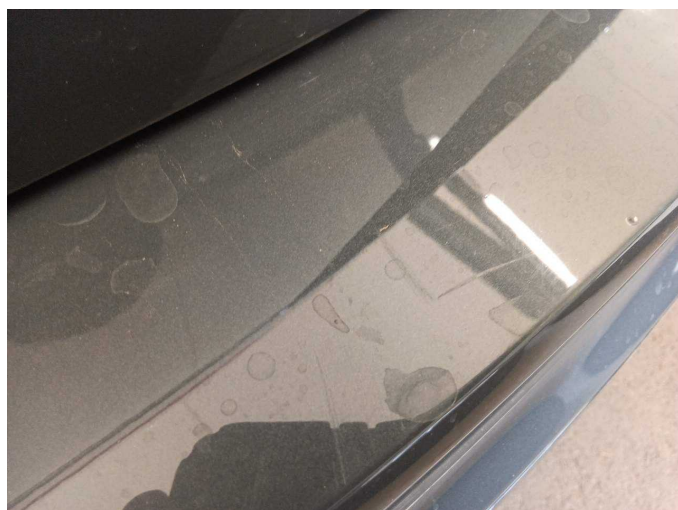
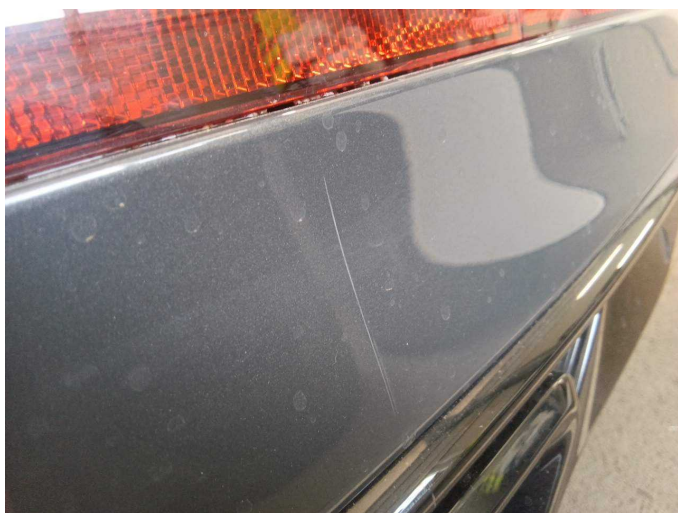
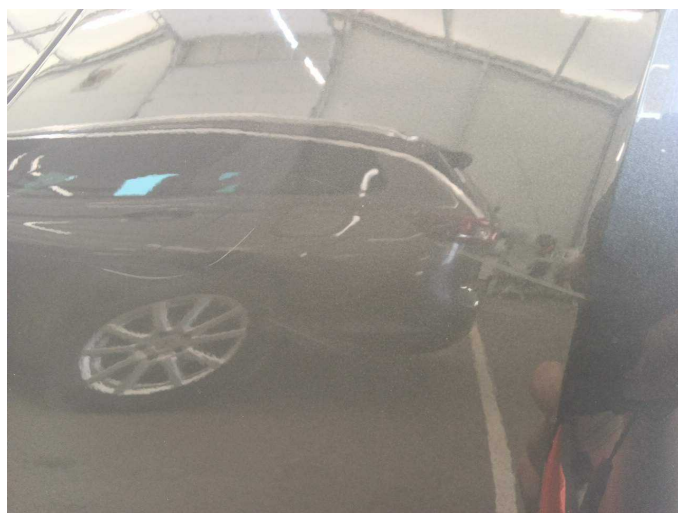
| No. | Component group | Description |
|---|---|---|
| 3 | Rear bumper | Rear bumper - Scratch(es) - Paint |

**Damage 3:** Rear bumper: Rear bumper - Scratch(es) - Paint

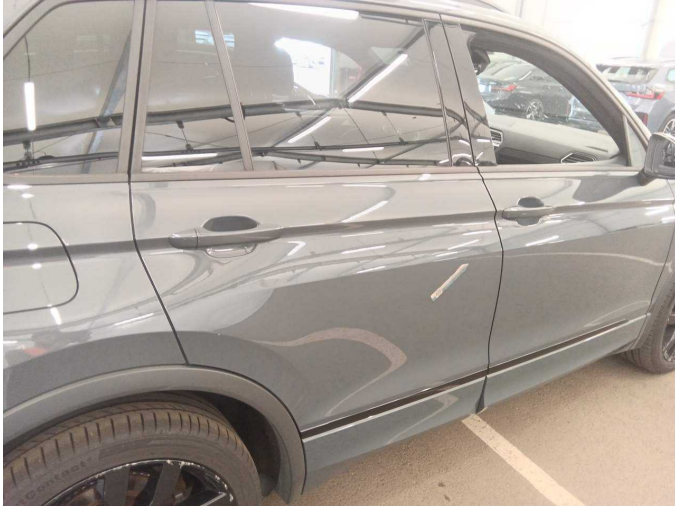
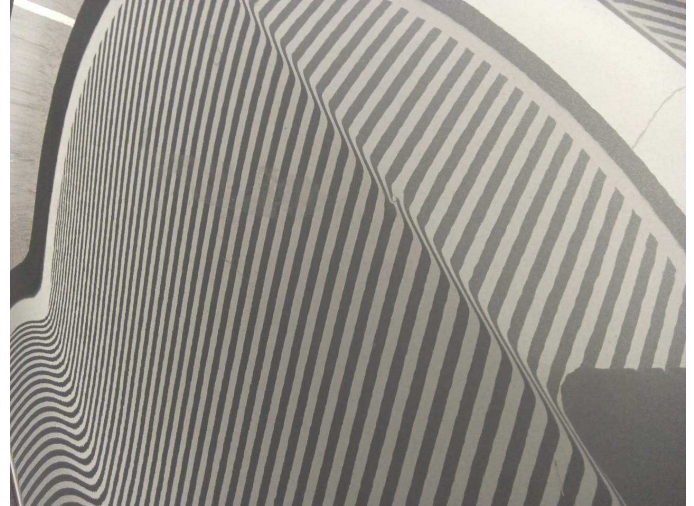
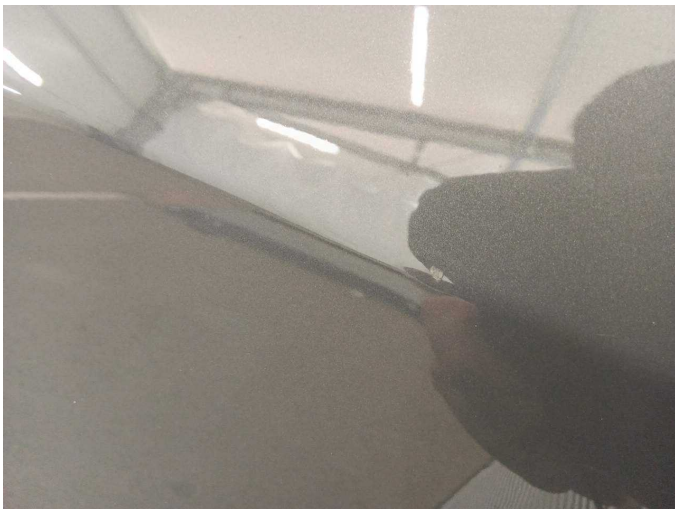
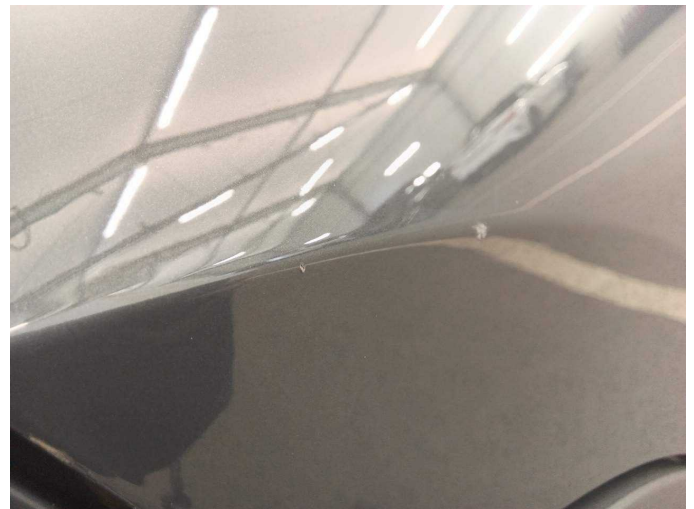
| No. | Component group | Description |
|---|---|---|
| 4 | Door - rear right side | Door - Dent / paintcoat damage - Repair and paint |

**Damage 4:** Door - rear right side: Door - Dent / paintcoat damage - Repair and paint

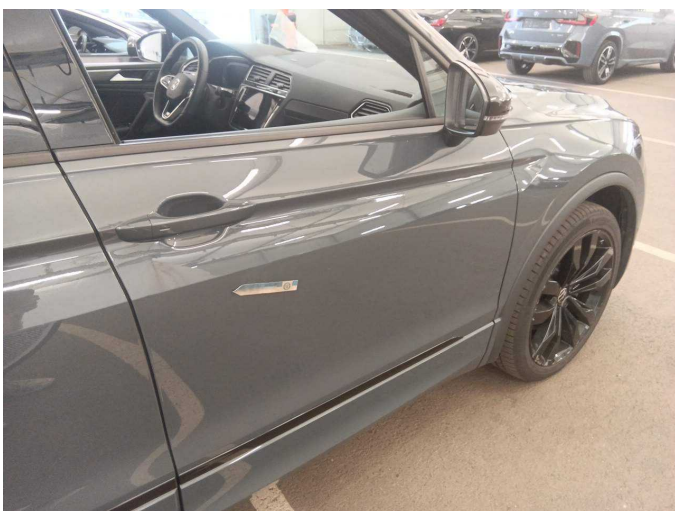
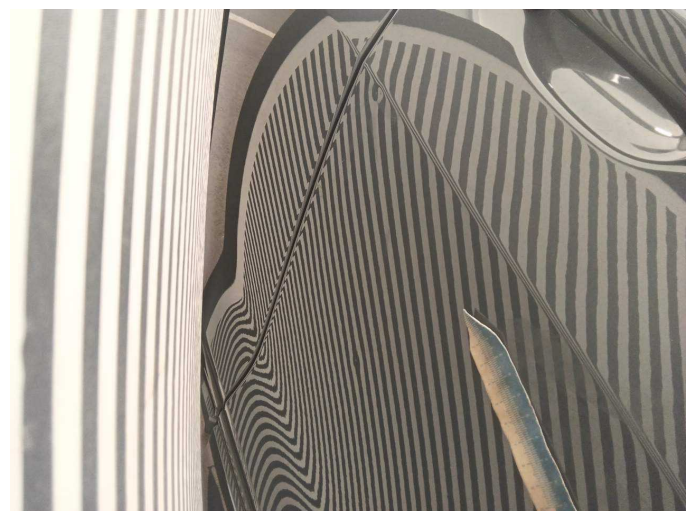
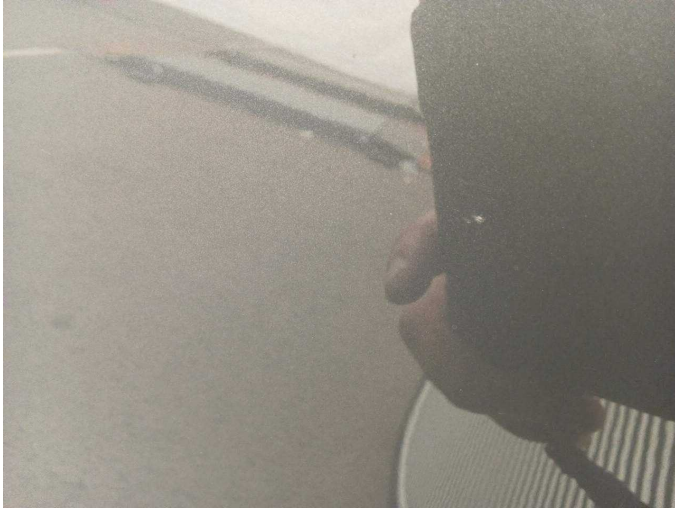
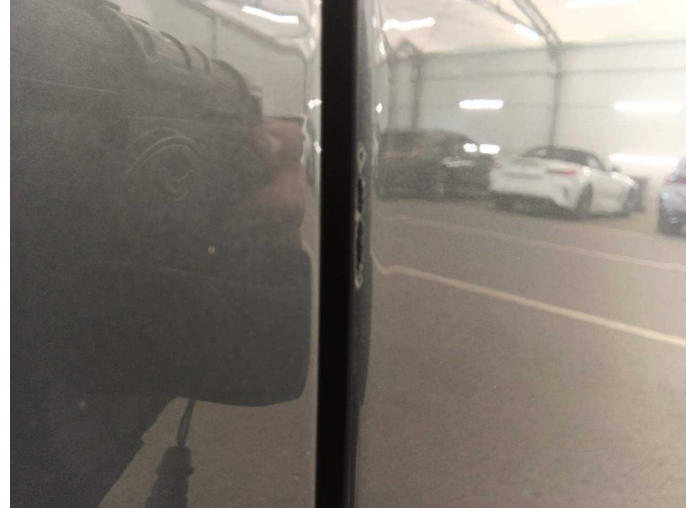
| No. | Component group | Description |
|---|---|---|
| 5 | Door - front right side | Door - Dent / paintcoat damage - Repair and paint |

**Damage 5:** Door - front right side: Door - Dent / paintcoat damage - Repair and paint

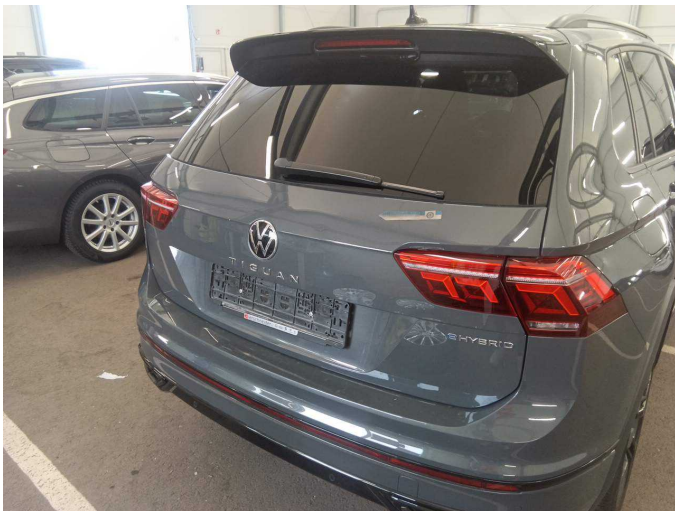
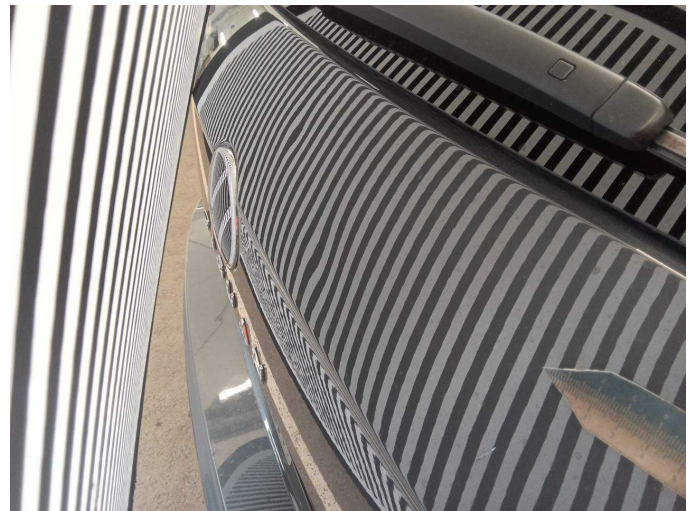
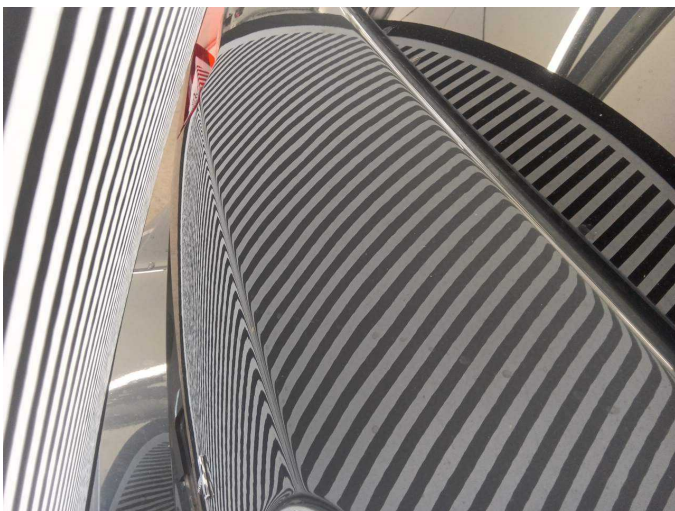
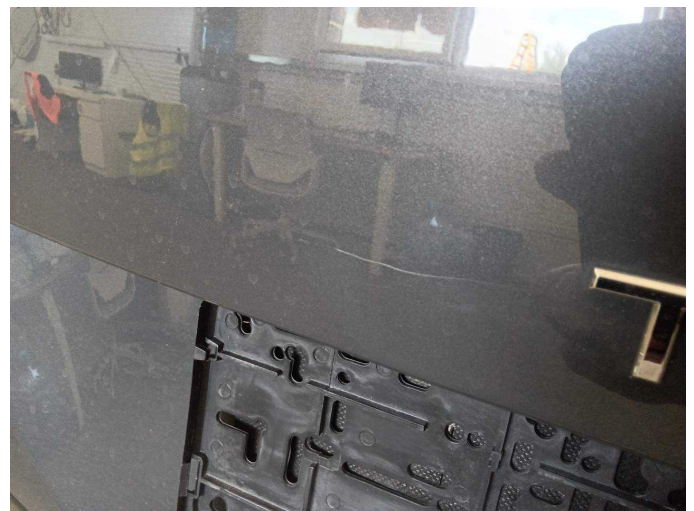
| No. | Component group | Description |
|---|---|---|
| 6 | Boot lid / rear door | Boot lid (& Lackschaden) - Dent / paintcoat damage - Repair and paint |

**Damage 6:** Boot lid / rear door: Boot lid (& Lackschaden) - Dent / paintcoat damage - Repair and paint

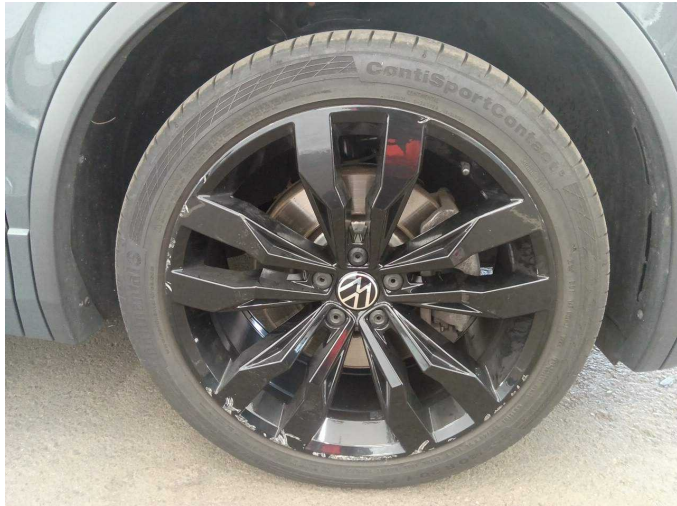
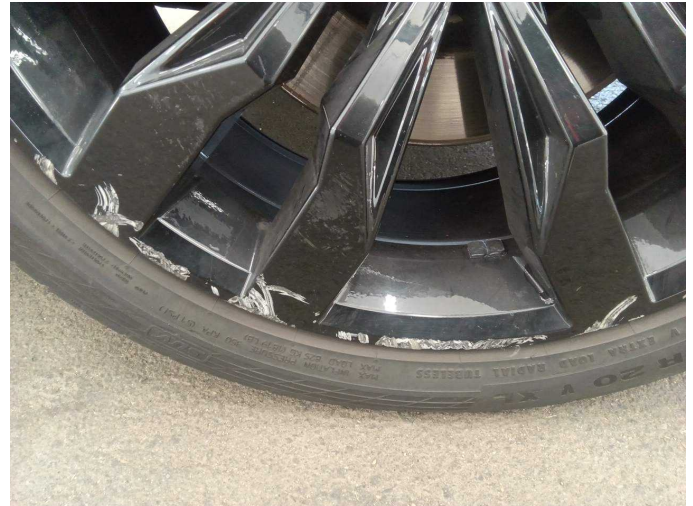
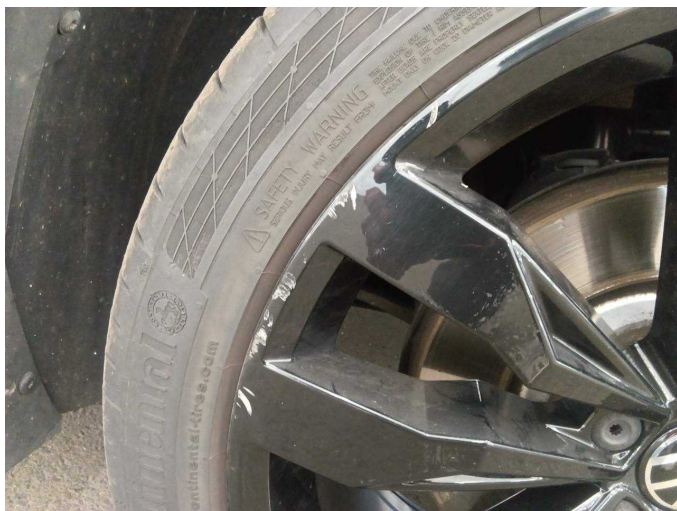
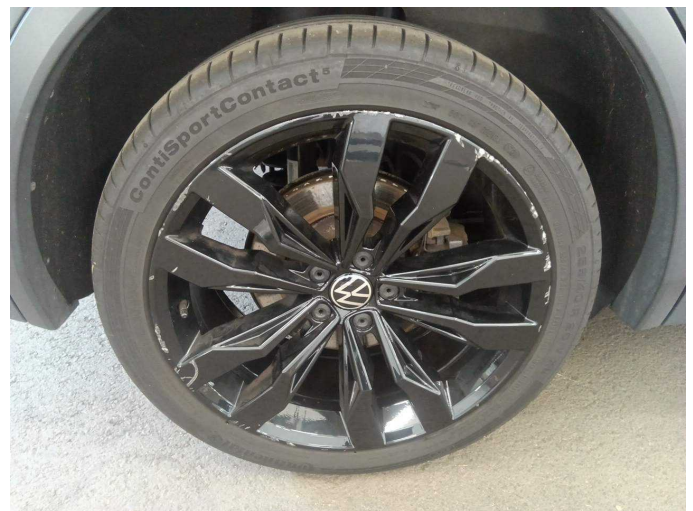
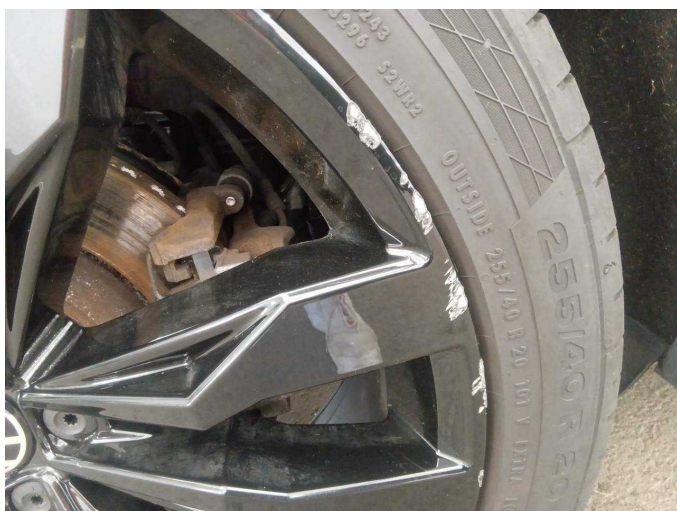
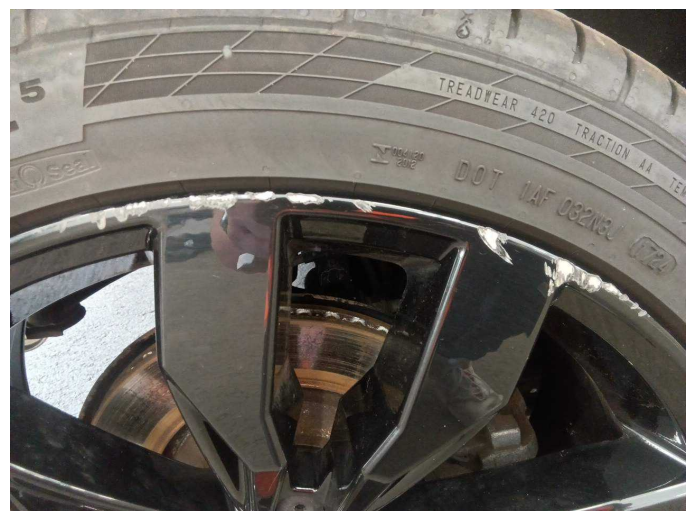
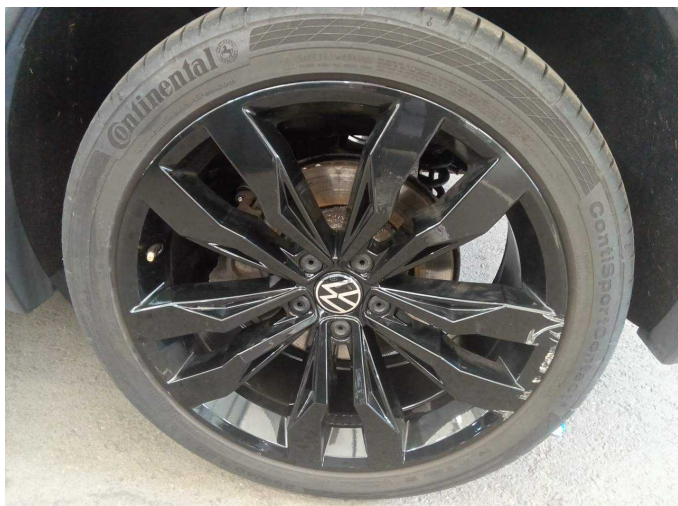
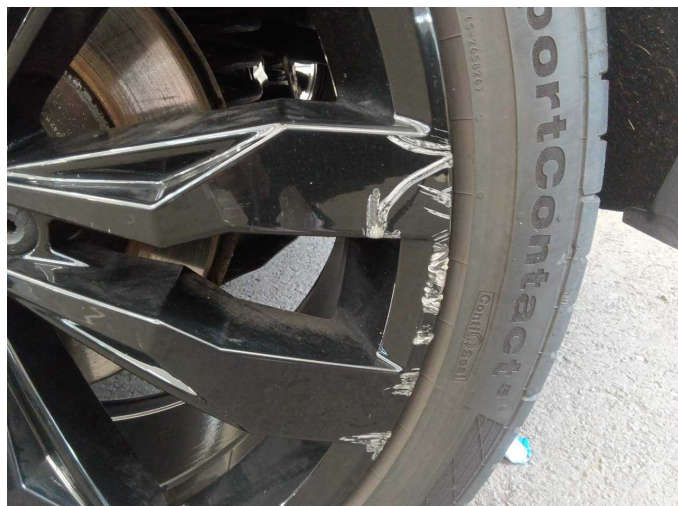
| No. | Component group | Description |
|---|---|---|
| 7 | Wheel / tyres | Alloy rim - front right side (+ beide Felgen an der Hinterachse) - Scratch(es) - Replace |

**Damage 7:** Wheel / tyres: Alloy rim - front right side (+ beide Felgen an der Hinterachse) - Scratch(es) - Replace

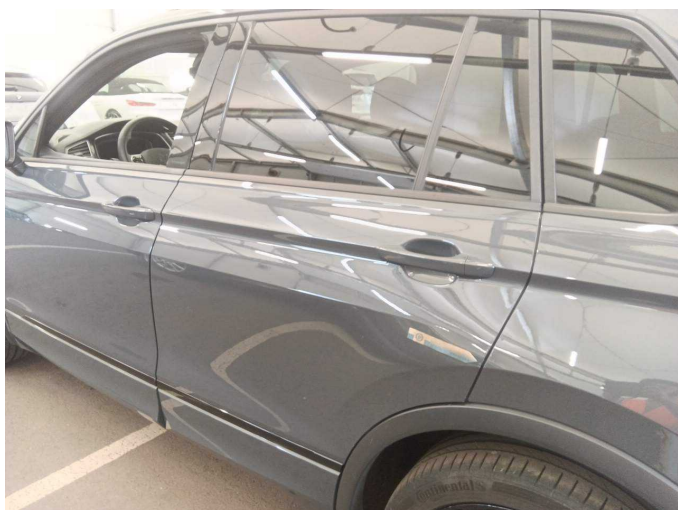
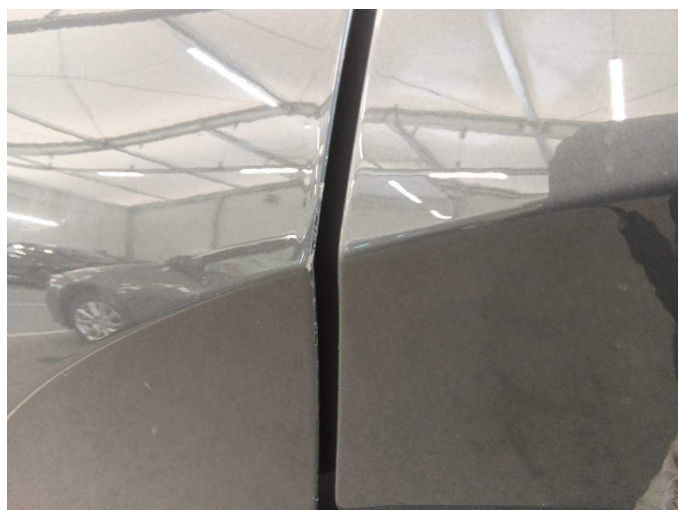
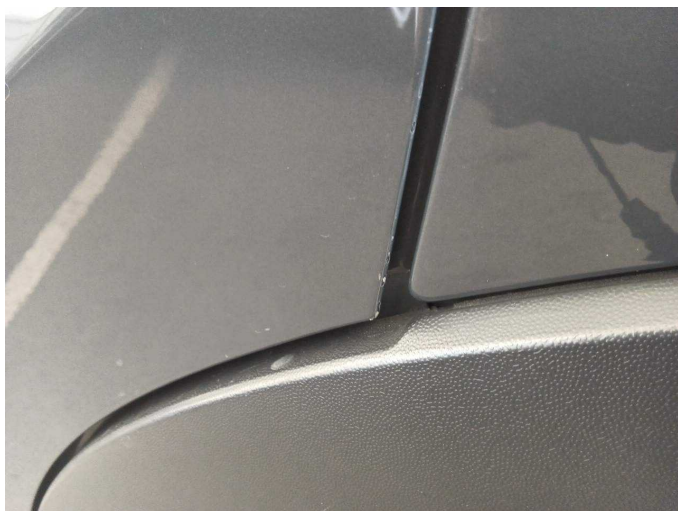
| No. | Component group | Description |
|---|---|---|
| 1 | Door - rear left side | Door edge - Scratch(es) - No deduction |

**Wear and tear 1:** Door - rear left side: Door edge - Scratch(es) - No deduction

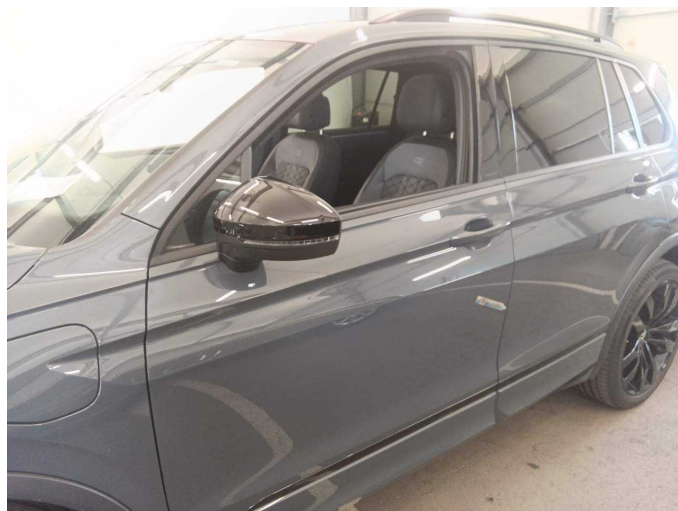
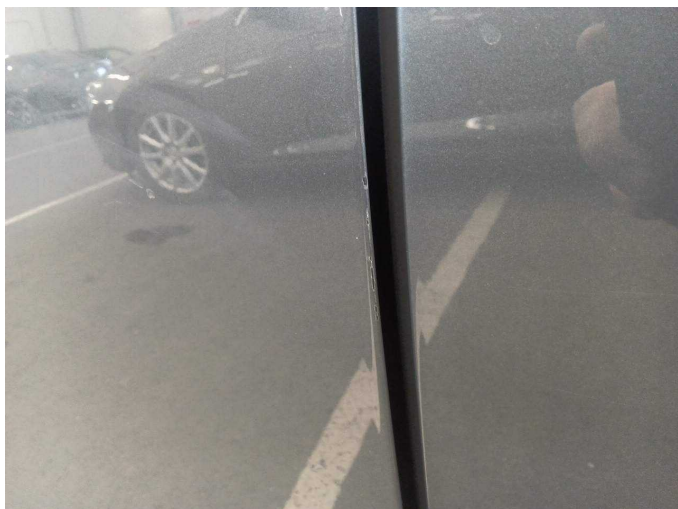
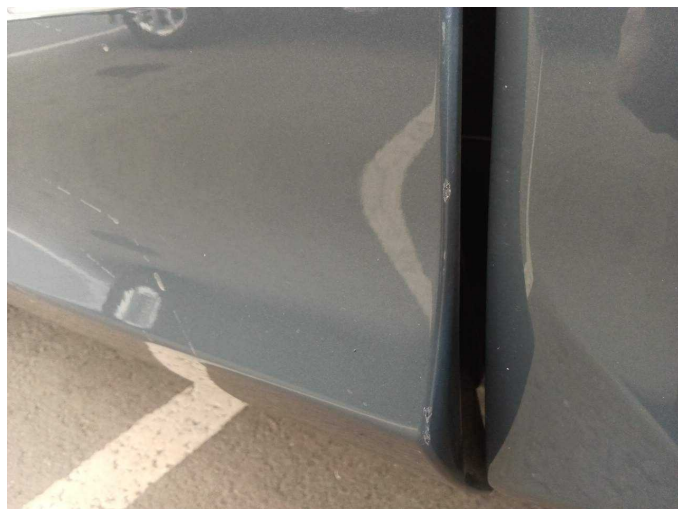
| No. | Component group | Description |
|---|---|---|
| 2 | Door - front left side | Door edge - Scratch(es) - No deduction |

**Wear and tear 2:** Door - front left side: Door edge - Scratch(es) - No deduction

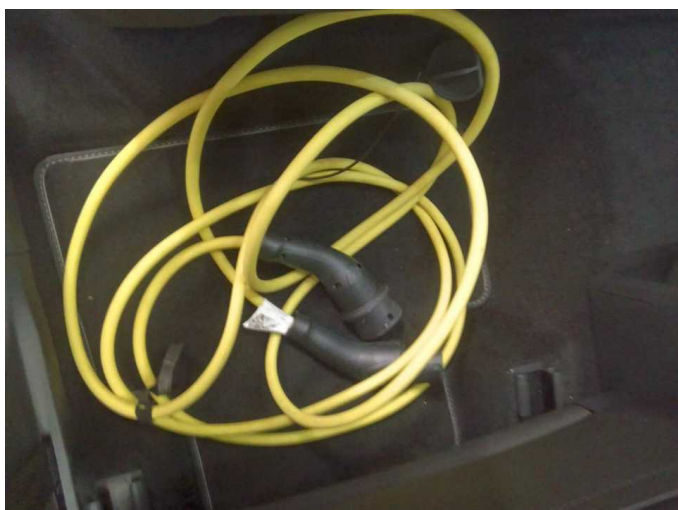
Equipment - charging cable (Schuko Stecker / Haushaltssteckdose)

**Missing part 1:** Equipment: charging cable (Schuko Stecker / Haushaltssteckdose) - Missing - Replace

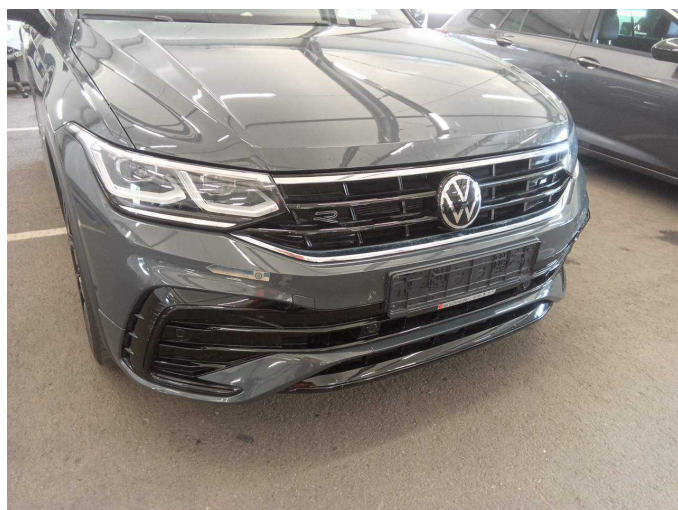
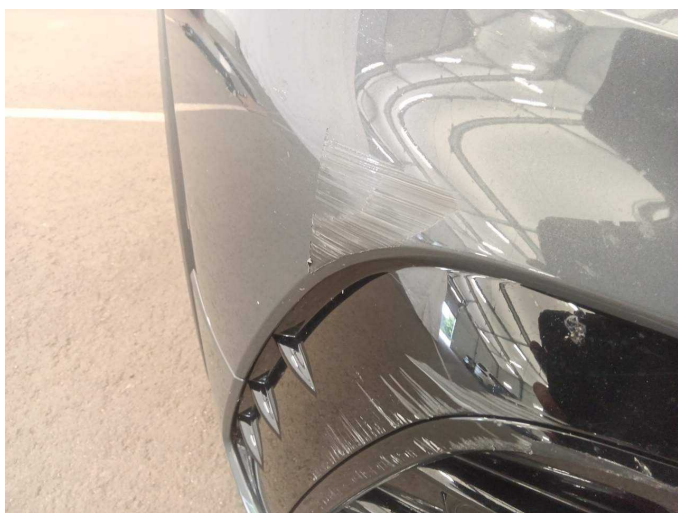
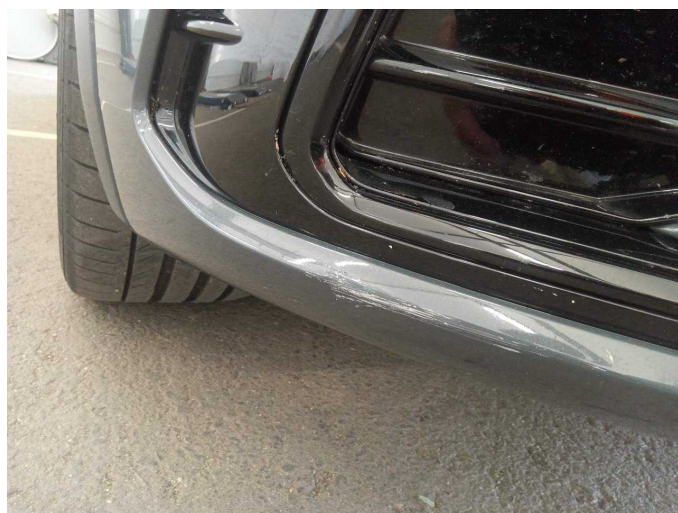
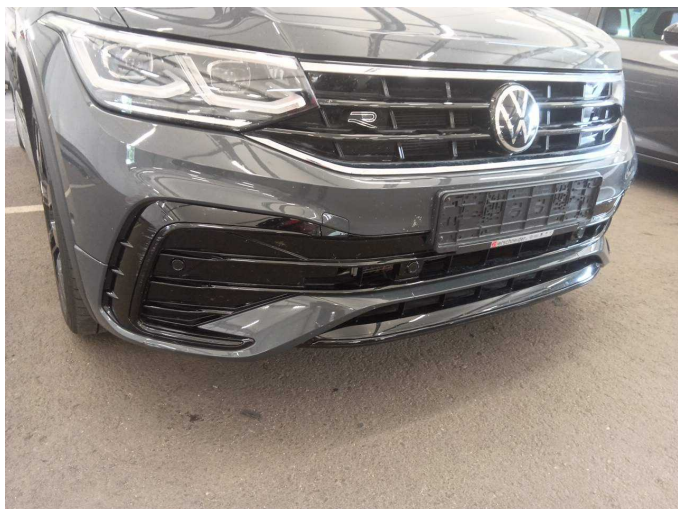
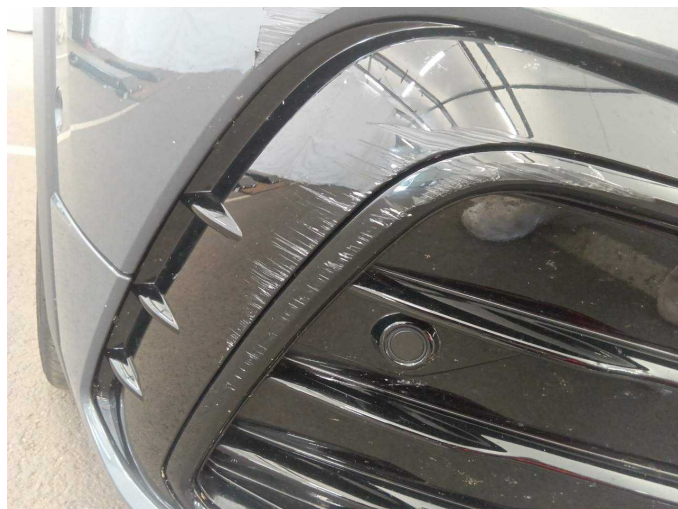
**Accident 1:** Front

Non-repaired previous damages were found at the vehicle. The necessary repair costs are listed in the expert report or if necessary, are listed in detail in a separately enclosed repair cost calculation.
