Expertise

Protocol number: 47165802  
Order No. / Reference: 26803673  
Inspection date: 19 Aug 2026

Manufacturer: Nissan

Model: Leaf 40 kWh N-Connecta

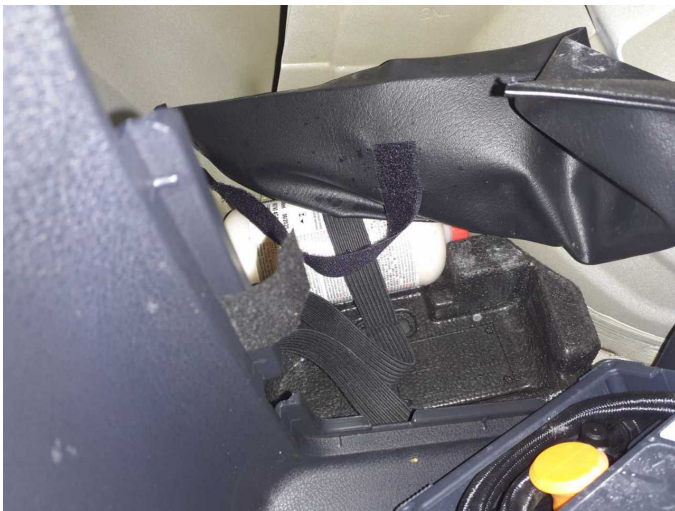
| No. | Component group | Description |
|---|---|---|
| 3 | Equipment | Tirefit filler - Expired - Replace |

**Damage 3:** Equipment: Tirefit filler - Expired - Replace

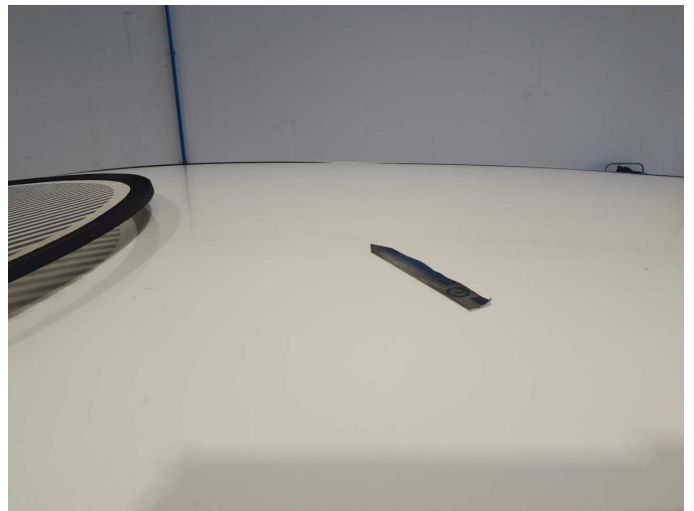
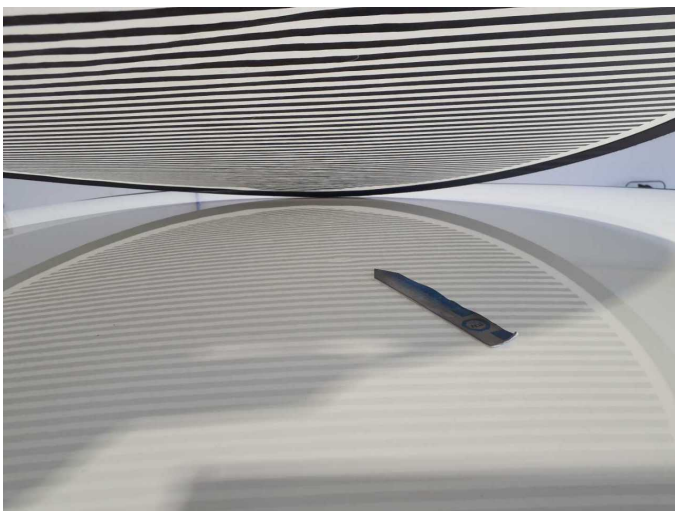
| No. | Component group | Description |
|---|---|---|
| 4 | Roof | Roof - dent(s) - Smart repair |

**Damage 4:** Roof: Roof - dent(s) - Smart repair

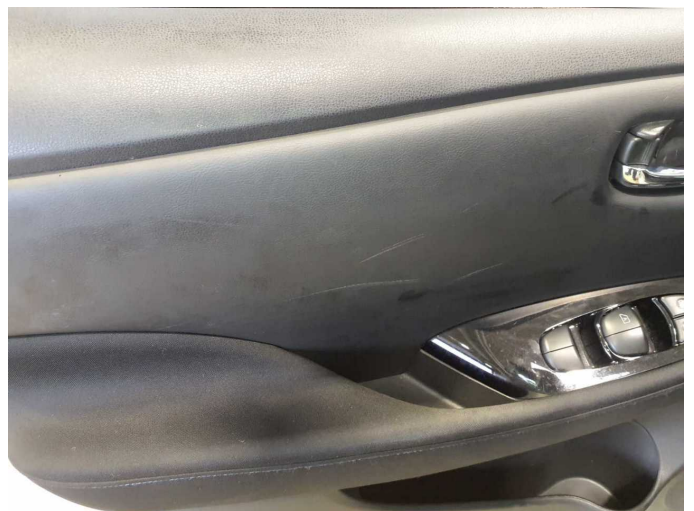
| No. | Component group | Description |
|---|---|---|
| 5 | Trim / covers | Door trim - front left side - Scratch(es) - Loss in value |

**Damage 5:** Trim / covers: Door trim - front left side - Scratch(es) - Loss in value

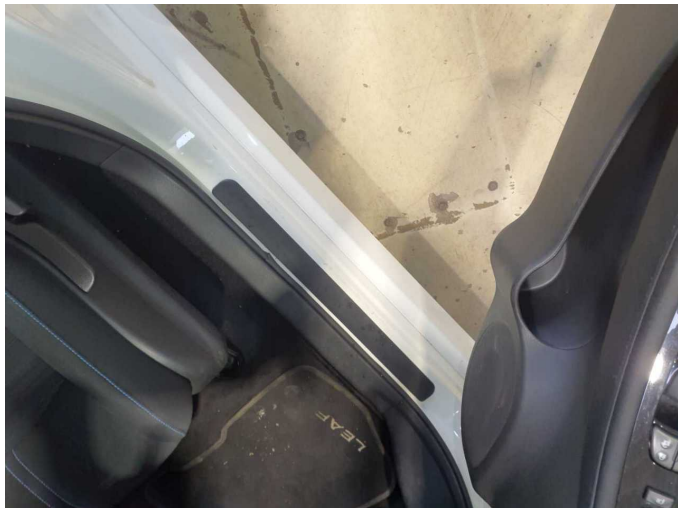
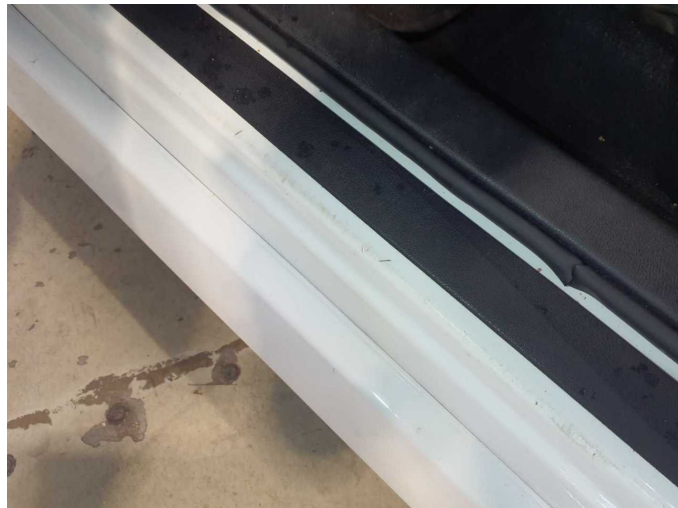
| No. | Component group | Description |
|---|---|---|
| 6 | Sill - left side | Sill - Scratch(es) - Smart repair |

**Damage 6:** Sill - left side: Sill - Scratch(es) - Smart repair

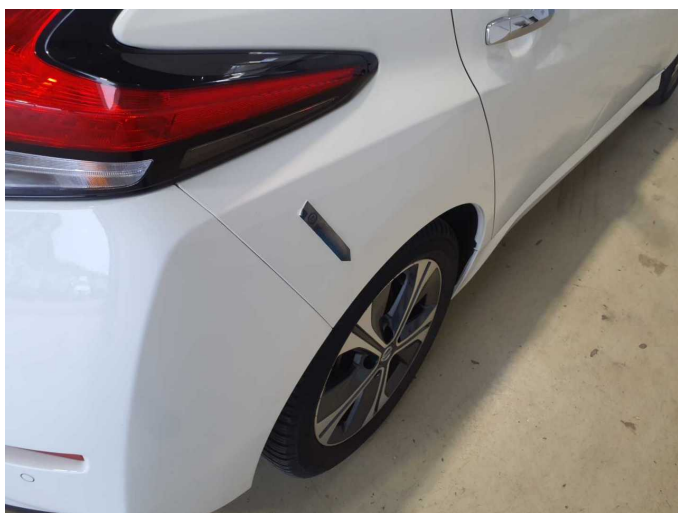
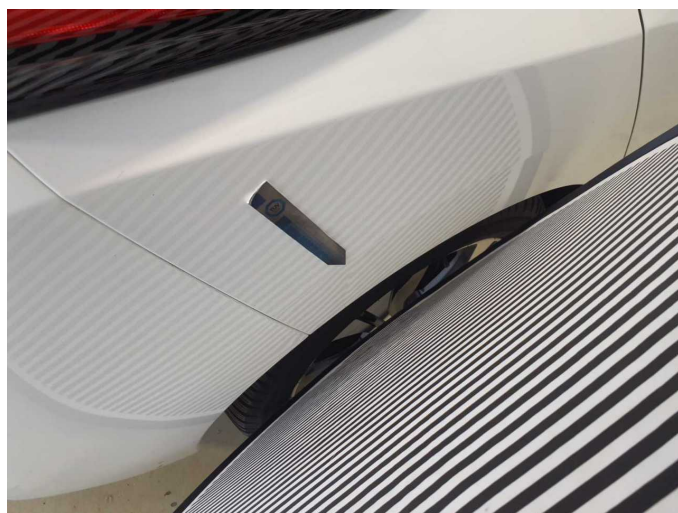
| No. | Component group | Description |
|---|---|---|
| 7 | Side panel - rear right side | Side panel - dent(s) - Smart repair |

**Damage 7:** Side panel - rear right side: Side panel - dent(s) - Smart repair

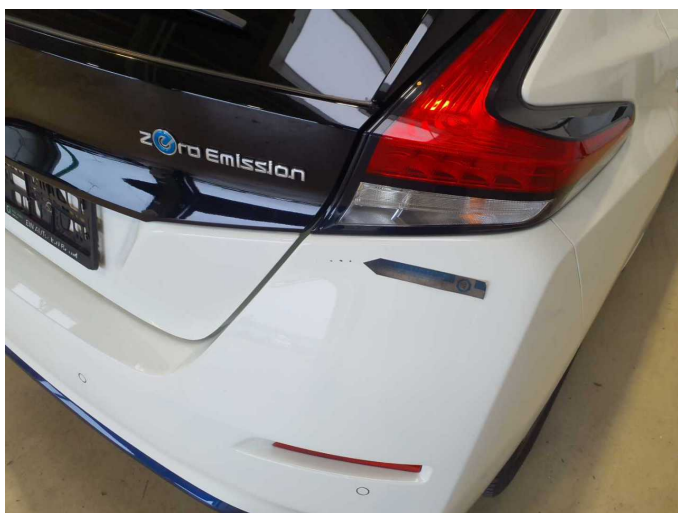
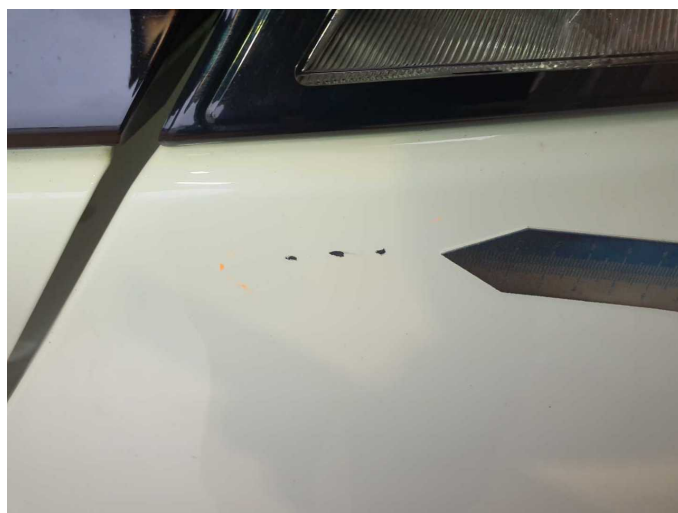
| No. | Component group | Description |
|---|---|---|
| 8 | Rear bumper | Rear bumper - Scratch(es) - Smart repair |

**Damage 8:** Rear bumper: Rear bumper - Scratch(es) - Smart repair

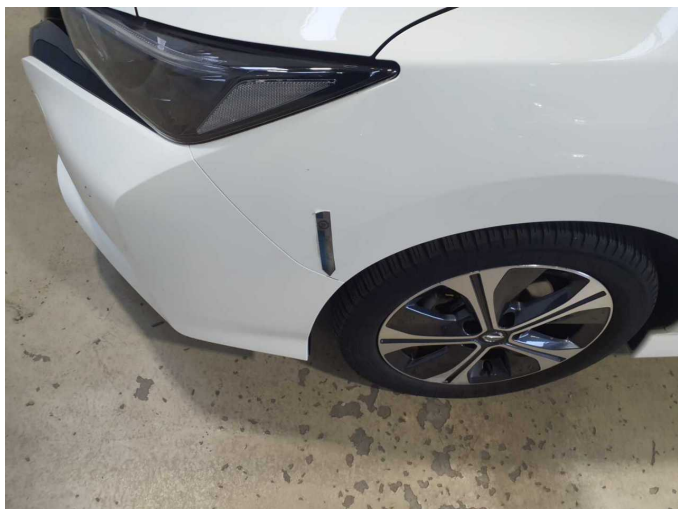
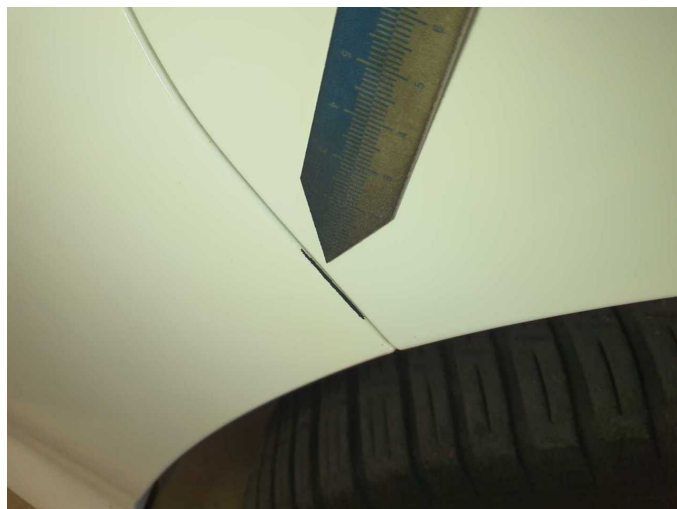
| No. | Component group | Description |
|---|---|---|
| 9 | Front bumper | Front bumper - Scratch(es) - Smart repair |

**Damage 9:** Front bumper: Front bumper - Scratch(es) - Smart repair

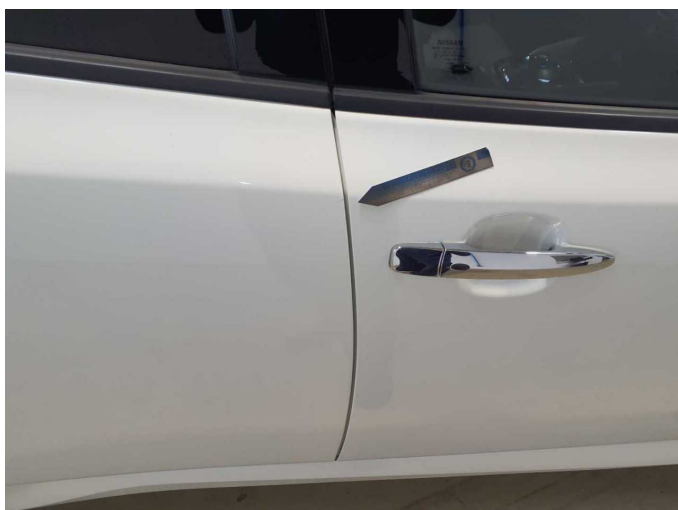
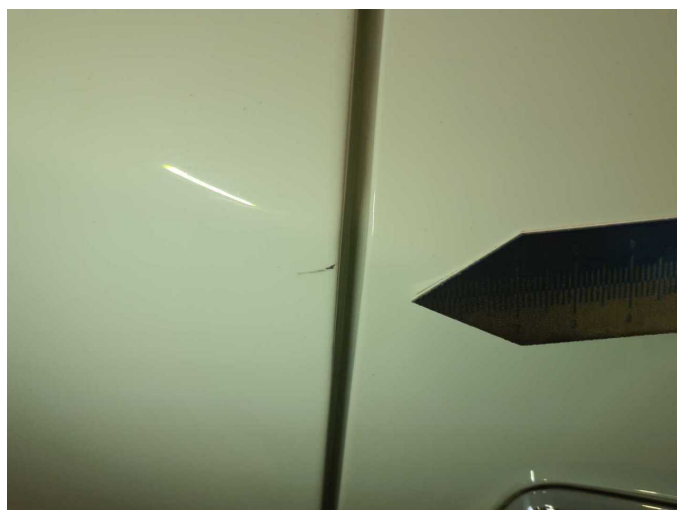
| No. | Component group | Description |
|---|---|---|
| 10 | Door - rear right side | Door - Scratch(es) - Smart repair |

**Damage 10:** Door - rear right side: Door - Scratch(es) - Smart repair

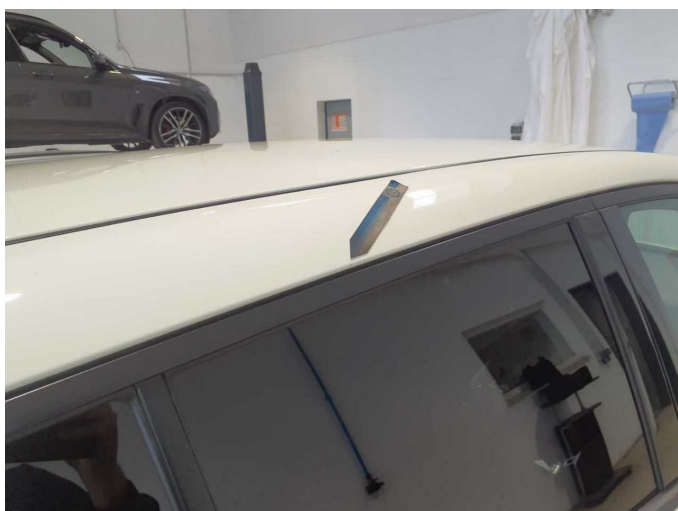
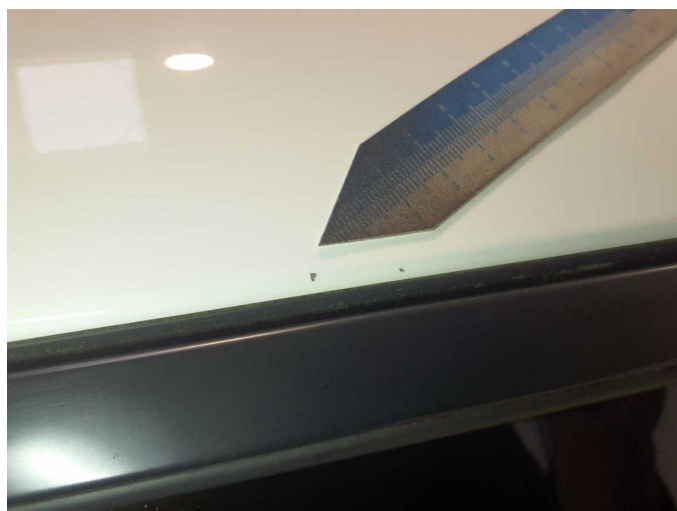
| No. | Component group | Description |
|---|---|---|
| 11 | Roof | Roof rail - right side - Scratch(es) - Smart repair |

**Damage 11:** Roof: Roof rail - right side - Scratch(es) - Smart repair

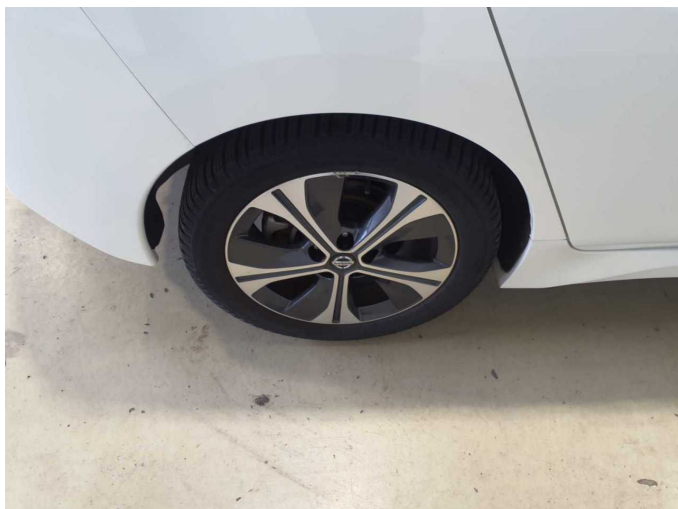
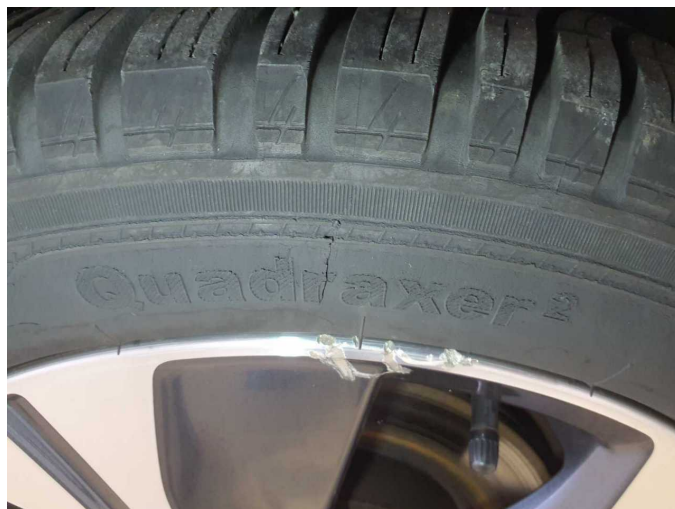
| No. | Component group | Description |
|---|---|---|
| 12 | Wheel / tyres | Tyre - rear right side (nicht fahrbereit) - Broken / torn - Replace |

**Damage 12:** Wheel / tyres: Tyre - rear right side (nicht fahrbereit) - Broken / torn - Replace

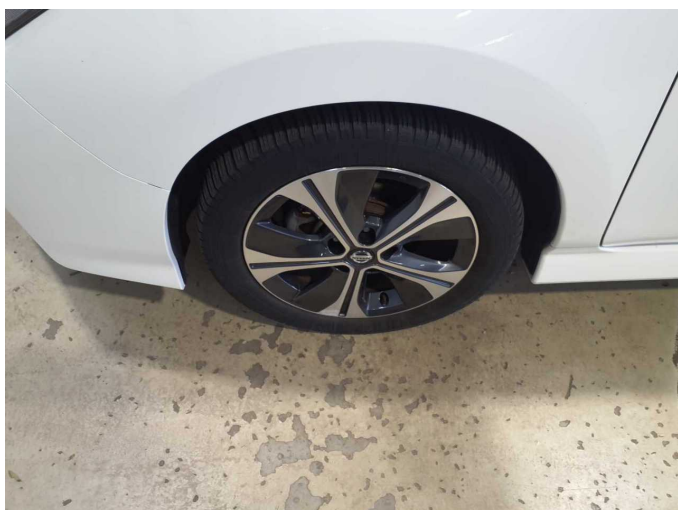
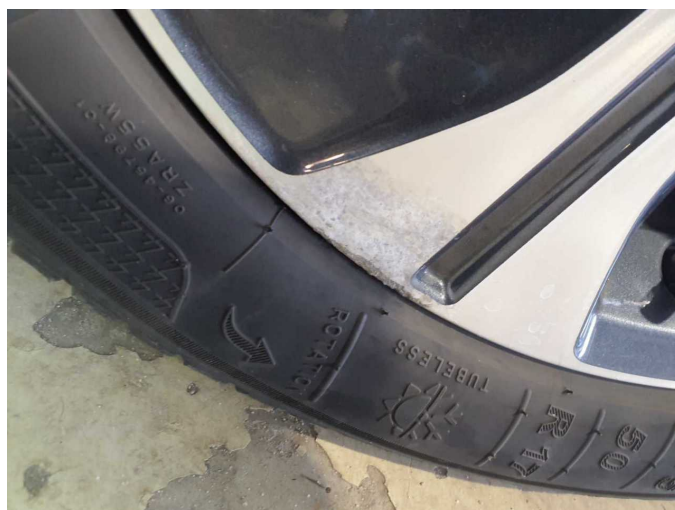
| No. | Component group | Description |
|---|---|---|
| 13 | Wheel / tyres | Alloy rim - front left side - Scratch(es) - Loss in value |

**Damage 13:** Wheel / tyres: Alloy rim - front left side - Scratch(es) - Loss in value

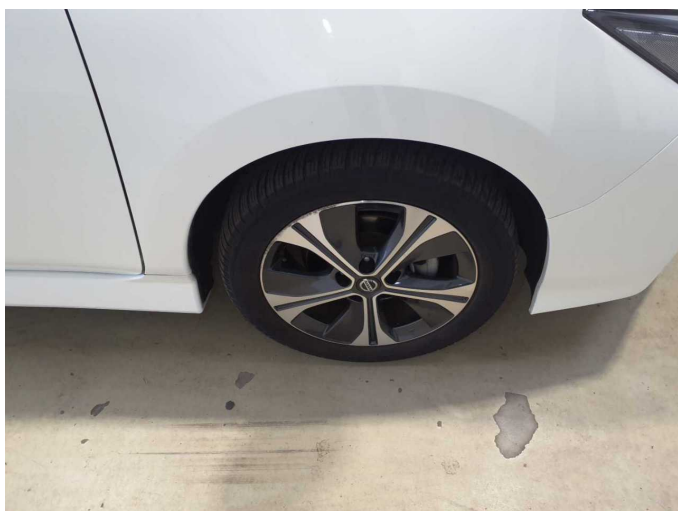
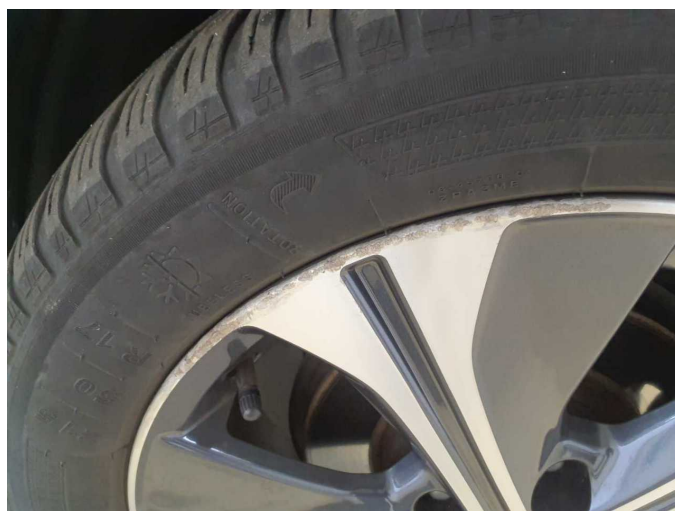
| No. | Component group | Description |
|---|---|---|
| 14 | Wheel / tyres | Alloy rim - front right side - Scratch(es) - Loss in value |

**Damage 14:** Wheel / tyres: Alloy rim - front right side - Scratch(es) - Loss in value

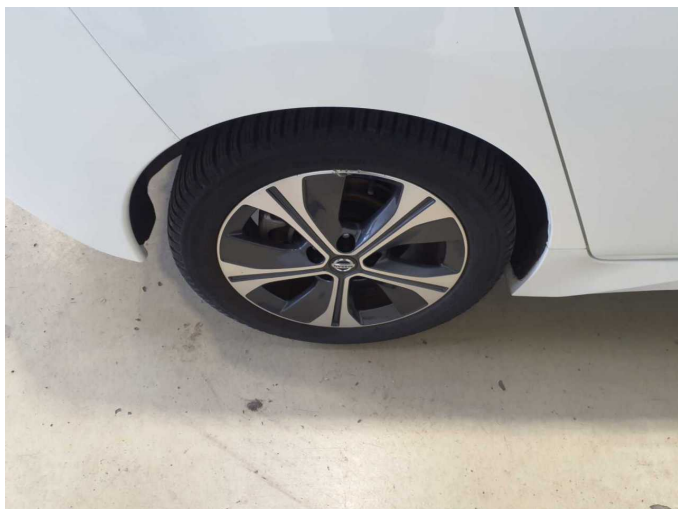
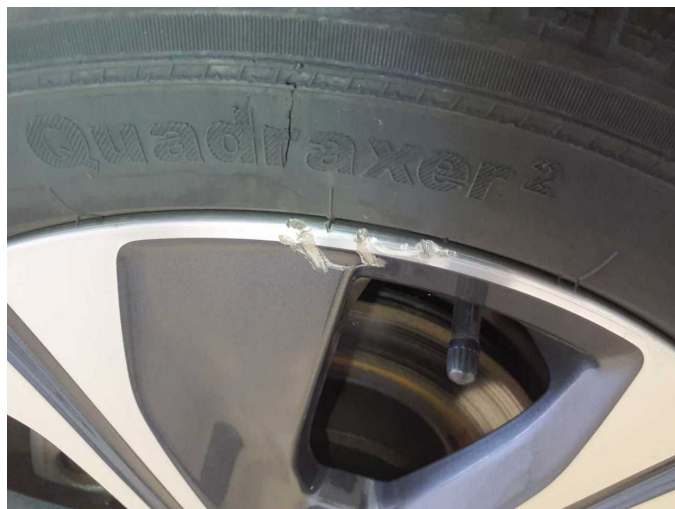
| No. | Component group | Description |
|---|---|---|
| 16 | Wheel / tyres | Alloy rim - rear right side - Scratch(es) - Replace |

**Damage 16:** Wheel / tyres: Alloy rim - rear right side - Scratch(es) - Replace

| No. | Component group | Description |
|---|---|---|
| 15 | Rear axle | Rear axle (wegen der beschädigten Felge) - Specify findings - Measure |

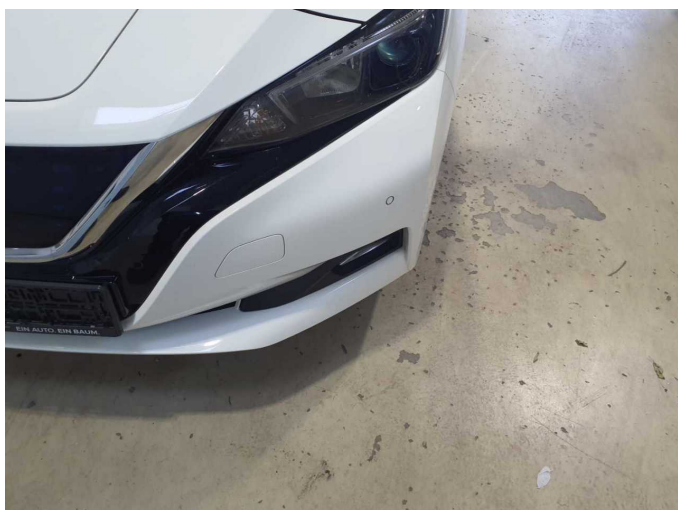
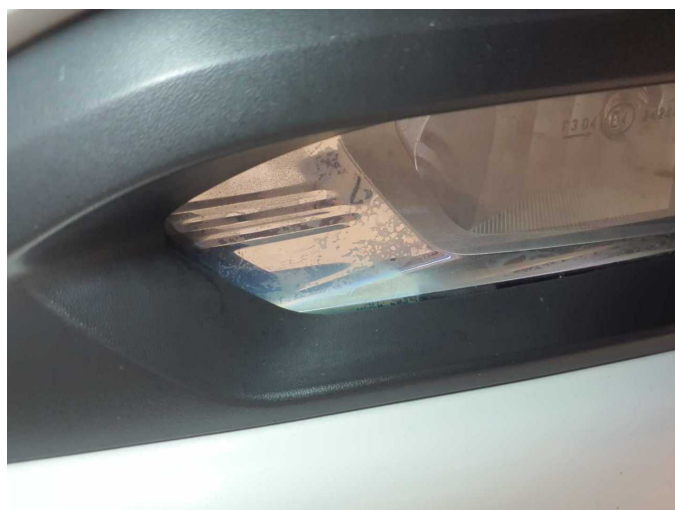
| No. | Component group | Description |
|---|---|---|
| 2 | Fog lamp | Fog lamp - front left side - Scratch(es) - No deduction |

**Wear and tear 2:** Fog lamp: Fog lamp - front left side - Scratch(es) - No deduction
