## Expertise

Protocol number: 46181648  
Order No. / Reference: 26554469  
Inspection date: 24 Jun 2026

Model: Astra 1.5 D Start/Stop Sports Tourer Automatik Business  
Elegance

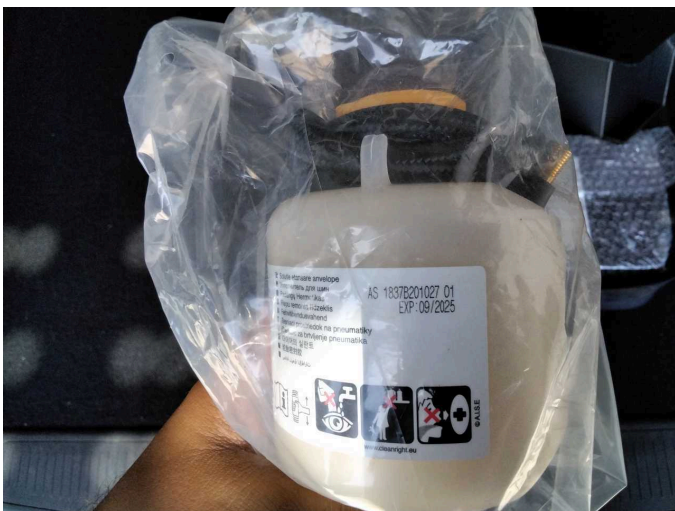
Damage 1: Equipment: Tirefit filler - Expired - Replace

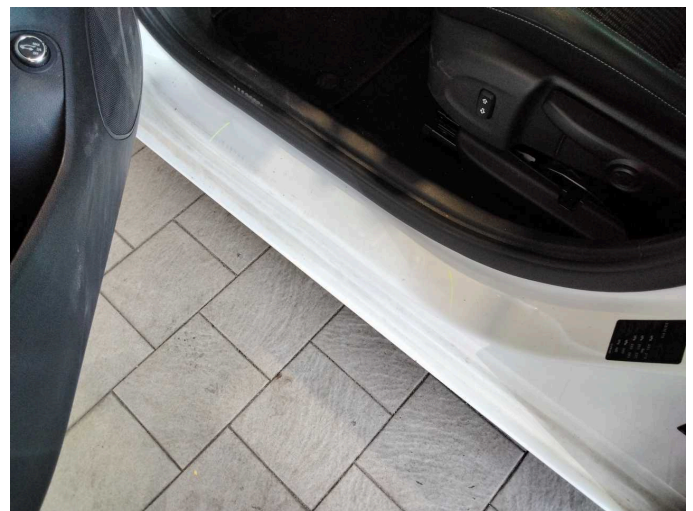
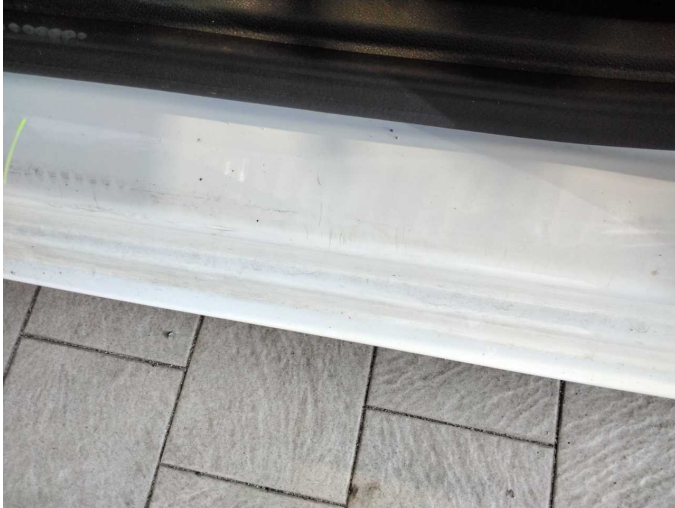
Damage 2: Sill - left side: Sill - Scratch(es) - Smart repair

**Damage 2:** Sill - left side: Sill - Scratch(es) - Smart repair

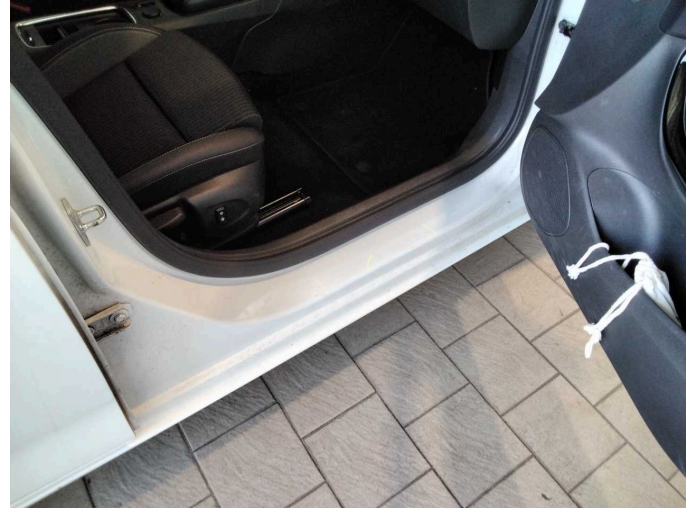
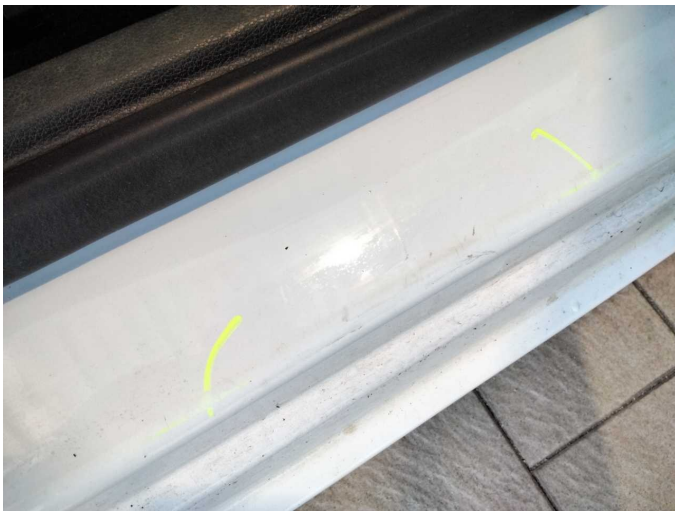
**Damage 3:** Sill - right side: Sill - Scratch(es) - Smart repair

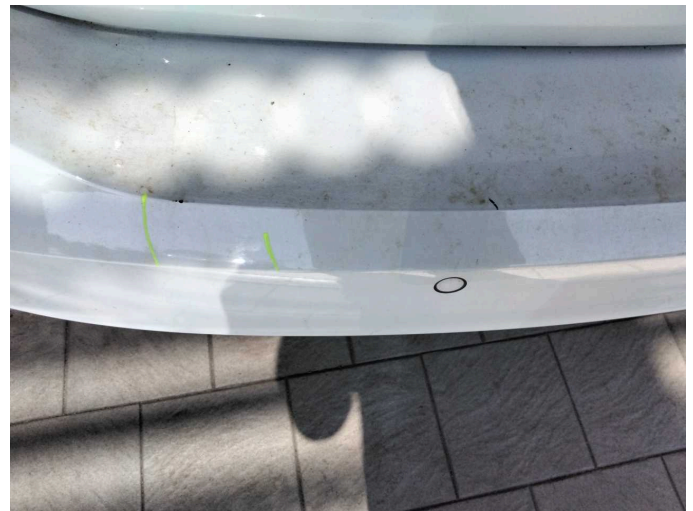
**Damage 4:** Rear bumper: Rear bumper - Scratch(es) - Smart repair

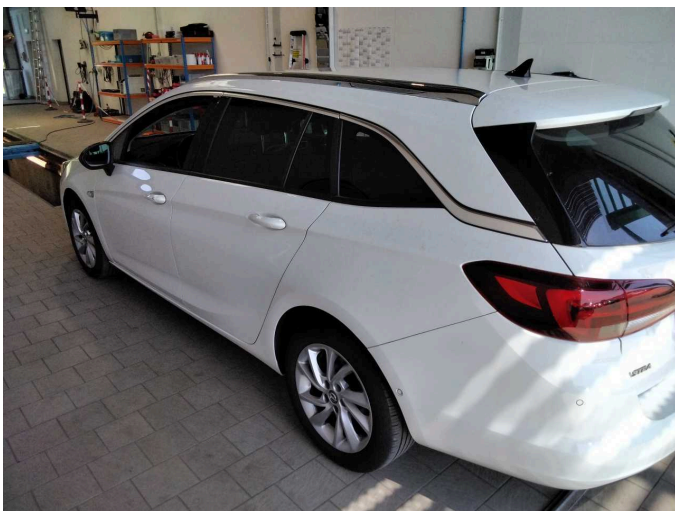
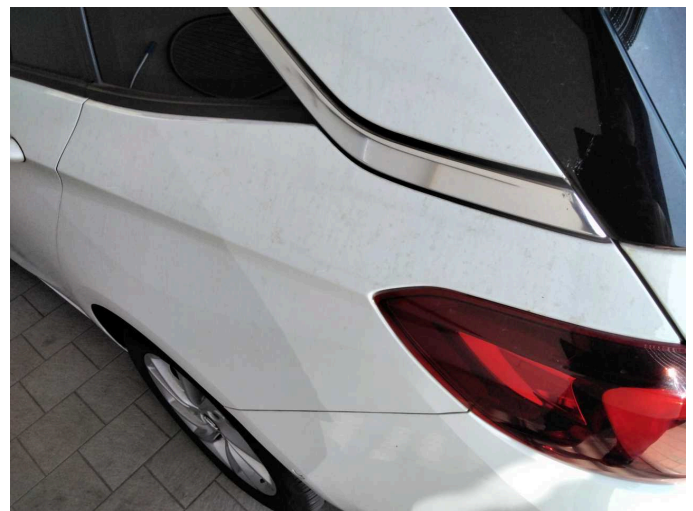
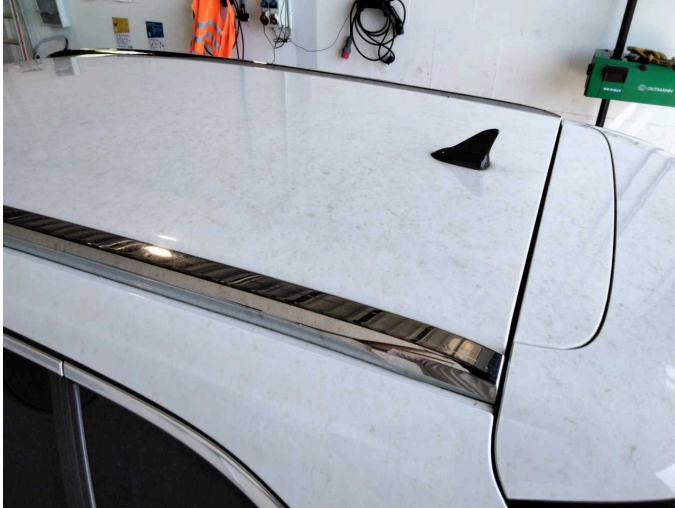
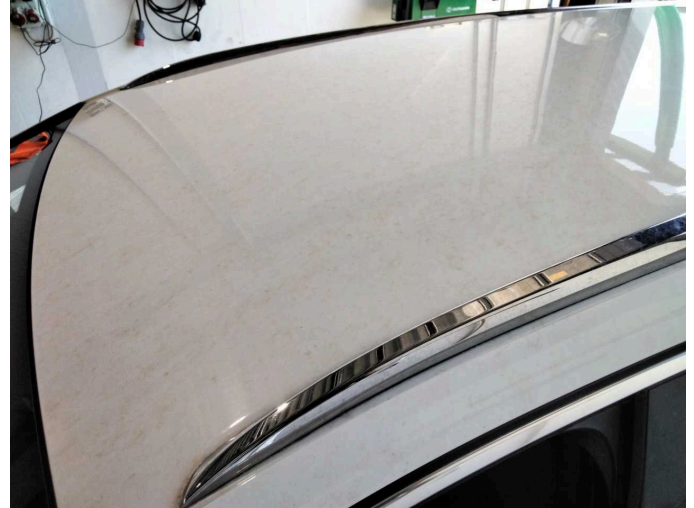
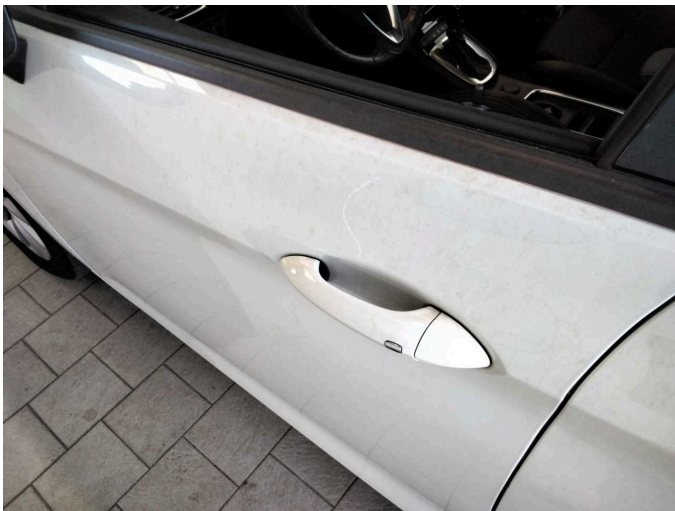
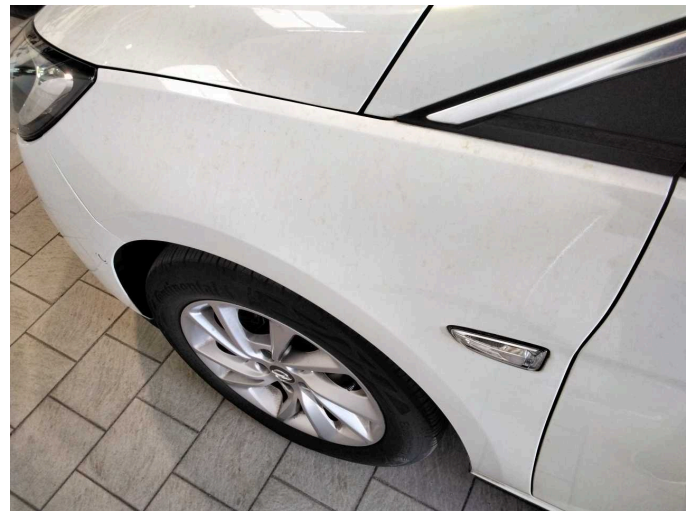
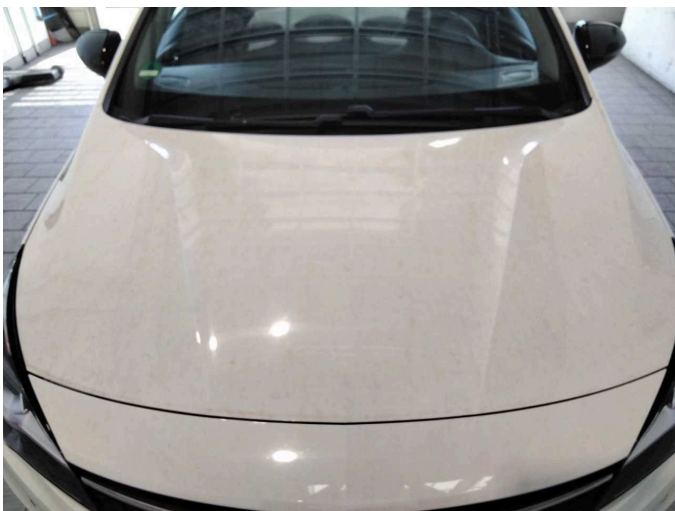
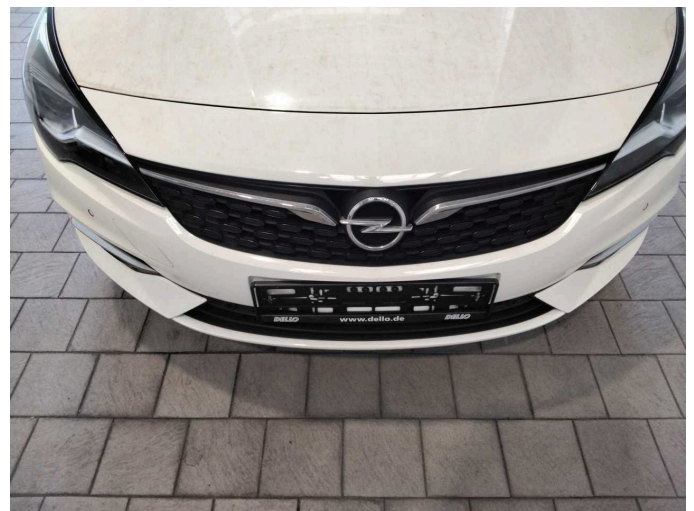
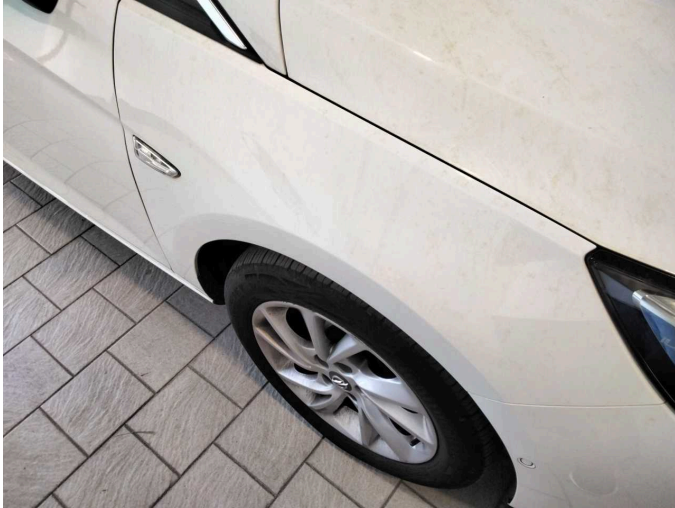
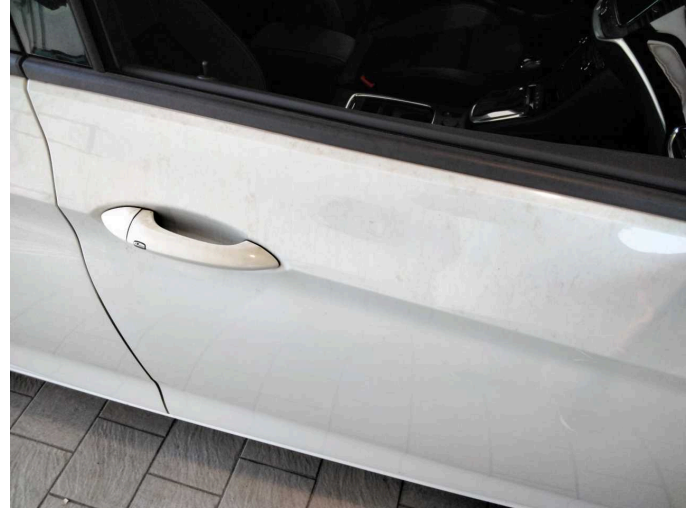
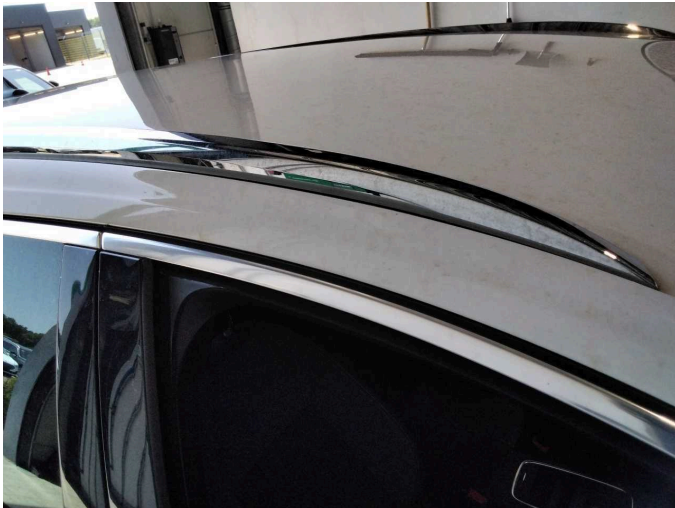
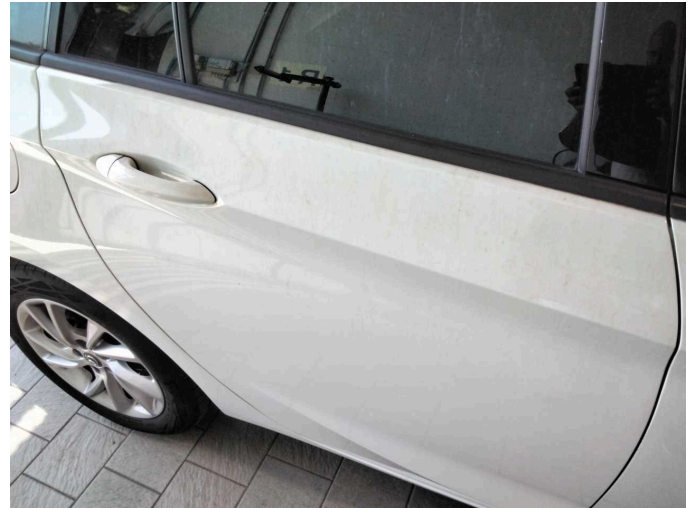
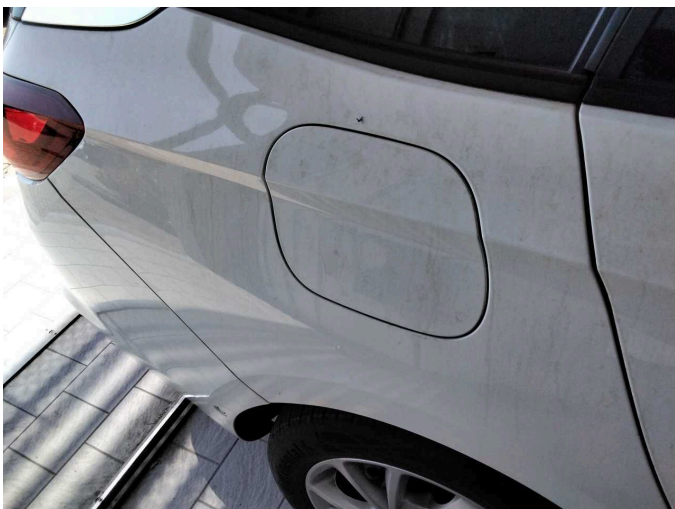
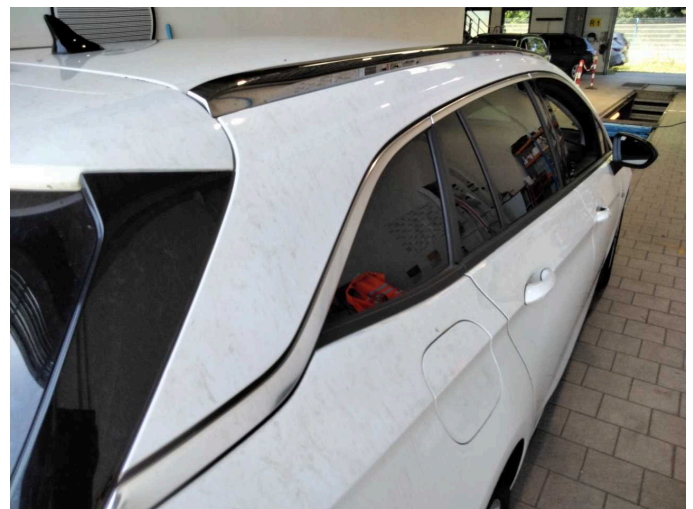
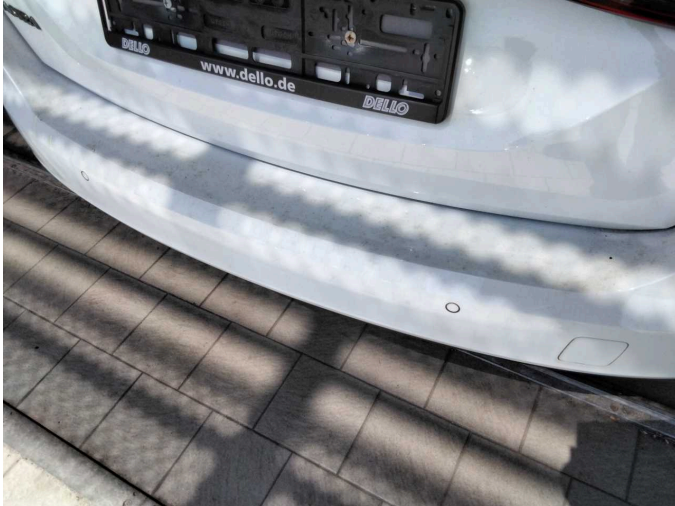
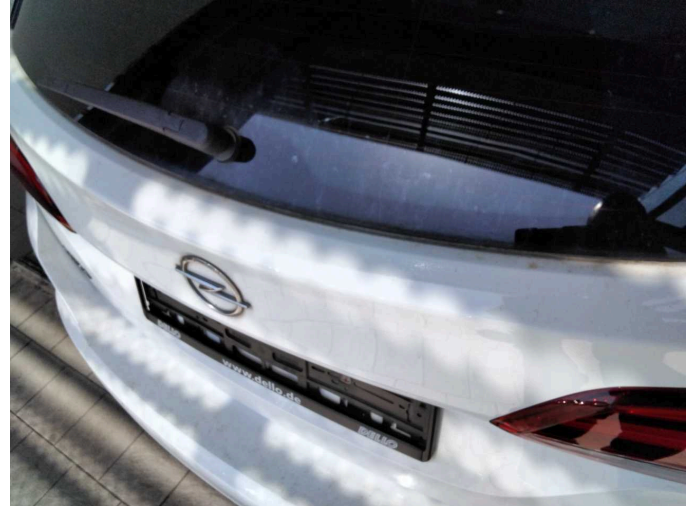
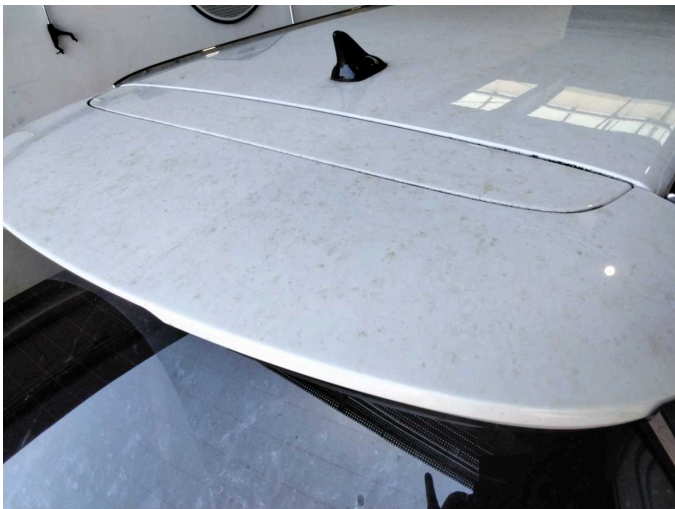
**Damage 5:** Body: Body (Flugrost, Mehrkosten sind möglich) - Paint defect - Clean

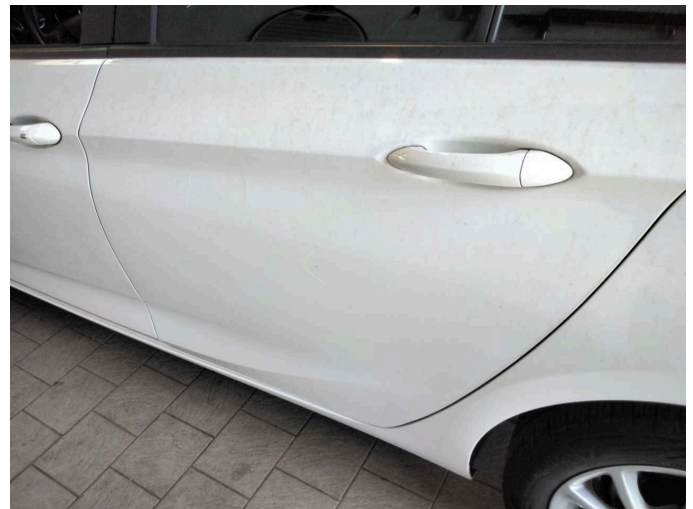
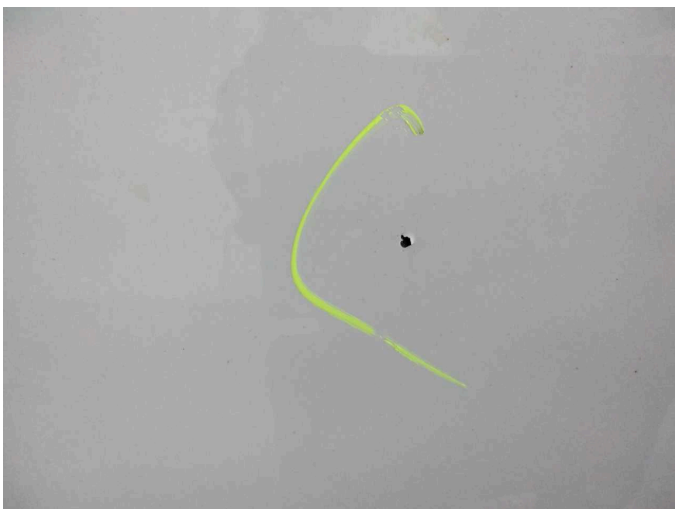
**Damage 6:** Door - rear left side: Door - Scratch(es) - Paint

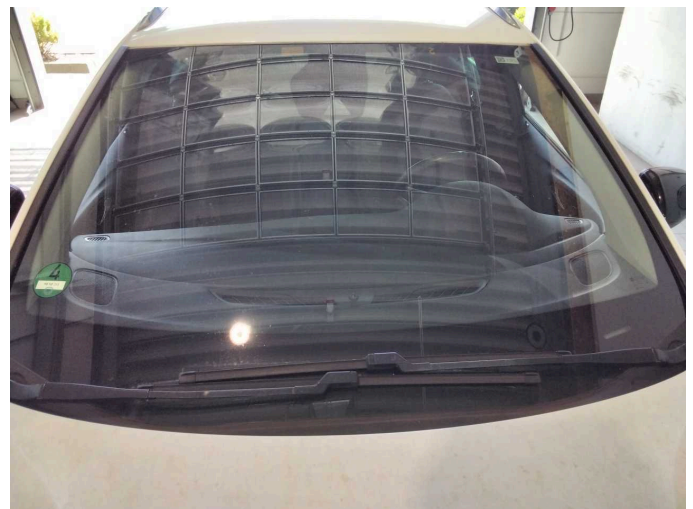
**Wear and tear 1:** Vehicle glazing: Windscreen - Stone chips - No deduction

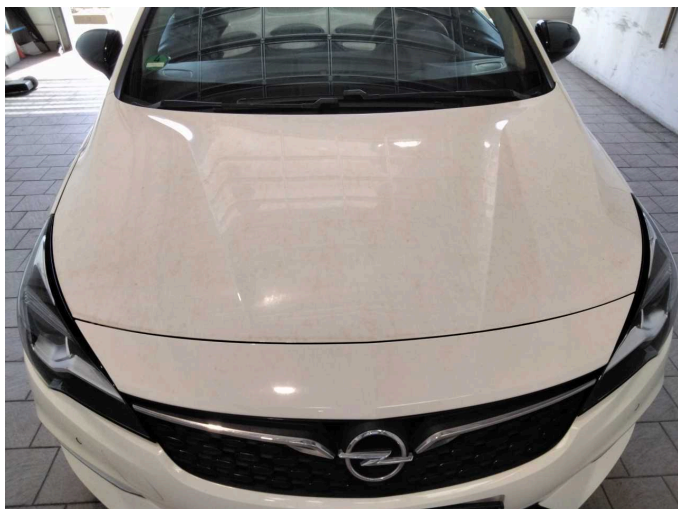
**Wear and tear 2:** Bonnet: Bonnet - Stone chips - No deduction

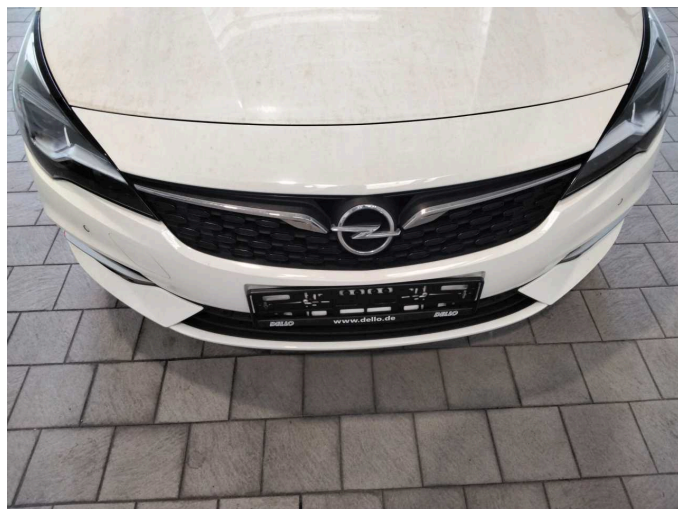
**Wear and tear 3:** Front bumper: Front bumper - Stone chips - No deduction
