## Expertise

Protocol number: 45566700  
Order No. / Reference: 26351944  
Inspection date: 18 May 2026

Model: Focus Turnier 2.0 EcoBlue Start-Stopp-System Aut.  
COOL&CONNECT

VIN: WF0PXXGCHPLK11797

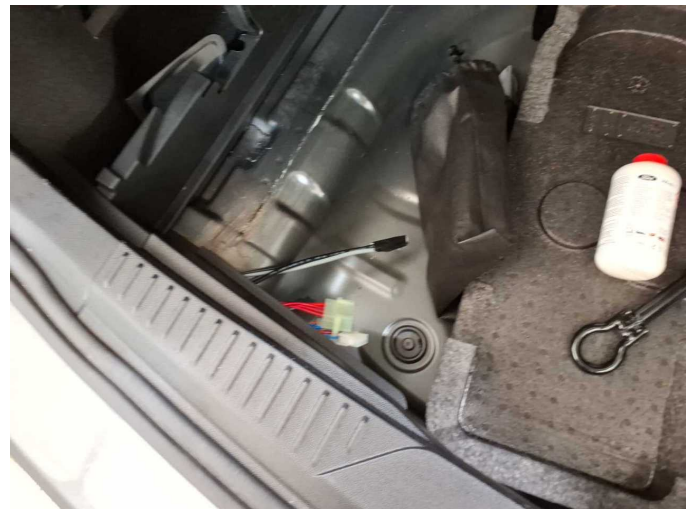
Damage 1: Electrical system: Cable strand (Kabelführung für Frontbereich im Laderaum) - Specify findings - Remove

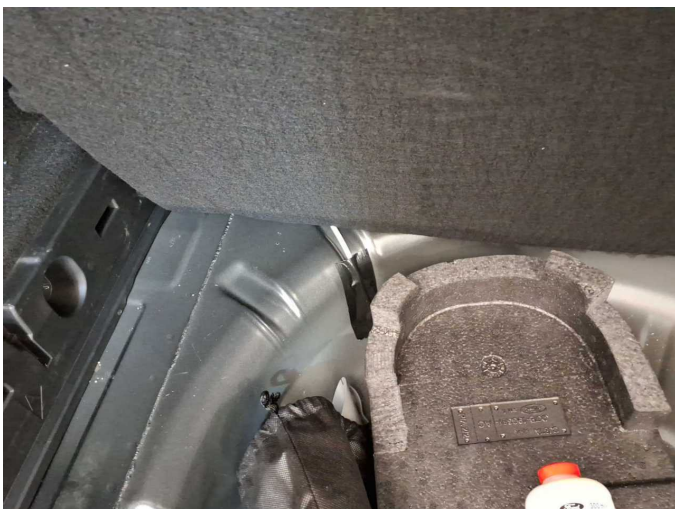
Damage 1: Electrical system: Cable strand (Kabelführung für Frontbereich im Laderaum) - Specify findings - Remove

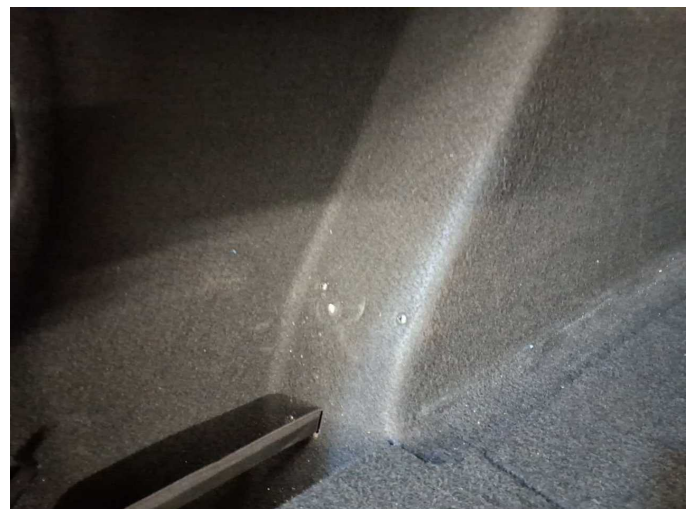
Damage 2: Side panel - rear left side: Interior trim - Damaged - Replace

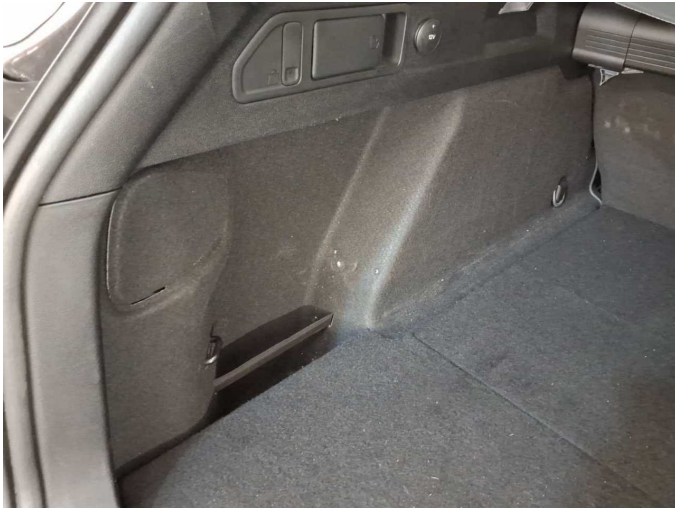
**Damage 2:** Side panel - rear left side: Interior trim - Damaged - Replace

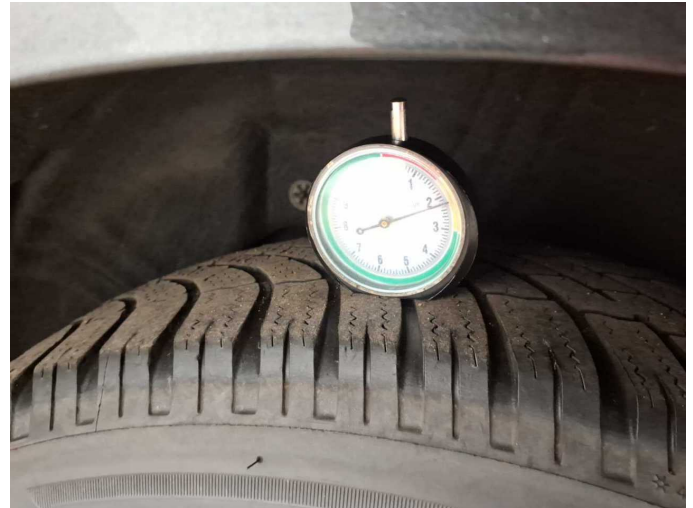
**Damage 3:** Wheel / tyres: Tyre - rear left side - Does not meet the leasing specifications - Replace

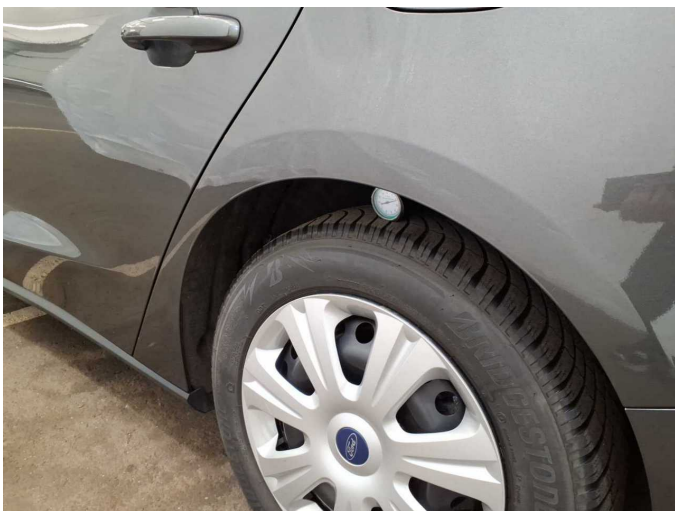
**Damage 3:** Wheel / tyres: Tyre - rear left side - Does not meet the leasing specifications - Replace

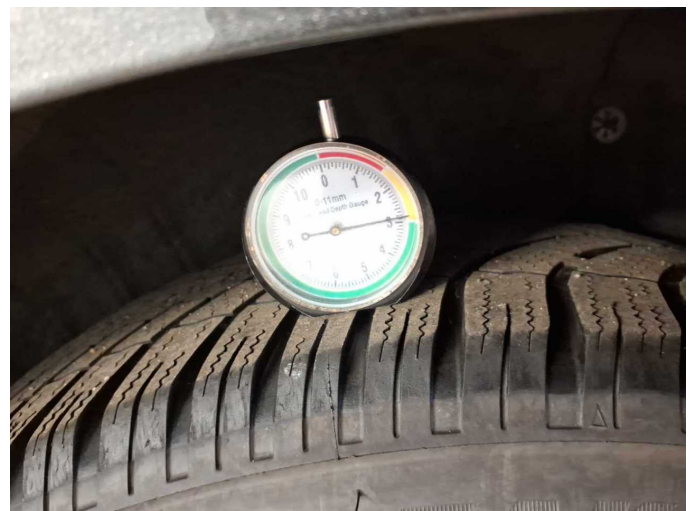
**Damage 4:** Wheel / tyres: Tyre - rear right side - Does not meet the leasing specifications - Replace

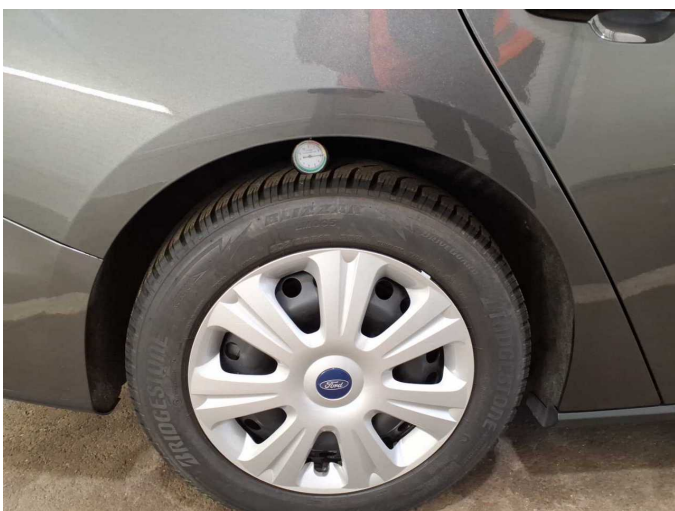
**Damage 4:** Wheel / tyres: Tyre - rear right side - Does not meet the leasing specifications - Replace

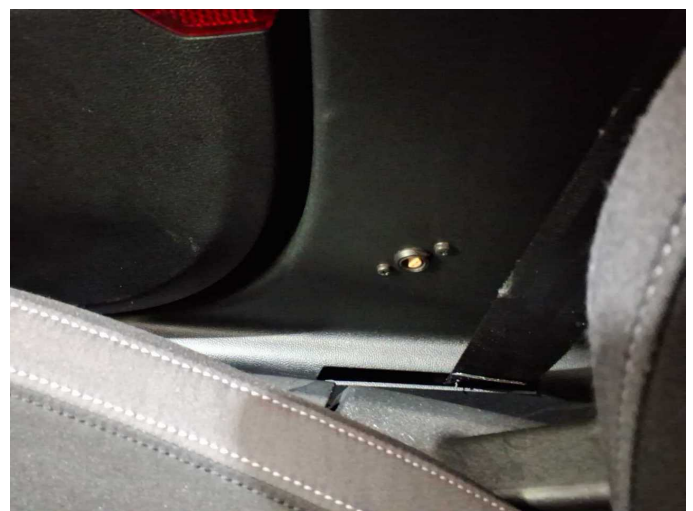
**Damage 5:** Trim / covers: B-pillar - trim - interior, right side - Damaged - Replace

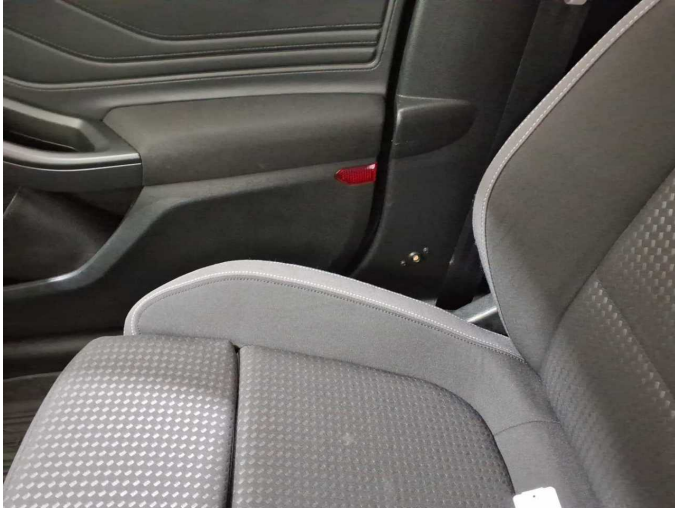
**Damage 5:** Trim / covers: B-pillar - trim - interior, right side - Damaged - Replace

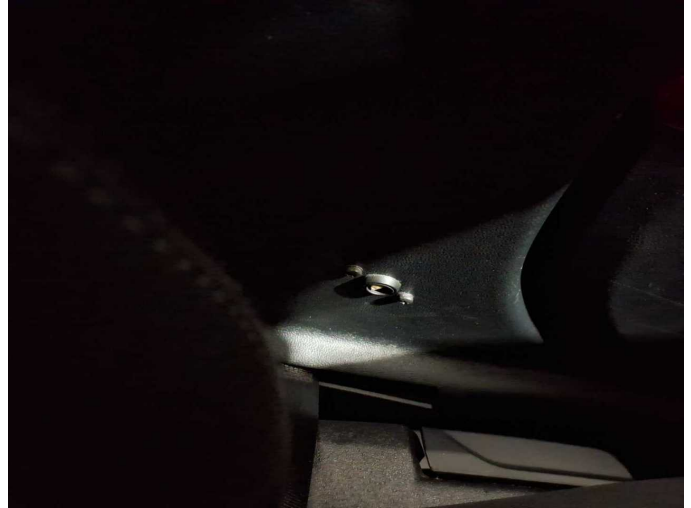
**Damage 6:** Trim / covers: B-pillar - trim - interior, left side - Damaged - Replace

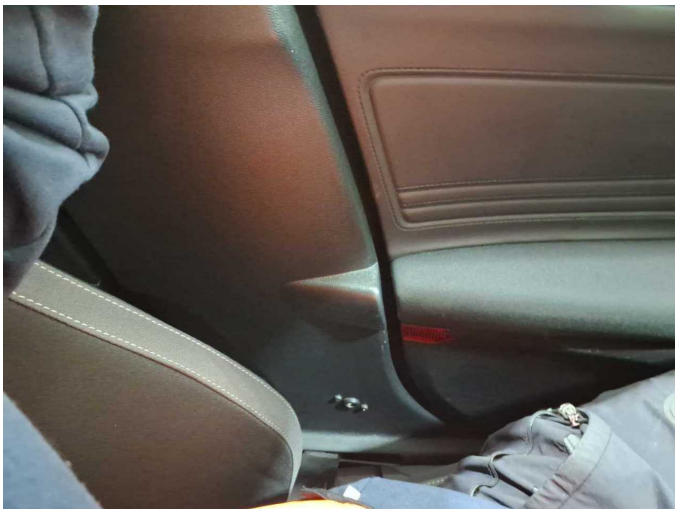
**Damage 6:** Trim / covers: B-pillar - trim - interior, left side - Damaged - Replace

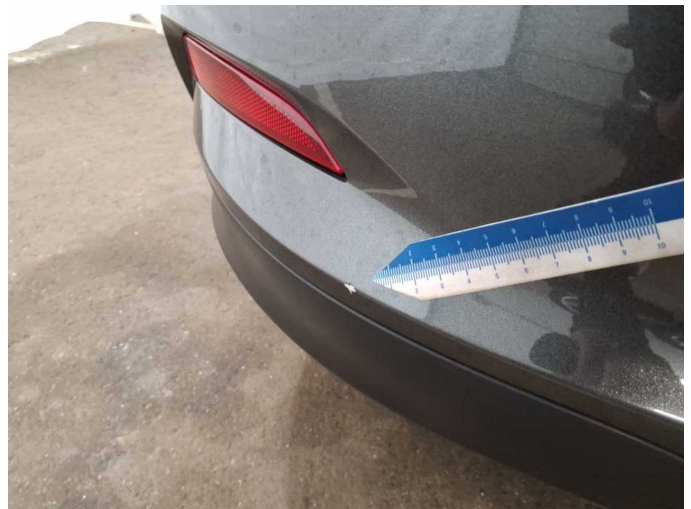
**Damage 7:** Rear bumper: Rear bumper - Scratch(es) - Smart repair

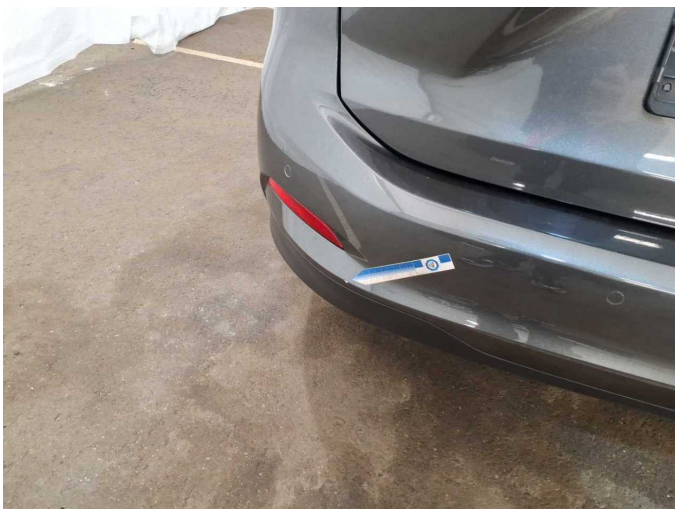
**Damage 7:** Rear bumper: Rear bumper - Scratch(es) - Smart repair

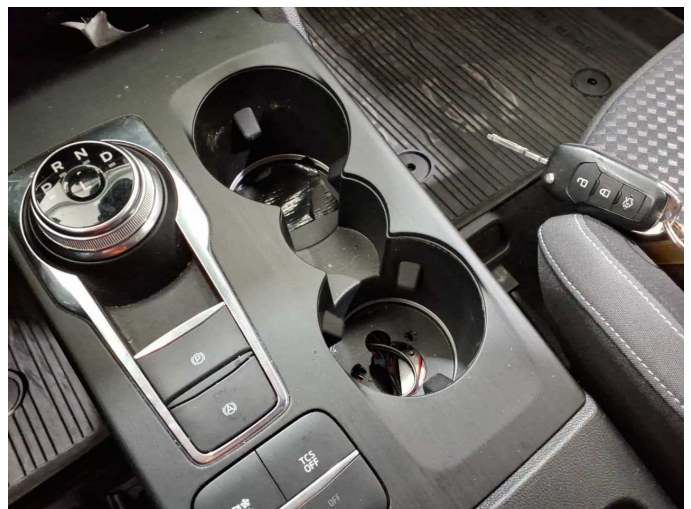
**Damage 8:** Instrument panel: Centre console - front (Fehlbohrung) - Damaged - Replace

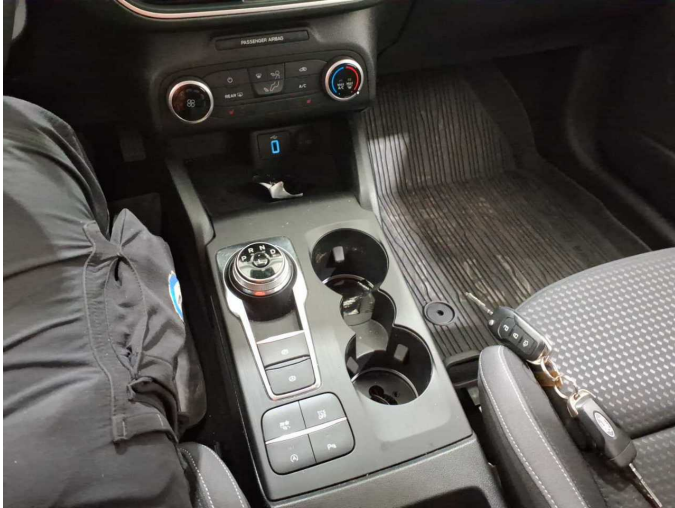
**Damage 8:** Instrument panel: Centre console - front (Fehlbohrung) - Damaged - Replace

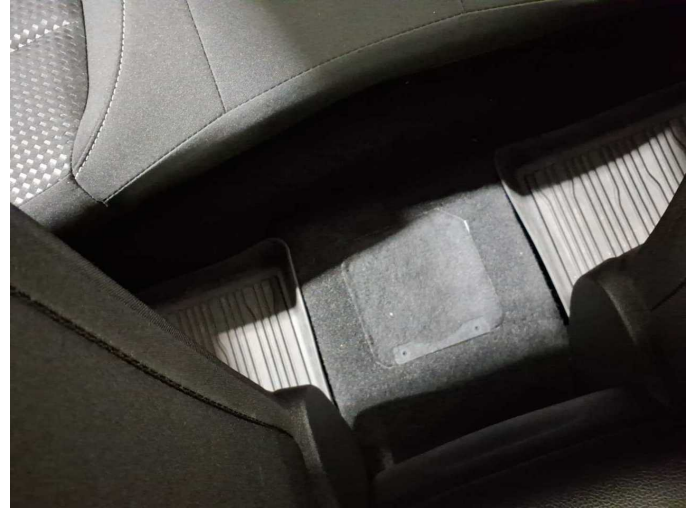
**Damage 9:** Trim / covers: Carpet - Damaged - Replace

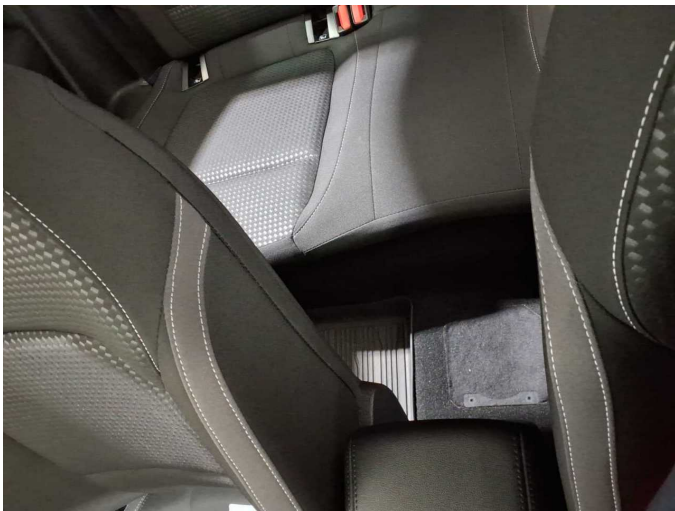
**Damage 9:** Trim / covers: Carpet - Damaged - Replace

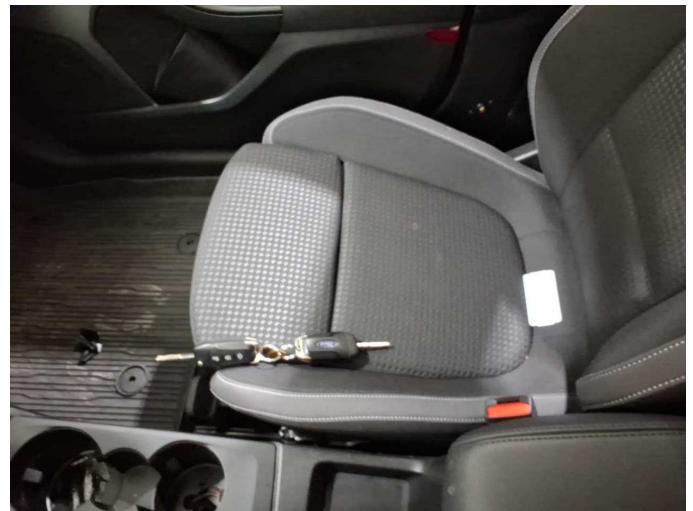
**Missing part 1:** Documents: Log book - Missing - Replace
