Expertise

Protocol number: 46730109  
Order No. / Reference: 26685943-1  
Inspection date: 22 Jul 2026

Manufacturer: Mazda

Model: 2 e-SKYACTIV G 90 M HYBRID Homura

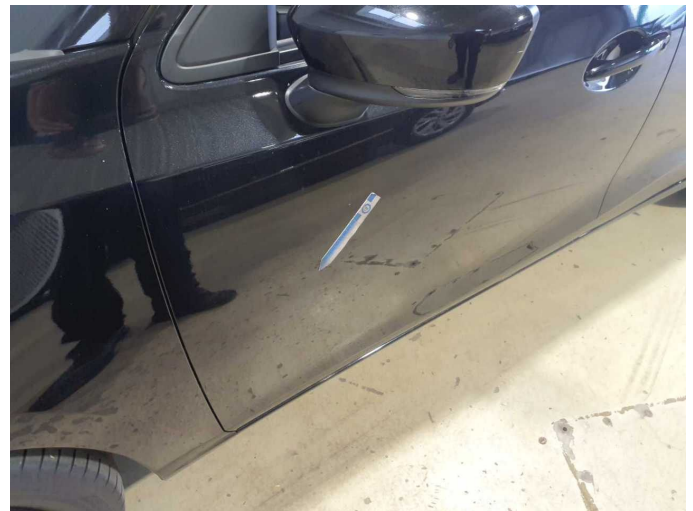
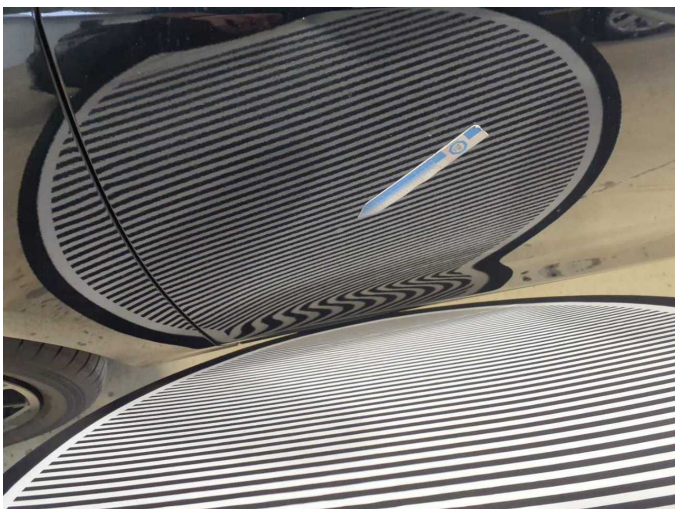
| No. | Component group | Description |
|---|---|---|
| 1 | Door - front left side | Door - dent(s) - Smooth repair work |

**Damage 1:** Door - front left side: Door - dent(s) - Smooth repair work

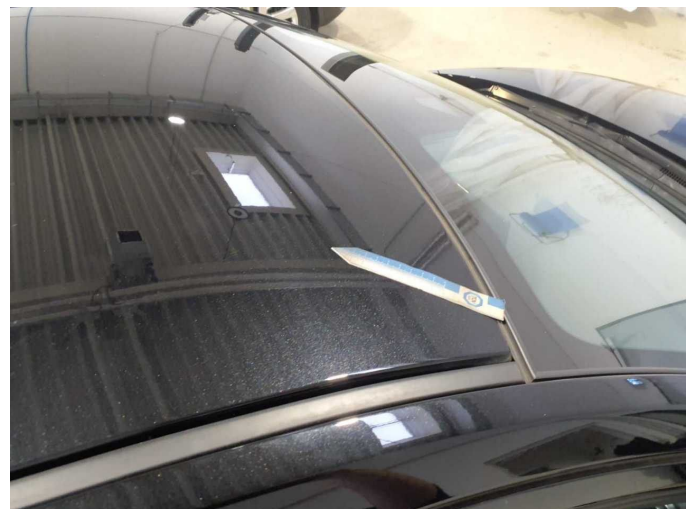
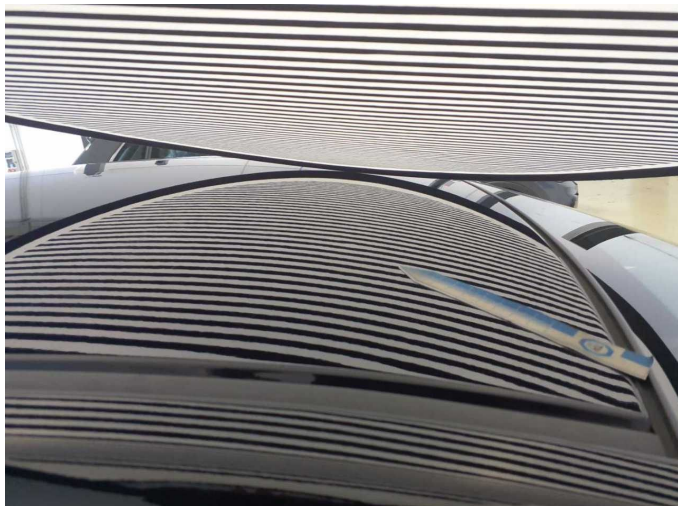
| No. | Component group | Description |
|---|---|---|
| 2 | Roof | Roof - dent(s) - Smooth repair work |

**Damage 2:** Roof: Roof - dent(s) - Smooth repair work

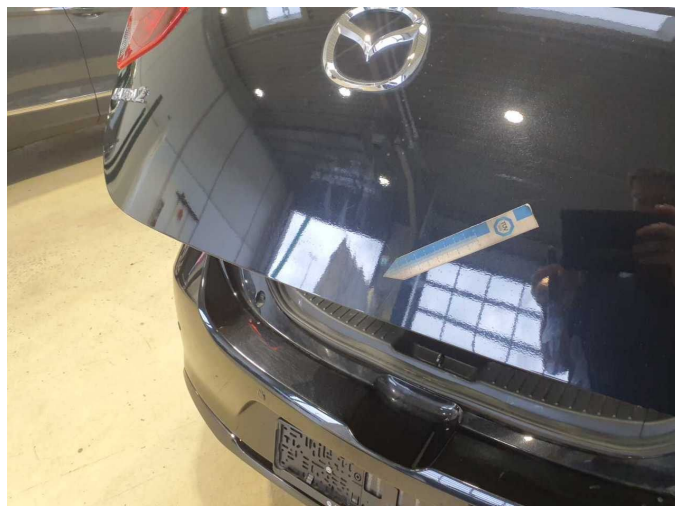
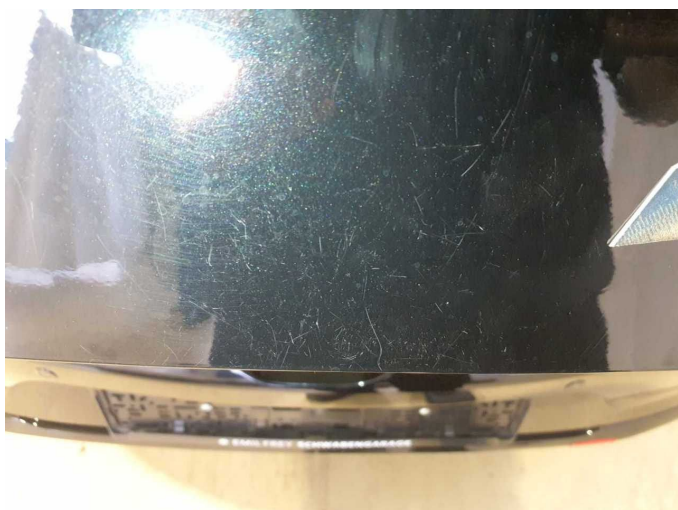
| No. | Component group | Description |
|---|---|---|
| 3 | Boot lid / rear door | Boot lid - Scratch(es) - Smart repair |

**Damage 3:** Boot lid / rear door: Boot lid - Scratch(es) - Smart repair

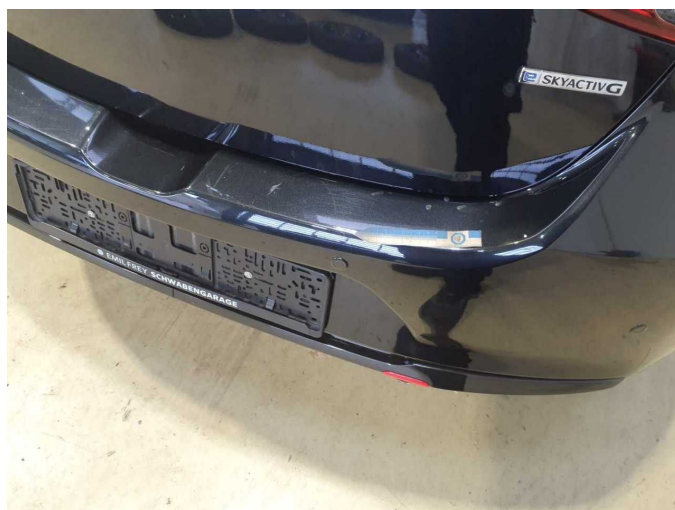
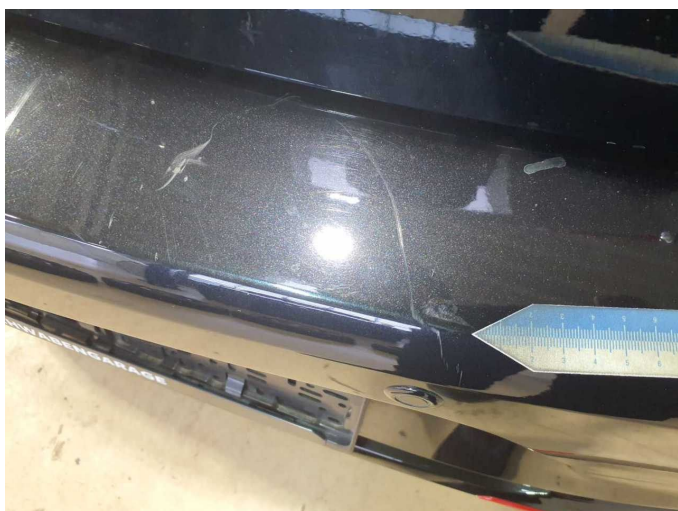
| No. | Component group | Description |
|---|---|---|
| 4 | Rear bumper | Rear bumper - Scratch(es) - Smart repair |

**Damage 4:** Rear bumper: Rear bumper - Scratch(es) - Smart repair

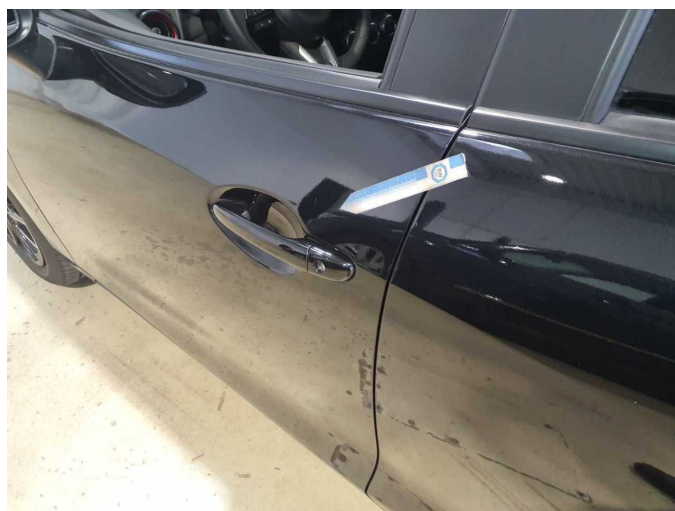
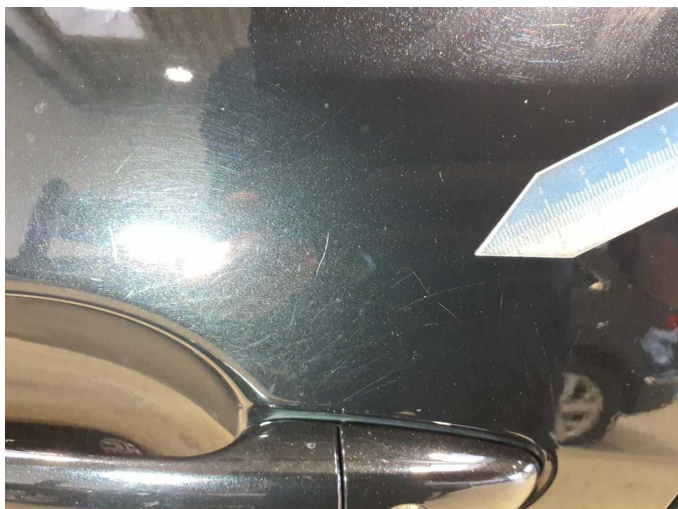
| No. | Component group | Description |
|---|---|---|
| 5 | Door - front left side | Door - Scratch(es) - Smart repair |

**Damage 5:** Door - front left side: Door - Scratch(es) - Smart repair

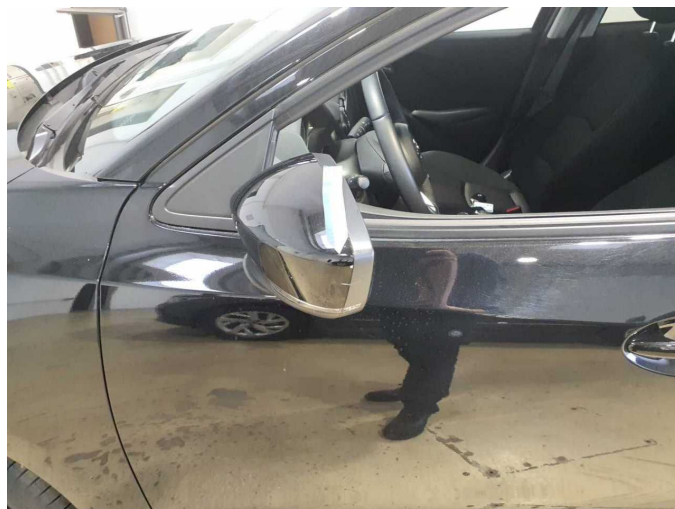
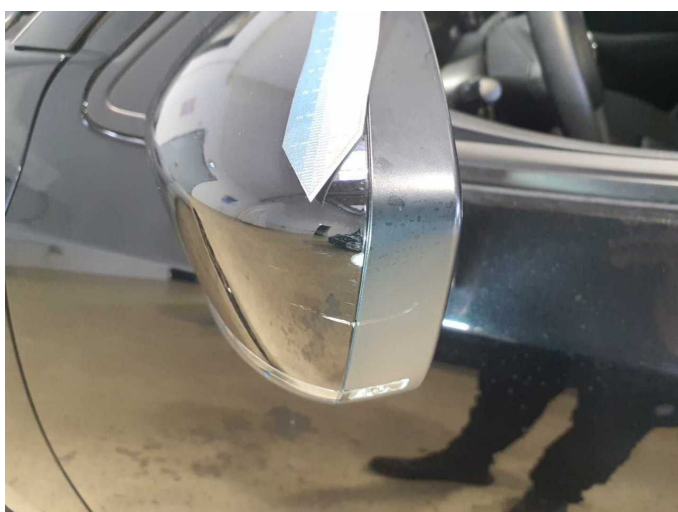
| No. | Component group | Description |
|---|---|---|
| 6 | Wing mirror - left side | Cap - Scratch(es) - Paint |

**Damage 6:** Wing mirror - left side: Cap - Scratch(es) - Paint

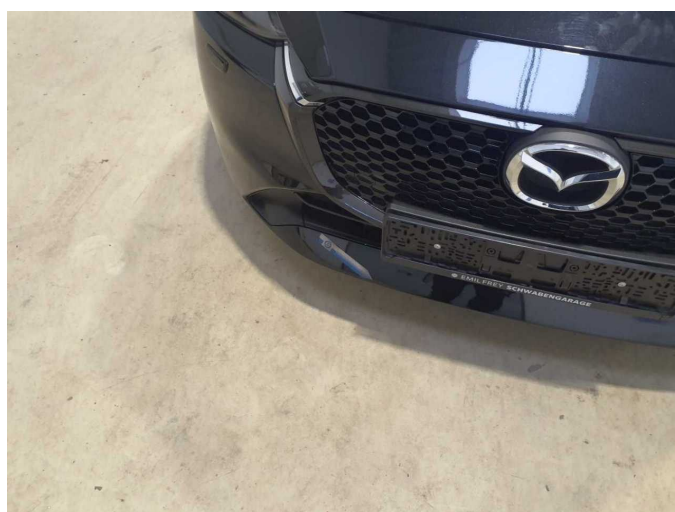
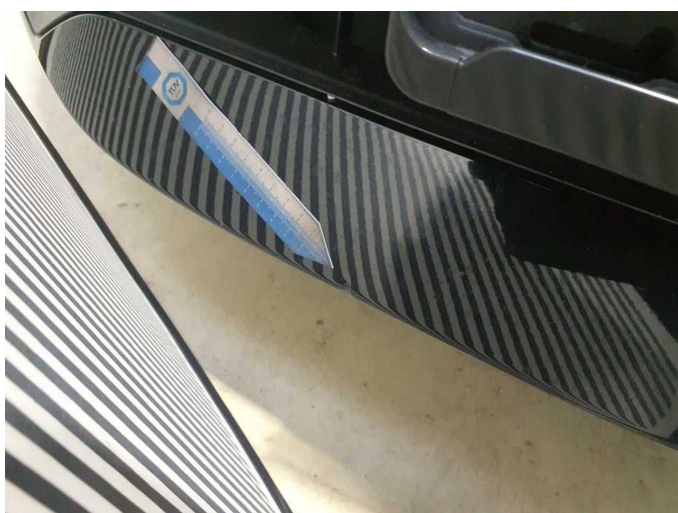
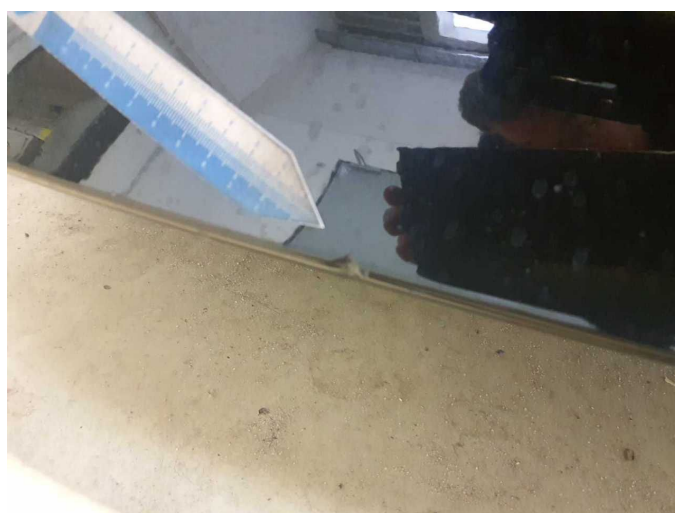
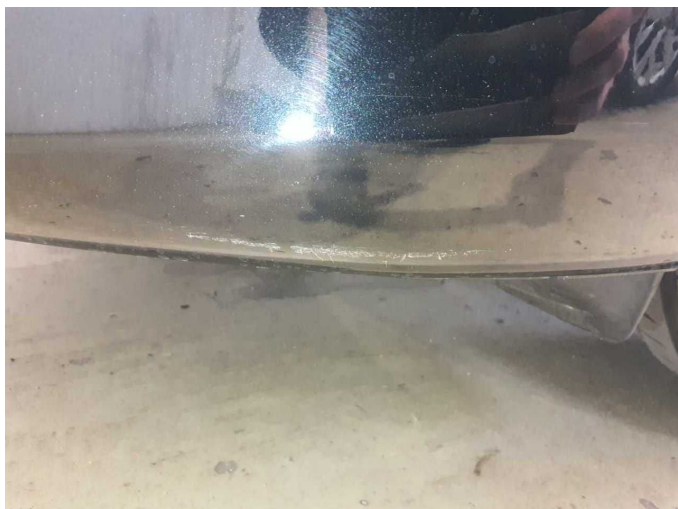
| No. | Component group | Description |
|---|---|---|
| 7 | Front bumper | Front bumper - Dent / paintcoat damage - Repair and paint |

**Damage 7:** Front bumper: Front bumper - Dent / paintcoat damage - Repair and paint

**Damage 7:** Front bumper: Front bumper - Dent / paintcoat damage -  
Repair and paint
