Expertise

Protocol number: 46837644  
Order No. / Reference: 26652432  
Inspection date: 29 Jul 2026

Manufacturer: Ford

Model: Mondeo Turnier 2.0 EcoBlue Trend

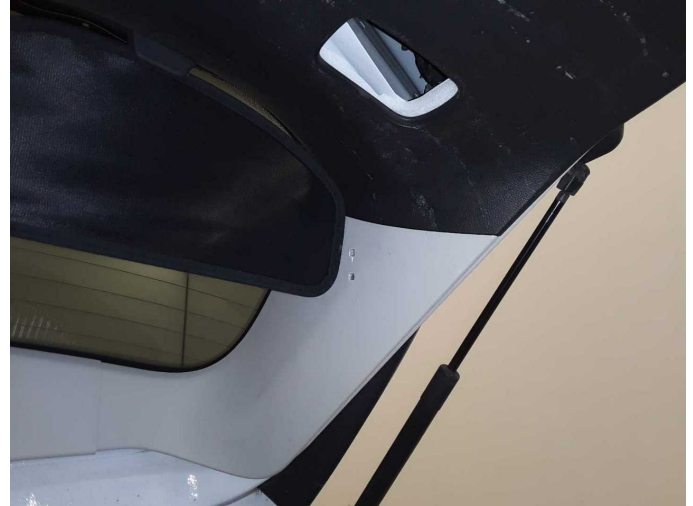
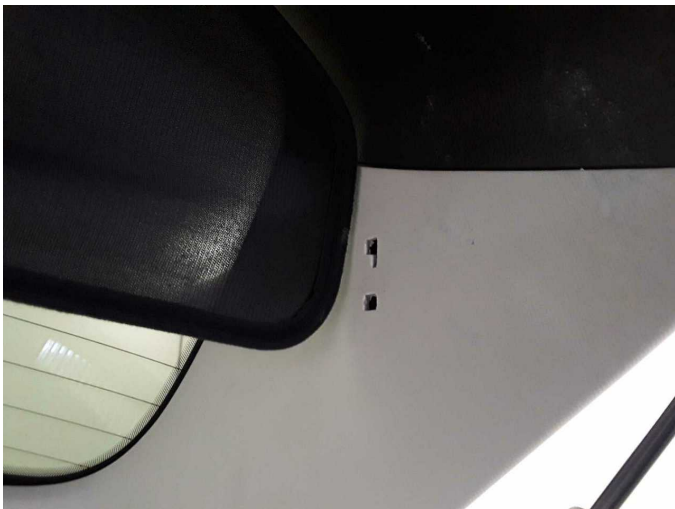
| No. | Component group | Description |
|---|---|---|
| 1 | Boot lid / rear door | Trim - standard - lower (Halterung Sonnensegel fehlt) - Missing - Replace |

**Damage 1:** Boot lid / rear door: Trim - standard - lower (Halterung Sonnensegel fehlt) - Missing - Replace

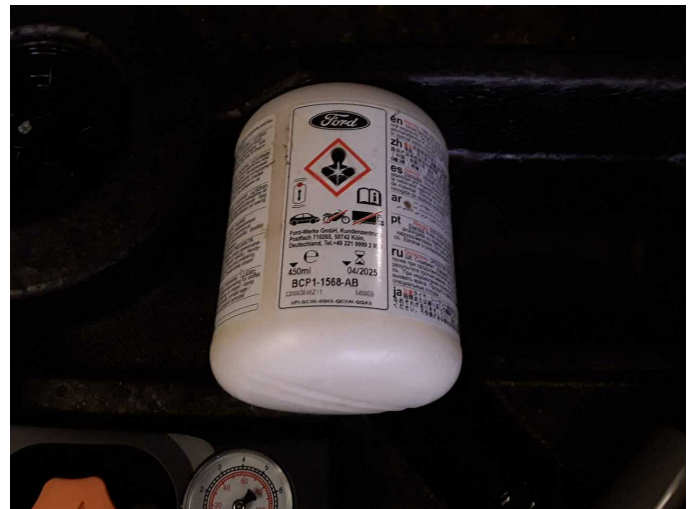
| No. | Component group | Description |
|---|---|---|
| 2 | Equipment | Tirefit filler - Expired - Replace |

**Damage 2:** Equipment: Tirefit filler - Expired - Replace

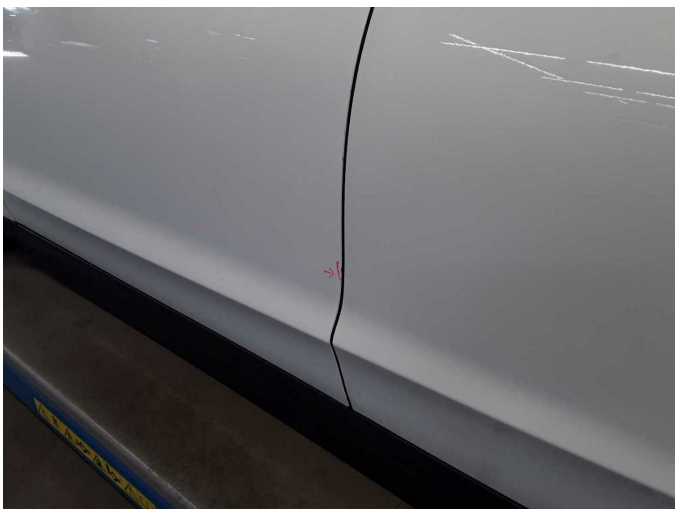
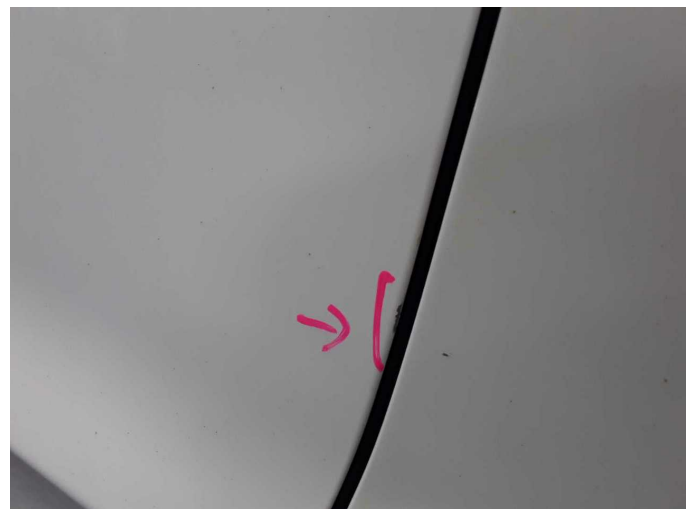
| No. | Component group | Description |
|---|---|---|
| 3 | Door - front left side | Door edge - Scratch(es) - Smart repair |

**Damage 3:** Door - front left side: Door edge - Scratch(es) - Smart repair

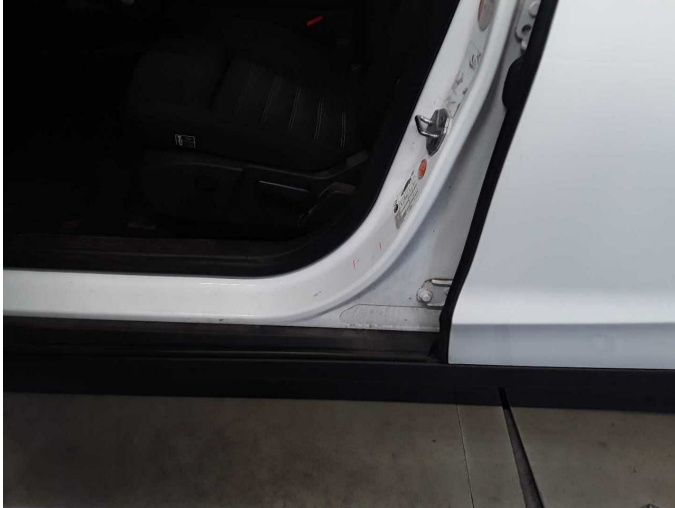
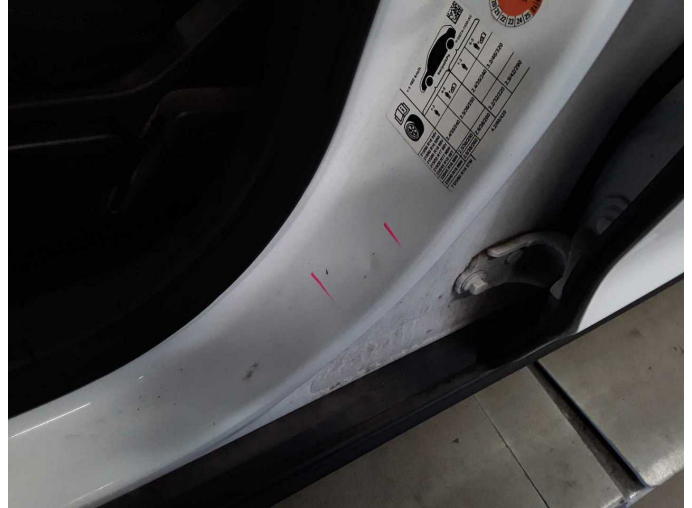
| No. | Component group | Description |
|---|---|---|
| 4 | Body | B-pillar - left side - Dent / paintcoat damage - Smart repair |

**Damage 4:** Body: B-pillar - left side - Dent / paintcoat damage - Smart repair

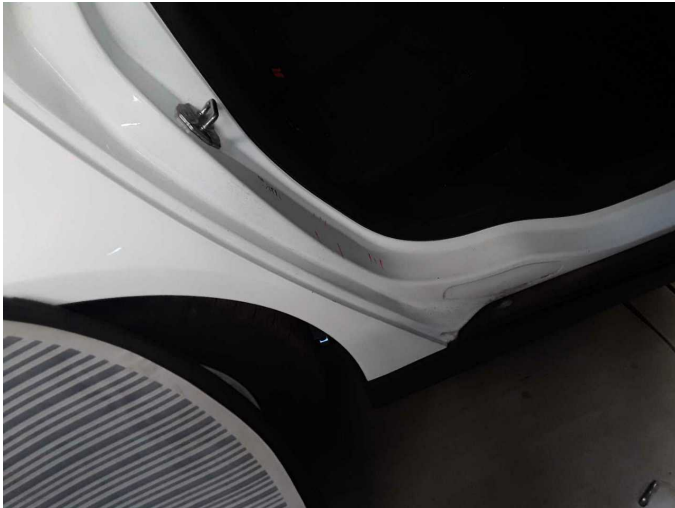
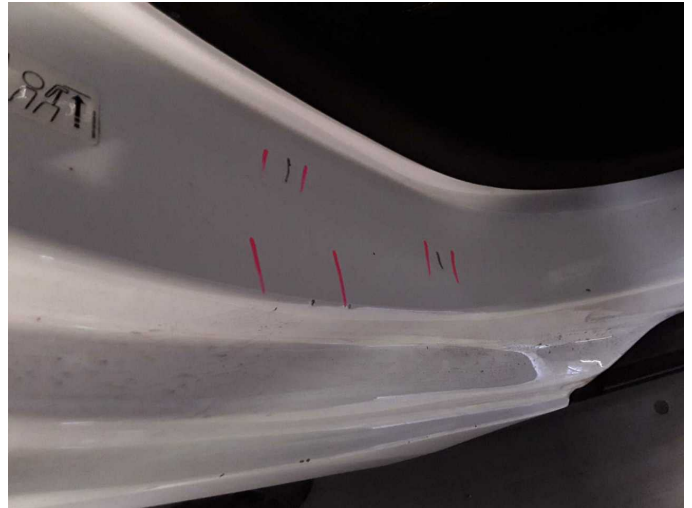
| No. | Component group | Description |
|---|---|---|
| 5 | Body | C-pillar - right side - Dent / paintcoat damage - Smart repair |

**Damage 5:** Body: C-pillar - right side - Dent / paintcoat damage - Smart repair

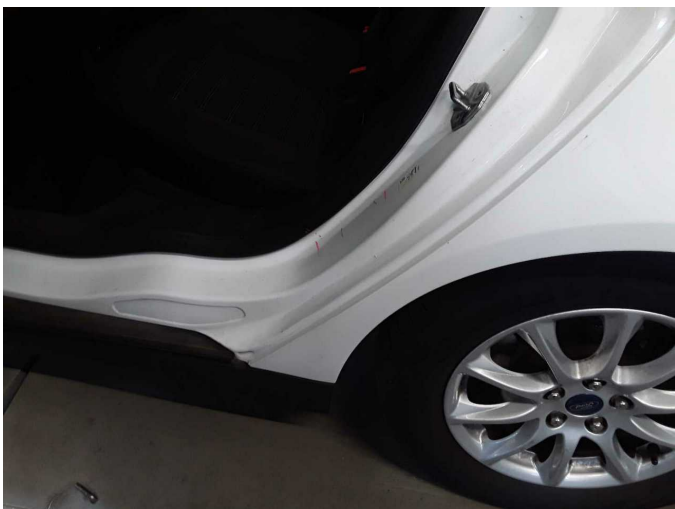
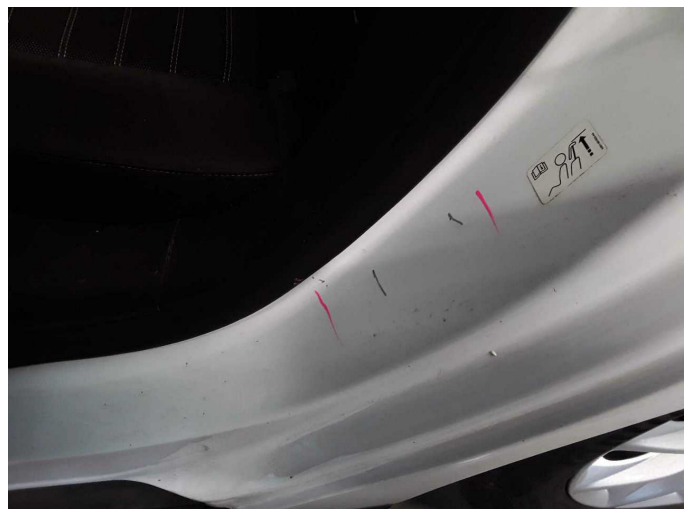
| No. | Component group | Description |
|---|---|---|
| 6 | Body | D-pillar - left side - Dent / paintcoat damage - Smart repair |

**Damage 6:** Body: D-pillar - left side - Dent / paintcoat damage - Smart repair

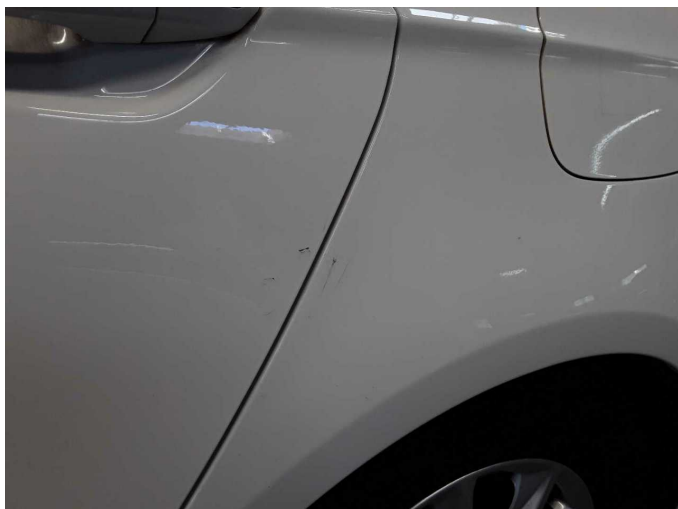
| No. | Component group | Description |
|---|---|---|
| 7 | Body | Body (Klebereste) - Glued / labelled - De-glue / neutralise |

**Damage 7:** Body: Body (Klebereste) - Glued / labelled - De-glue / neutralise

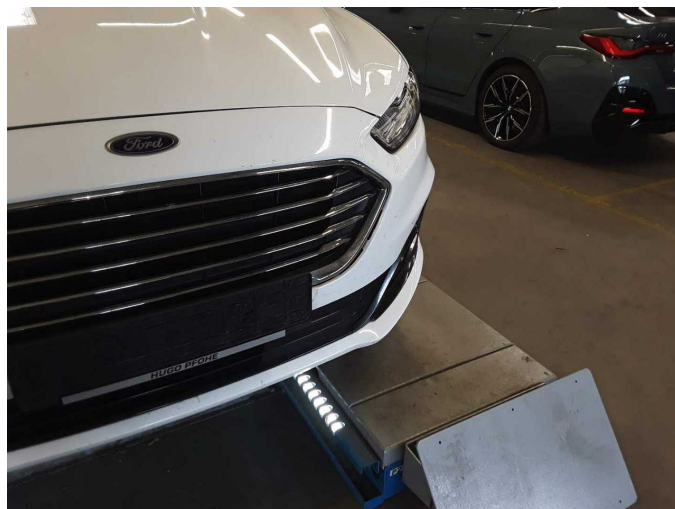
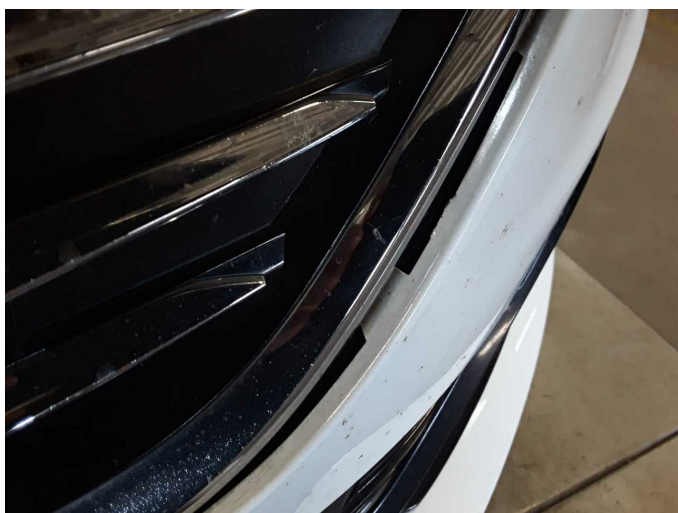
| No. | Component group | Description |
|---|---|---|
| 8 | Front bumper | Grille - Malposition - Un- / install |

**Damage 8:** Front bumper: Grille - Malposition - Un- / install

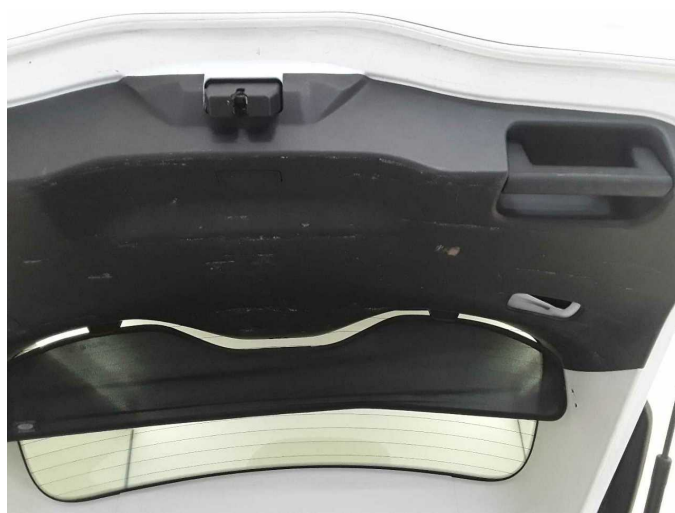
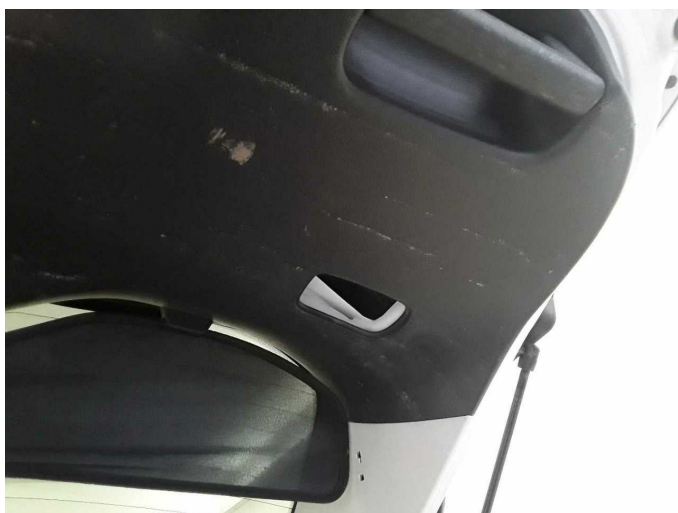
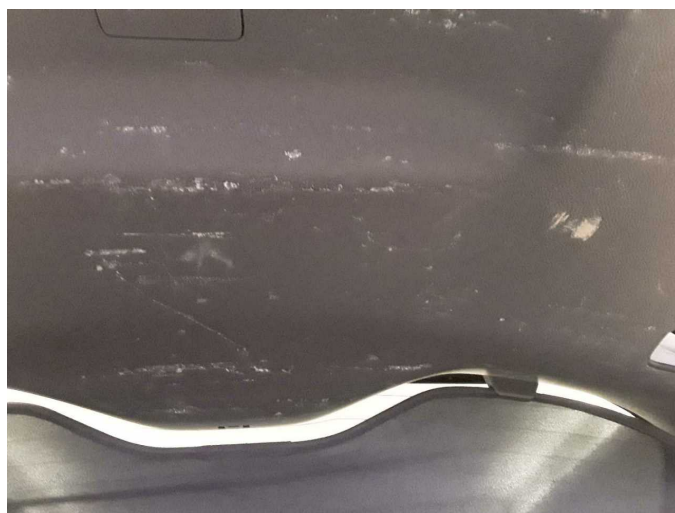
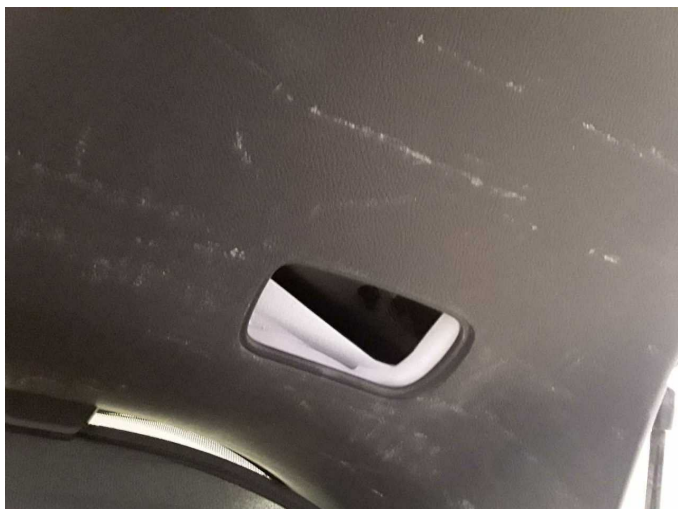
| No. | Component group | Description |
|---|---|---|
| 9 | Boot lid / rear door | Trim - standard - lower (+ unvollständig) - Scratched - Replace |

**Damage 9:** Boot lid / rear door: Trim - standard - lower (+ unvollständig) - Scratched - Replace

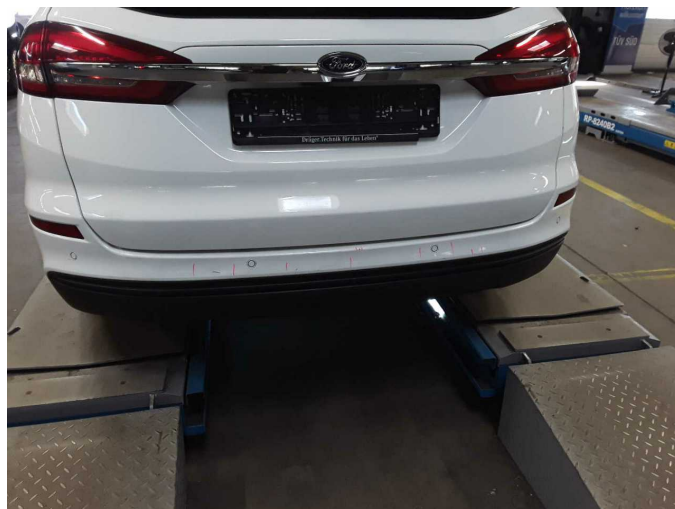
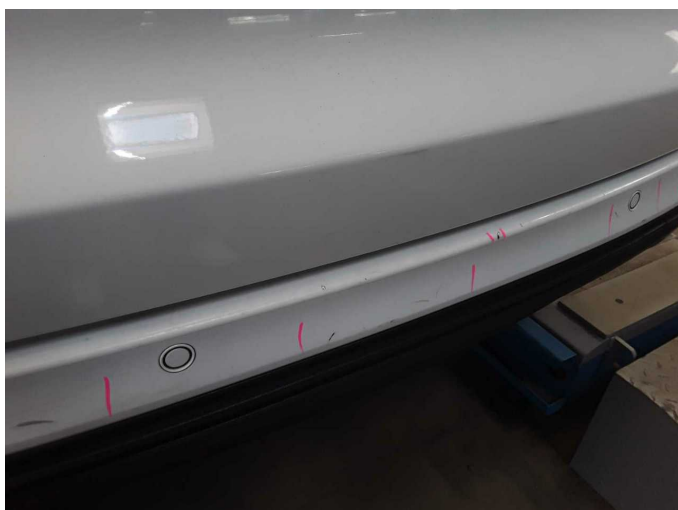
| No. | Component group | Description |
|---|---|---|
| 10 | Rear bumper | Rear bumper - Scratch(es) - Paint |

**Damage 10:** Rear bumper: Rear bumper - Scratch(es) - Paint

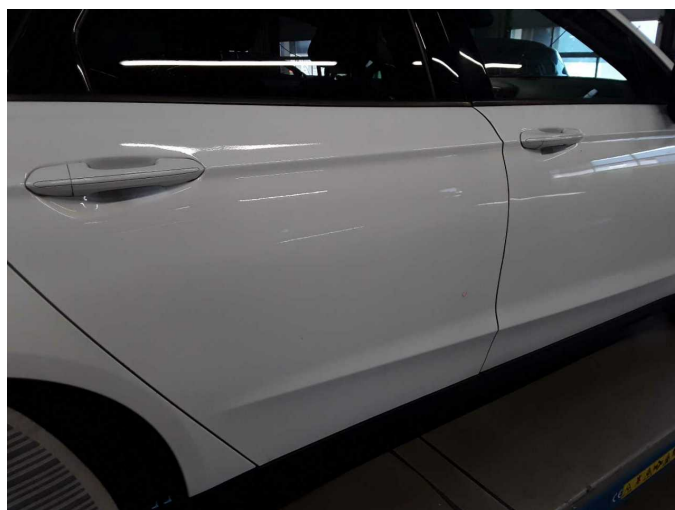
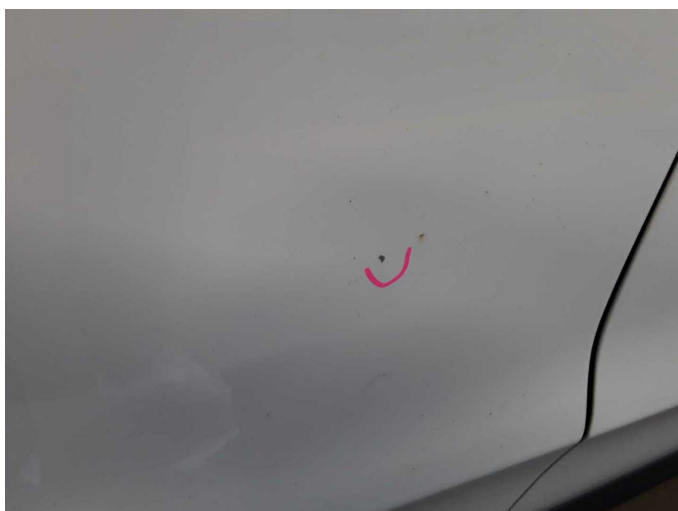
| No. | Component group | Description |
|---|---|---|
| 11 | Door - rear right side | Door - Scratch(es) - Paint |

**Damage 11:** Door - rear right side: Door - Scratch(es) - Paint

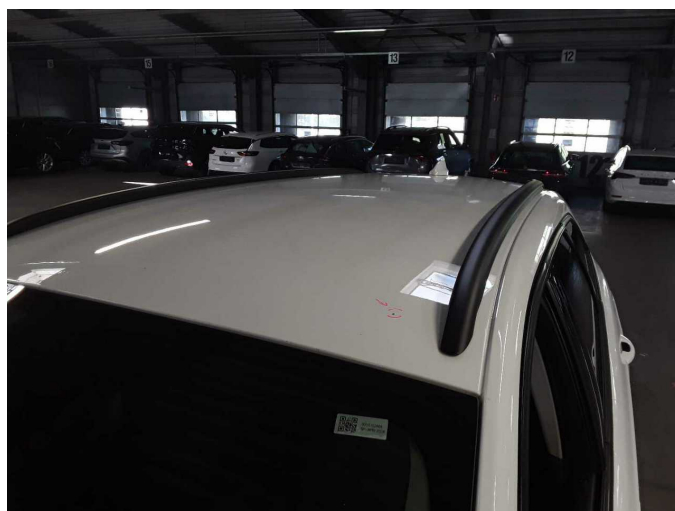
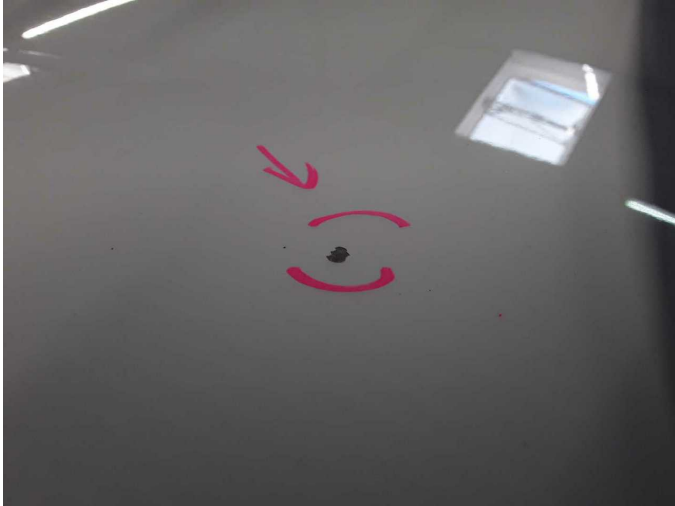
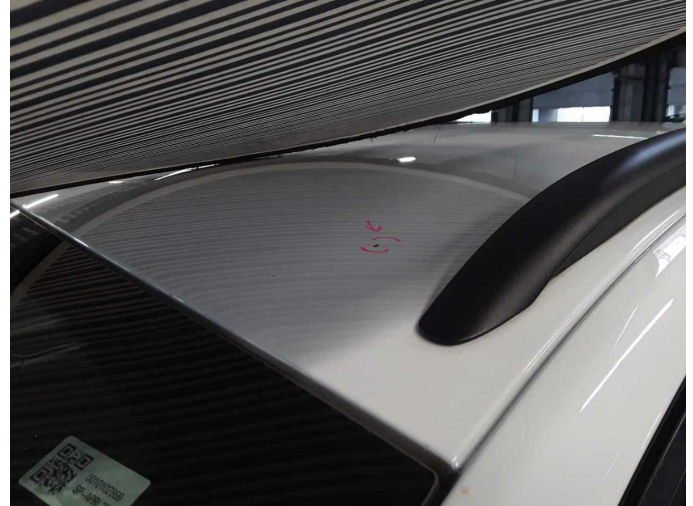
| No. | Component group | Description |
|---|---|---|
| 12 | Roof | Roof - Dent / paintcoat damage - Repair and paint |

**Damage 12:** Roof: Roof - Dent / paintcoat damage - Repair and paint

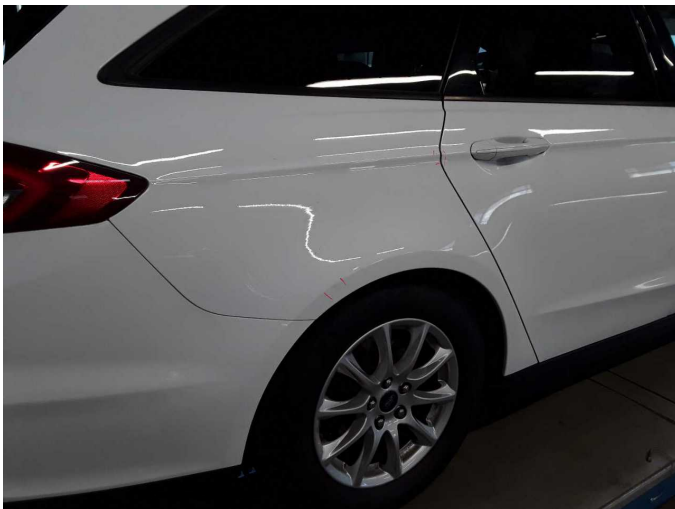
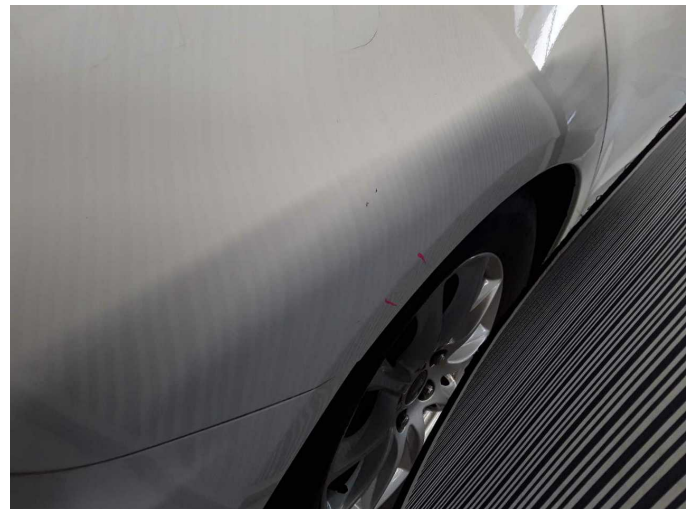
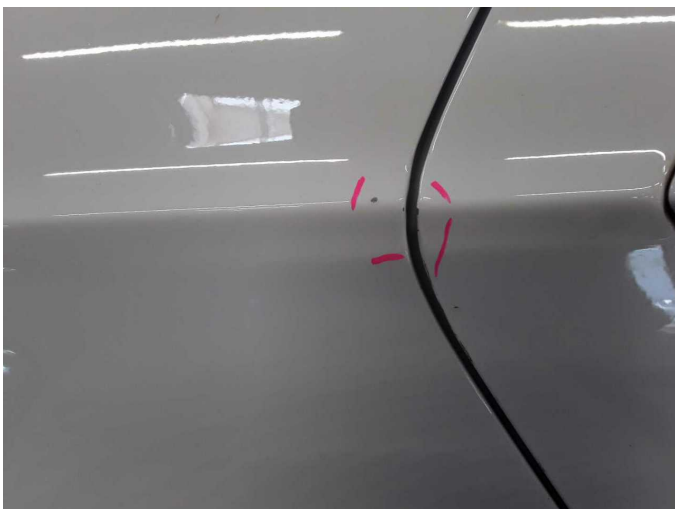
| No. | Component group | Description |
|---|---|---|
| 13 | Side panel - rear right side | Side panel - Dent / paintcoat damage - Repair and paint |

**Damage 13:** Side panel - rear right side: Side panel - Dent / paintcoat damage - Repair and paint

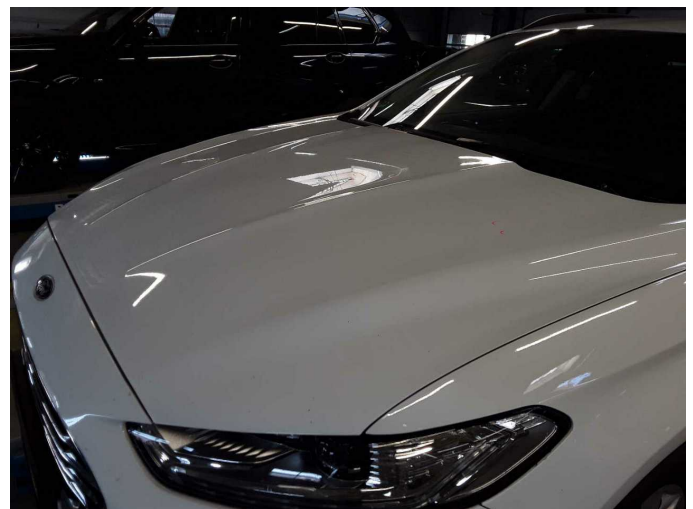
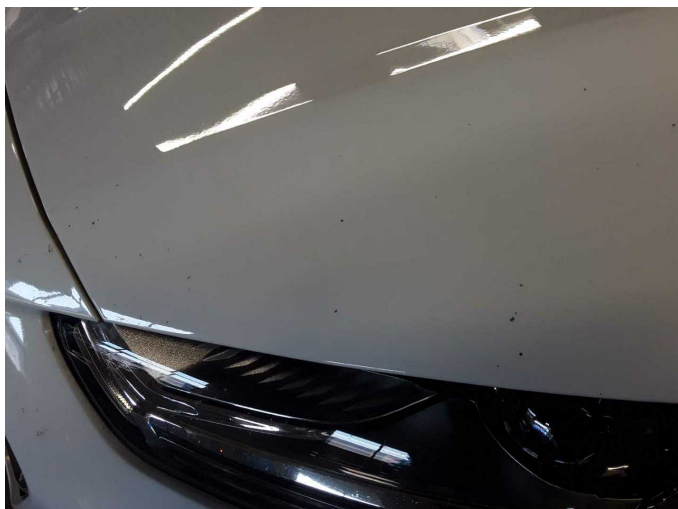
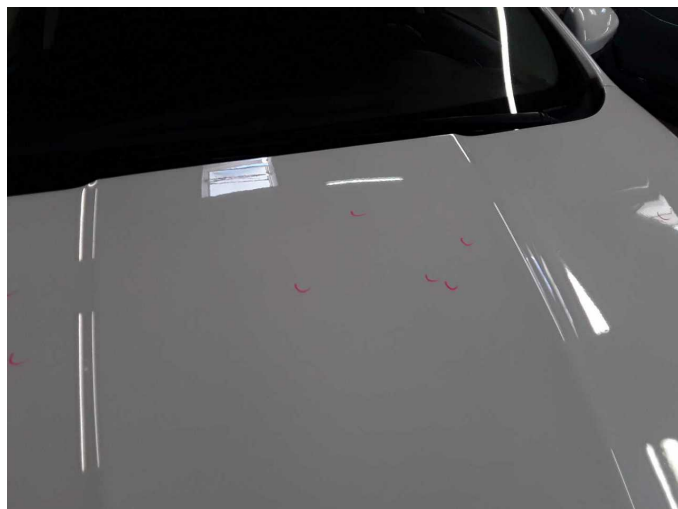
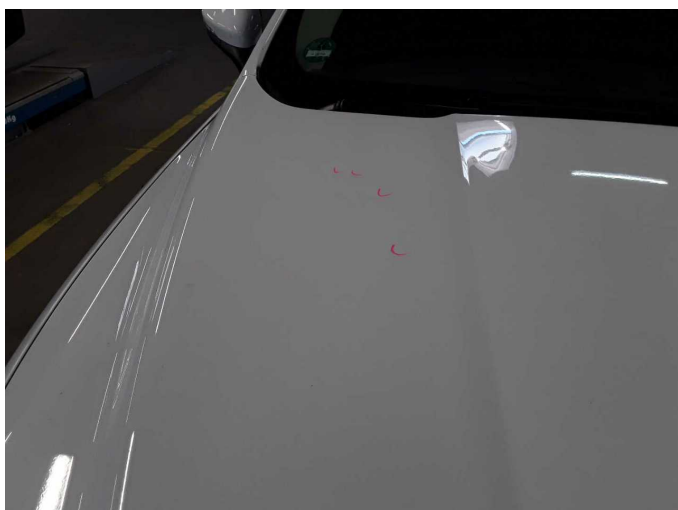
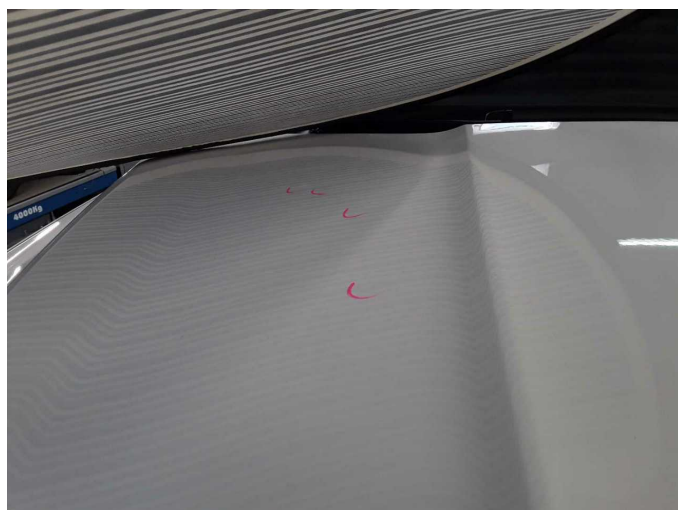
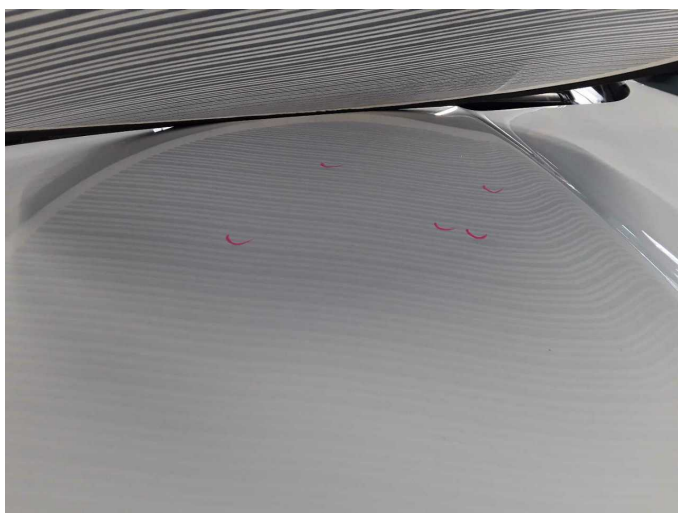
| No. | Component group | Description |
|---|---|---|
| 14 | Bonnet | Bonnet - Dent / paintcoat damage - Repair and paint |

**Damage 14:** Bonnet: Bonnet - Dent / paintcoat damage - Repair and paint

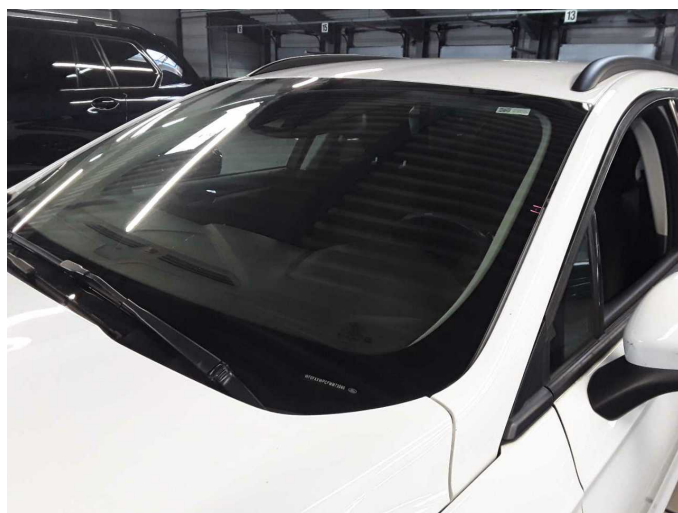
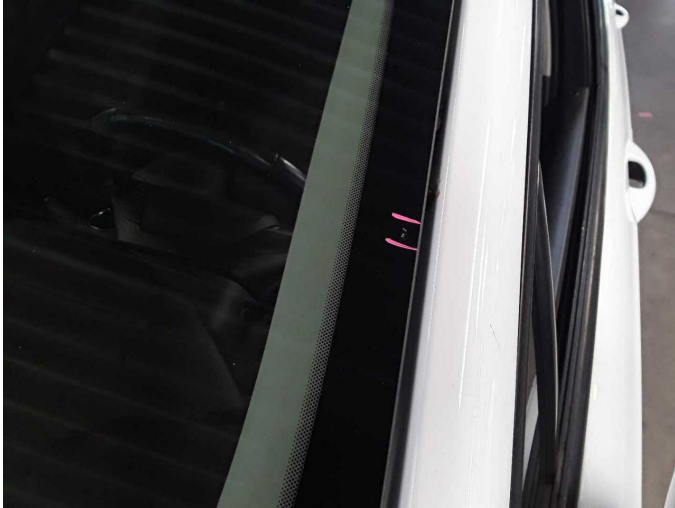
| No. | Component group | Description |
|---|---|---|
| 15 | Vehicle glazing | Windscreen - Broken / torn - Replace |

**Damage 15:** Vehicle glazing: Windscreen - Broken / torn - Replace

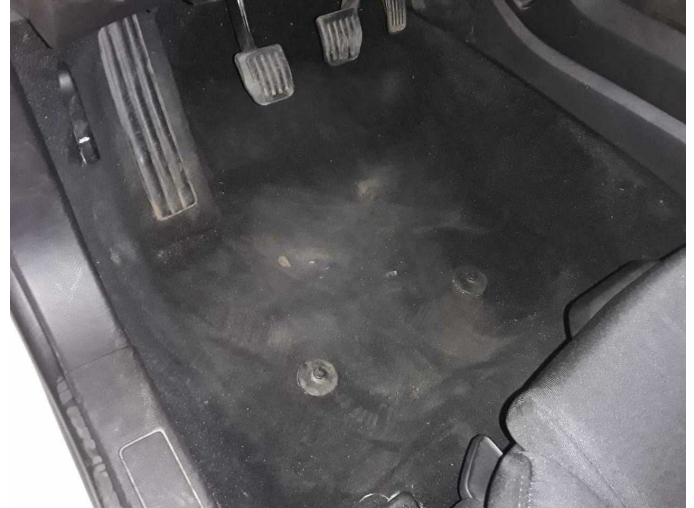
**Missing part 1:** Trim / covers: Floor mats - Missing - Replace

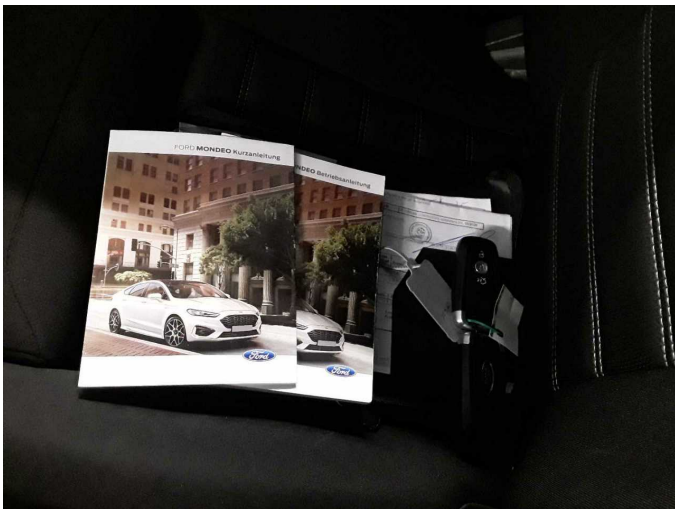
**Missing part 2:** Documents: Service book - Missing - Replace
