## Expertise

Protocol number: 46199646  
Order No. / Reference: 26154059  
Inspection date: 16 Jun 2026

Model: Vito 116 CDI Tourer Lang Aut. PRO

VIN: W1VVLFEZ9T4555834

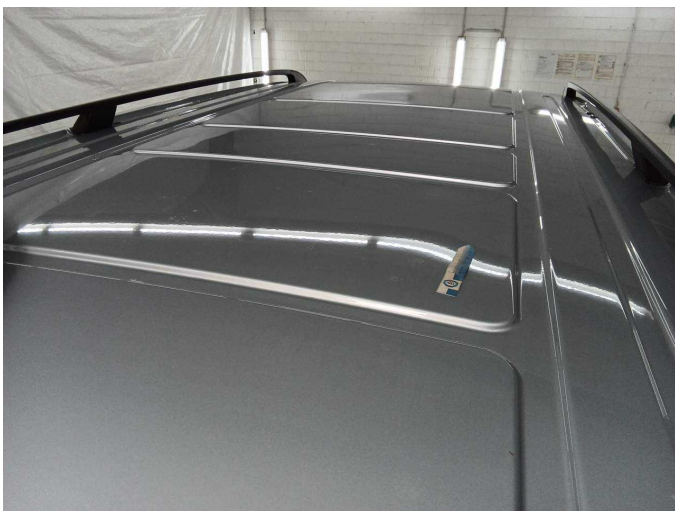
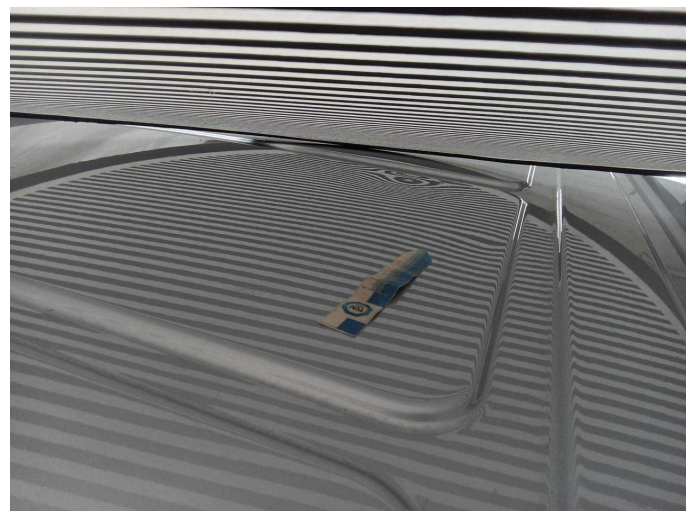
Damage 1: Roof: Roof - dent(s) - Smooth repair work

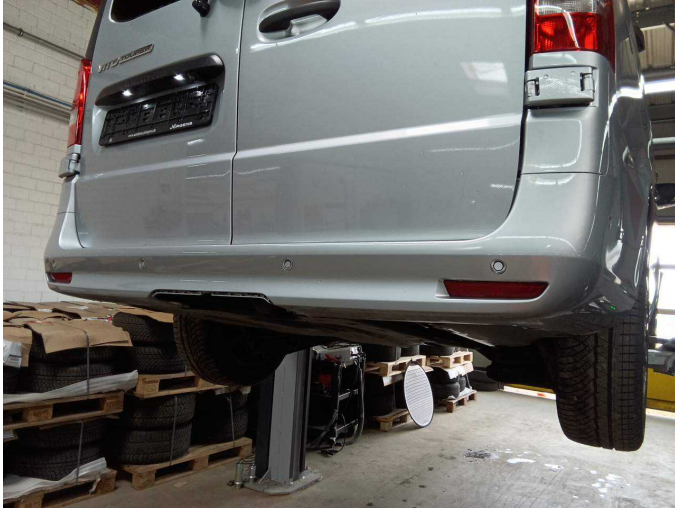
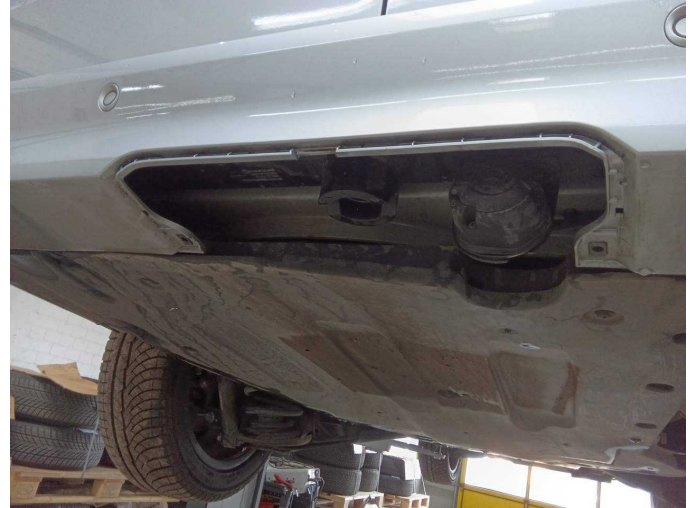
**Damage 2:** Rear bumper: Cap (Ausschnitt Anhängerkupplung) - Missing - Replace

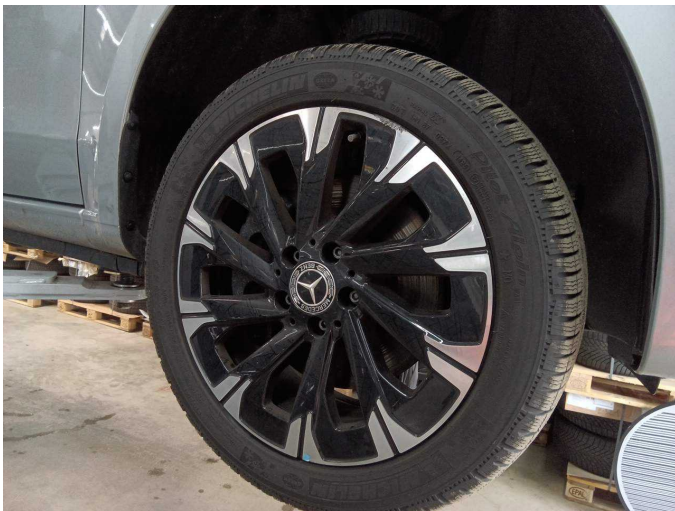
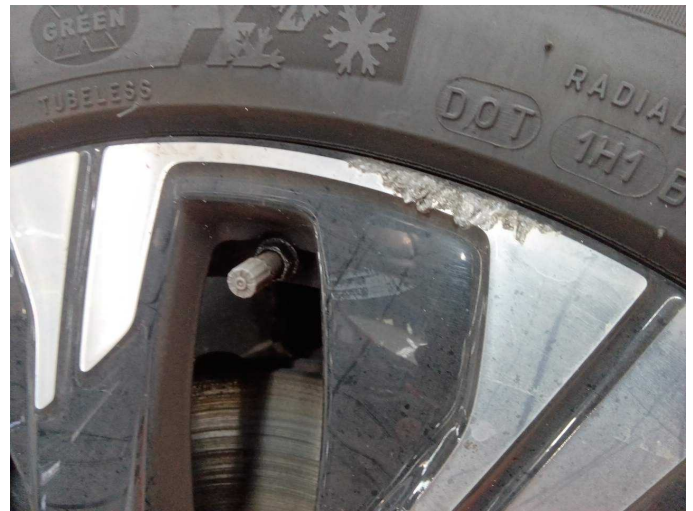
**Damage 3:** Wheel / tyres: Alloy rim - front right side - Scratch(es) - Replace

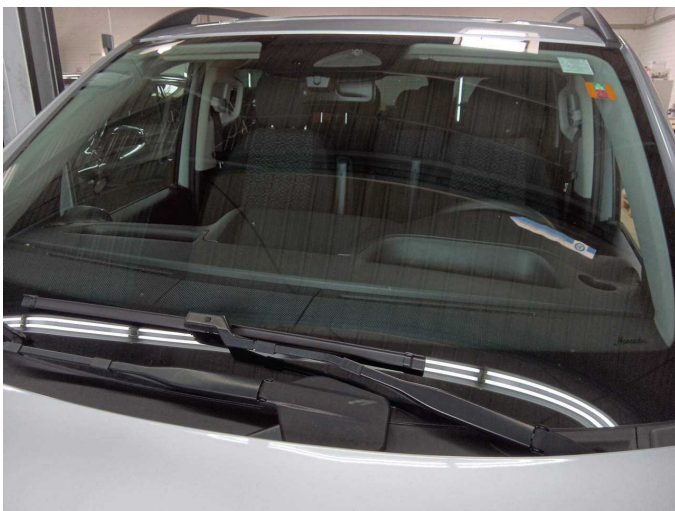
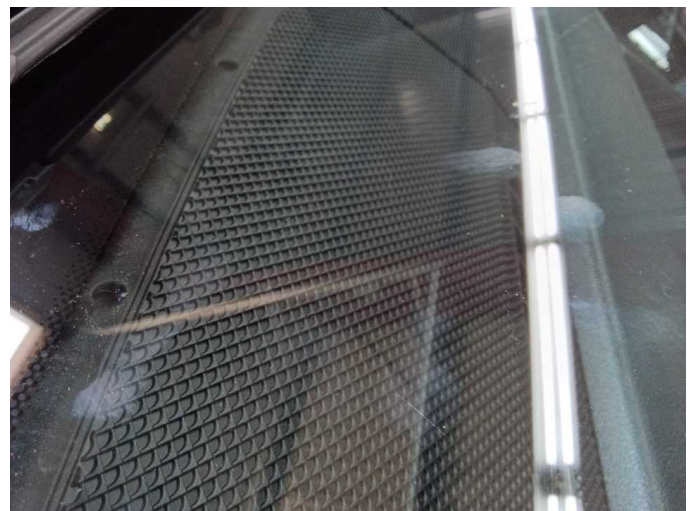
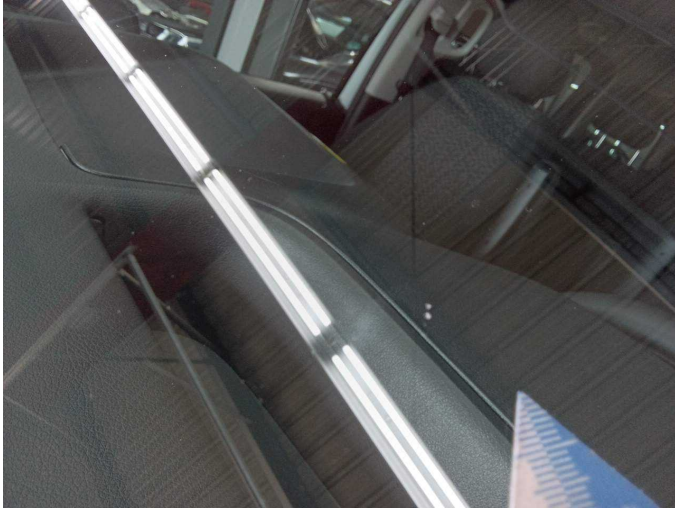
**Damage 4:** Vehicle glazing: Windscreen (+ Steinschläge) - Scratch(es) - Replace

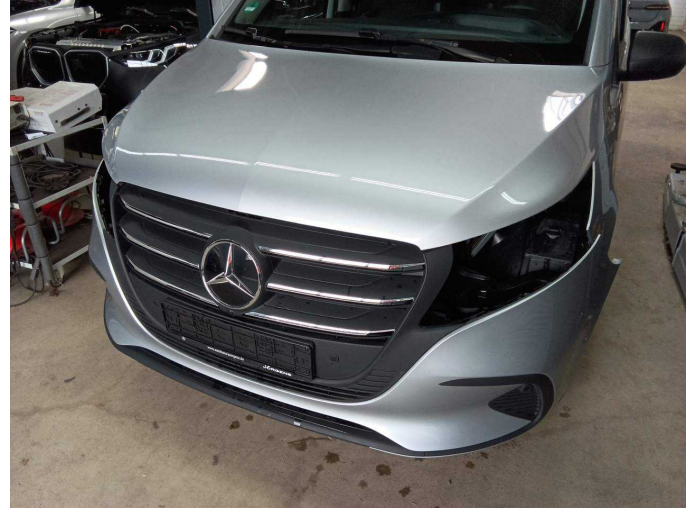
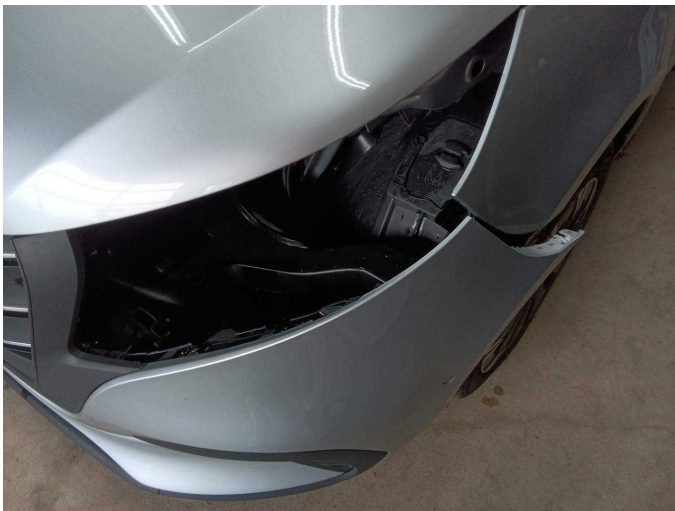
**Damage 5:** Front bumper: Front bumper - Broken / torn - Replace

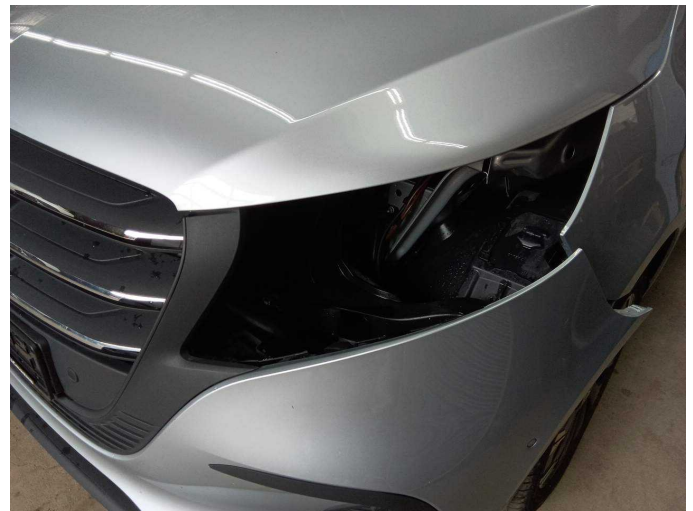
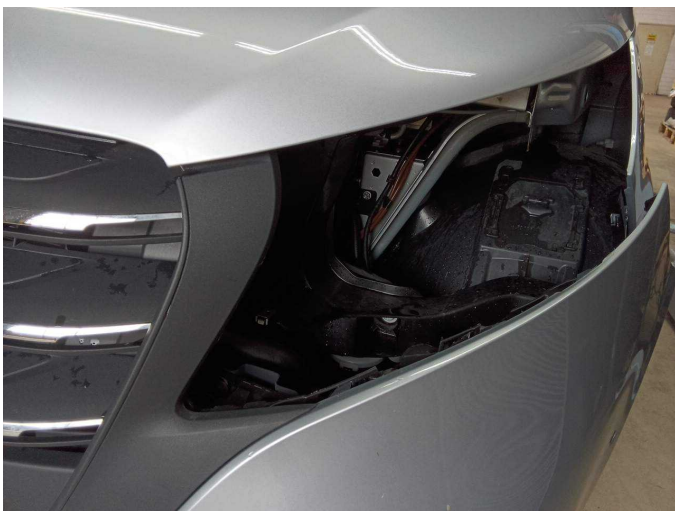
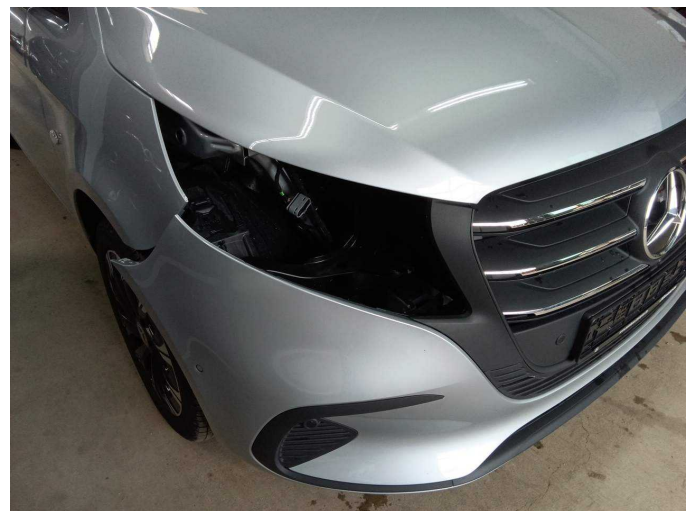
**Damage 6:** Headlight: Headlight - left side (+ rechts) - Missing - Replace

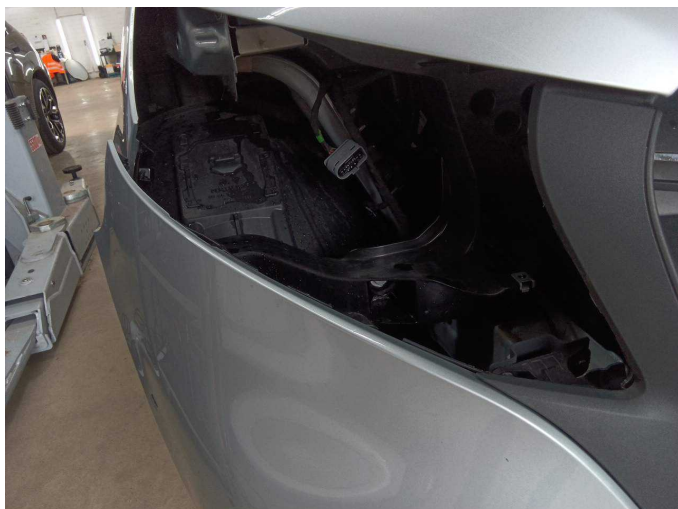
**Damage 6:** Headlight: Headlight - left side (+ rechts) - Missing - Replace

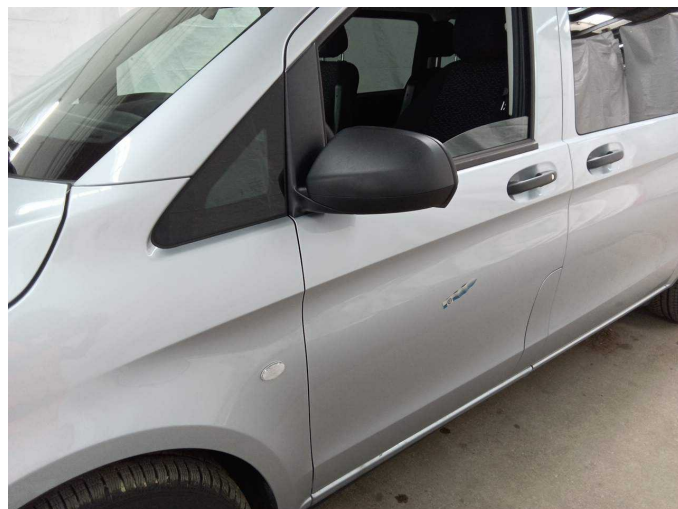
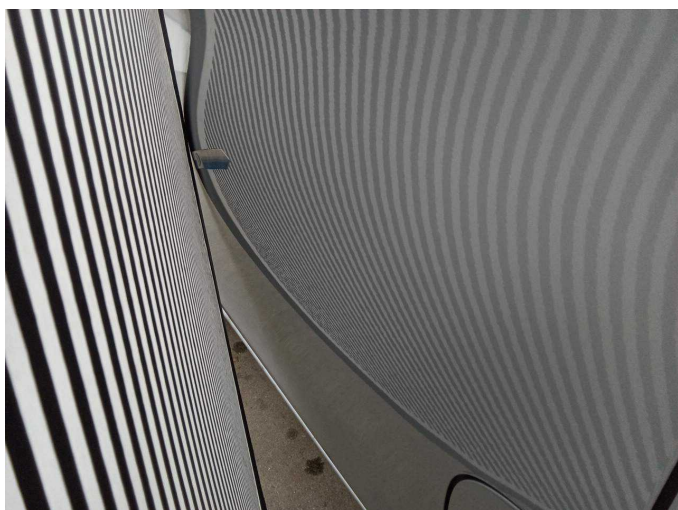
**Wear and tear 3:** Door - front right side: Door - dent(s) - No deduction
