## Expertise

Protocol number: 46344869  
Order No. / Reference: 26184516  
Inspection date: 30 Jun 2026

Model: Vito 116 CDI Extralang HA Aut. PRO

VIN: W1VVLCEZ3T4567556

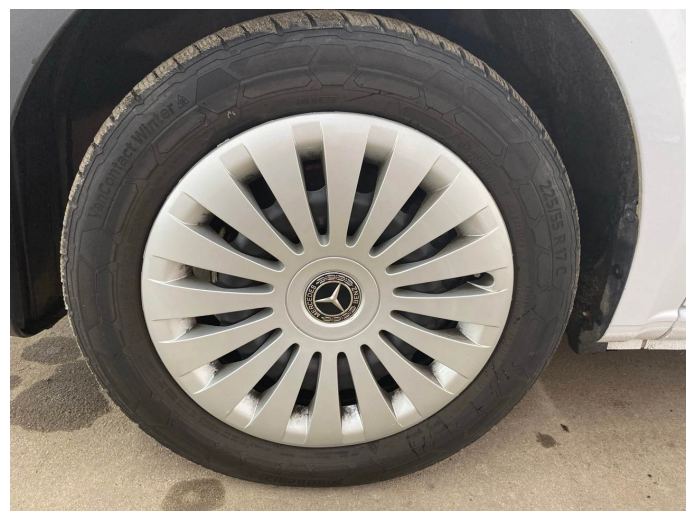
Figure 12: Mounted tyres

#	Tyre size	Type of tyre	Manufacturer	Tread depth
1)	225/55 R17 109T	Winter tyres on Steel rim with wheel cover	Continental	5mm / 5mm
2)	225/55 R17 109T	Winter tyres on Steel rim with wheel cover	Continental	5mm / 5mm

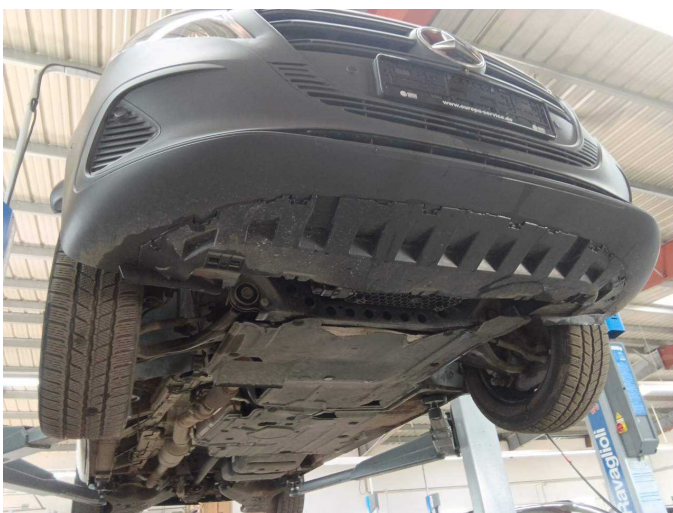
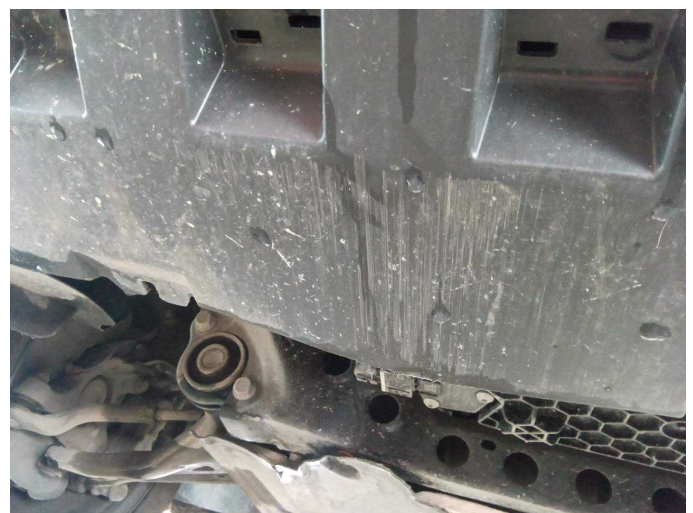
Damage 1: Body: Underbody panelling - Scratch(es) - Replace

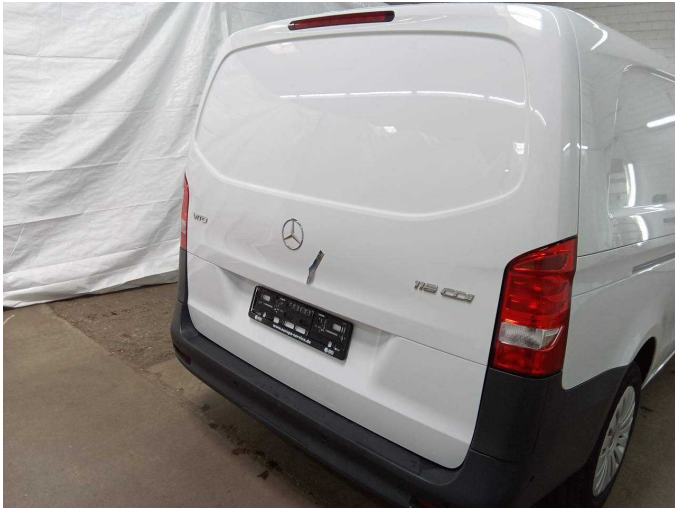
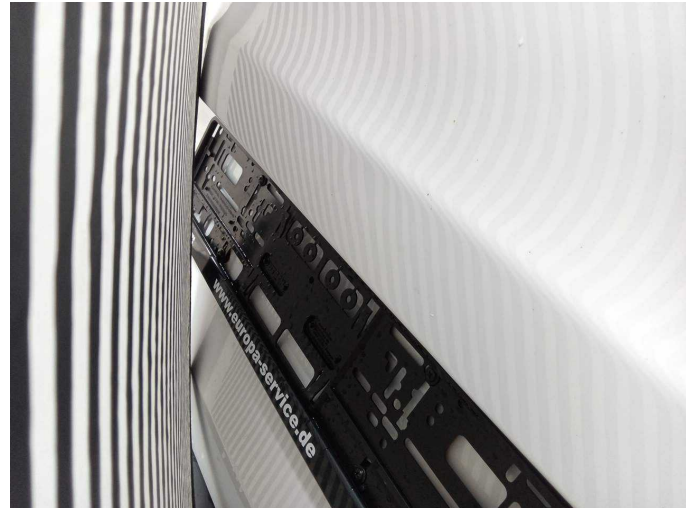
**Damage 2:** Boot lid / rear door: Boot lid - dent(s) - Smooth repair work

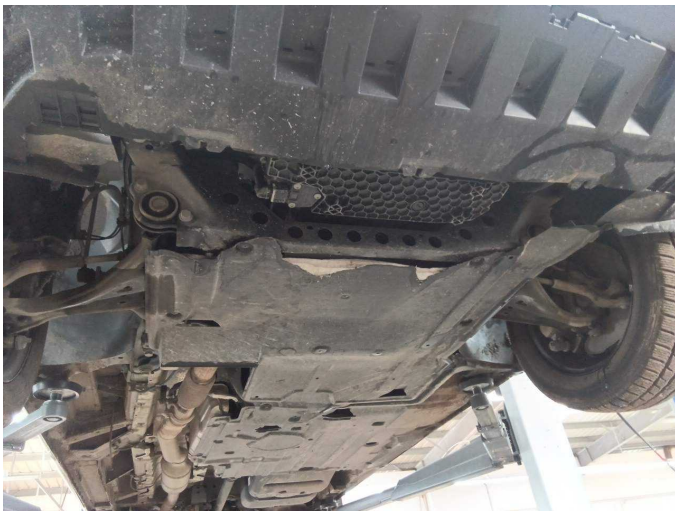
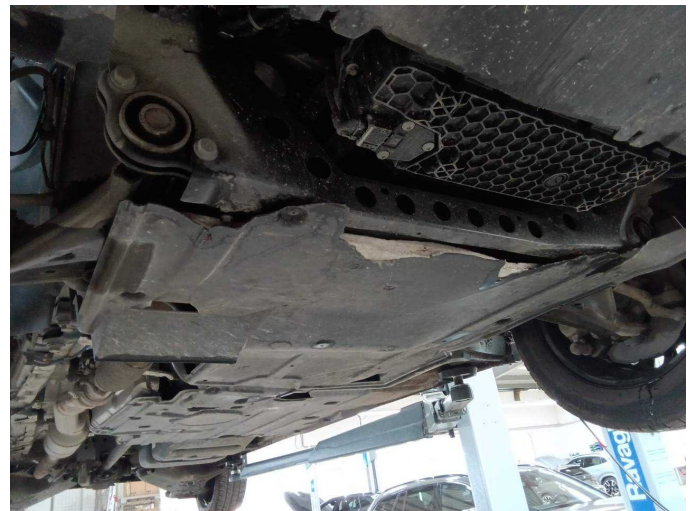
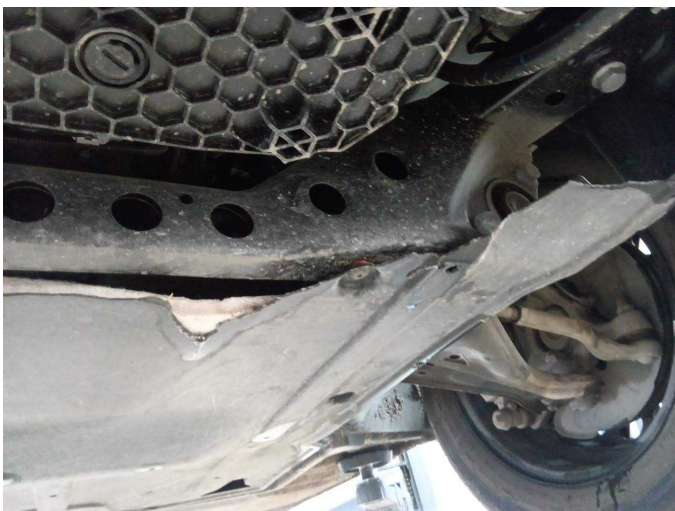
**Damage 3:** Engine: Engine cowling - lower - Broken / torn - Replace

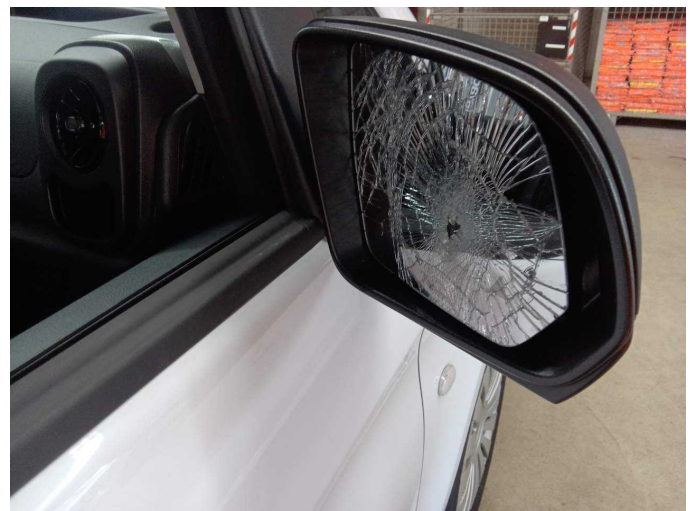
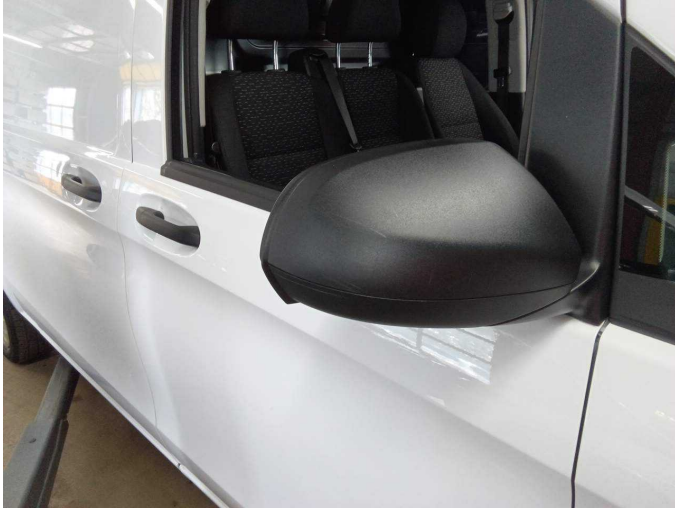
**Damage 4:** Wing mirror - right side: Mirror glass (Spie) - Broken / torn - Replace

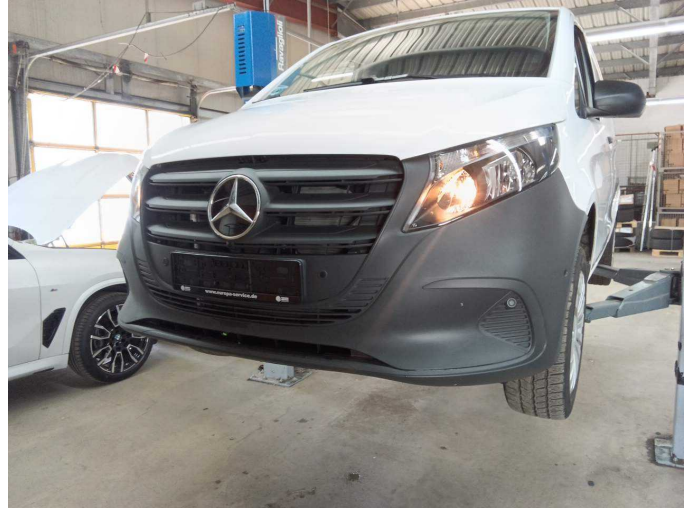
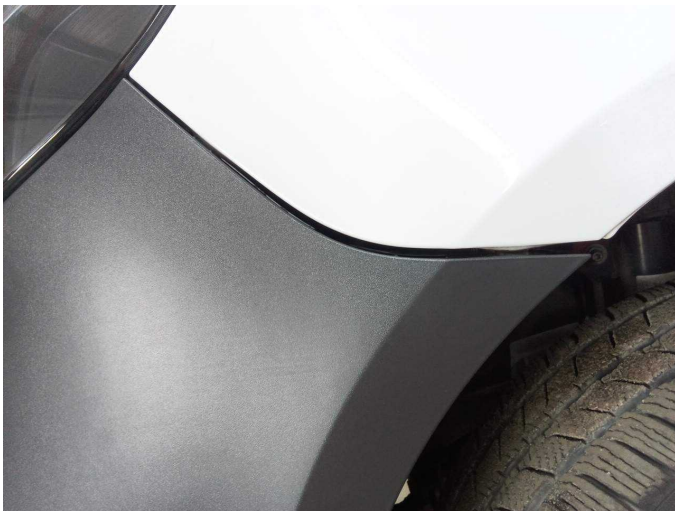
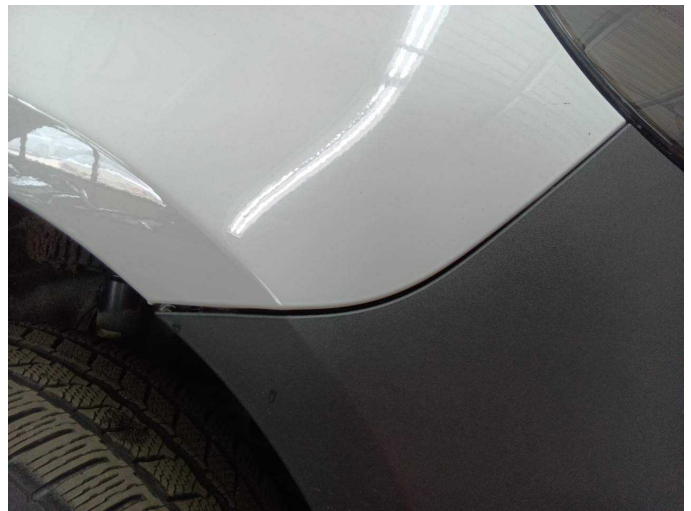
**Damage 5:** Front bumper: Front bumper - Malposition - Un- / install

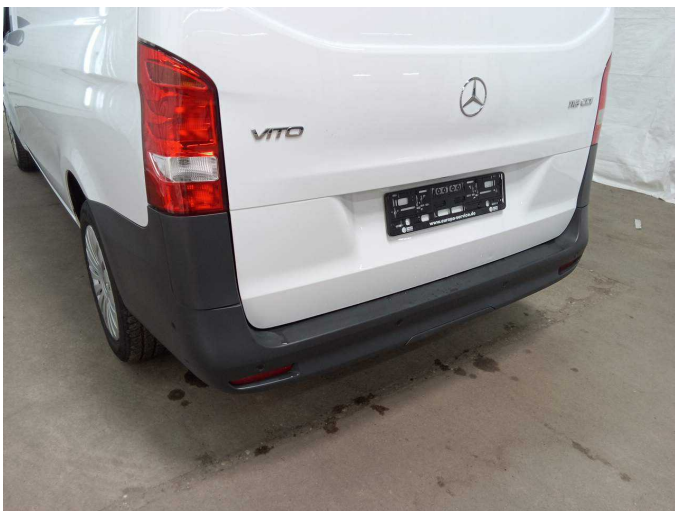
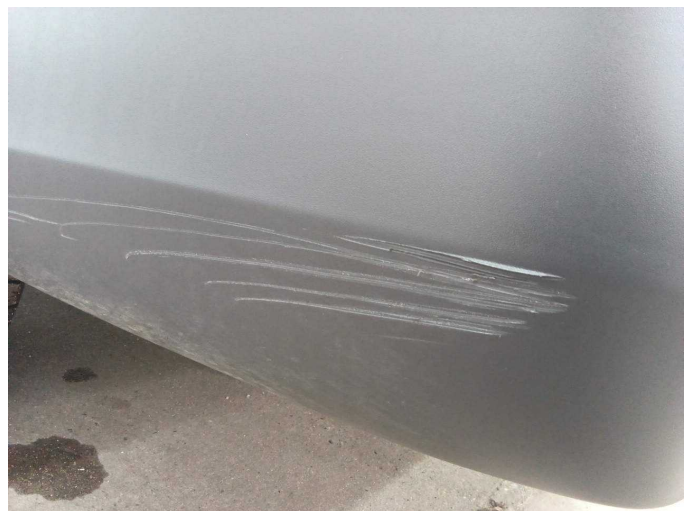
**Damage 6:** Rear bumper: Rear bumper - Scratch(es) - Replace
