# INSPECTION REPORT

**End of contract**

| License plate | 2DSE985 |
| Make | Ford Kuga 2.5i EB 165kW ST-Lin |

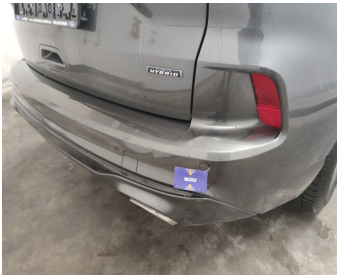
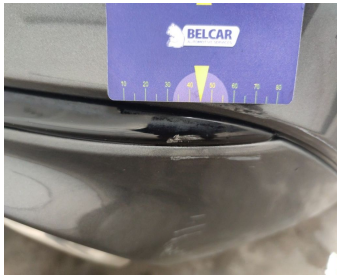
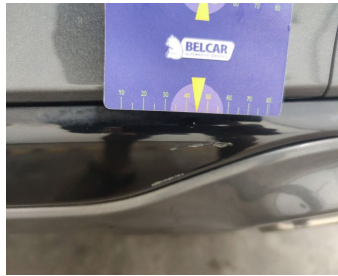
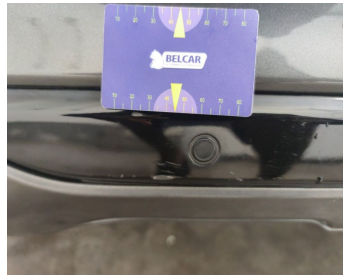
| Damages | Type | Acceptable |
|---|---|---|
| 138 | Bumper Rear / Lower Cover Not Painted / Replace | N |

Bumper Rear / Lower Cover Not Painted / Replace-scratch

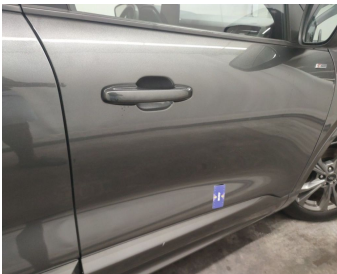
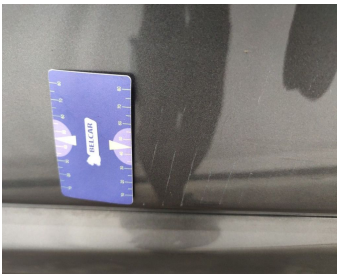
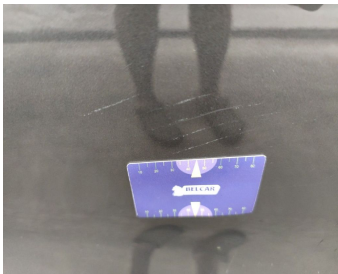
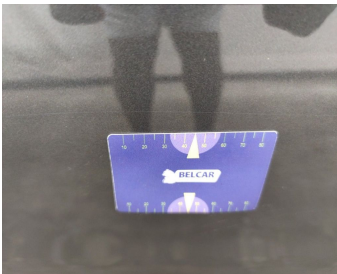
| Damages | Type | Acceptable |
|---|---|---|
| 217 | Door Front Right / Trim / Replace | Y |

Door Front Right / Trim / Replace-scratch
