Expertise

Protocol number: 46712390  
Order No. / Reference: 26750186  
Inspection date: 24 Jul 2026

Manufacturer: Mercedes-Benz

Model: 317 CDI Sprinter Kompakt HA 9G-TRONIC

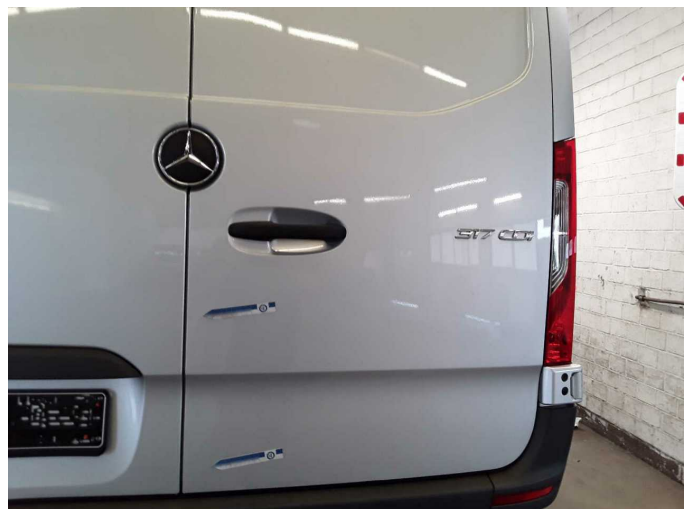
| No. | Component group | Description |
|---|---|---|
| 2 | Boot lid / rear door | Rear door - right side - Dent / paintcoat damage - Smart repair |

**Damage 2:** Boot lid / rear door: Rear door - right side - Dent / paintcoat damage - Smart repair

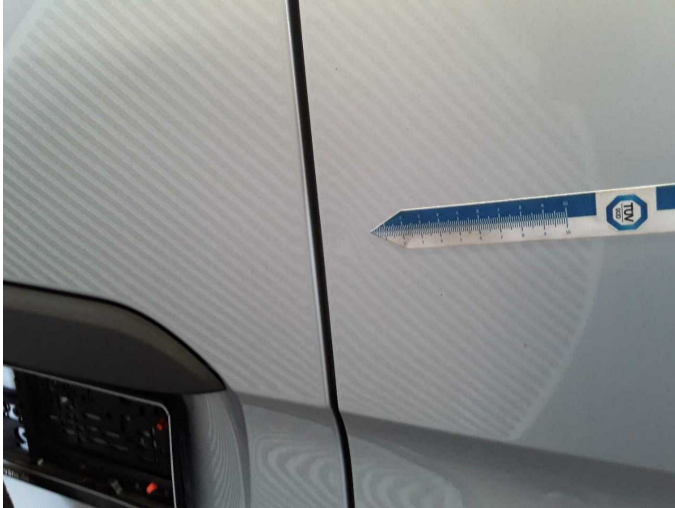
**Damage 2:** Boot lid / rear door: Rear door - right side - Dent / paintcoat damage - Smart repair

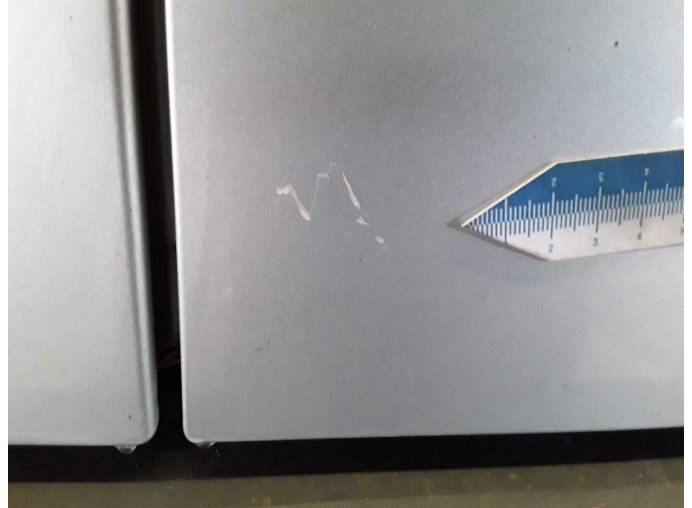
**Damage 2:** Boot lid / rear door: Rear door - right side - Dent / paintcoat damage - Smart repair

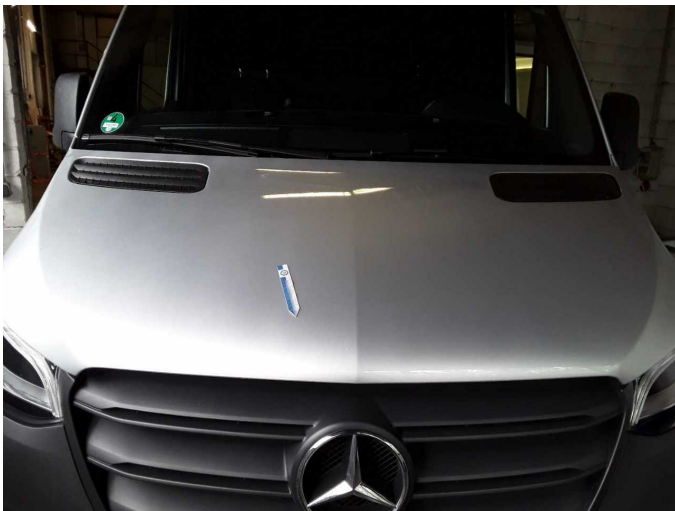
| No. | Component group | Description |
|---|---|---|
| 3 | Bonnet | Bonnet - Stone chips - Paint |

**Damage 3:** Bonnet: Bonnet - Stone chips - Paint

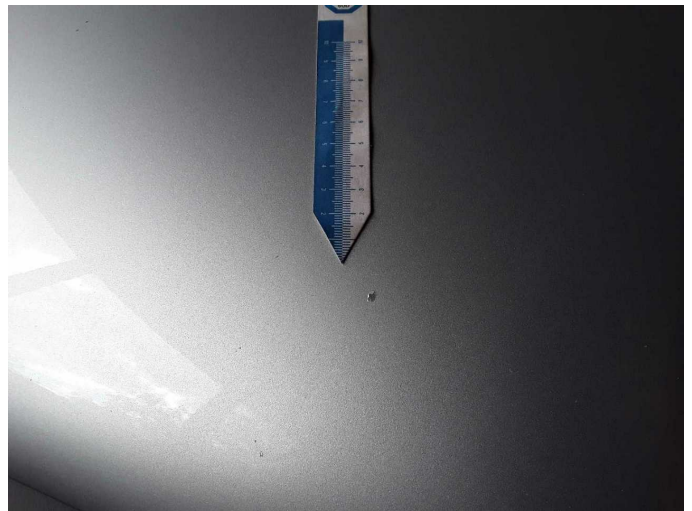
**Damage 3:** Bonnet: Bonnet - Stone chips - Paint

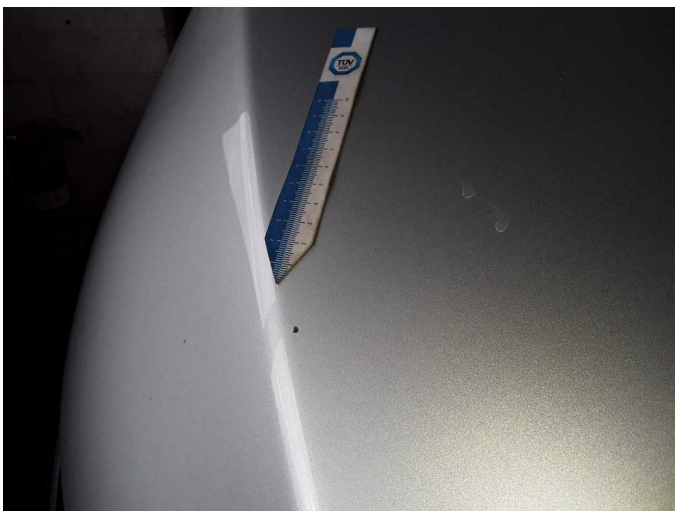
**Damage 3:** Bonnet: Bonnet - Stone chips - Paint

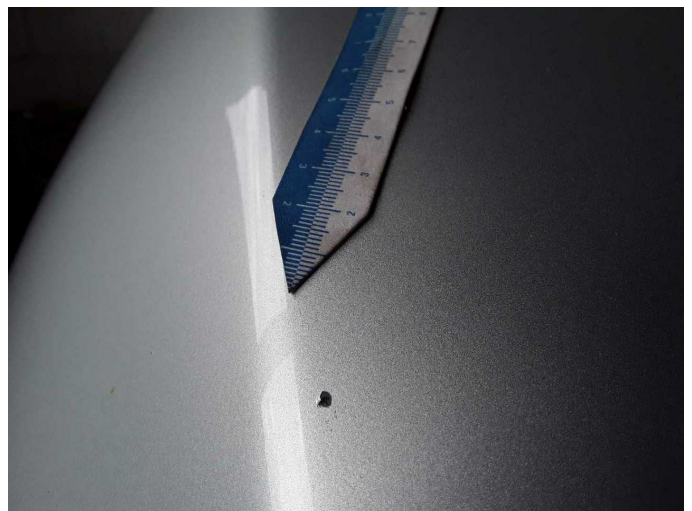
**Damage 3:** Bonnet: Bonnet - Stone chips - Paint

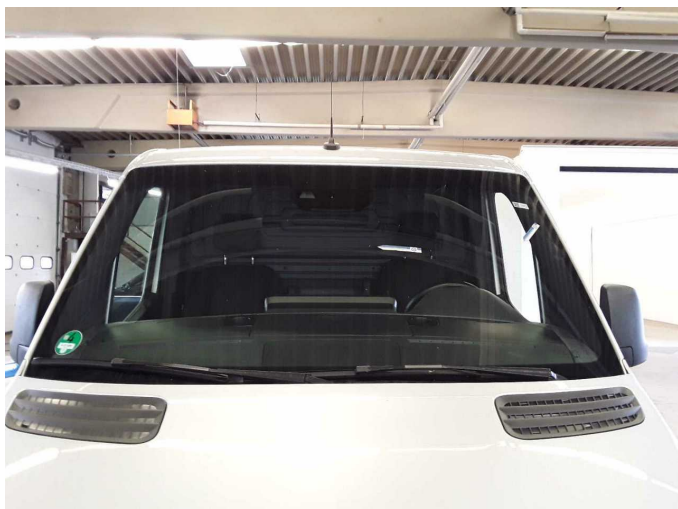
| No. | Component group | Description |
|---|---|---|
| 4 | Vehicle glazing | Windscreen - Broken / torn - Replace |

**Damage 4:** Vehicle glazing: Windscreen - Broken / torn - Replace

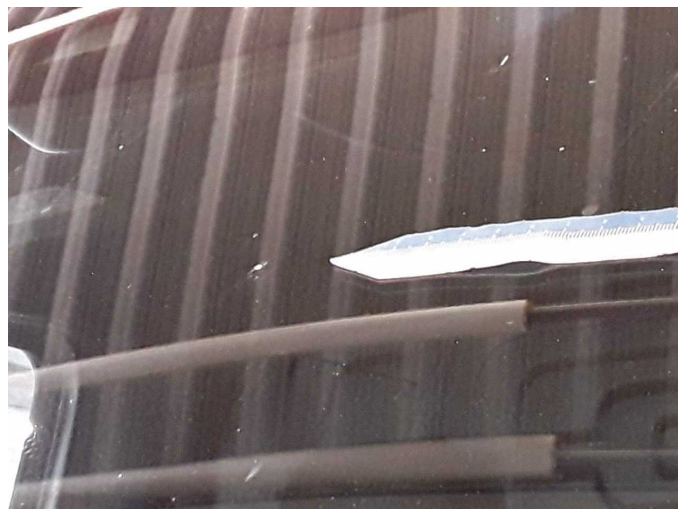
**Damage 4:** Vehicle glazing: Windscreen - Broken / torn - Replace

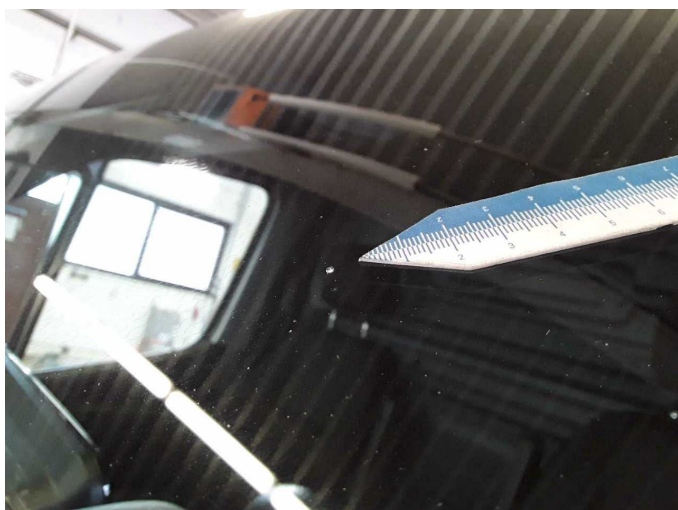
**Damage 4:** Vehicle glazing: Windscreen - Broken / torn - Replace

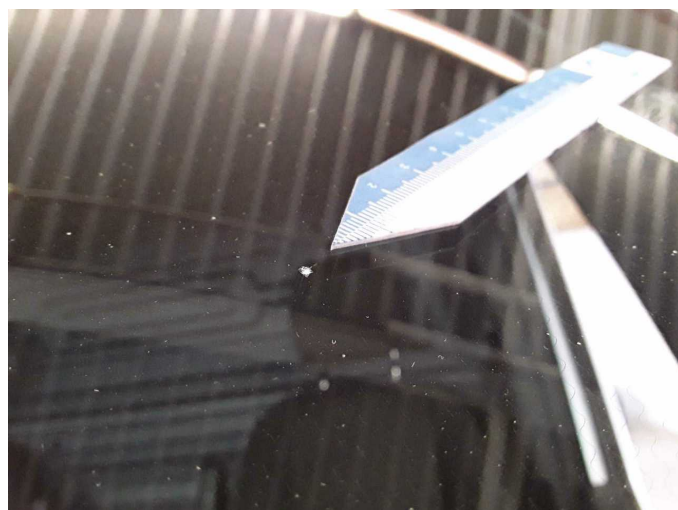
**Damage 4:** Vehicle glazing: Windscreen - Broken / torn - Replace

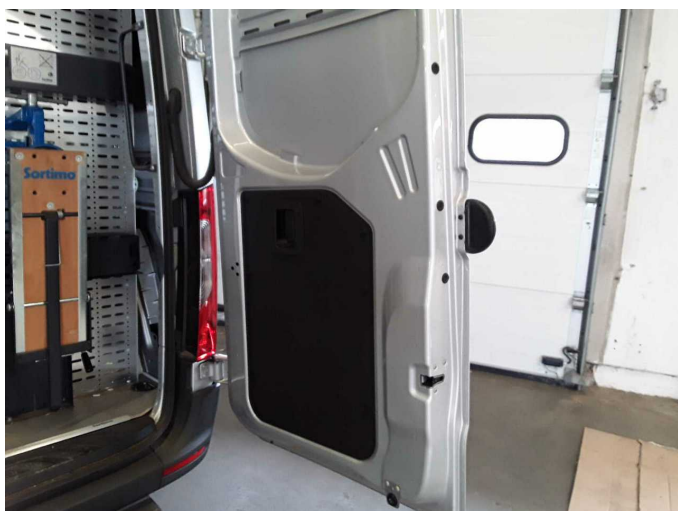
| No. | Component group | Description |
|---|---|---|
| 1 | Boot lid / rear door | Rear door - right side (Innen) - Scratched - No deduction |

**Wear and tear 1:** Boot lid / rear door: Rear door - right side (Innen) - Scratched - No deduction

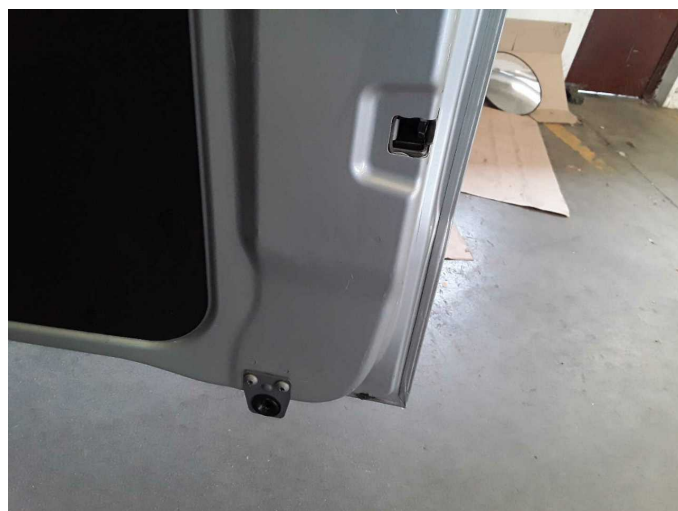
**Wear and tear 1:** Boot lid / rear door: Rear door - right side (Innen) - Scratched - No deduction

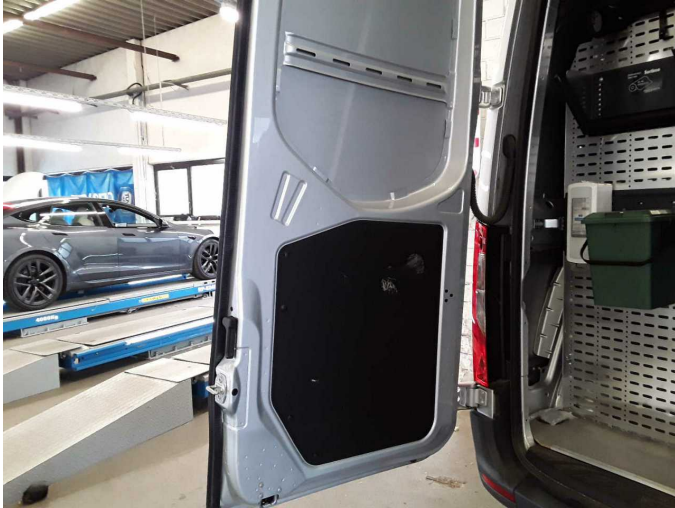
| No. | Component group | Description |
|---|---|---|
| 2 | Boot lid / rear door | Rear door - left side (Innen) - Scratched - No deduction |

**Wear and tear 2:** Boot lid / rear door: Rear door - left side (Innen) - Scratched - No deduction

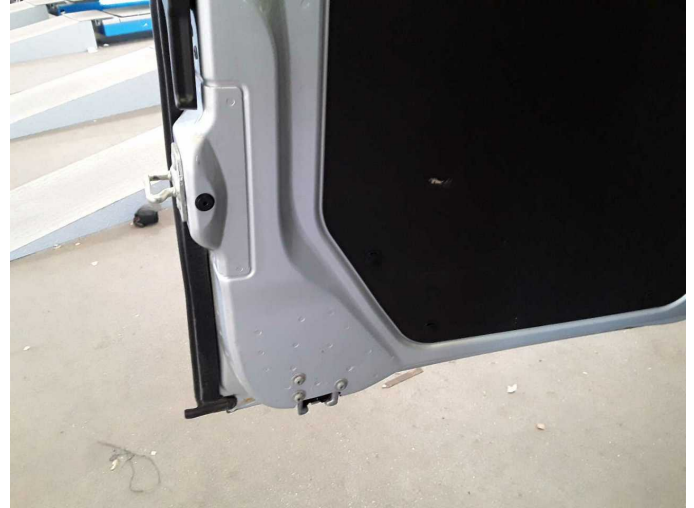
**Wear and tear 2:** Boot lid / rear door: Rear door - left side (Innen) - Scratched - No deduction

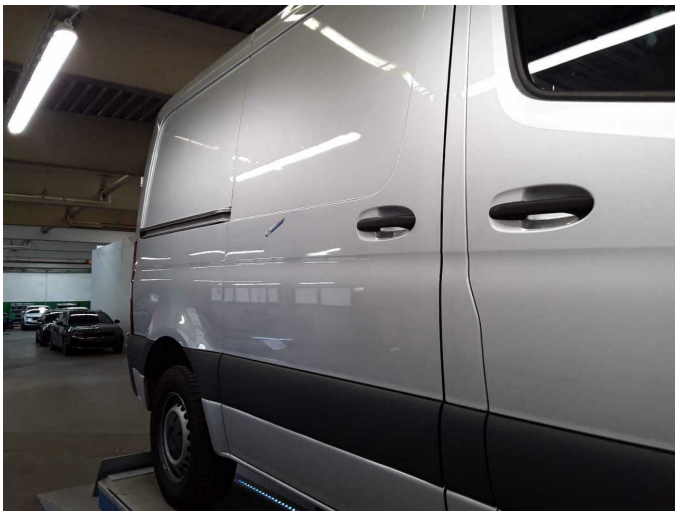
| No. | Component group | Description |
|---|---|---|
| 3 | Sliding door, right | Sliding door - dent(s) - No deduction |

**Wear and tear 3:** Sliding door, right: Sliding door - dent(s) - No deduction

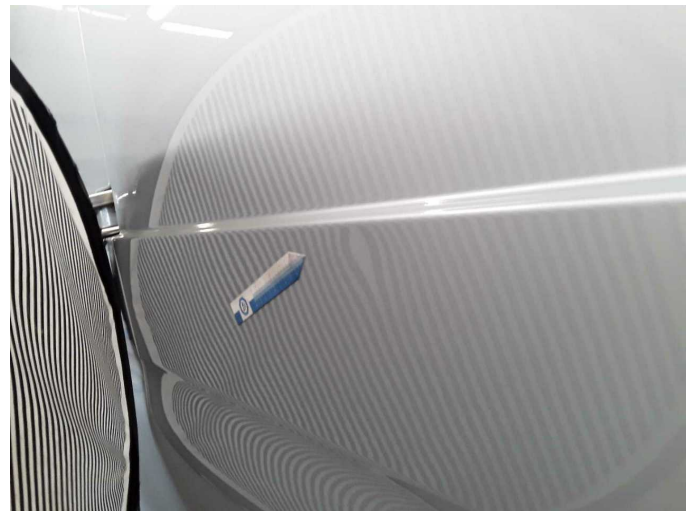
**Wear and tear 3:** Sliding door, right: Sliding door - dent(s) - No deduction

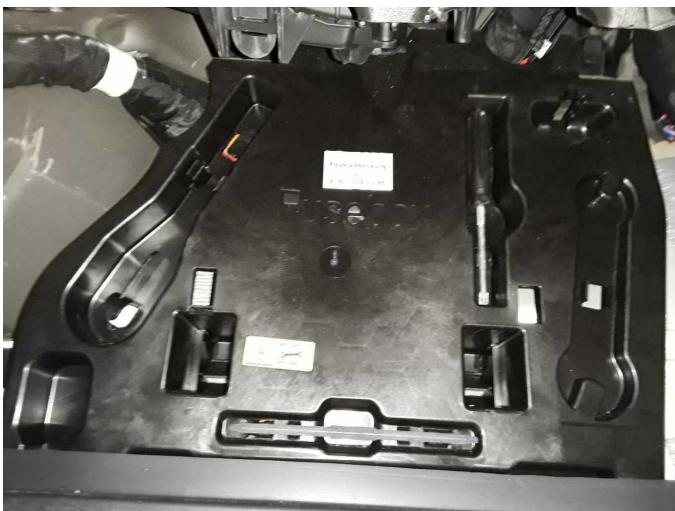
| Description |
|---|
| Equipment - Vehicle tool kit |

**Missing part 1:** Equipment: Vehicle tool kit - Missing - Replace

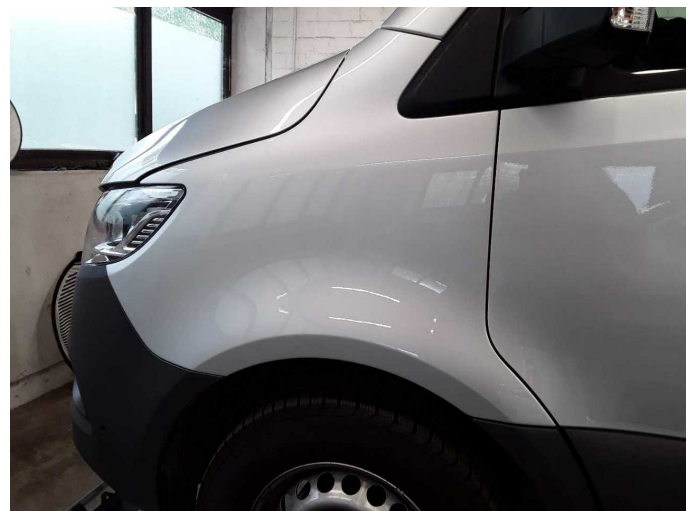
| No. | Repainting |
|---|---|
| 1 | Mudguard - left side, Mudguard - right side |

| Mudguard - left side | 137 µm | Mudguard - right side | 150 µm |

**Repainting 1:** Mudguard - left side, Mudguard - right side

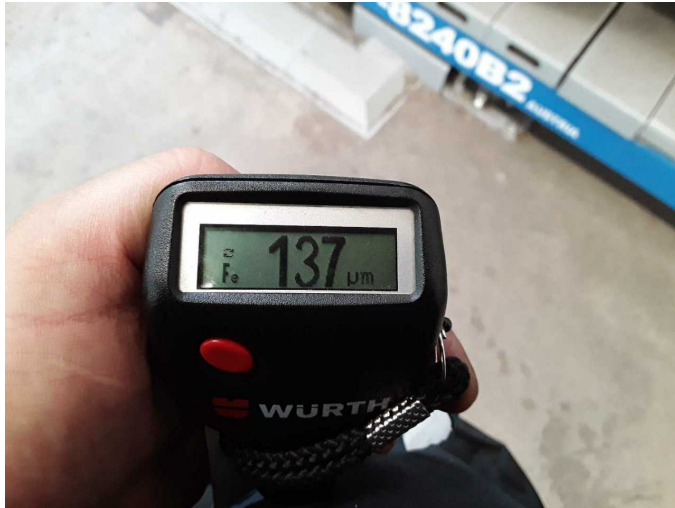
**Repainting 1:** Mudguard - left side, Mudguard - right side

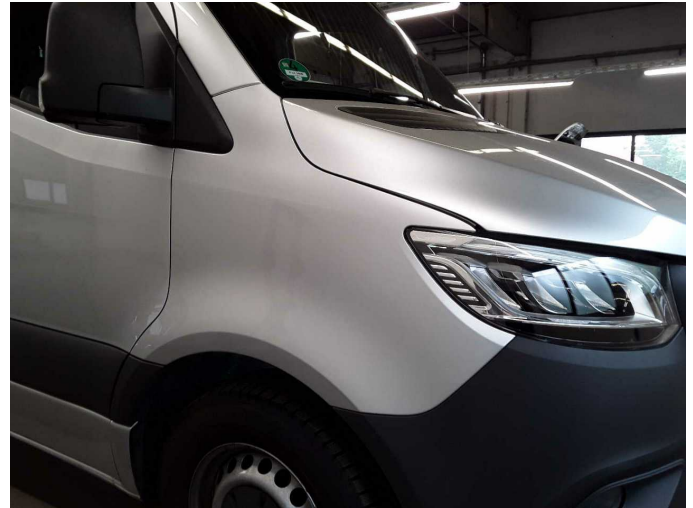
**Repainting 1:** Mudguard - left side, Mudguard - right side

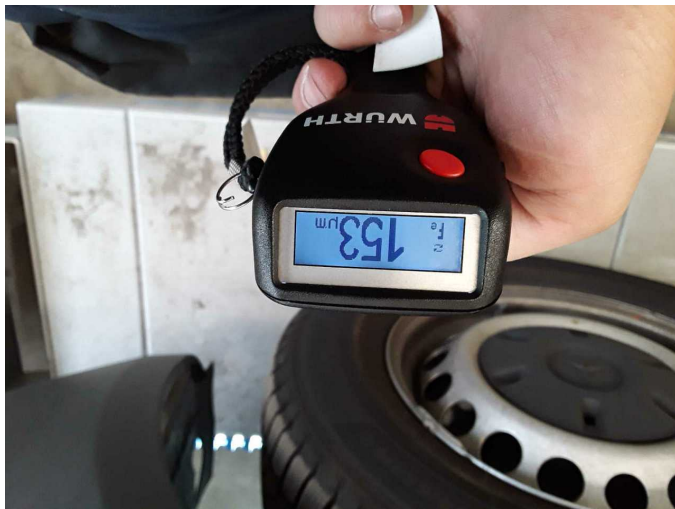
**Repainting 1:** Mudguard - left side, Mudguard - right side
