Expertise

Protocol number: 46379924
Order No. / Reference: 26561916
Inspection date: 7 Jul 2026

Manufacturer: Volkswagen

Model: Caravelle T6.1 DSG Kurz 4MOTION Comfortline

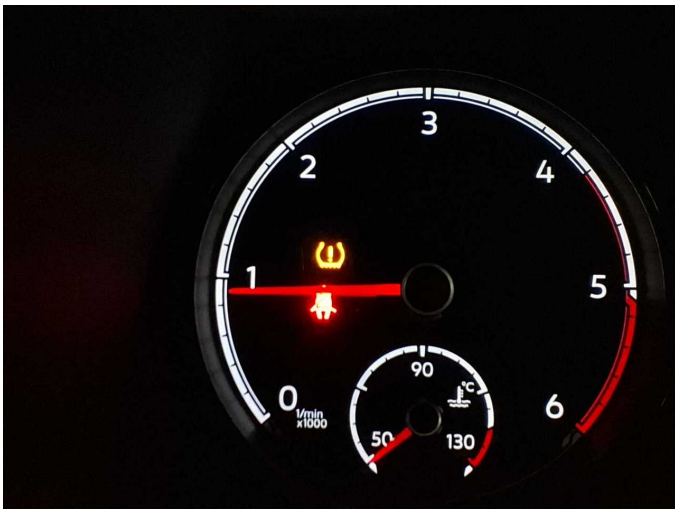
Damage 1: Wheel / tyres: Pressure sensor - Functional / admissibility - Perform diagnosis

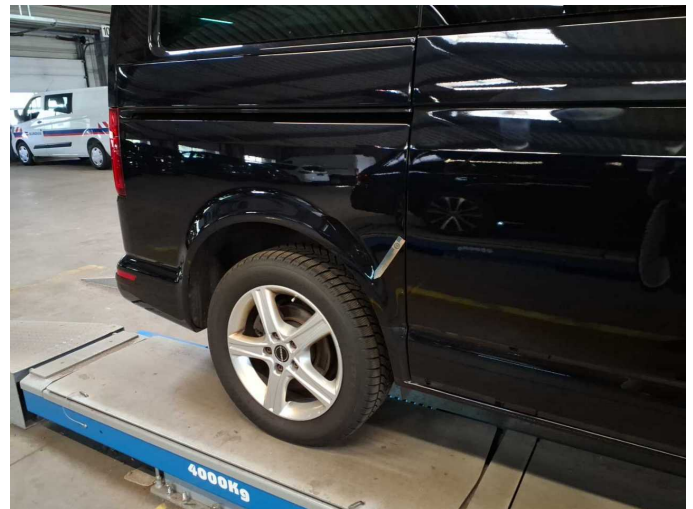
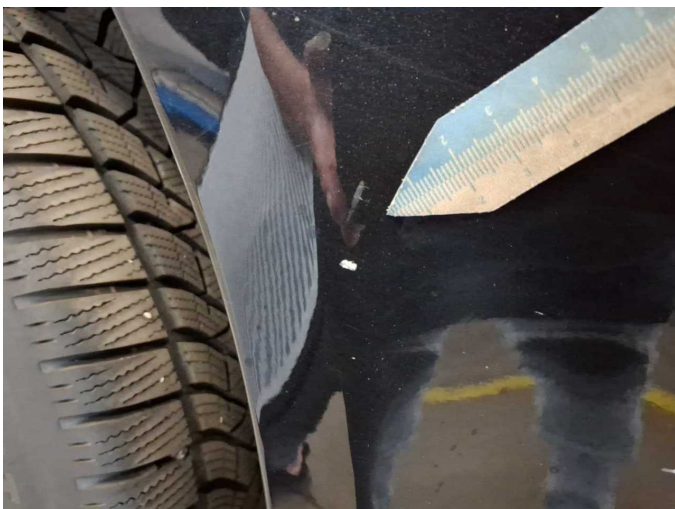
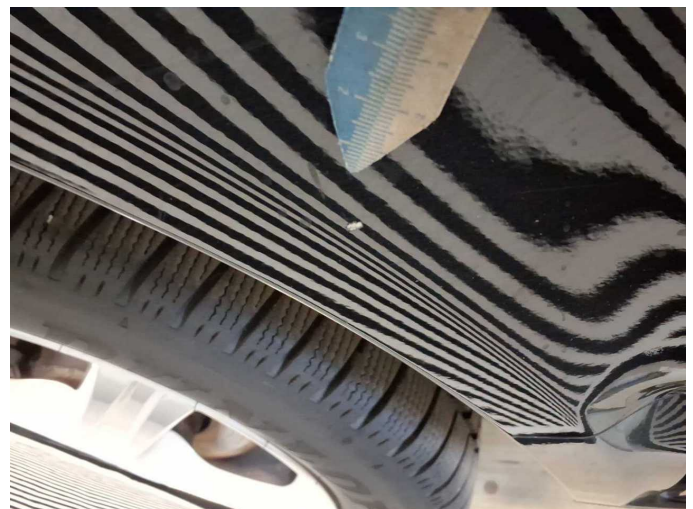
Damage 2: Side panel - rear right side: Side panel (Tief) - Stone chips - Smart repair

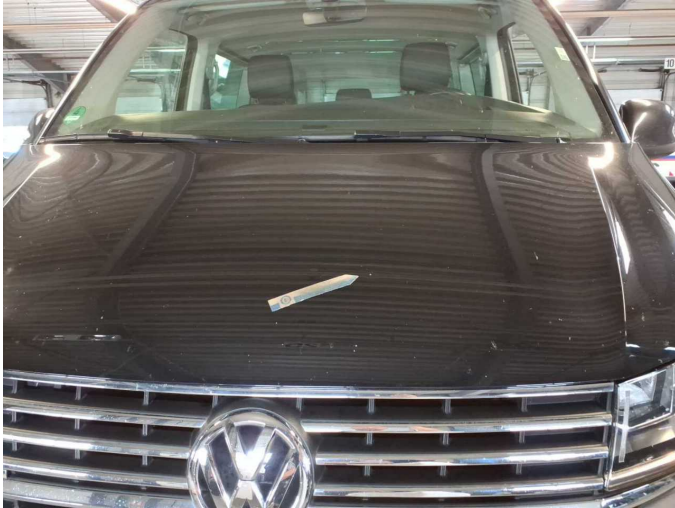
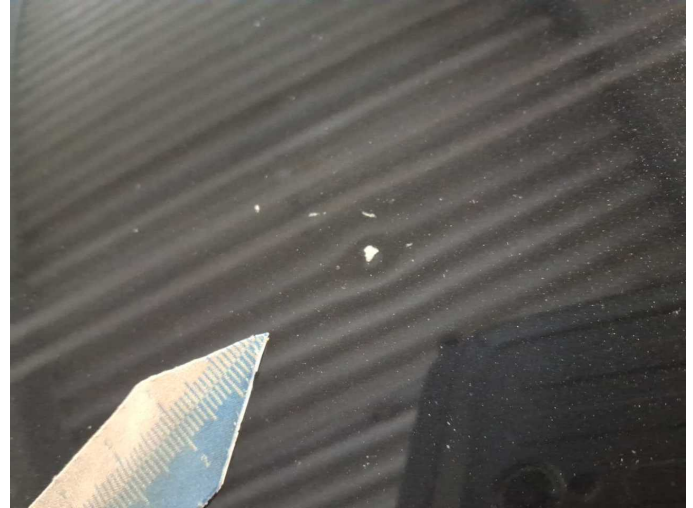
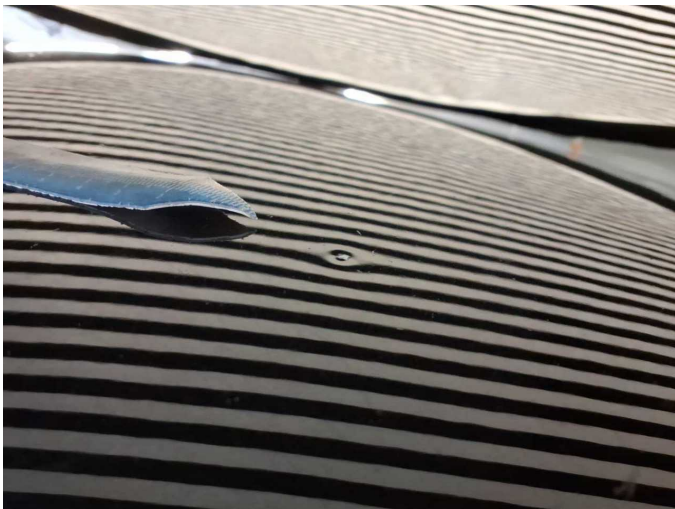
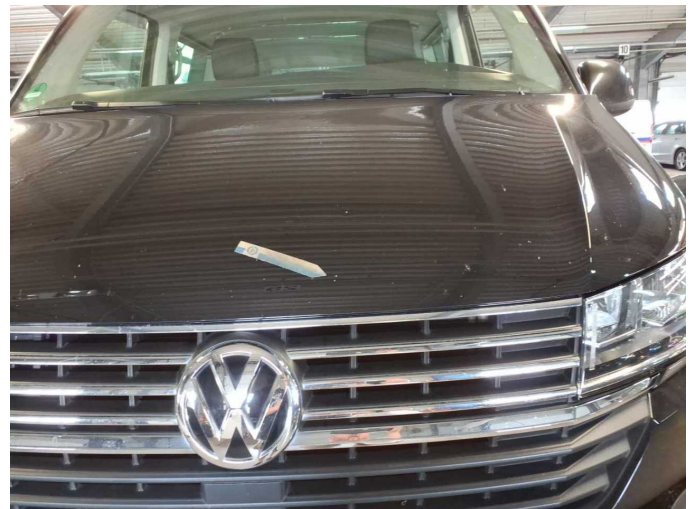
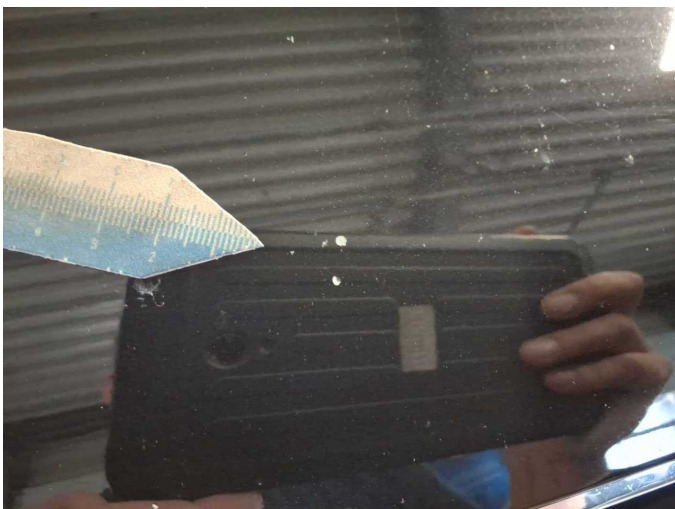
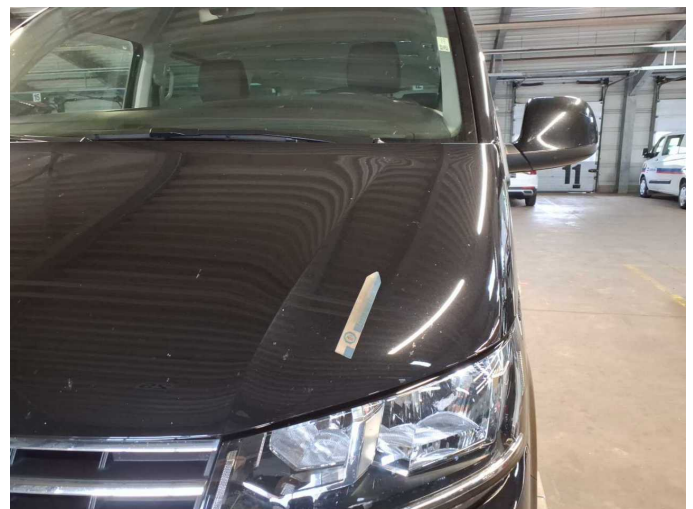
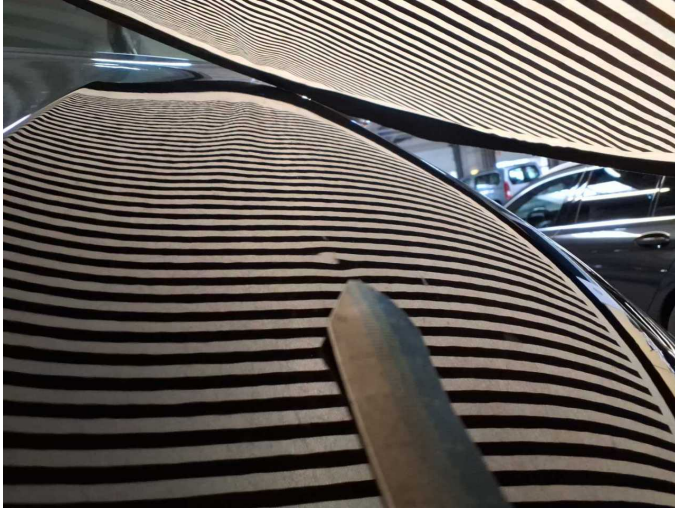
Damage 3: Bonnet: Bonnet - Dent / paintcoat damage - Smart repair

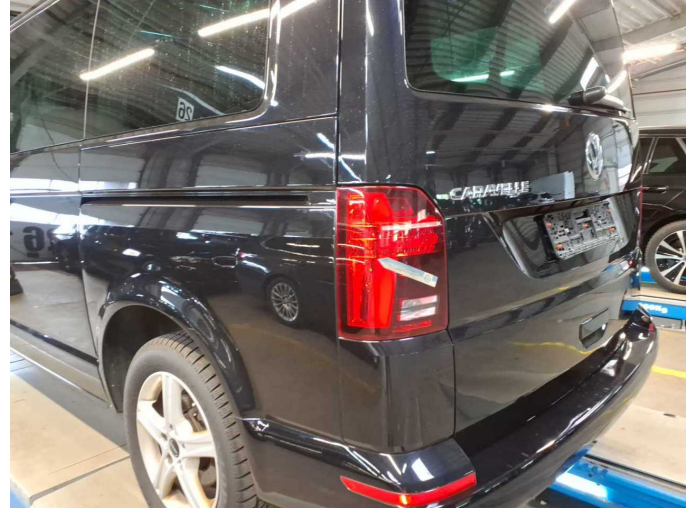
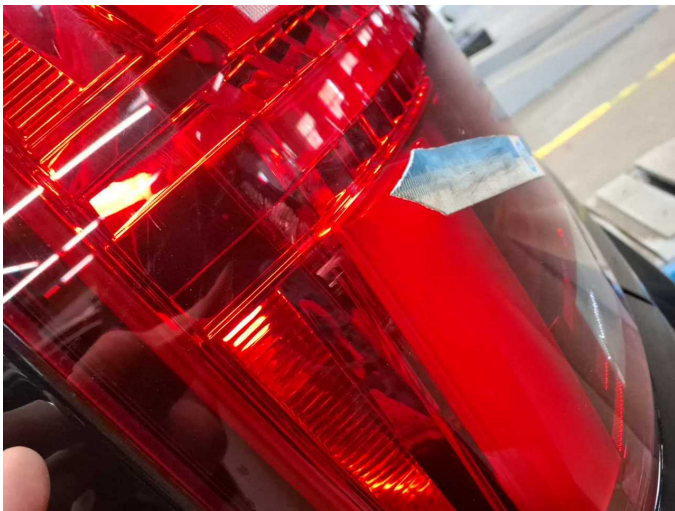
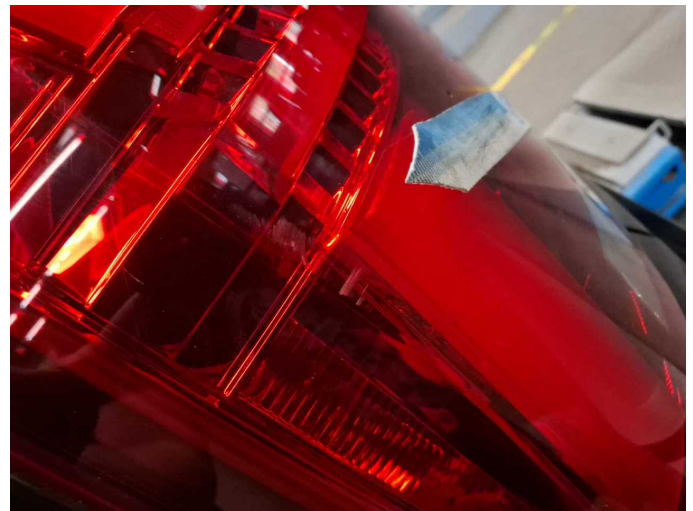
Damage 4: Tail light: Tail lamp - left side - Scratched - Replace

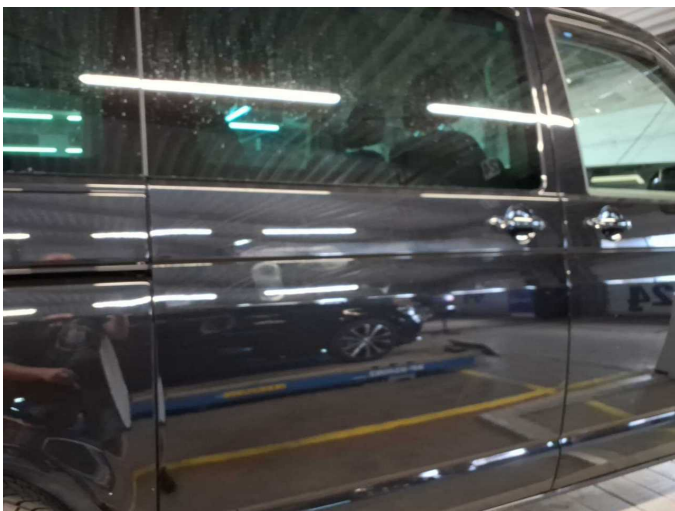
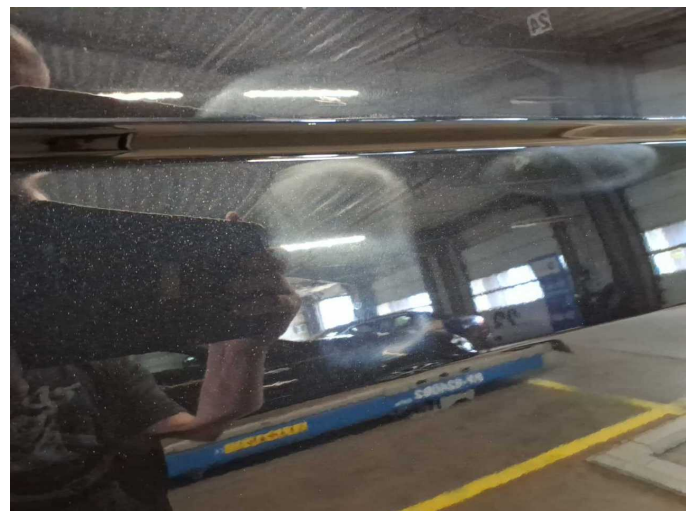
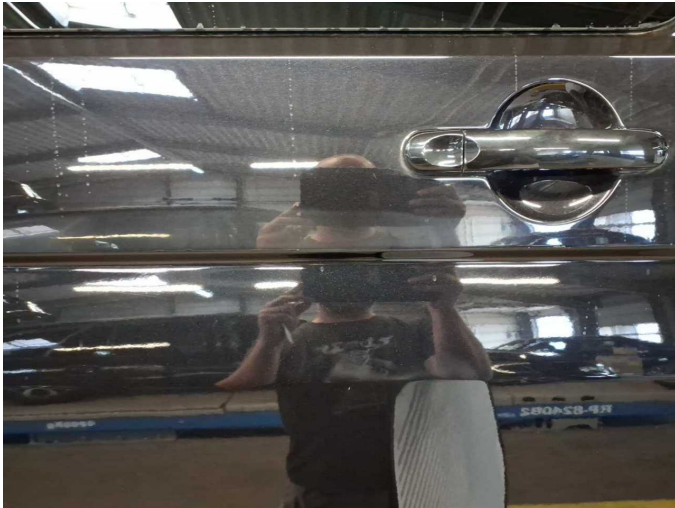
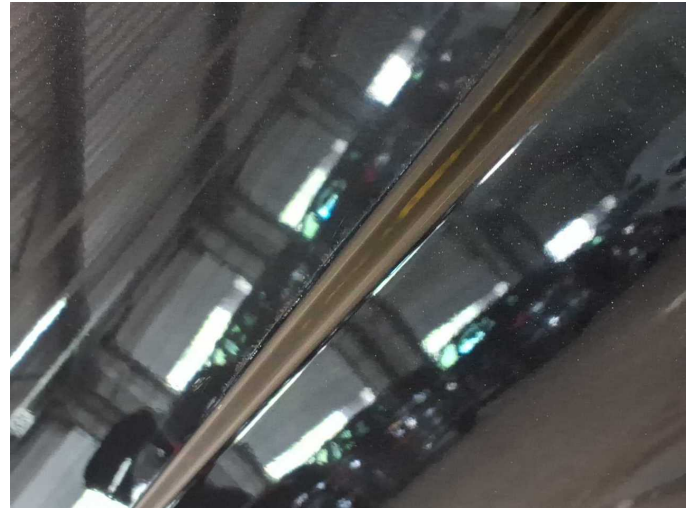
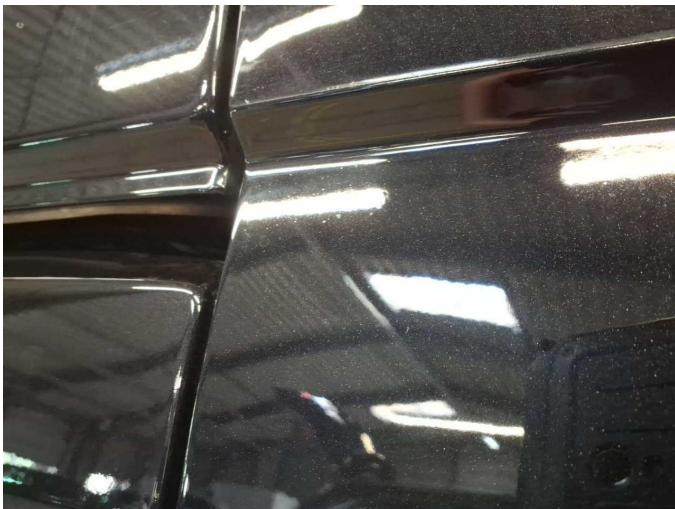
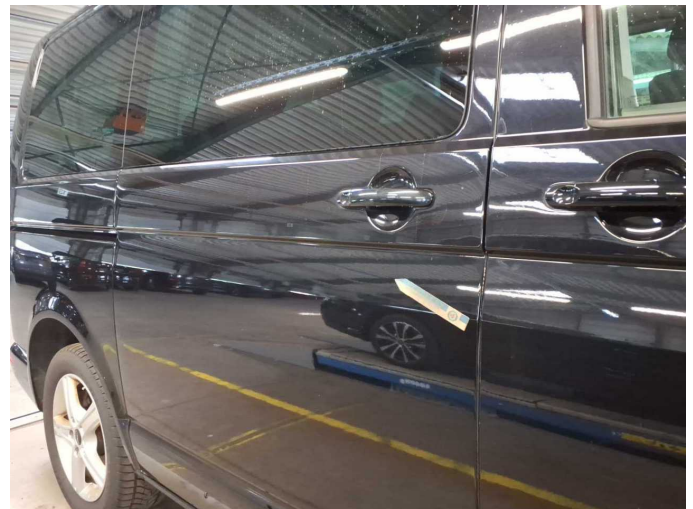
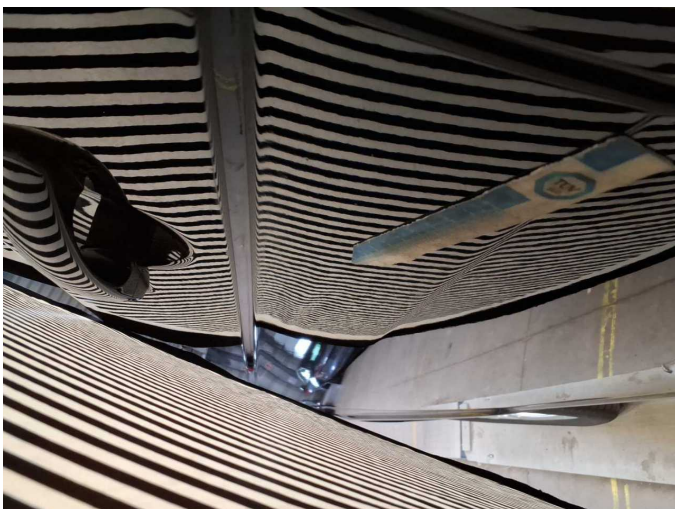
Damage 5: Sliding door, right: Sliding door with glass panel (Einschlüsse, matt poliert, wellig, kante unsauber) - Unprofessionally repaired - Repair and paint

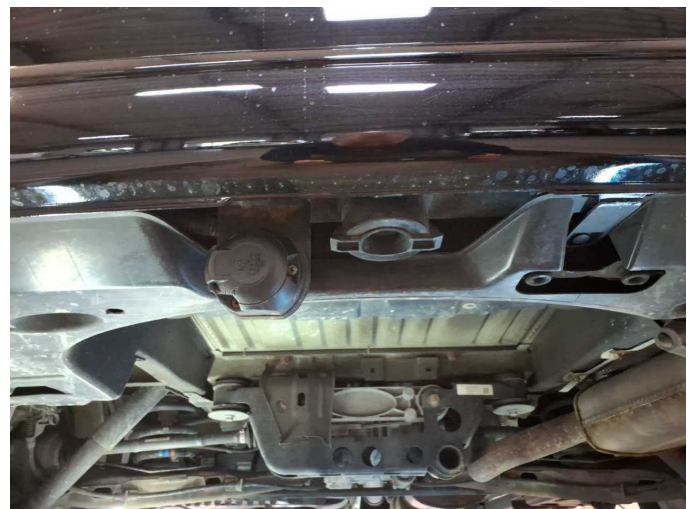
Missing part 1: Rear of vehicle: Trailer hitch - removable (+ Schlüssel) - Missing - Replace

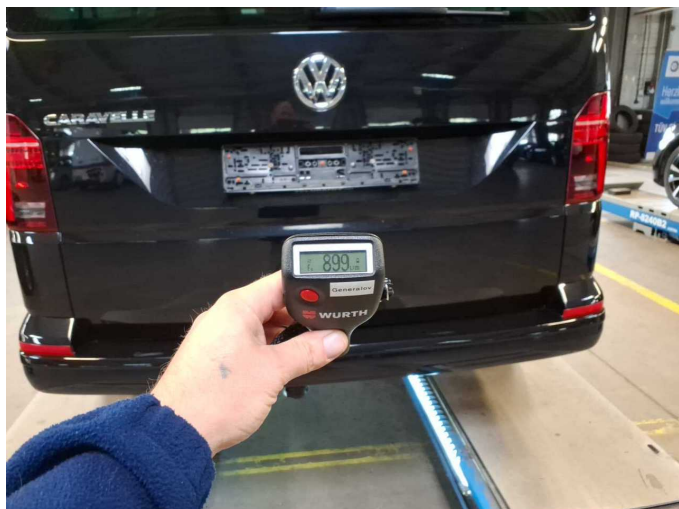
Repainting 1: Boot lid / rear door

- 1 Boot lid / rear door, Professionally carried out, Invoice of repair done Non-existent
- 2 Door - rear right side, Unprofessionally carried out, Invoice of repair done Non-existent

Boot lid / rear door	899 µm	Door - rear right side	163 µm
----------------------	--------	------------------------	--------
