Expertise

Protocol number: 46202509  
Order No. / Reference: 26539874  
Inspection date: 19 Jun 2026

Manufacturer: CUPRA

Model: Born 150kW/58kWh

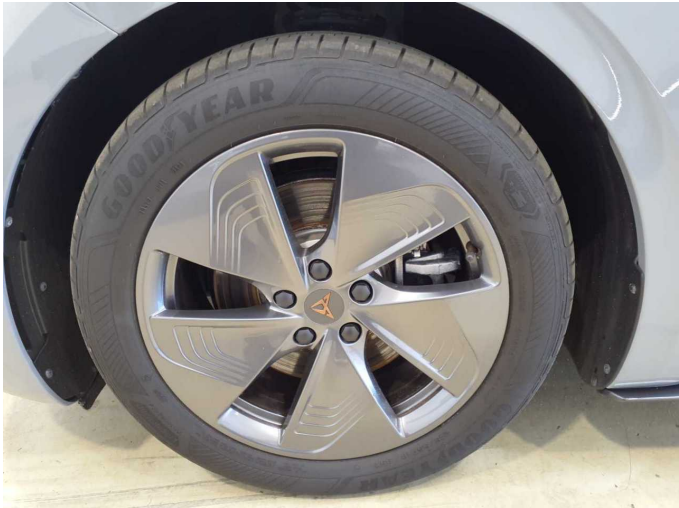
| No. | Component group | Description |
|---|---|---|
| 1 | Wheel / tyres | Tyre - front left side - Porous / cracked - Replace |

Damage 1: Wheel / tyres: Tyre - front left side - Porous / cracked - Replace

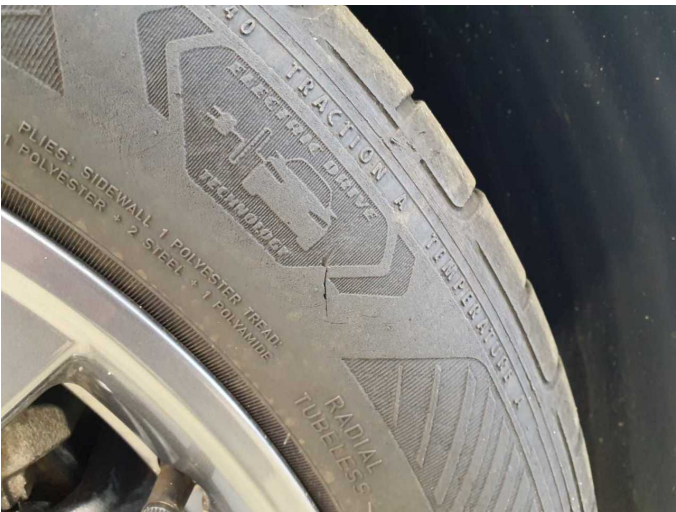
Damage 1: Wheel / tyres: Tyre - front left side - Porous / cracked - Replace

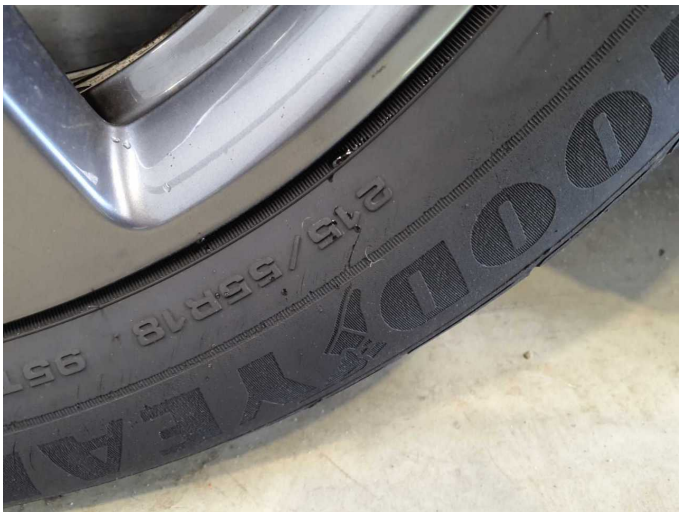
Damage 1: Wheel / tyres: Tyre - front left side - Porous / cracked - Replace

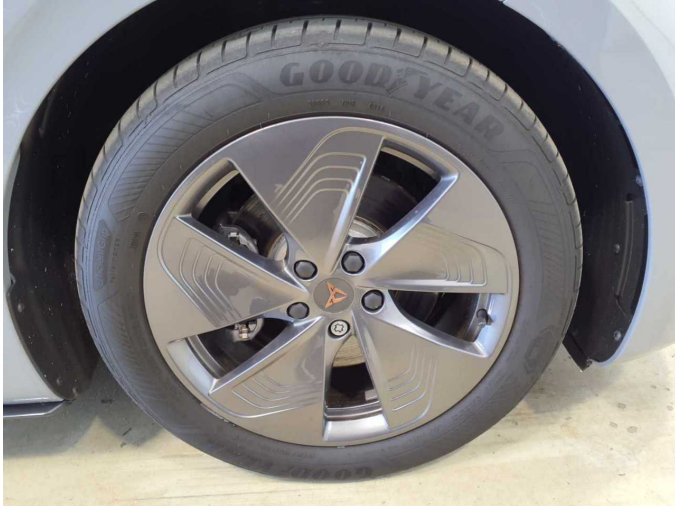
| No. | Component group | Description |
|---|---|---|
| 2 | Wheel / tyres | Tyre - front right side - Porous / cracked - Replace |

**Damage 2:** Wheel / tyres: Tyre - front right side - Porous / cracked - Replace

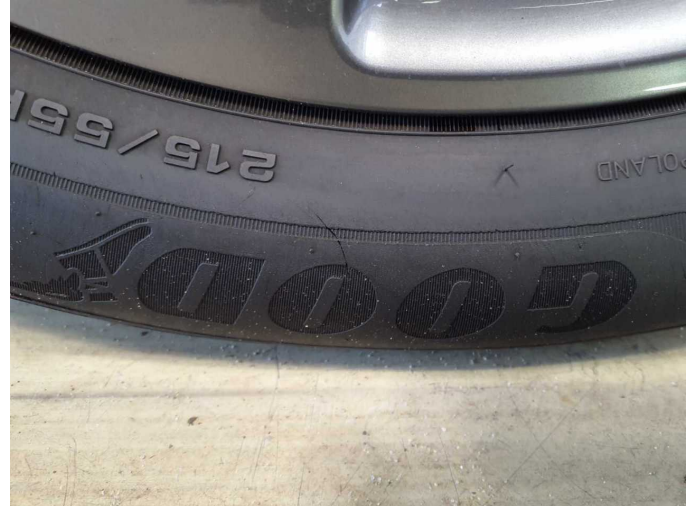
**Damage 2:** Wheel / tyres: Tyre - front right side - Porous / cracked - Replace

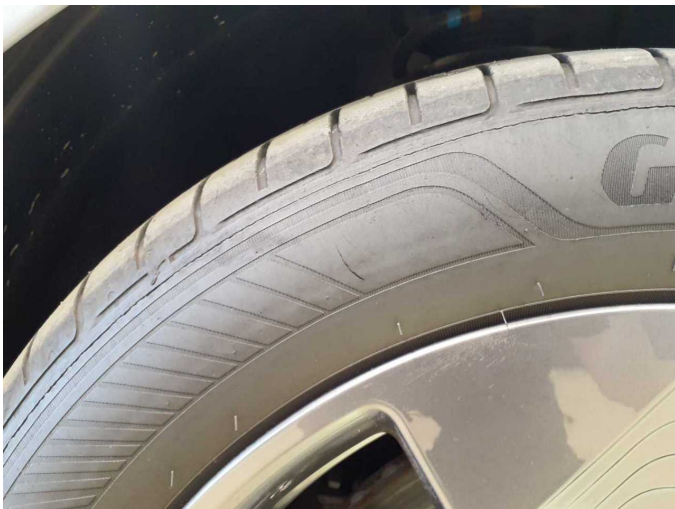
**Damage 2:** Wheel / tyres: Tyre - front right side - Porous / cracked - Replace

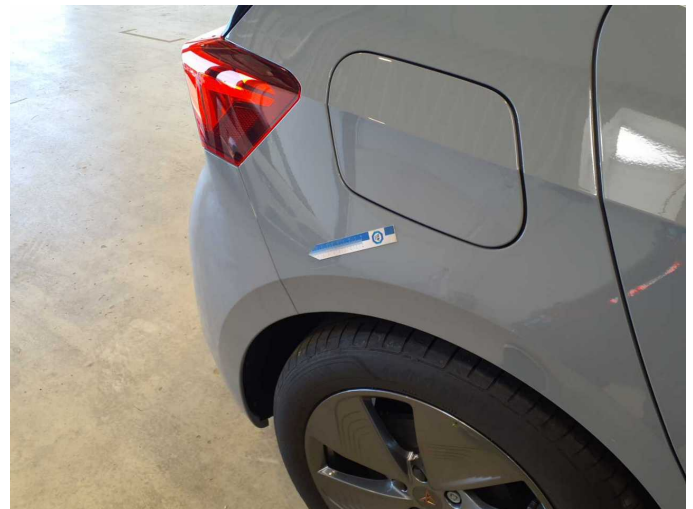
| No. | Component group | Description |
|---|---|---|
| 3 | Side panel - rear right side | Side panel - Scratch(es) - Smart repair |

**Damage 3:** Side panel - rear right side: Side panel - Scratch(es) - Smart repair

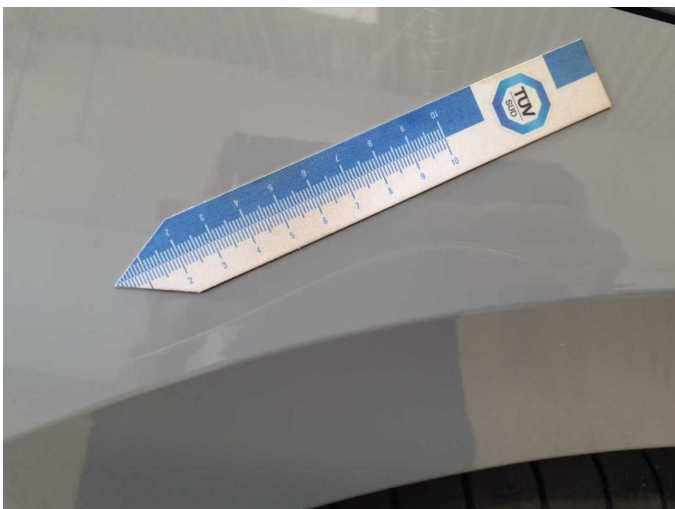
**Damage 3:** Side panel - rear right side: Side panel - Scratch(es) - Smart repair

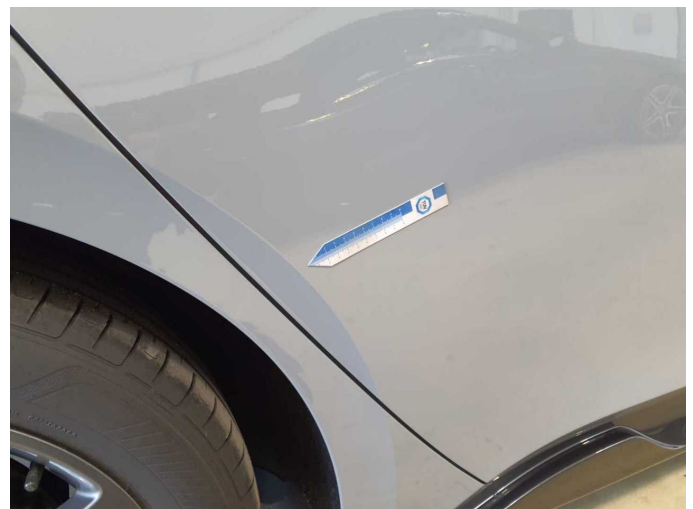
| No. | Component group | Description |
|---|---|---|
| 4 | Door - rear right side | Door - Scratch(es) - Paint |

**Damage 4:** Door - rear right side: Door - Scratch(es) - Paint

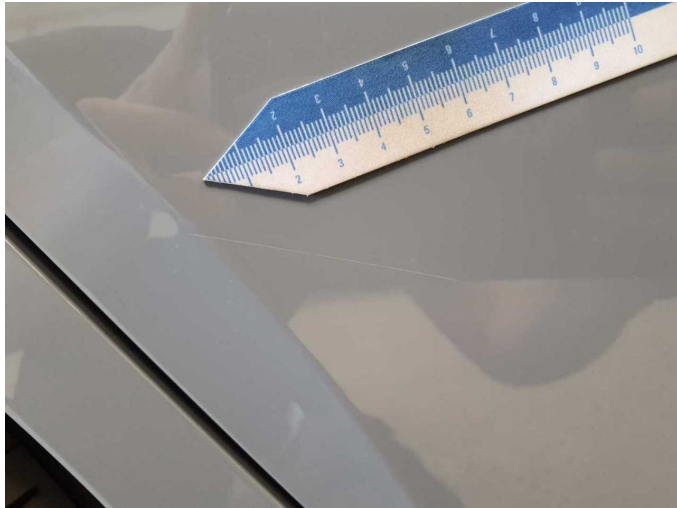
**Damage 4:** Door - rear right side: Door - Scratch(es) - Paint

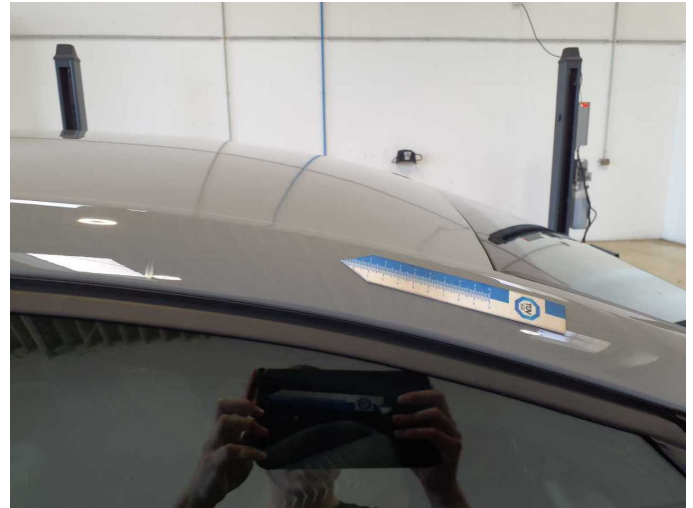
| No. | Component group | Description |
|---|---|---|
| 2 | Roof | Roof rail - right side - Scratch(es) - No deduction |

**Wear and tear 2:** Roof: Roof rail - right side - Scratch(es) - No deduction

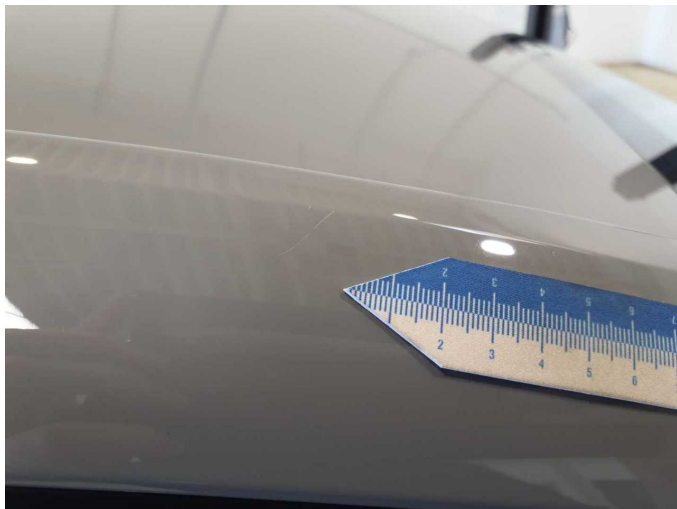
**Wear and tear 2:** Roof: Roof rail - right side - Scratch(es) - No deduction

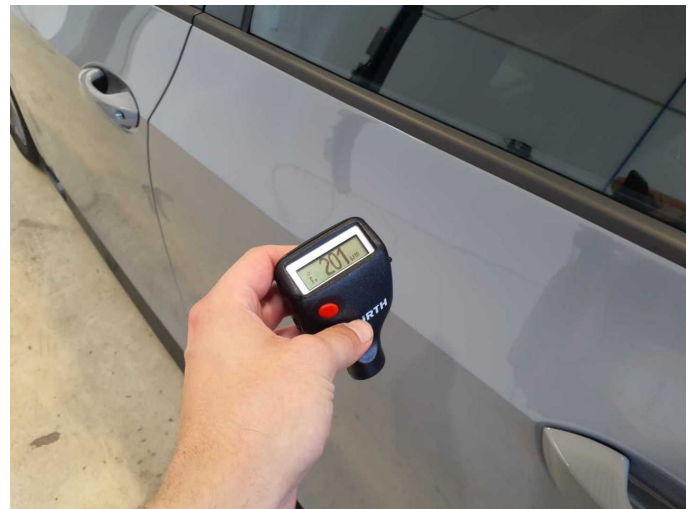
| 1 | Mudguard - left side, Door - rear left side, Door - front left side, Professionally carried out, Invoice of repair done Non-existent |

| Mudguard - left side | 175 µm | Door - rear left side | 201 µm |
| Door - front left side | 162 µm | | |

**Repainting 1:** Mudguard - left side, Door - rear left side, Door - front left side

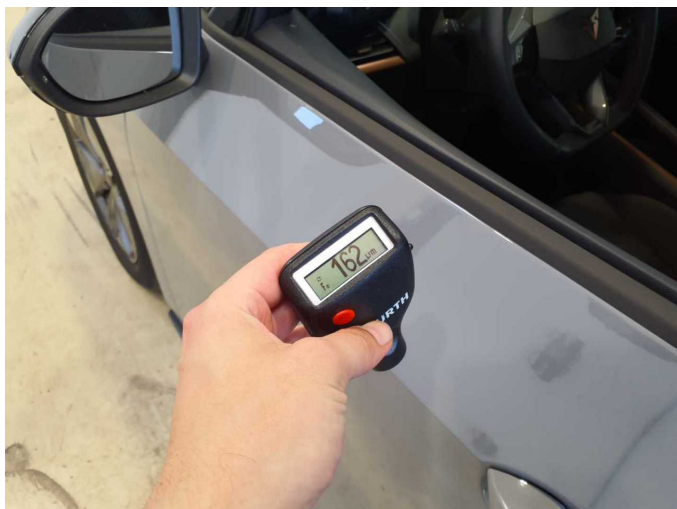
**Repainting 1:** Mudguard - left side, Door - rear left side, Door - front left side

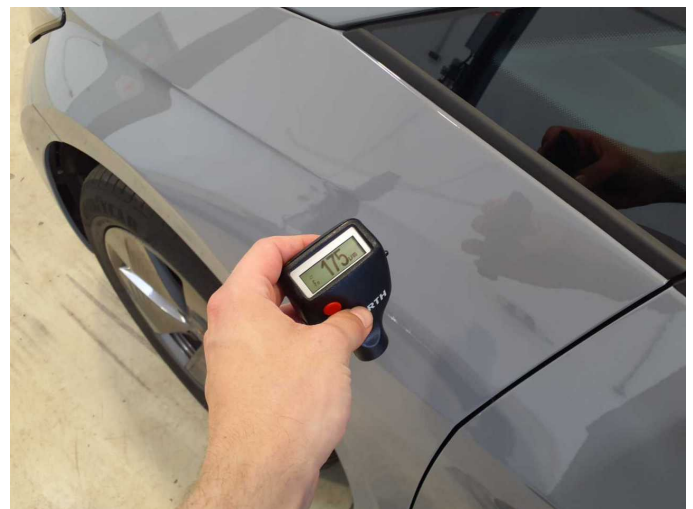
**Repainting 1:** Mudguard - left side, Door - rear left side, Door - front left side
