Expertise

Protocol number: 46193336
Order No. / Reference: 25933026
Inspection date: 21 May 2026

Manufacturer: Mercedes-Benz

Model: Vito 116 CDI Lang HA Aut. PRO

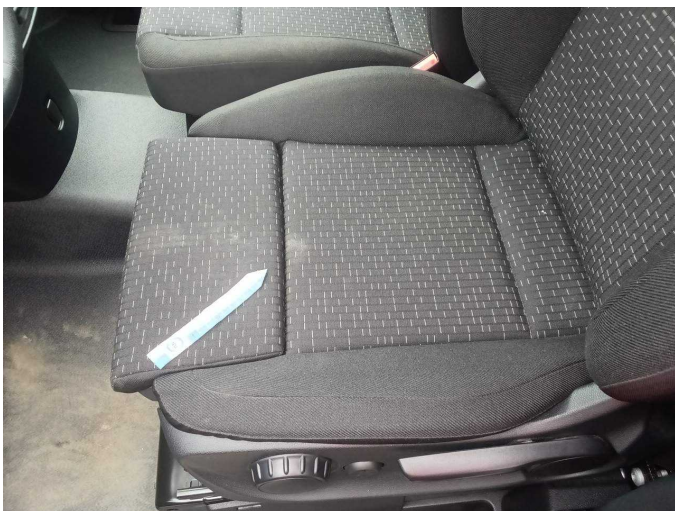
Damage 2: Seat - front: Seat cover - left side - Soiled - Clean

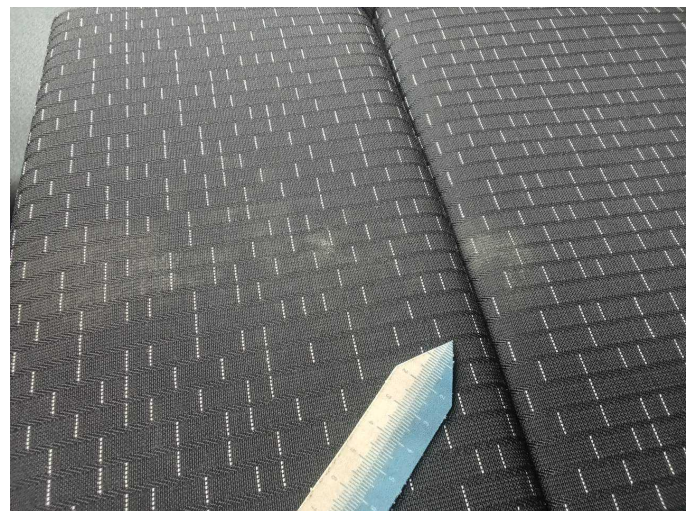
Damage 2: Seat - front: Seat cover - left side - Soiled - Clean

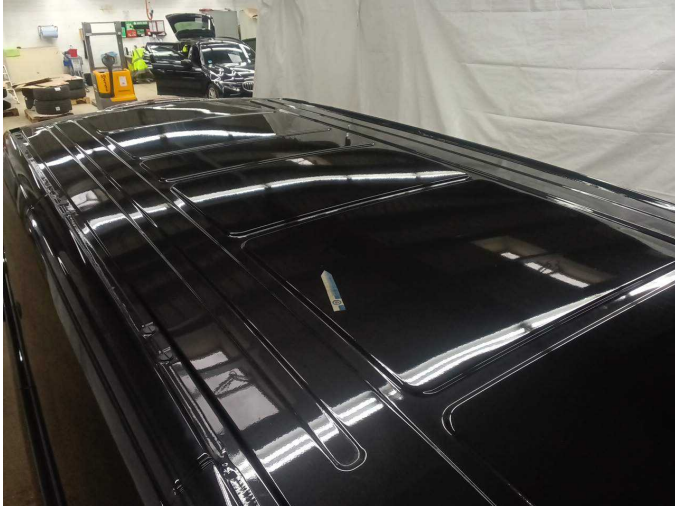
Damage 3: Roof: Roof - dent(s) - Smooth repair work

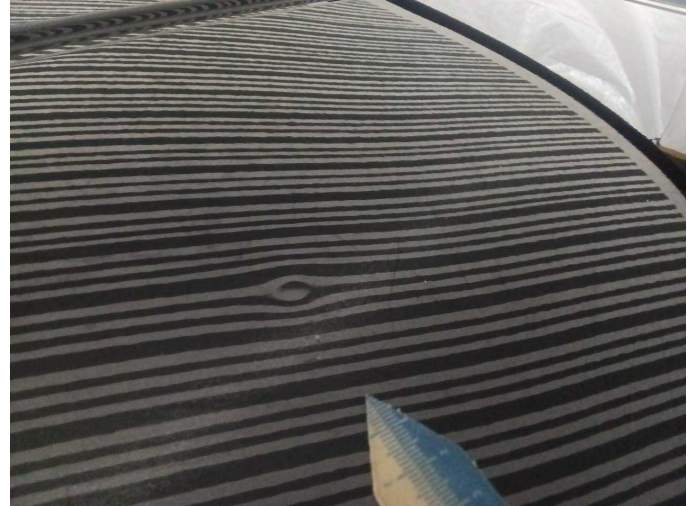
Damage 3: Roof: Roof - dent(s) - Smooth repair work

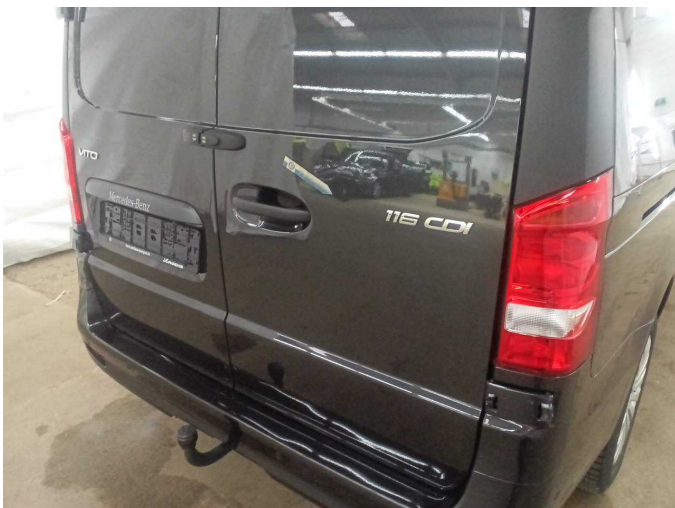
Damage 4: Boot lid / rear door: Boot lid - dent(s) - Smooth repair work

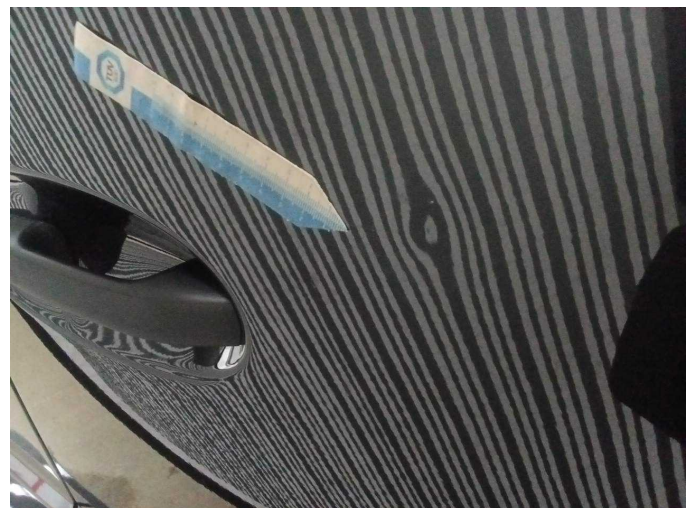
Damage 4: Boot lid / rear door: Boot lid - dent(s) - Smooth repair work

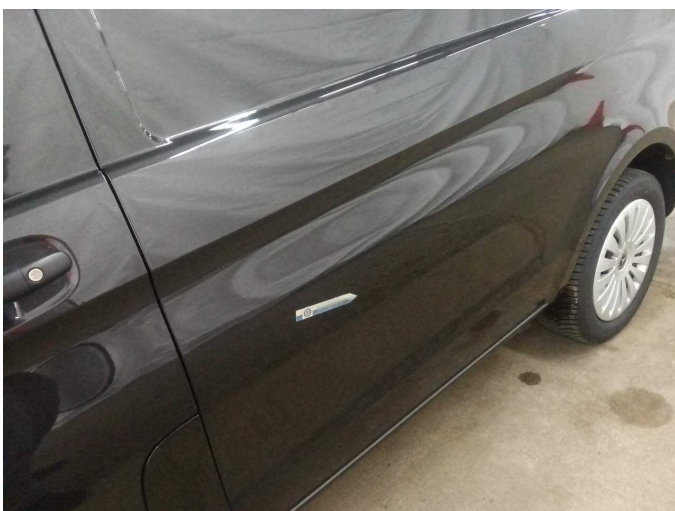
Damage 5: Side panel - rear left side: Side panel - dent(s) - Smooth repair work

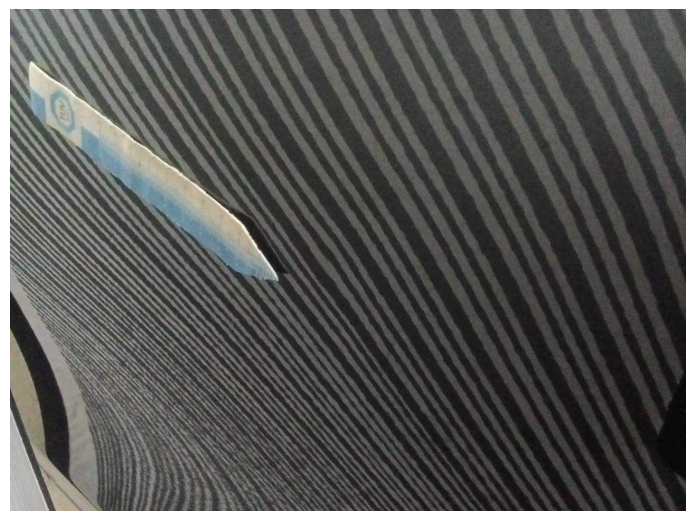
Damage 5: Side panel - rear left side: Side panel - dent(s) - Smooth repair work

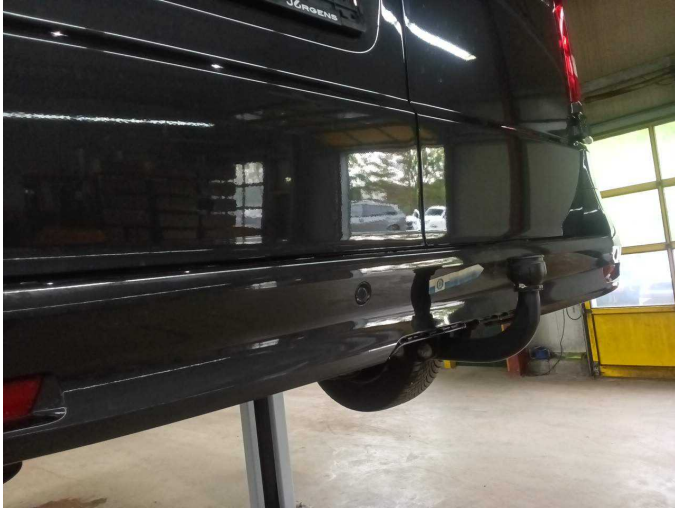
Damage 6: Rear bumper: Rear bumper - Dent / paintcoat damage - Repair and paint

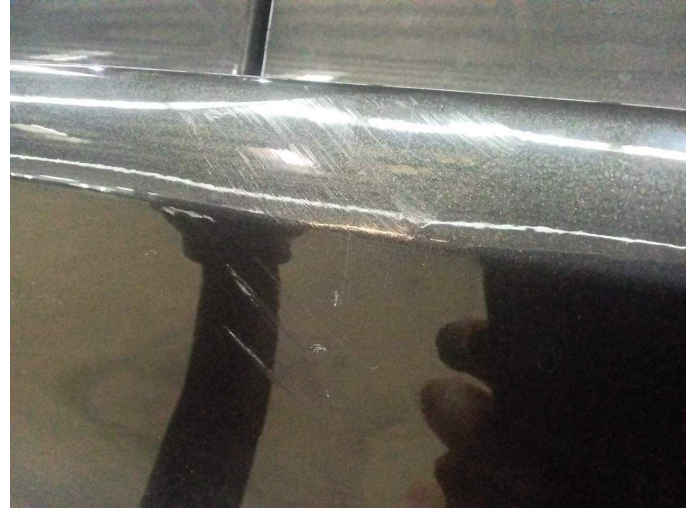
Damage 6: Rear bumper: Rear bumper - Dent / paintcoat damage - Repair and paint

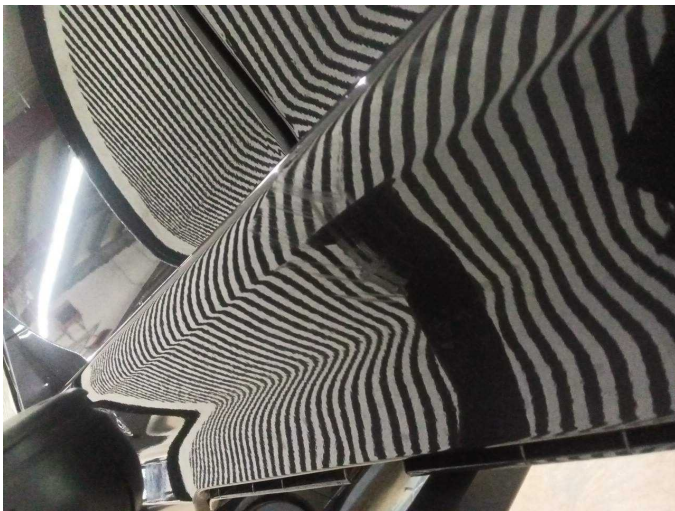
Damage 6: Rear bumper: Rear bumper - Dent / paintcoat damage - Repair and paint
