Expertise

Protocol number: 46605981  
Order No. / Reference: 26701943  
Inspection date: 20 Jul 2026

Manufacturer: Volkswagen  
VIN: WVGZZCD1PW513507

Model: Golf Variant 2.0 TDI SCR DSG Style

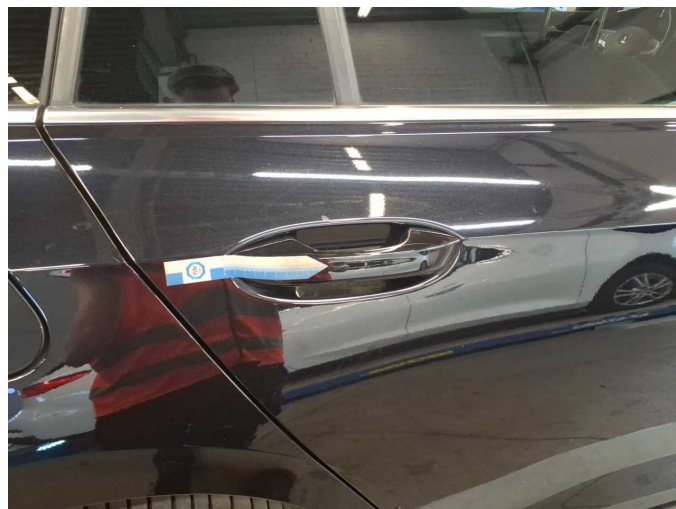
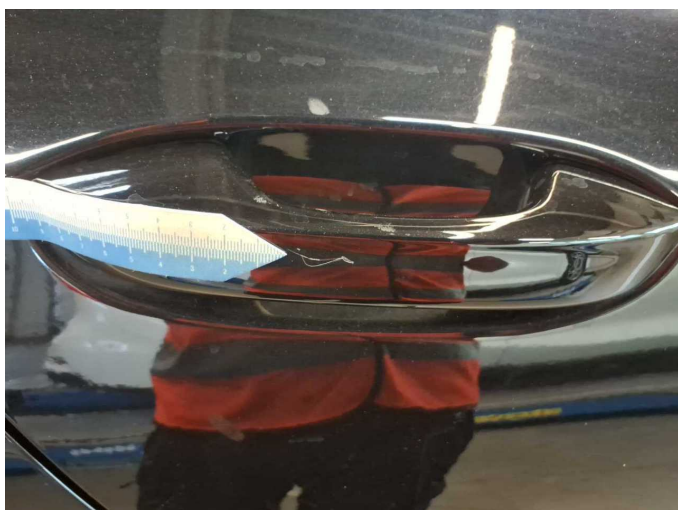
| No. | Component group | Description |
|---|---|---|
| 1 | Door - rear right side | Door handle - outside - Scratch(es) - Smart repair |

**Damage 1:** Door - rear right side: Door handle - outside - Scratch(es) - Smart repair

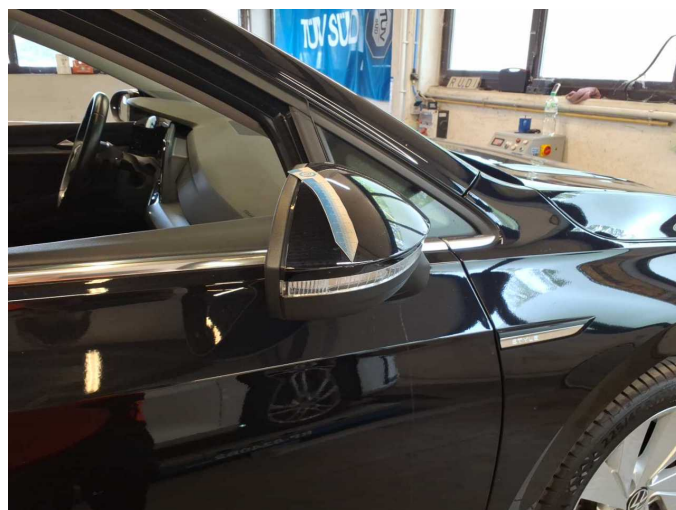
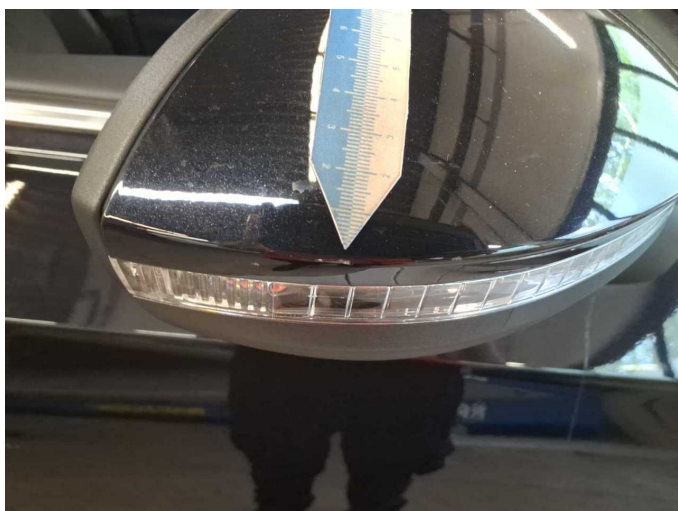
| No. | Component group | Description |
|---|---|---|
| 2 | Wing mirror - right side | Cap - Scratch(es) - Smart repair |

**Damage 2:** Wing mirror - right side: Cap - Scratch(es) - Smart repair

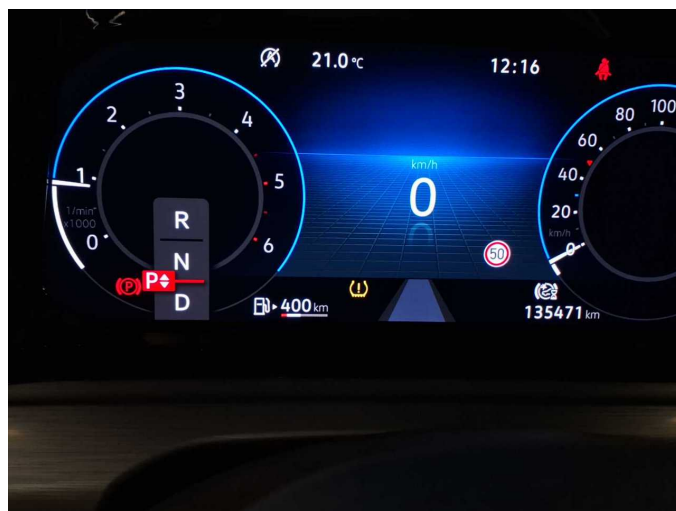
| No. | Component group | Description |
|---|---|---|
| 3 | Instrument panel | Indicator light (Reifendruck) - on - Perform diagnosis |

**Damage 3:** Instrument panel: Indicator light (Reifendruck) - on - Perform diagnosis

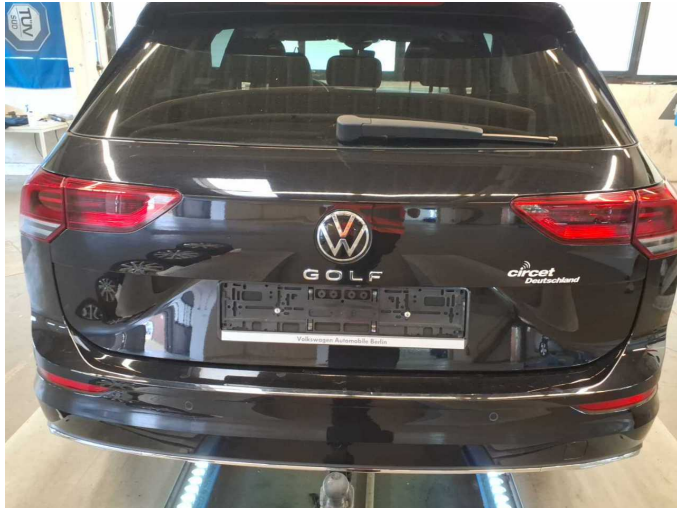
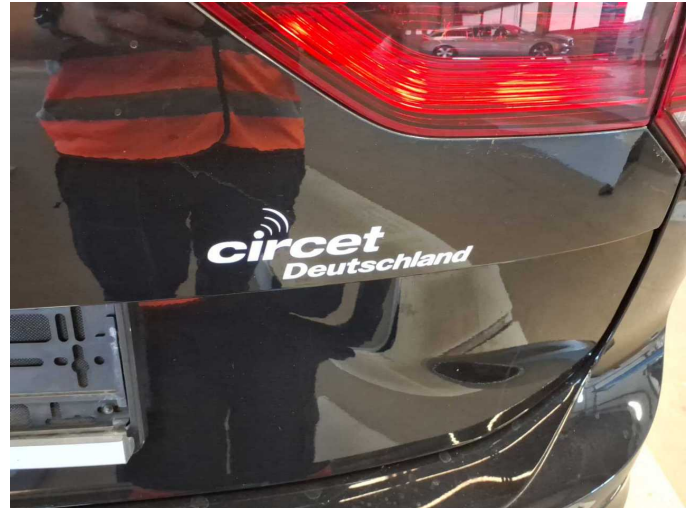
| No. | Component group | Description |
|---|---|---|
| 4 | Boot lid / rear door | Boot lid - Glued / labelled - De-glue / neutralise |

**Damage 4:** Boot lid / rear door: Boot lid - Glued / labelled - De-glue / neutralise

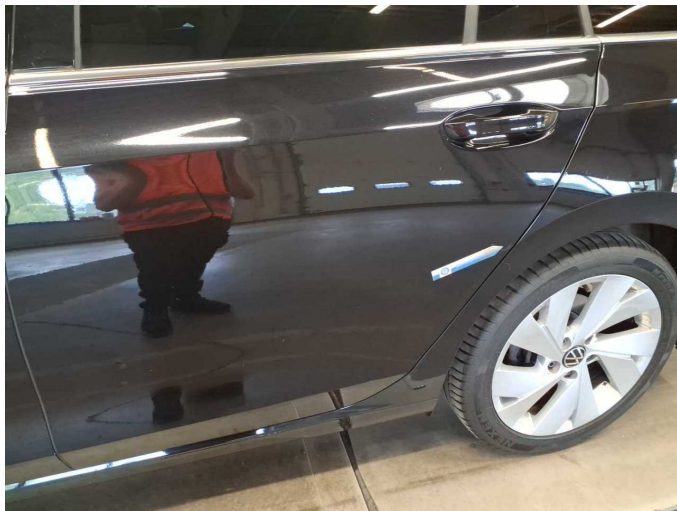
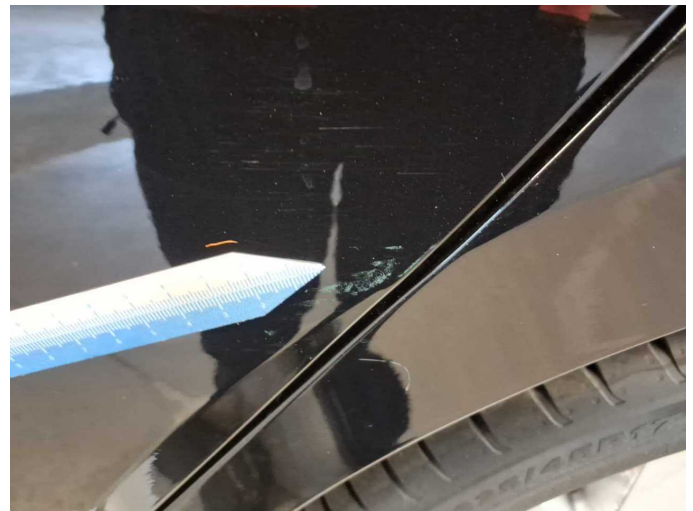
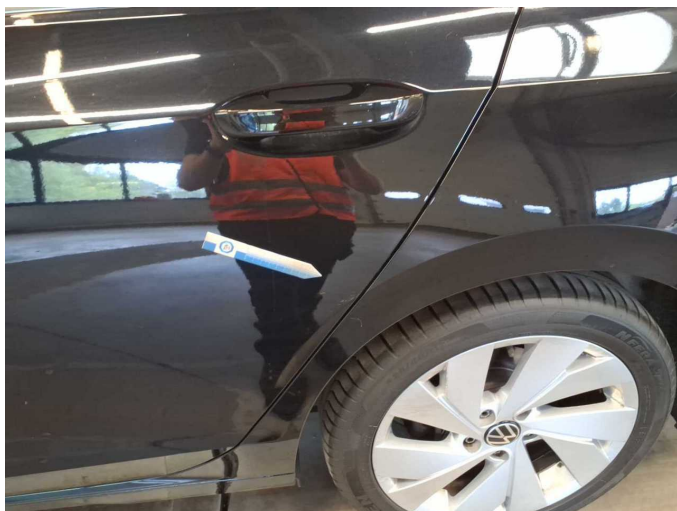
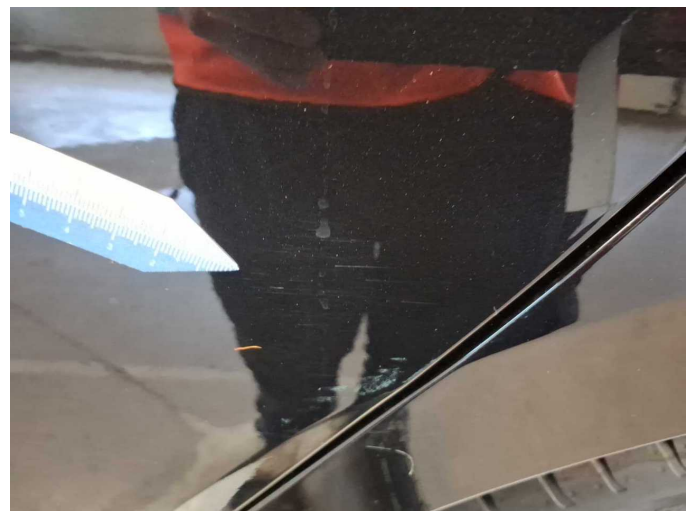
| No. | Component group | Description |
|---|---|---|
| 5 | Door - rear left side | Door - Scratched - Smart repair |

**Damage 5:** Door - rear left side: Door - Scratched - Smart repair

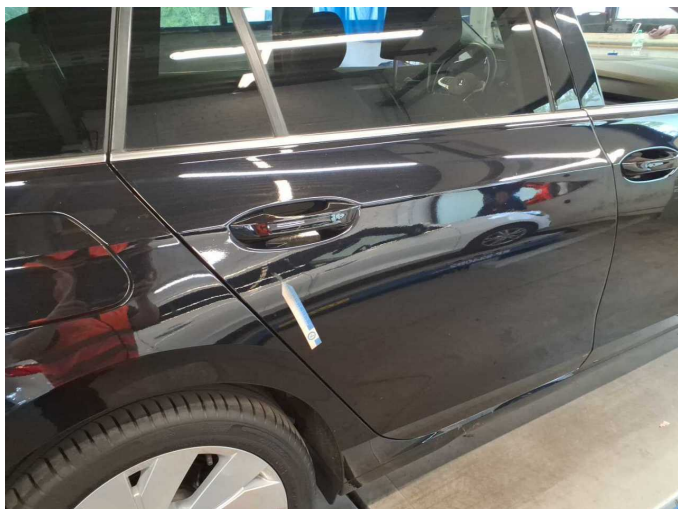
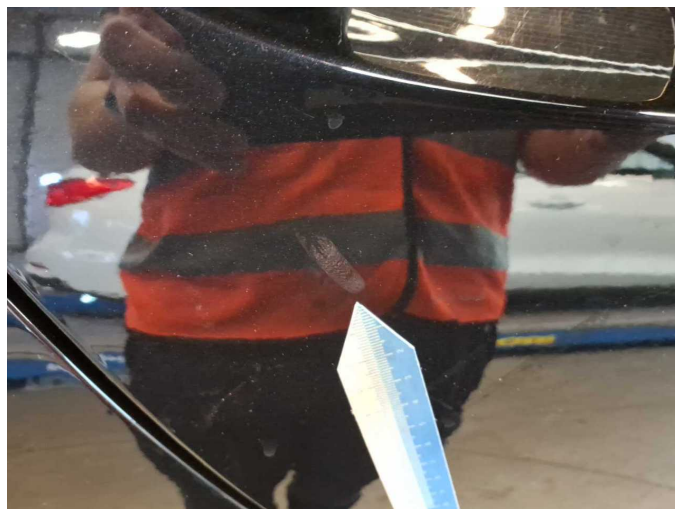
| No. | Component group | Description |
|---|---|---|
| 6 | Door - rear right side | Door - Scratched - Smart repair |

**Damage 6:** Door - rear right side: Door - Scratched - Smart repair

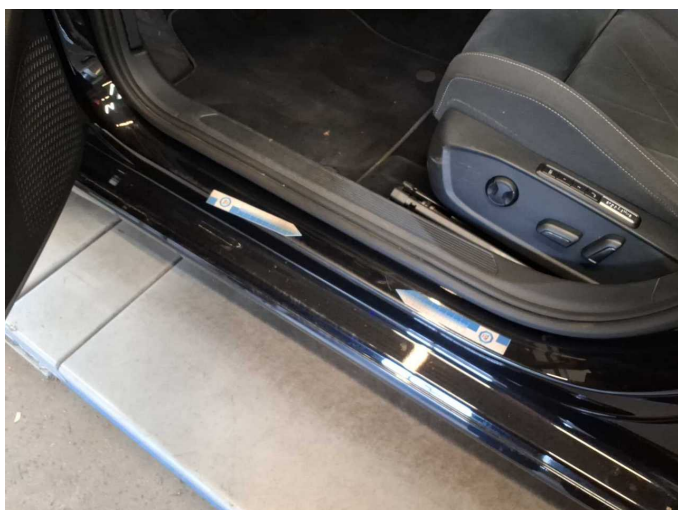
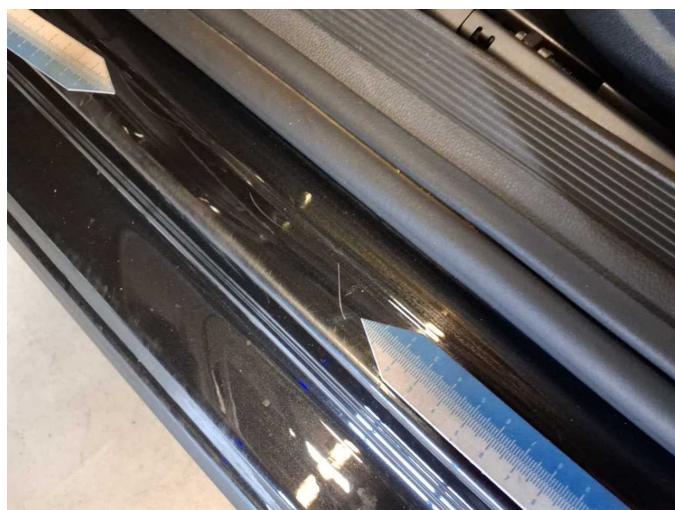
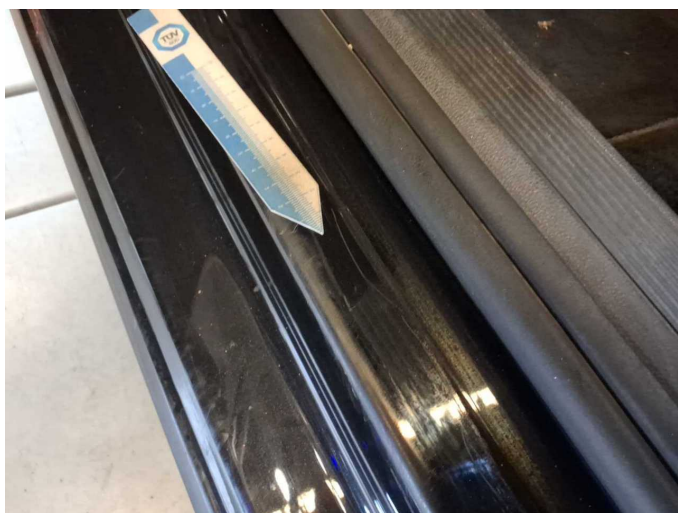
| No. | Component group | Description |
|---|---|---|
| 7 | Sill - left side | Sill - Scratch(es) - Smart repair |

**Damage 7:** Sill - left side: Sill - Scratch(es) - Smart repair

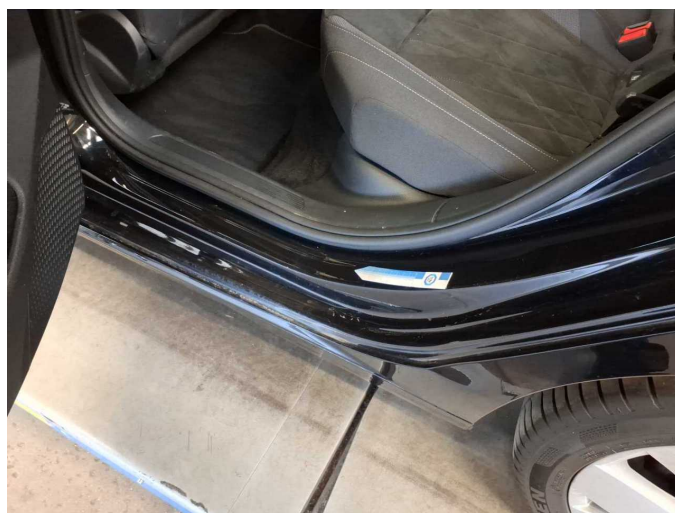
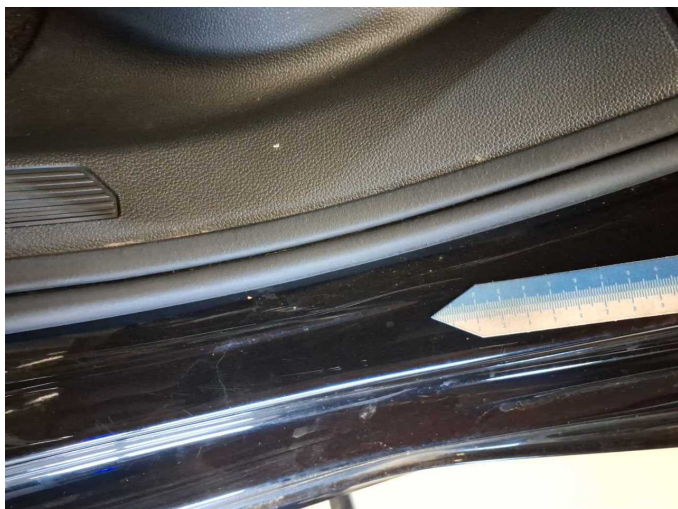
| No. | Component group | Description |
|---|---|---|
| 8 | Side panel - rear left side | Sill - Scratch(es) - Smart repair |

**Damage 8:** Side panel - rear left side: Sill - Scratch(es) - Smart repair

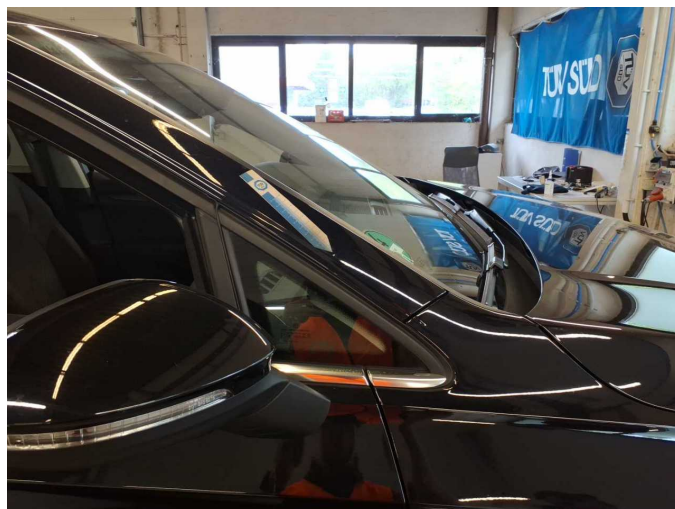
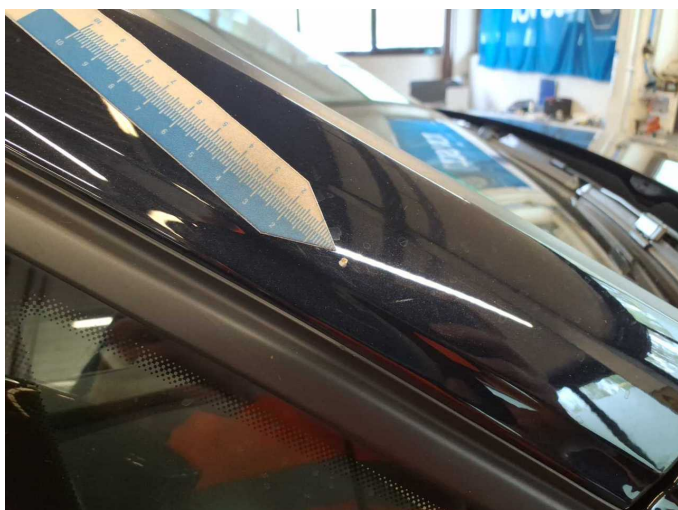
| No. | Component group | Description |
|---|---|---|
| 9 | Roof | Roof rail - right side - Stone chips - Smart repair |

**Damage 9:** Roof: Roof rail - right side - Stone chips - Smart repair

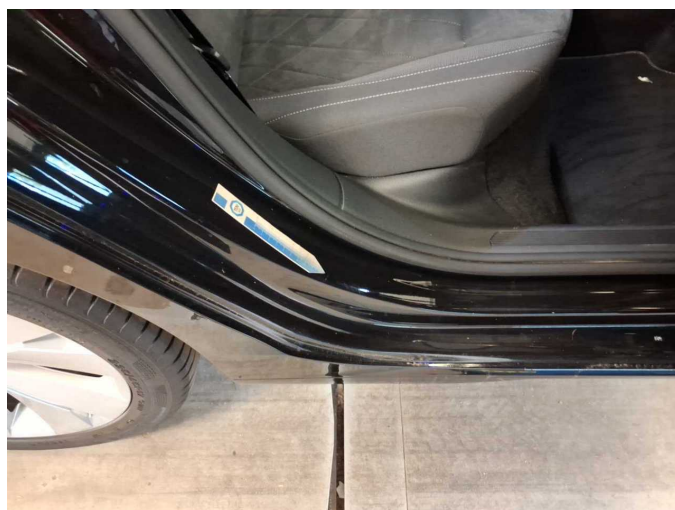
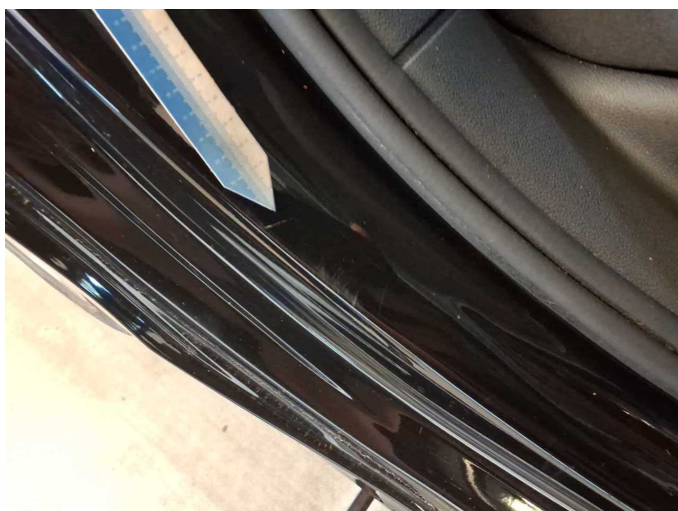
| No. | Component group | Description |
|---|---|---|
| 10 | Side panel - rear right side | Sill - Scratch(es) - Smart repair |

**Damage 10:** Side panel - rear right side: Sill - Scratch(es) - Smart repair

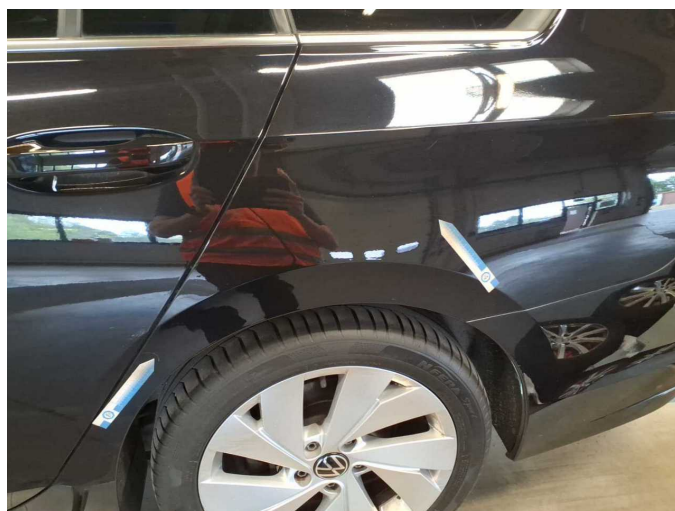
| No. | Component group | Description |
|---|---|---|
| 11 | Side panel - rear left side | Side panel - Scratch(es) - Smart repair |

**Damage 11:** Side panel - rear left side: Side panel - Scratch(es) - Smart repair

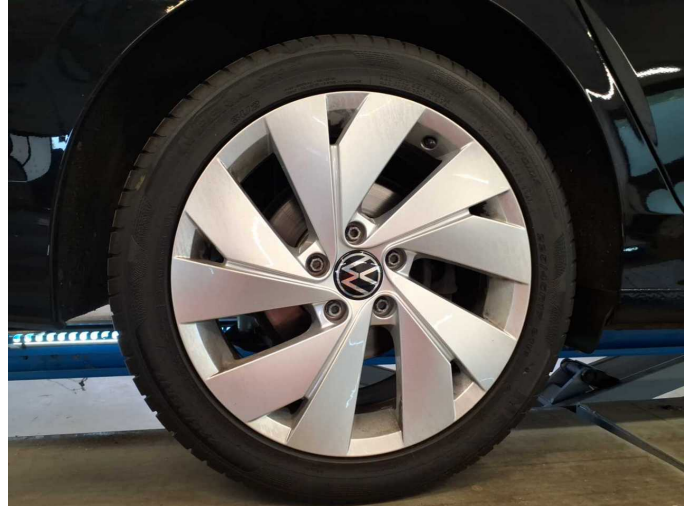
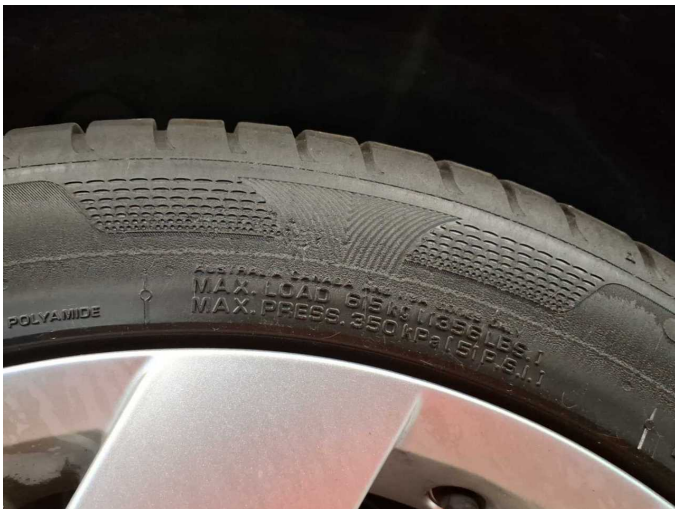
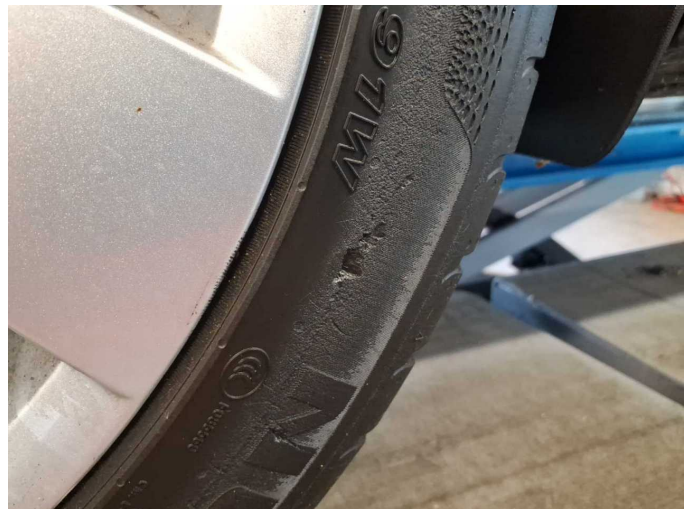
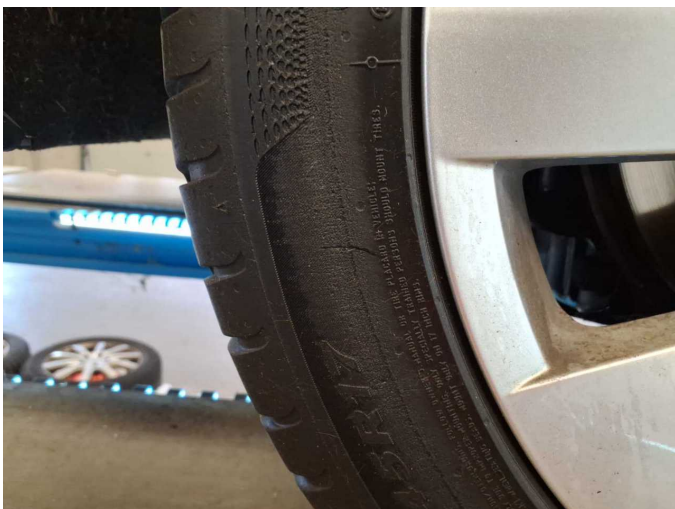
| No. | Component group | Description |
|---|---|---|
| 12 | Wheel / tyres | Tyre - rear right side - Porous / cracked - Replace |

**Damage 12:** Wheel / tyres: Tyre - rear right side - Porous / cracked - Replace

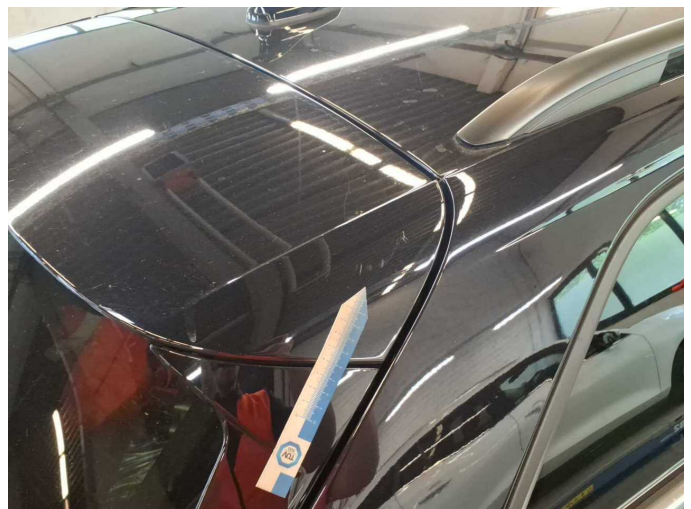
| No. | Component group | Description |
|---|---|---|
| 13 | Boot lid / rear door | Boot lid - Scratch(es) - Paint |

**Damage 13:** Boot lid / rear door: Boot lid - Scratch(es) - Paint

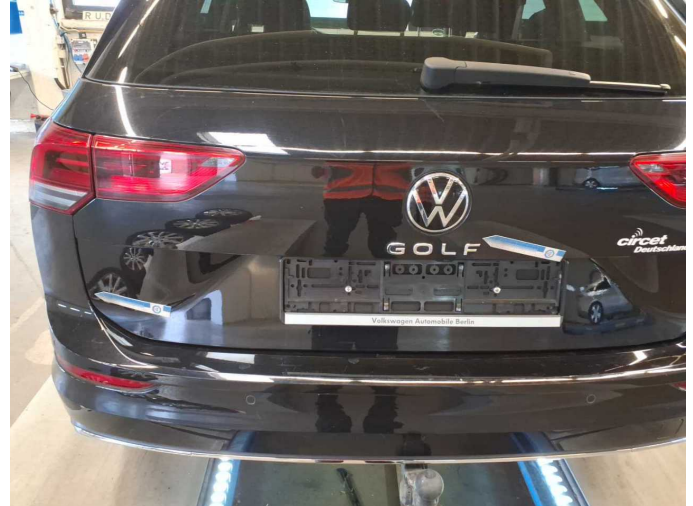
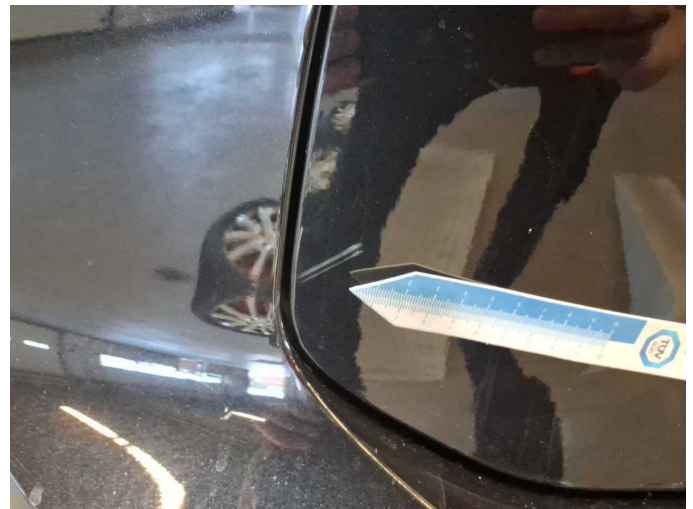
| No. | Component group | Description |
|---|---|---|
| 14 | Boot lid / rear door | Boot lid - Scratch(es) - Paint |

**Damage 14:** Boot lid / rear door: Boot lid - Scratch(es) - Paint

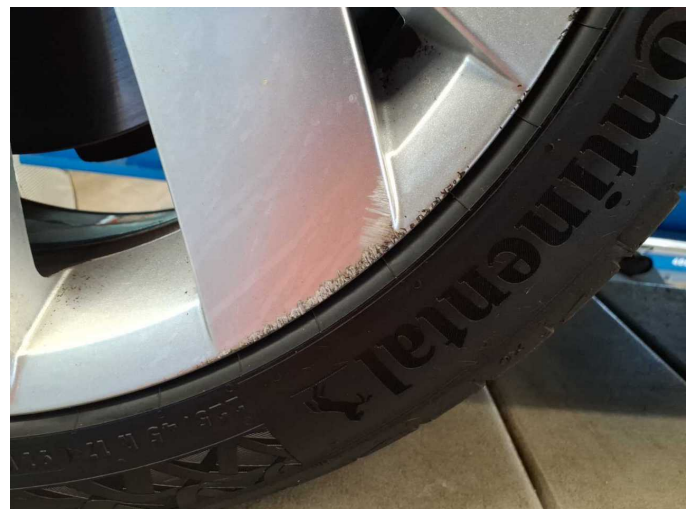
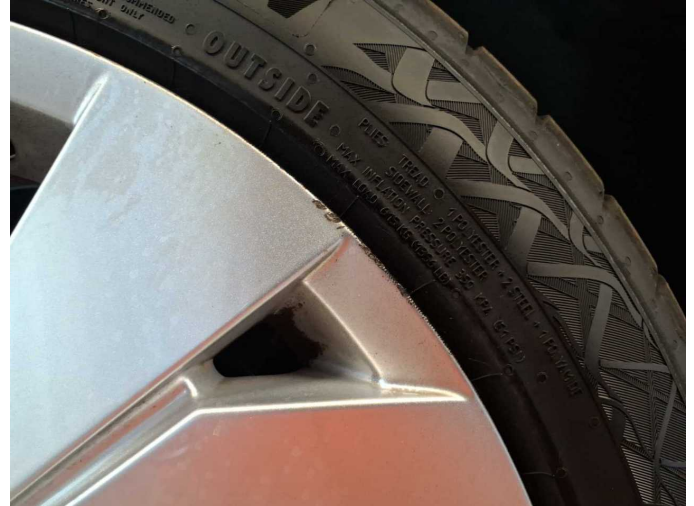
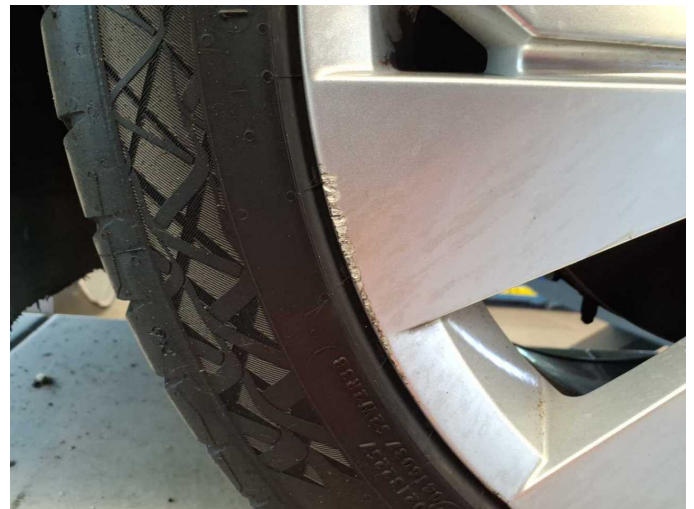
| No. | Component group | Description |
|---|---|---|
| 15 | Wheel / tyres | Alloy rim - front left side - Scratch(es) - Replace |

**Damage 15:** Wheel / tyres: Alloy rim - front left side - Scratch(es) - Replace

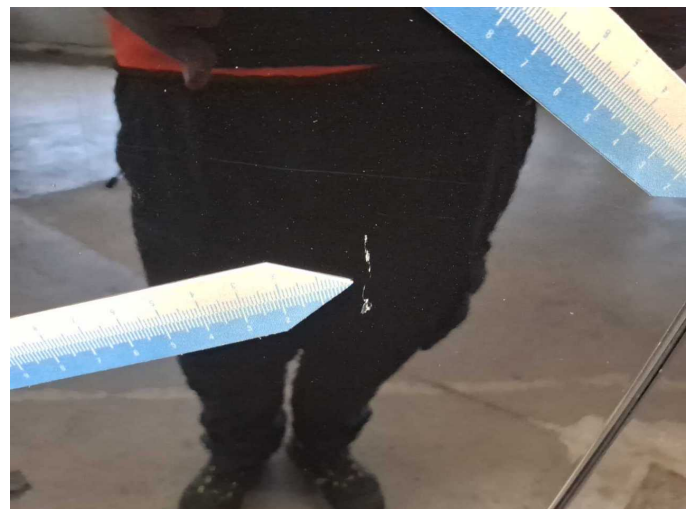
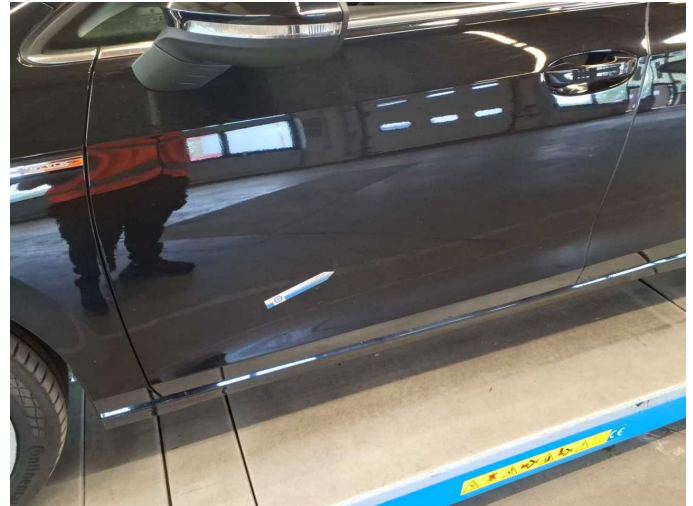
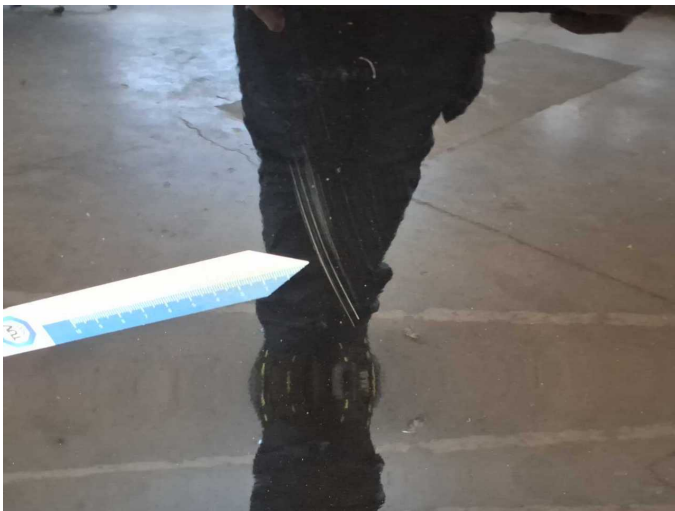
| No. | Component group | Description |
|---|---|---|
| 16 | Door - front left side | Door - Scratch(es) - Paint |

**Damage 16:** Door - front left side: Door - Scratch(es) - Paint

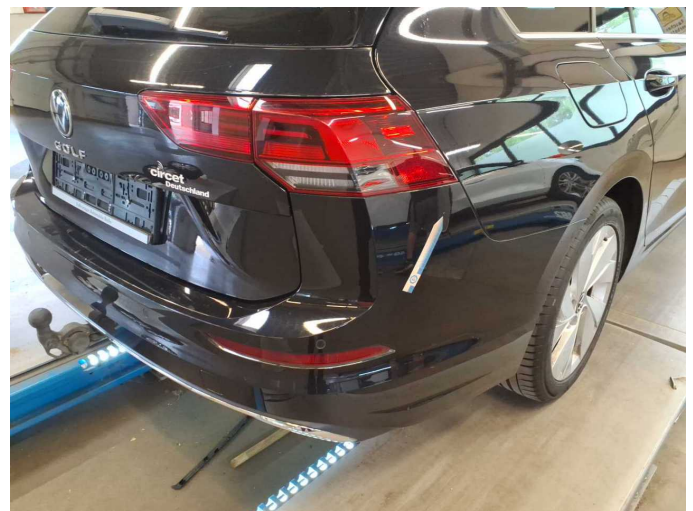
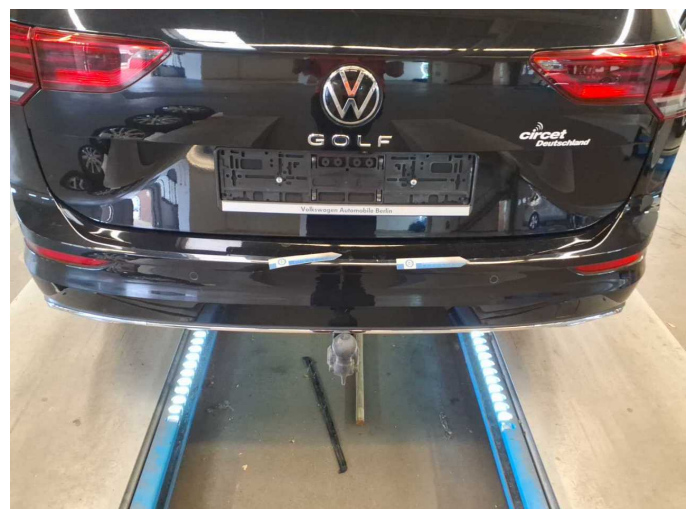
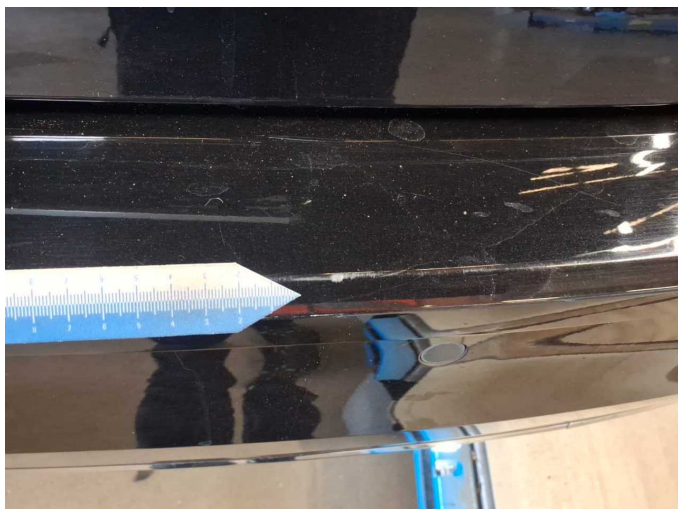
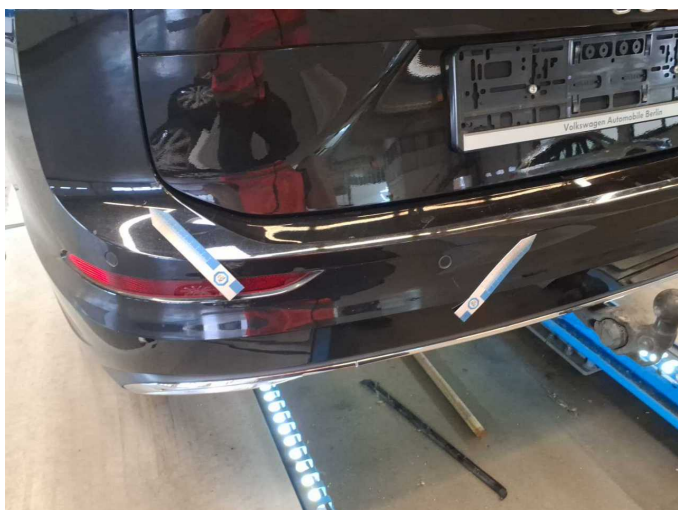
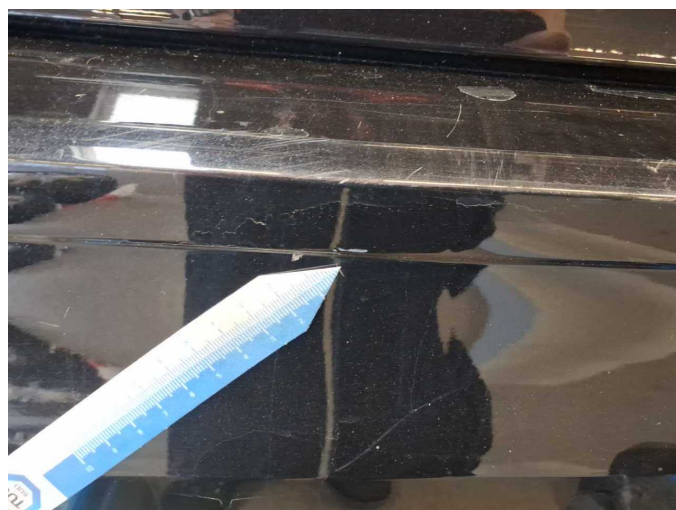
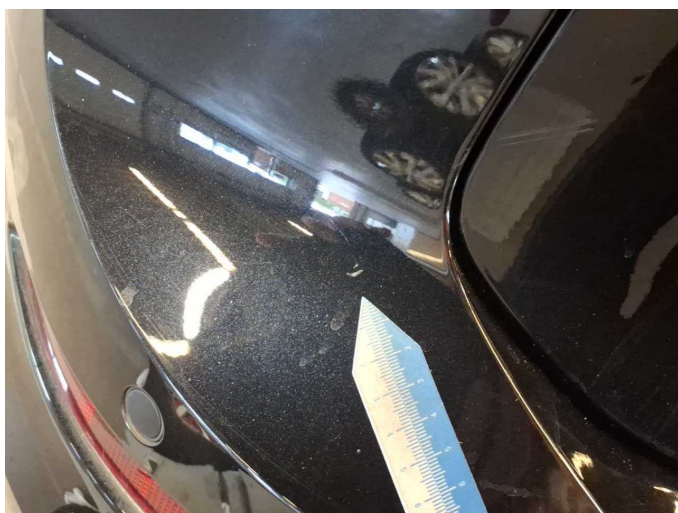
| No. | Component group | Description |
|---|---|---|
| 17 | Rear bumper | Rear bumper - Scratch(es) - Paint |

**Damage 17:** Rear bumper: Rear bumper - Scratch(es) - Paint

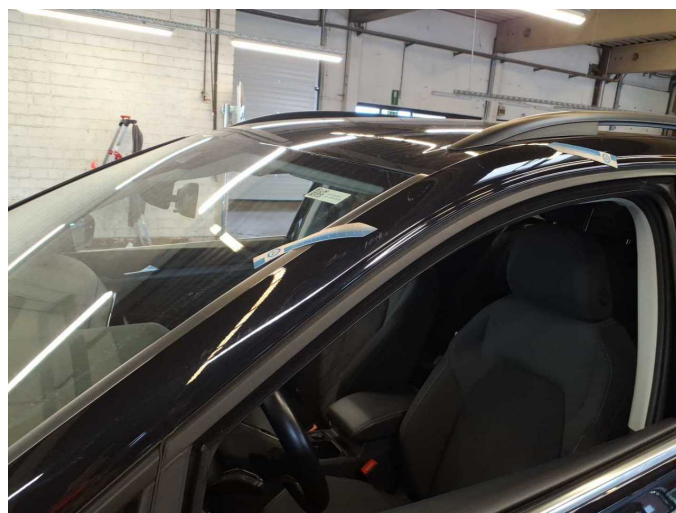
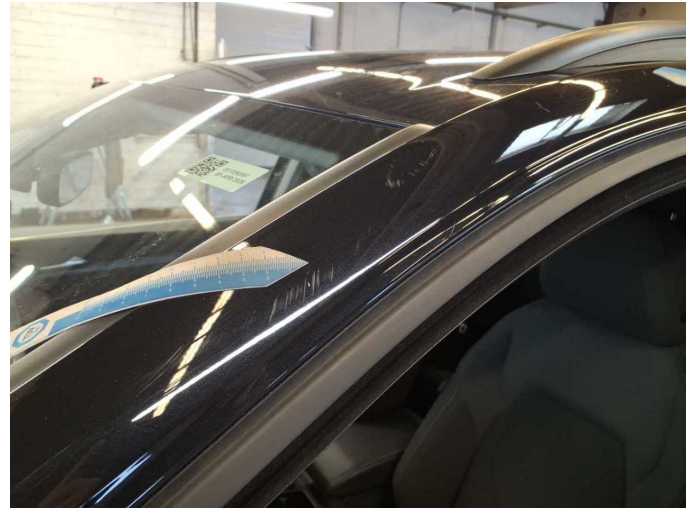
| No. | Component group | Description |
|---|---|---|
| 18 | Roof | Roof rail - left side - Scratch(es) - Paint |

**Damage 18:** Roof: Roof rail - left side - Scratch(es) - Paint

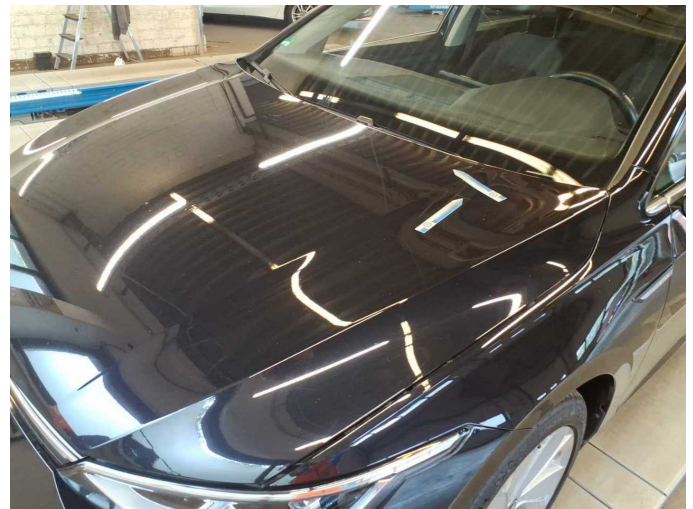
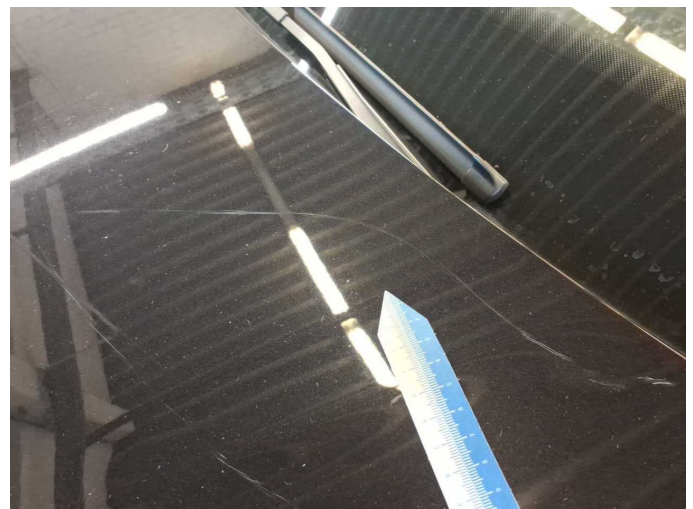
| No. | Component group | Description |
|---|---|---|
| 19 | Bonnet | Bonnet - Scratch(es) - Paint |

**Damage 19:** Bonnet: Bonnet - Scratch(es) - Paint

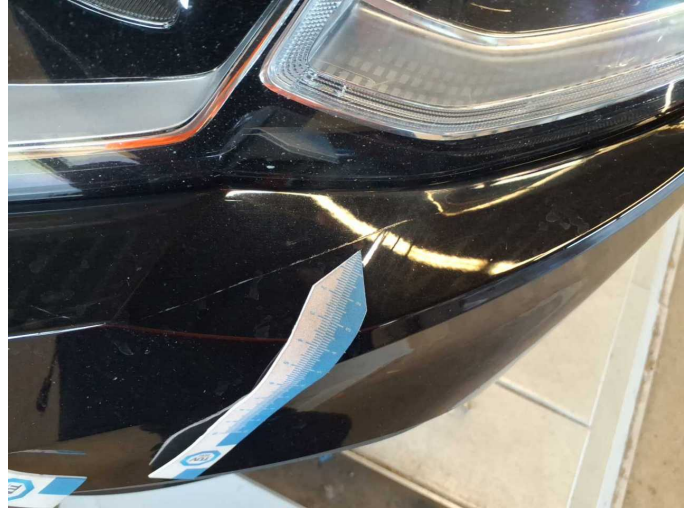
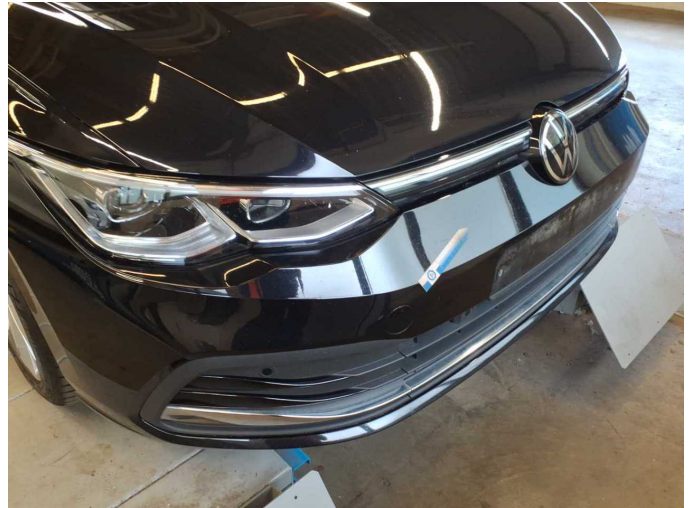
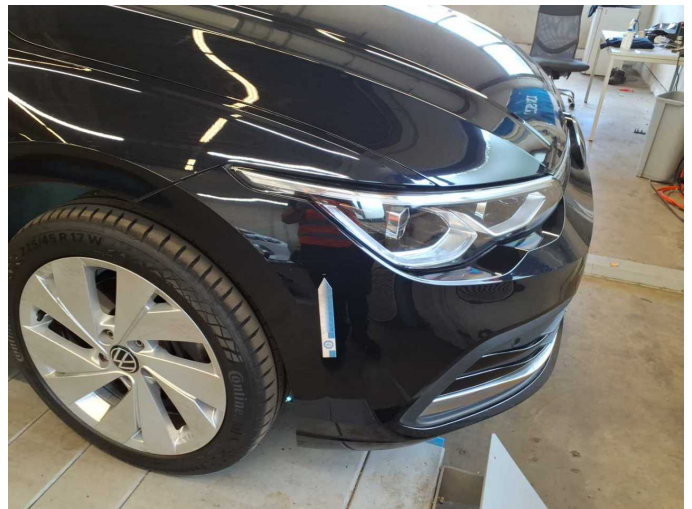
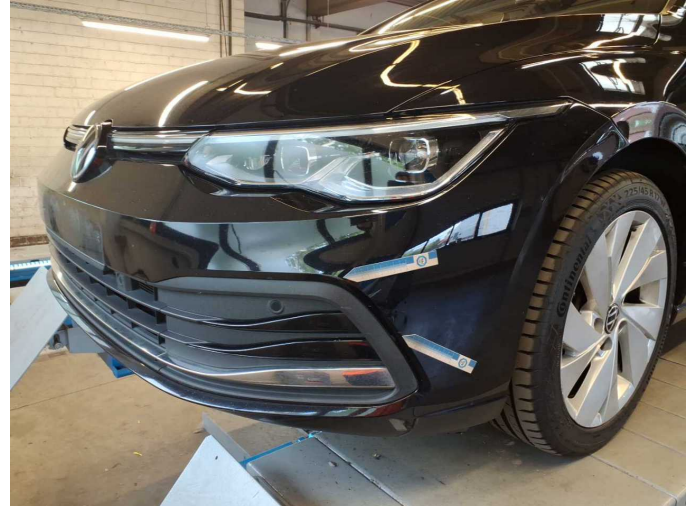
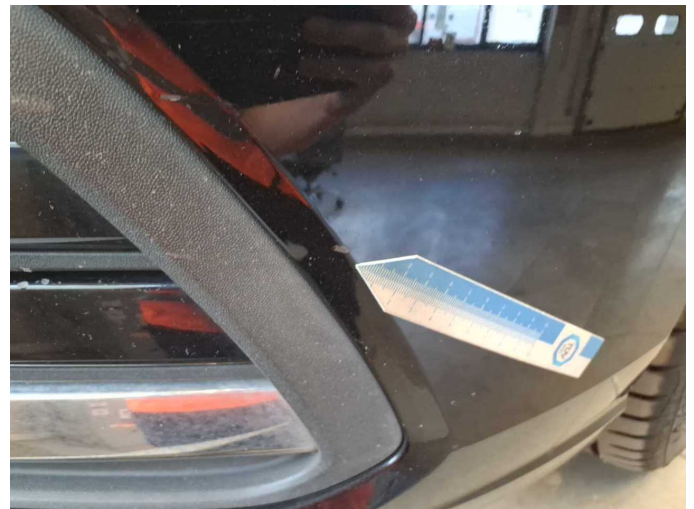
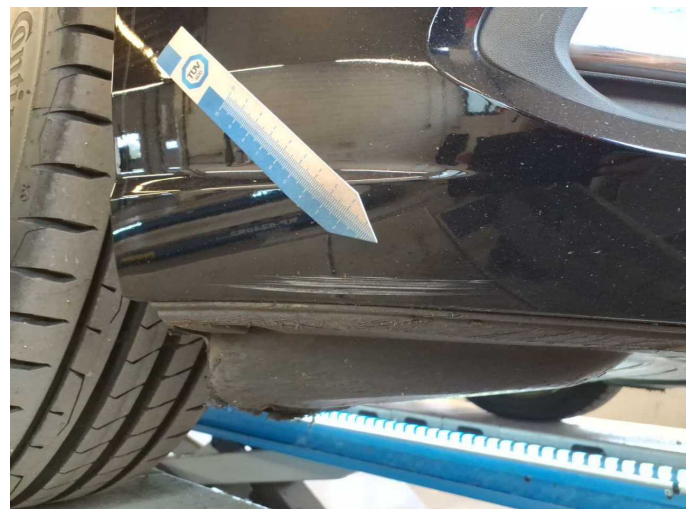
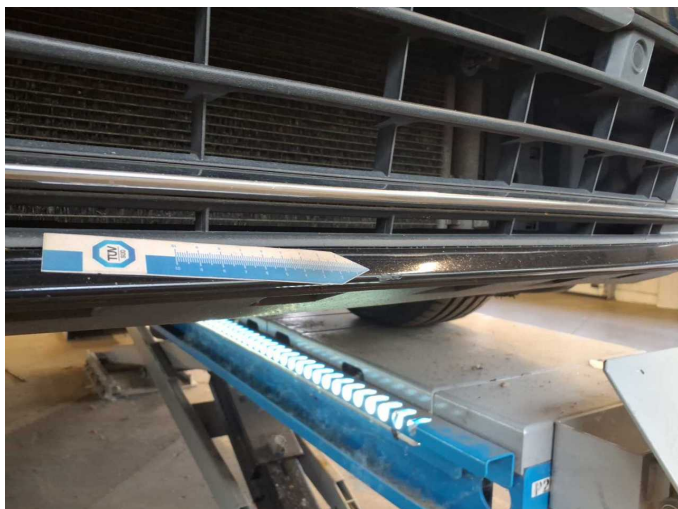
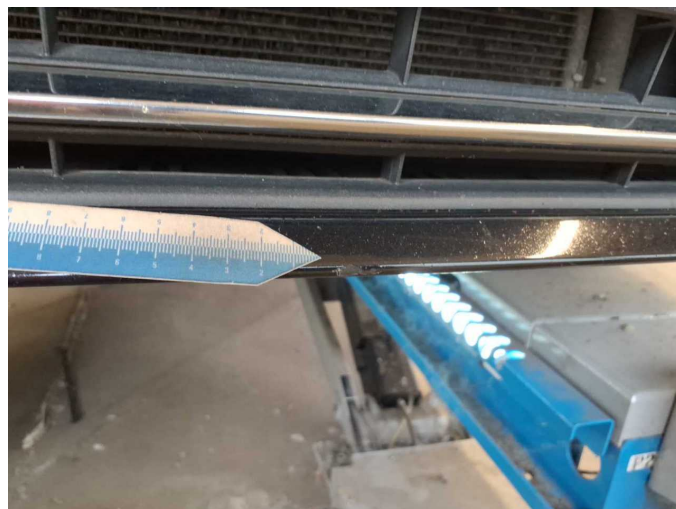
| No. | Component group | Description |
|---|---|---|
| 20 | Front bumper | Front bumper (+ Steinschläge) - Scratch(es) - Paint |

**Damage 20:** Front bumper: Front bumper (+ Steinschläge) - Scratch(es) - Paint

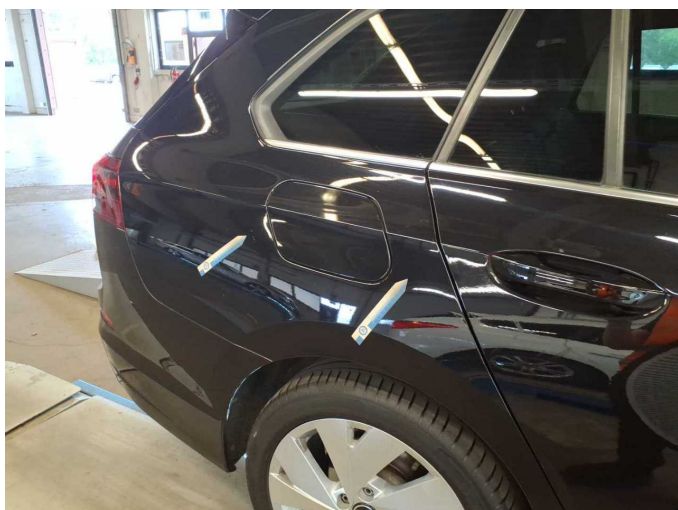
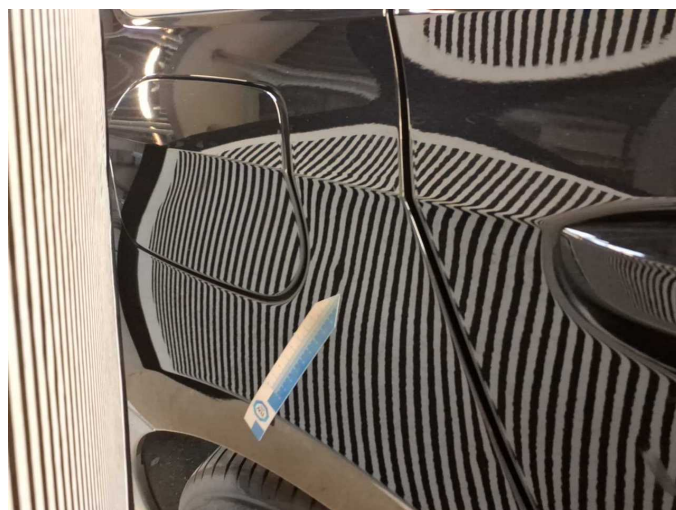
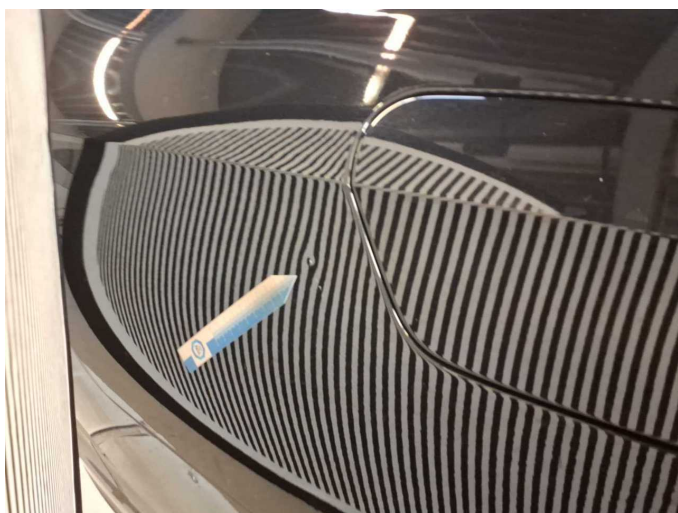
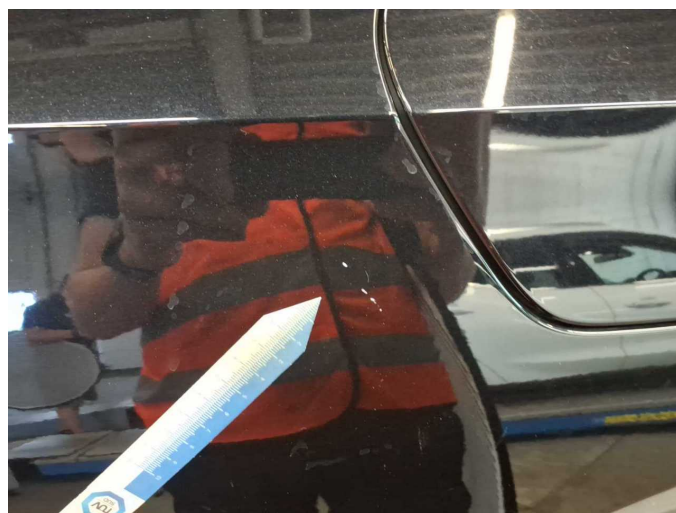
| No. | Component group | Description |
|---|---|---|
| 21 | Side panel - rear right side | Side panel - Dent / paintcoat damage - Repair and paint |

**Damage 21:** Side panel - rear right side: Side panel - Dent / paintcoat damage - Repair and paint

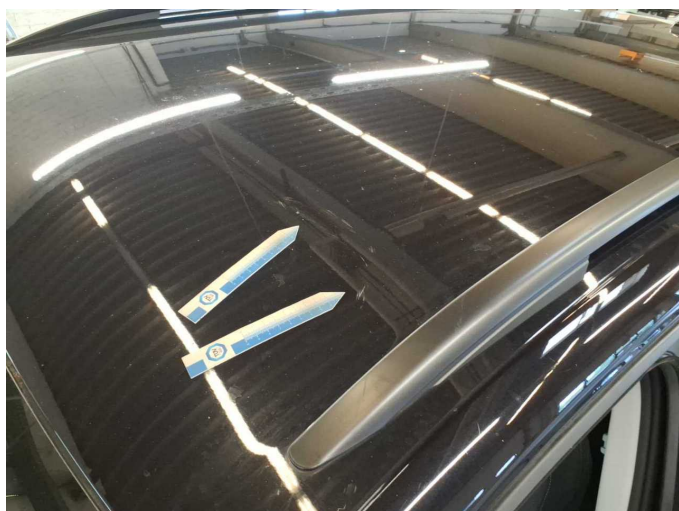
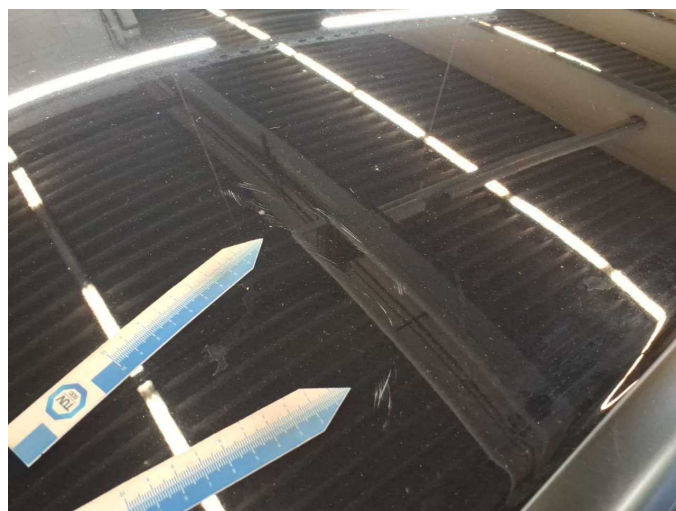
| No. | Component group | Description |
|---|---|---|
| 22 | Roof | Roof - Scratch(es) - Paint |

**Damage 22:** Roof: Roof - Scratch(es) - Paint

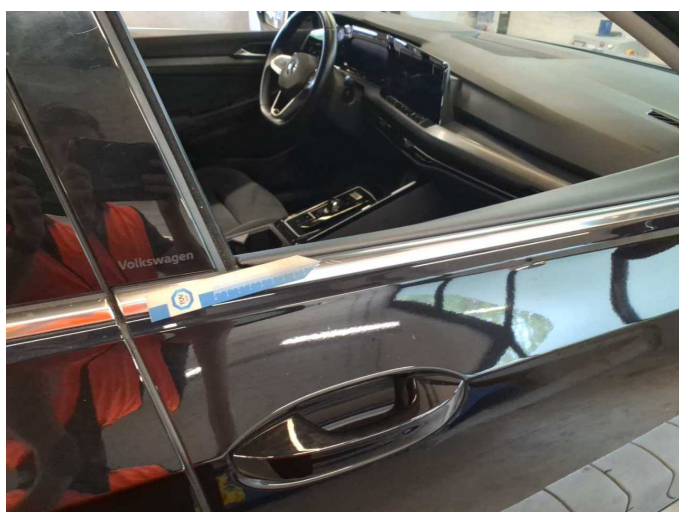
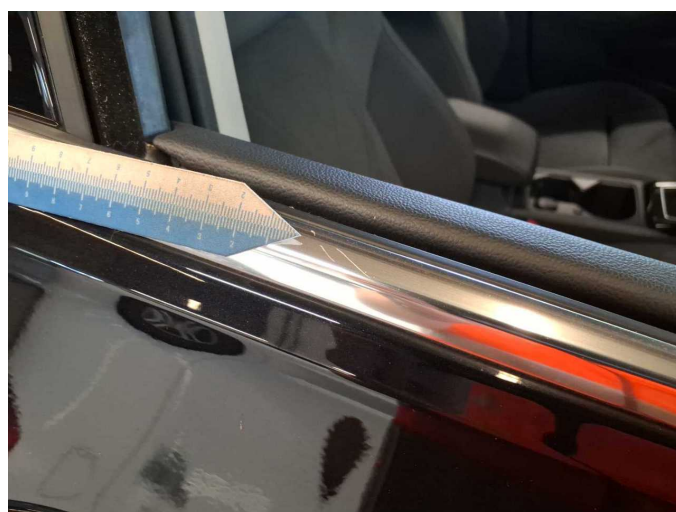
| No. | Component group | Description |
|---|---|---|
| 4 | Door - front right side | Brightware - upper - Scratch(es) - No deduction |

**Wear and tear 4:** Door - front right side: Brightware - upper - Scratch(es)  
- No deduction
