Expertise

Protocol number: 46605981  
Order No. / Reference: 26701943  
Inspection date: 20 Jul 2026

Manufacturer: Volkswagen  
VIN: WVGZZCD1PW513507

Model: Golf Variant 2.0 TDI SCR DSG Style

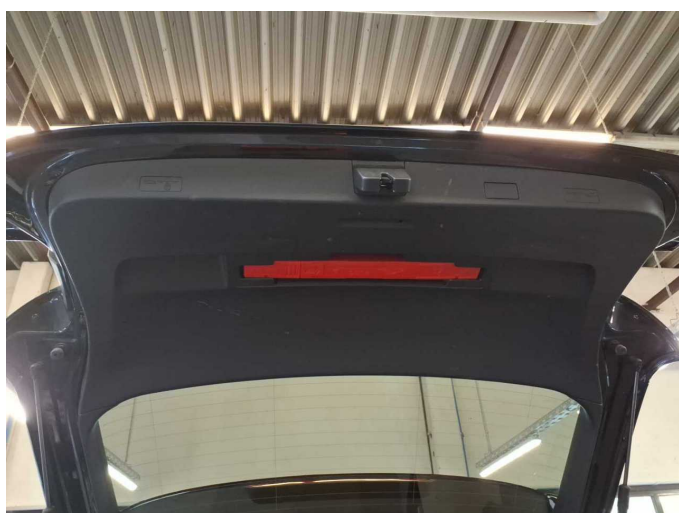
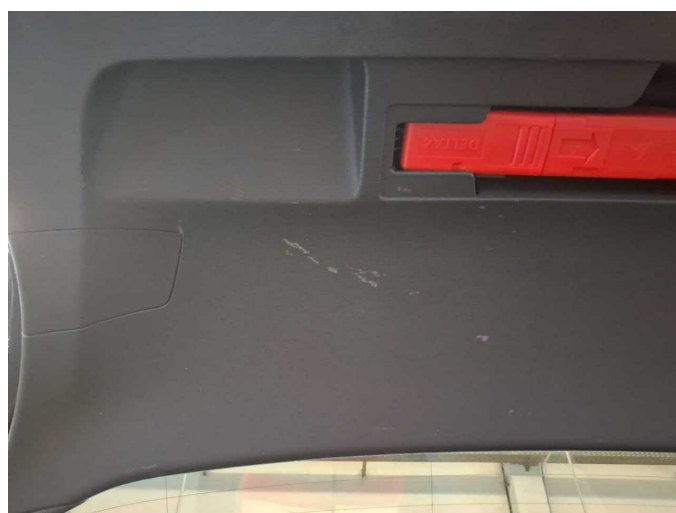
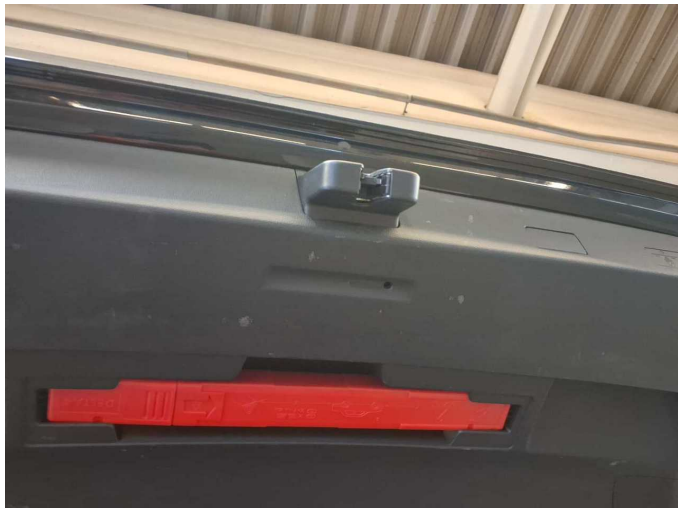
| No. | Component group | Description |
|---|---|---|
| 5 | Trim / covers | Boot lid - interior trim - Scratched - No deduction |

**Wear and tear 5:** Trim / covers: Boot lid - interior trim - Scratched - No deduction

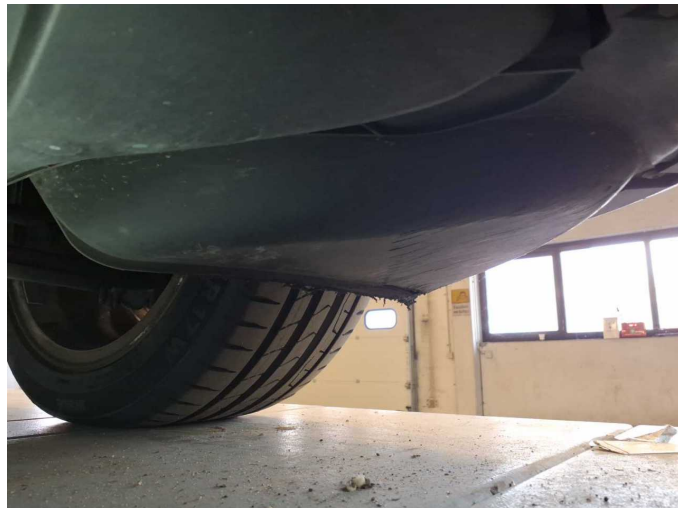
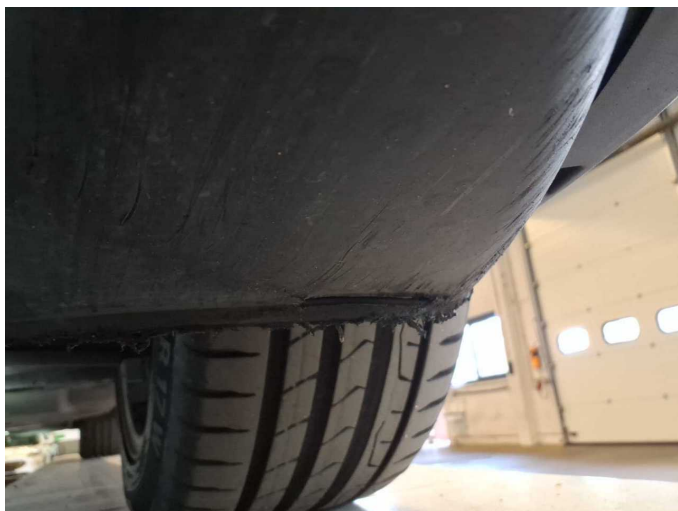
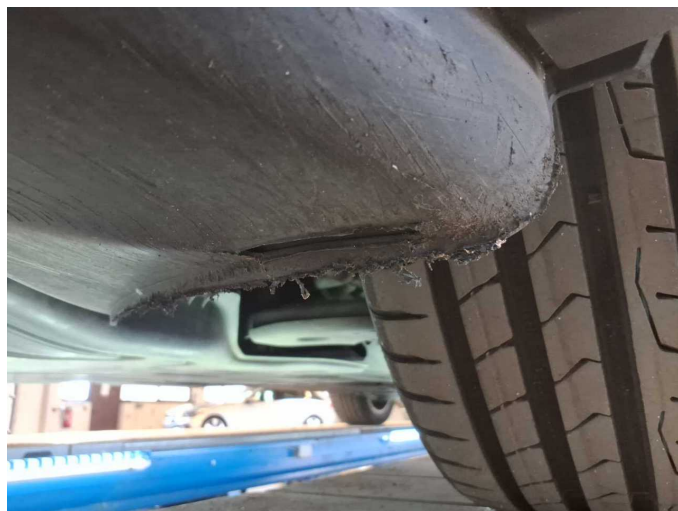
| No. | Component group | Description |
|---|---|---|
| 6 | Body | Wheel well - front left side (Radhausschale unterhalb) - Scratched - No deduction |

**Wear and tear 6:** Body: Wheel well - front left side (Radhausschale unterhalb) - Scratched - No deduction

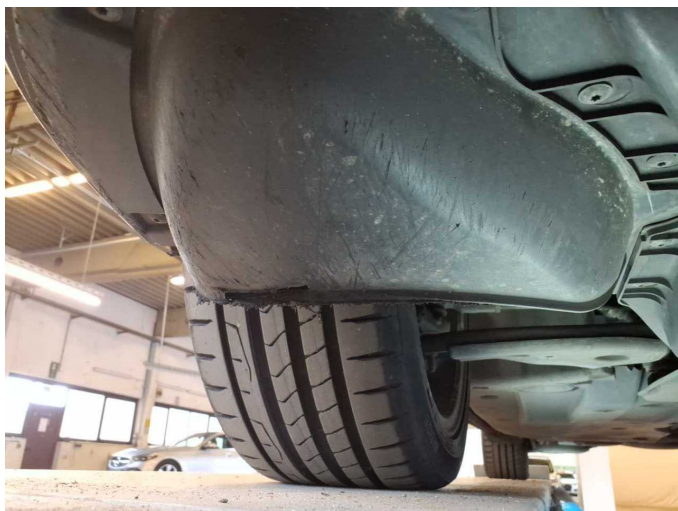
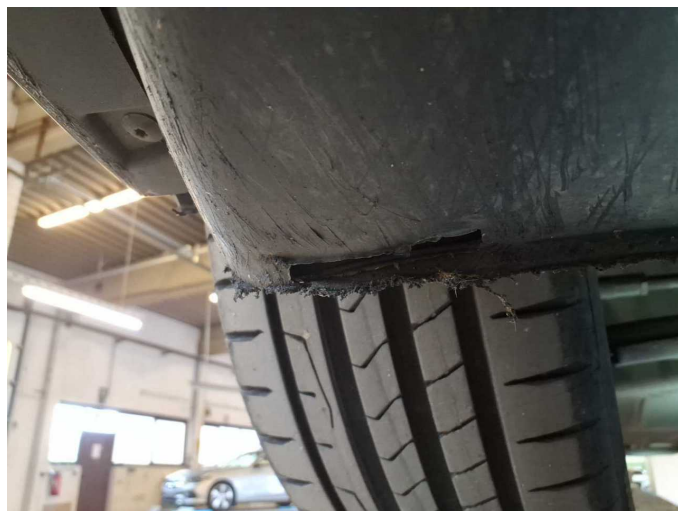
| No. | Component group | Description |
|---|---|---|
| 7 | Body | Wheel well - front right side (Radhausschale unterhalb) - Scratched - No deduction |

**Wear and tear 7:** Body: Wheel well - front right side (Radhausschale unterhalb) - Scratched - No deduction
