Expertise

Protocol number: 46174128
Order No. / Reference: 26505080
Inspection date: 22 Jun 2026

Manufacturer: Volkswagen

Model: Multivan T6.1 Kurz Family

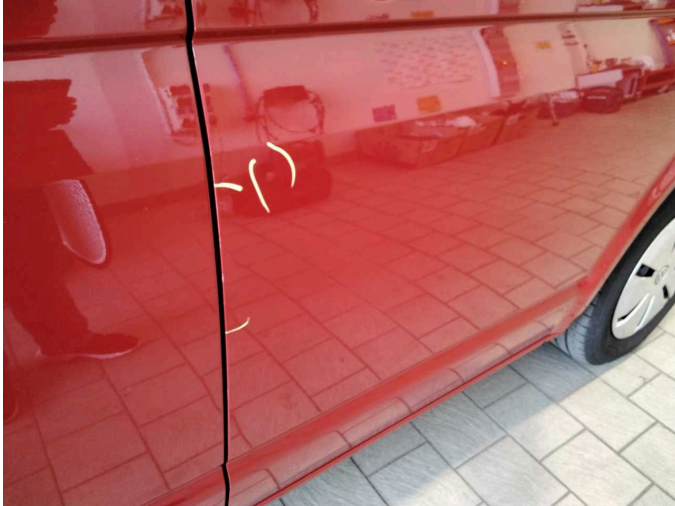
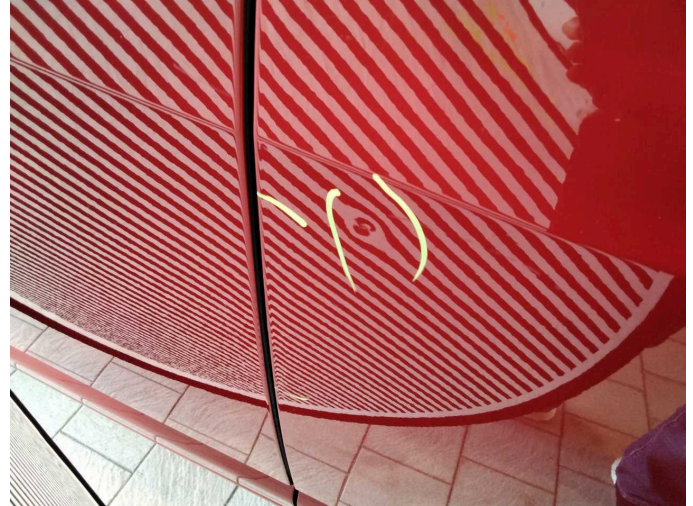
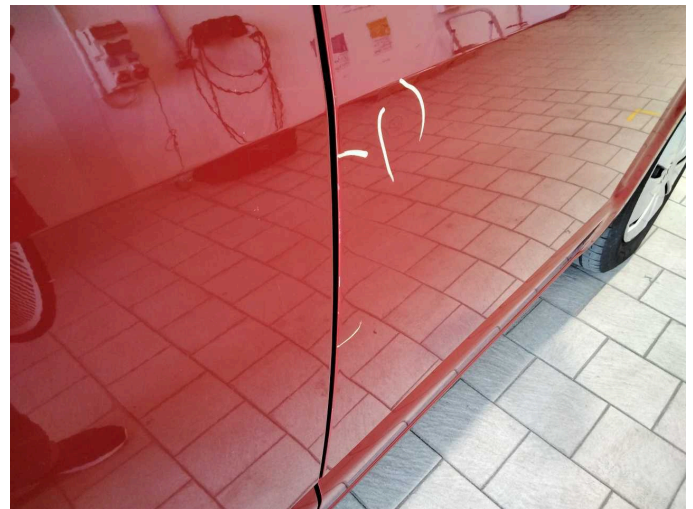
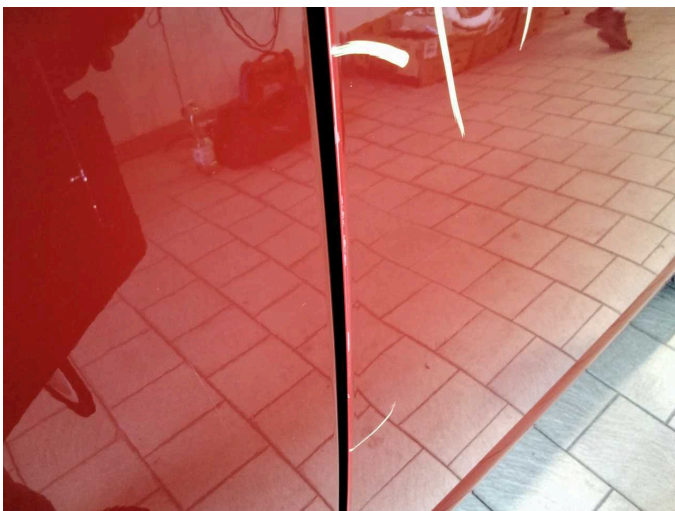
Damage 2: Door - front right side: Door - dent(s) - Smooth repair work

Damage 4: Door - front right side: Door edge - Scratch(es) - Smart repair

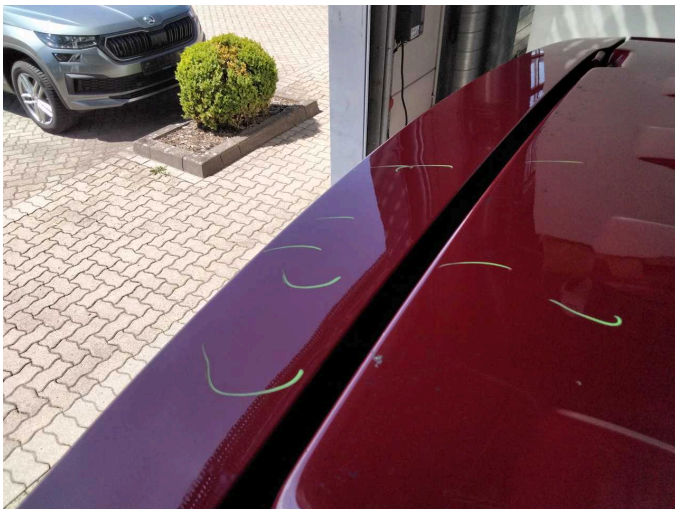
Damage 3: Boot lid / rear door: Boot lid - dent(s) - Smooth repair work

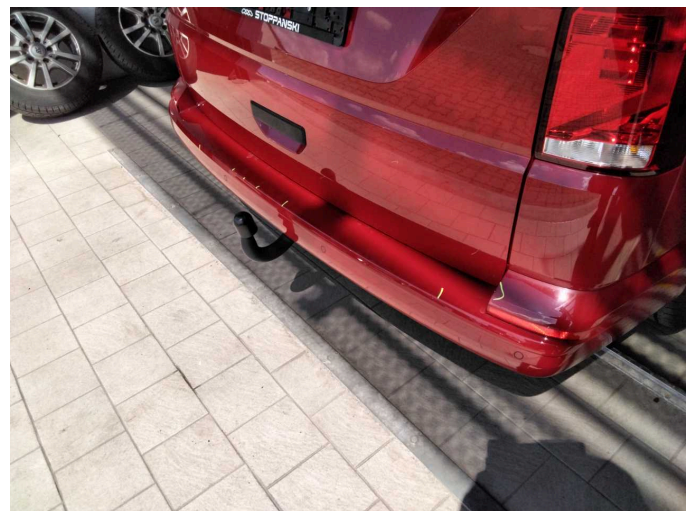
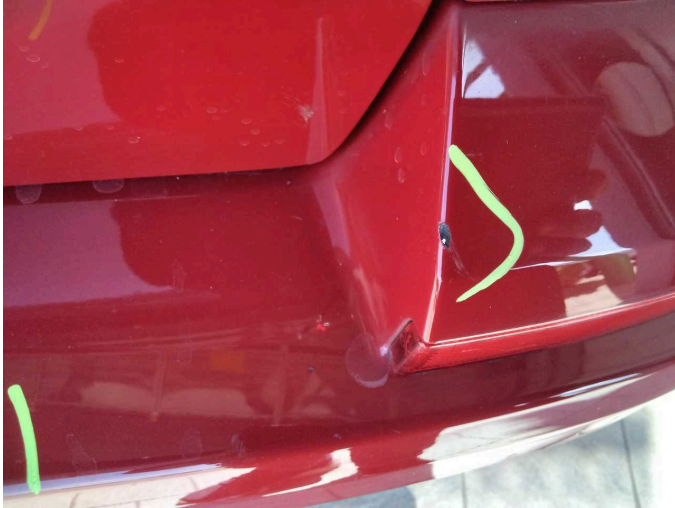
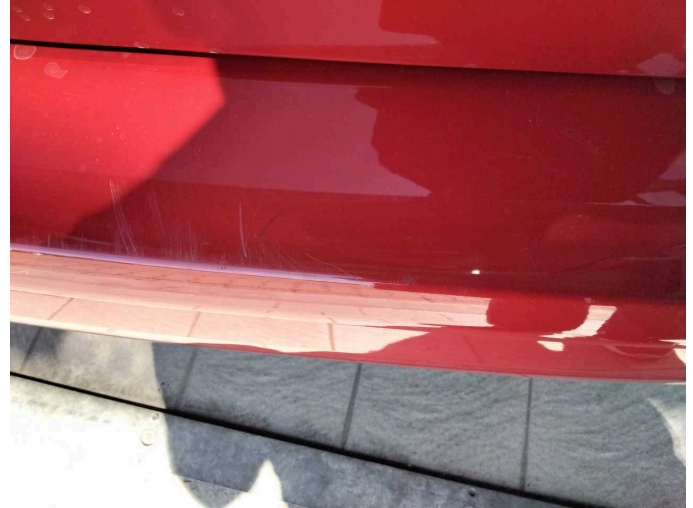
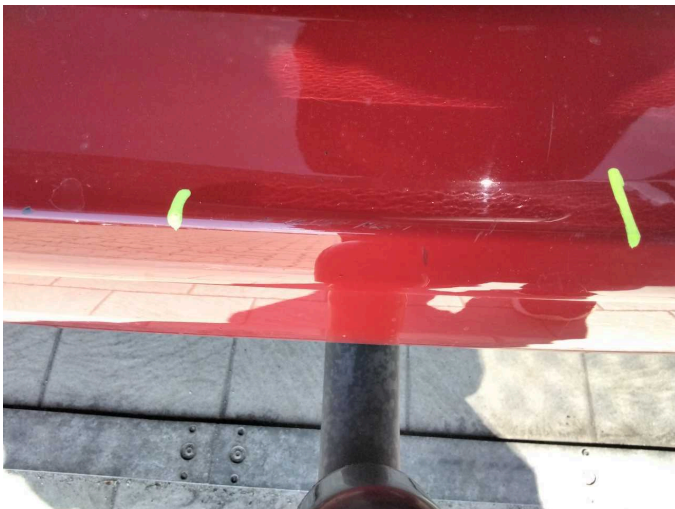
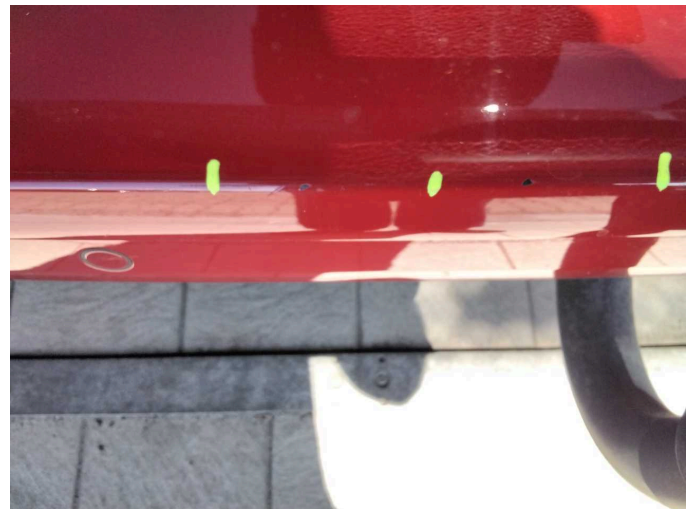
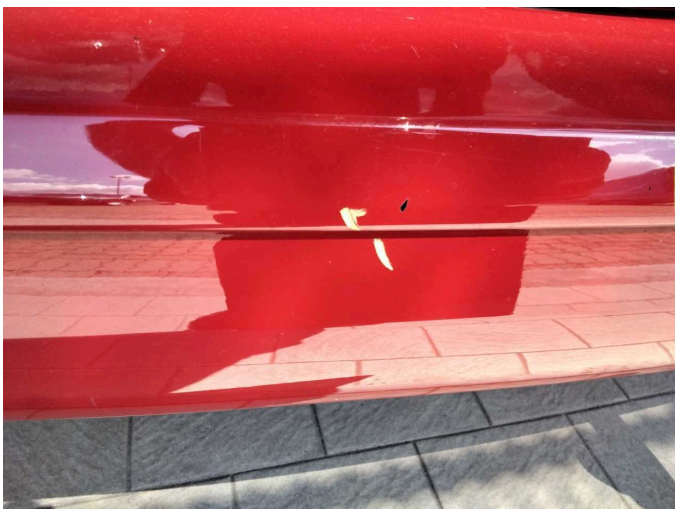
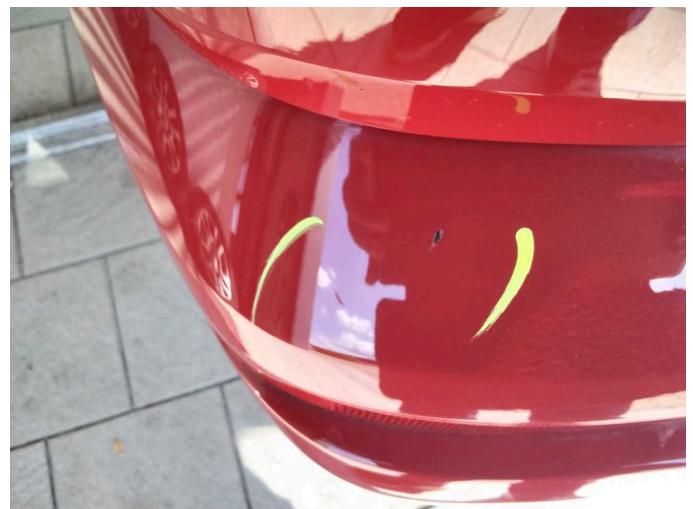
Damage 5: Rear bumper: Rear bumper - Scratch(es) - Paint

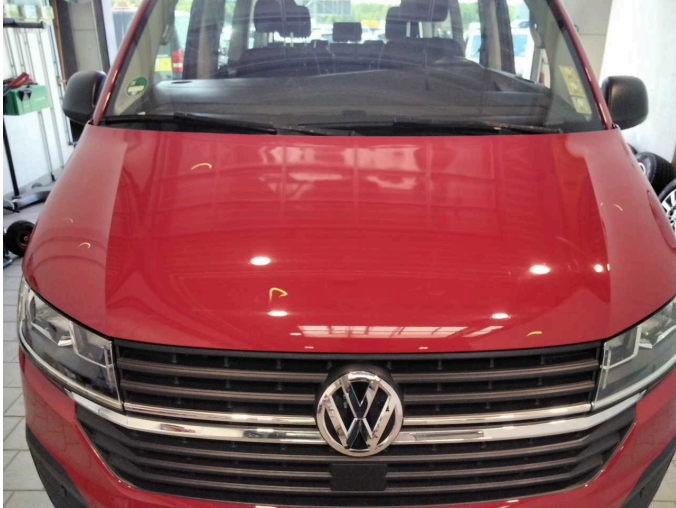
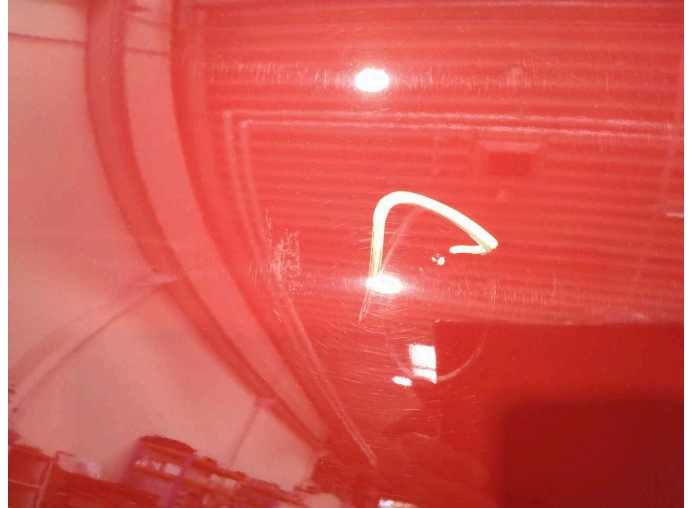
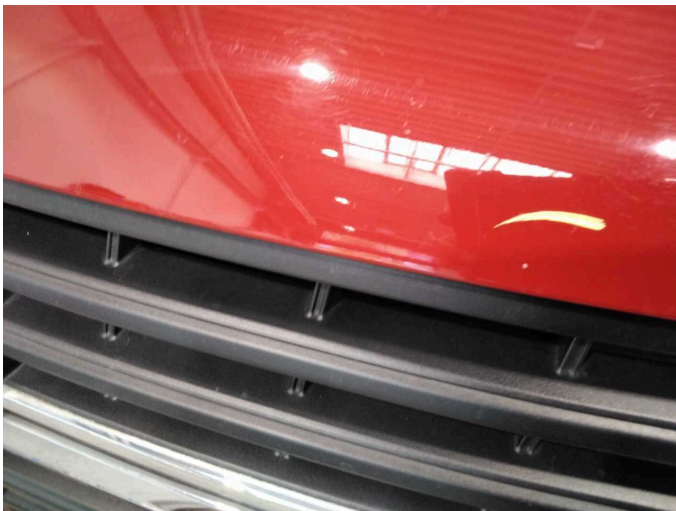
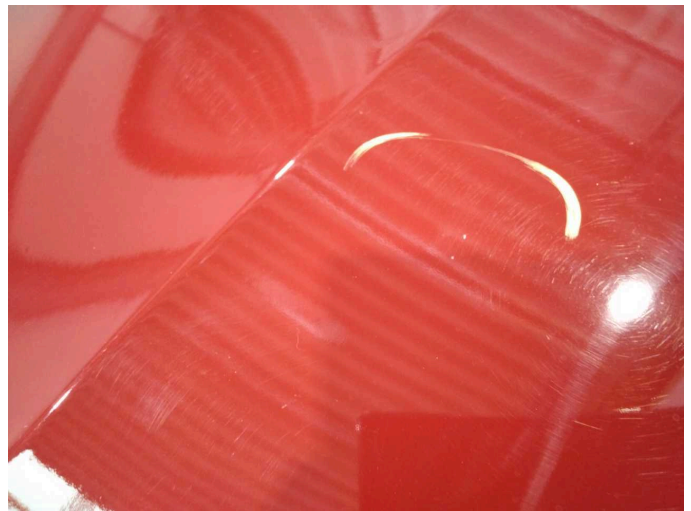
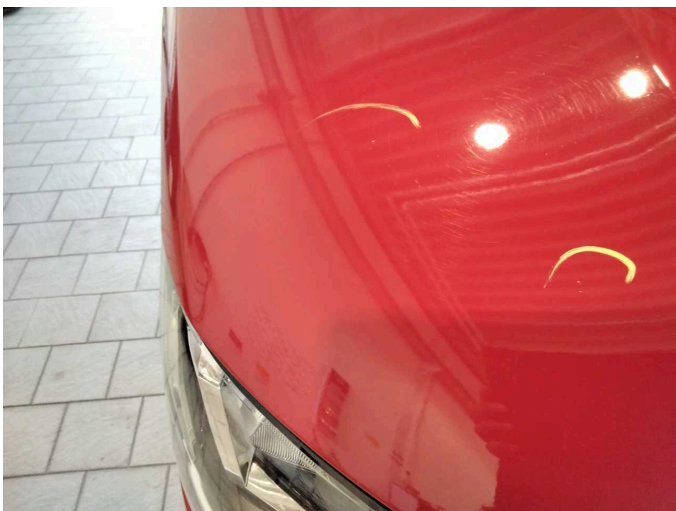
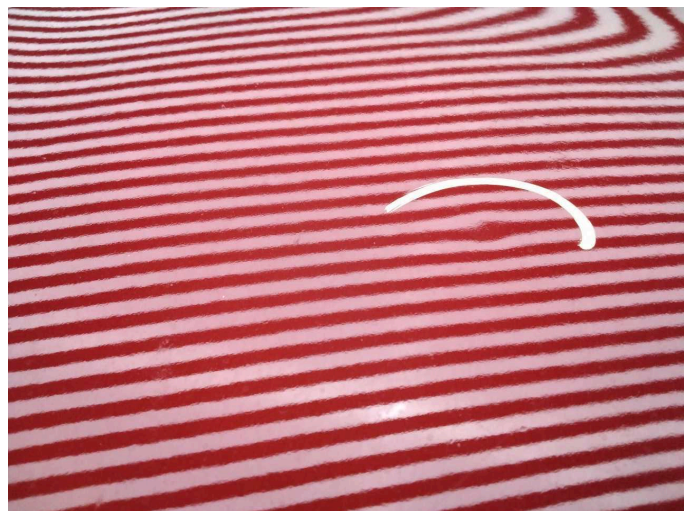
Damage 6: Bonnet: Bonnet - Dent / paintcoat damage - Paint

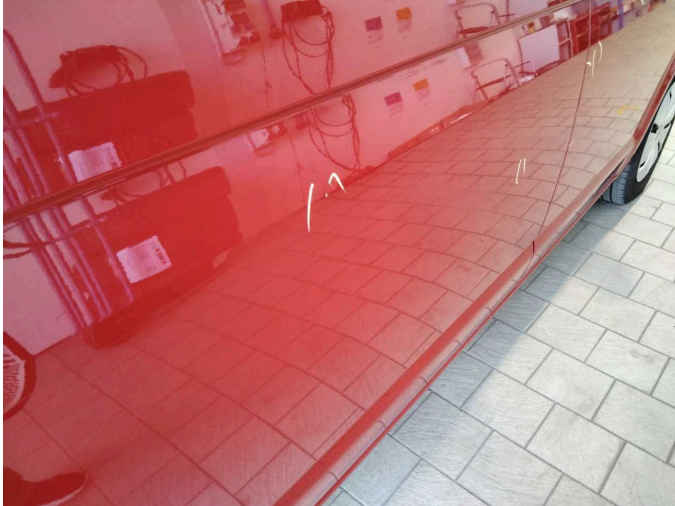
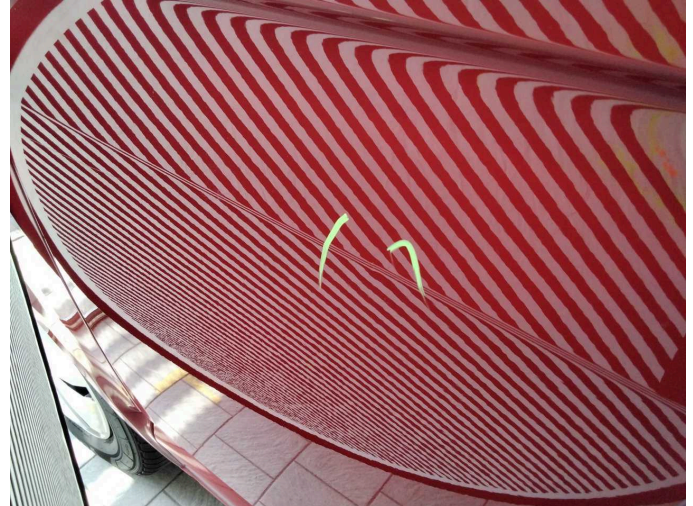
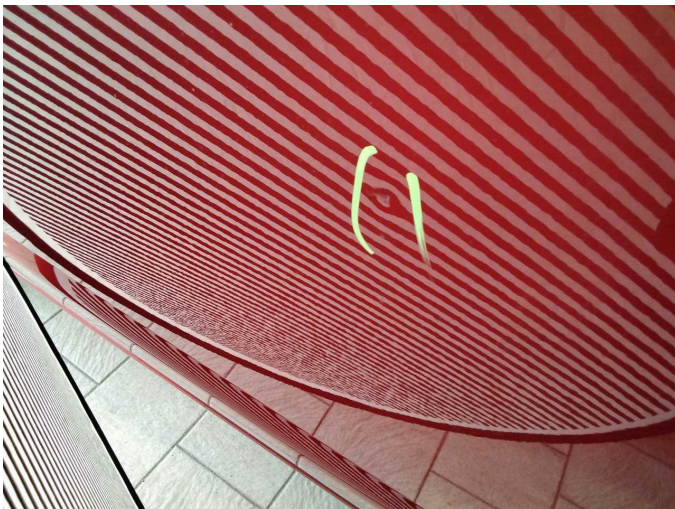
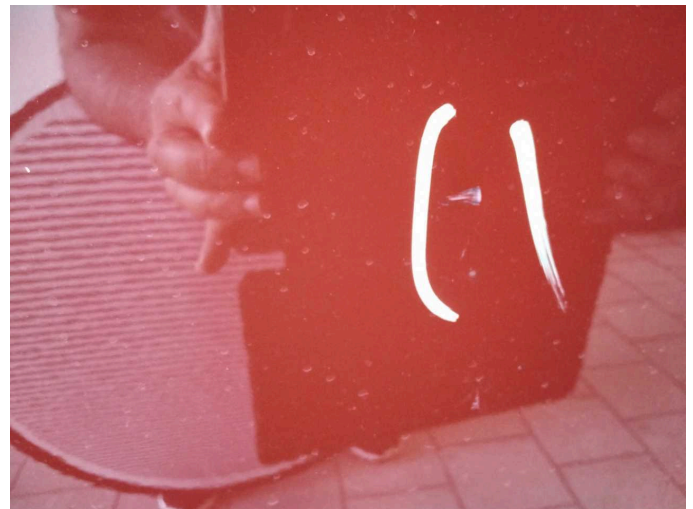
Damage 7: Sliding door, right: Sliding door with glass panel - Dent / paintcoat damage - Paint

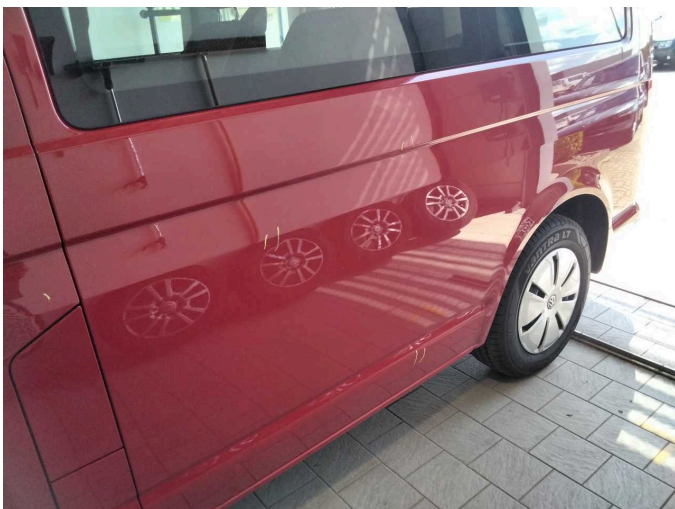
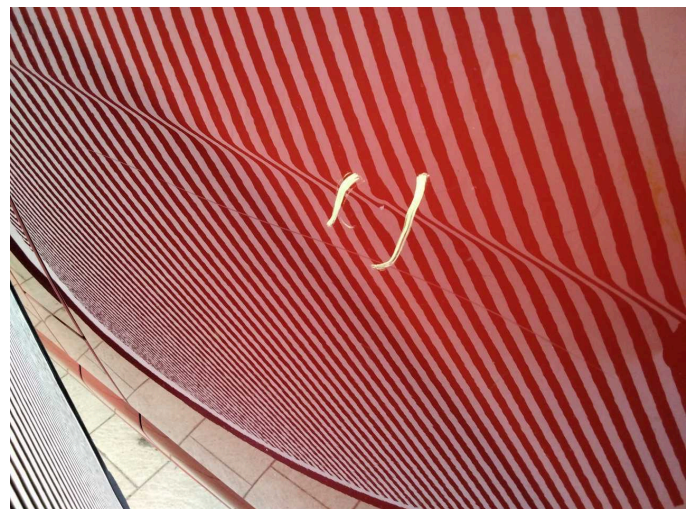
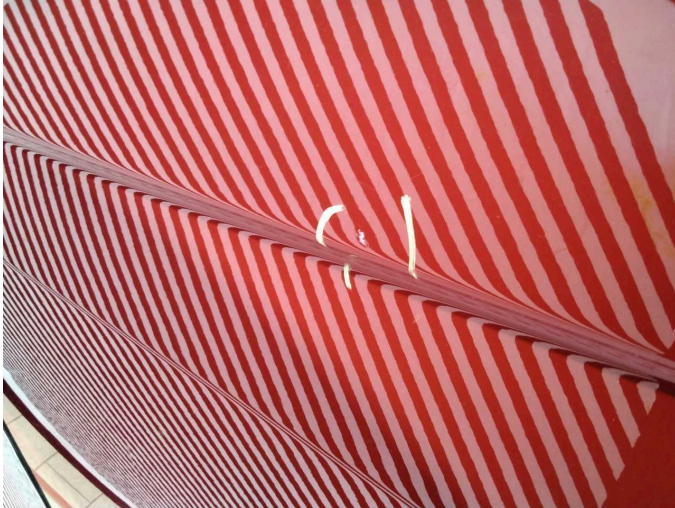
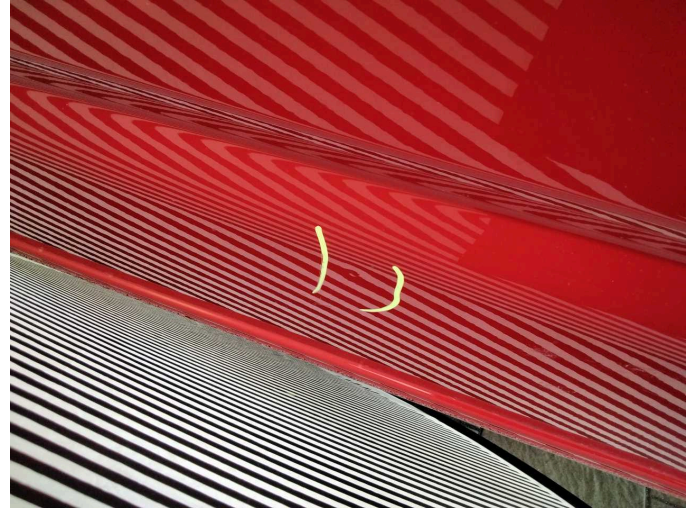
Damage 8: Side panel - rear left side: Side panel - Dent / paintcoat damage - Repair and paint

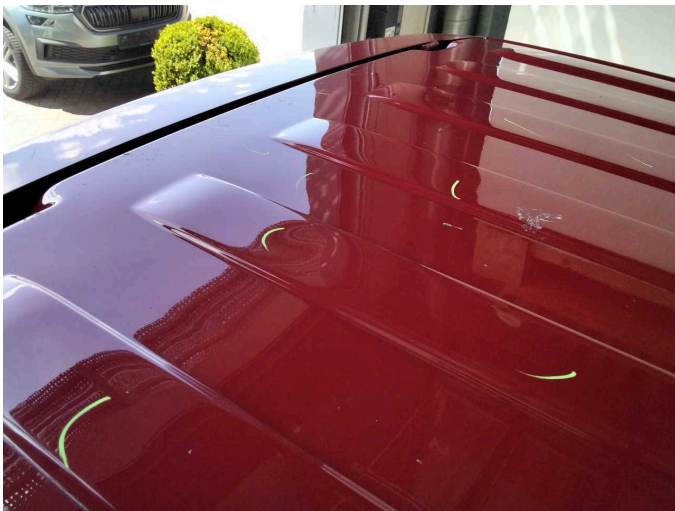
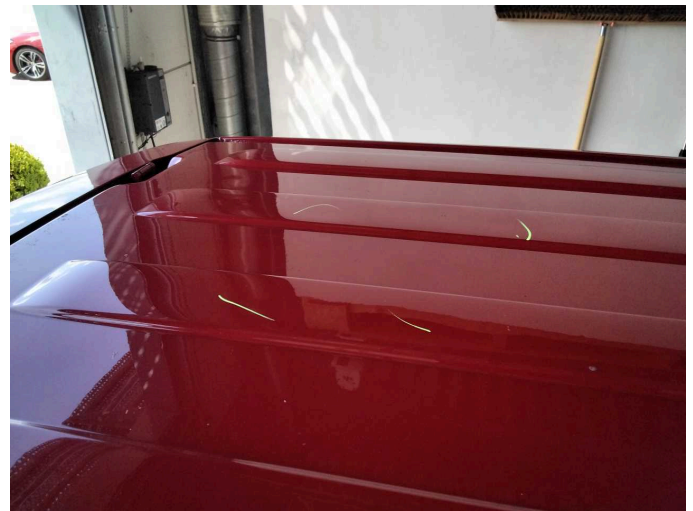
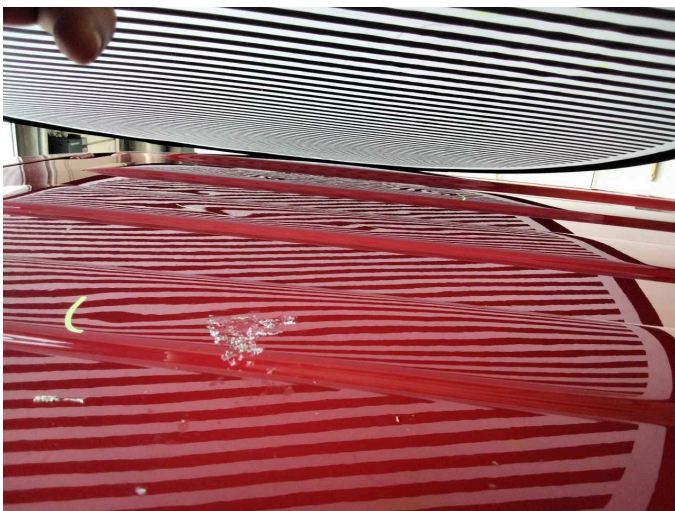
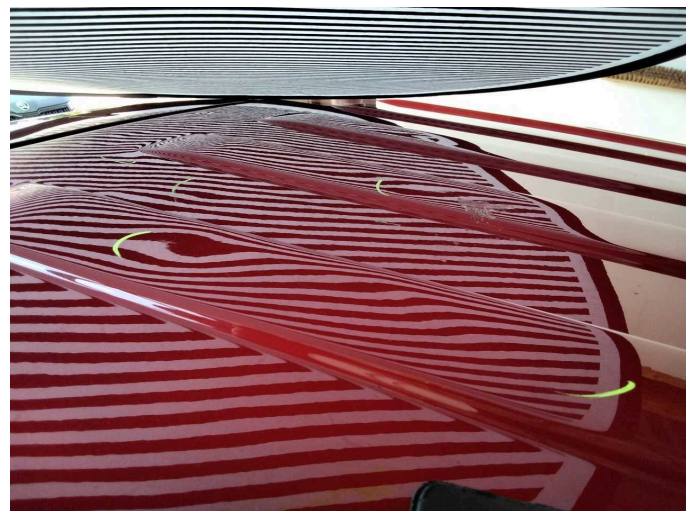
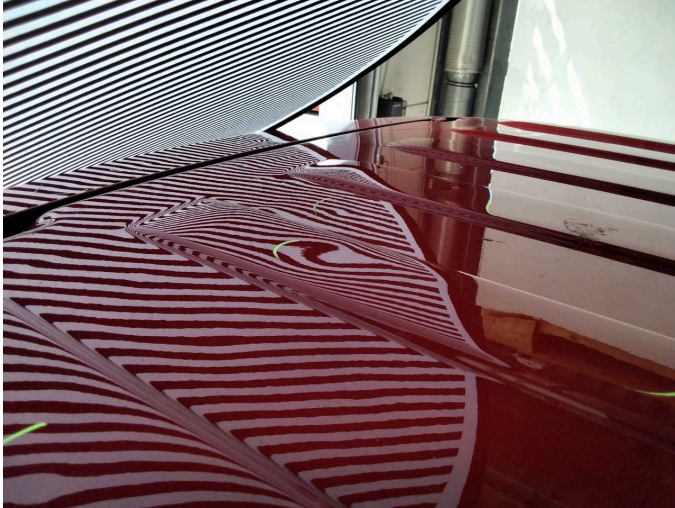
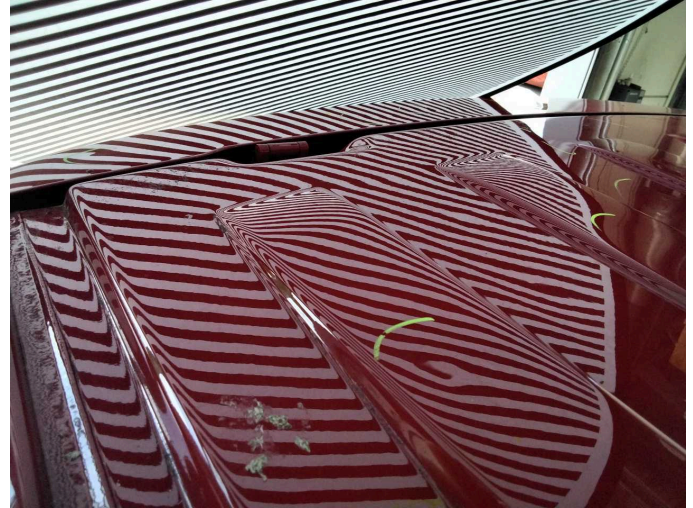
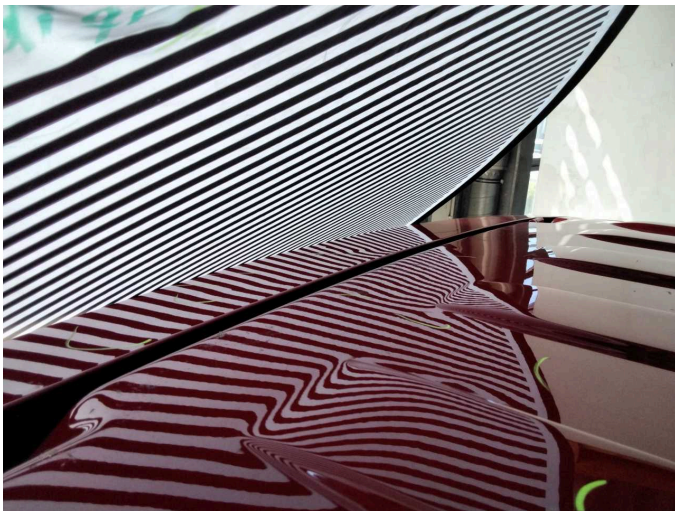
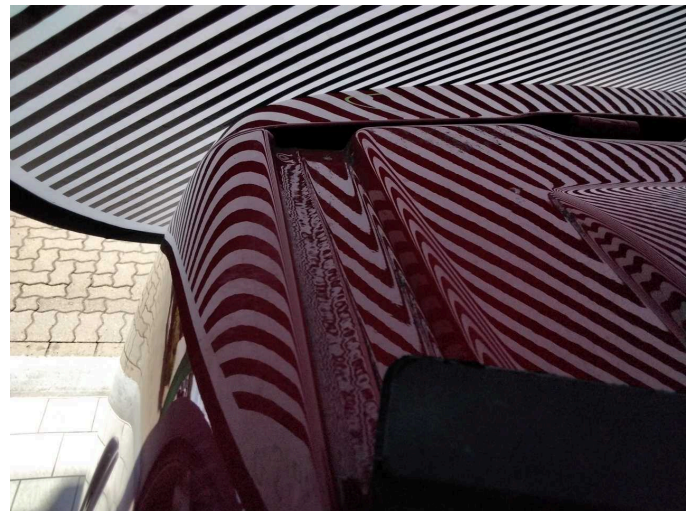
Damage 9: Roof: Roof (Verätzung) - Dent / paintcoat damage - repair according to calculation

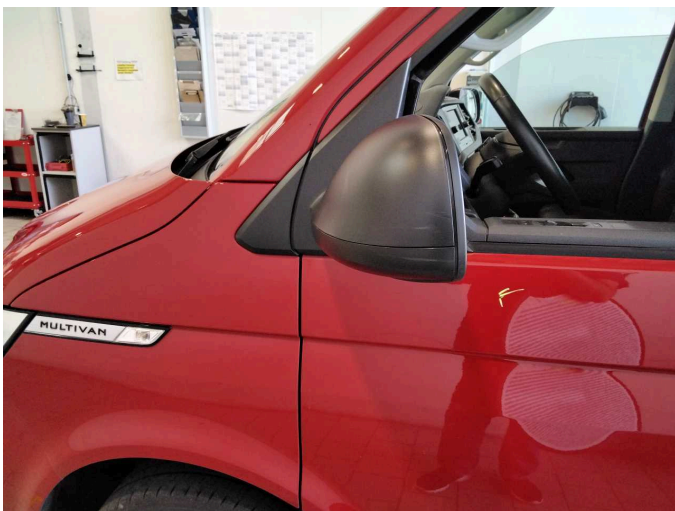
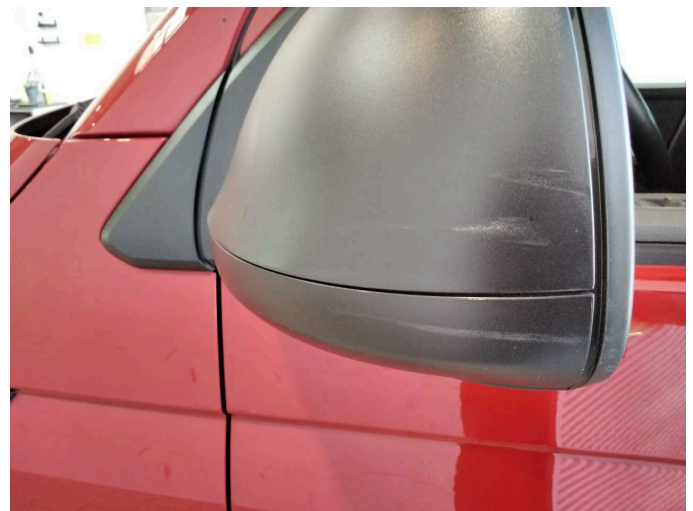
Wear and tear 1: Wing mirror - right side: Cap - Scratch(es) - No deduction

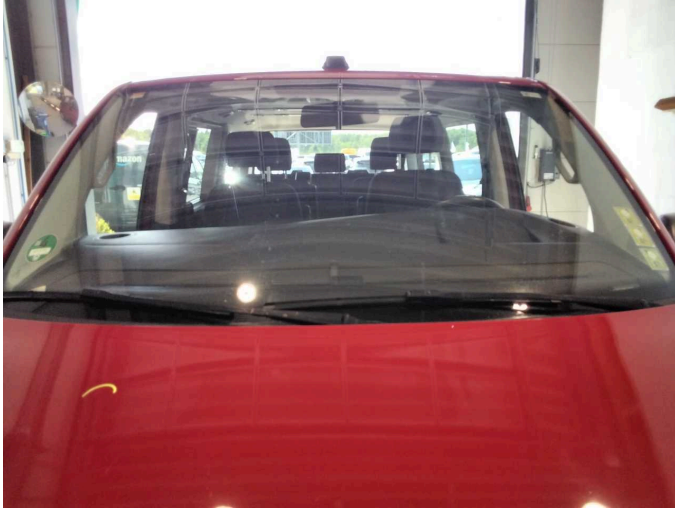
Wear and tear 2: Vehicle glazing: Windscreen - Stone chips - No deduction

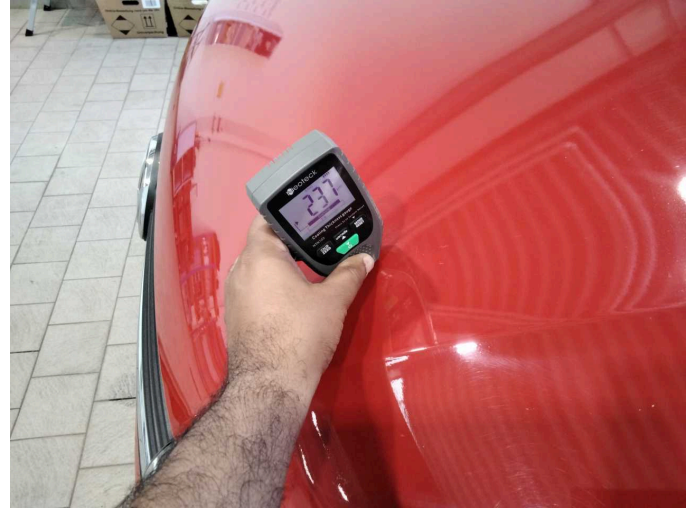
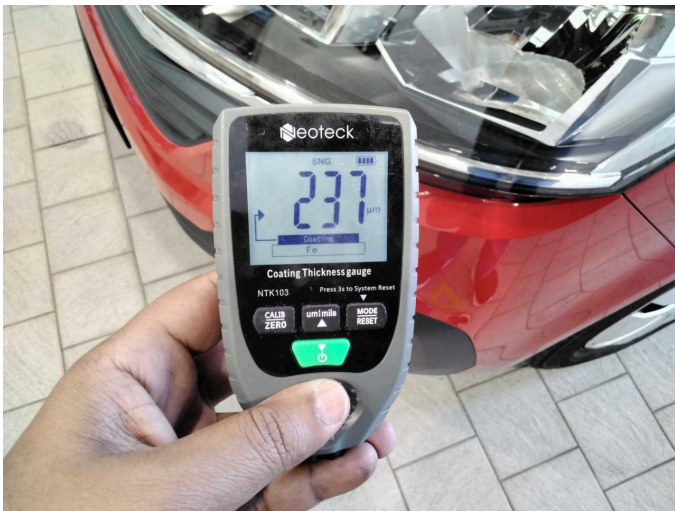
Bonnet: 237 µm
