Expertise

Protocol number: 46046185  
Order No. / Reference: 26308038  
Inspection date: 18 Jun 2026

Manufacturer: Opel

Model: Astra Sports Tourer 1.2 Turbo Automatik GS

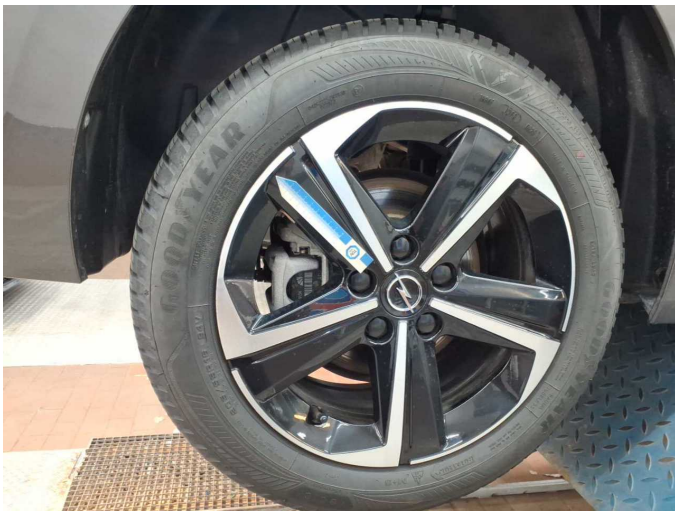
| No. | Component group | Description |
|---|---|---|
| 1 | Wheel / tyres | Alloy rim - rear right side - Scratch(es) - Loss in value |

**Damage 1:** Wheel / tyres: Alloy rim - rear right side - Scratch(es) - Loss in value

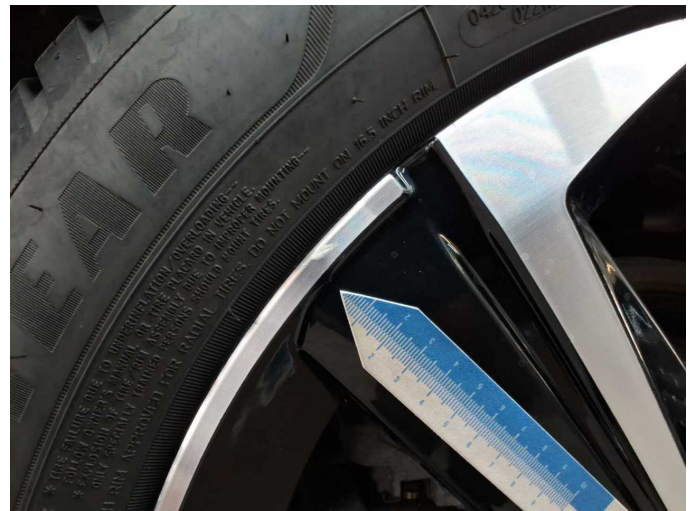
**Damage 1:** Wheel / tyres: Alloy rim - rear right side - Scratch(es) - Loss in value

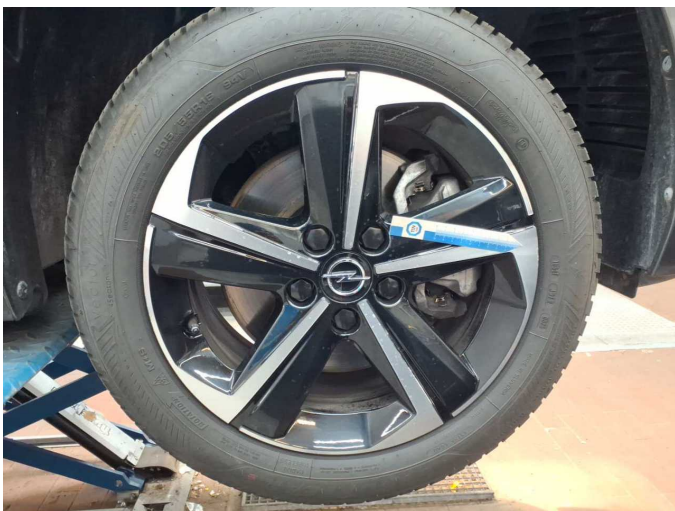
| No. | Component group | Description |
|---|---|---|
| 2 | Wheel / tyres | Alloy rim - front right side - Scratch(es) - Loss in value |

**Damage 2:** Wheel / tyres: Alloy rim - front right side - Scratch(es) - Loss in value

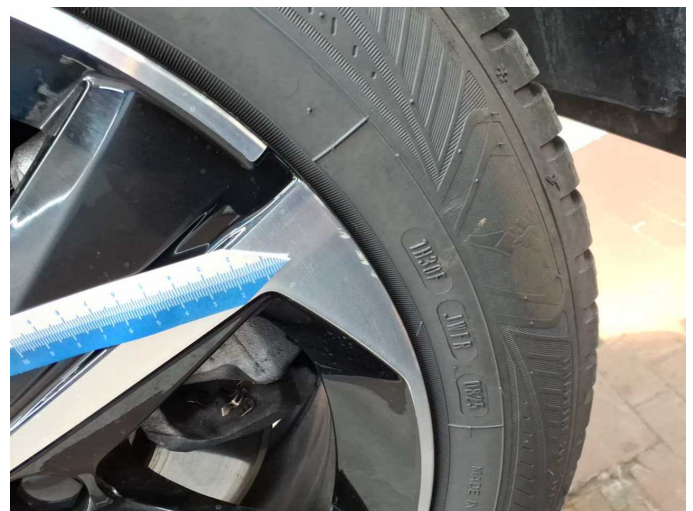
**Damage 2:** Wheel / tyres: Alloy rim - front right side - Scratch(es) - Loss in value

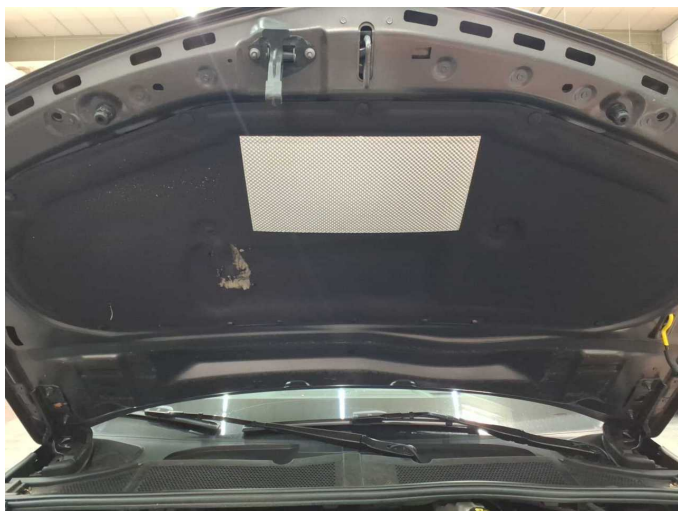
| No. | Component group | Description |
|---|---|---|
| 3 | Bonnet | Insulation lining - Holes - Replace |

**Damage 3:** Bonnet: Insulation lining - Holes - Replace

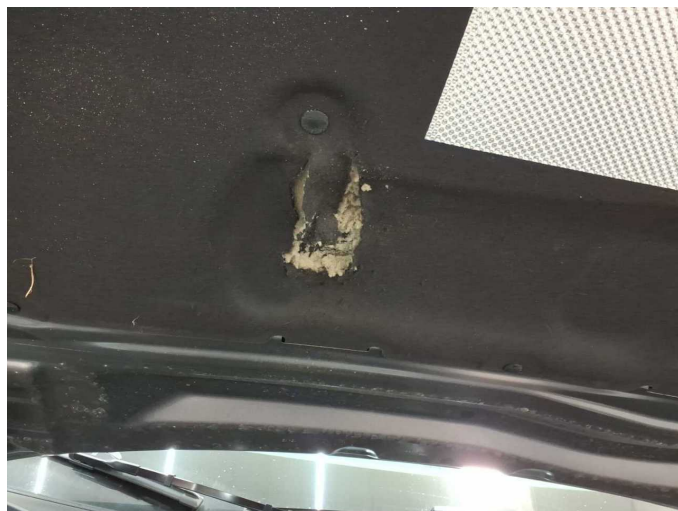
**Damage 3:** Bonnet: Insulation lining - Holes - Replace

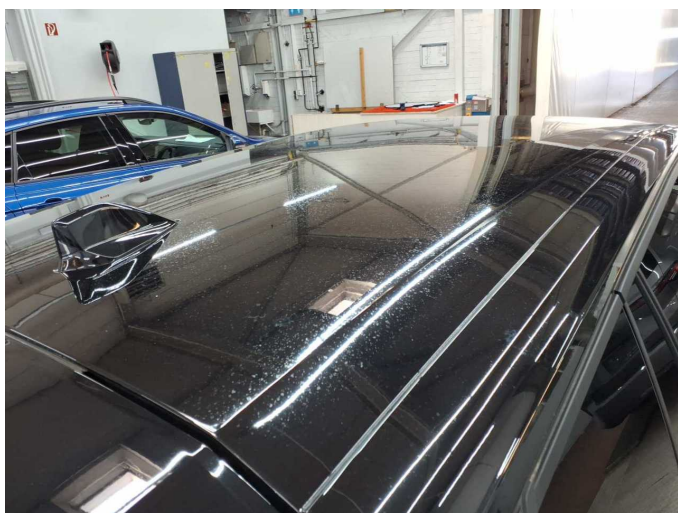
| No. | Component group | Description |
|---|---|---|
| 4 | Roof | Roof (Anhaftung Harz-Mehrkosten möglich) - Paint defect - Conditioning |

**Damage 4:** Roof: Roof (Anhaftung Harz-Mehrkosten möglich) - Paint defect - Conditioning

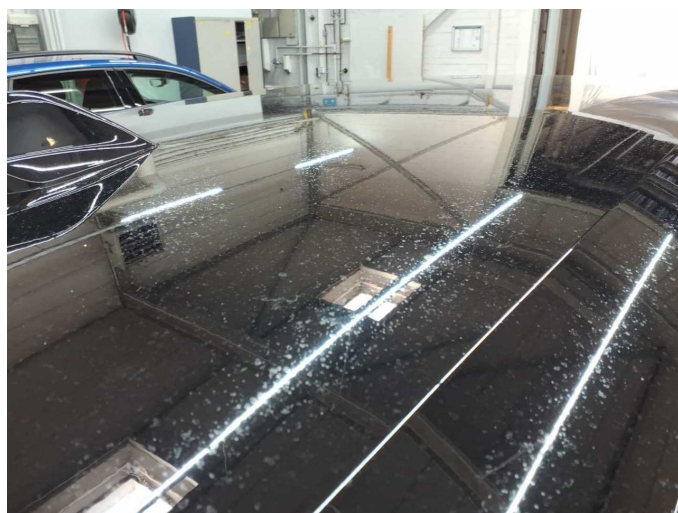
**Damage 4:** Roof: Roof (Anhaftung Harz-Mehrkosten möglich) - Paint defect - Conditioning

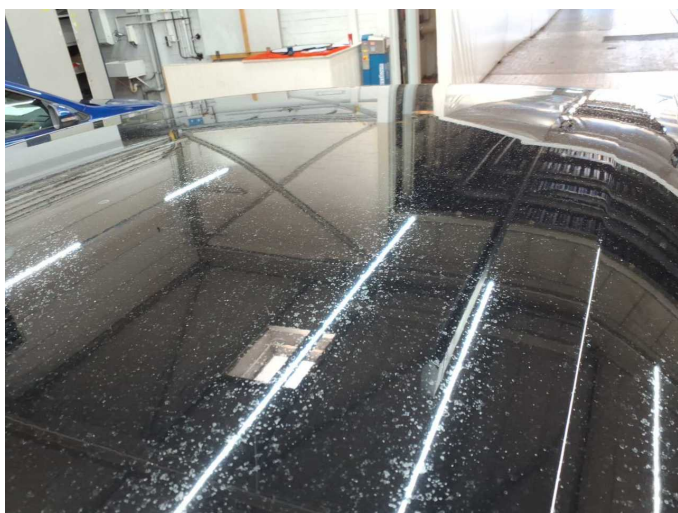
**Damage 4:** Roof: Roof (Anhaftung Harz-Mehrkosten möglich) - Paint defect - Conditioning

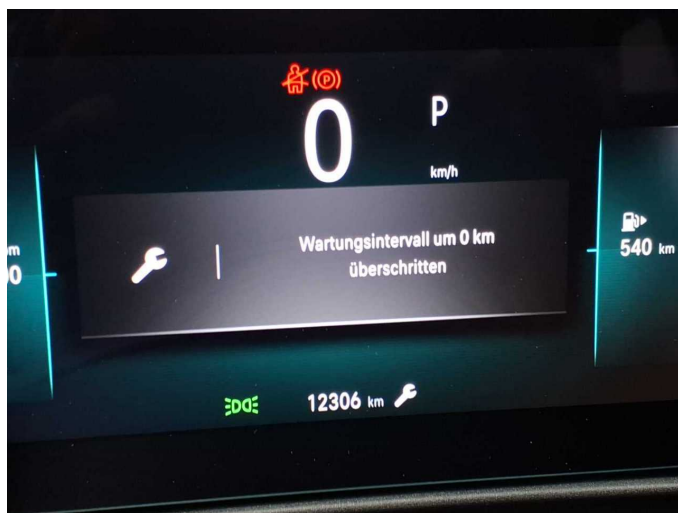
| No. | Component group | Description |
|---|---|---|
| 5 | Misc. | Inspection / maintenance - Due - Replace |

**Damage 5:** Misc.: Inspection / maintenance - Due - Replace
