Expertise

Protocol number: 46113789
Order No. / Reference: 26397668
Inspection date: 24 Jun 2026

Manufacturer: Volkswagen

Model: ID.4 4Motion GTX

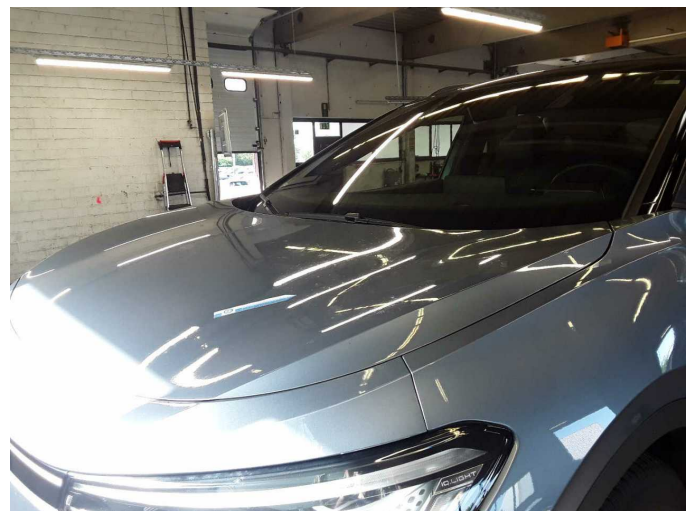
No.	Component group	Description
1	Body	Body (Vogelkot) - Paint defect - Smart repair
2	2nd wheel set	2 alloy rims - Scratched - Loss in value

Damage 1: Body: Body (Vogelkot) - Paint defect - Smart repair

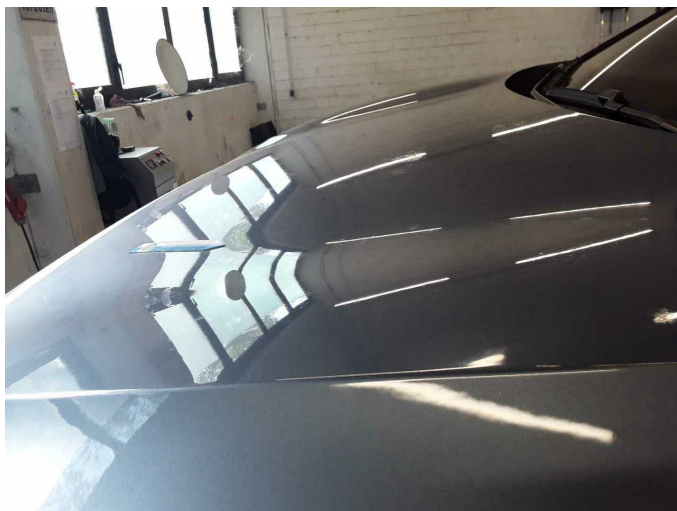
Damage 1: Body: Body (Vogelkot) - Paint defect - Smart repair

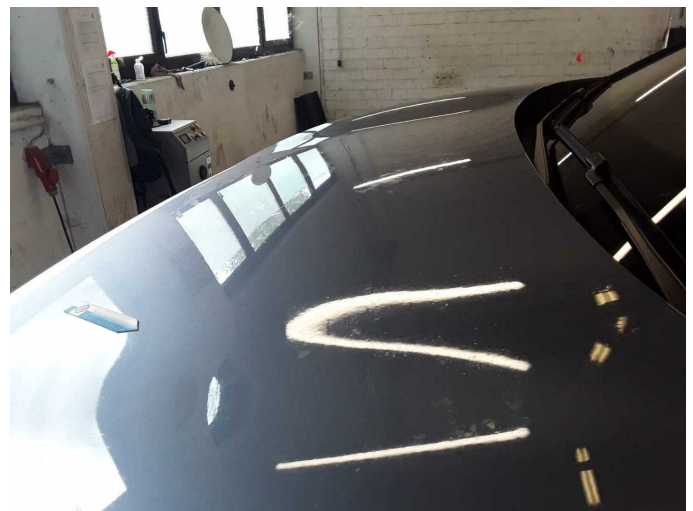
Damage 1: Body: Body (Vogelkot) - Paint defect - Smart repair

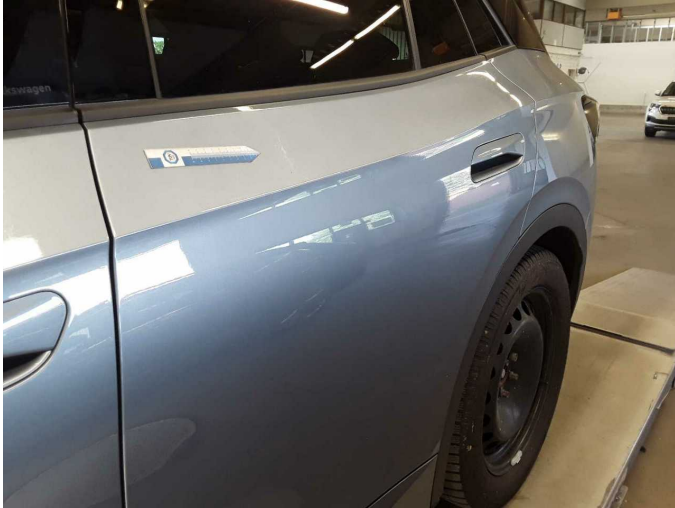
Damage 1: Body: Body (Vogelkot) - Paint defect - Smart repair

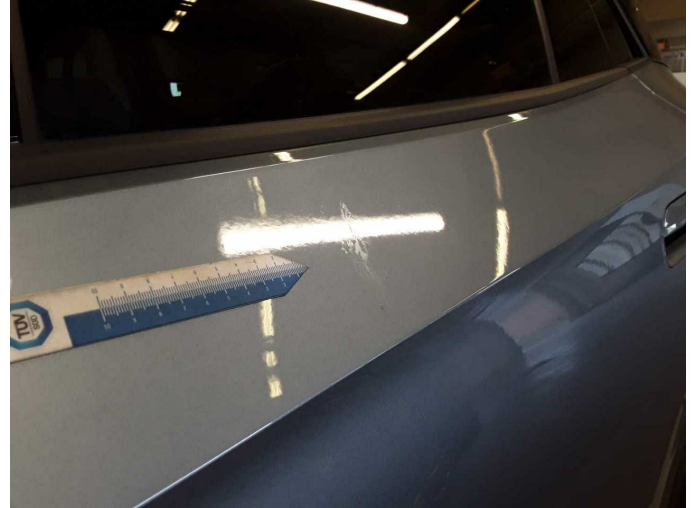
Damage 1: Body: Body (Vogelkot) - Paint defect - Smart repair

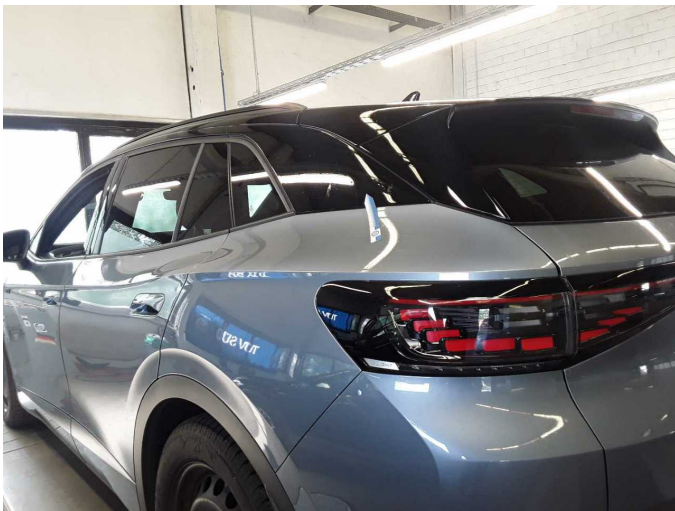
Damage 1: Body: Body (Vogelkot) - Paint defect - Smart repair

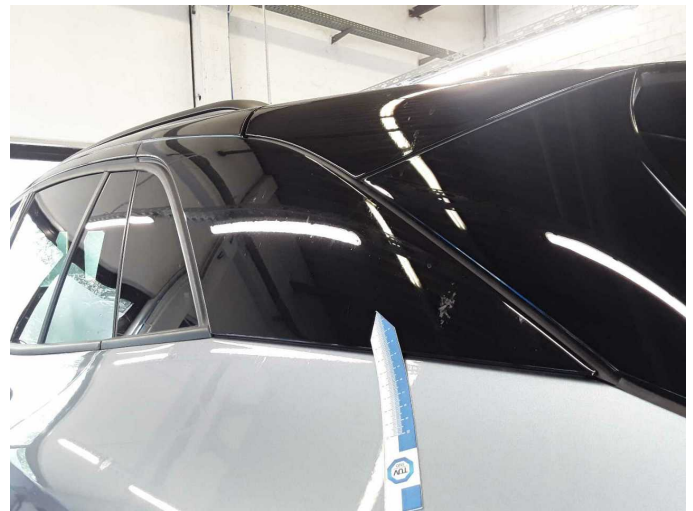
Damage 1: Body: Body (Vogelkot) - Paint defect - Smart repair

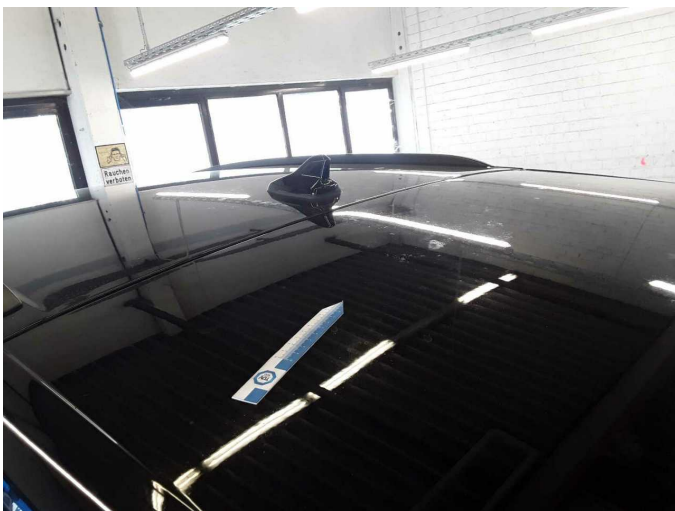
Damage 1: Body: Body (Vogelkot) - Paint defect - Smart repair

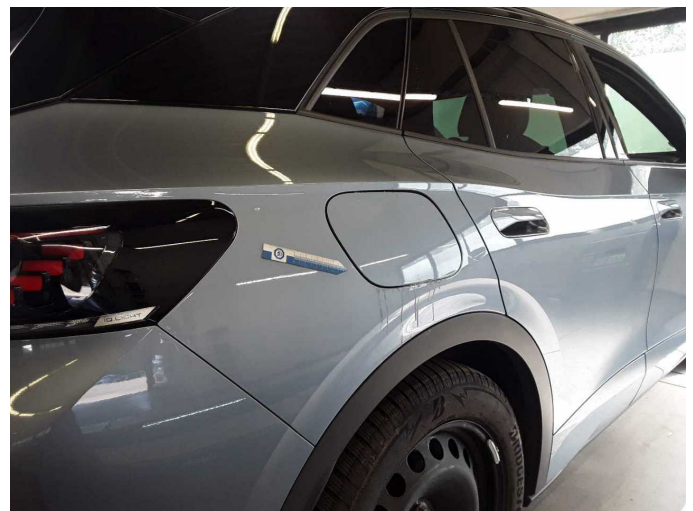
Damage 1: Body: Body (Vogelkot) - Paint defect - Smart repair

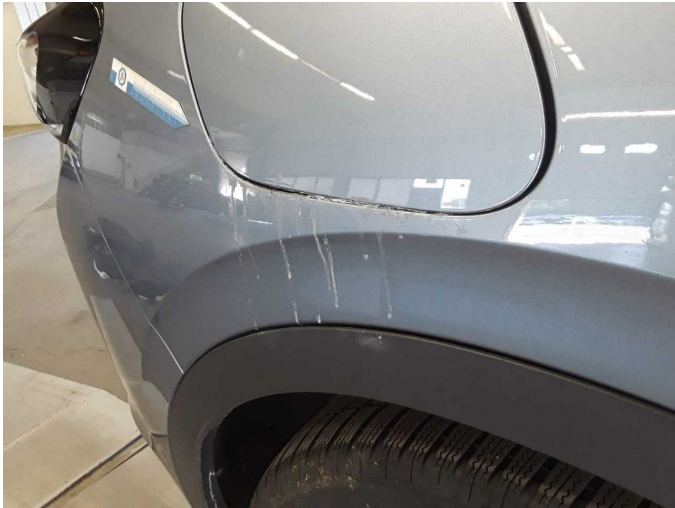
Damage 1: Body: Body (Vogelkot) - Paint defect - Smart repair

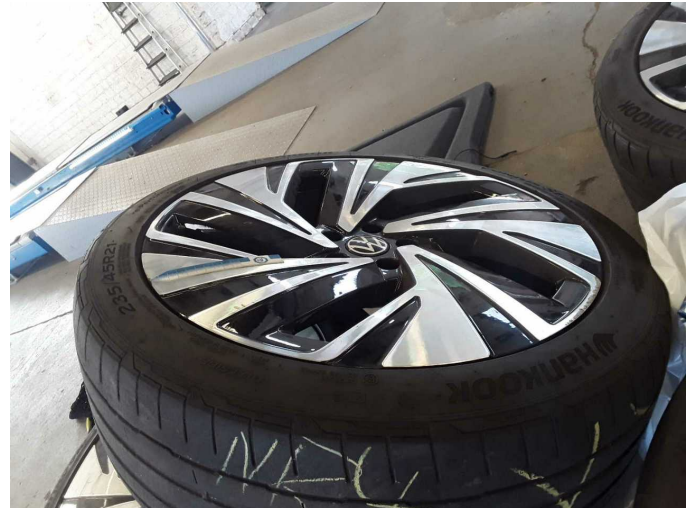
Damage 2: 2nd wheel set: 2 alloy rims - Scratched - Loss in value

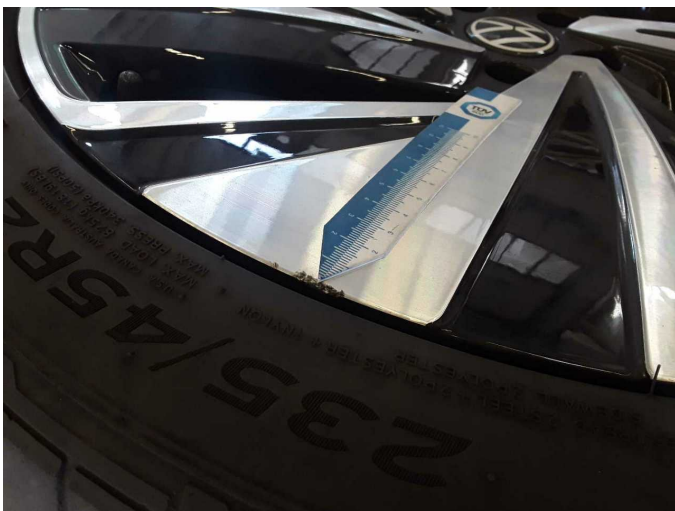
Damage 2: 2nd wheel set: 2 alloy rims - Scratched - Loss in value

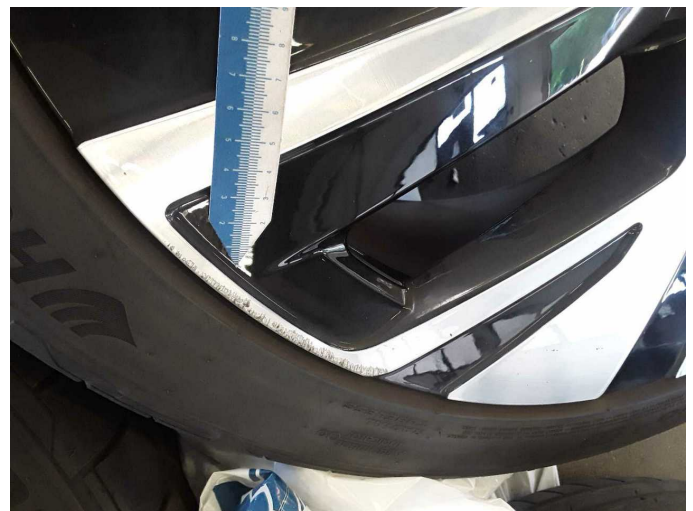
Damage 2: 2nd wheel set: 2 alloy rims - Scratched - Loss in value

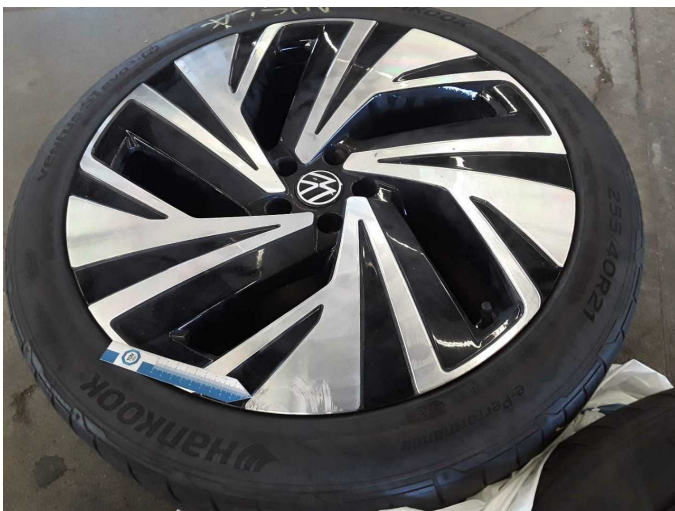
Damage 2: 2nd wheel set: 2 alloy rims - Scratched - Loss in value

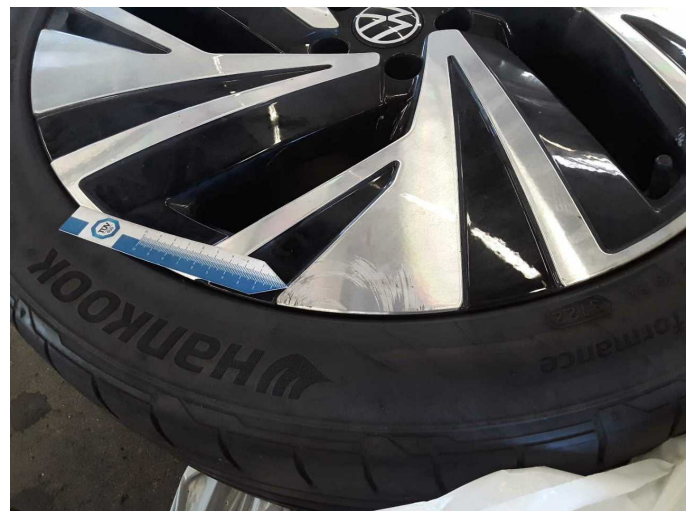
Damage 2: 2nd wheel set: 2 alloy rims - Scratched - Loss in value

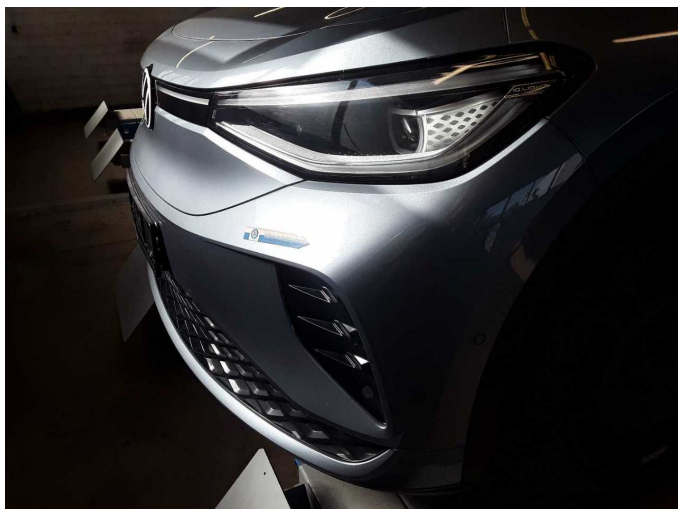
Wear and tear 1: Front bumper: Front bumper - Stone chips - No deduction

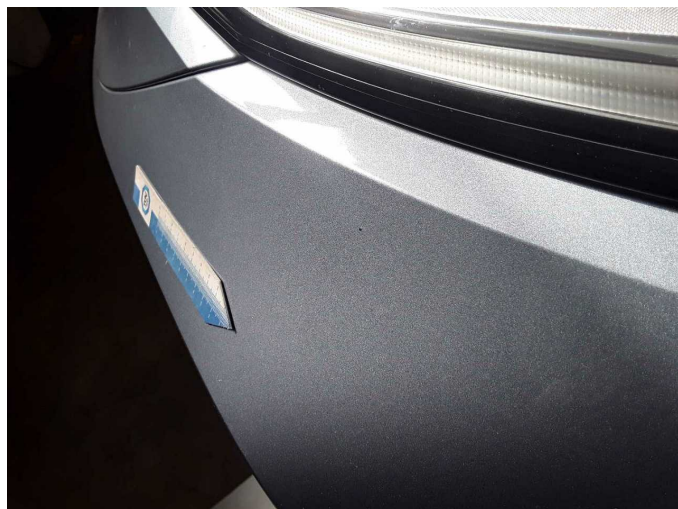
Wear and tear 1: Front bumper: Front bumper - Stone chips - No deduction

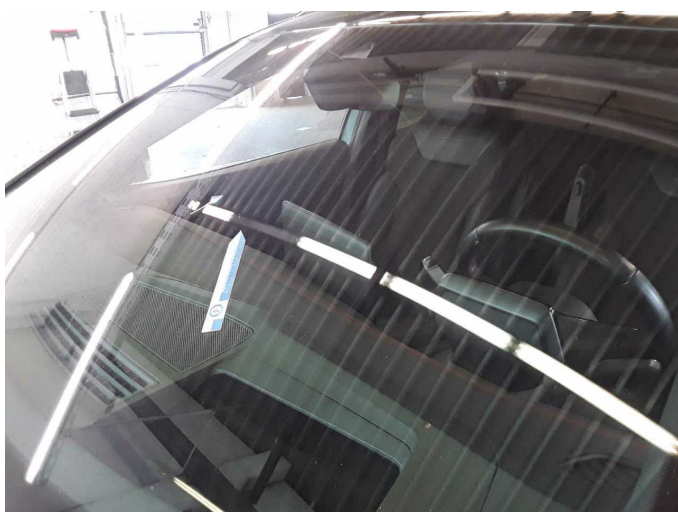
Wear and tear 2: Vehicle glazing: Windscreen - Stone chips - No deduction
