## Expertise

Protocol number: 46231579  
Order No. / Reference: 26153858  
Inspection date: 15 Jun 2026

Model: Vito 116 CDI Tourer Lang Aut. SELECT

VIN: W1VVLFEZ3T4547566

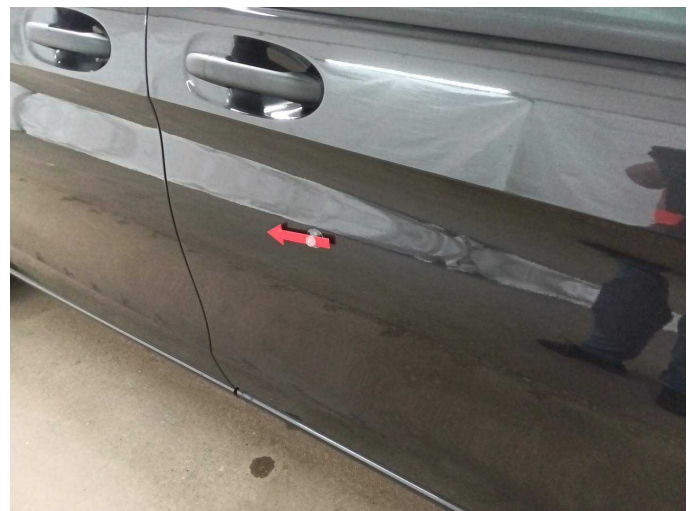
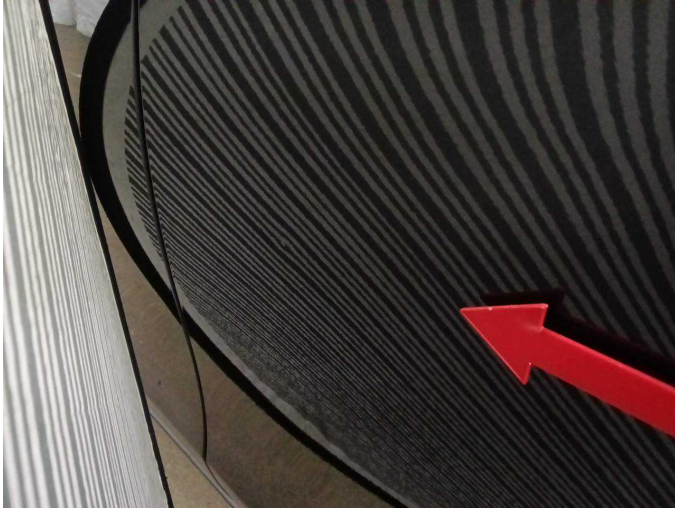
Damage 1: Door - front right side: Door - dent(s) - Smooth repair work

**Damage 1:** Door - front right side: Door - dent(s) - Smooth repair work

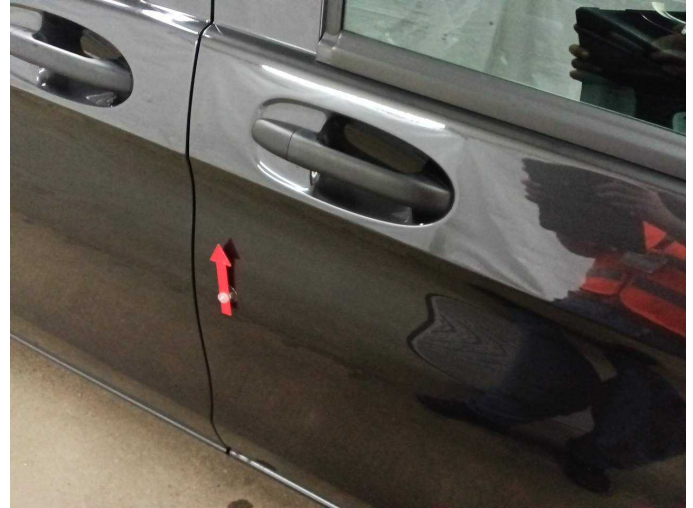
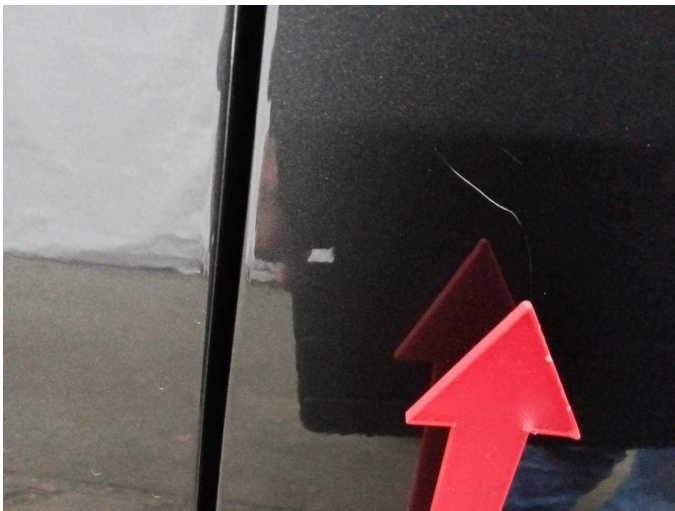
**Damage 2:** Door - front right side: Door - Scratch(es) - Smart repair

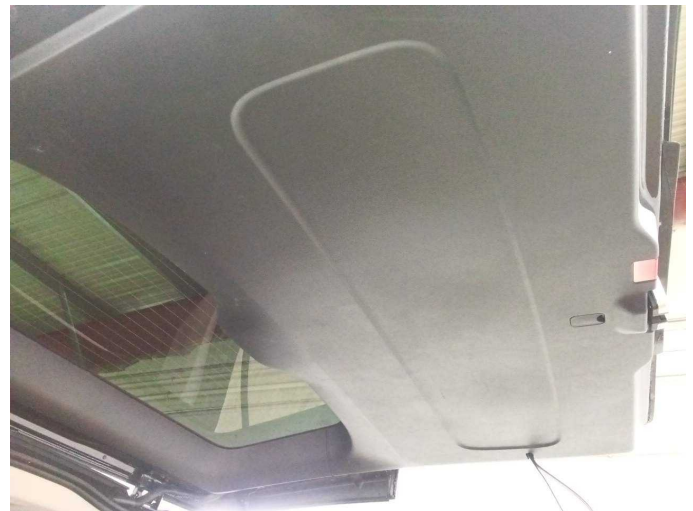
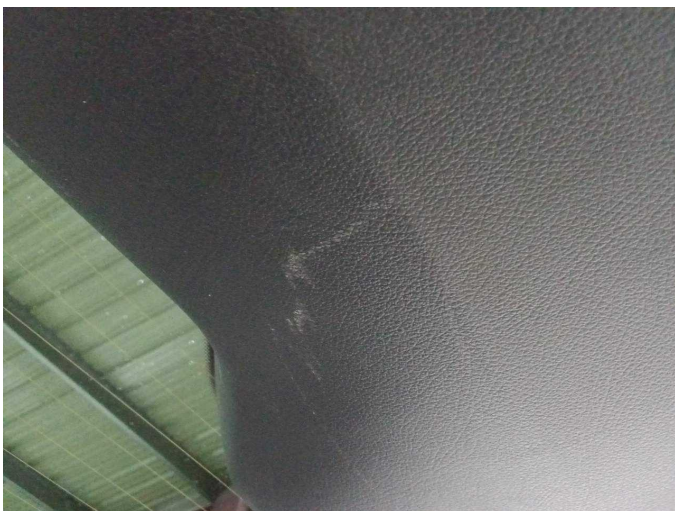
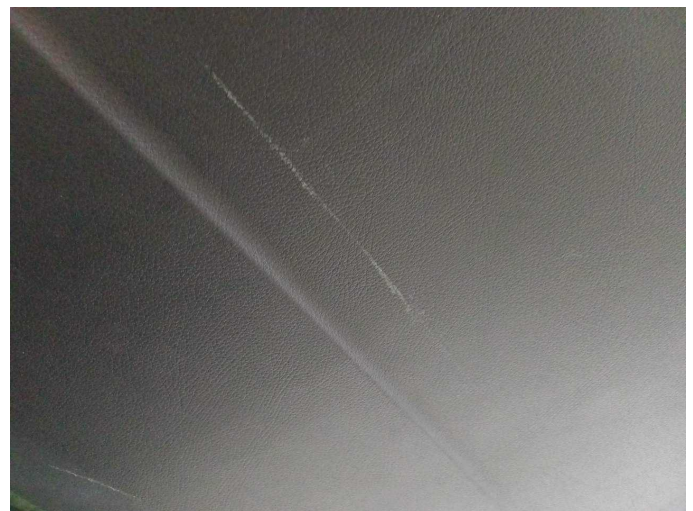
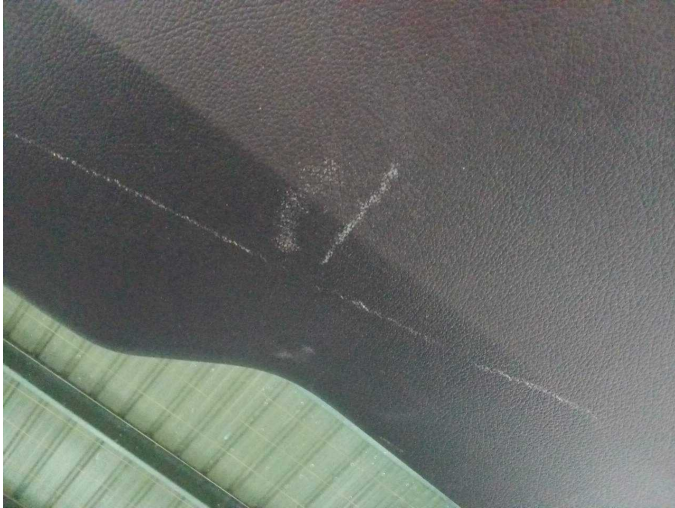
**Damage 3:** Trim / covers: Boot lid - interior trim - Scratched - Replace

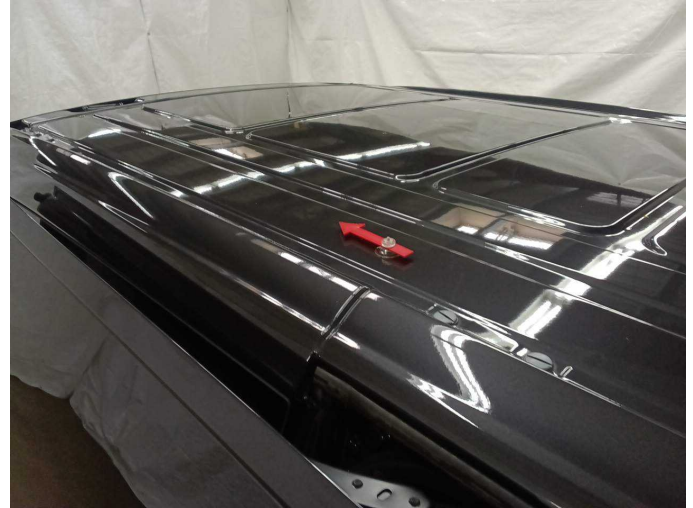
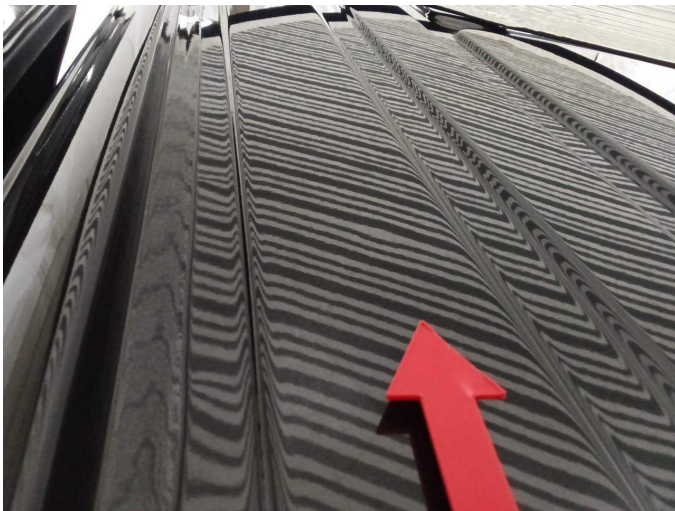
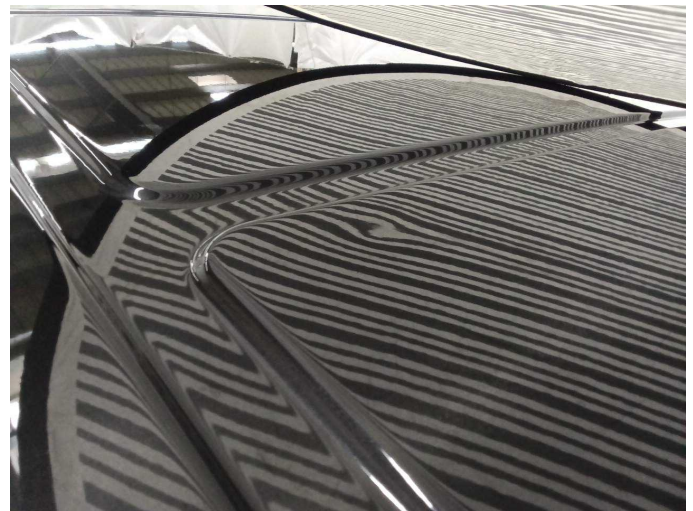
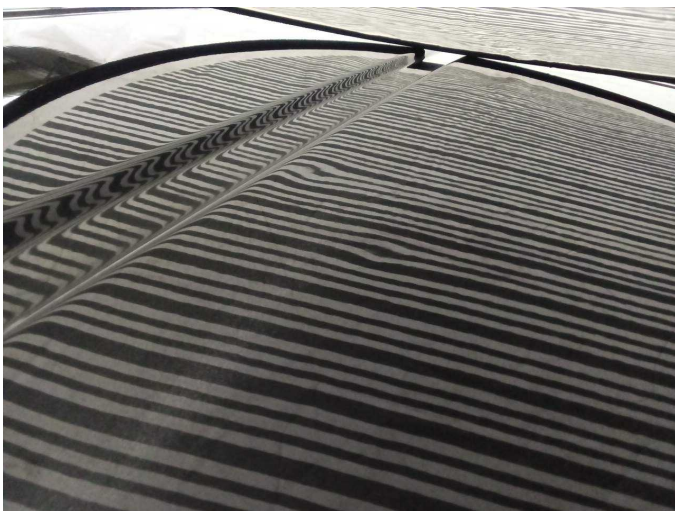
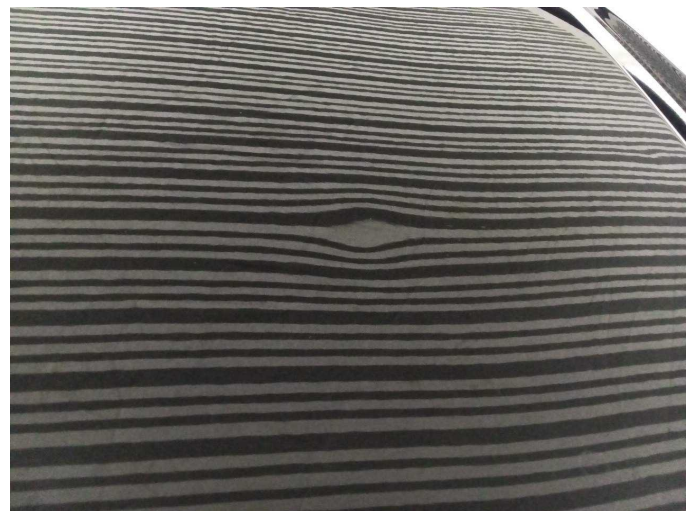
**Damage 4:** Roof: Roof (4 Dellen) - dent(s) - Smooth repair work

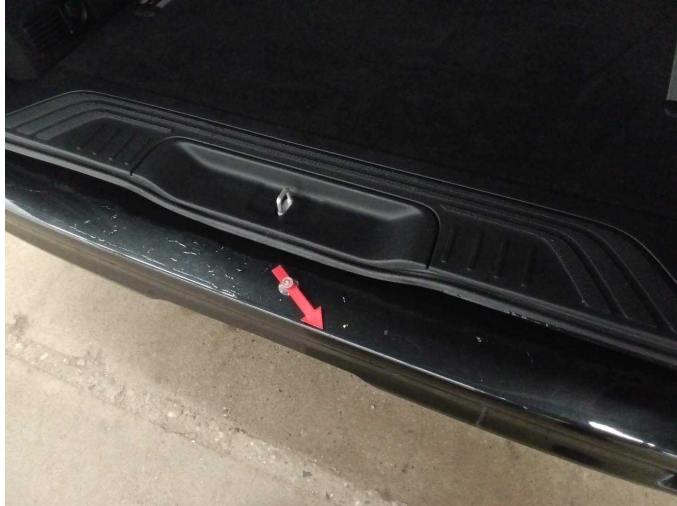
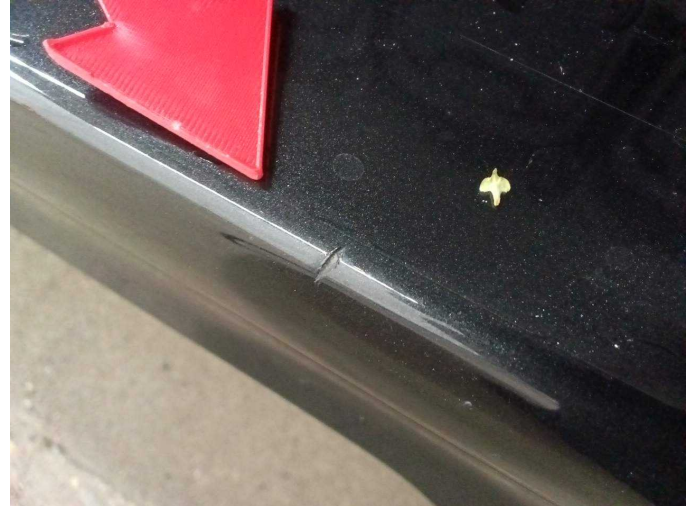
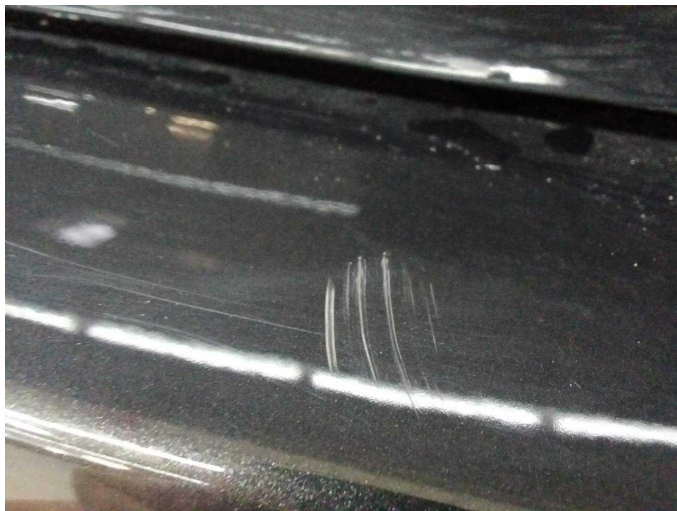
**Damage 5:** Rear bumper: Rear bumper - Scratch(es) - Paint
