Expertise

Protocol number: 46002977
Order No. / Reference: 26488790
Inspection date: 16 Jun 2026

Manufacturer: MAN

Model: TGE 3.140 4X2F SB

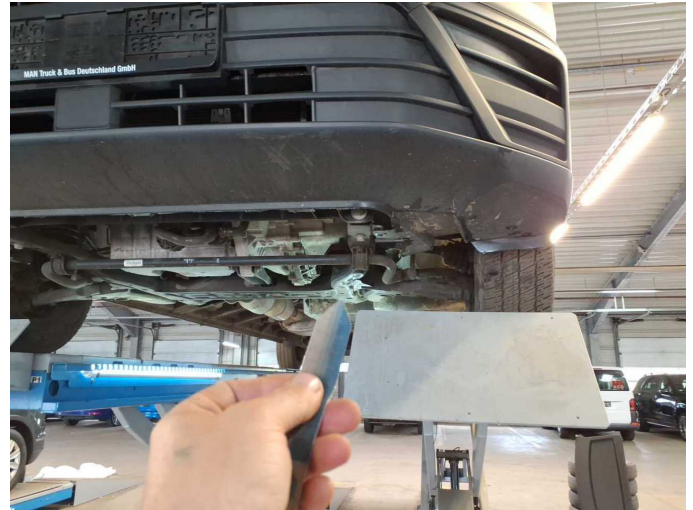
No.	Component group	Description
1	Front axle	Axles / undercarriage (Voller Fett, evtl. Mehrkosten) - Perform diagnosis

Damage 1: Front axle: Axles / undercarriage (Voller Fett, evtl. Mehrkosten) - Perform diagnosis

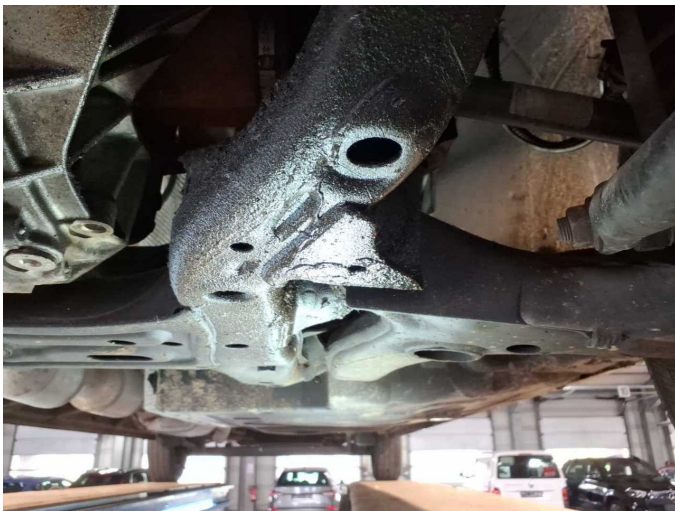
Damage 1: Front axle: Axles / undercarriage (Voller Fett, evtl. Mehrkosten) - Perform diagnosis

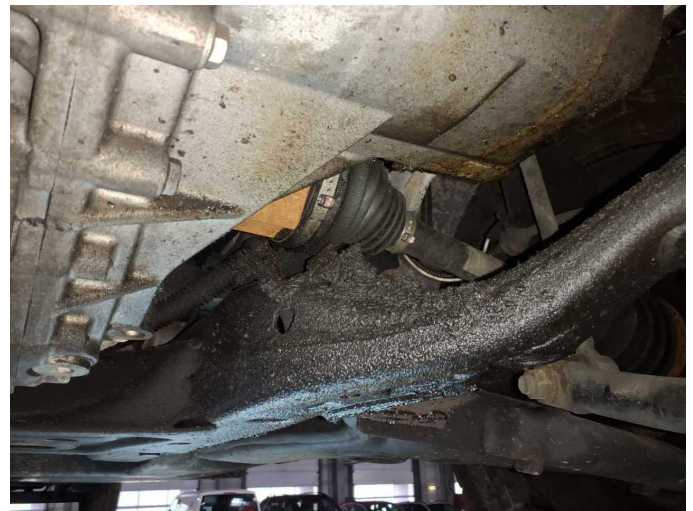
Damage 1: Front axle: Axles / undercarriage (Voller Fett, evtl. Mehrkosten) - Perform diagnosis

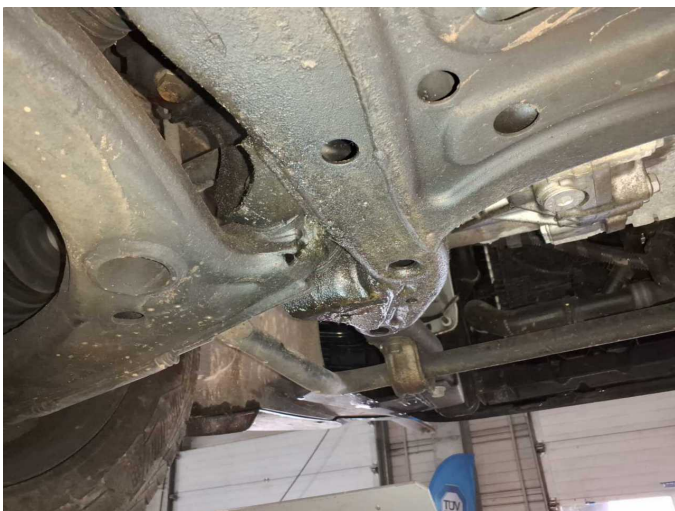
Damage 1: Front axle: Axles / undercarriage (Voller Fett, evtl. Mehrkosten) - Perform diagnosis
