Expertise

Protocol number: 46523470  
Order No. / Reference: 26656700  
Inspection date: 15 Jul 2026

| Manufacturer: Opel | Model: Astra 1.5 D Start/Stop Sports Tourer Automatik Edition |

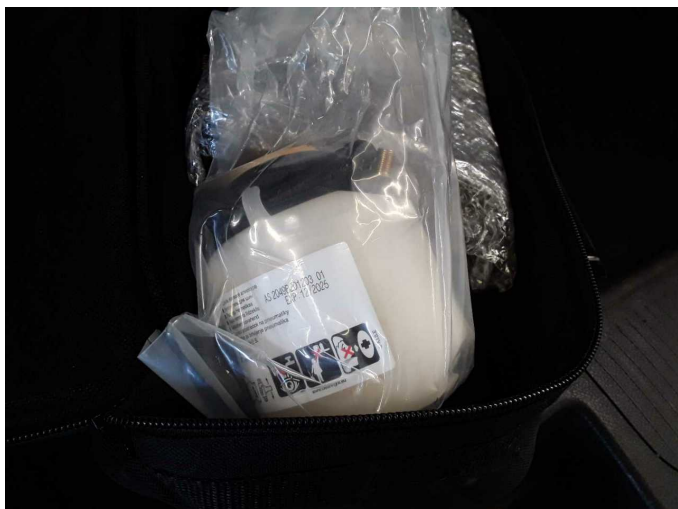
| No. | Component group | Description |
|---|---|---|
| 1 | Equipment | Tirefit filler - Expired - Replace |

**Damage 1:** Equipment: Tirefit filler - Expired - Replace

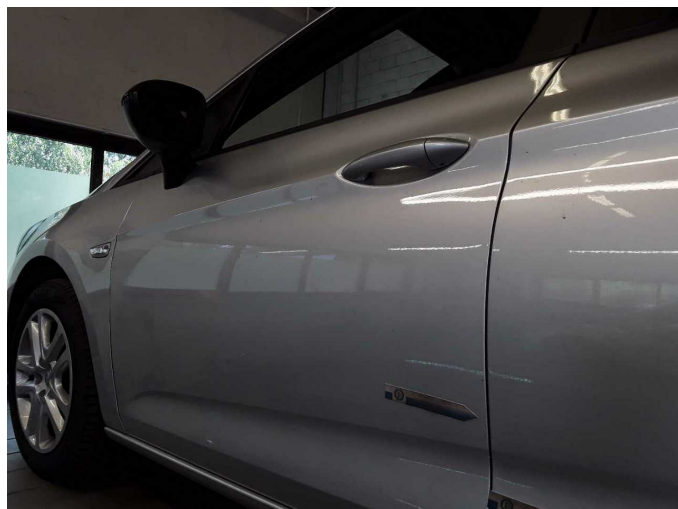
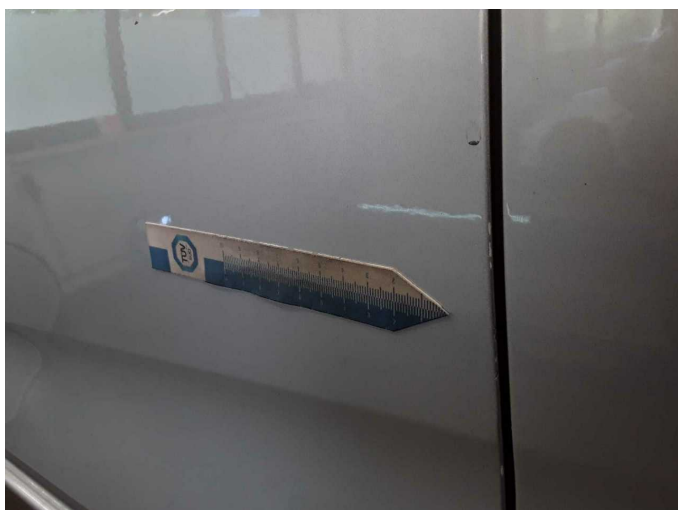
| No. | Component group | Description |
|---|---|---|
| 2 | Door - front left side | Door - Scratch(es) - Smart repair |

**Damage 2:** Door - front left side: Door - Scratch(es) - Smart repair

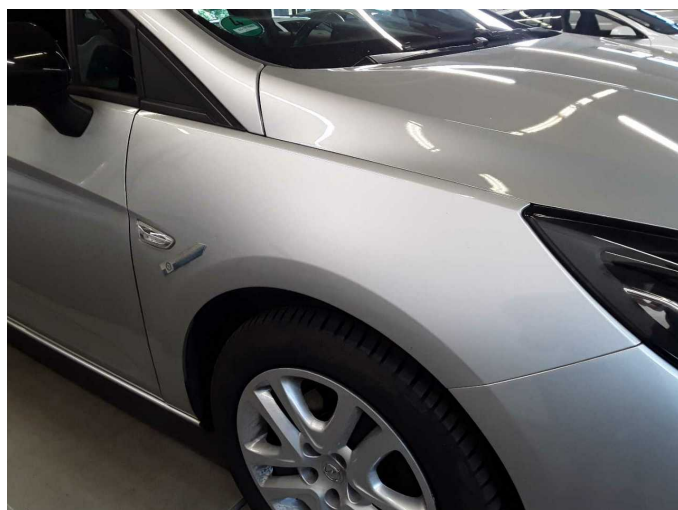
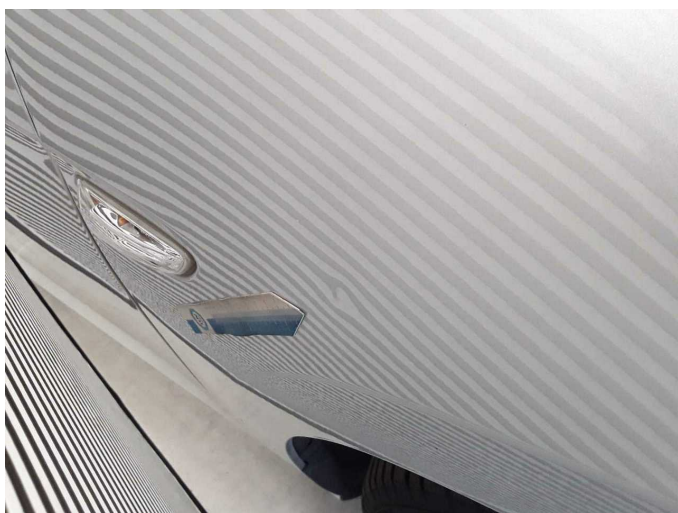
| No. | Component group | Description |
|---|---|---|
| 3 | Mudguard - right side | Mudguard - right side - dent(s) - Smooth repair work |

**Damage 3:** Mudguard - right side: Mudguard - right side - dent(s) - Smooth repair work

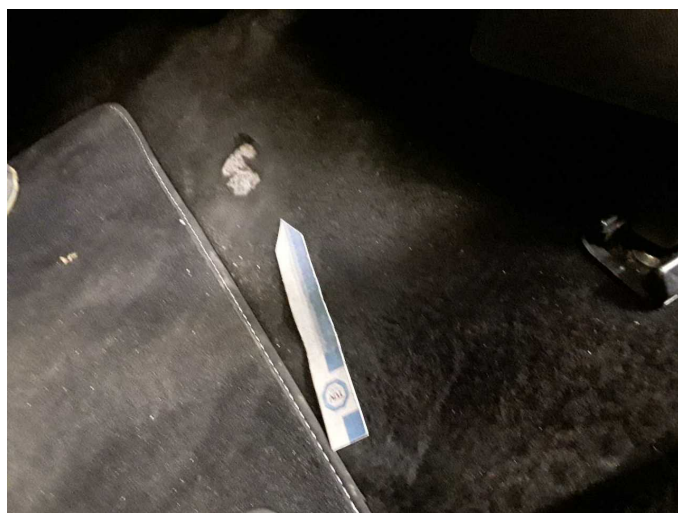
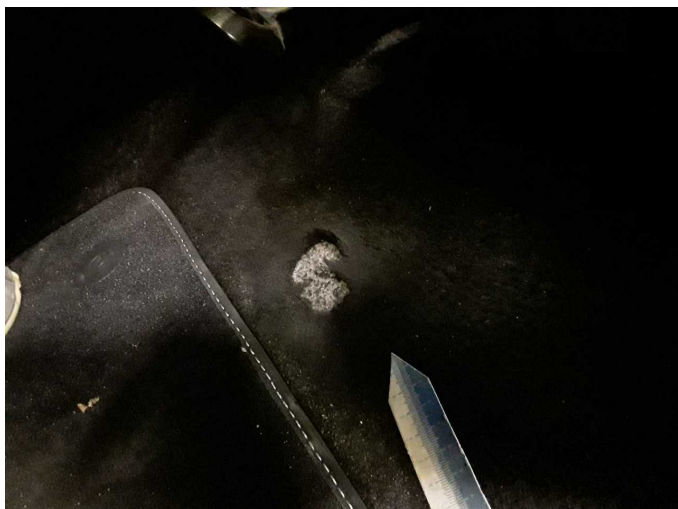
| No. | Component group | Description |
|---|---|---|
| 4 | Trim / covers | Carpet - front left side - Damaged - Smart repair |

**Damage 4:** Trim / covers: Carpet - front left side - Damaged - Smart repair

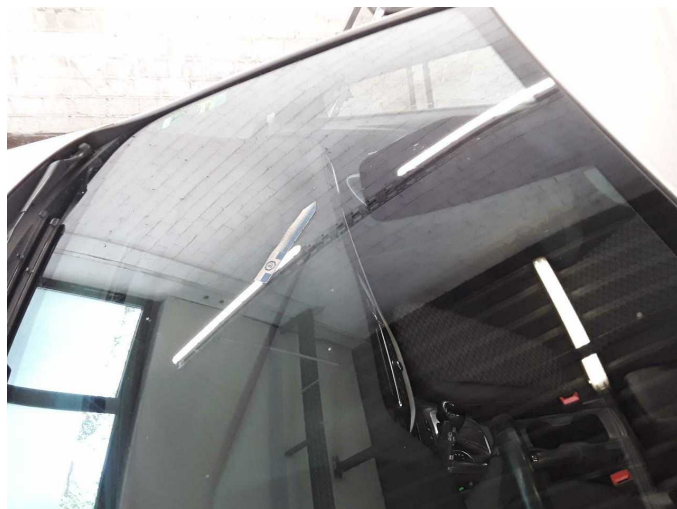
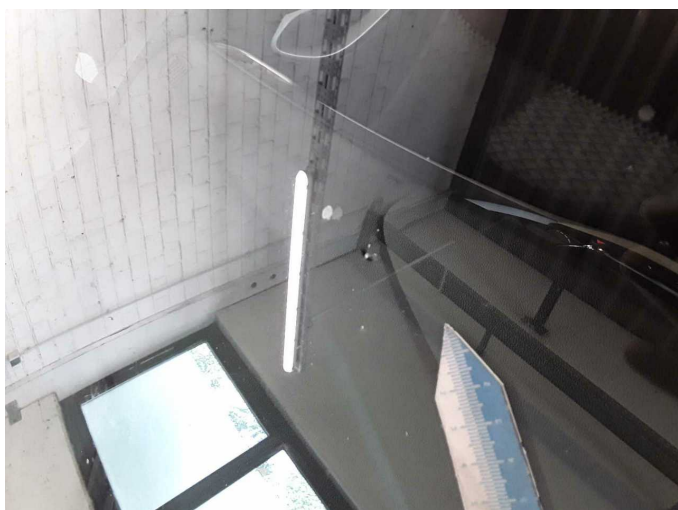
| No. | Component group | Description |
|---|---|---|
| 5 | Vehicle glazing | Windscreen (Rissbildung) - Stone chips - Replace |

**Damage 5:** Vehicle glazing: Windscreen (Rissbildung) - Stone chips - Replace

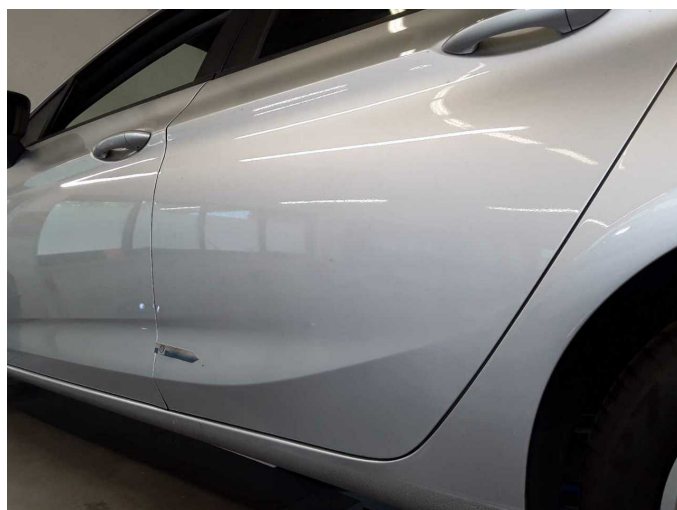
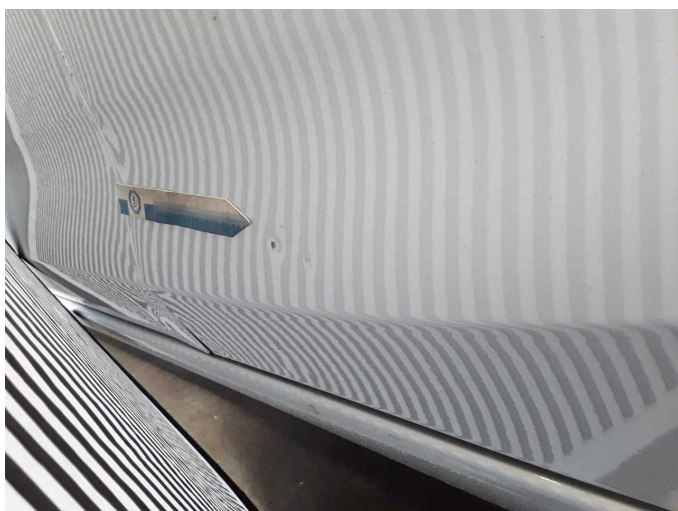
| No. | Component group | Description |
|---|---|---|
| 6 | Door - rear left side | Door - Dent / paintcoat damage - Repair and paint |

**Damage 6:** Door - rear left side: Door - Dent / paintcoat damage - Repair and paint

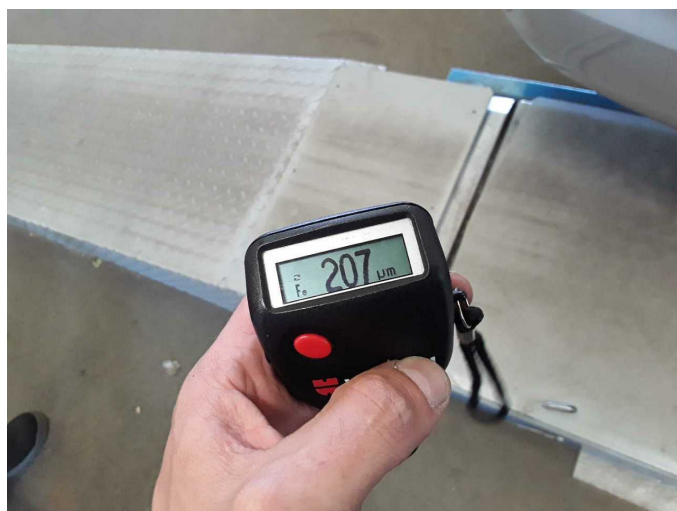
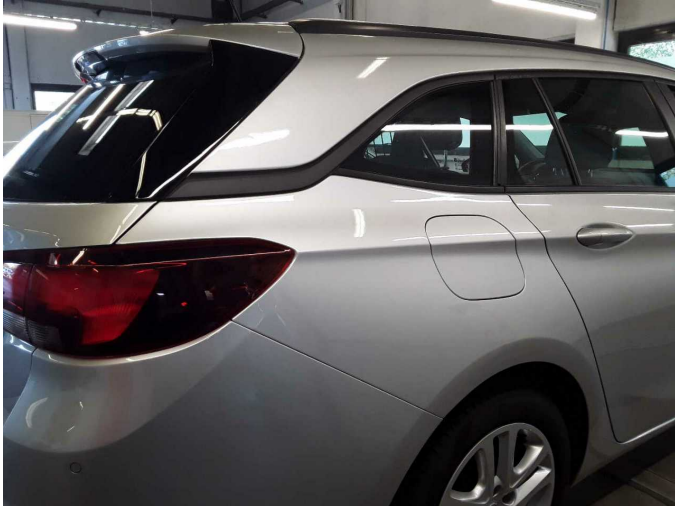
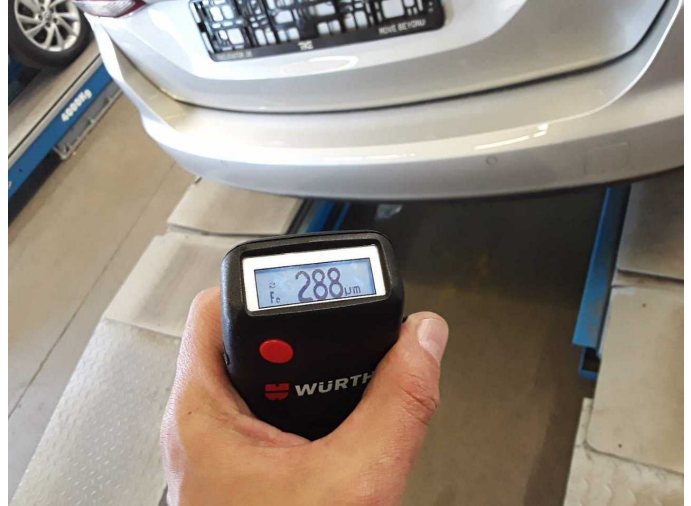
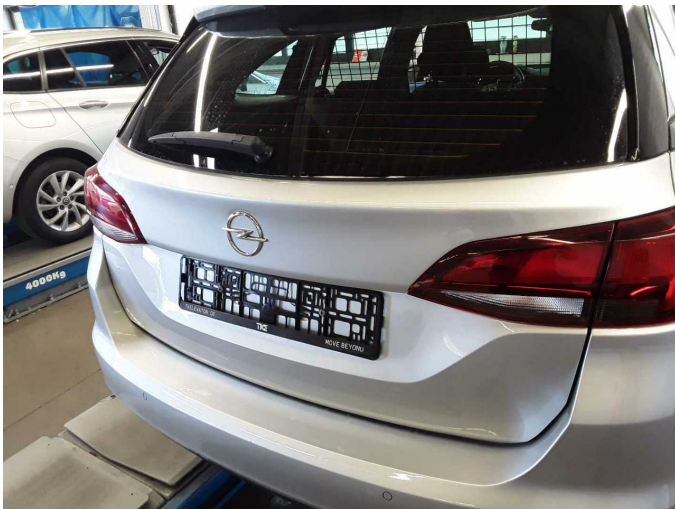
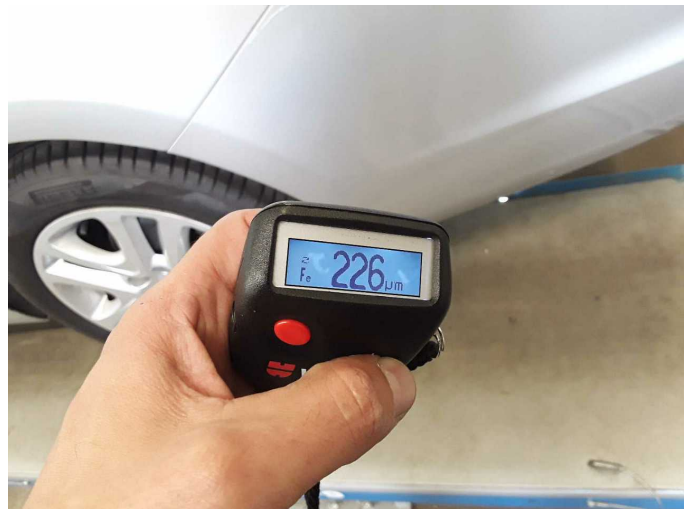
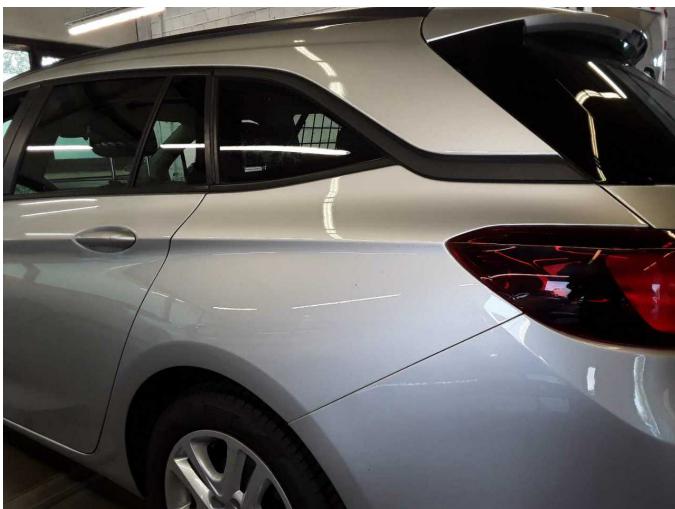
| 1 | Boot lid / rear door, Side panel - rear left side, Side panel - rear right side, Professionally carried out, Invoice of repair done Non-existent |

**Repainting 1:** Boot lid / rear door, Side panel - rear left side, Side panel - rear right side
