Expertise

Protocol number: 46347422  
Order No. / Reference: 26407554  
Inspection date: 6 Jul 2026

Manufacturer: Volkswagen

Model: Tiguan 2.0 TDI SCR 4MOTION DSG Life

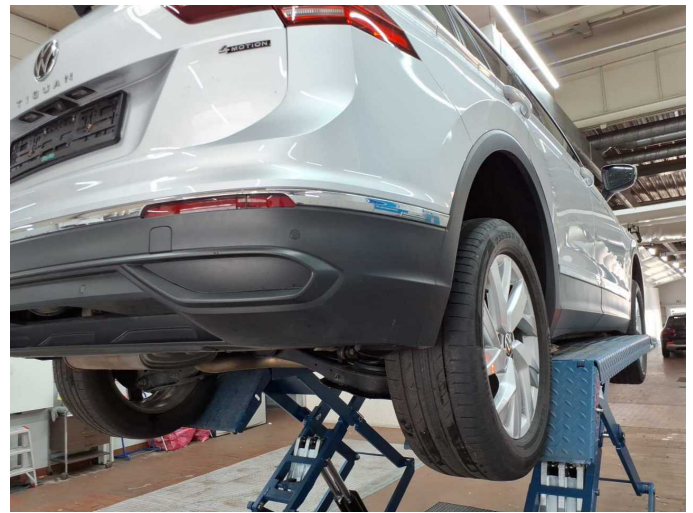
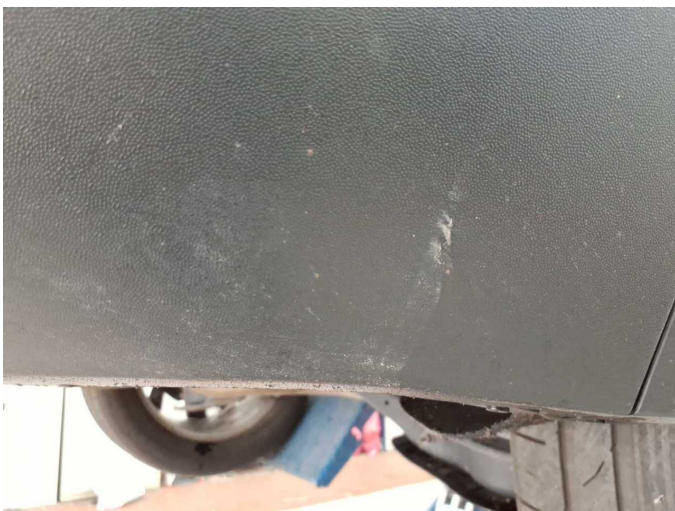
| No. | Component group | Description |
|---|---|---|
| 1 | Rear bumper | Spoiler - Scratched - Loss in value |

**Damage 1:** Rear bumper: Spoiler - Scratched - Loss in value

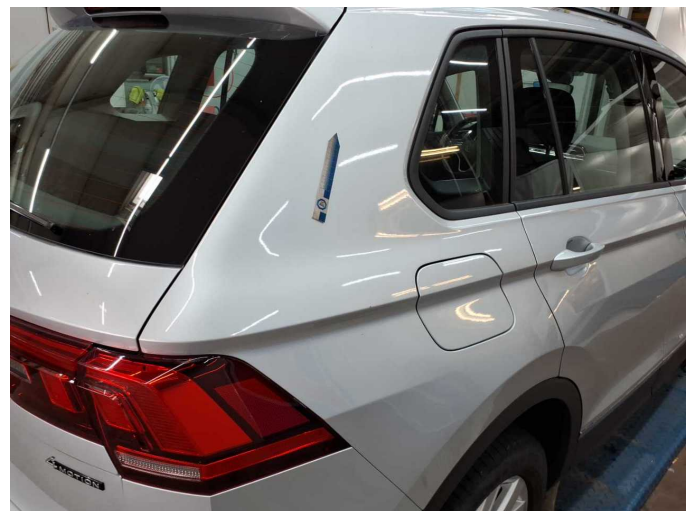
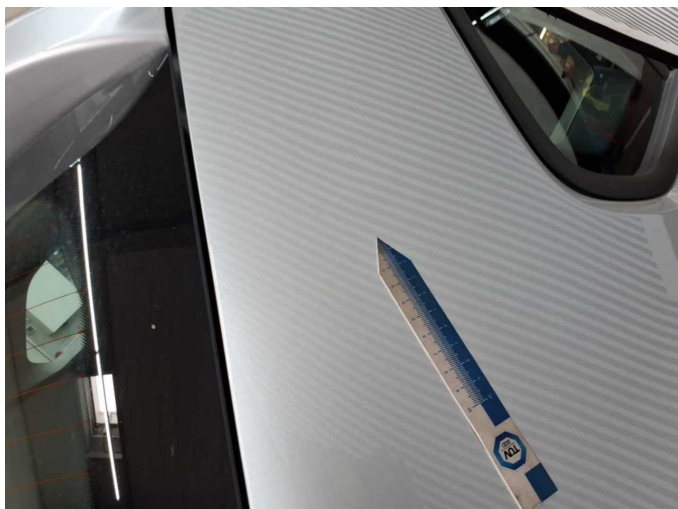
| No. | Component group | Description |
|---|---|---|
| 2 | Side panel - rear right side | Side panel - dent(s) - Smart repair |

**Damage 2:** Side panel - rear right side: Side panel - dent(s) - Smart repair

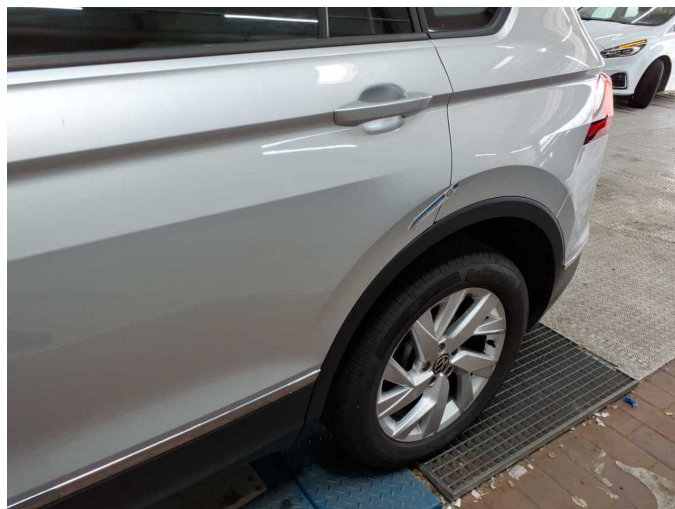
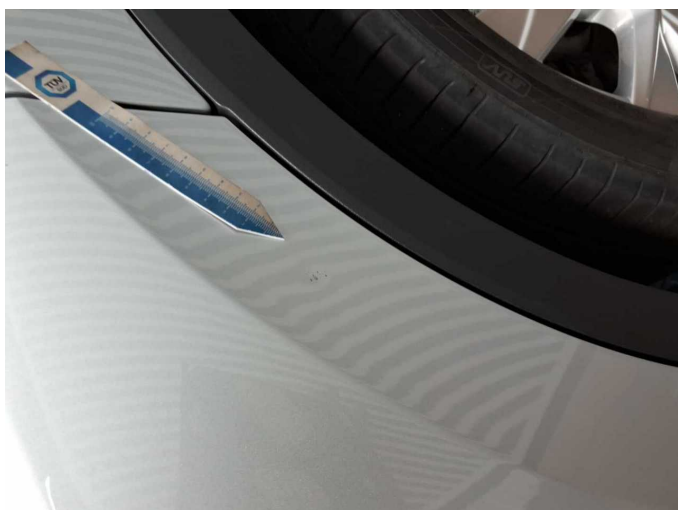
| No. | Component group | Description |
|---|---|---|
| 3 | Door - rear left side | Door - dent(s) - Smart repair |

**Damage 3:** Door - rear left side: Door - dent(s) - Smart repair

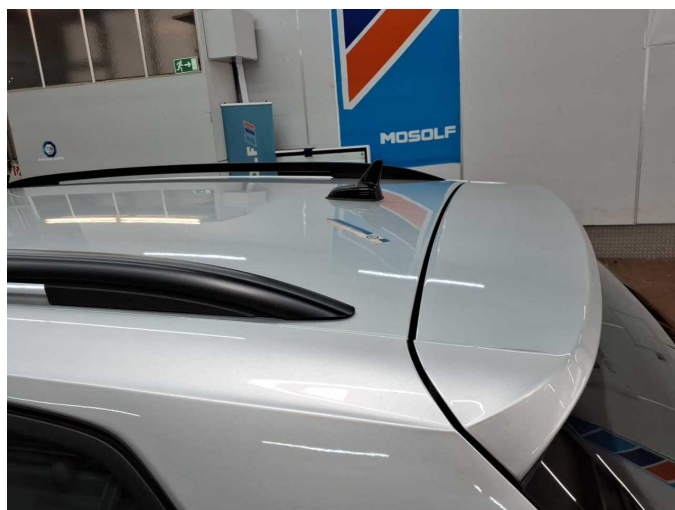
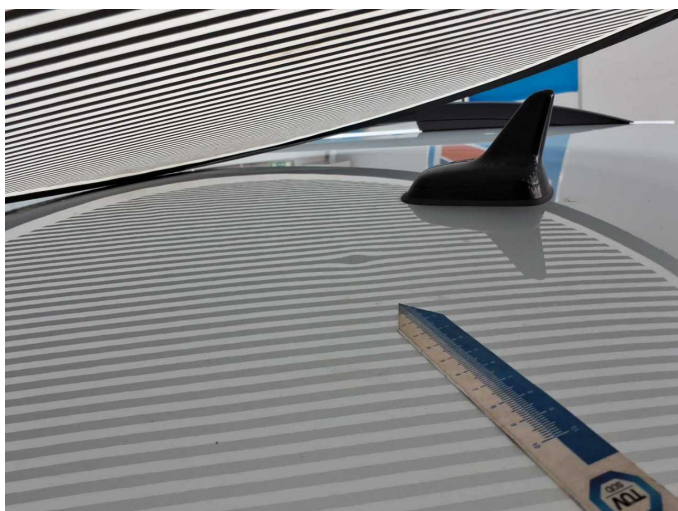
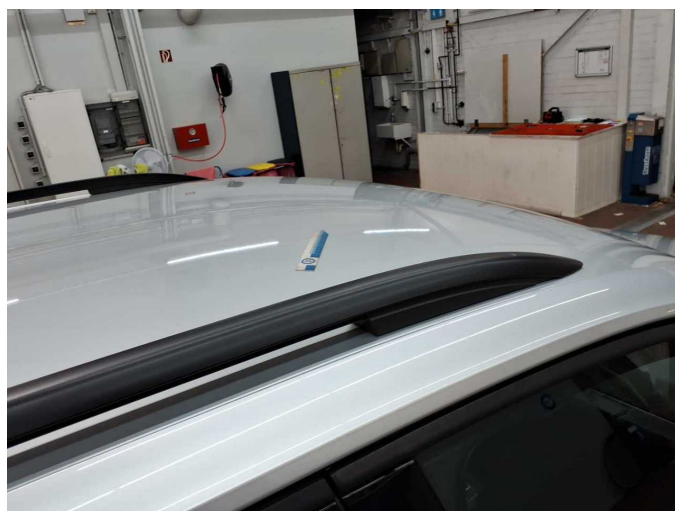
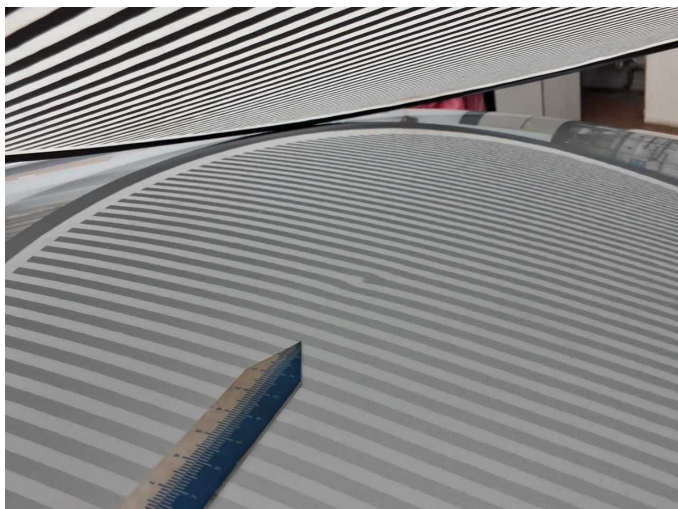
| No. | Component group | Description |
|---|---|---|
| 4 | Roof | Roof - dent(s) - Smart repair |

**Damage 4:** Roof: Roof - dent(s) - Smart repair

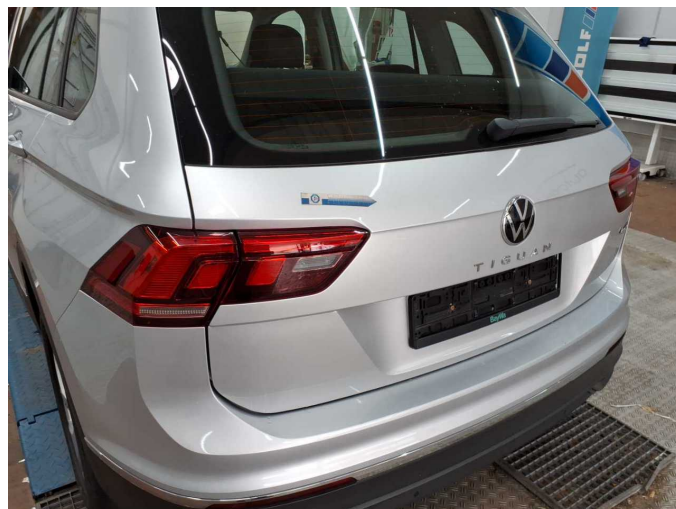
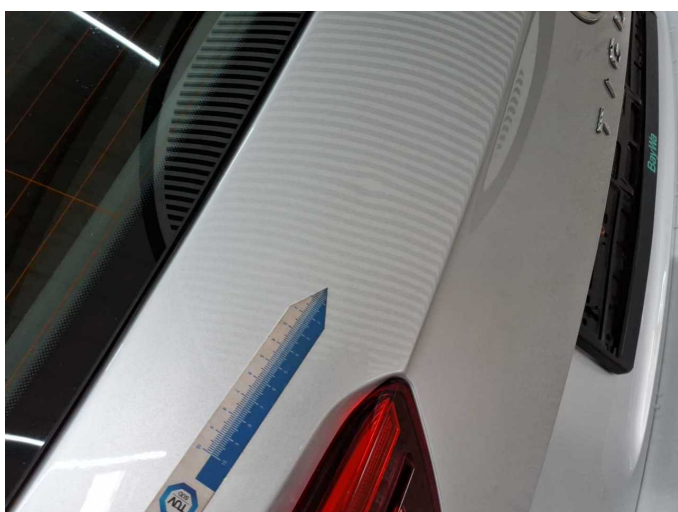
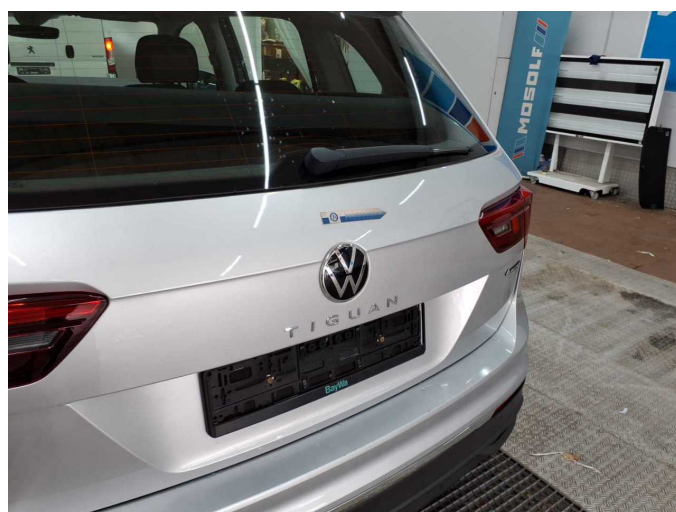
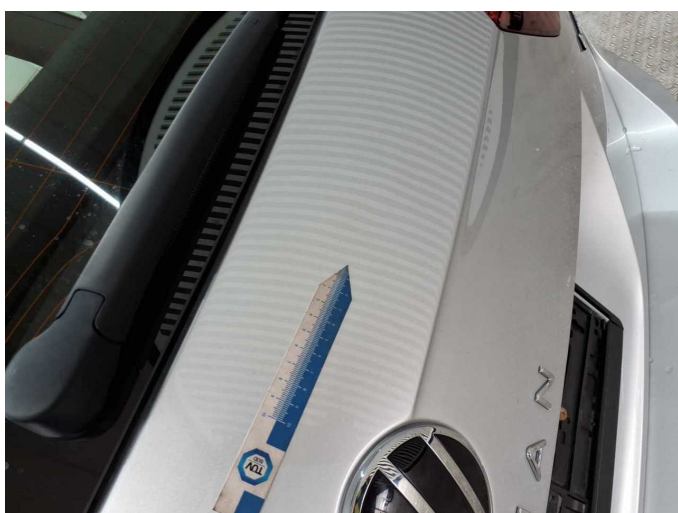
| No. | Component group | Description |
|---|---|---|
| 5 | Boot lid / rear door | Boot lid - dent(s) - Smart repair |

**Damage 5:** Boot lid / rear door: Boot lid - dent(s) - Smart repair

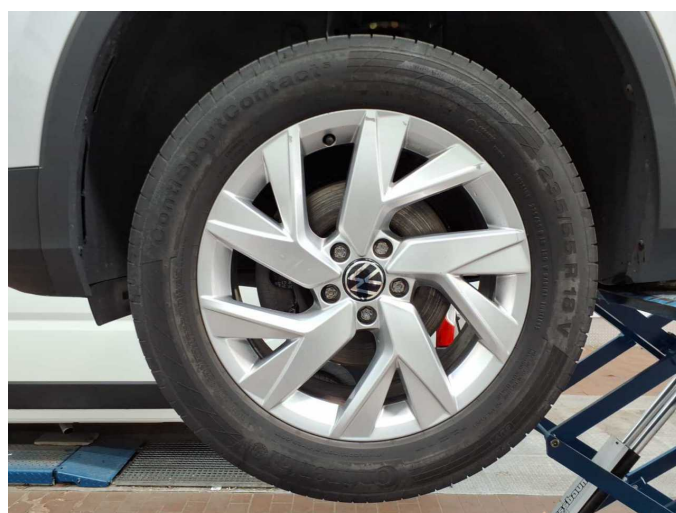
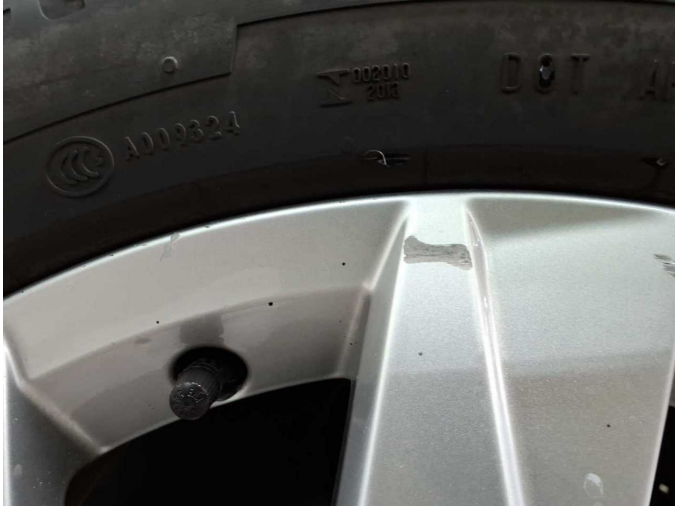
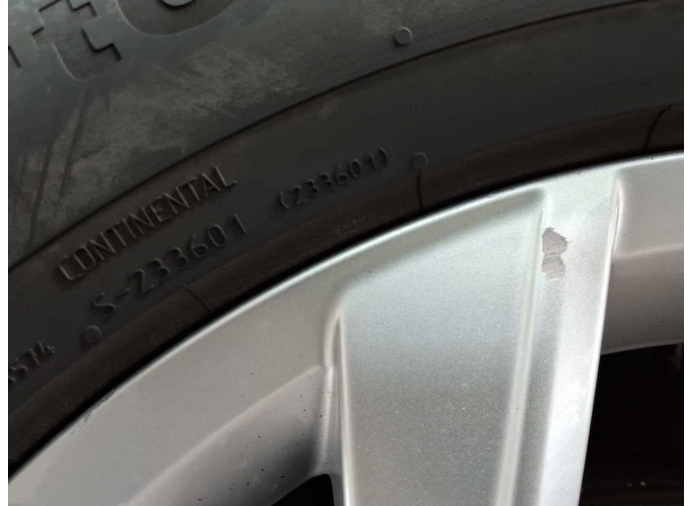
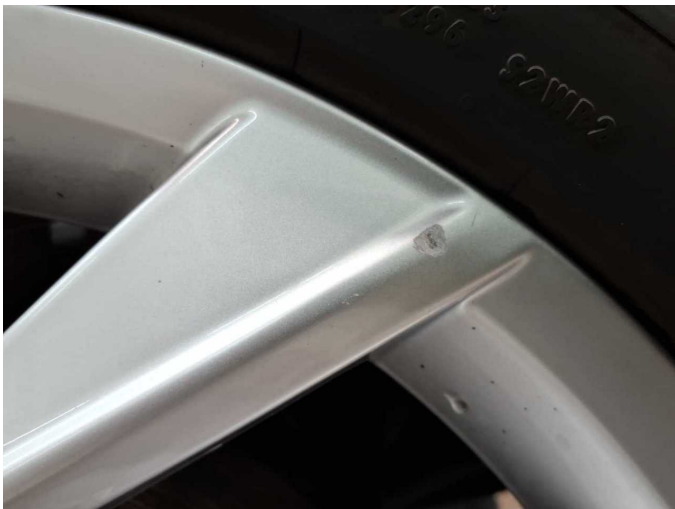
| No. | Component group | Description |
|---|---|---|
| 6 | Wheel / tyres | Alloy rim - front left side - Scratched - Loss in value |

**Damage 6:** Wheel / tyres: Alloy rim - front left side - Scratched - Loss in value

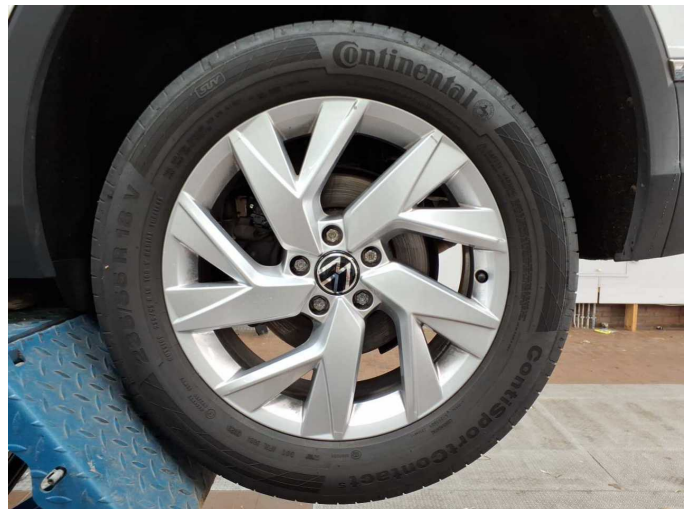
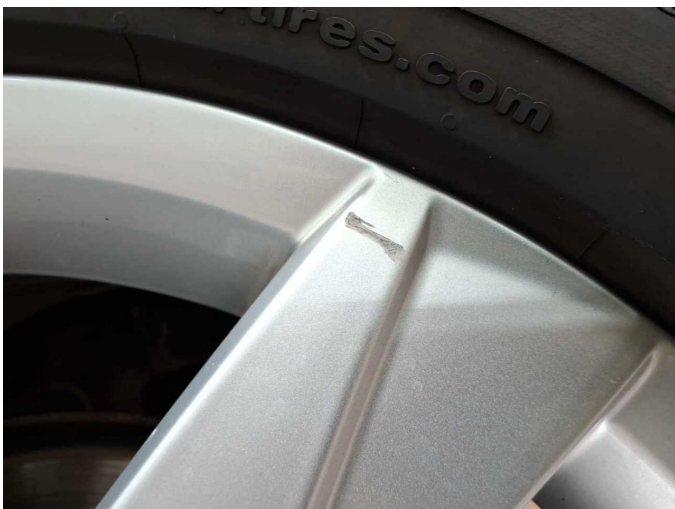
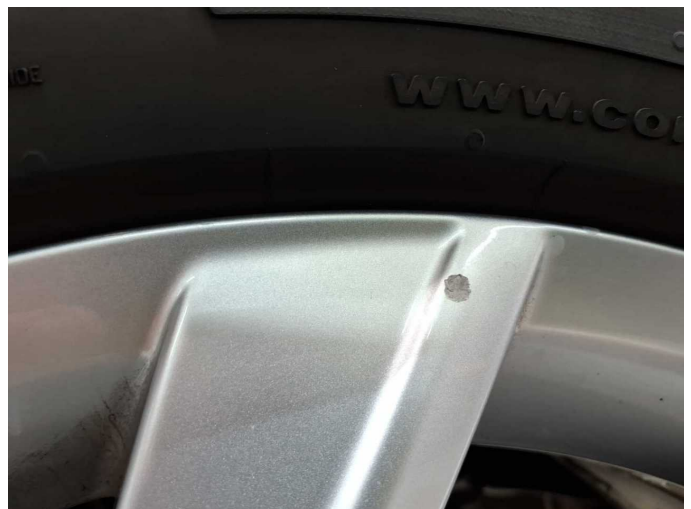
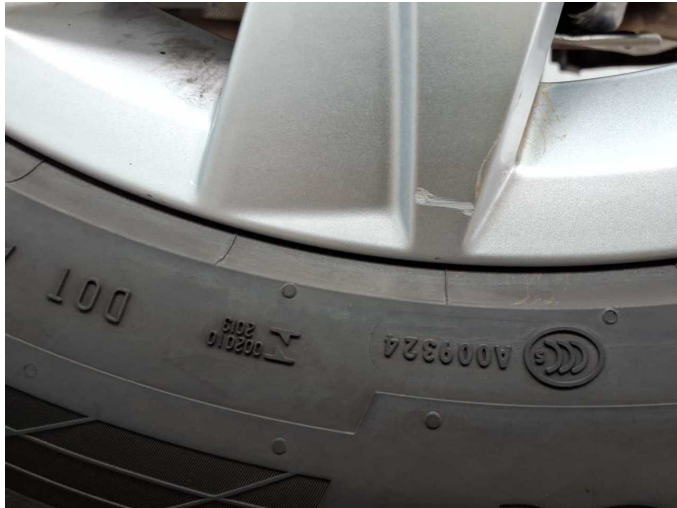
| No. | Component group | Description |
|---|---|---|
| 7 | Wheel / tyres | Alloy rim - rear left side - Scratched - Loss in value |

**Damage 7:** Wheel / tyres: Alloy rim - rear left side - Scratched - Loss in value

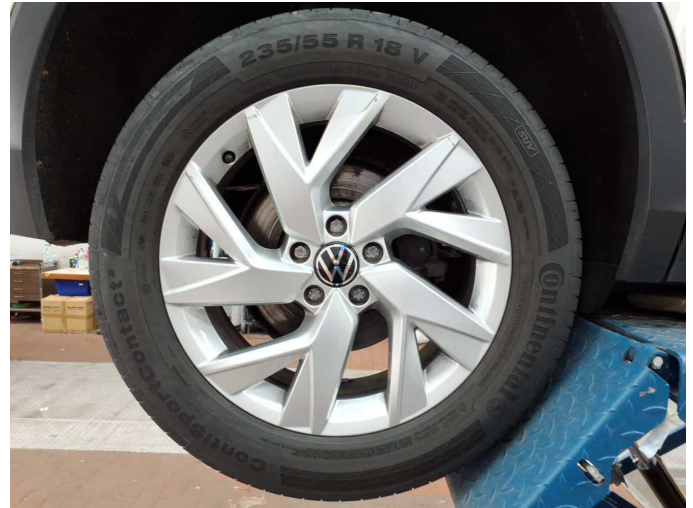
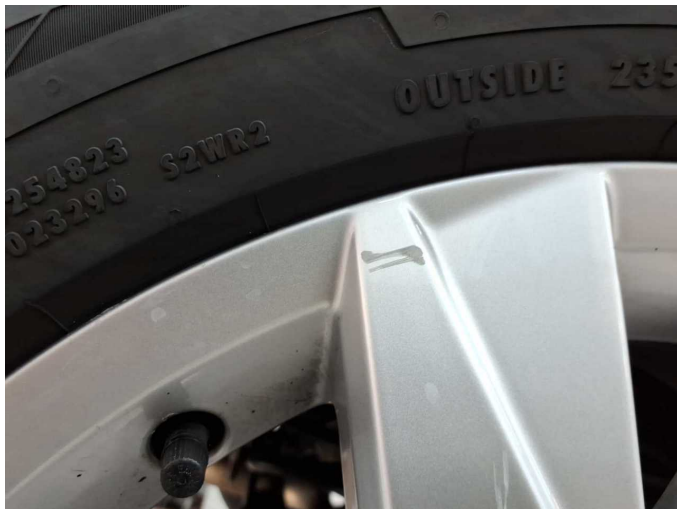
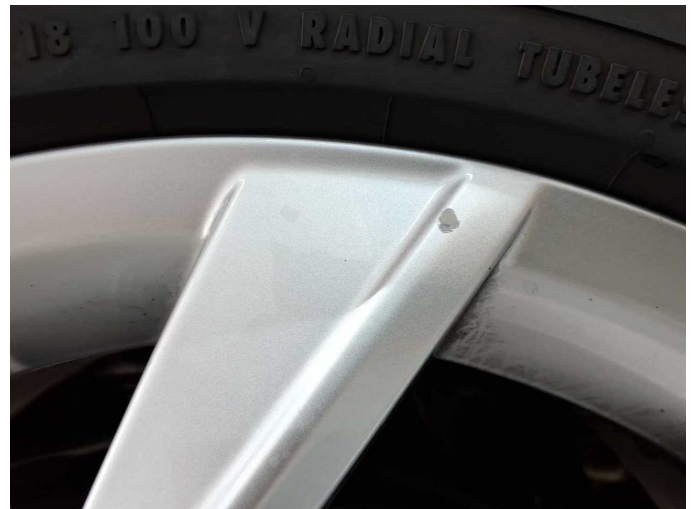
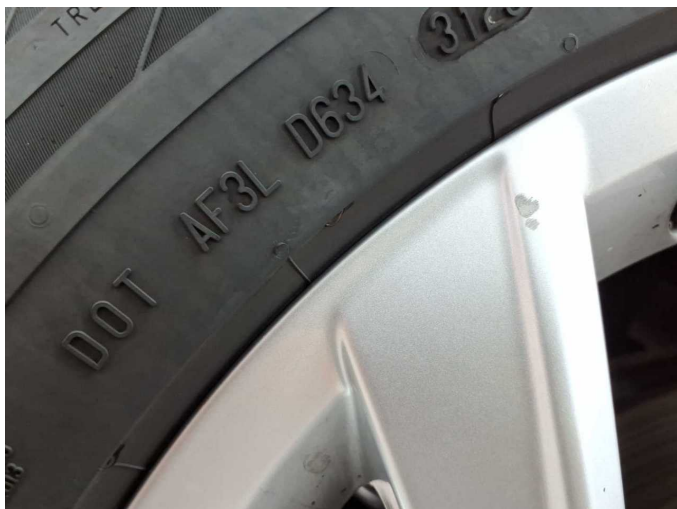
| No. | Component group | Description |
|---|---|---|
| 8 | Wheel / tyres | Alloy rim - rear right side - Scratched - Loss in value |

**Damage 8:** Wheel / tyres: Alloy rim - rear right side - Scratched - Loss in value

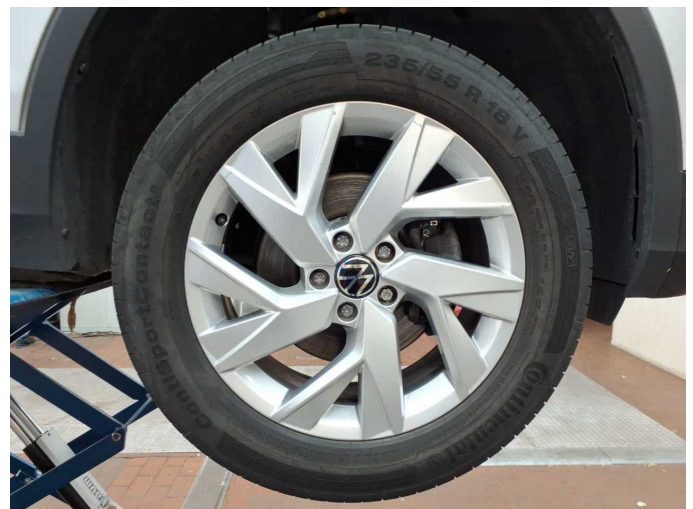
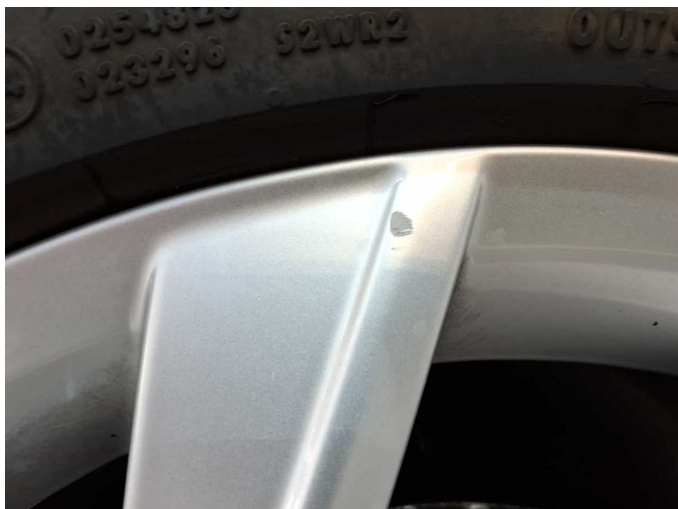
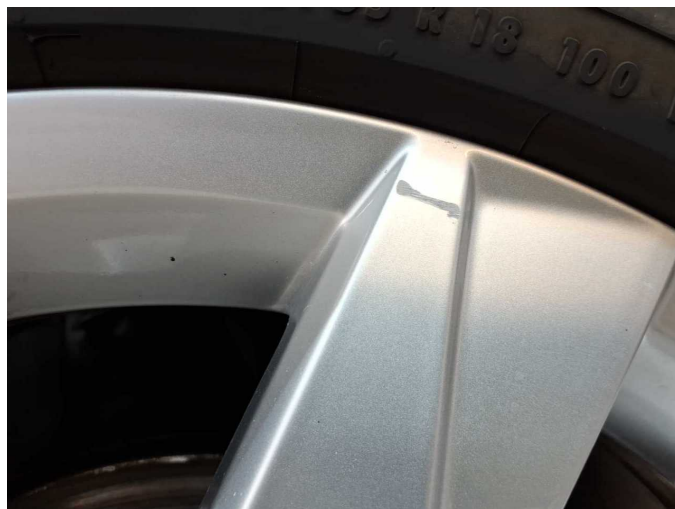
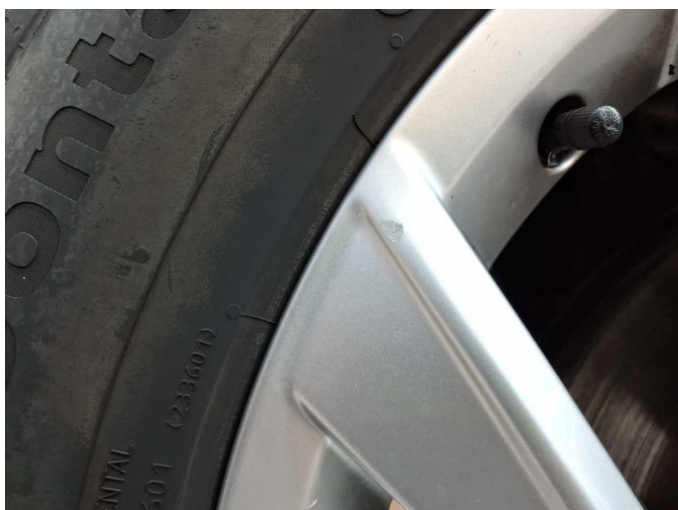
| No. | Component group | Description |
|---|---|---|
| 9 | Wheel / tyres | Alloy rim - front right side - Scratched - Loss in value |

**Damage 9:** Wheel / tyres: Alloy rim - front right side - Scratched - Loss in value

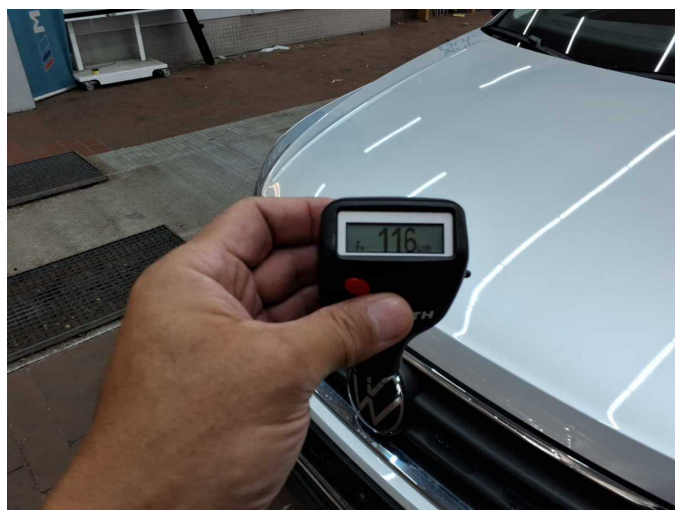
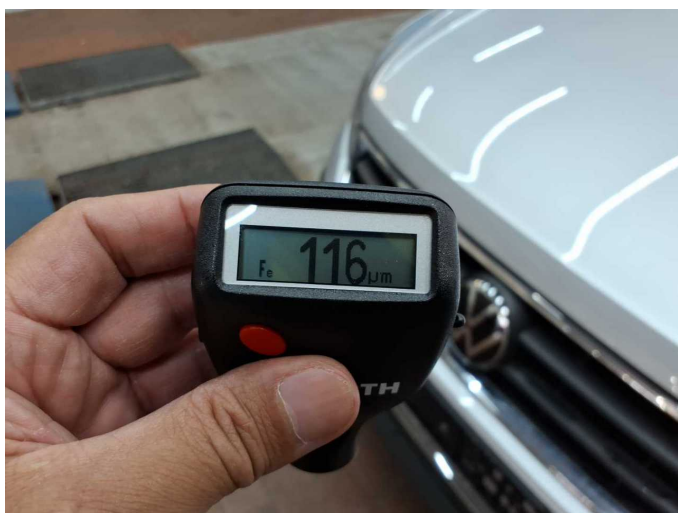
| No. | Repainting |
|---|---|
| 1 | Bonnet, Professionally carried out |

| Bonnet | 116 µm |

**Repainting 1:** Bonnet
