Expertise

Protocol number: 45918278  
Order No. / Reference: 26446096  
Inspection date: 12 Jun 2026

Manufacturer: Mercedes-Benz  
VIN: W1KAH0DB8PF098426

Model: C 200 d T 9G-TRONIC Avantgarde

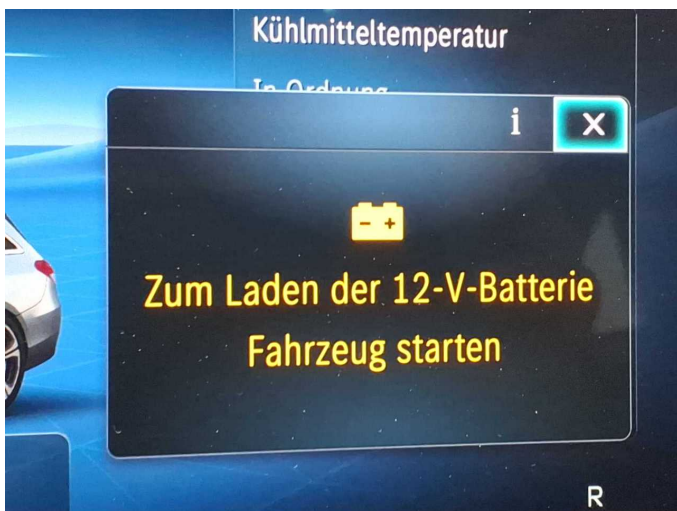
| No. | Component group | Description |
|---|---|---|
| 1 | Electrical system | Battery - Empty - Perform diagnosis |

Damage 1: Electrical system: Battery - Empty - Perform diagnosis

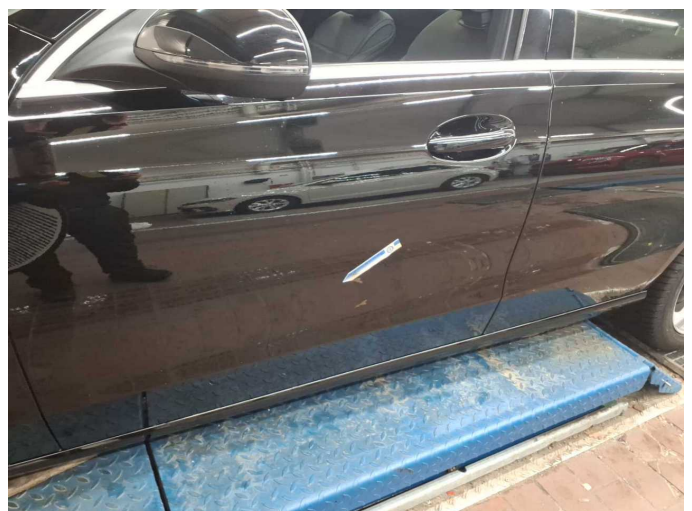
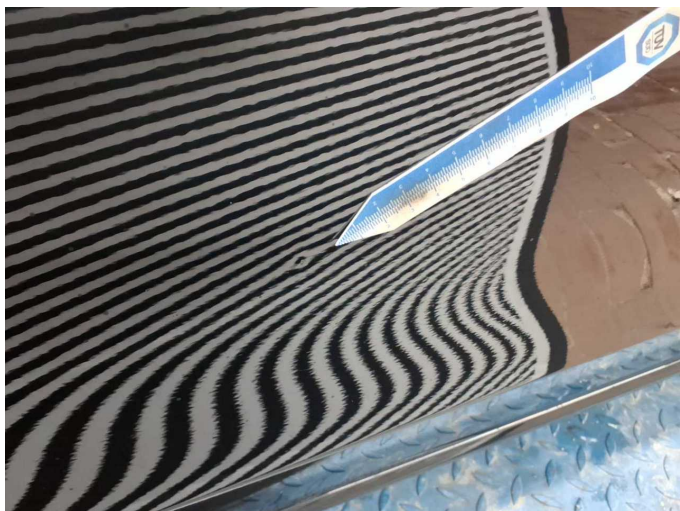
| No. | Component group | Description |
|---|---|---|
| 2 | Door - front left side | Door - dent(s) - Smart repair |

Damage 2: Door - front left side: Door - dent(s) - Smart repair

**Damage 2:** Door - front left side: Door - dent(s) - Smart repair

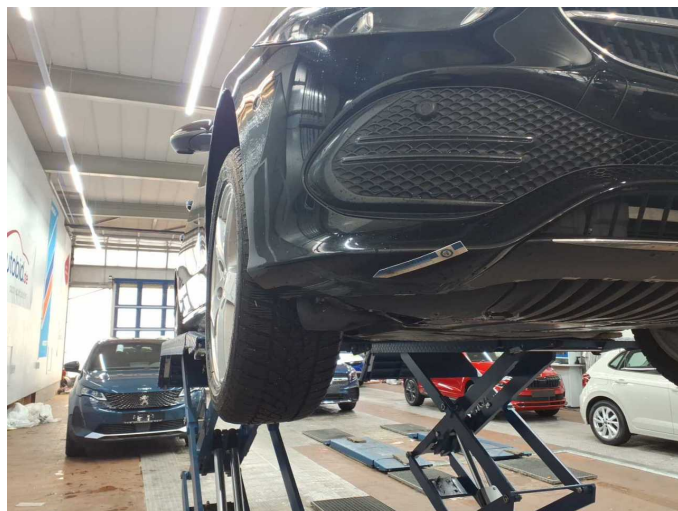
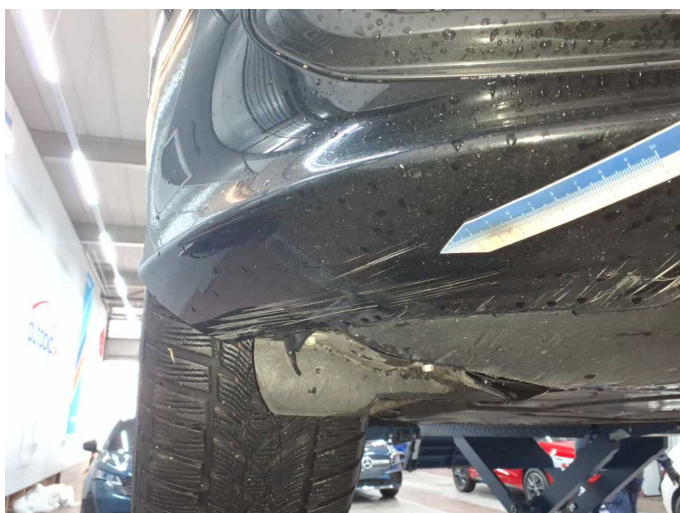
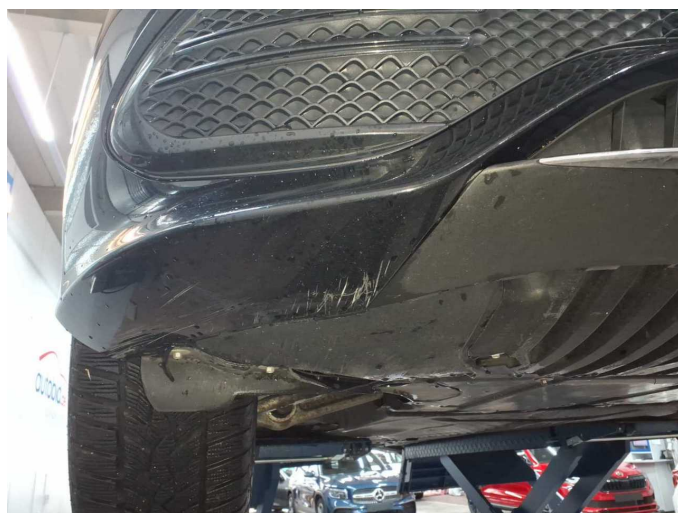
| No. | Component group | Description |
|---|---|---|
| 3 | Front bumper | Front bumper - Scratch(es) - Smart repair |

**Damage 3:** Front bumper: Front bumper - Scratch(es) - Smart repair

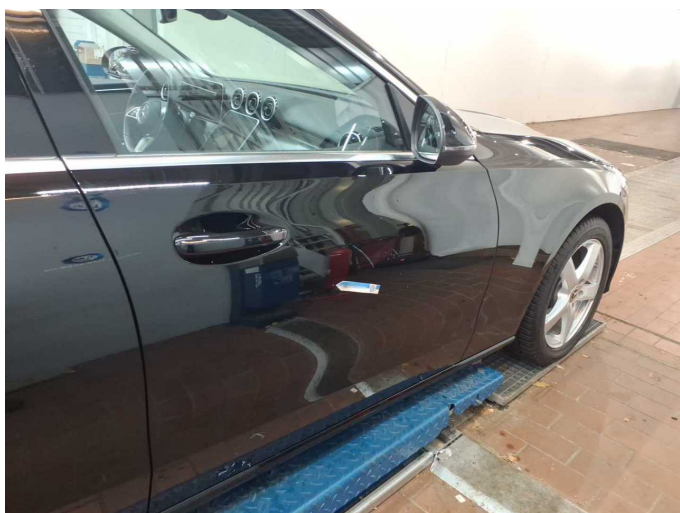
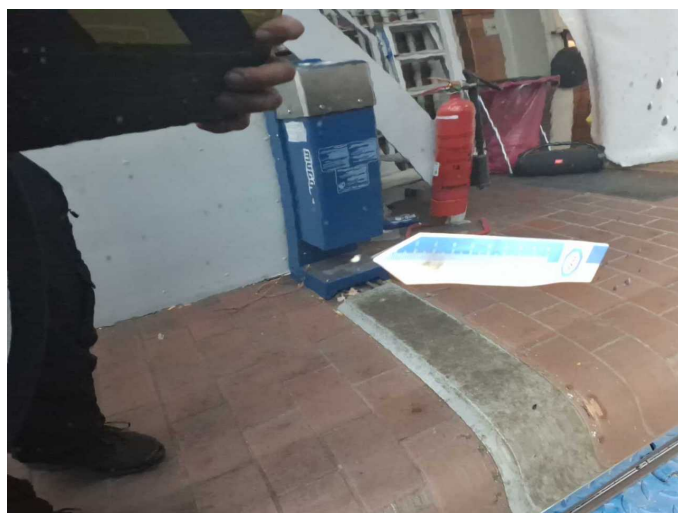
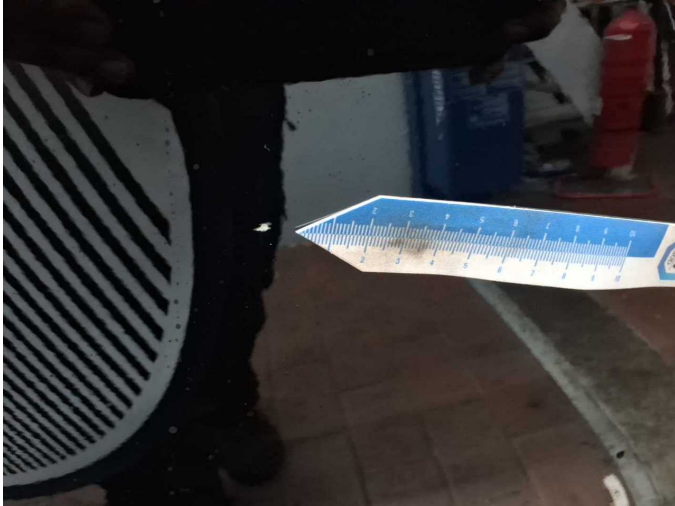
| No. | Component group | Description |
|---|---|---|
| 4 | Door - front right side | Door - Scratch(es) - Smart repair |

**Damage 4:** Door - front right side: Door - Scratch(es) - Smart repair

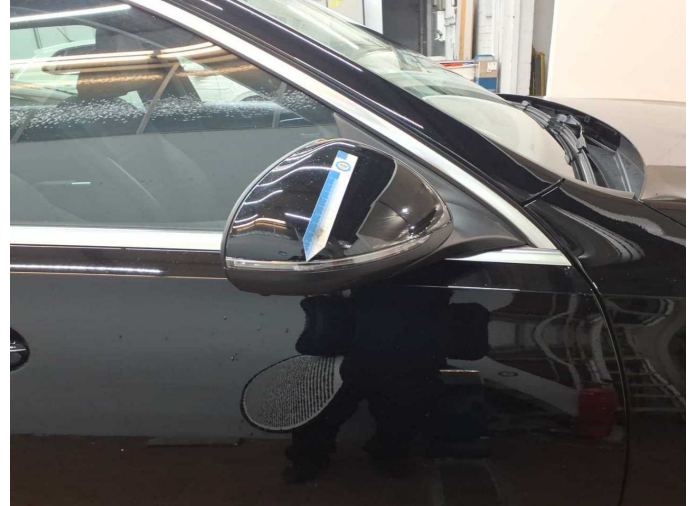
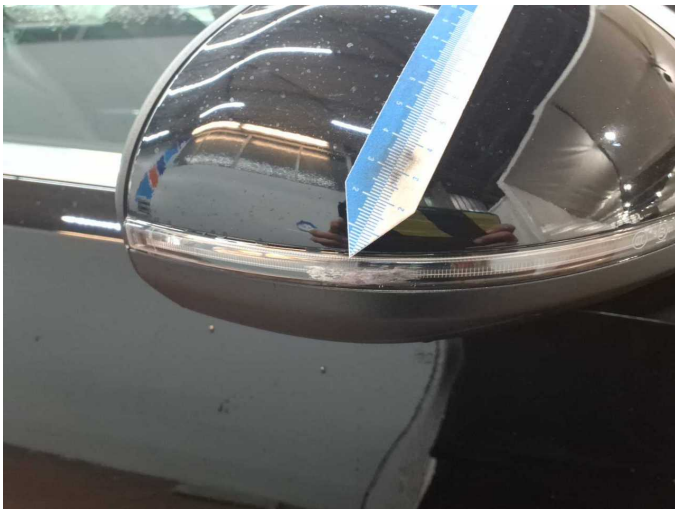
| No. | Component group | Description |
|---|---|---|
| 5 | Indicator - front | Mirror - right side - Scratch(es) - Replace |

**Damage 5:** Indicator - front: Mirror - right side - Scratch(es) - Replace

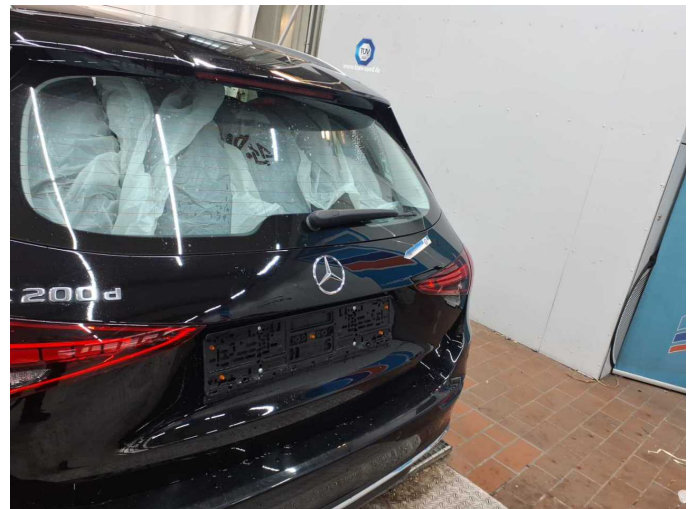
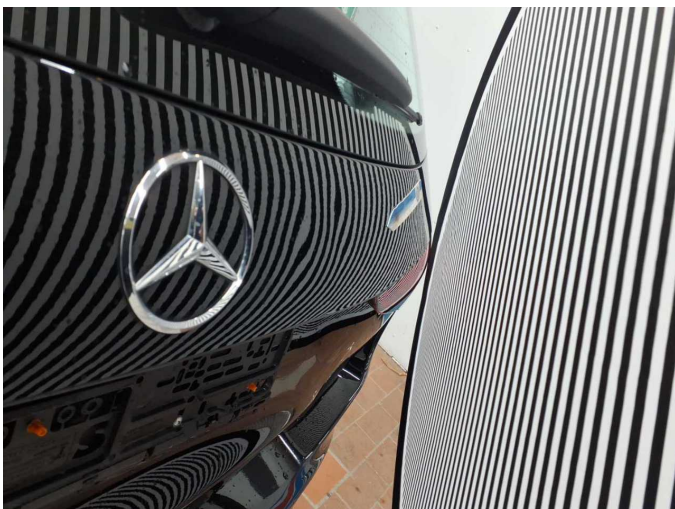
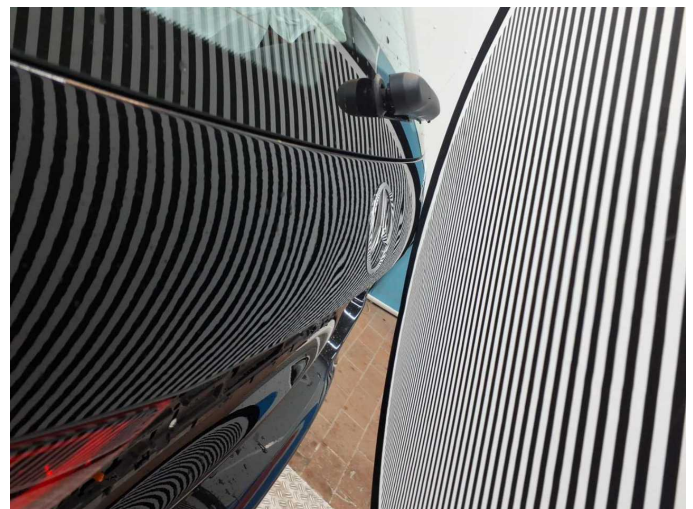
| No. | Component group | Description |
|---|---|---|
| 6 | Boot lid / rear door | Boot lid - dent(s) - Repair and paint |

**Damage 6:** Boot lid / rear door: Boot lid - dent(s) - Repair and paint

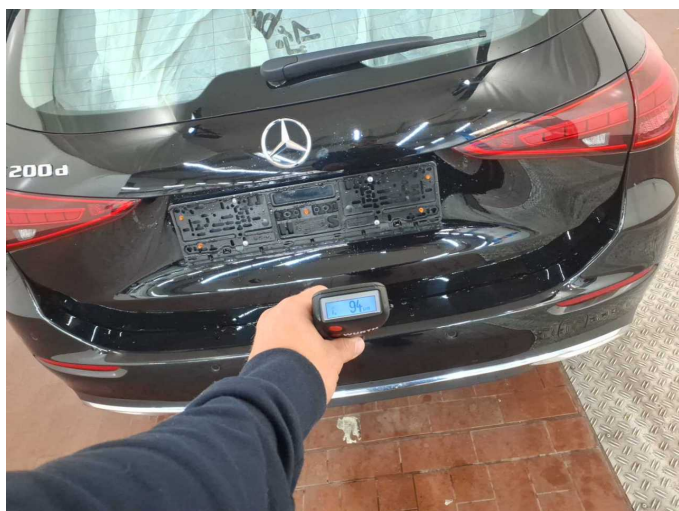
**Previous damage 1: Rear**

| No. | Previous damage | Extent of damage (Net) |
|---|---|---|
| 1 | Rear, Provided by user / customer, from 4 Nov 2023 | 2.312,20 € |

According to available information previous damages were repaired at the vehicle. Traces of repairs, which allow conclusions about the area of repair, were not recognizable during the inspection.
