Expertise

Protocol number: 46328414
Order No. / Reference: 26581946
Inspection date: 6 Jul 2026

Manufacturer: Ford

Model: Focus Turnier 1.5 EcoBlue Start-Stopp-System
COOL&CONNECT

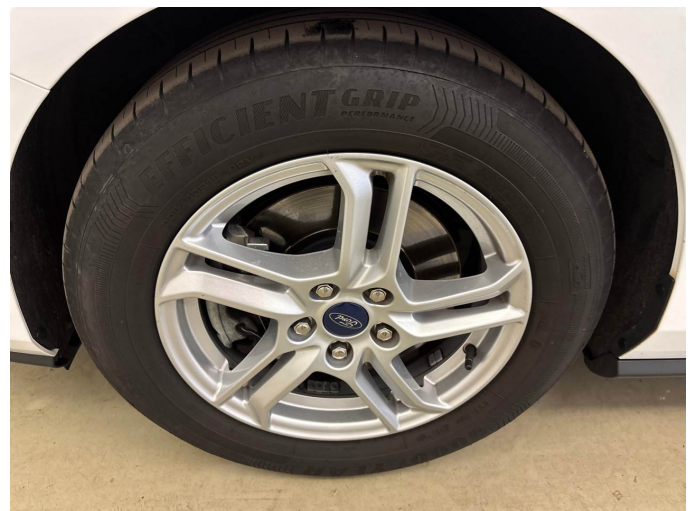
Figure 12: Mounted tyres

- Beim montierten Radsatz handelt es sich um einen vom Standard abweichenden Auslieferungszustand.
- Für den montierten Radsatz lag zum Besichtigungszeitpunkt kein Nachweis über die Zulässigkeit vor.

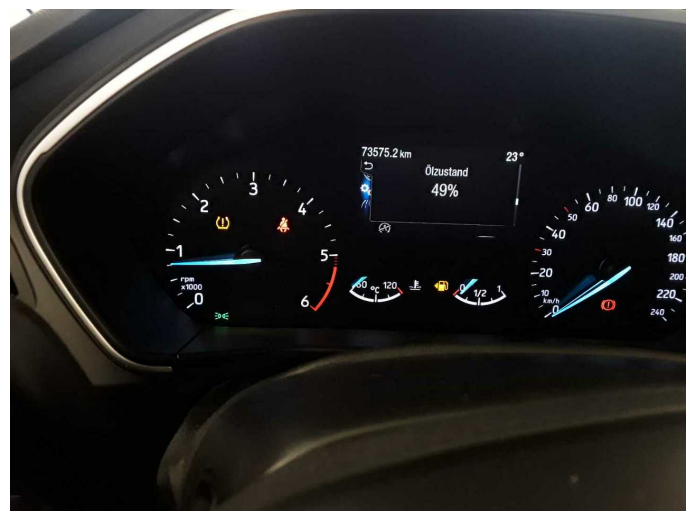
Damage 1: Wheel / tyres: Pressure sensor - on - Perform diagnosis

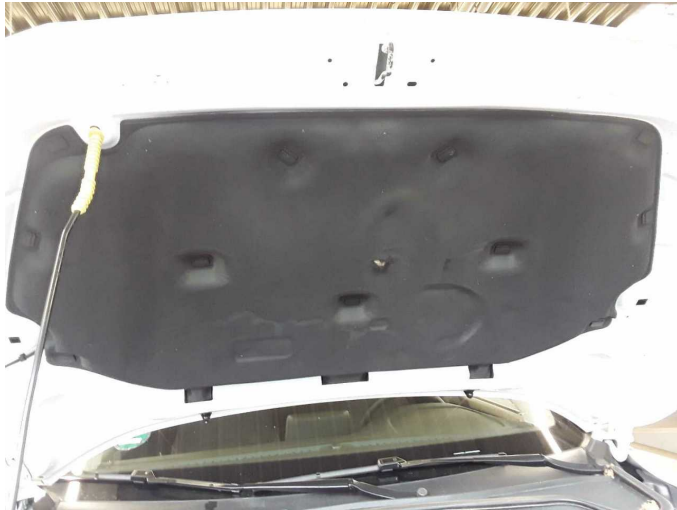
Damage 2: Bonnet: Insulation lining - Damaged - Replace

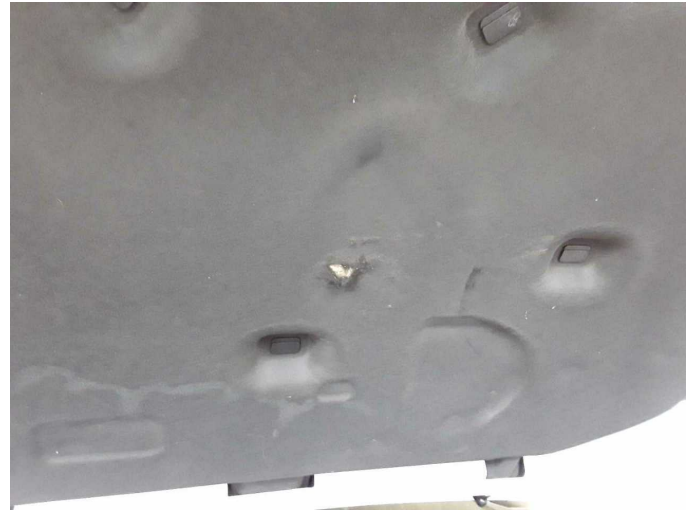
Damage 2: Bonnet: Insulation lining - Damaged - Replace

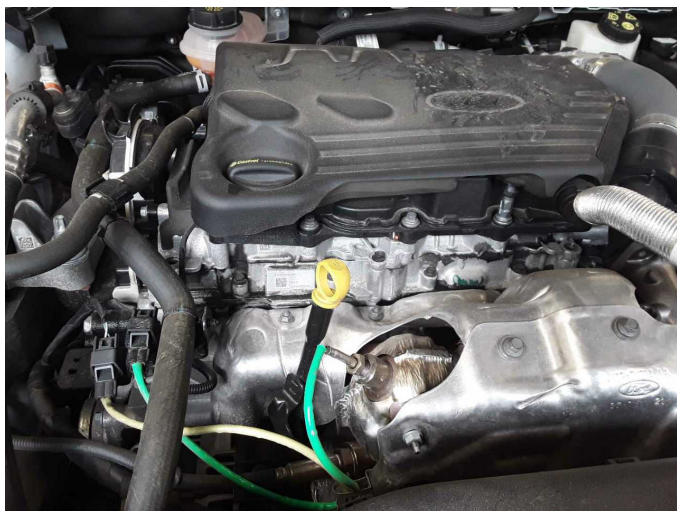
Damage 3: Engine: Engine - Leaking - Diagnosed and repair if necessary

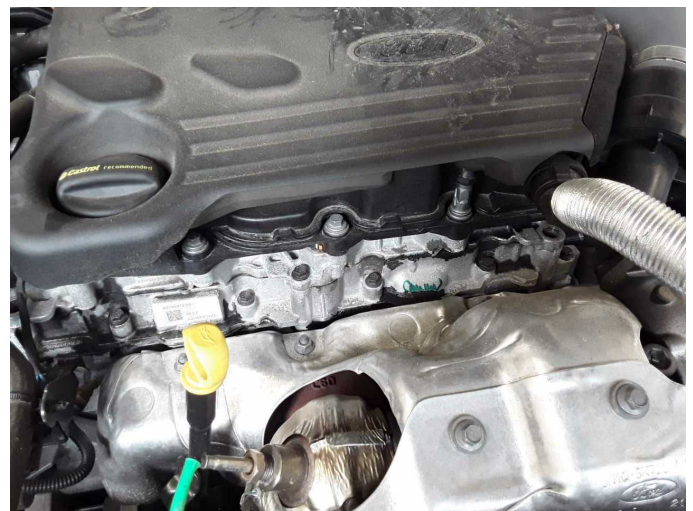
Damage 3: Engine: Engine - Leaking - Diagnosed and repair if necessary

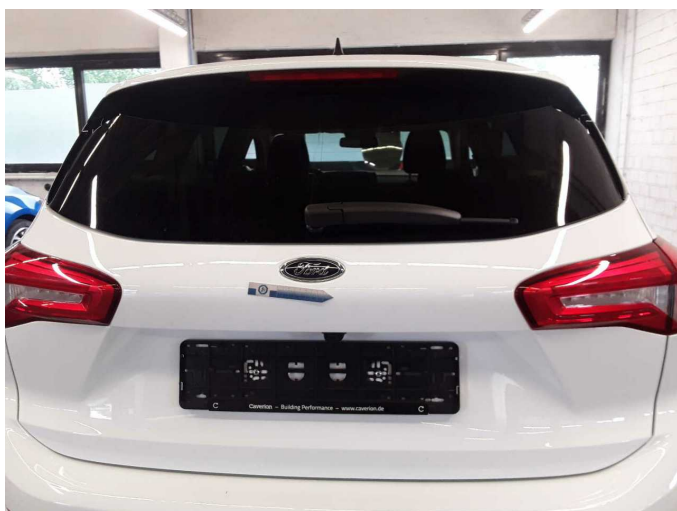
Damage 4: Boot lid / rear door: Boot lid - Deformed - Repair and paint

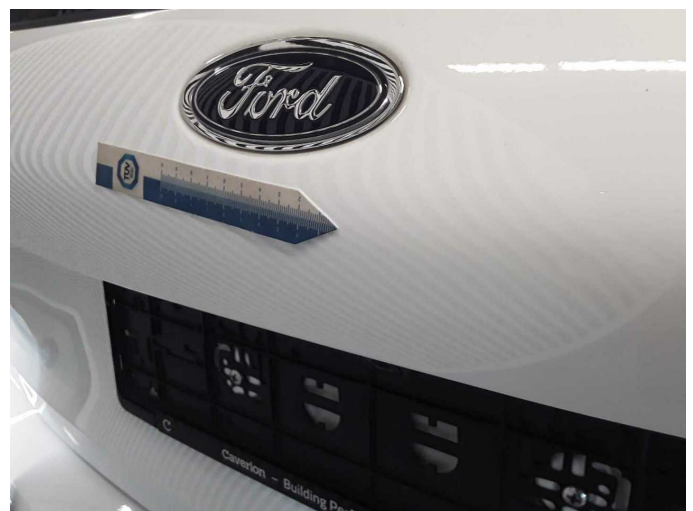
Damage 4: Boot lid / rear door: Boot lid - Deformed - Repair and paint

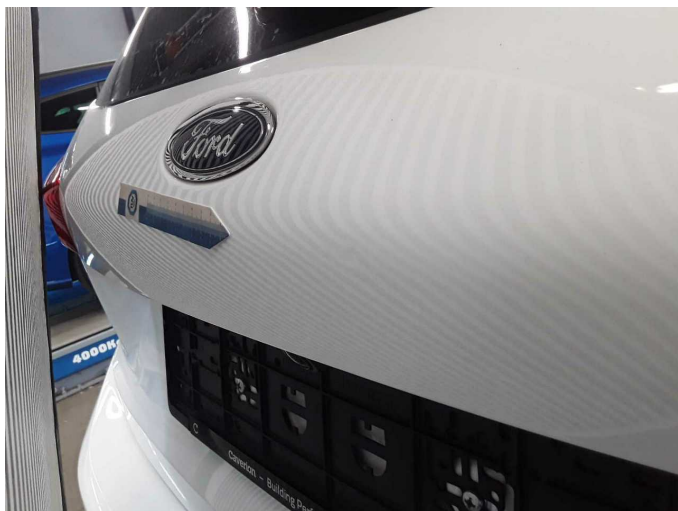
Damage 4: Boot lid / rear door: Boot lid - Deformed - Repair and paint
