## Expertise

Protocol number: 45919315  
Order No. / Reference: 26466894  
Inspection date: 11 Jun 2026

Model: Focus Turnier 1.5 EcoBlue Start-Stopp-System Aut.  
COOL&CONNECT

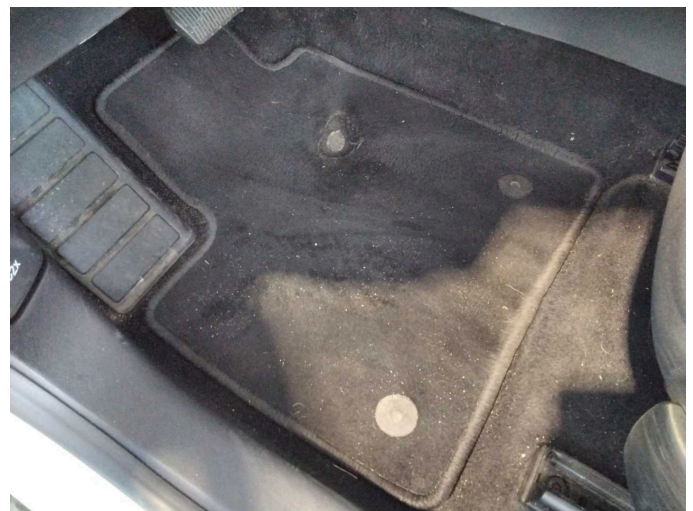
Damage 1: Trim / covers: Floor mats - Broken / torn - Replace

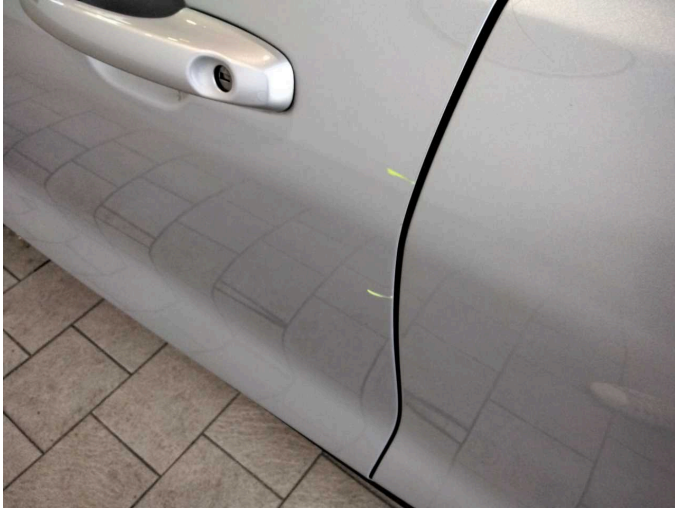
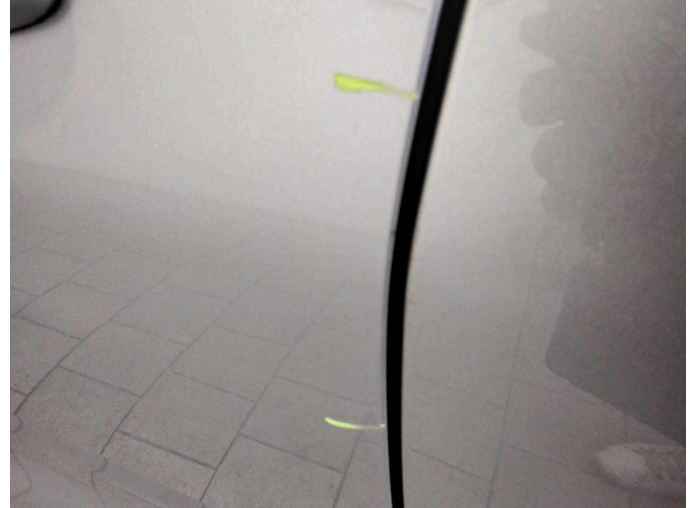
**Damage 2:** Door - front left side: Door edge - Scratch(es) - Smart repair

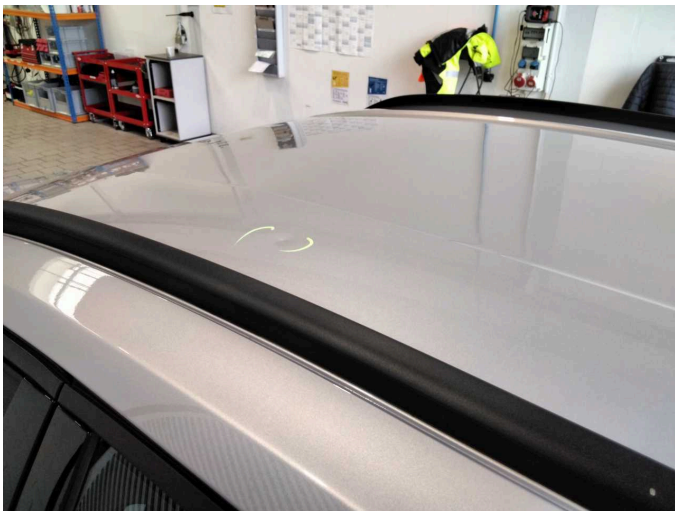
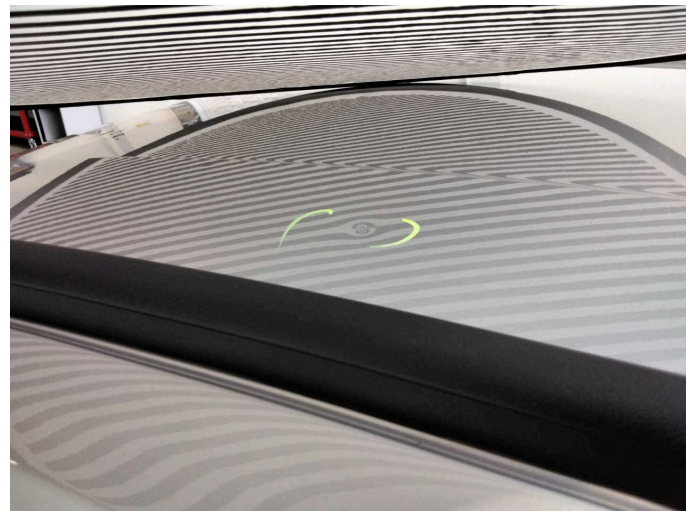
**Damage 3:** Roof: Roof - dent(s) - Smooth repair work

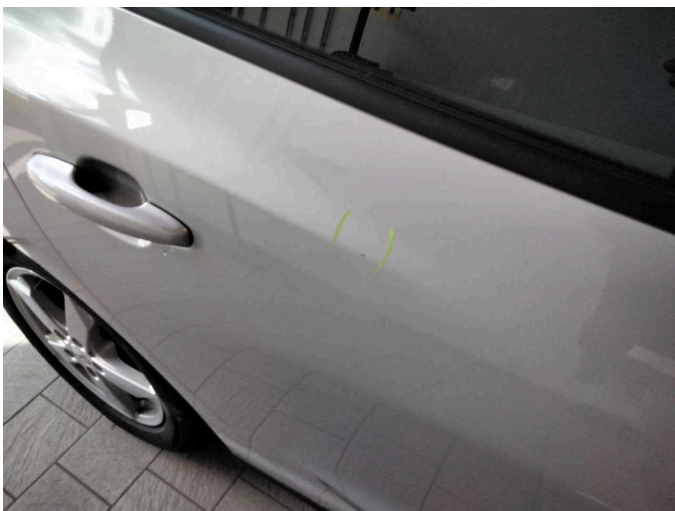
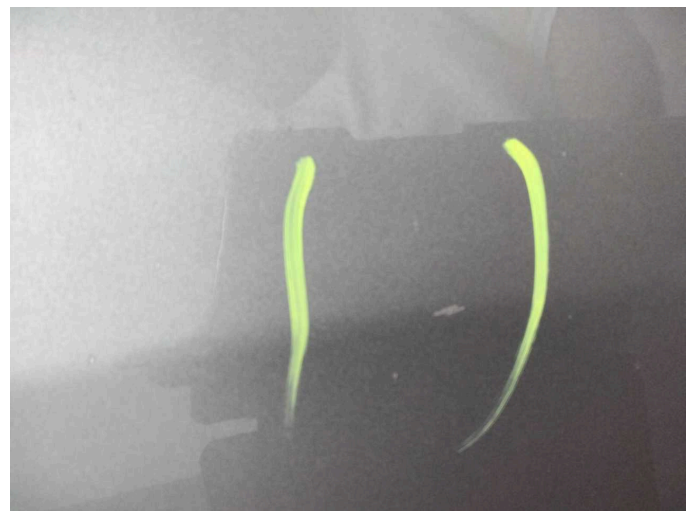
**Damage 4:** Door - rear right side: Door - Scratch(es) - Smart repair

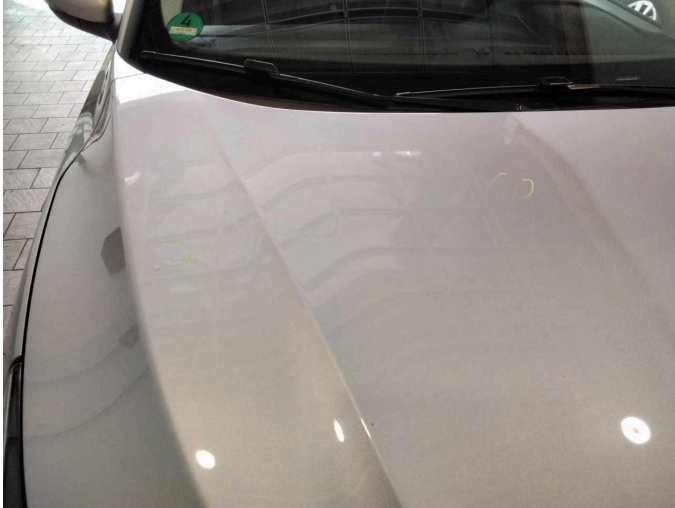
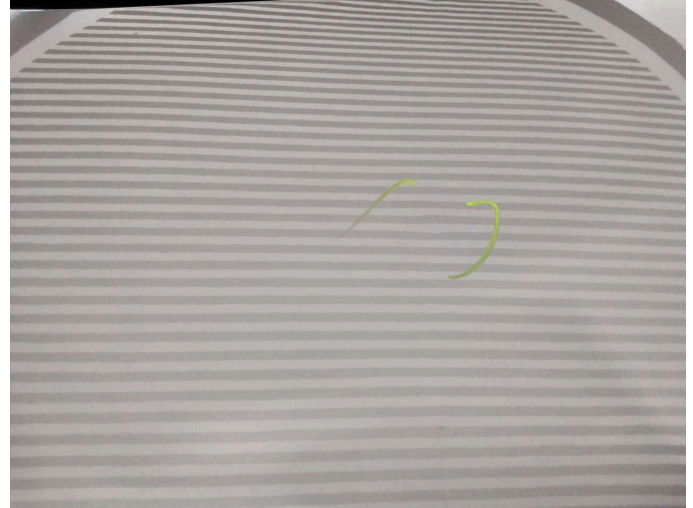
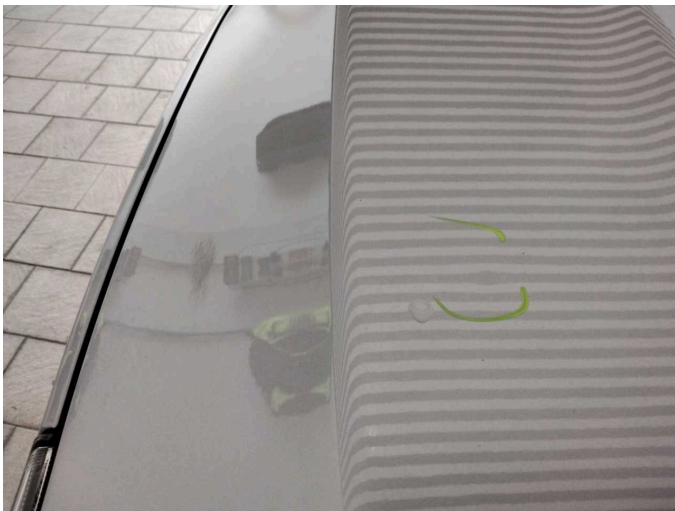
No.	Repainting
1	Bonnet, Professionally carried out, Invoice of repair done Non-existent

**Damage 5:** Bonnet: Bonnet - dent(s) - Smooth repair work

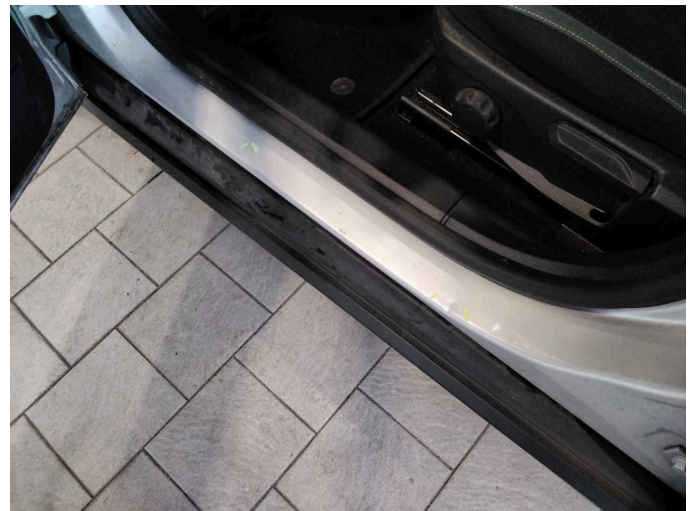
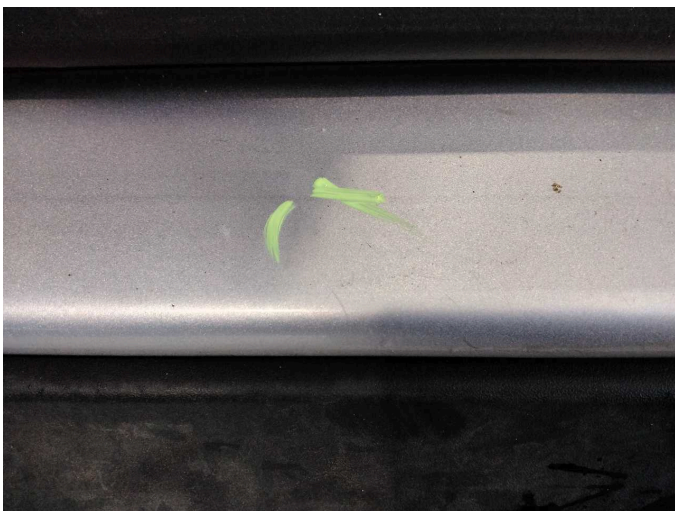
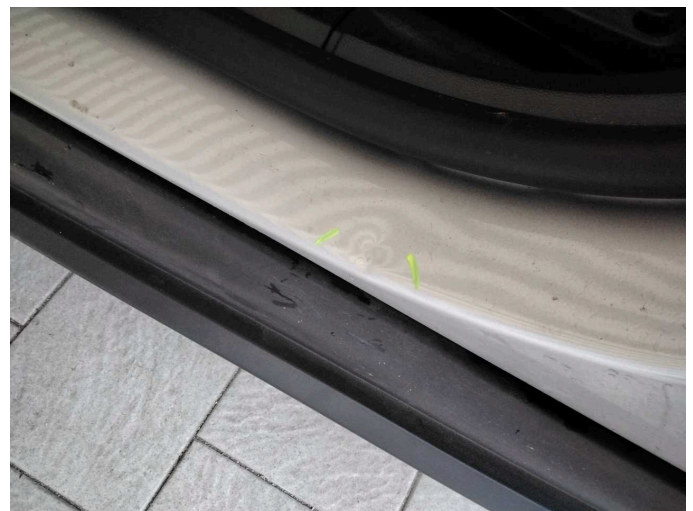
**Damage 6:** Sill - left side: Sill - Dent / paintcoat damage - Smart repair

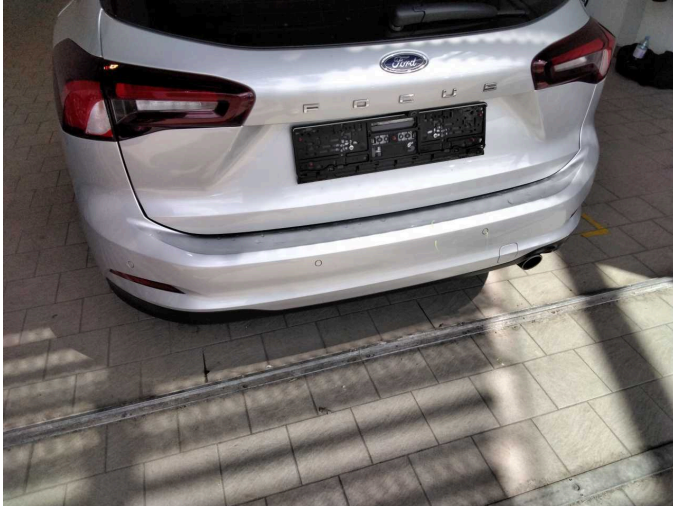
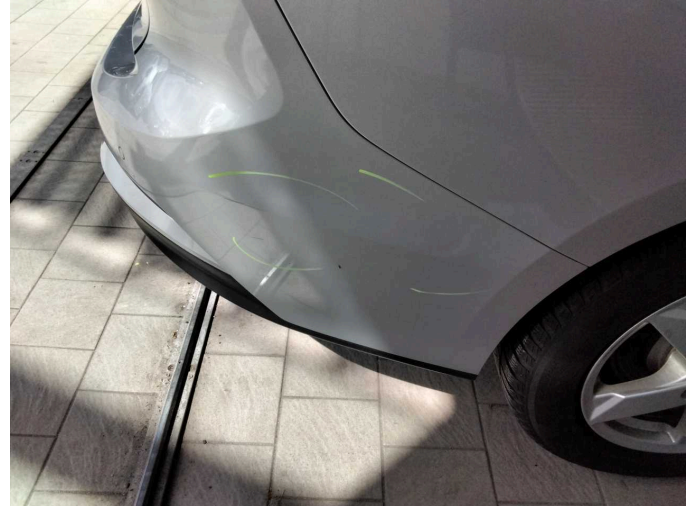
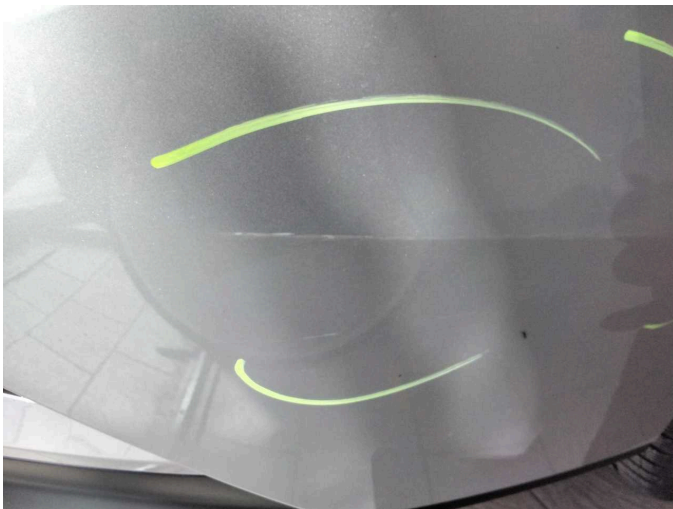
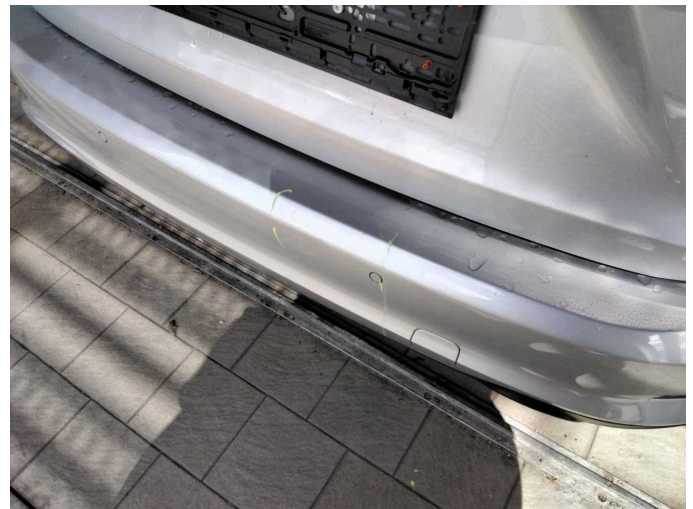
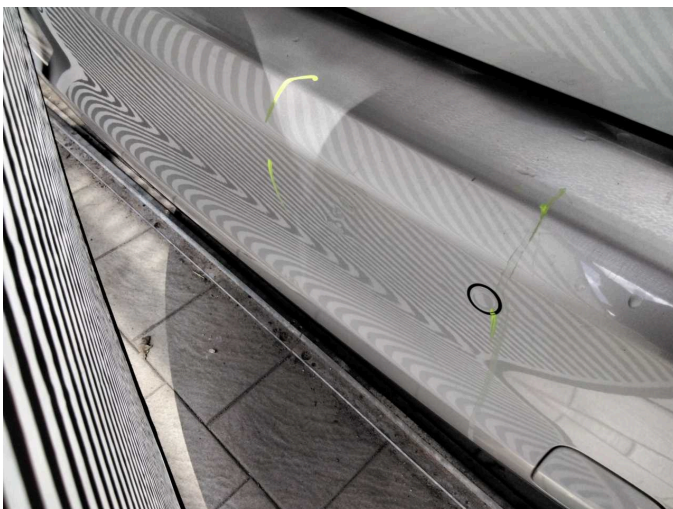
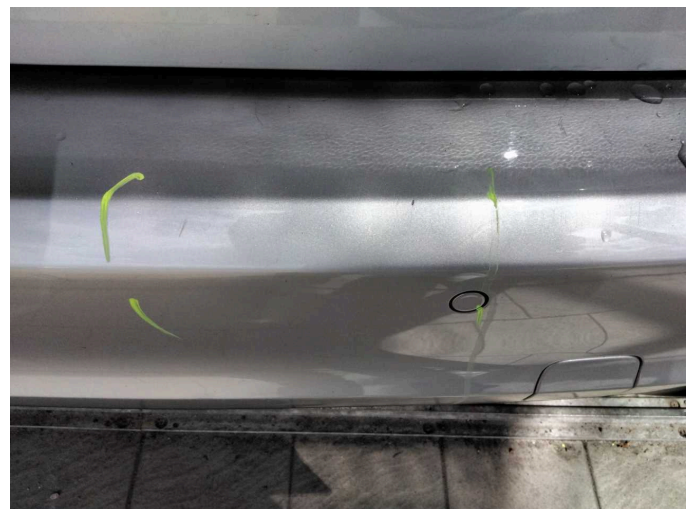
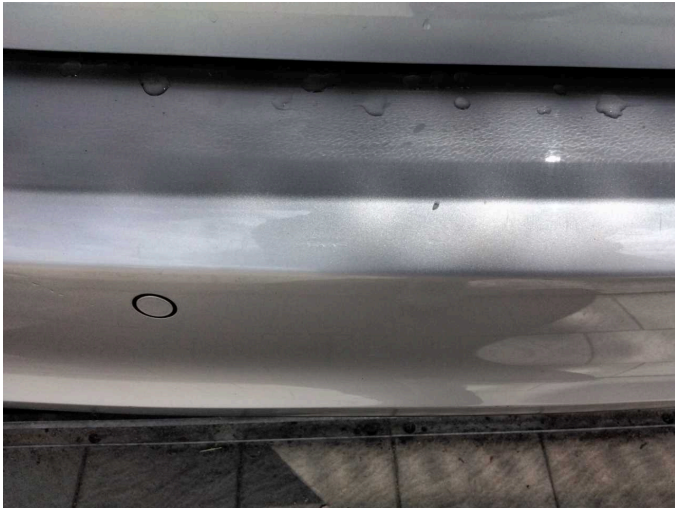
**Damage 7:** Rear bumper: Rear bumper - Dent / paintcoat damage - Repair and paint

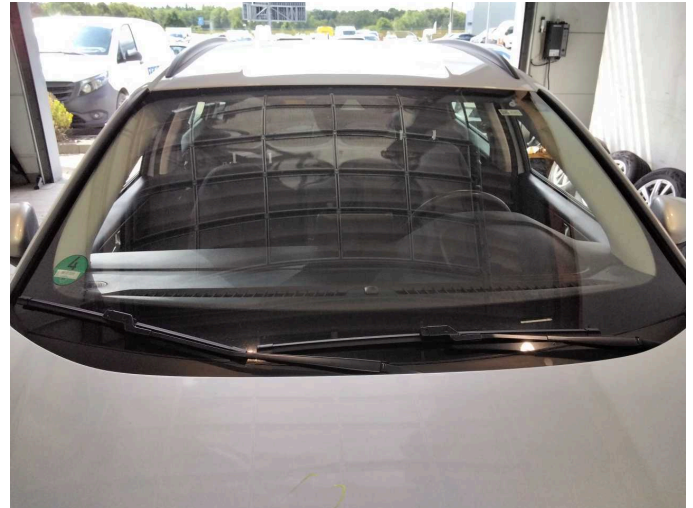
**Wear and tear 1:** Vehicle glazing: Windscreen - Stone chips - No deduction

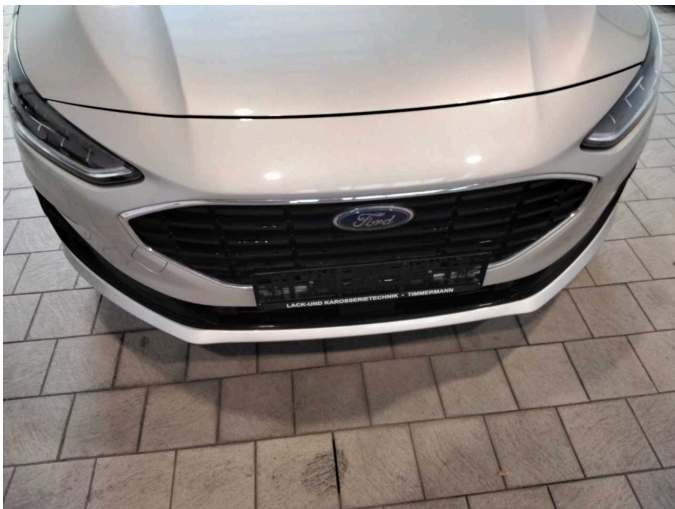
**Wear and tear 2:** Front bumper: Front bumper - Stone chips - No deduction

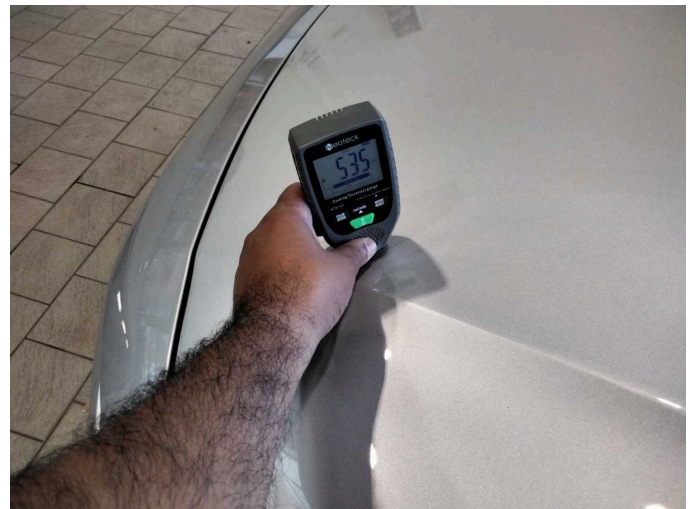
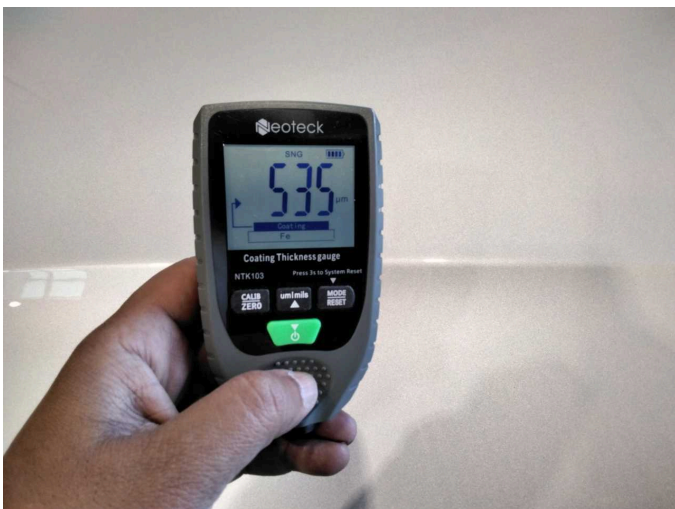
**Bonnet:** 535 µm
