Expertise

Protocol number: 46472077  
Order No. / Reference: 26192065  
Inspection date: 9 Jul 2026

Manufacturer: Mercedes-Benz

Model: Vito 116 CDI Tourer Lang Aut. PRO

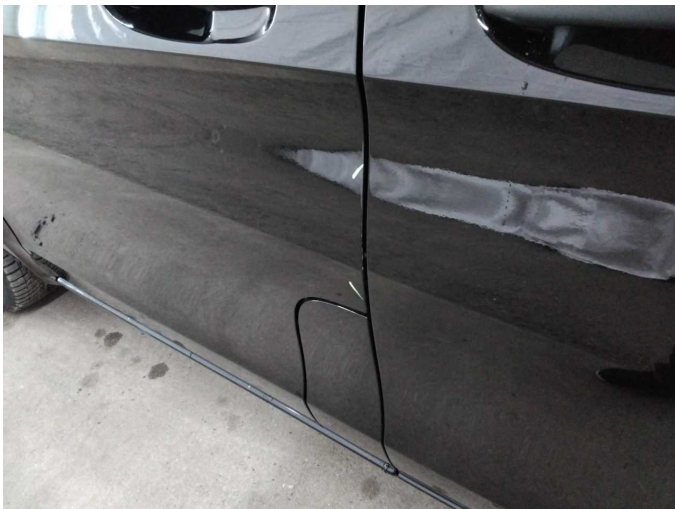
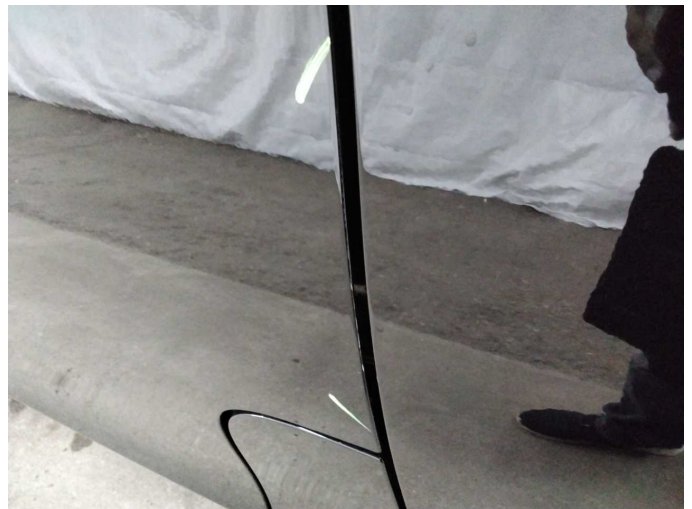
| No. | Component group | Description |
|---|---|---|
| 1 | Door - front left side | Door edge - Scratch(es) - Smart repair |

**Damage 1:** Door - front left side: Door edge - Scratch(es) - Smart repair

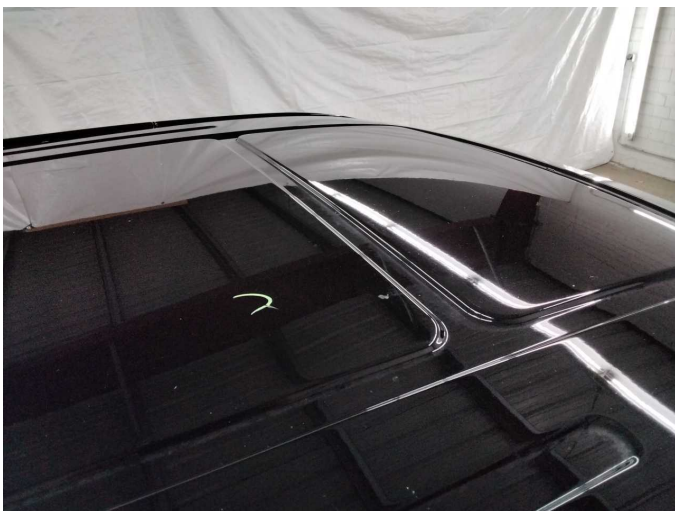
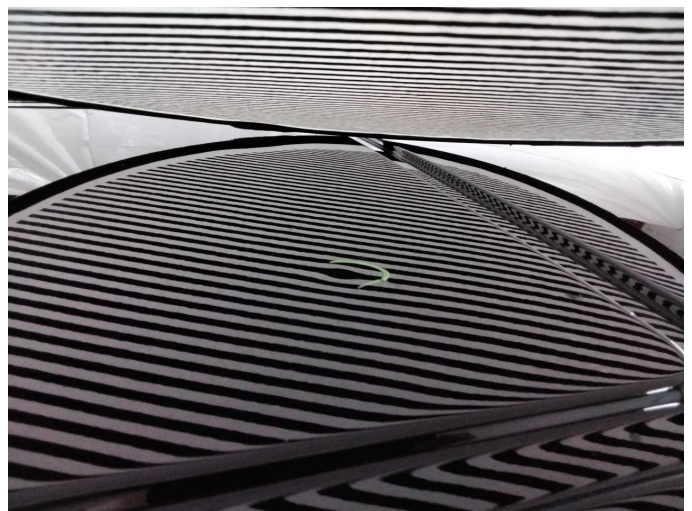
| No. | Component group | Description |
|---|---|---|
| 2 | Roof | Roof - dent(s) - Smooth repair work |

**Damage 2:** Roof: Roof - dent(s) - Smooth repair work

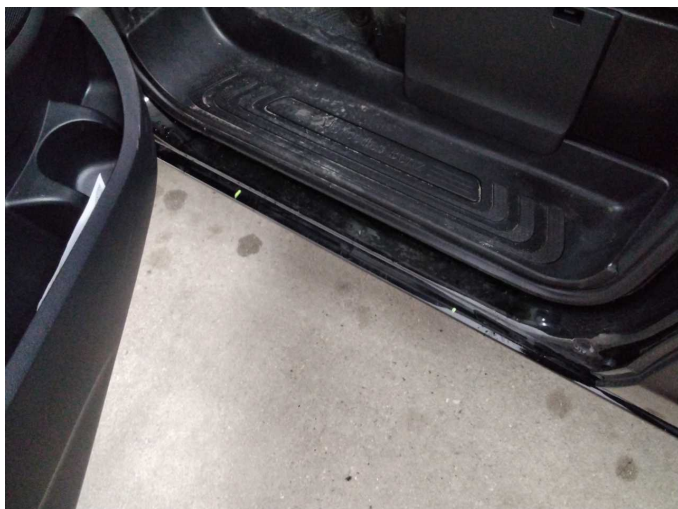
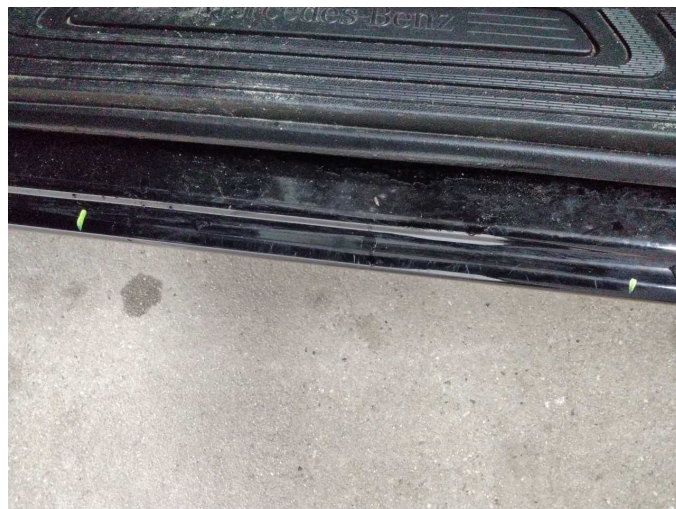
| No. | Component group | Description |
|---|---|---|
| 3 | Sill - left side | Sill - Scratch(es) - Smart repair |

**Damage 3:** Sill - left side: Sill - Scratch(es) - Smart repair

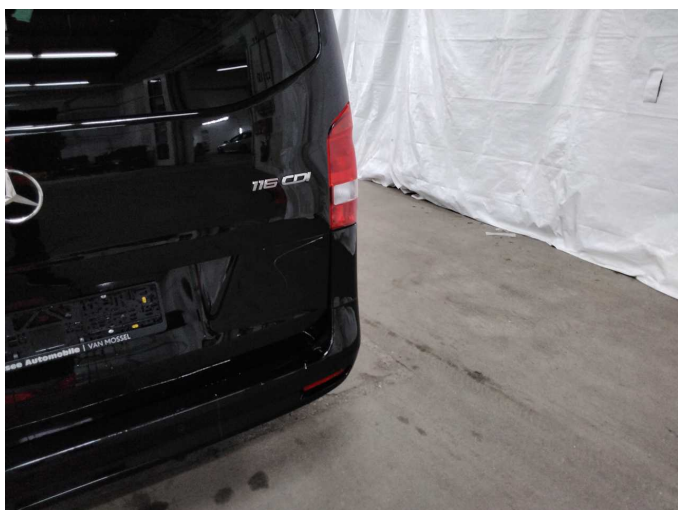
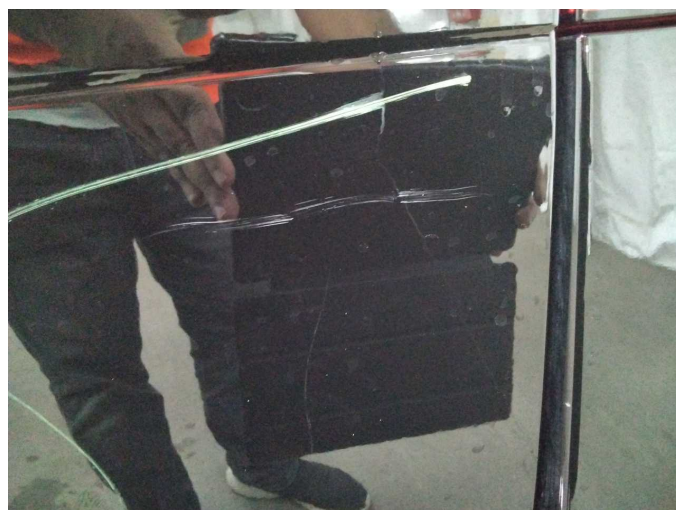
| No. | Component group | Description |
|---|---|---|
| 4 | Boot lid / rear door | Boot lid - Scratch(es) - Smart repair |

**Damage 4:** Boot lid / rear door: Boot lid - Scratch(es) - Smart repair

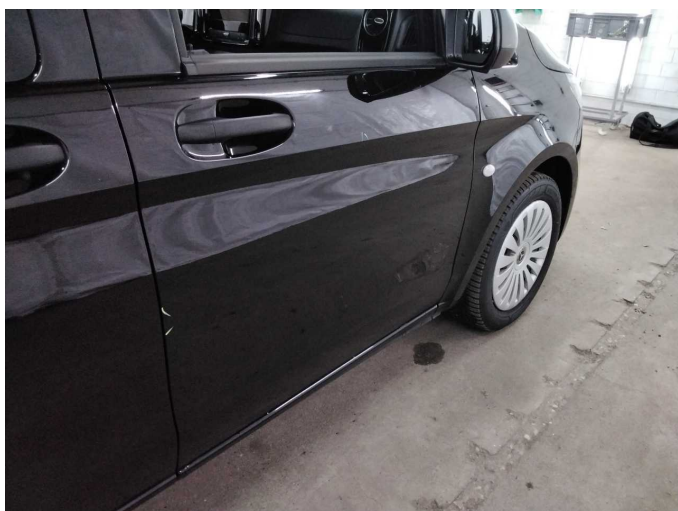
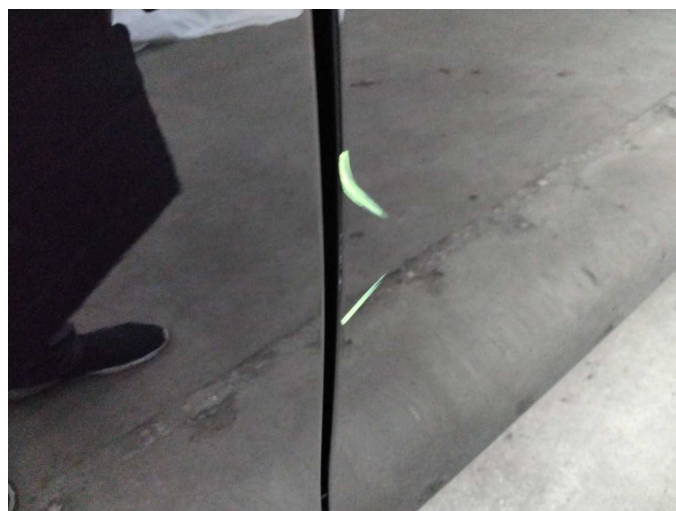
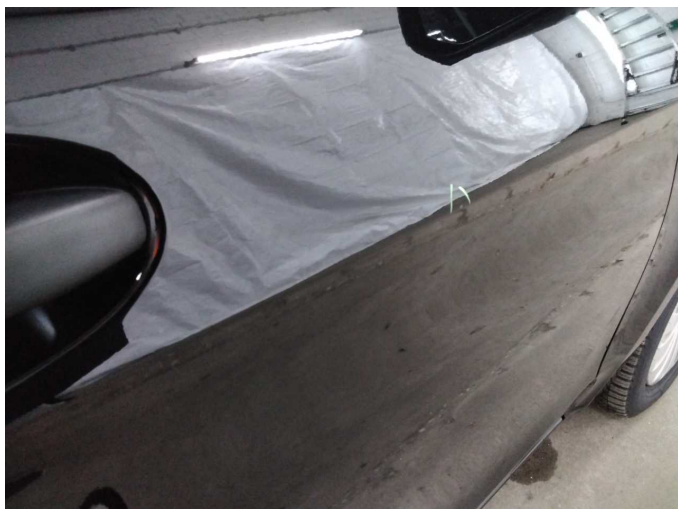
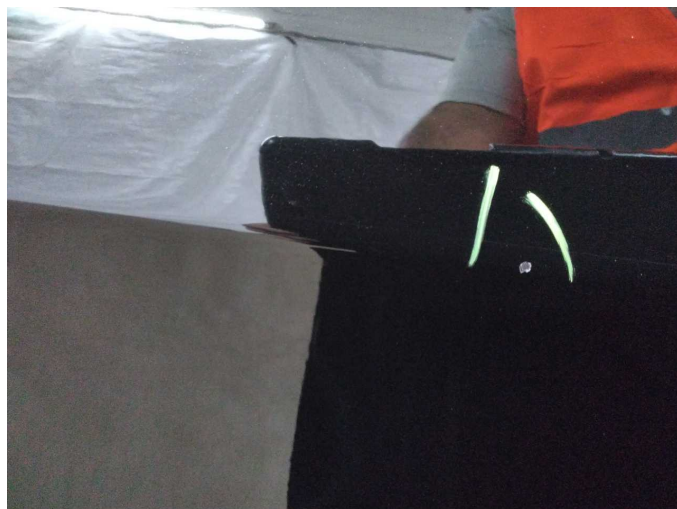
| No. | Component group | Description |
|---|---|---|
| 5 | Door - front right side | Door - Scratch(es) - Paint |

**Damage 5:** Door - front right side: Door - Scratch(es) - Paint

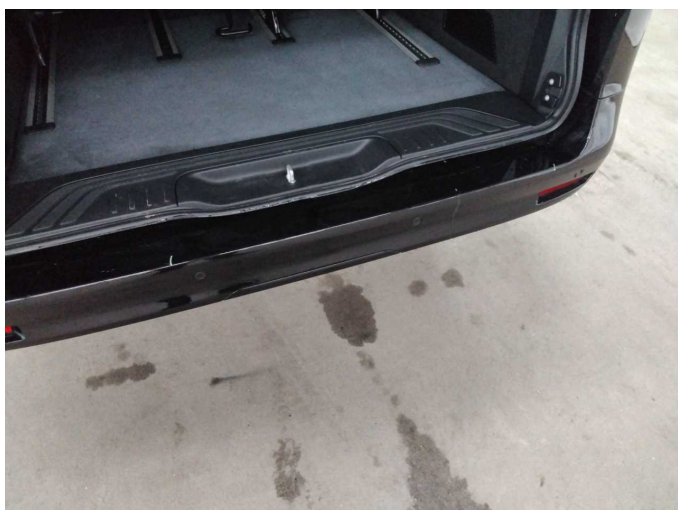
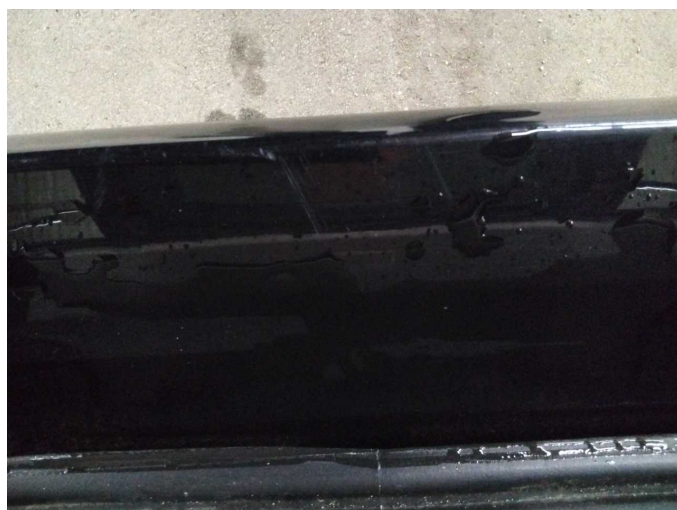
| No. | Component group | Description |
|---|---|---|
| 4 | Rear bumper | Rear bumper - Scratch(es) - No deduction |

**Wear and tear 4:** Rear bumper: Rear bumper - Scratch(es) - No deduction

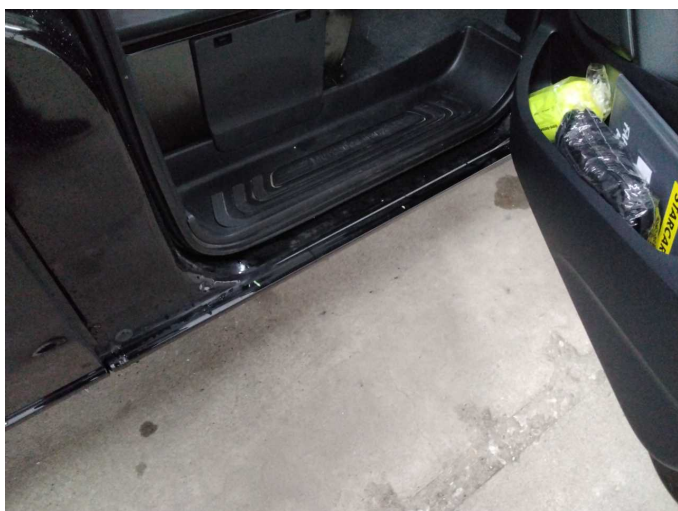
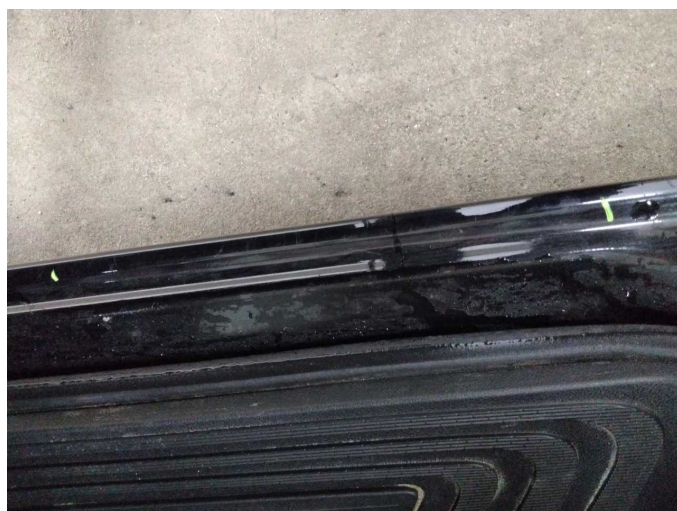
| No. | Component group | Description |
|---|---|---|
| 5 | Sill - right side | Sill - Scratch(es) - No deduction |

**Wear and tear 5:** Sill - right side: Sill - Scratch(es) - No deduction

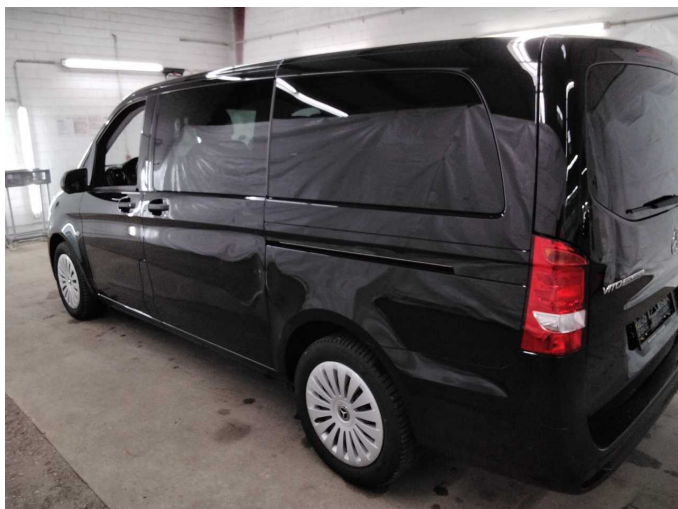
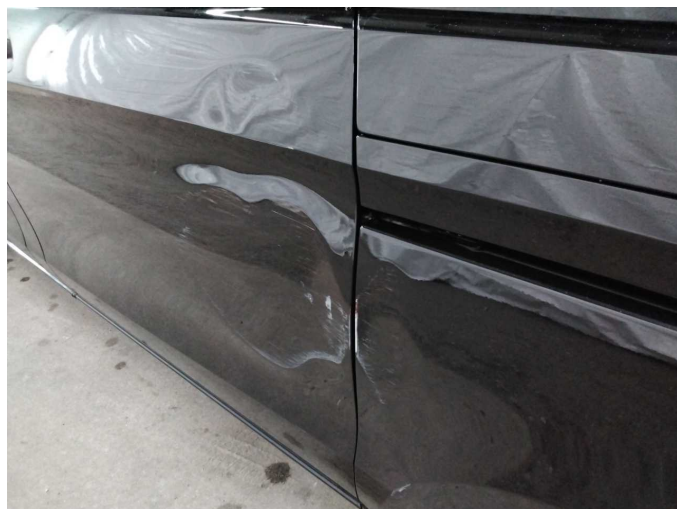
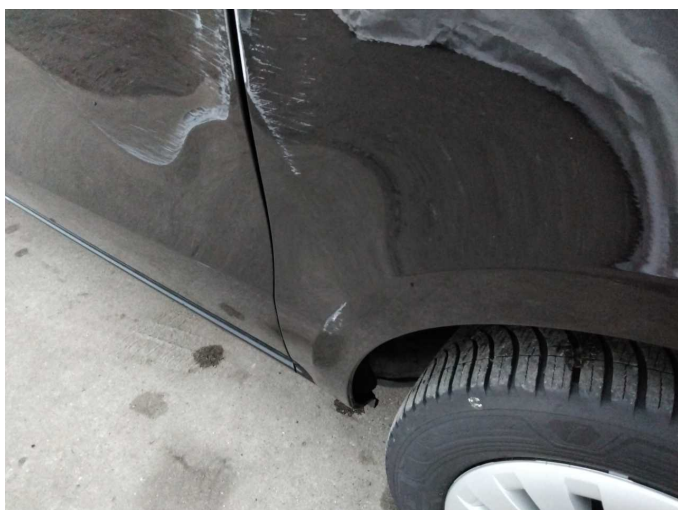
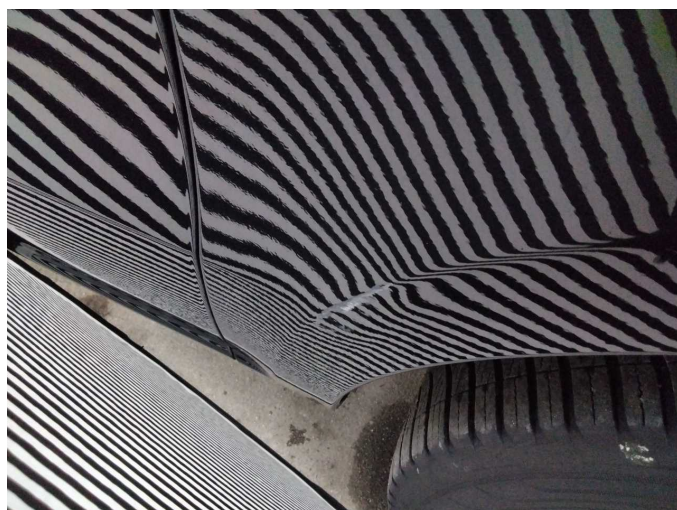
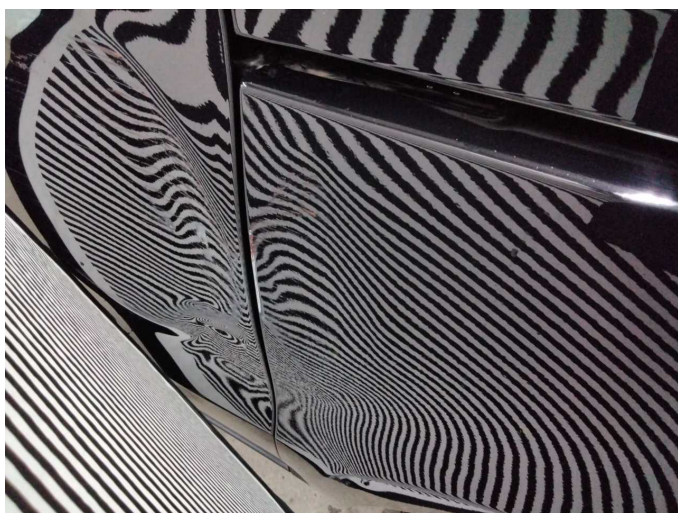
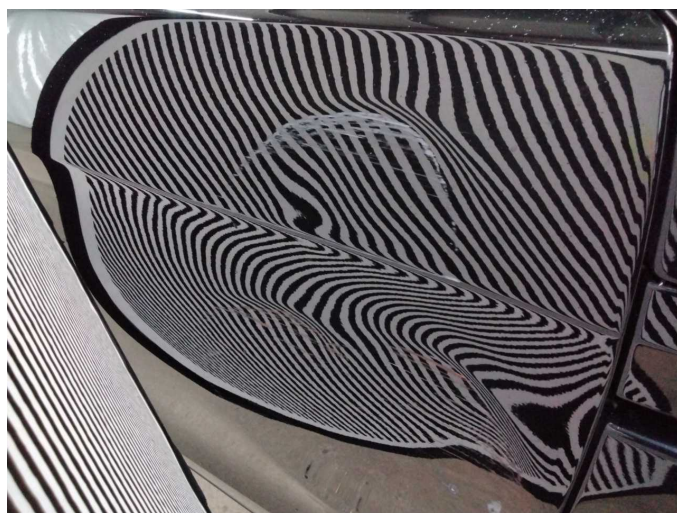
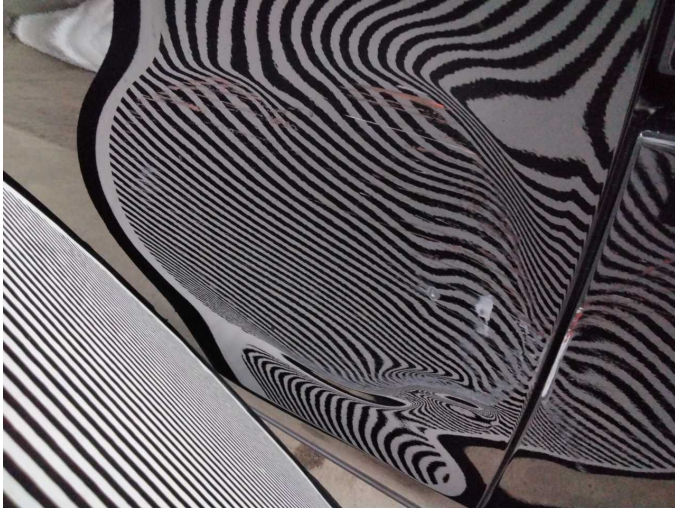
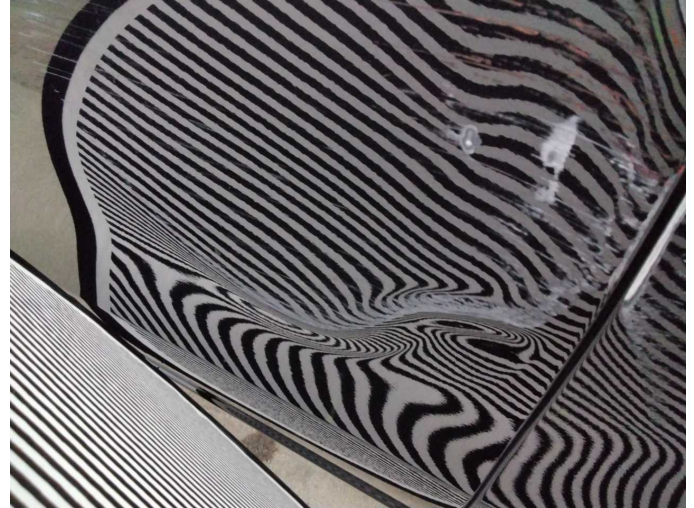
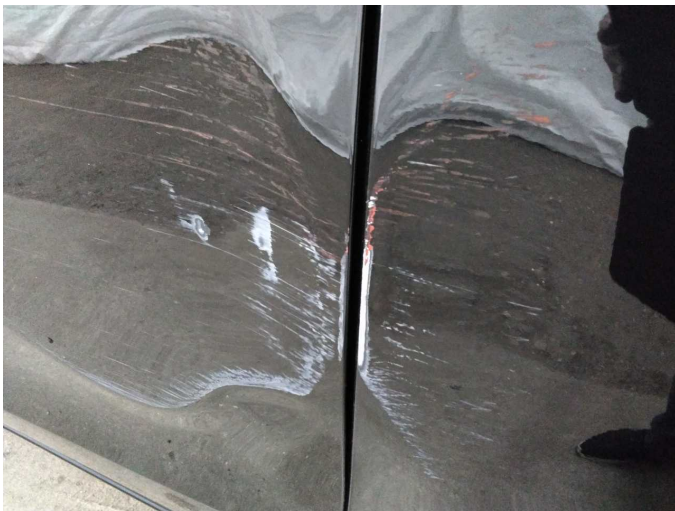
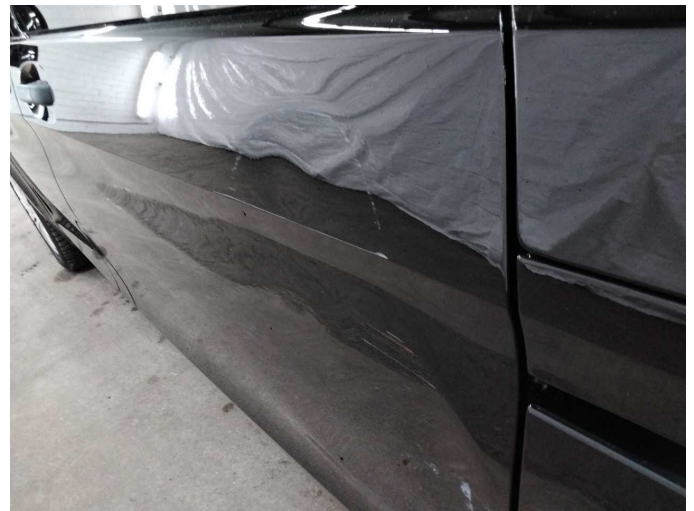
1 Side - left

Non-repaired previous damages were found at the vehicle. The necessary repair costs are listed in the expert report or if necessary, are listed in detail in a separately enclosed repair cost calculation.

**Accident 1: Side - left**
