Expertise

Protocol number: 46400602  
Order No. / Reference: 26640149  
Inspection date: 8 Jul 2026

Manufacturer: Opel

Model: Astra 1.5 D Automatik Business Elegance

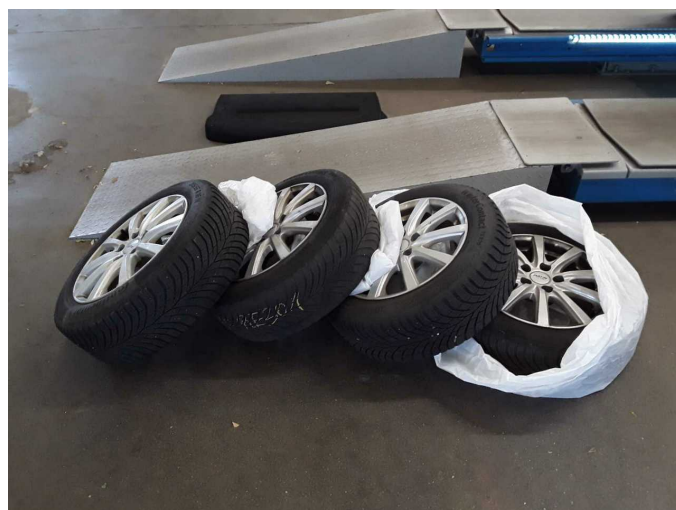
**Figure 16: Additional tyres**

| # | Tyre size | Type of tyre | Manufacturer | Tread depth |
|---|---|---|---|---|
| 1) | 205/55 R16 91H | Winter tyres on Light alloy | Continental | 3mm / 3mm |
| 2) | 205/55 R16 91H | Winter tyres on Light alloy | Continental | 5mm / 5mm |

| No. | Component group | Description |
|---|---|---|
| 4 | 2nd wheel set | 2 tyres - Does not meet the leasing specifications - Replace |

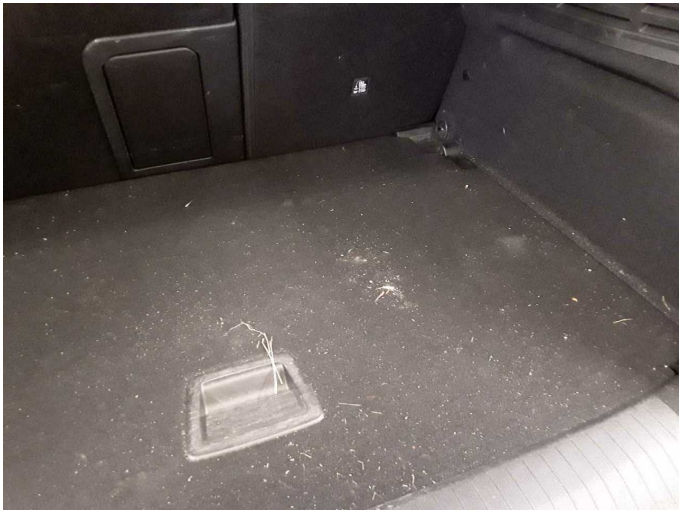
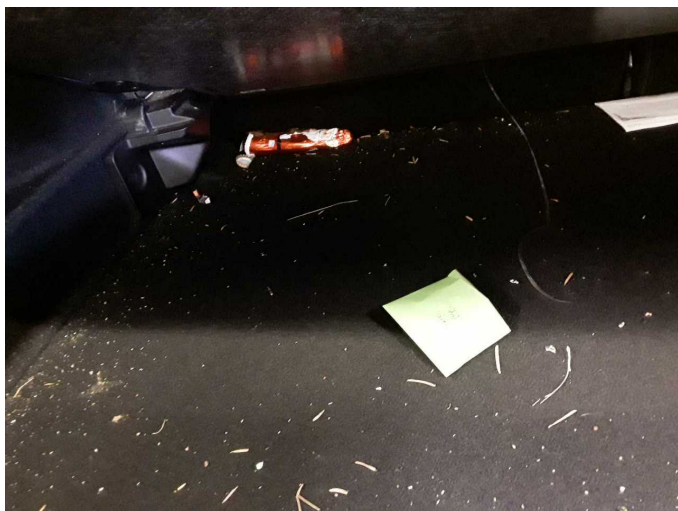
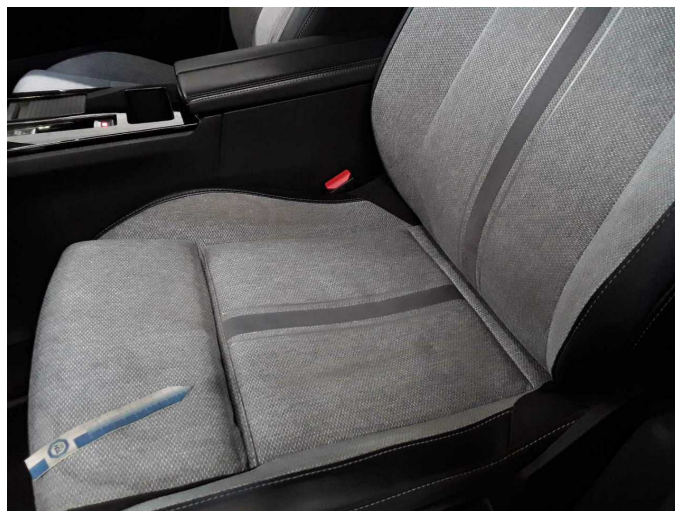
| No. | Component group | Description |
|---|---|---|
| 1 | Interior | Interior - Soiled - Clean |

Damage 1: Interior: Interior - Soiled - Clean

**Damage 1:** Interior: Interior - Soiled - Clean

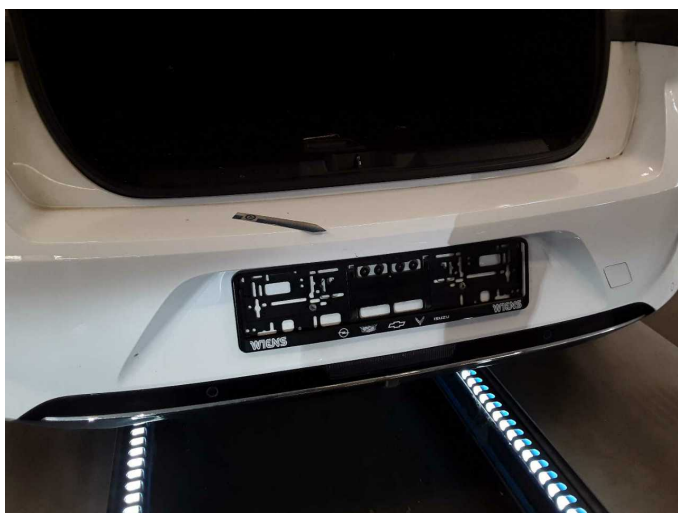
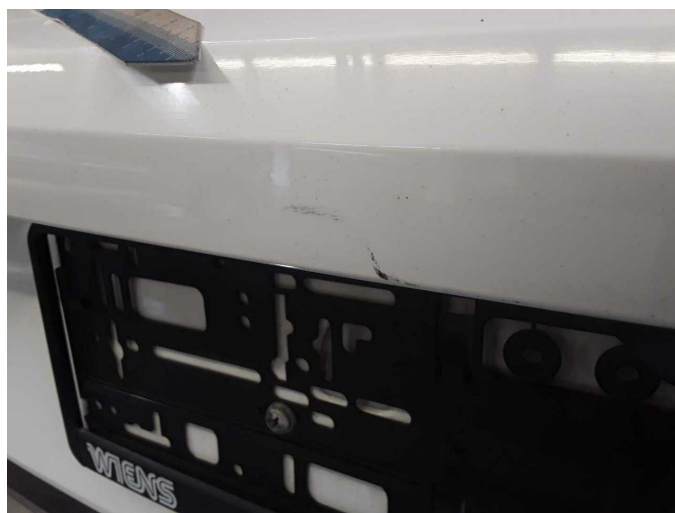
| No. | Component group | Description |
|---|---|---|
| 2 | Rear bumper | Rear bumper - Scratch(es) - Smart repair |

**Damage 2:** Rear bumper: Rear bumper - Scratch(es) - Smart repair

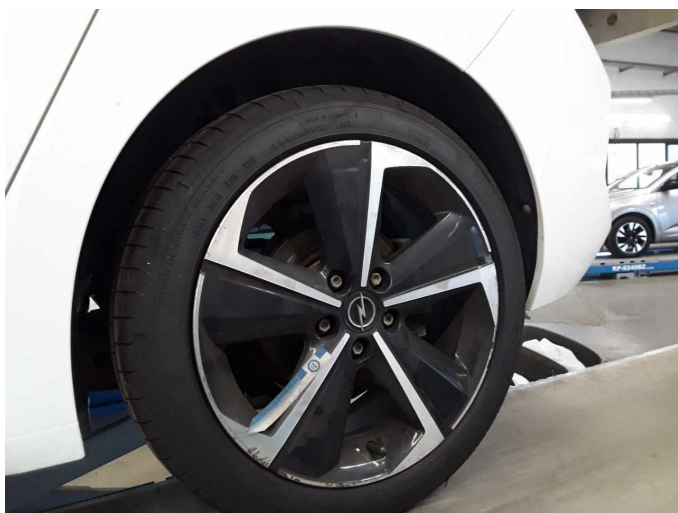
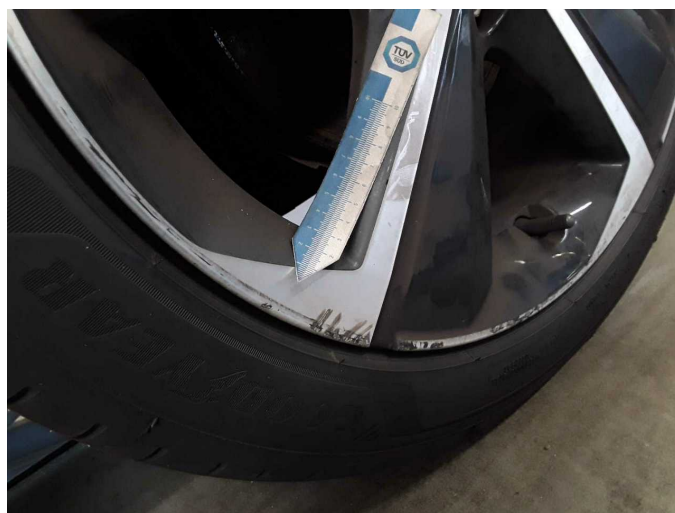
| No. | Component group | Description |
|---|---|---|
| 3 | Wheel / tyres | Alloy rim - rear left side - Scratch(es) - Loss in value |

**Damage 3:** Wheel / tyres: Alloy rim - rear left side - Scratch(es) - Loss in value
