Expertise

Protocol number: 46230240
Order No. / Reference: 26153758
Inspection date: 15 Jun 2026

Model: 319 CDI Sprinter 4x4 Standard 9G-TRONIC PRO

VIN: W1V3MBTZ4TP849883

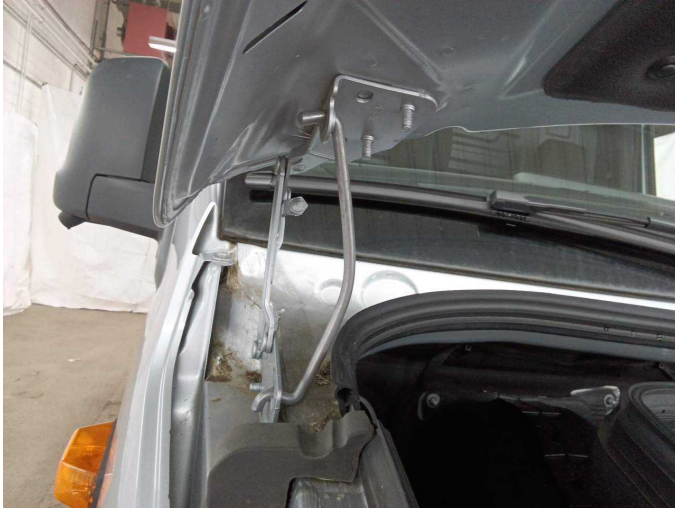
Damage 1: Bonnet: Support - Damaged - Replace

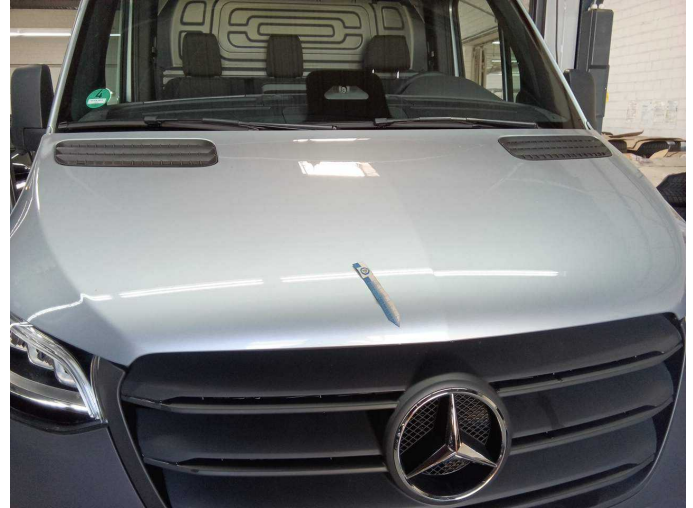
Damage 1: Bonnet: Support - Damaged - Replace

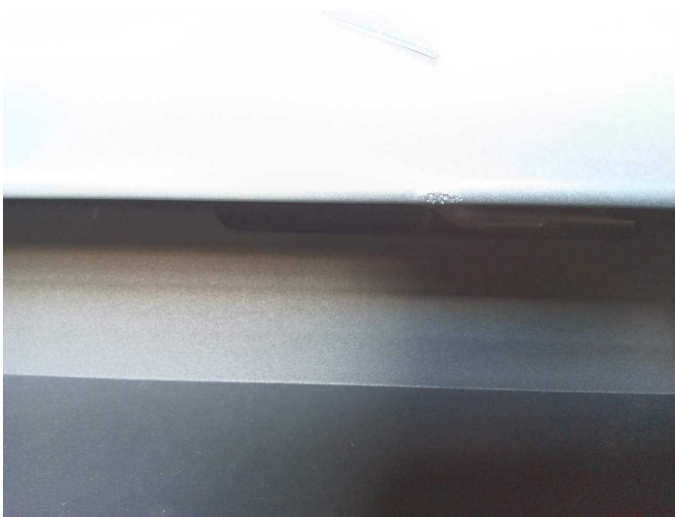
Damage 2: Bonnet: Bonnet - Scratch(es) - Smart repair

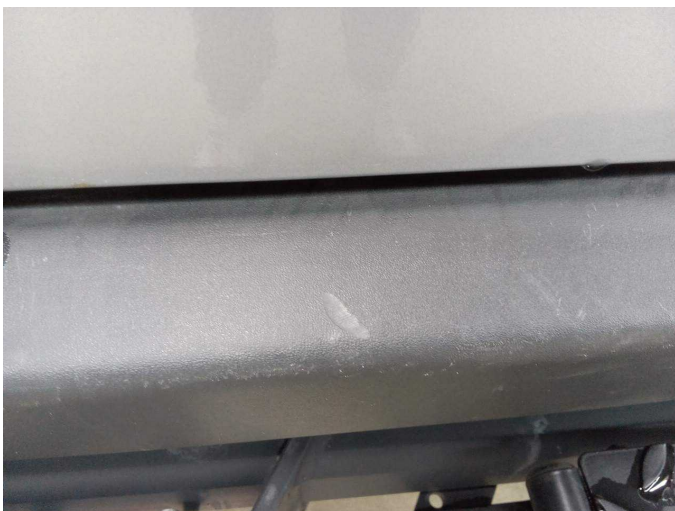
Damage 3: Rear bumper: Rear bumper - Scratch(es) - Loss in value

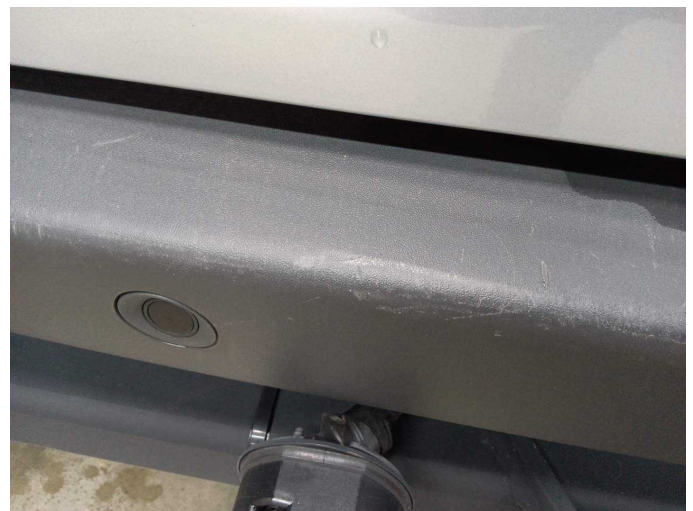
Damage 3: Rear bumper: Rear bumper - Scratch(es) - Loss in value

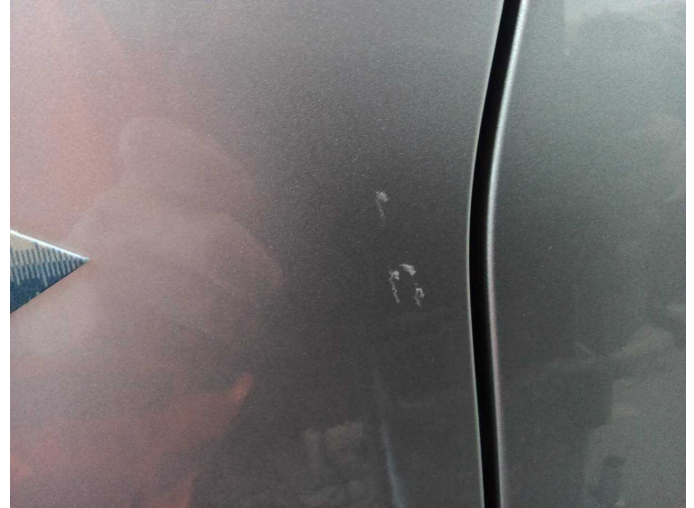
Damage 4: Door - front left side: Door - Scratch(es) - Smart repair

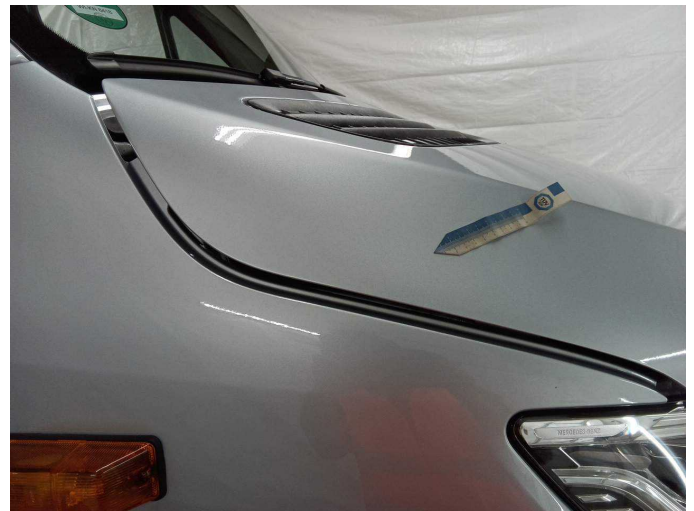
Damage 5: Bonnet: Bonnet - Malposition - Un- / install

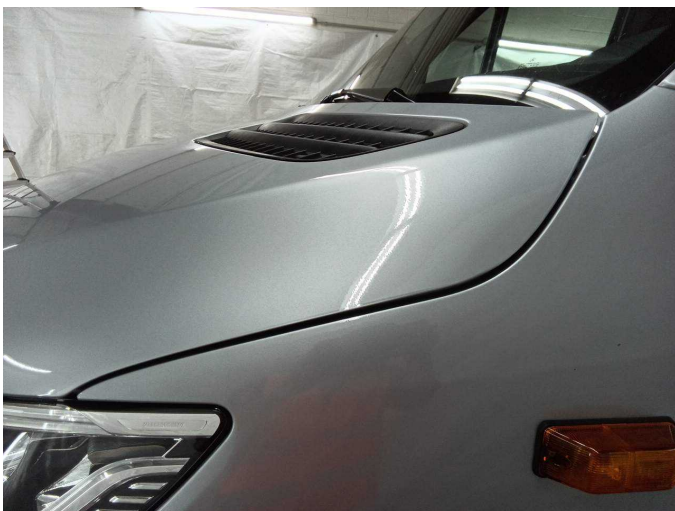
Damage 5: Bonnet: Bonnet - Malposition - Un- / install

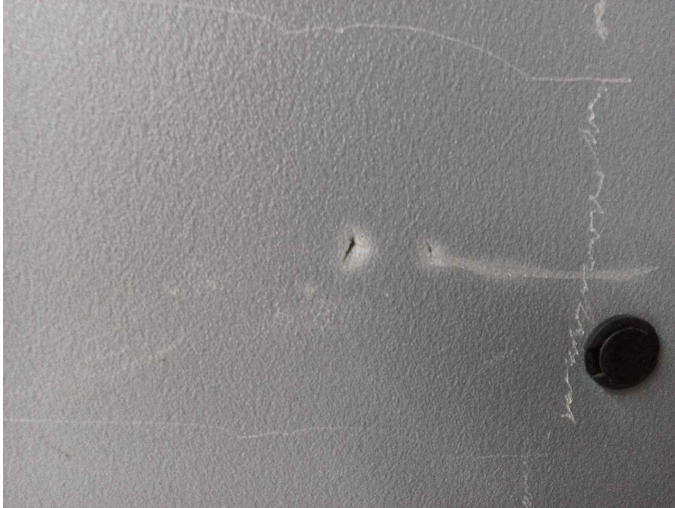
Damage 6: Trim / covers: Boot lining (Tür links unten) - Holes - Replace

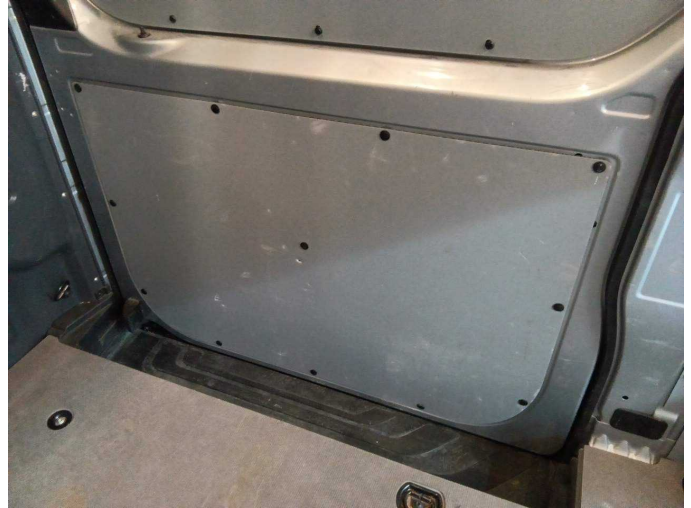
Damage 6: Trim / covers: Boot lining (Tür links unten) - Holes - Replace

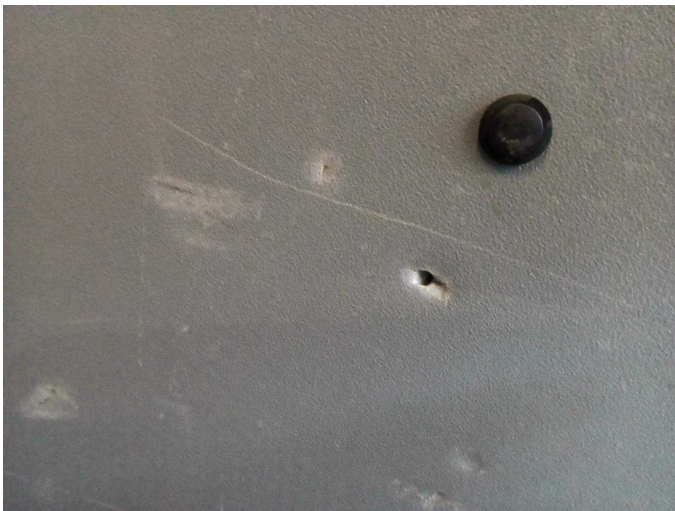
Damage 7: Sliding door, right: Trim (Unten) - Holes - Replace

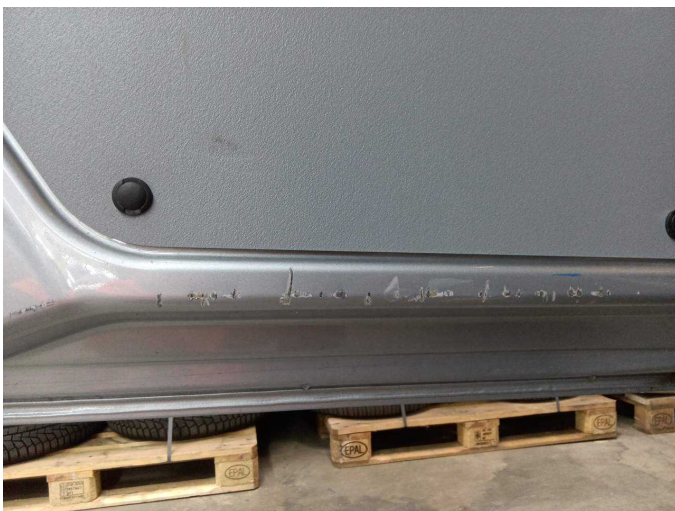
Damage 8: Boot lid / rear door: Rear door - left side - Scratch(es) - Paint

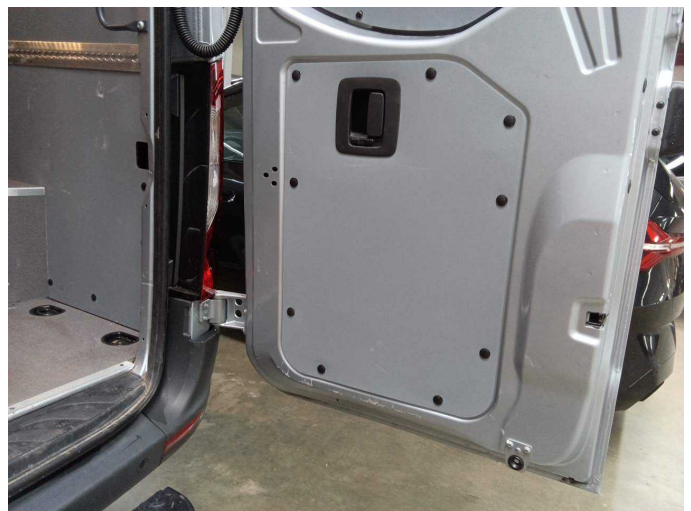
Damage 8: Boot lid / rear door: Rear door - left side - Scratch(es) - Paint

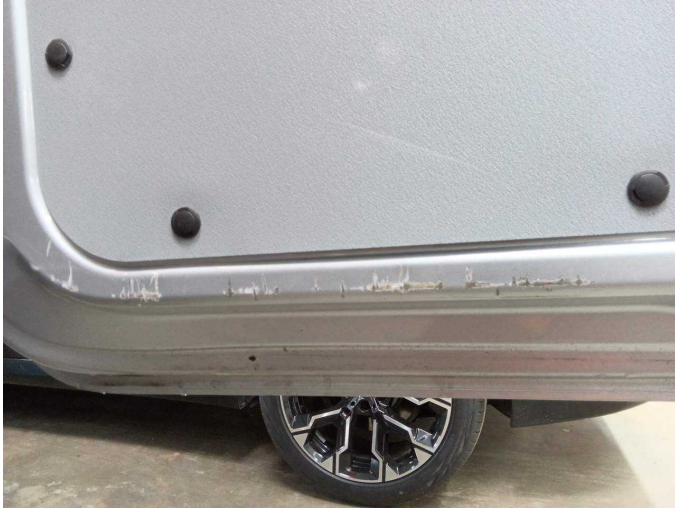
Damage 9: Boot lid / rear door: Rear door - right side - Scratch(es) - Paint

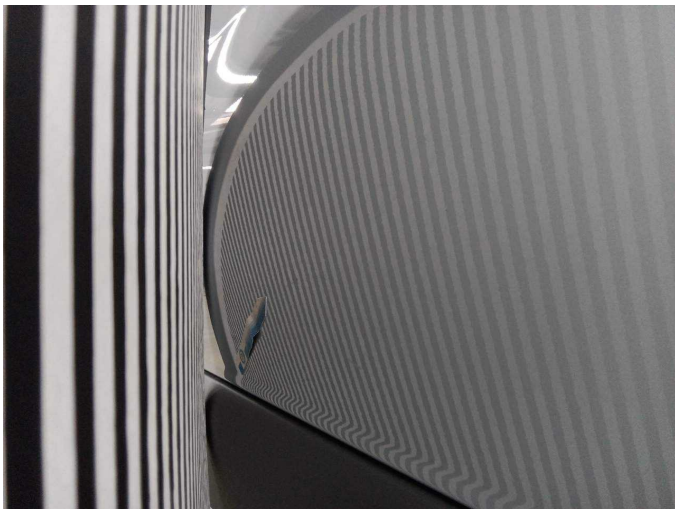
Damage 10: Sliding door, right: Sliding door - Dent / paintcoat damage - Paint

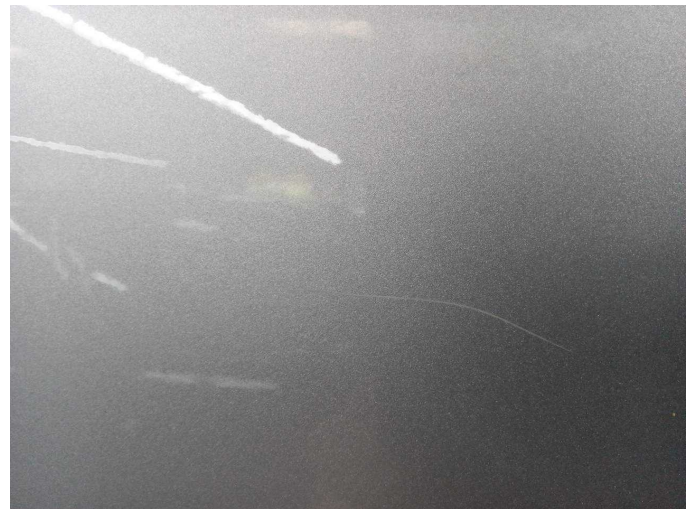
Damage 10: Sliding door, right: Sliding door - Dent / paintcoat damage - Paint
