Expertise

Protocol number: 46547785  
Order No. / Reference: 26681461  
Inspection date: 16 Jul 2026

Manufacturer: Ford

Model: Explorer EcoBoost Plug-in Hybrid PLATINUM

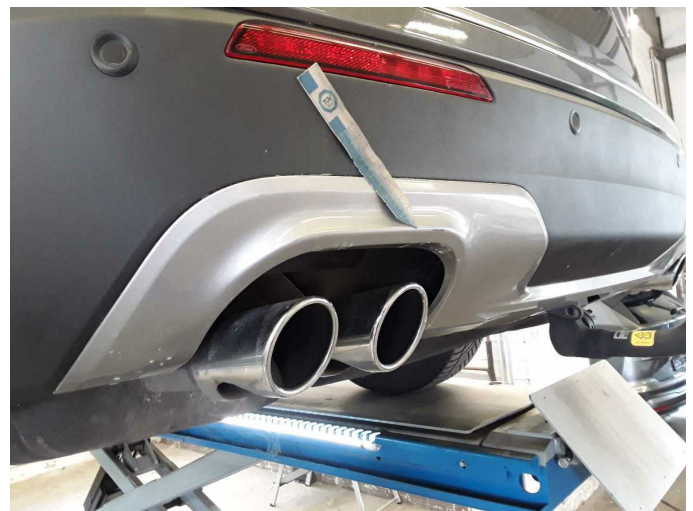
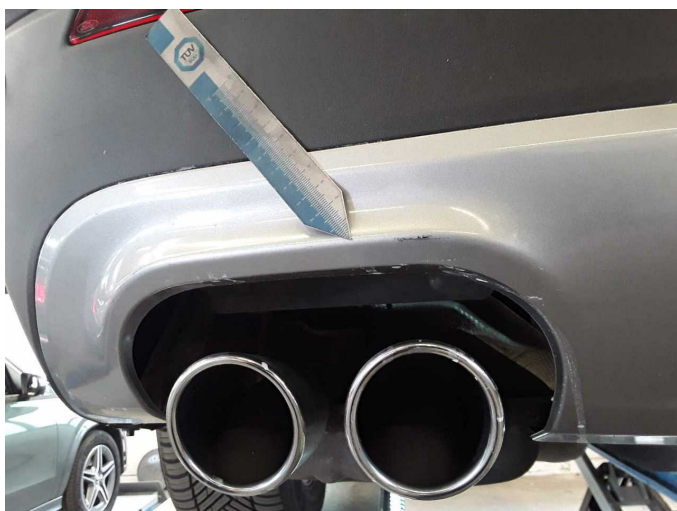
| No. | Component group | Description |
|---|---|---|
| 1 | Rear bumper | Spoiler - Scratch(es) - Smart repair |

Damage 1: Rear bumper: Spoiler - Scratch(es) - Smart repair

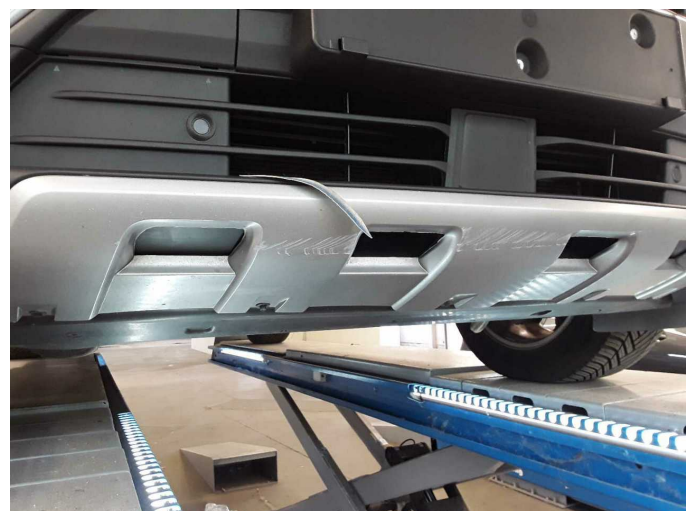
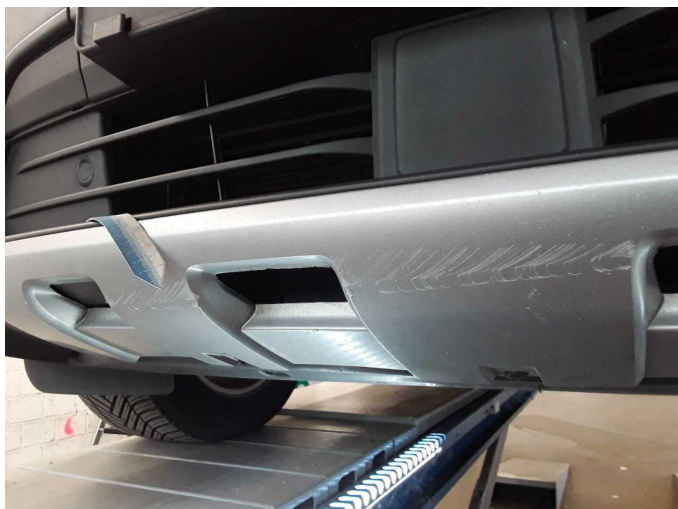
| No. | Component group | Description |
|---|---|---|
| 2 | Front bumper | Spoiler - Scratched - Smart repair |

Damage 2: Front bumper: Spoiler - Scratched - Smart repair

**Damage 2:** Front bumper: Spoiler - Scratched - Smart repair

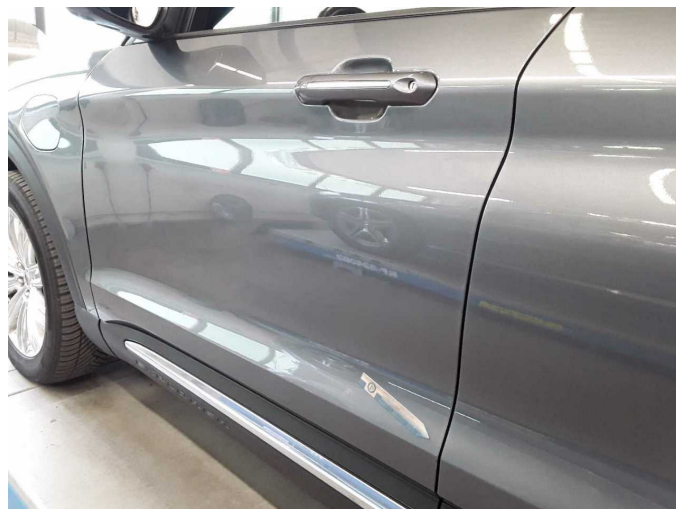
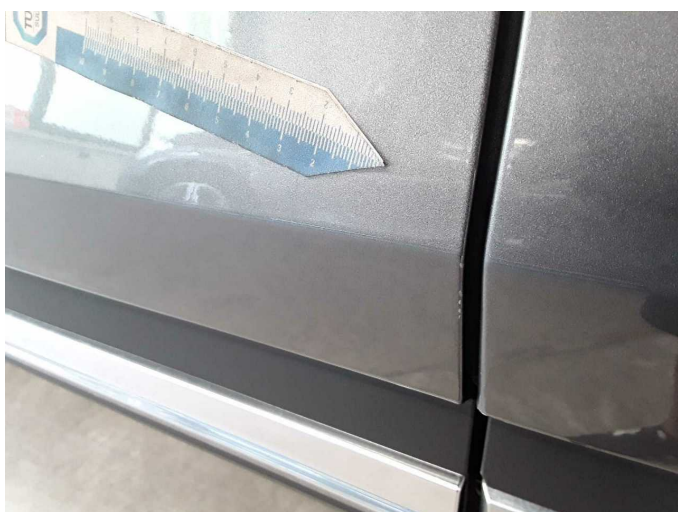
| No. | Component group | Description |
|---|---|---|
| 3 | Door - front left side | Door - Scratch(es) - Smart repair |

**Damage 3:** Door - front left side: Door - Scratch(es) - Smart repair

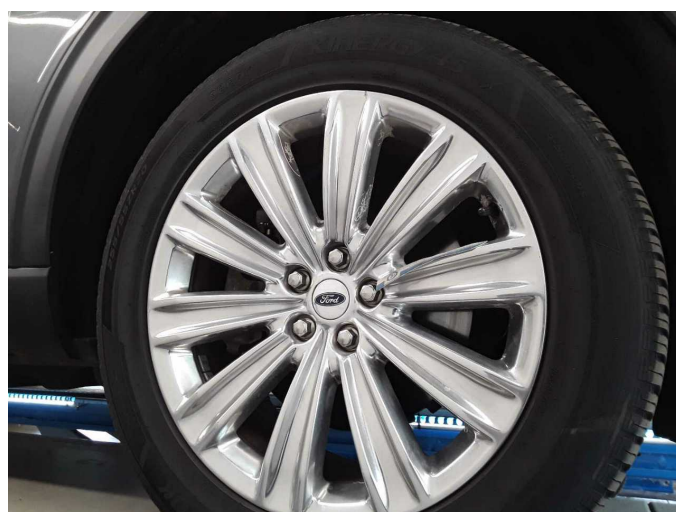
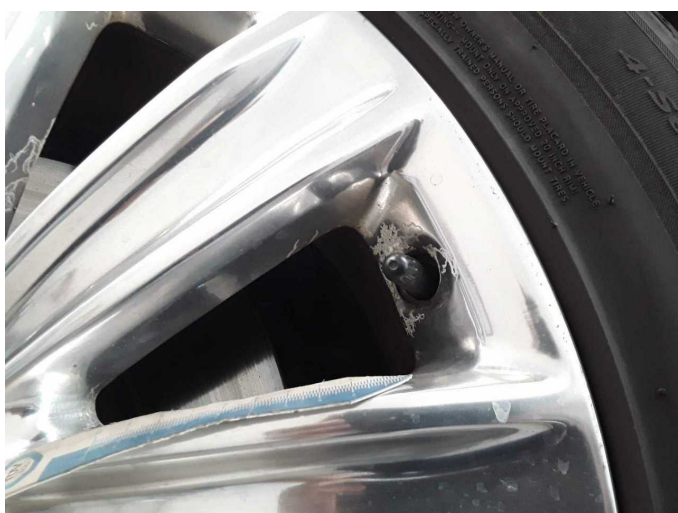
| No. | Component group | Description |
|---|---|---|
| 4 | Wheel / tyres | Alloy rim - front right side (Oxidiert) - Worn - Loss in value |

**Damage 4:** Wheel / tyres: Alloy rim - front right side (Oxidiert) - Worn - Loss in value

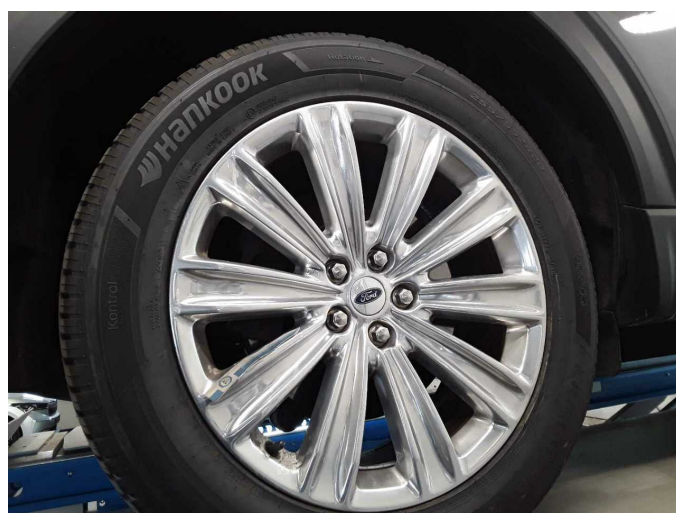
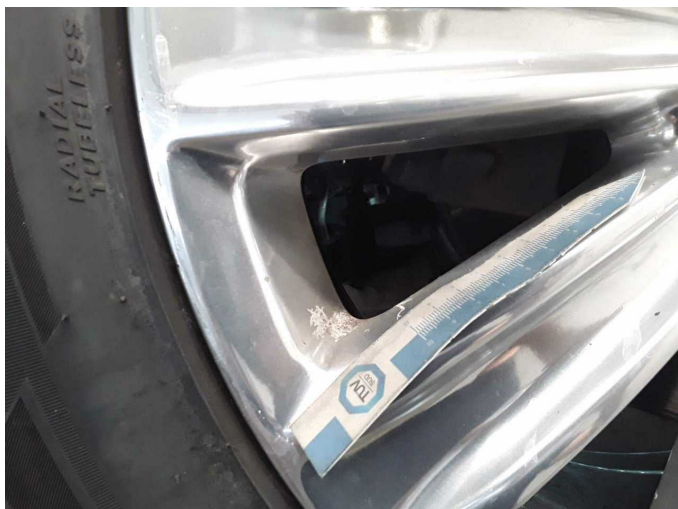
| No. | Component group | Description |
|---|---|---|
| 5 | Wheel / tyres | Alloy rim - rear right side (Oxidiert) - Worn - Loss in value |

**Damage 5:** Wheel / tyres: Alloy rim - rear right side (Oxidiert) - Worn - Loss in value

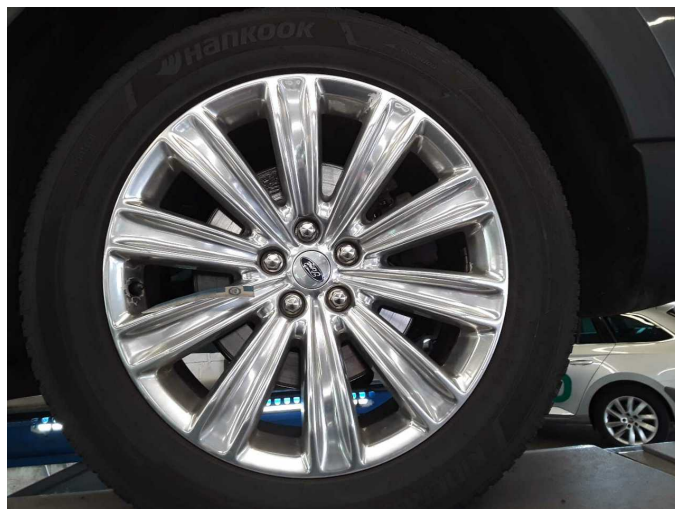
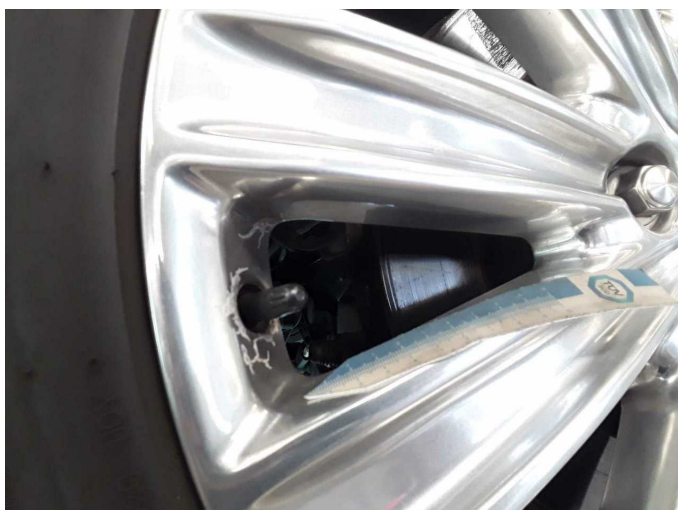
| No. | Component group | Description |
|---|---|---|
| 6 | Wheel / tyres | Alloy rim - rear left side (Oxidiert) - Worn - Loss in value |

**Damage 6:** Wheel / tyres: Alloy rim - rear left side (Oxidiert) - Worn - Loss in value

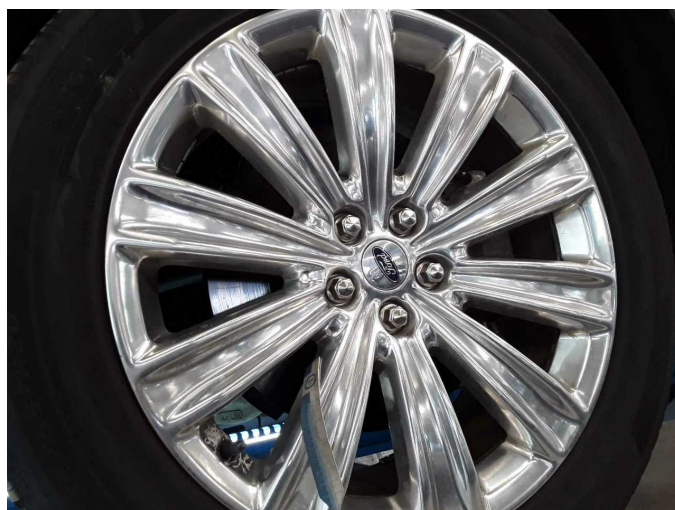
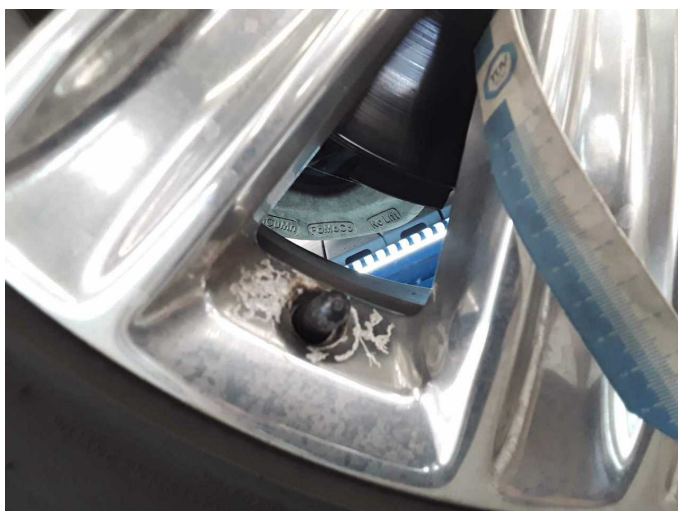
| No. | Component group | Description |
|---|---|---|
| 7 | Wheel / tyres | Alloy rim - front left side (Oxidiert) - Worn - Loss in value |

**Damage 7:** Wheel / tyres: Alloy rim - front left side (Oxidiert) - Worn - Loss in value

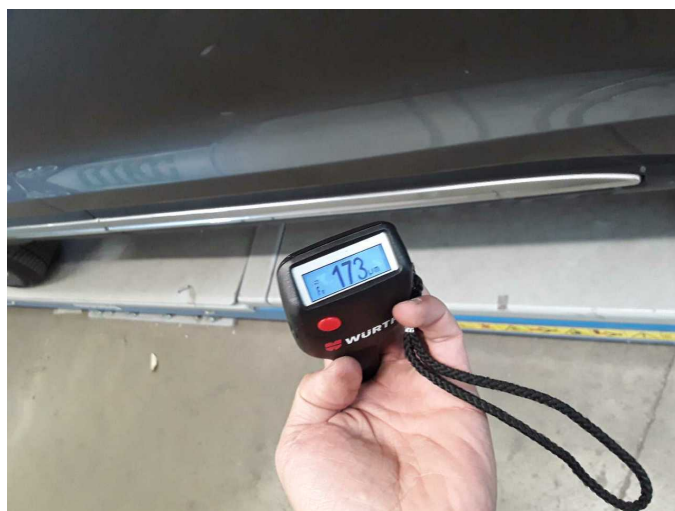
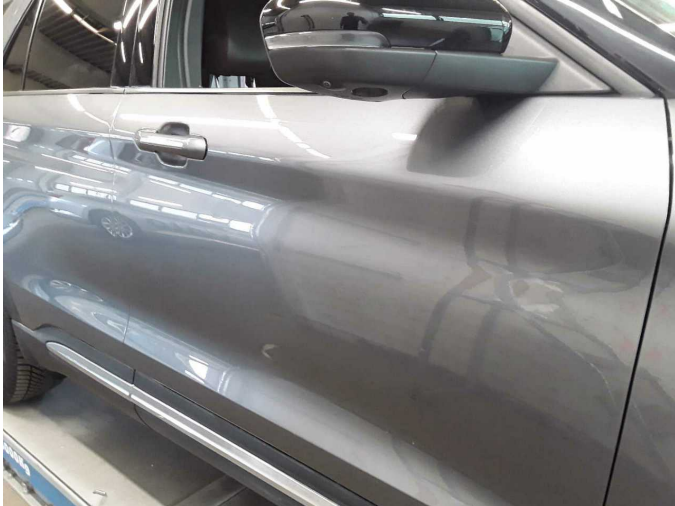
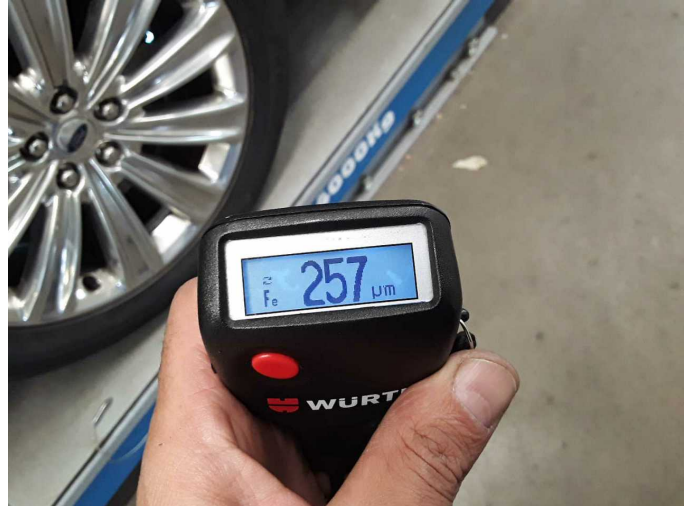
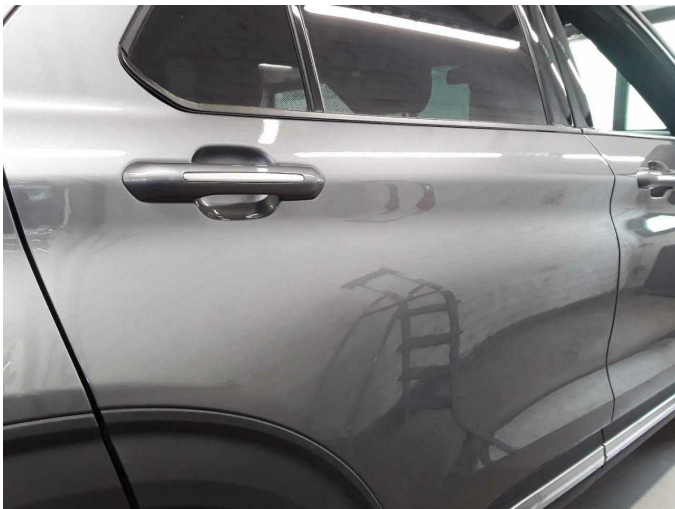
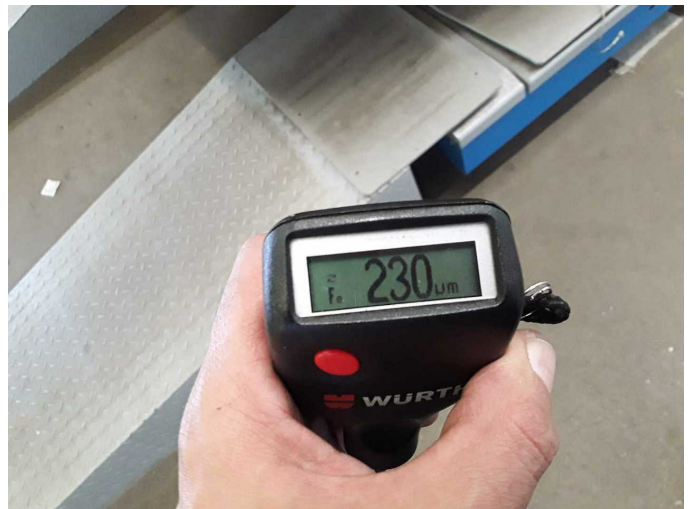
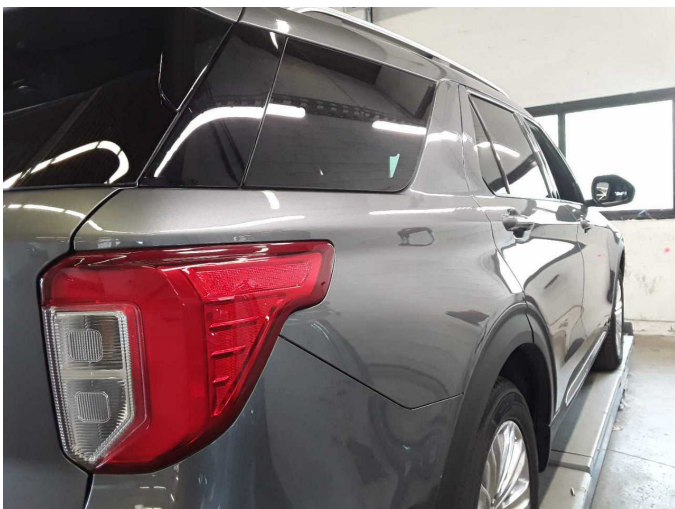
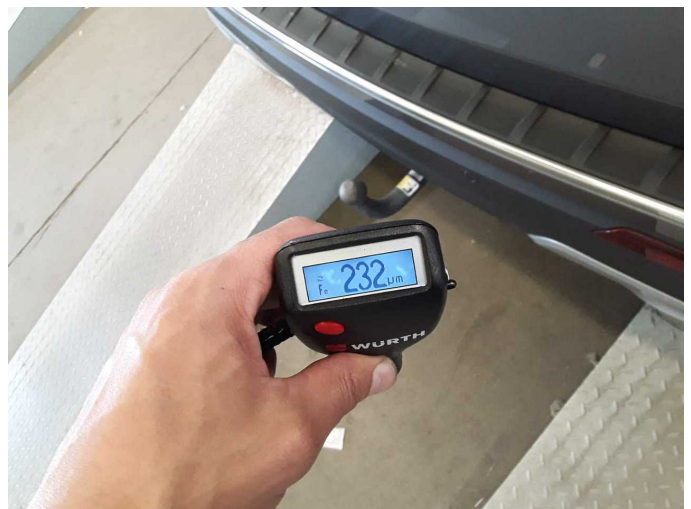
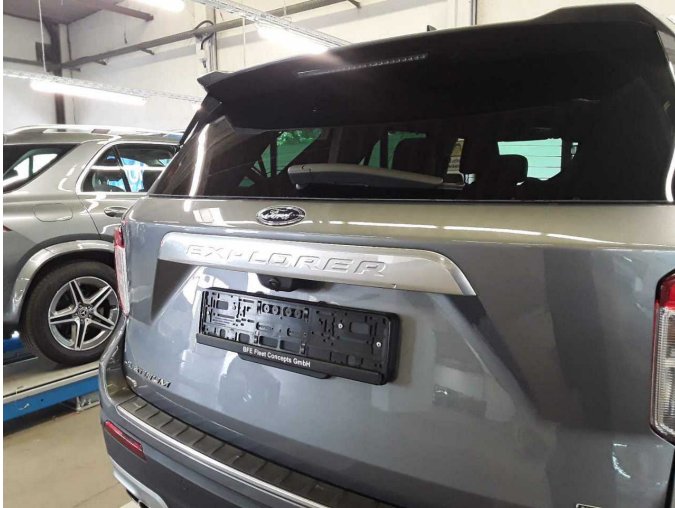
| No. | Repainting |
|---|---|
| 1 | Boot lid / rear door, Side panel - rear right side, Door - rear right side, Door - front right side, Professionally carried out, Invoice of repair done Non-existent |

| Boot lid / rear door | 232 µm | Side panel - rear right side | 230 µm |
| Door - rear right side | 257 µm | Door - front right side | 173 µm |

**Repainting 1:** Boot lid / rear door, Side panel - rear right side, Door - rear right side, Door - front right side
